# Shoreline Status

The aerial photographs used in this presentation were taken on March 13th, 14th, and 16th of 2021

Fripp Island - Shoreline Committee

March 18, 2021

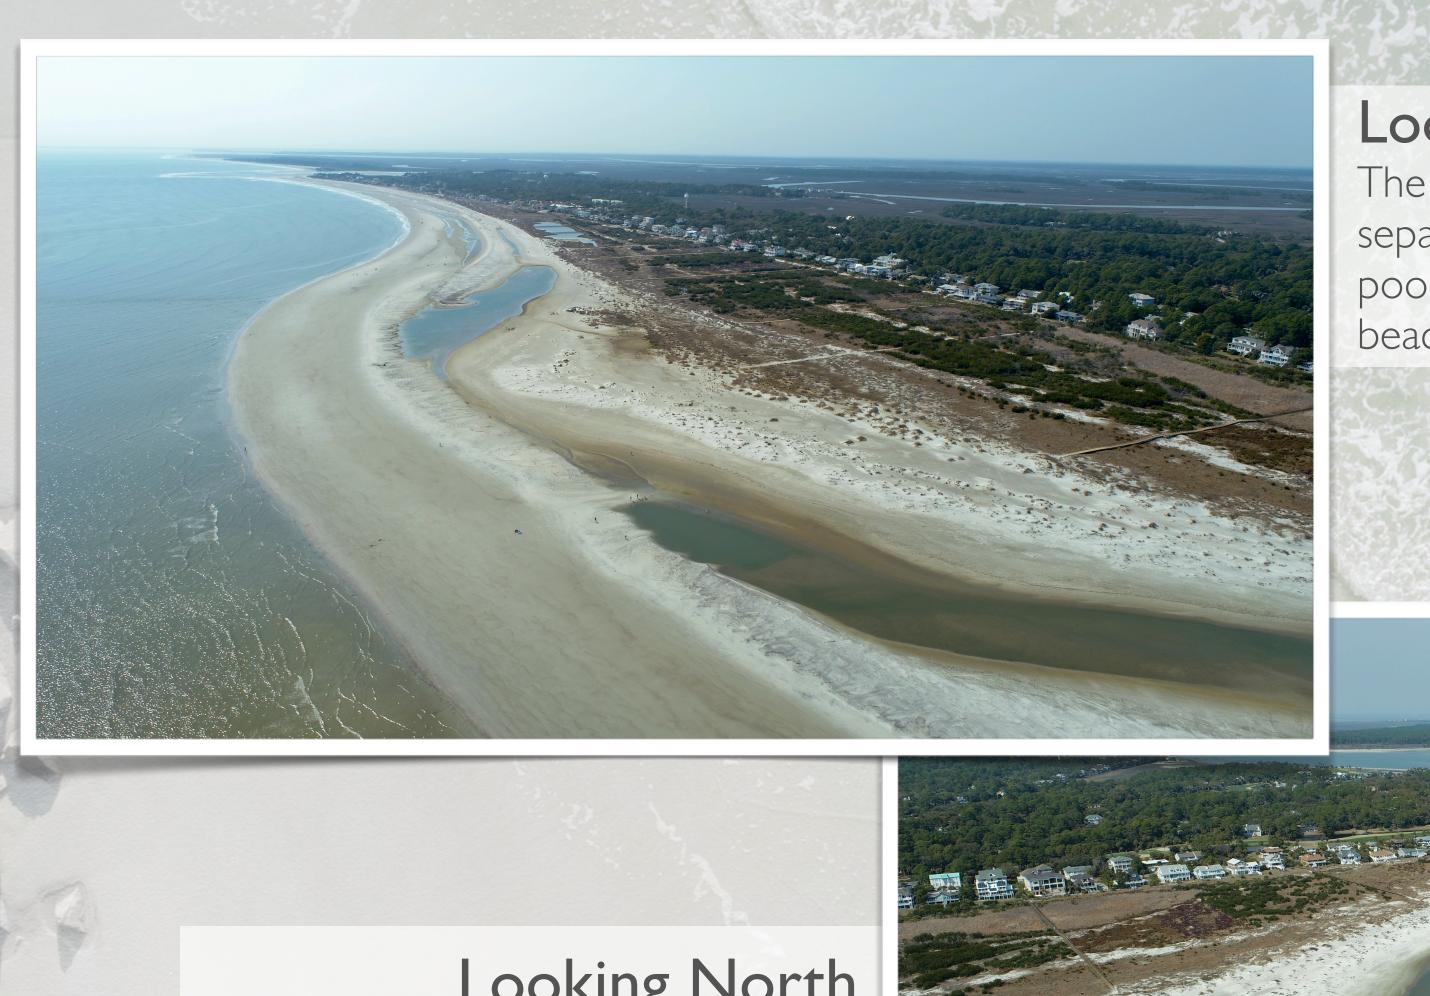
#### Looking South

The flattening of the attached shoal has separated the tidal pools. The "south pool" drains southwards along the beach into a series of smaller pools.

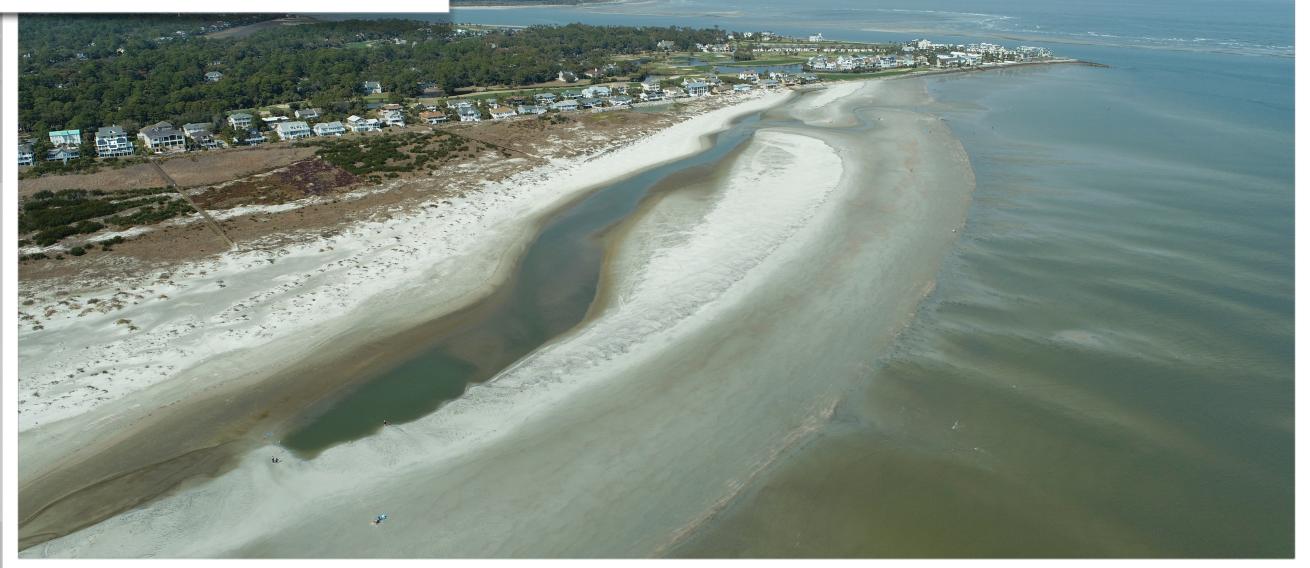
### Looking North

The "north pool" runs the length of the beach, draining to the ocean in the center with small remaining pockets of water on each end.

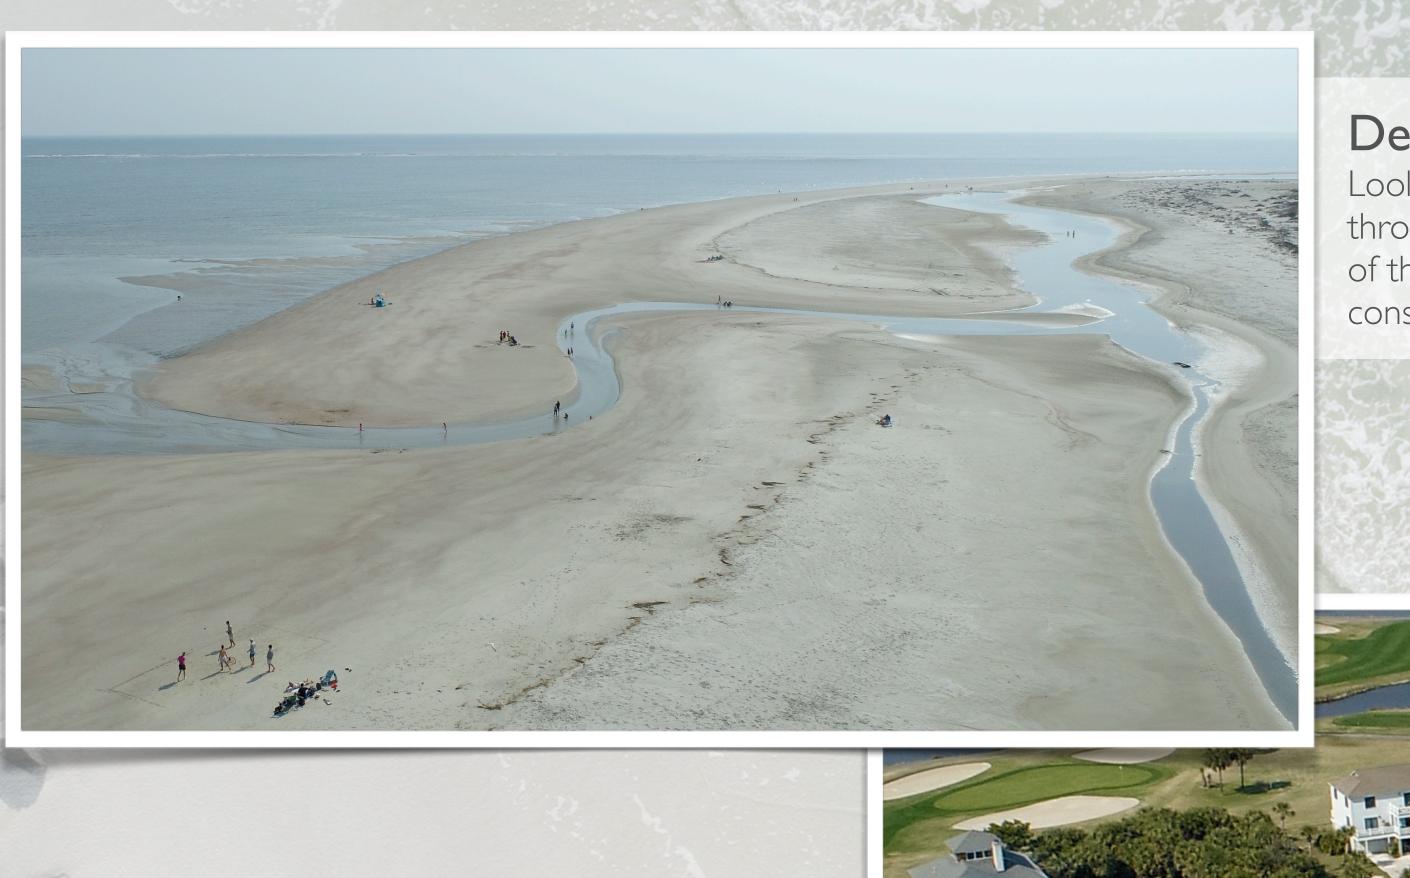
#### Detail of "north pool"

Looking south. Main body of water drains out through a winding egress located in the center of the stretch of water. Egress changes shape constantly.

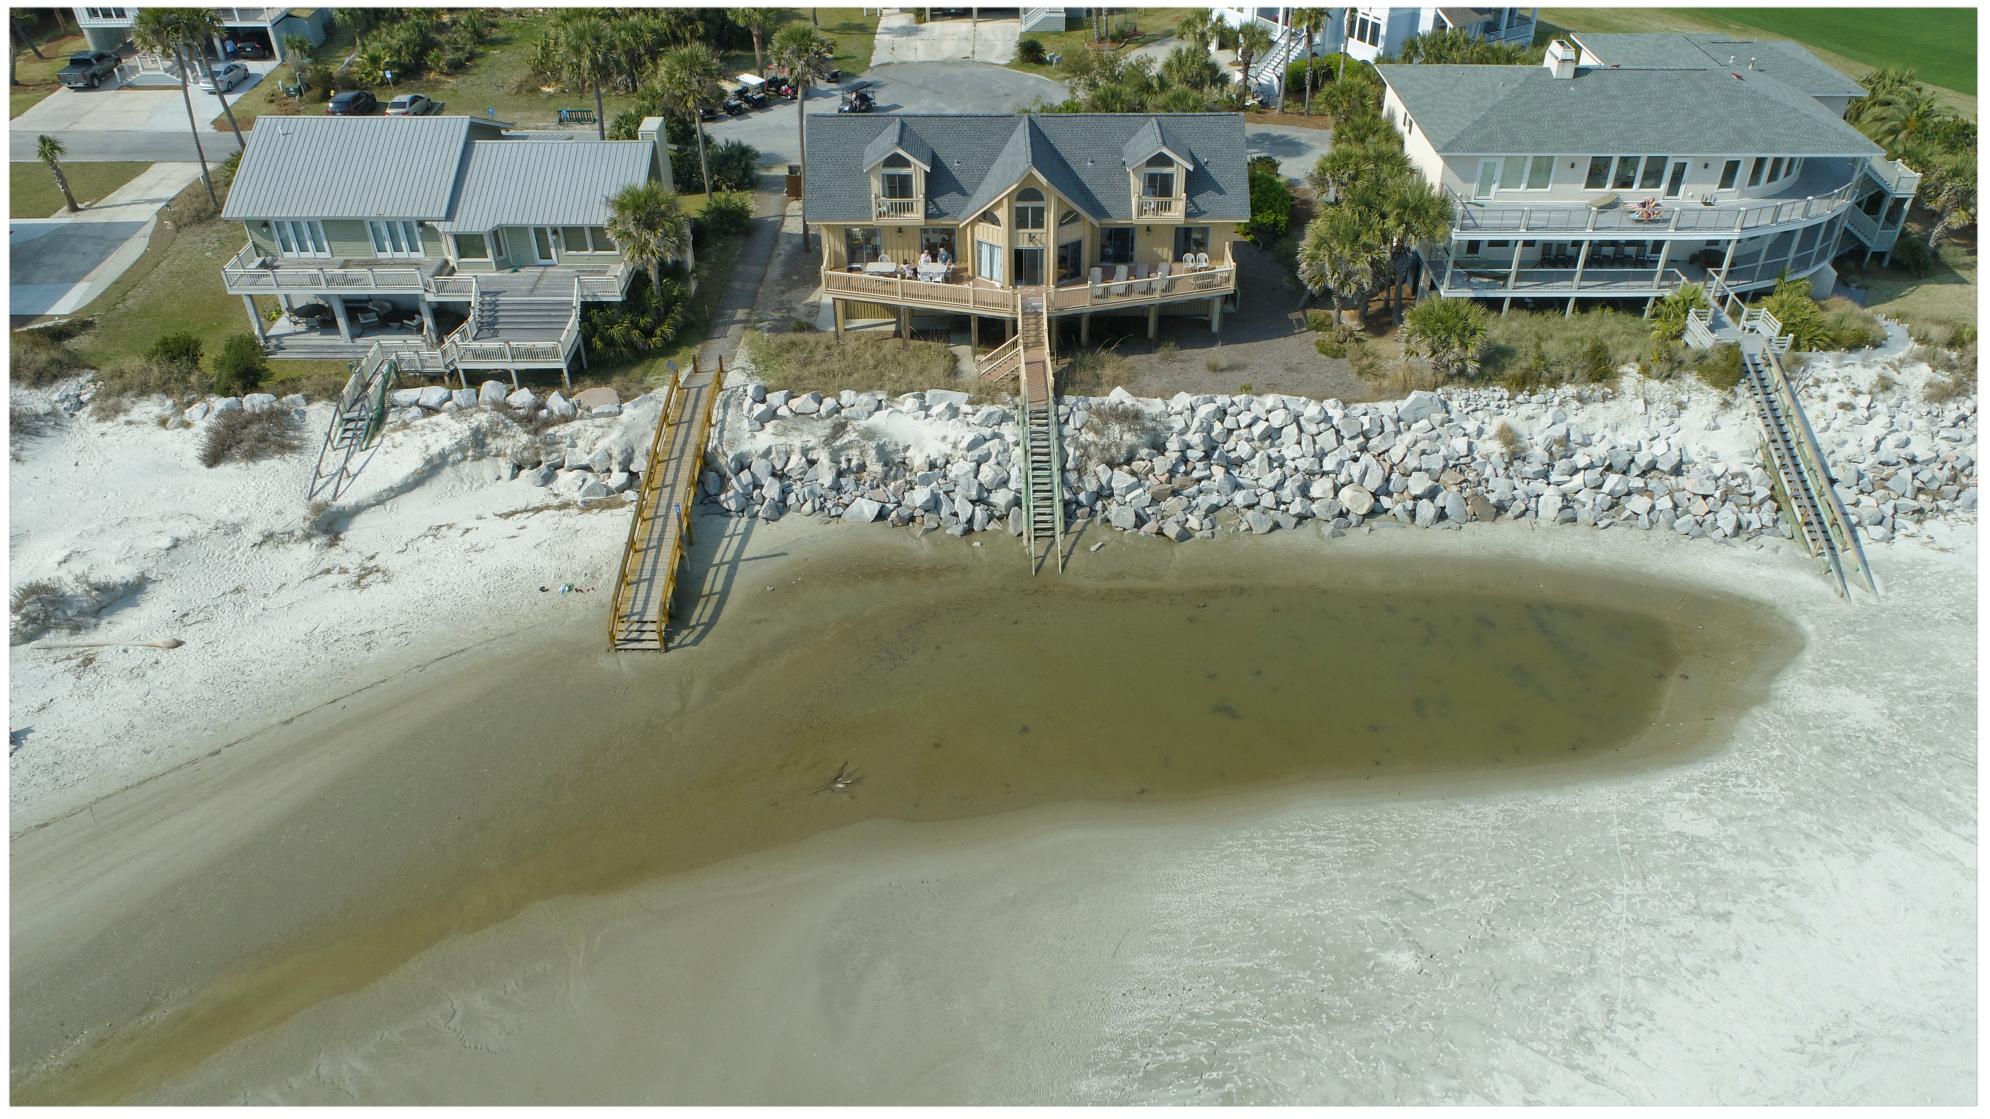
The recently formed tidal pool at #1b, rises and falls with tide cycle but doesn't drain completely. Not impassable, but user would get wet feet at high tide. Also, very slick mud around the area of the stairs even at low tide. Mud could be an issue.

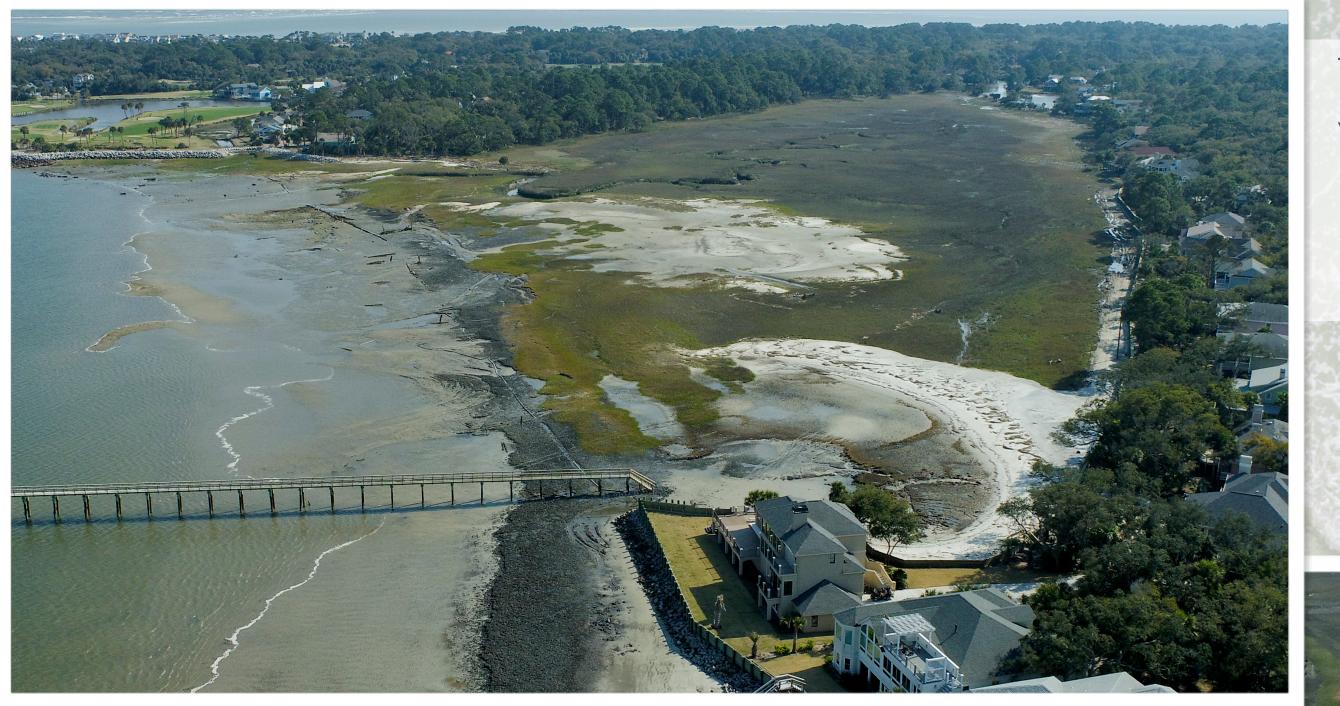
Two large areas of scouring damage viewed at the opening of the salt marsh. New seawall visible along River Club towards Quail Cove neighborhood.

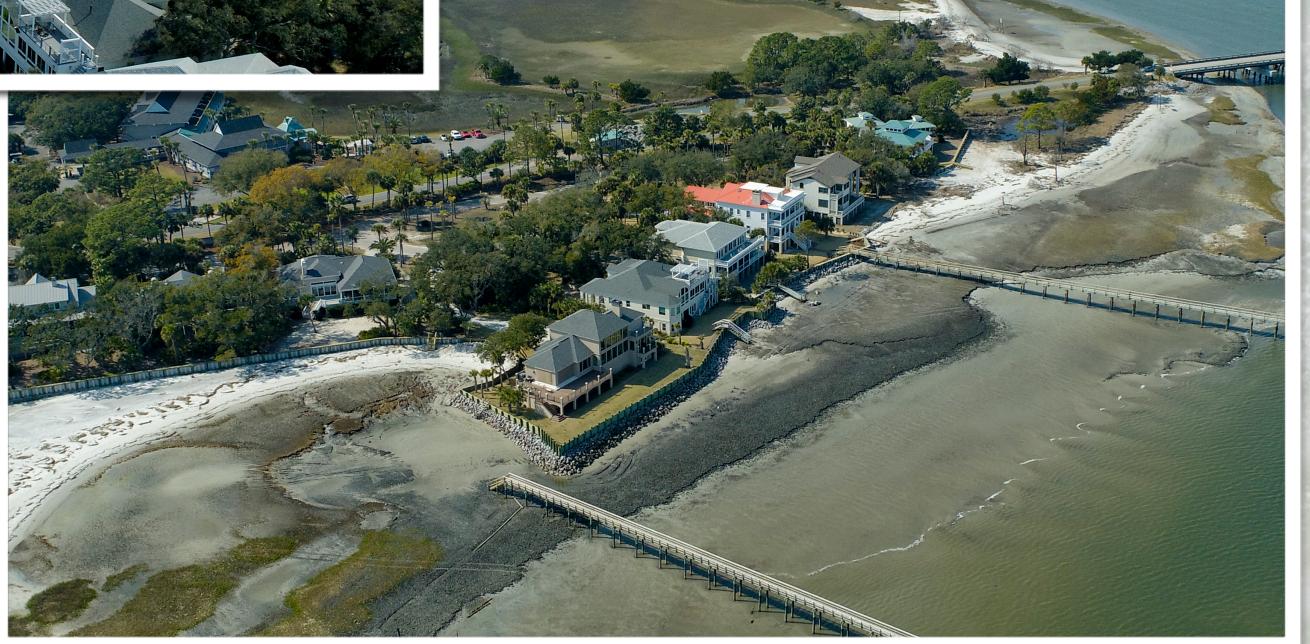
View of scouring damage next to Mollura residence. Also visible, high tide mark in the sand leading towards bridge area shows two (maybe three) homes sit forward of the high tide wrack line.

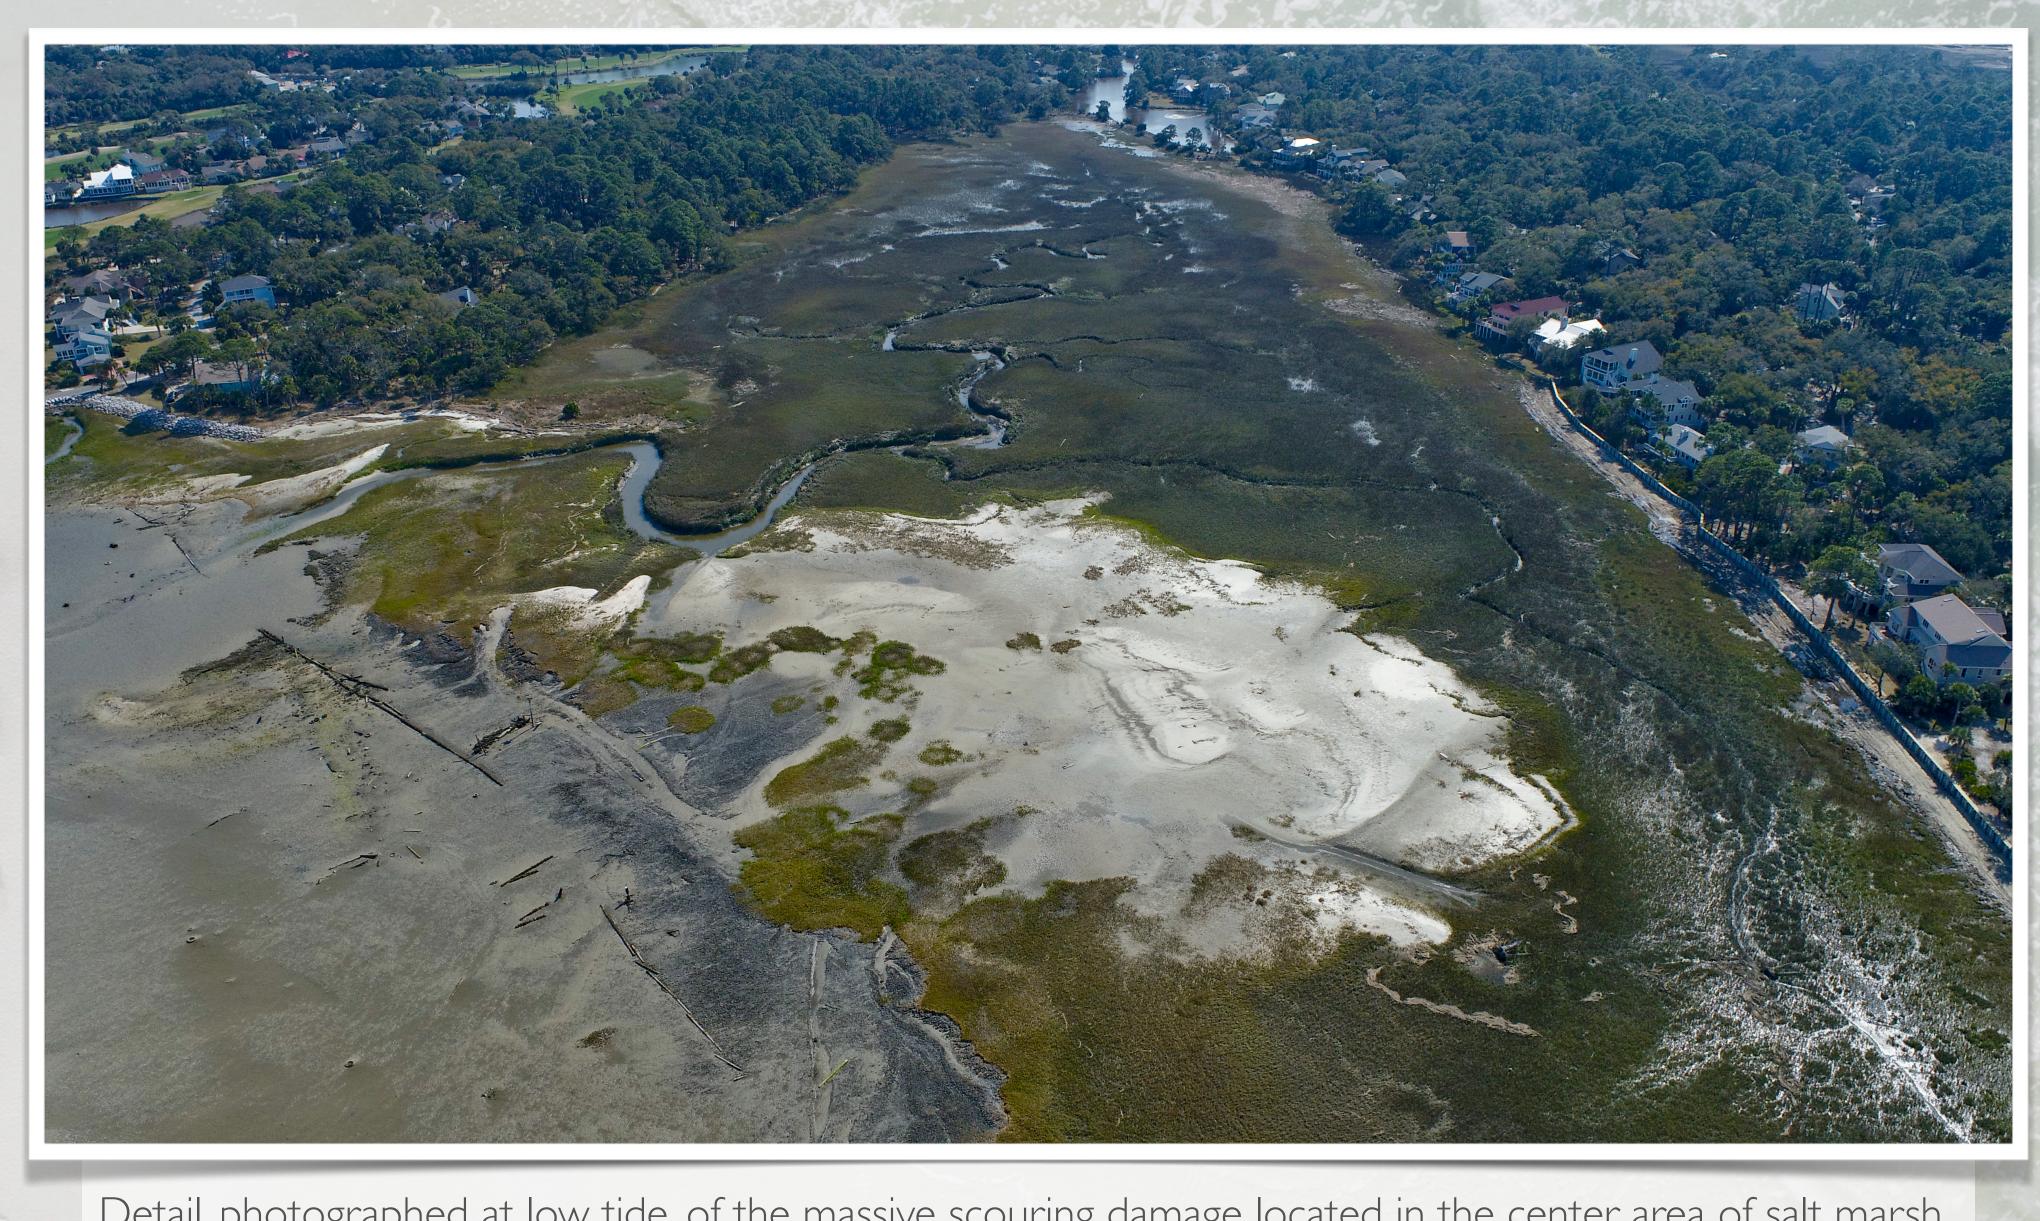
Detail, photographed at low tide, of the massive scouring damage located in the center area of salt marsh.

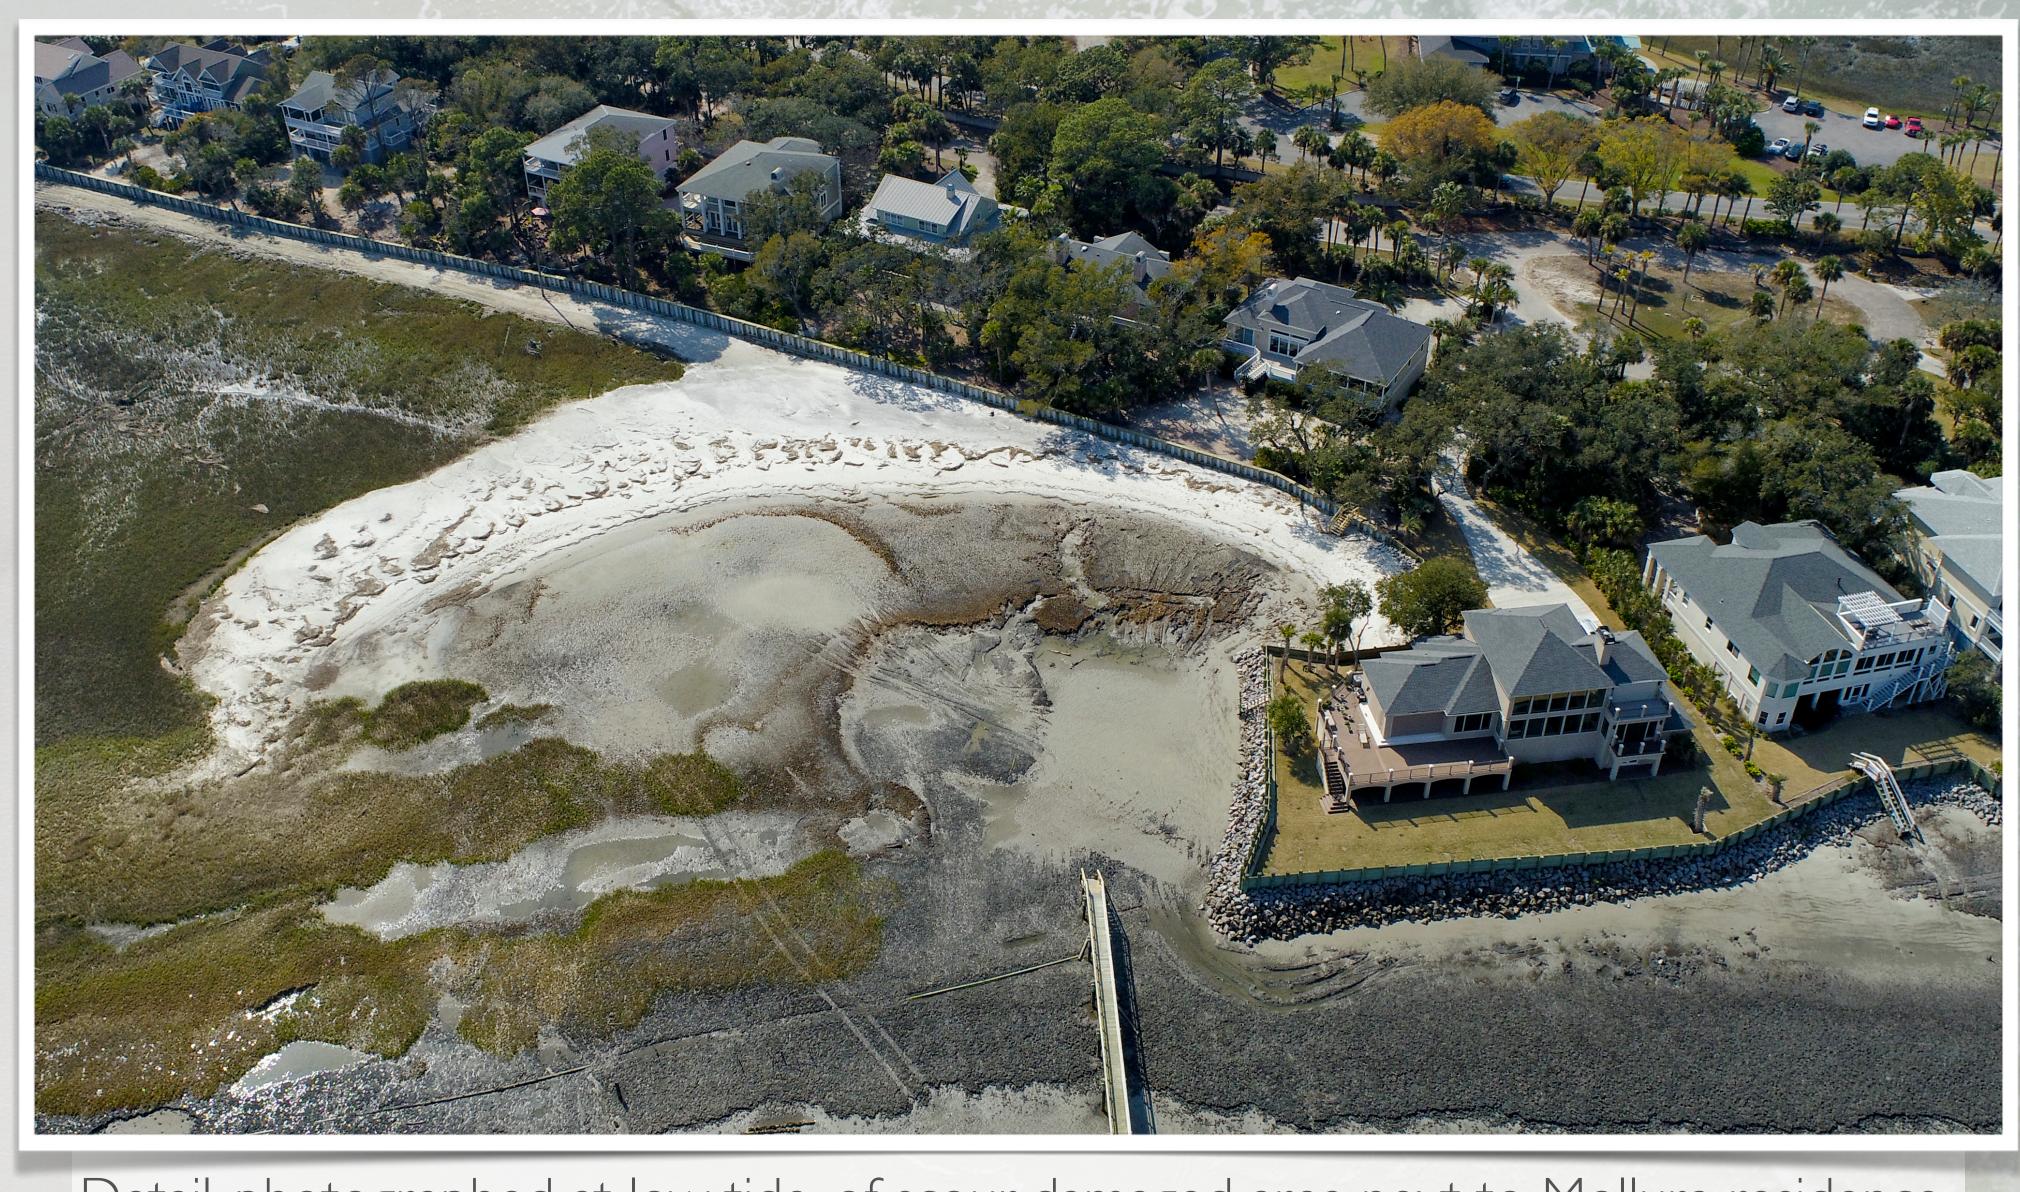
Detail, photographed at low tide, of scour-damaged area next to Mollura residence.

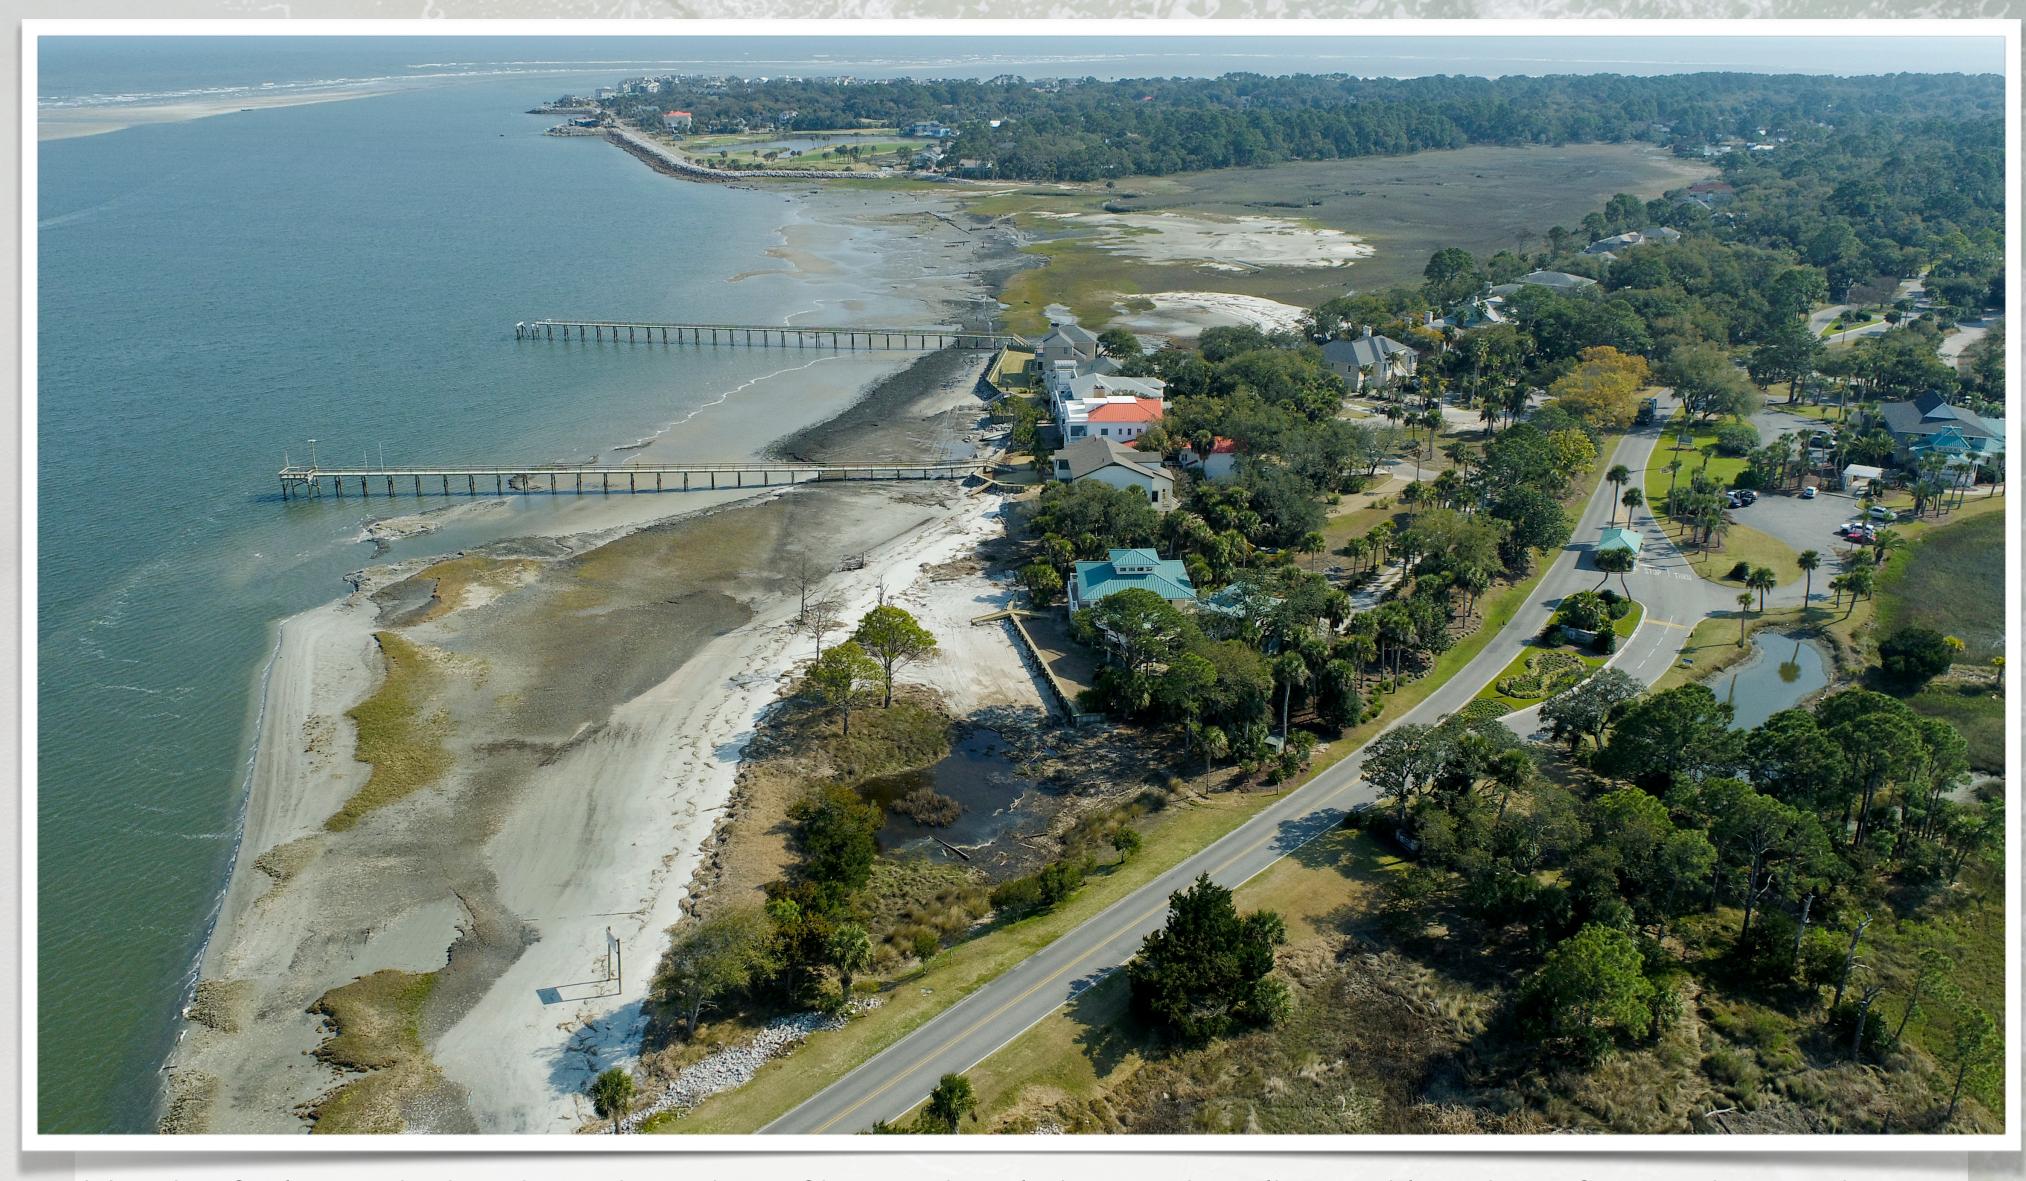
Mouth of salt marsh showing orientation of homes in relation to shoreline and location of scour-damaged areas.

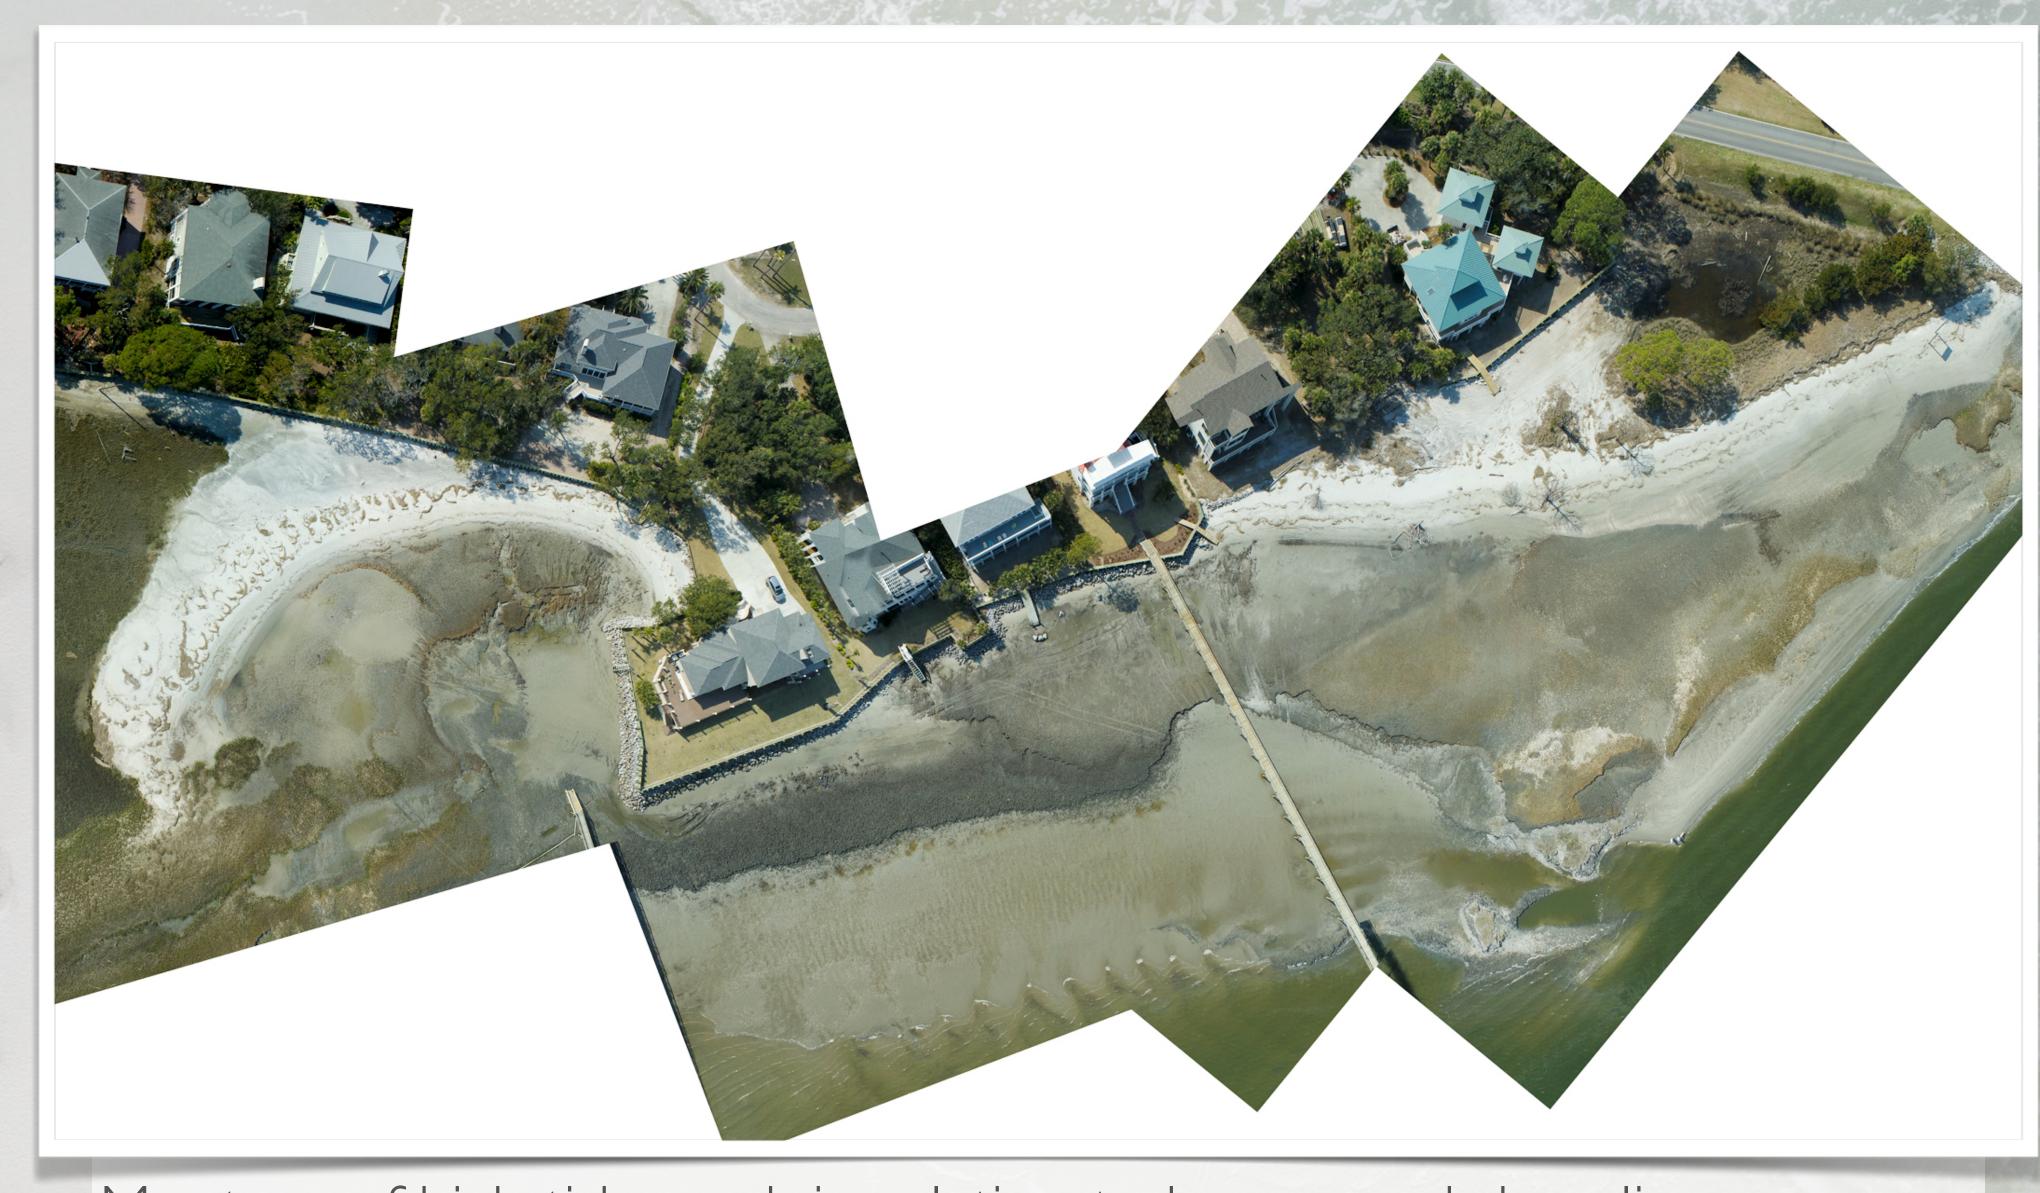
Montage of high tide mark in relation to homes and shoreline.

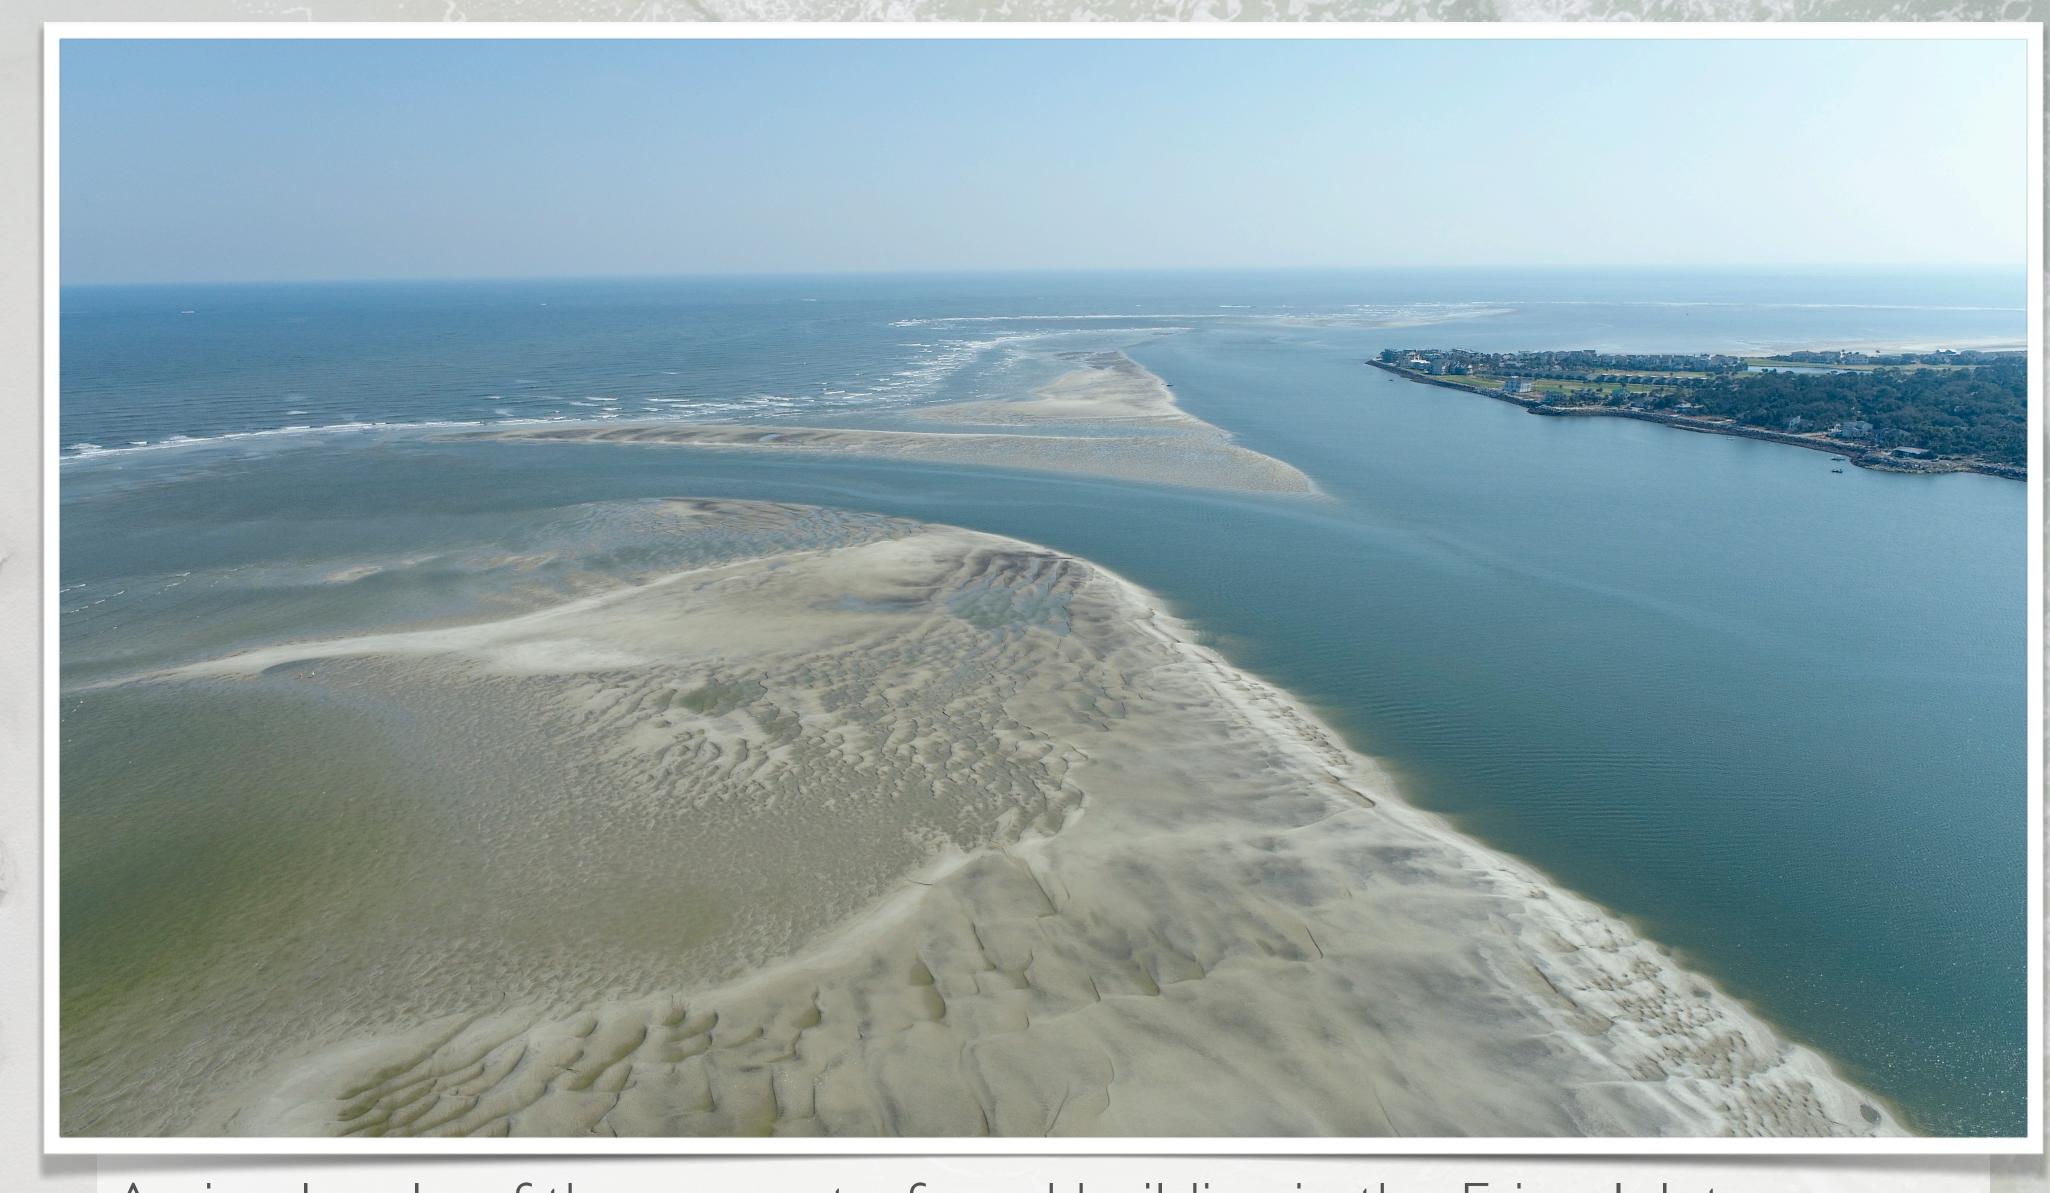
A visual scale of the amount of sand building in the Fripp Inlet.

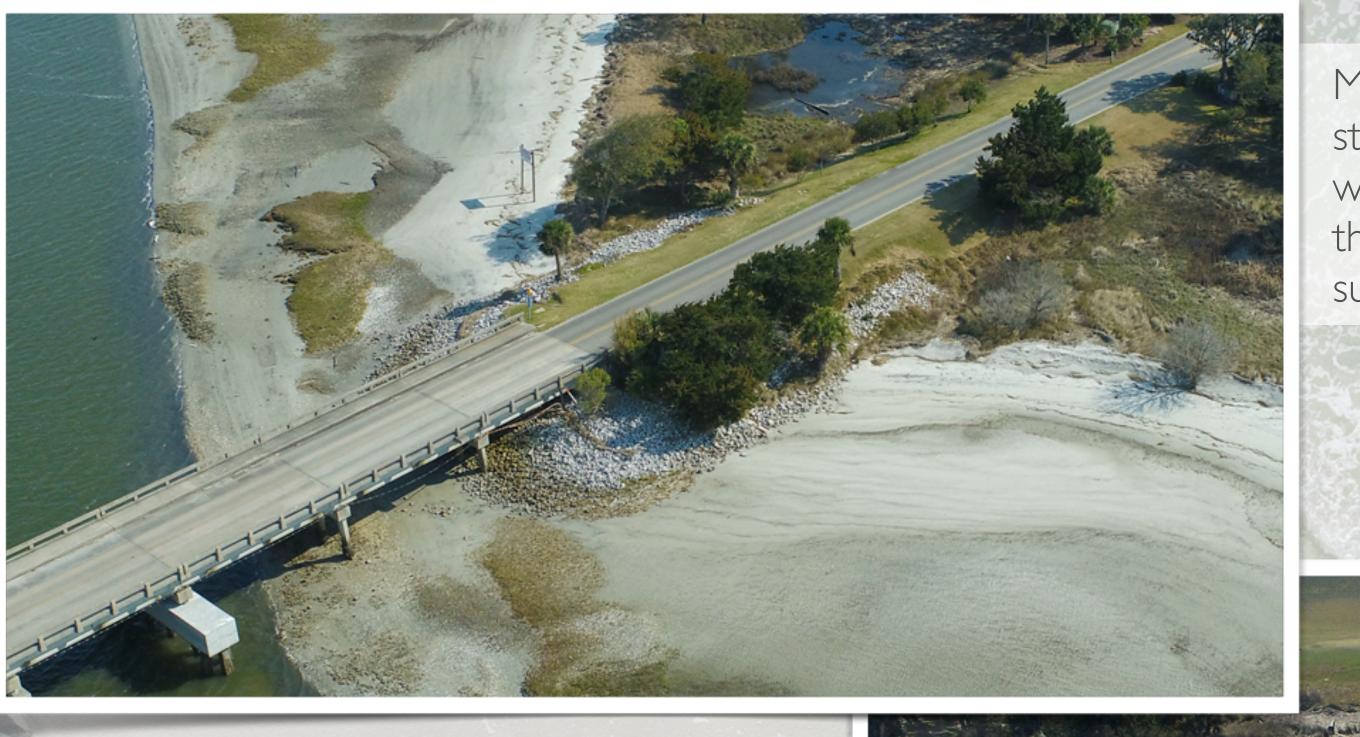
More of the earthen approach ramp sticks out as the scouring caused by wave action removes the vegetation, and then the soil, leaving only sand which is subject to shifting and movement.
