# Shoreline Status

The aerial photographs used in this presentation were taken on March 13th, 14th, and 16th of 2021

Fripp Island - Shoreline Committee

March 18, 2021

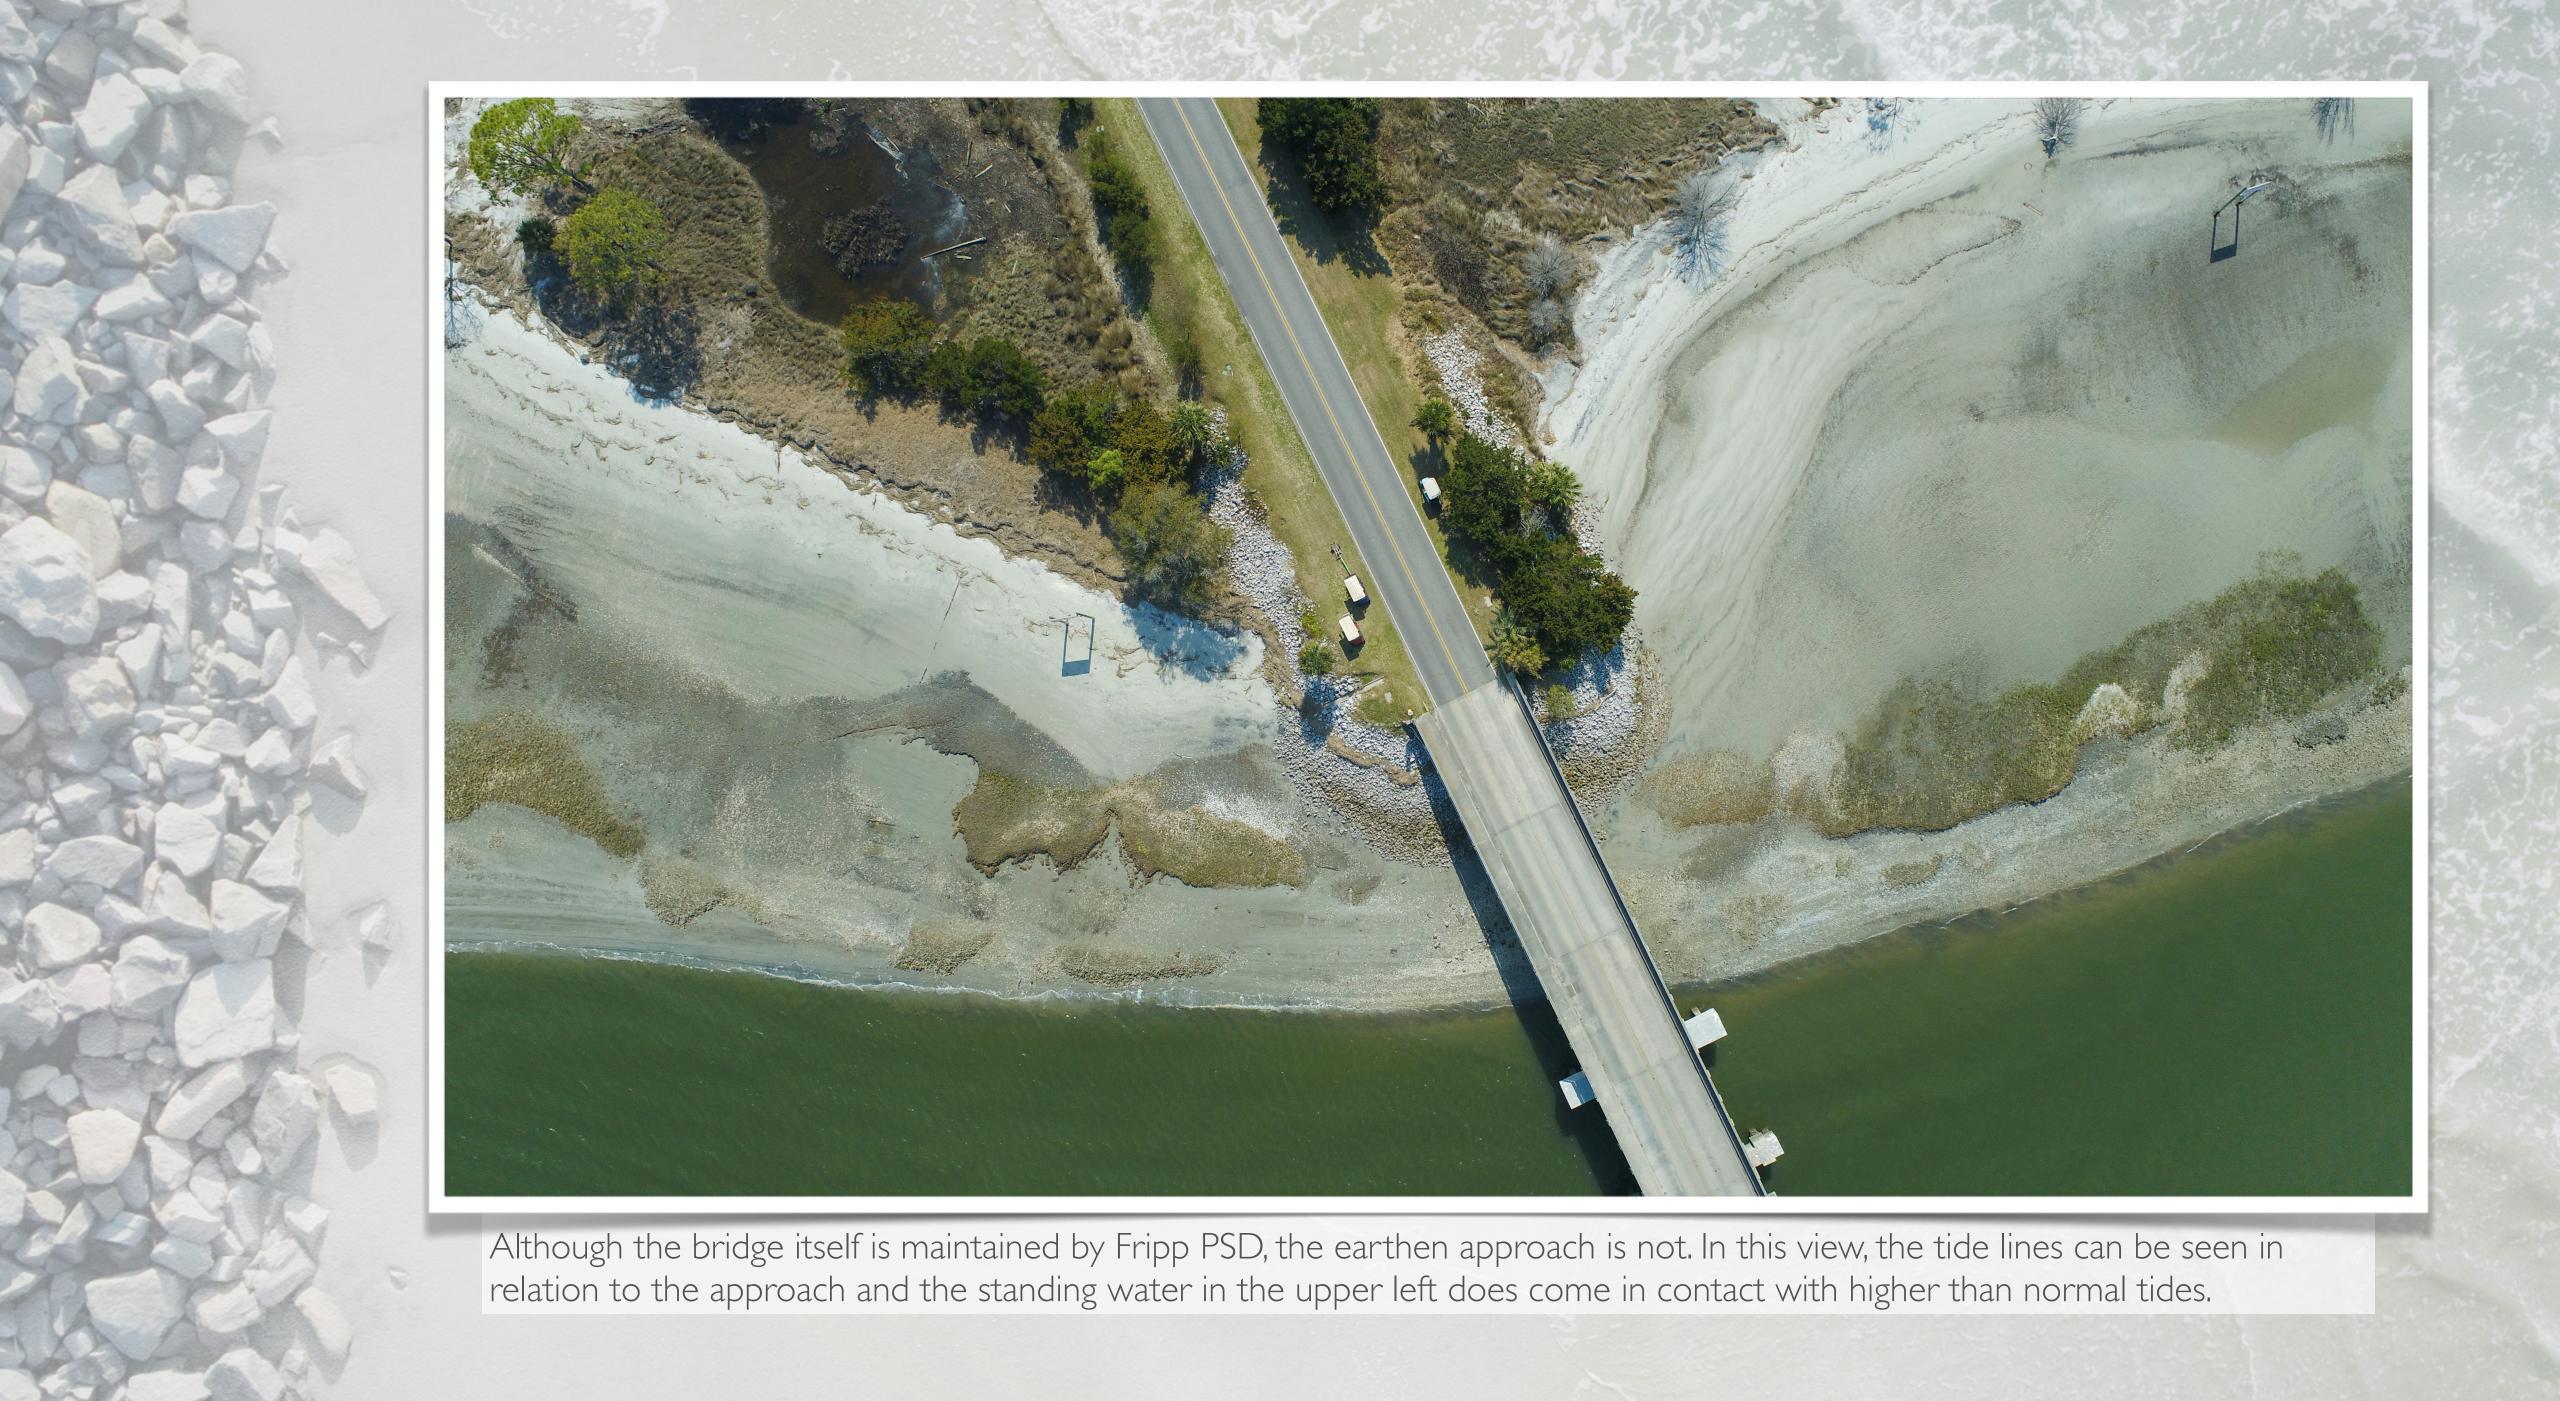
Another angle shows the wrack line midway up the protective rock and extending well beyond the end of the bridge. The earthen approach begins to take on the role as part of the bridge instead of a just a ramp to the bridge.
