BEACH ACCESS #1B

Fripp Island - Shoreline Committee

Darryl Zoeckler - April 15, 2021

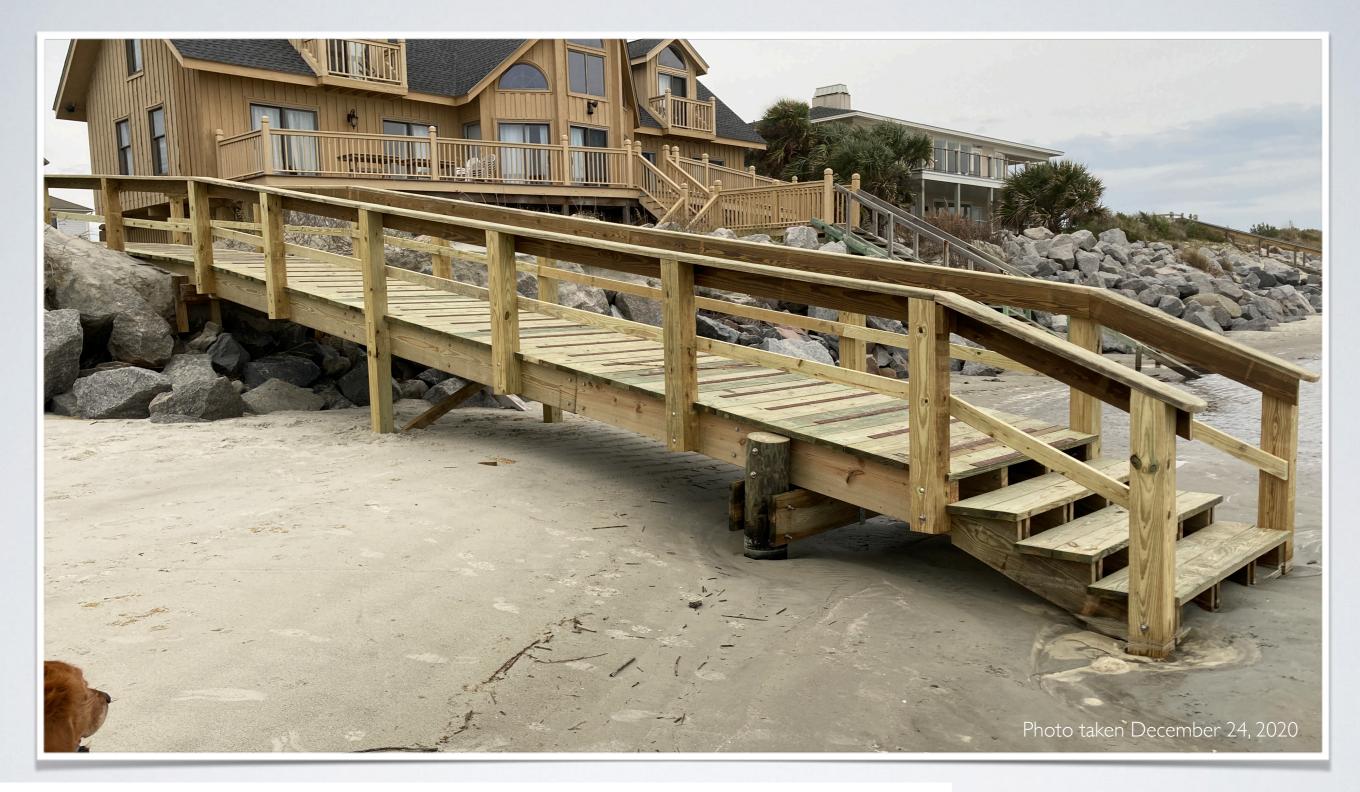
Access #1b - ramp and steps extension added after the previous structure was damaged by eroding sand.

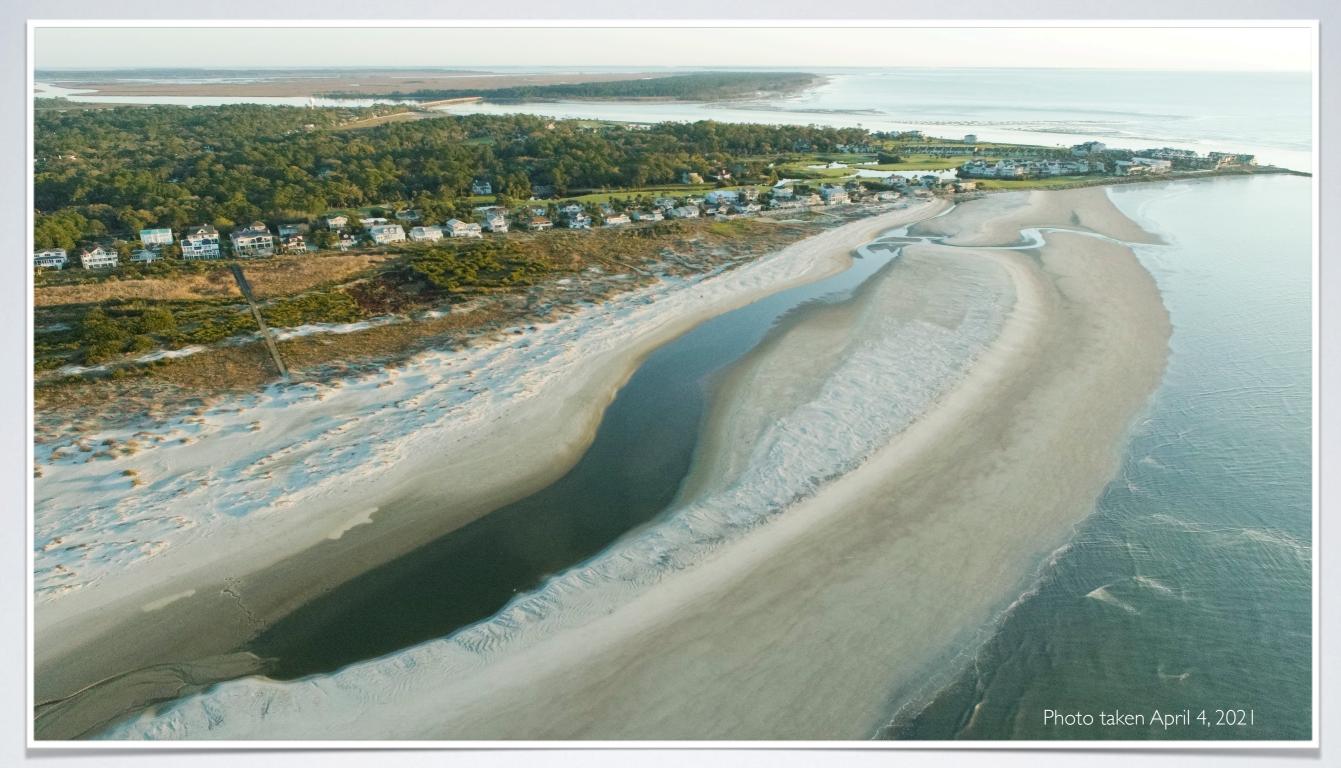
Access #1b - The attaching shoal continues to become a permanent part of the beach, flattening out as it spreads northwards and southwards along the beach. This view, looking north towards Ocean Point shows the trapped seawater that was once in-between the attaching shoal and the existing beach. Until the sand closes this gap, if it ever does completely, this pool remains tidal expanding and contracting with the tide.

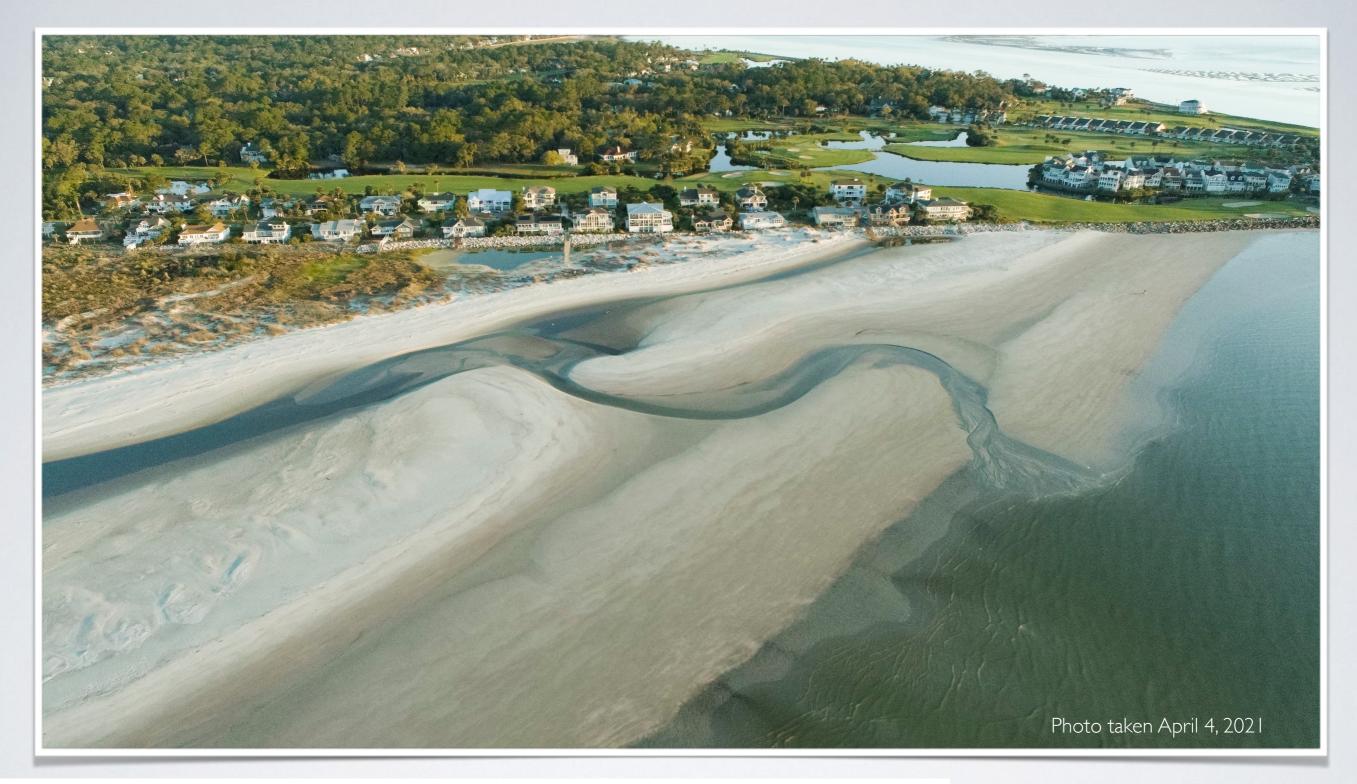
Access #1b - This outlet "creek", located in roughly the center of the tidal pool, is currently the only inflow and outflow for the rising and falling seawater. Access #1b is located at the far end of the pool where the water stops and collects.

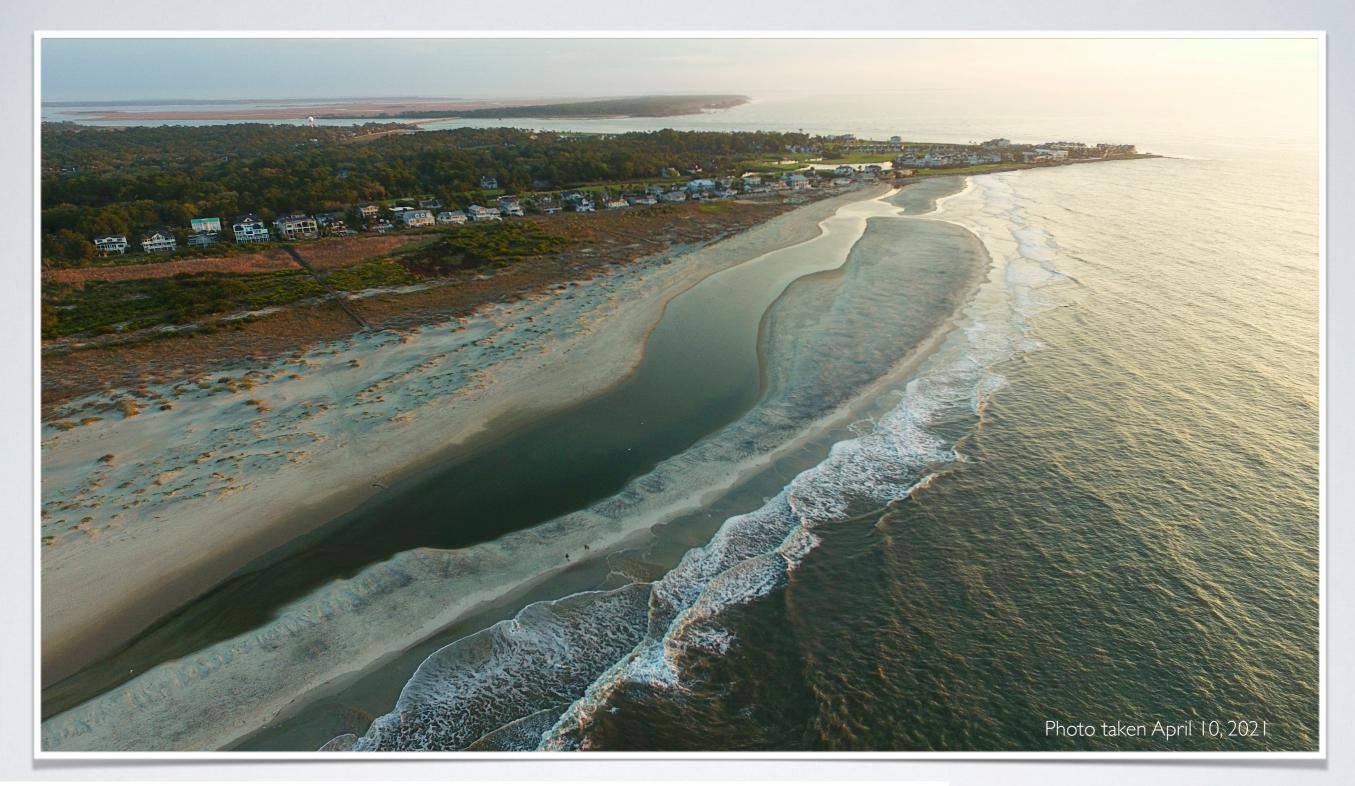
Access #1b - This view taken at high tide, shows the active tidal pool extending all the way to the beach access, also that the center outflow/inflow is where the seawater enters and exits.

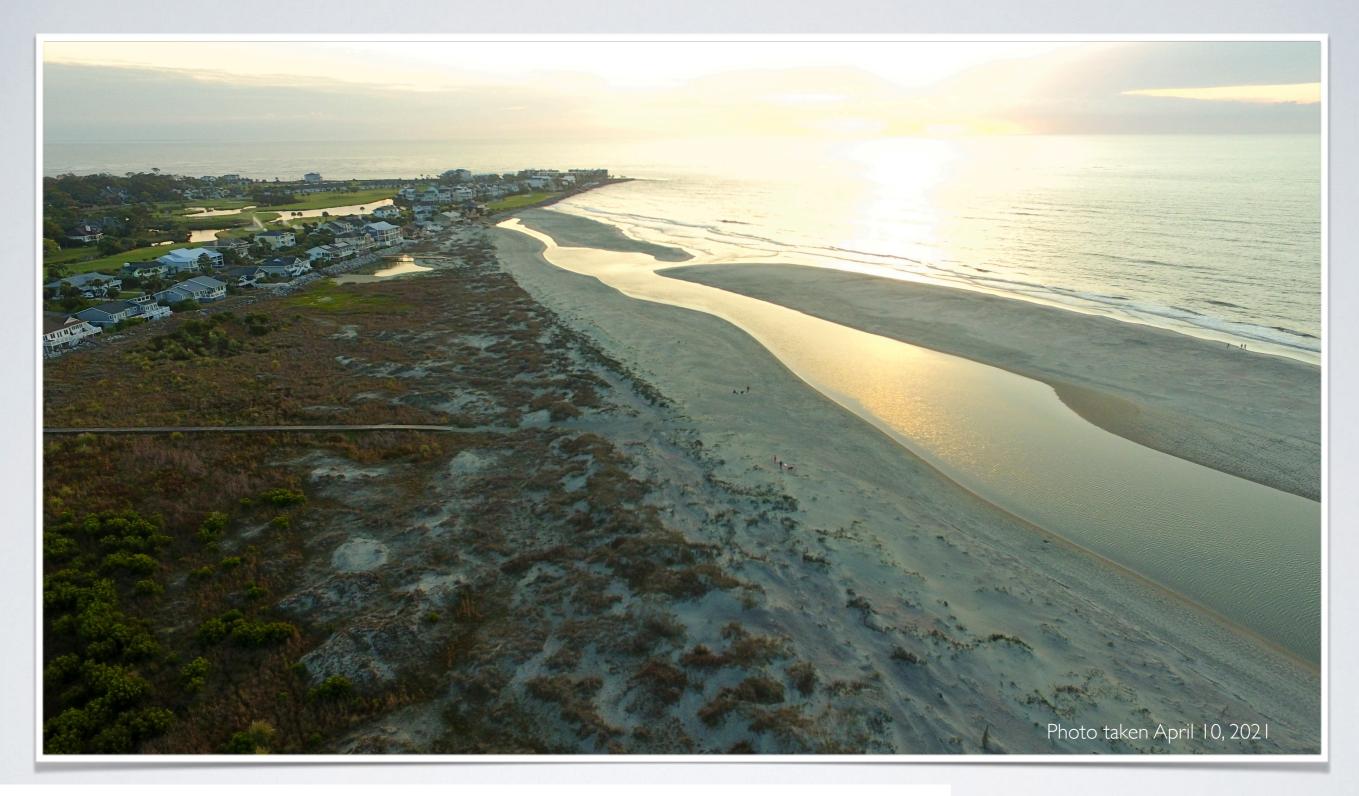
Access #1b - Another view taken at the same high tide shows better detail of the tidal pool expansion.

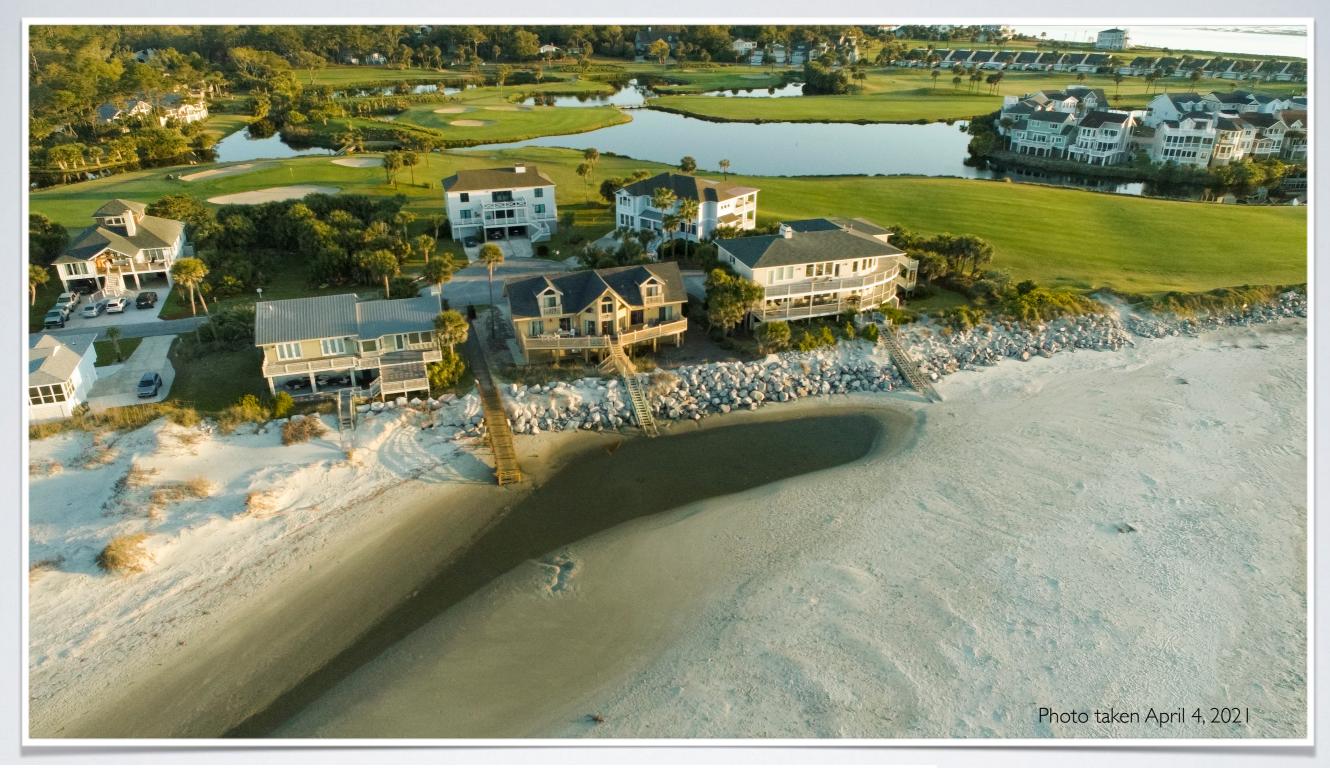
Access #1b - This photo, taken at low tide shows the beach access stairs end at the muddy sediment near the edge of the tide pool. As the pool drains, this pluff mud remains at the base of the stairs leaving a very slick surface with which to step down onto the beach. The beach sand in front of the tidal pool has filled back in and is at a much higher profile than the area around the tidal pool leaving the only drainage direction back towards where the water originally flows in.

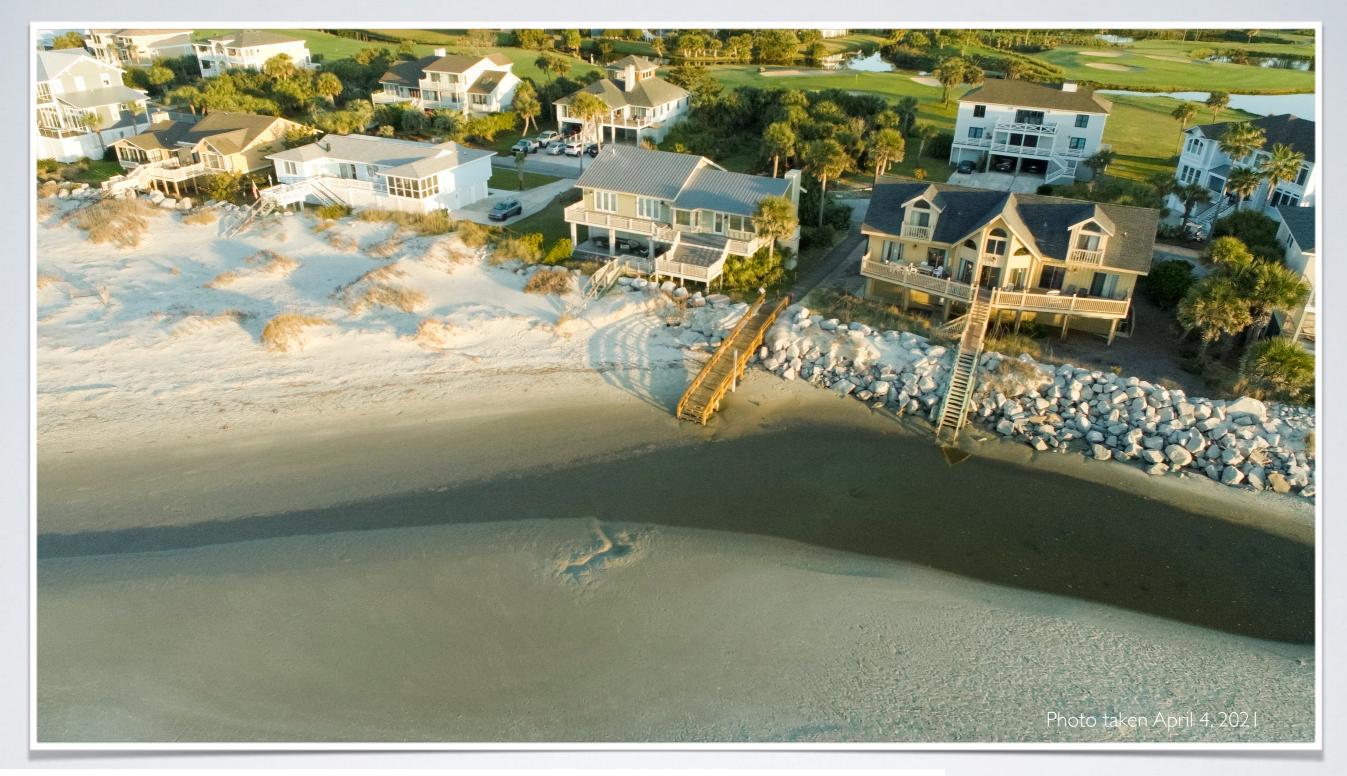
Access #1b - At high tide, the end of the stairs touches the water. The darker brown rim is the slick, pluff mud left behind. This mud is in a high traffic area making use of this access unsafe. The mud also gets tracked a good portion of the length of the access stairs and ramp causing the whole structure to be slippery.
