BEACH STATUS

Aerial Observations - high tide
June 8, 2022

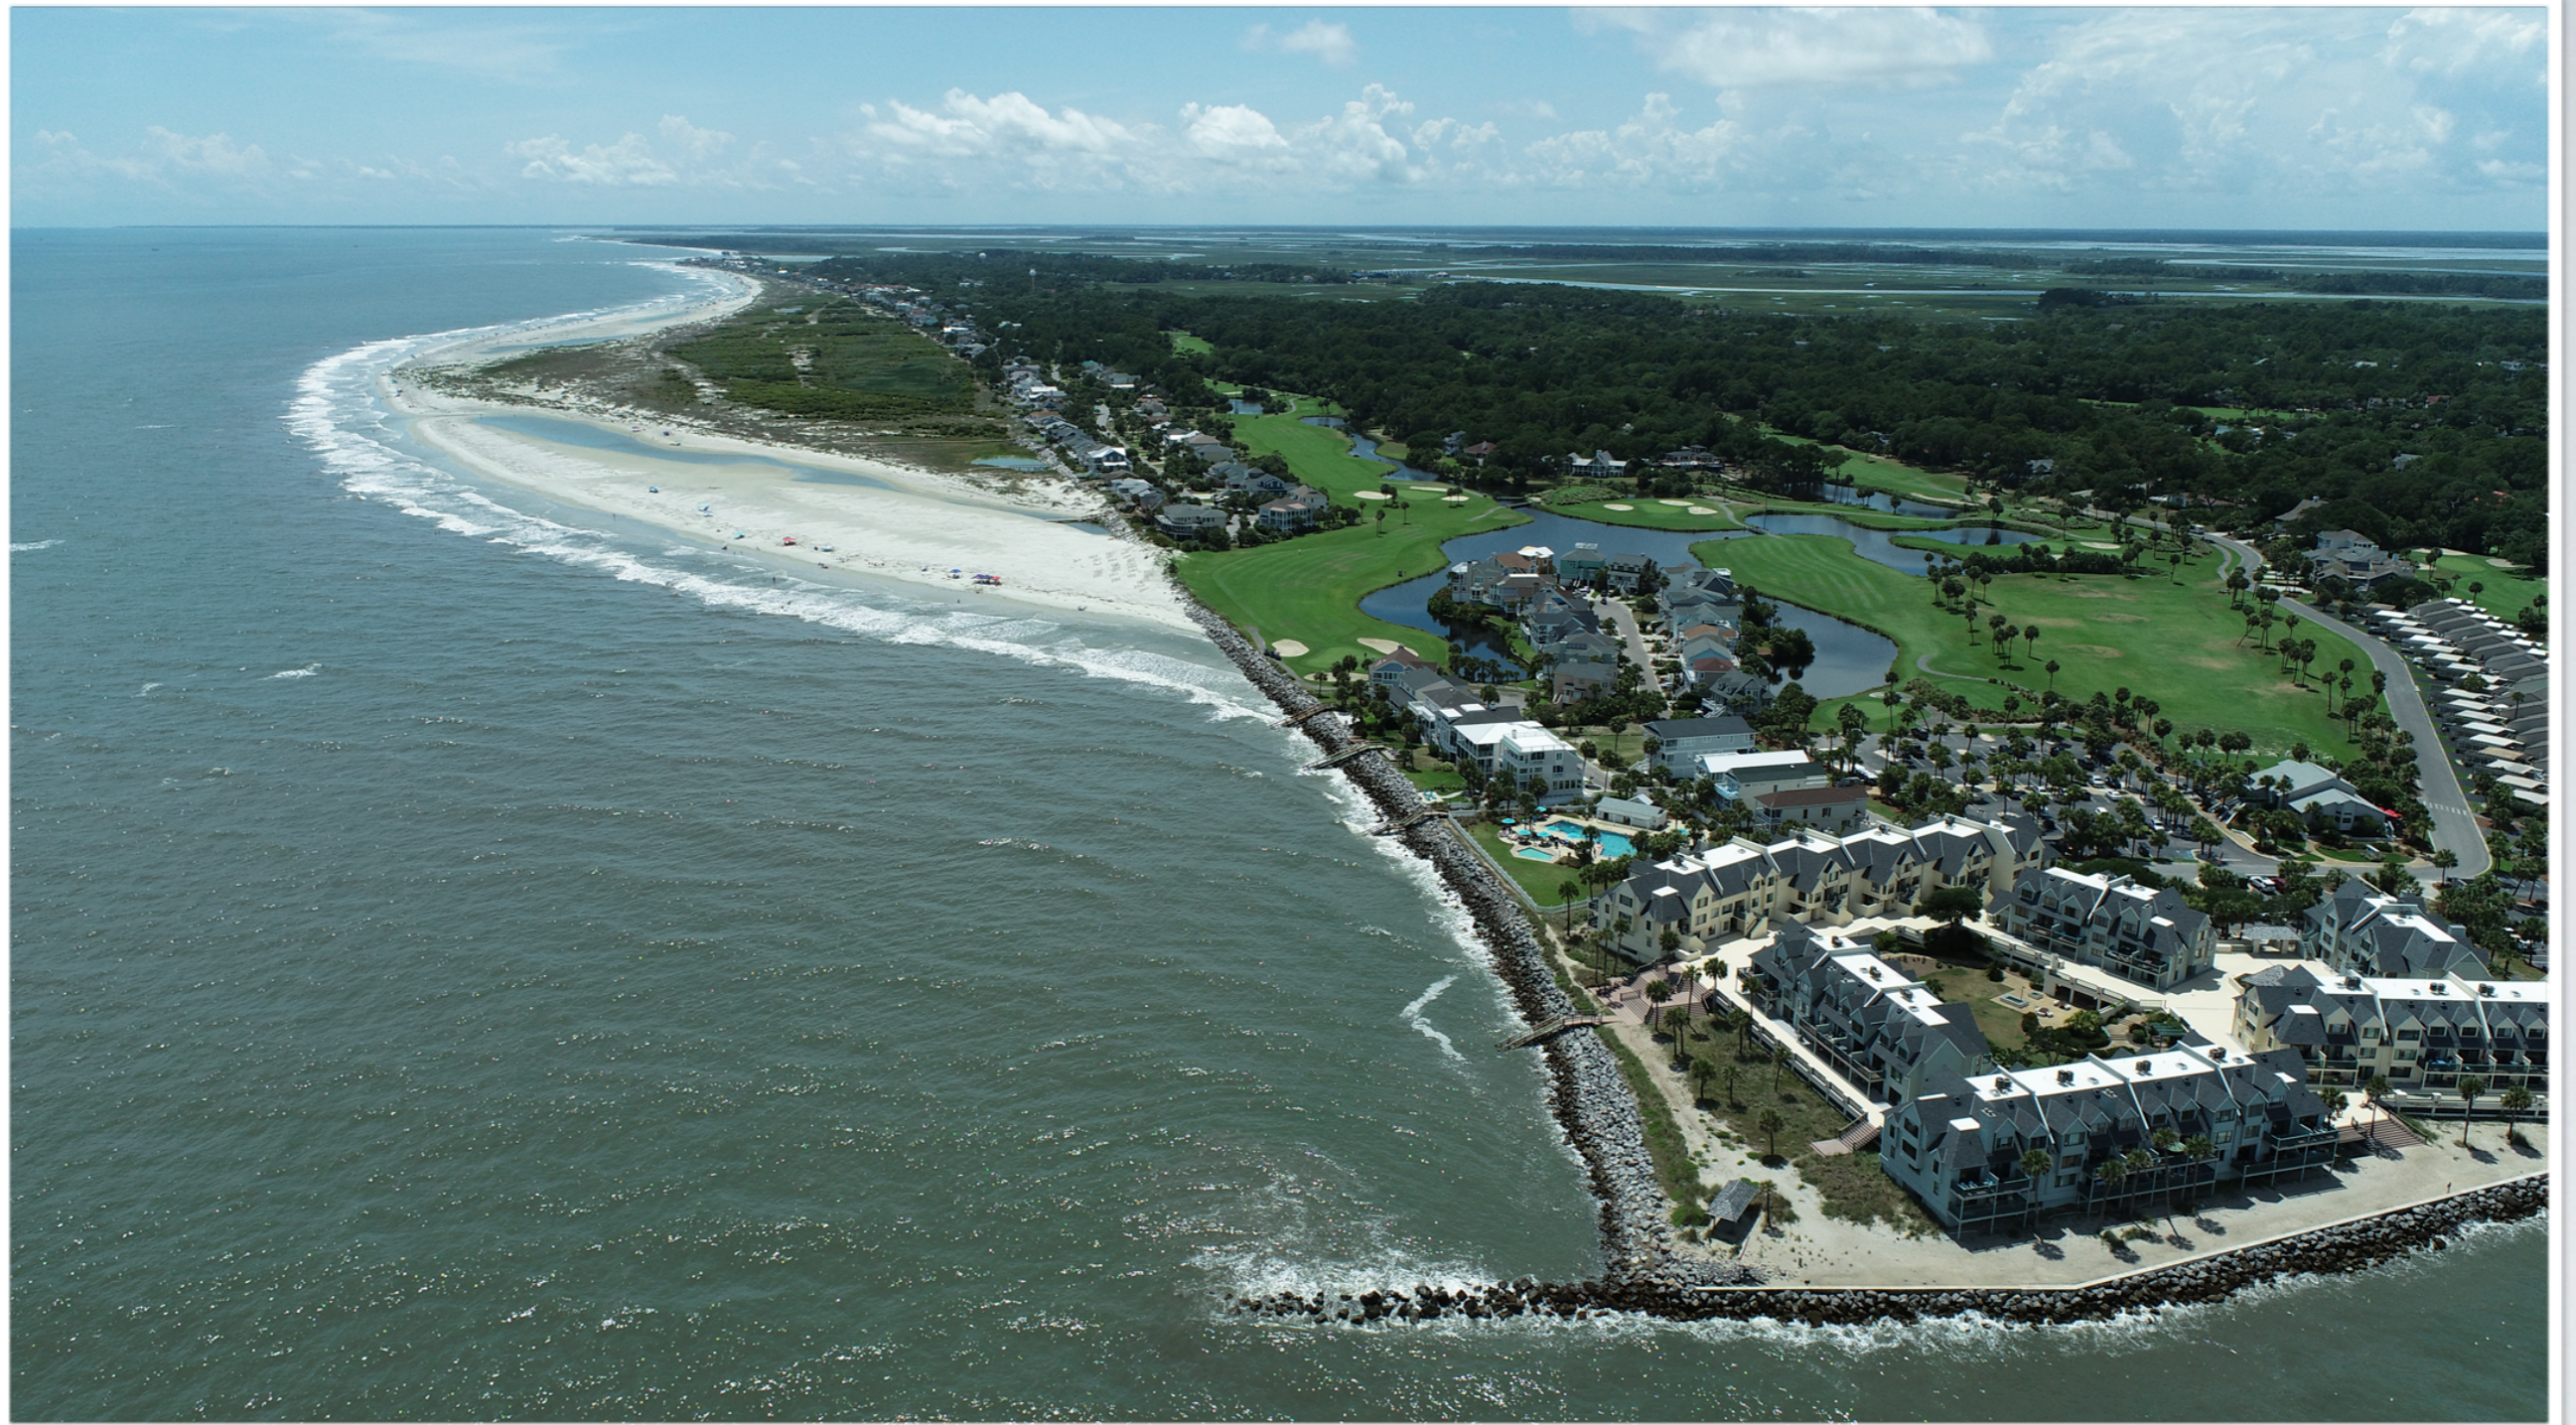
Ocean Point is now the only part of the beach that is inaccessible during high tide, this includes beach access #1a.

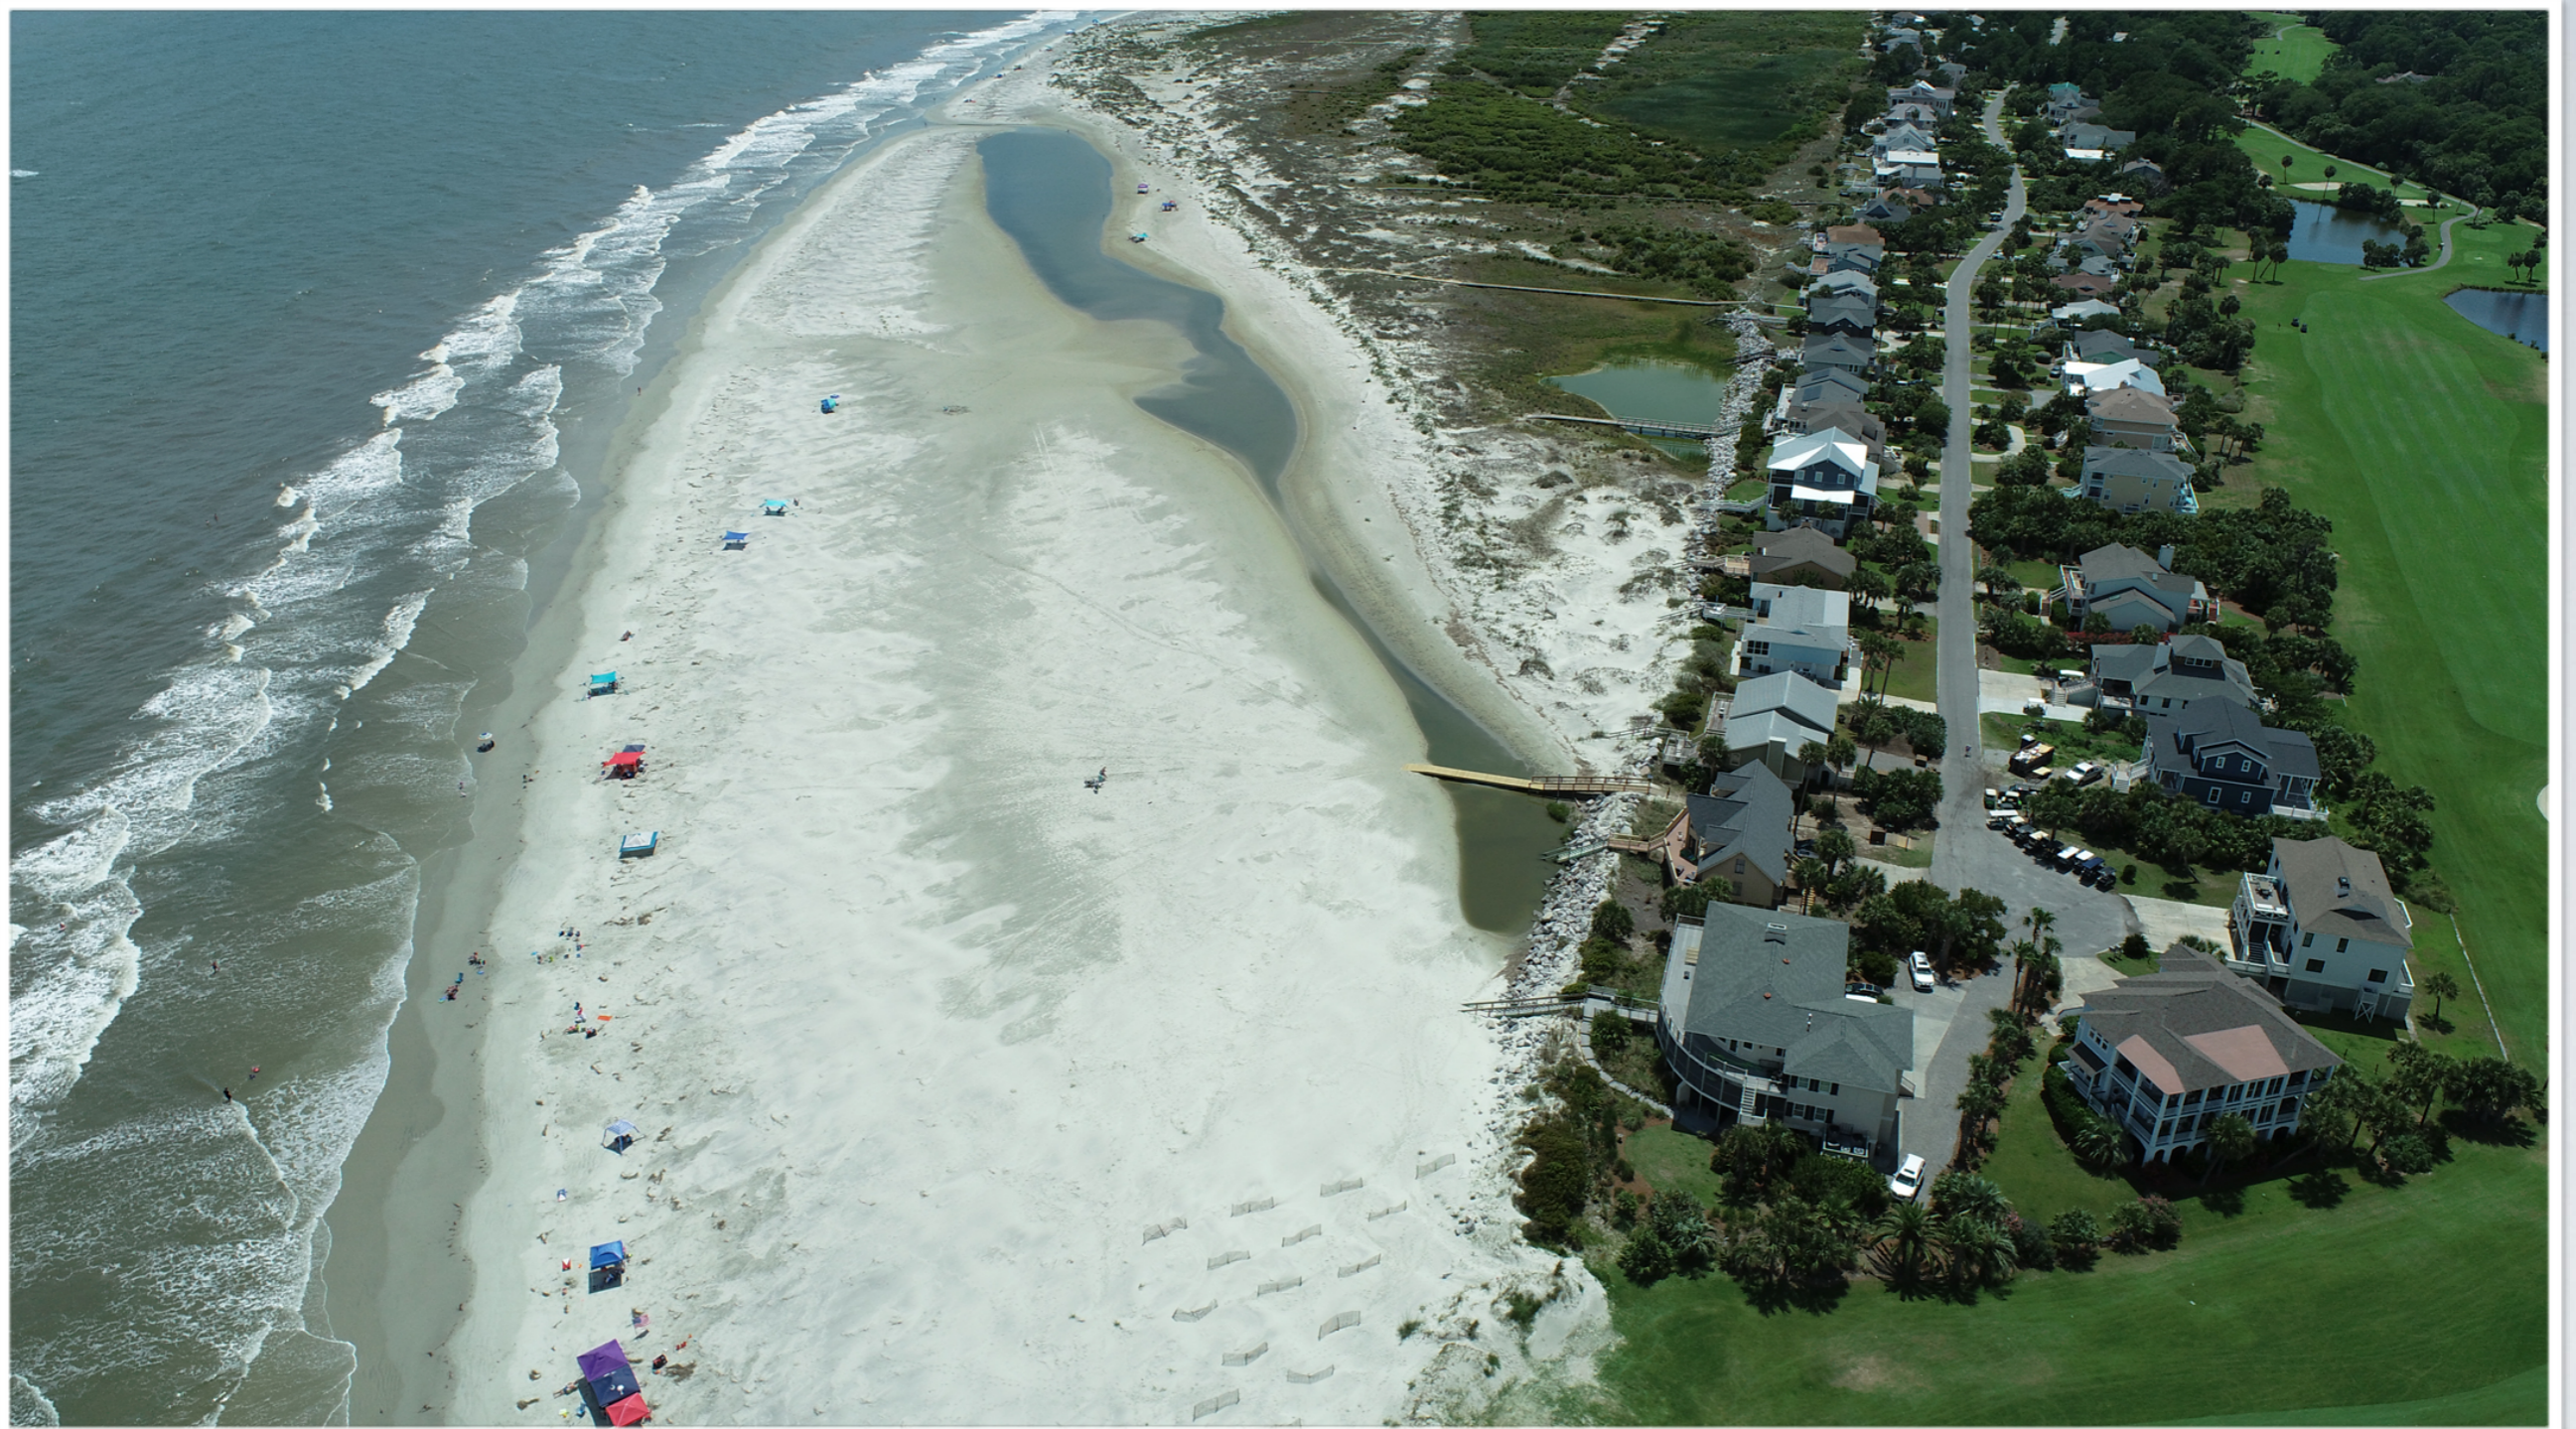
The new extension on Access 1b is being used a lot. The issue moving forward will be parking, note the parking area in the cul de sac is full. The eight golf cart spaces allotted fills early and remains full throughout the day.

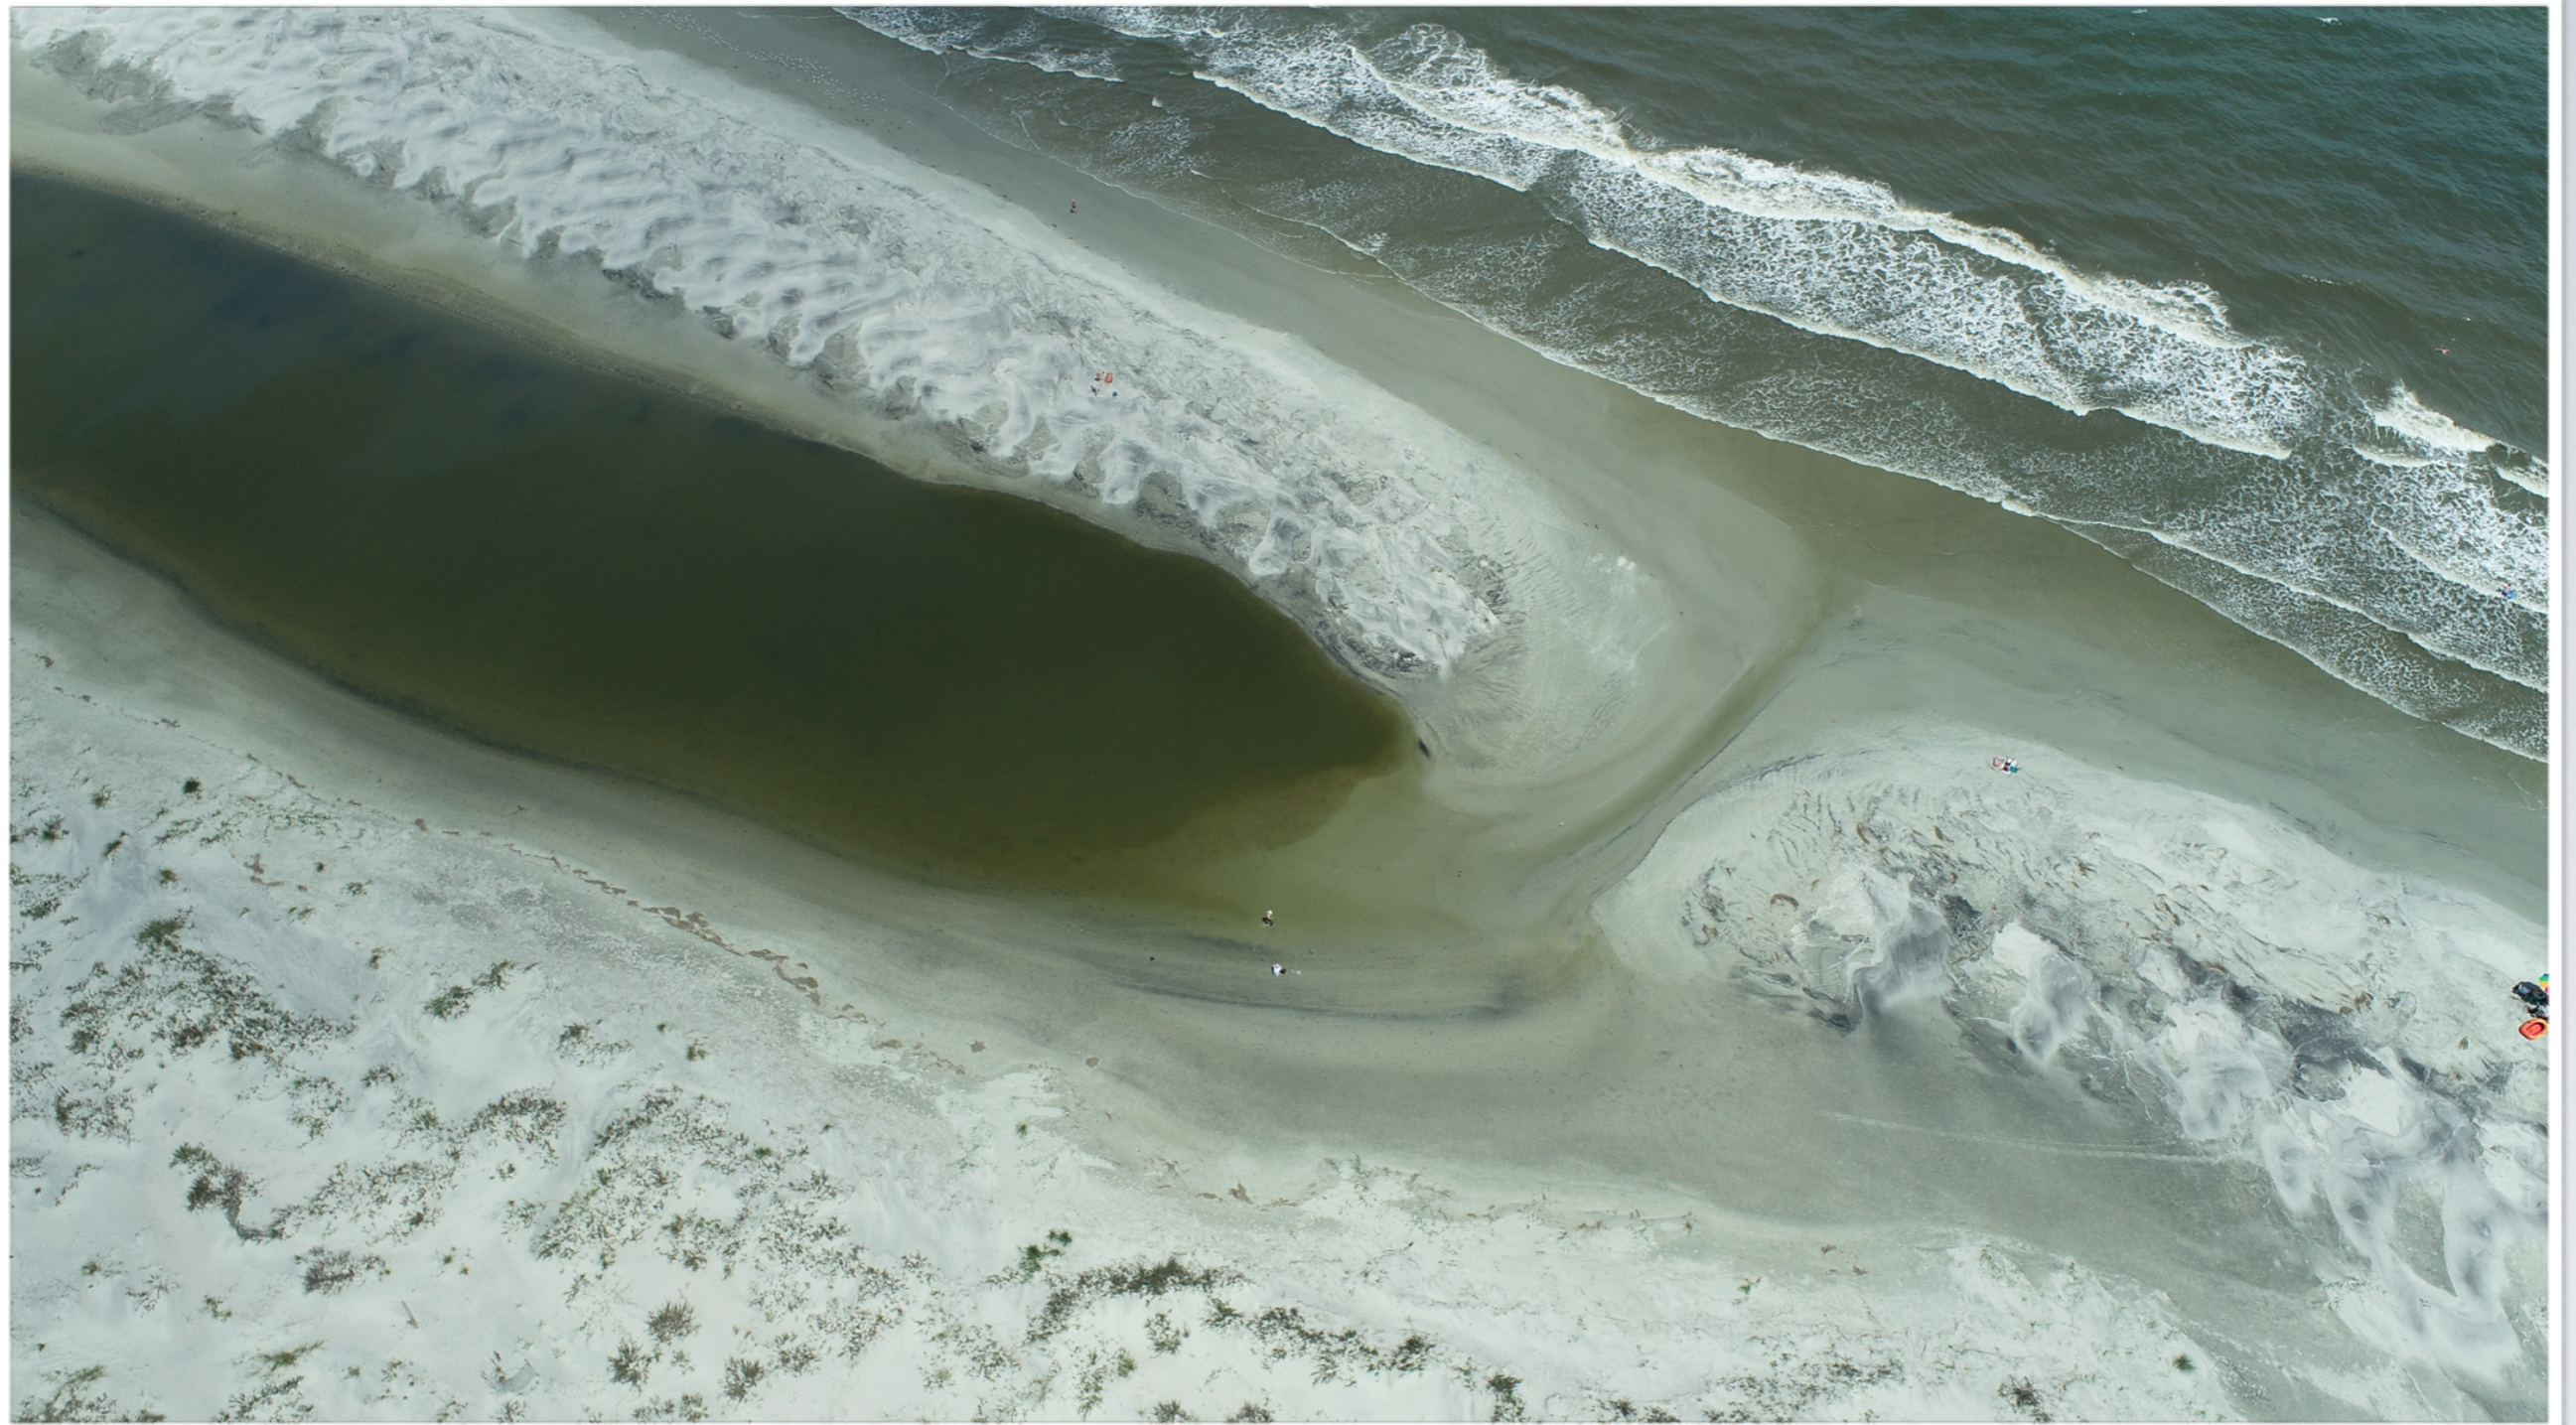
The tide pool is closed off in the center but has opened up on the far end. This opening, located between access #2 and #3, is the only access for seawater to enter the tide pool.

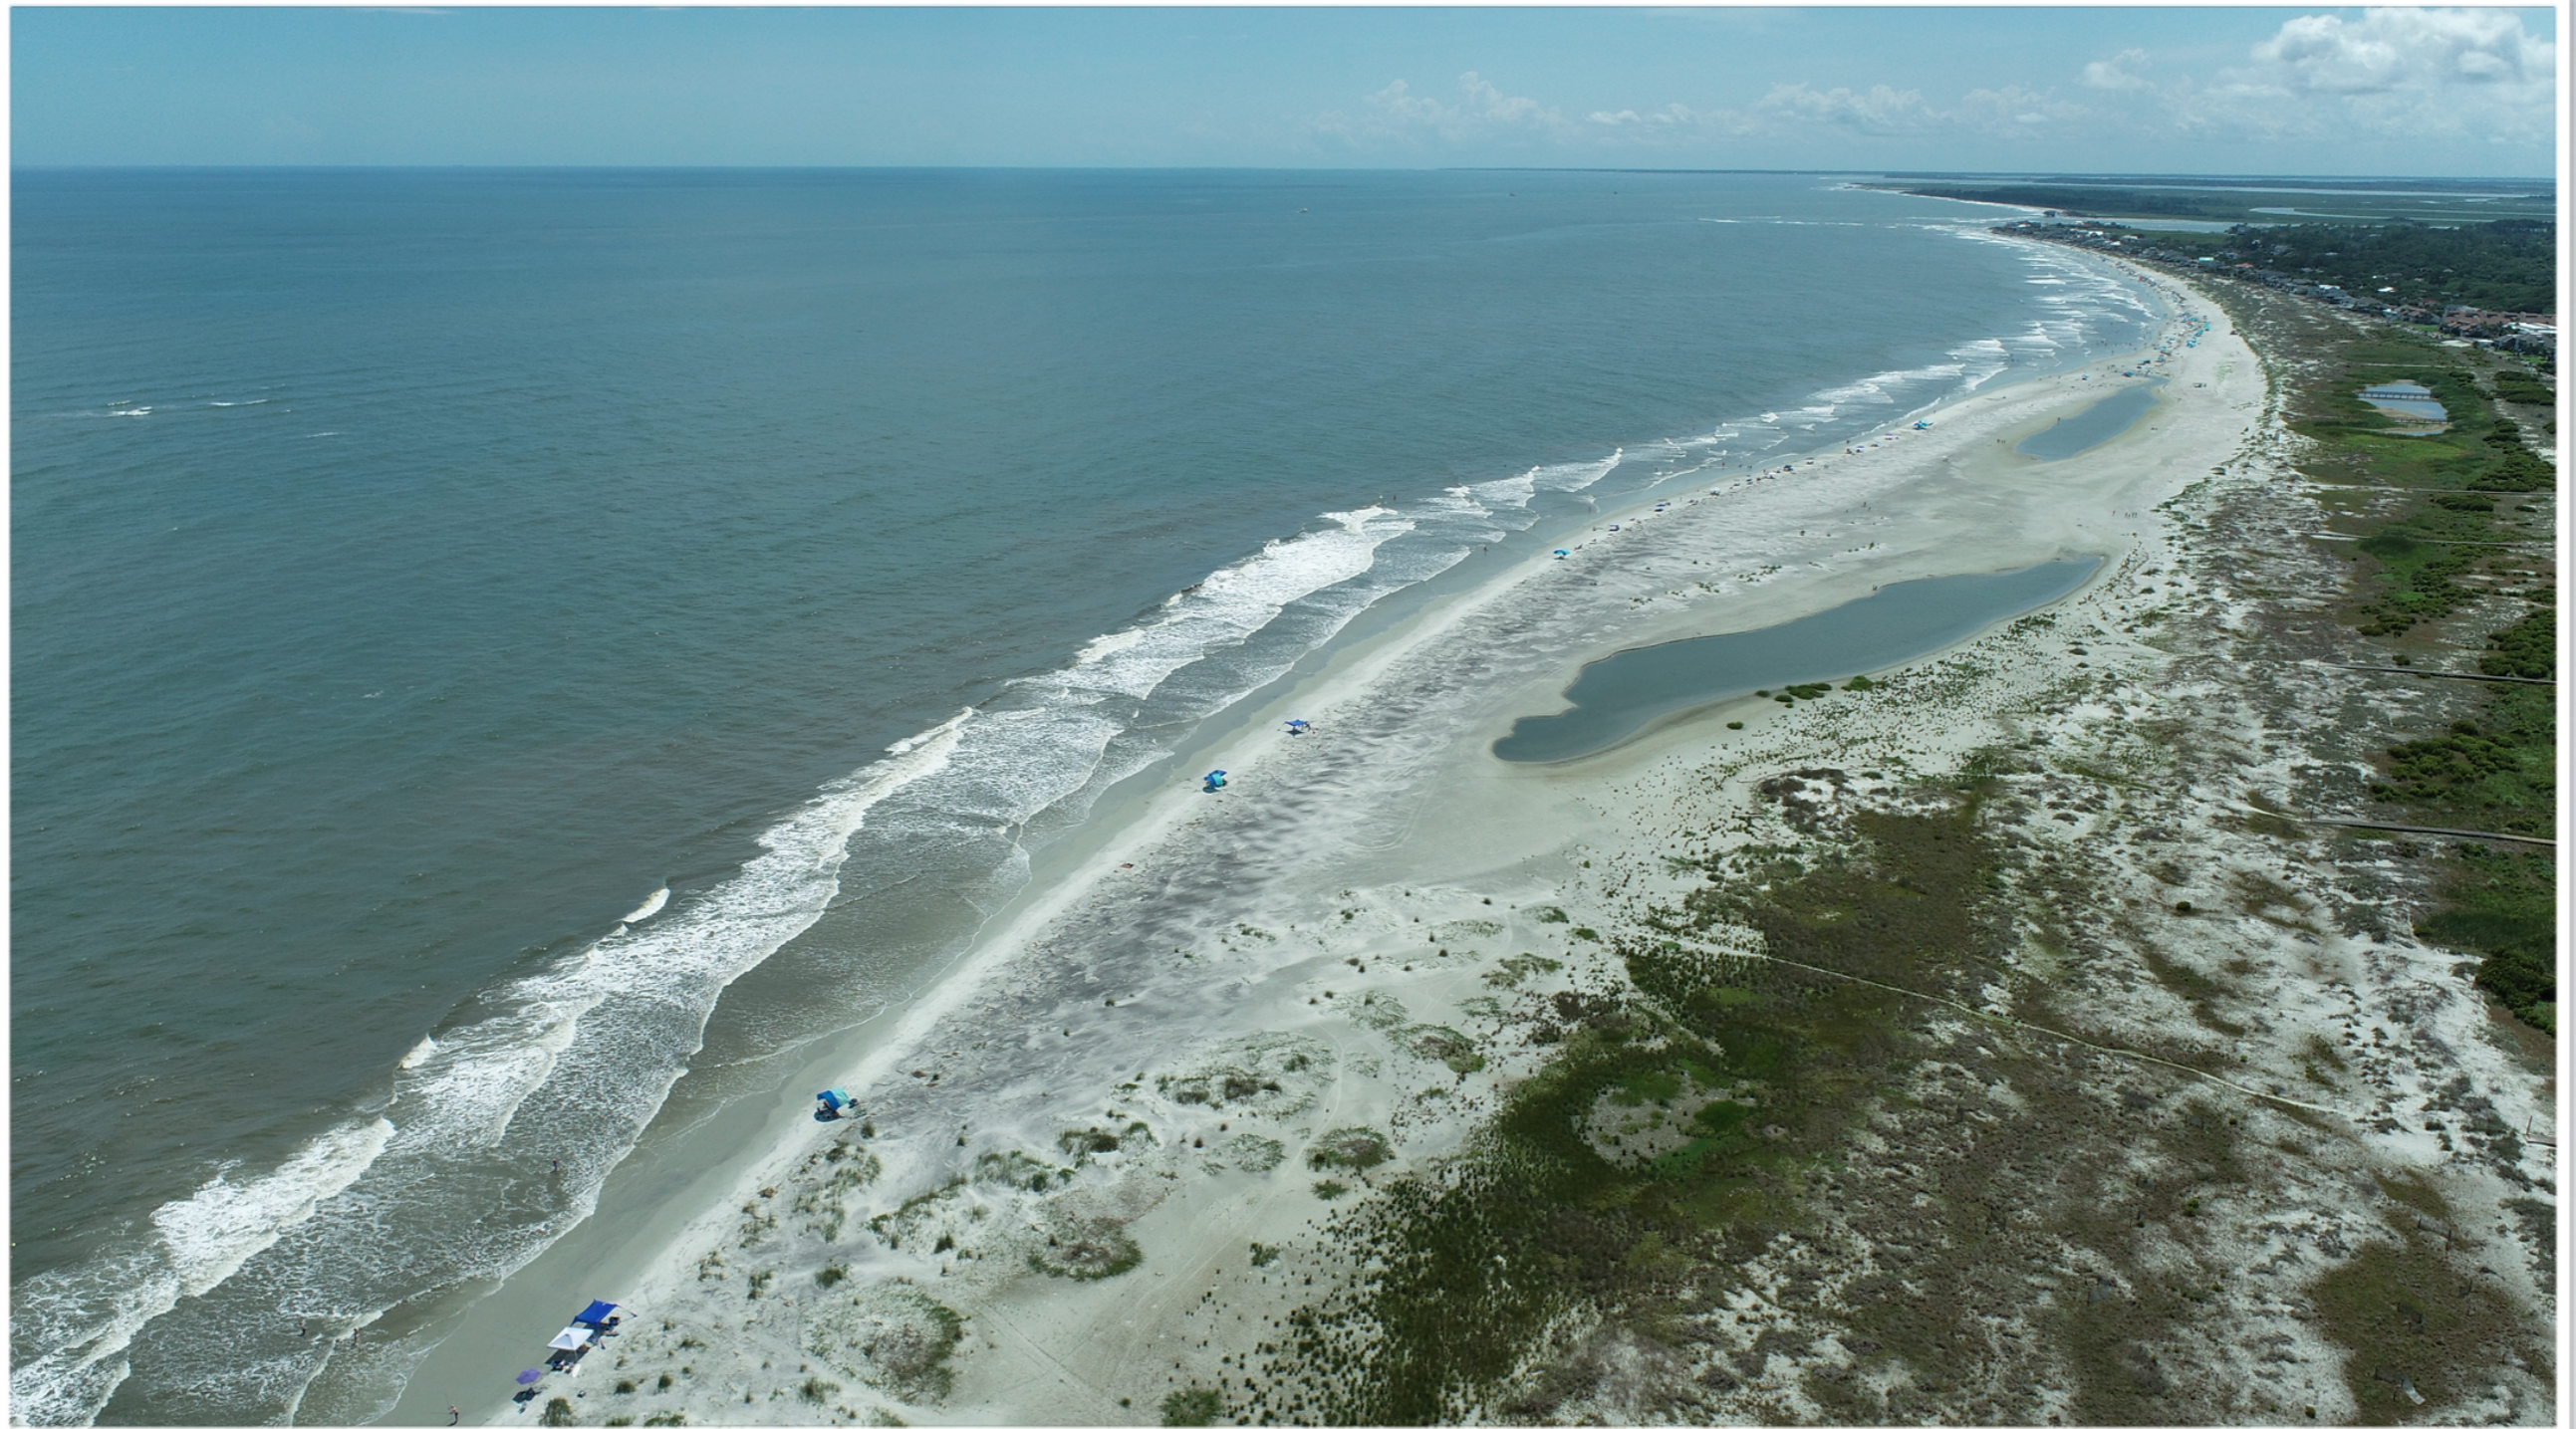
Looking south at two large tide pools on the beach. The closest is a remnant from the shoal attachment trapping seawater and distant one formed from the sea water draining down the beach from the first.

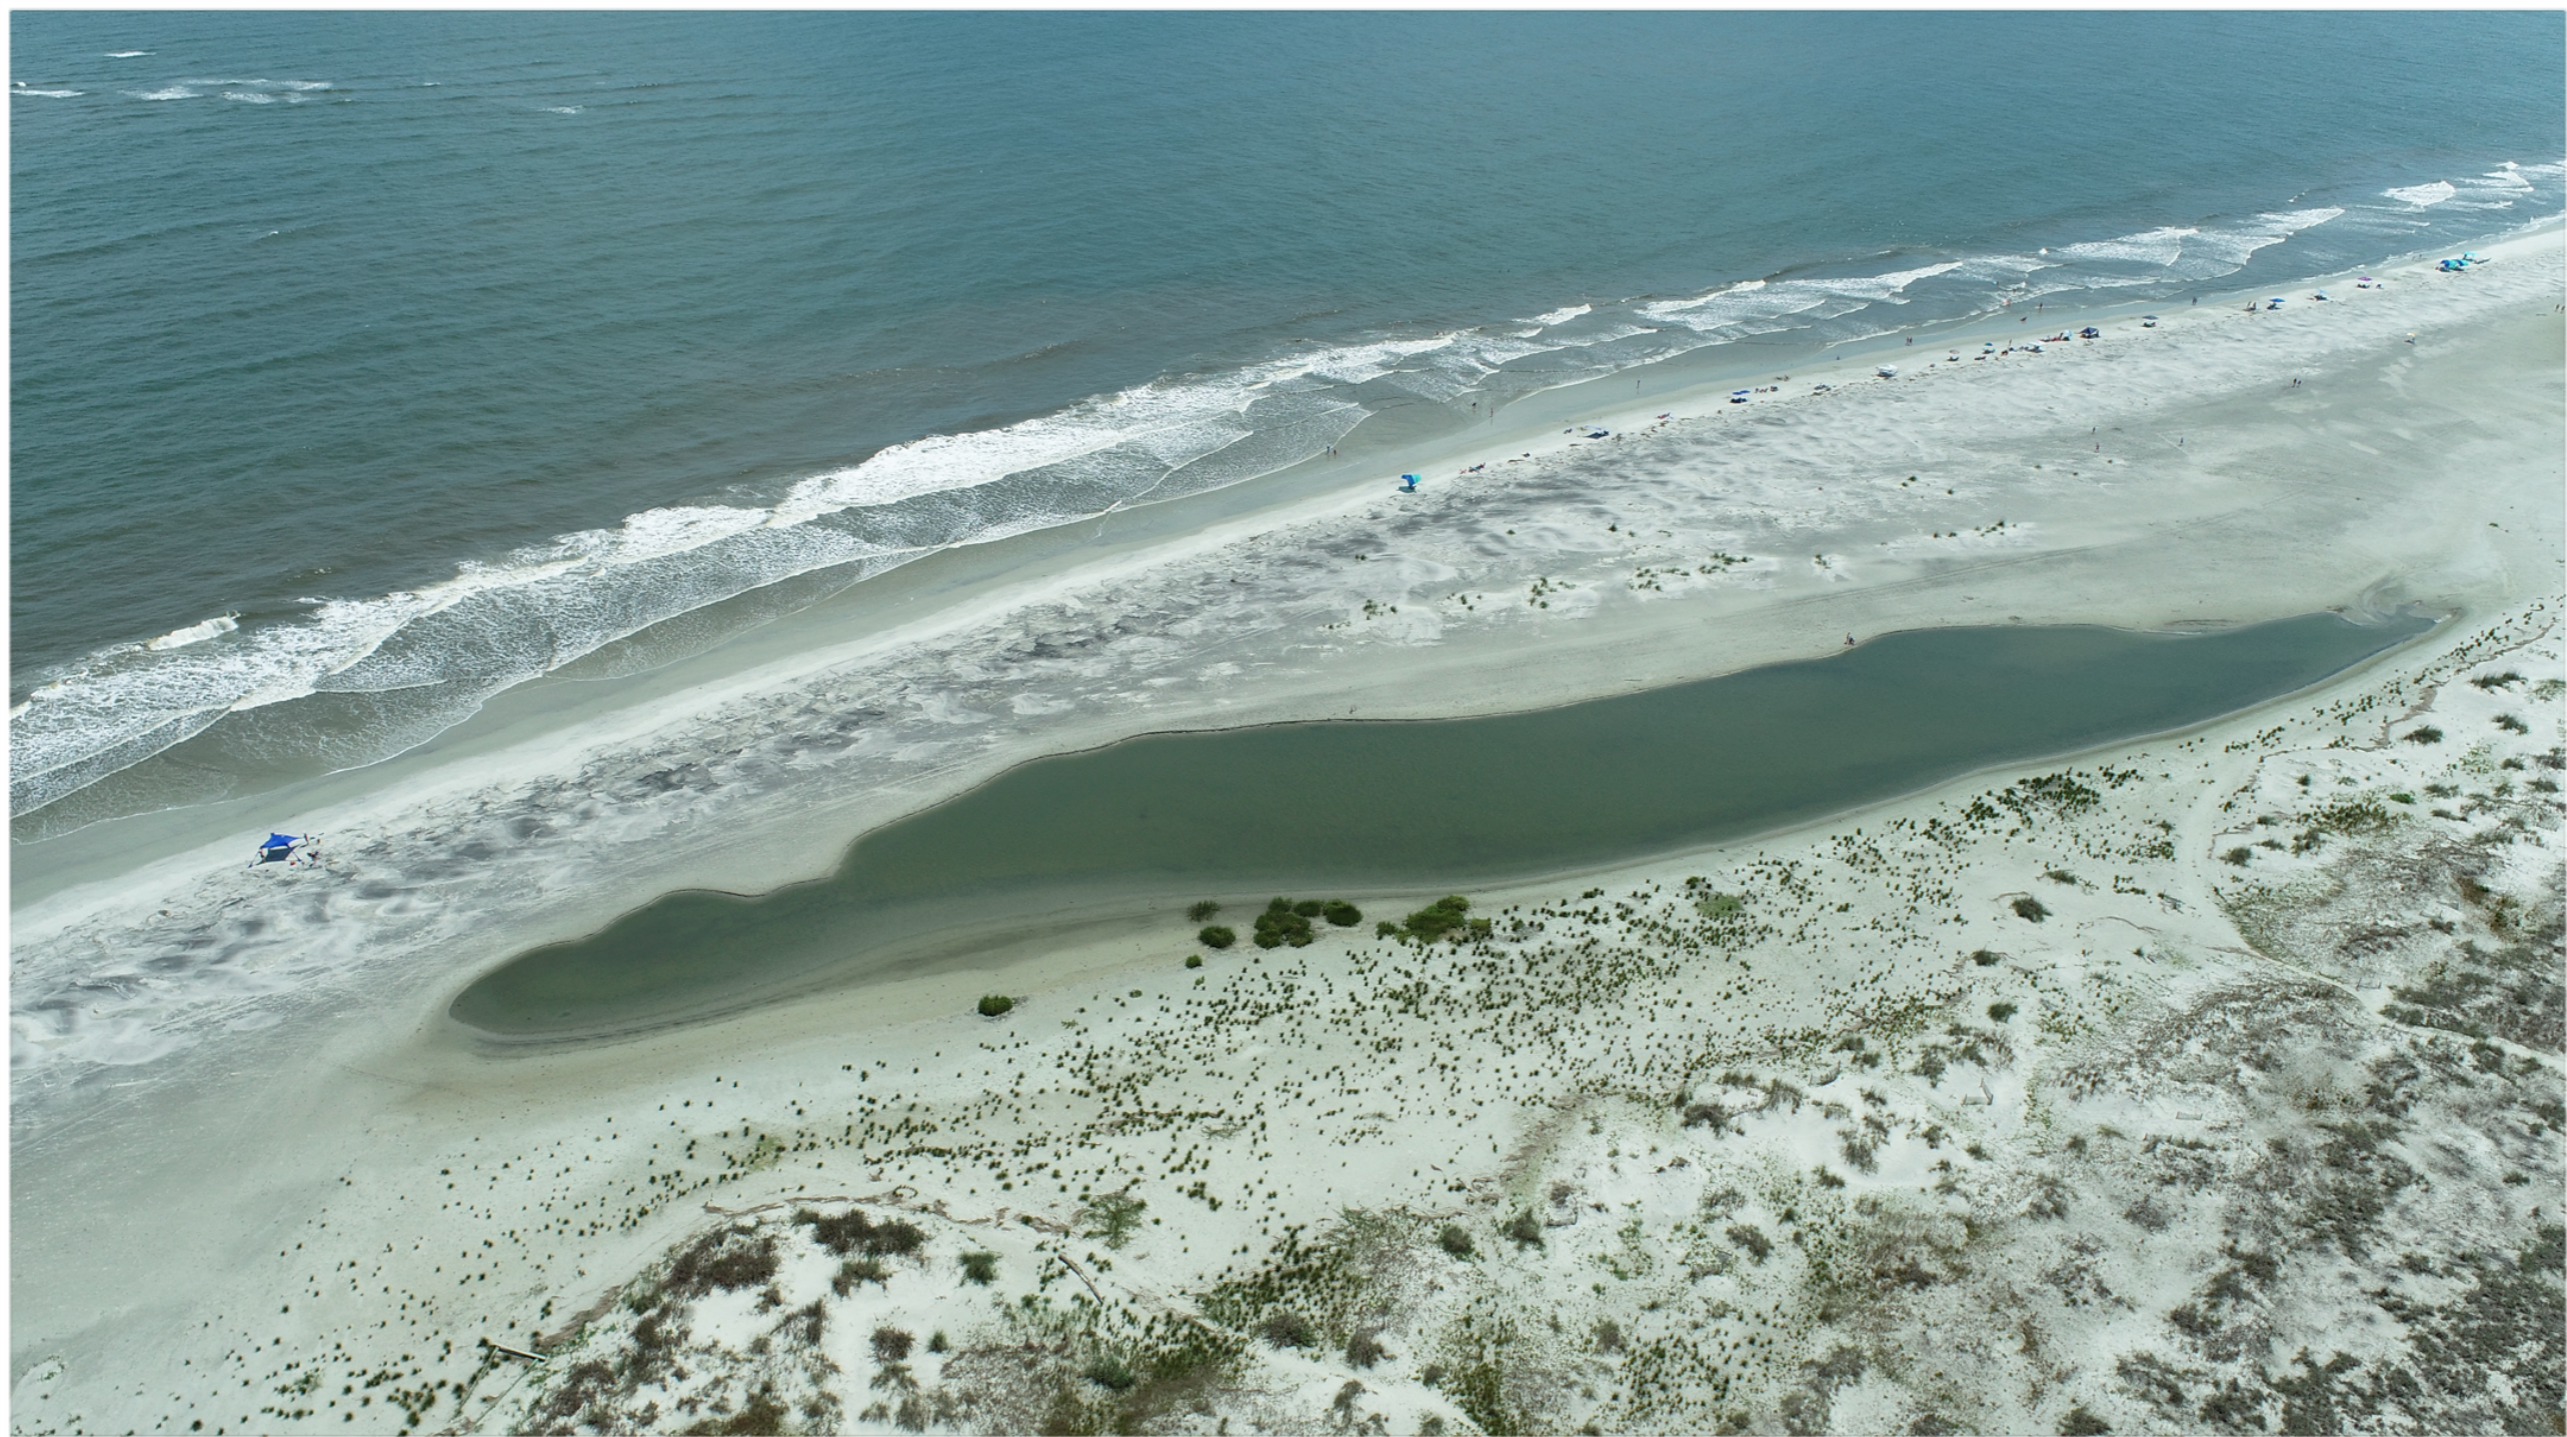
The first of the two large pools. This tide pool was formed by the 2016 offshore shoal attaching to the beach and trapping water. It is now completely closed off and will likely shrink quickly from evaporation.

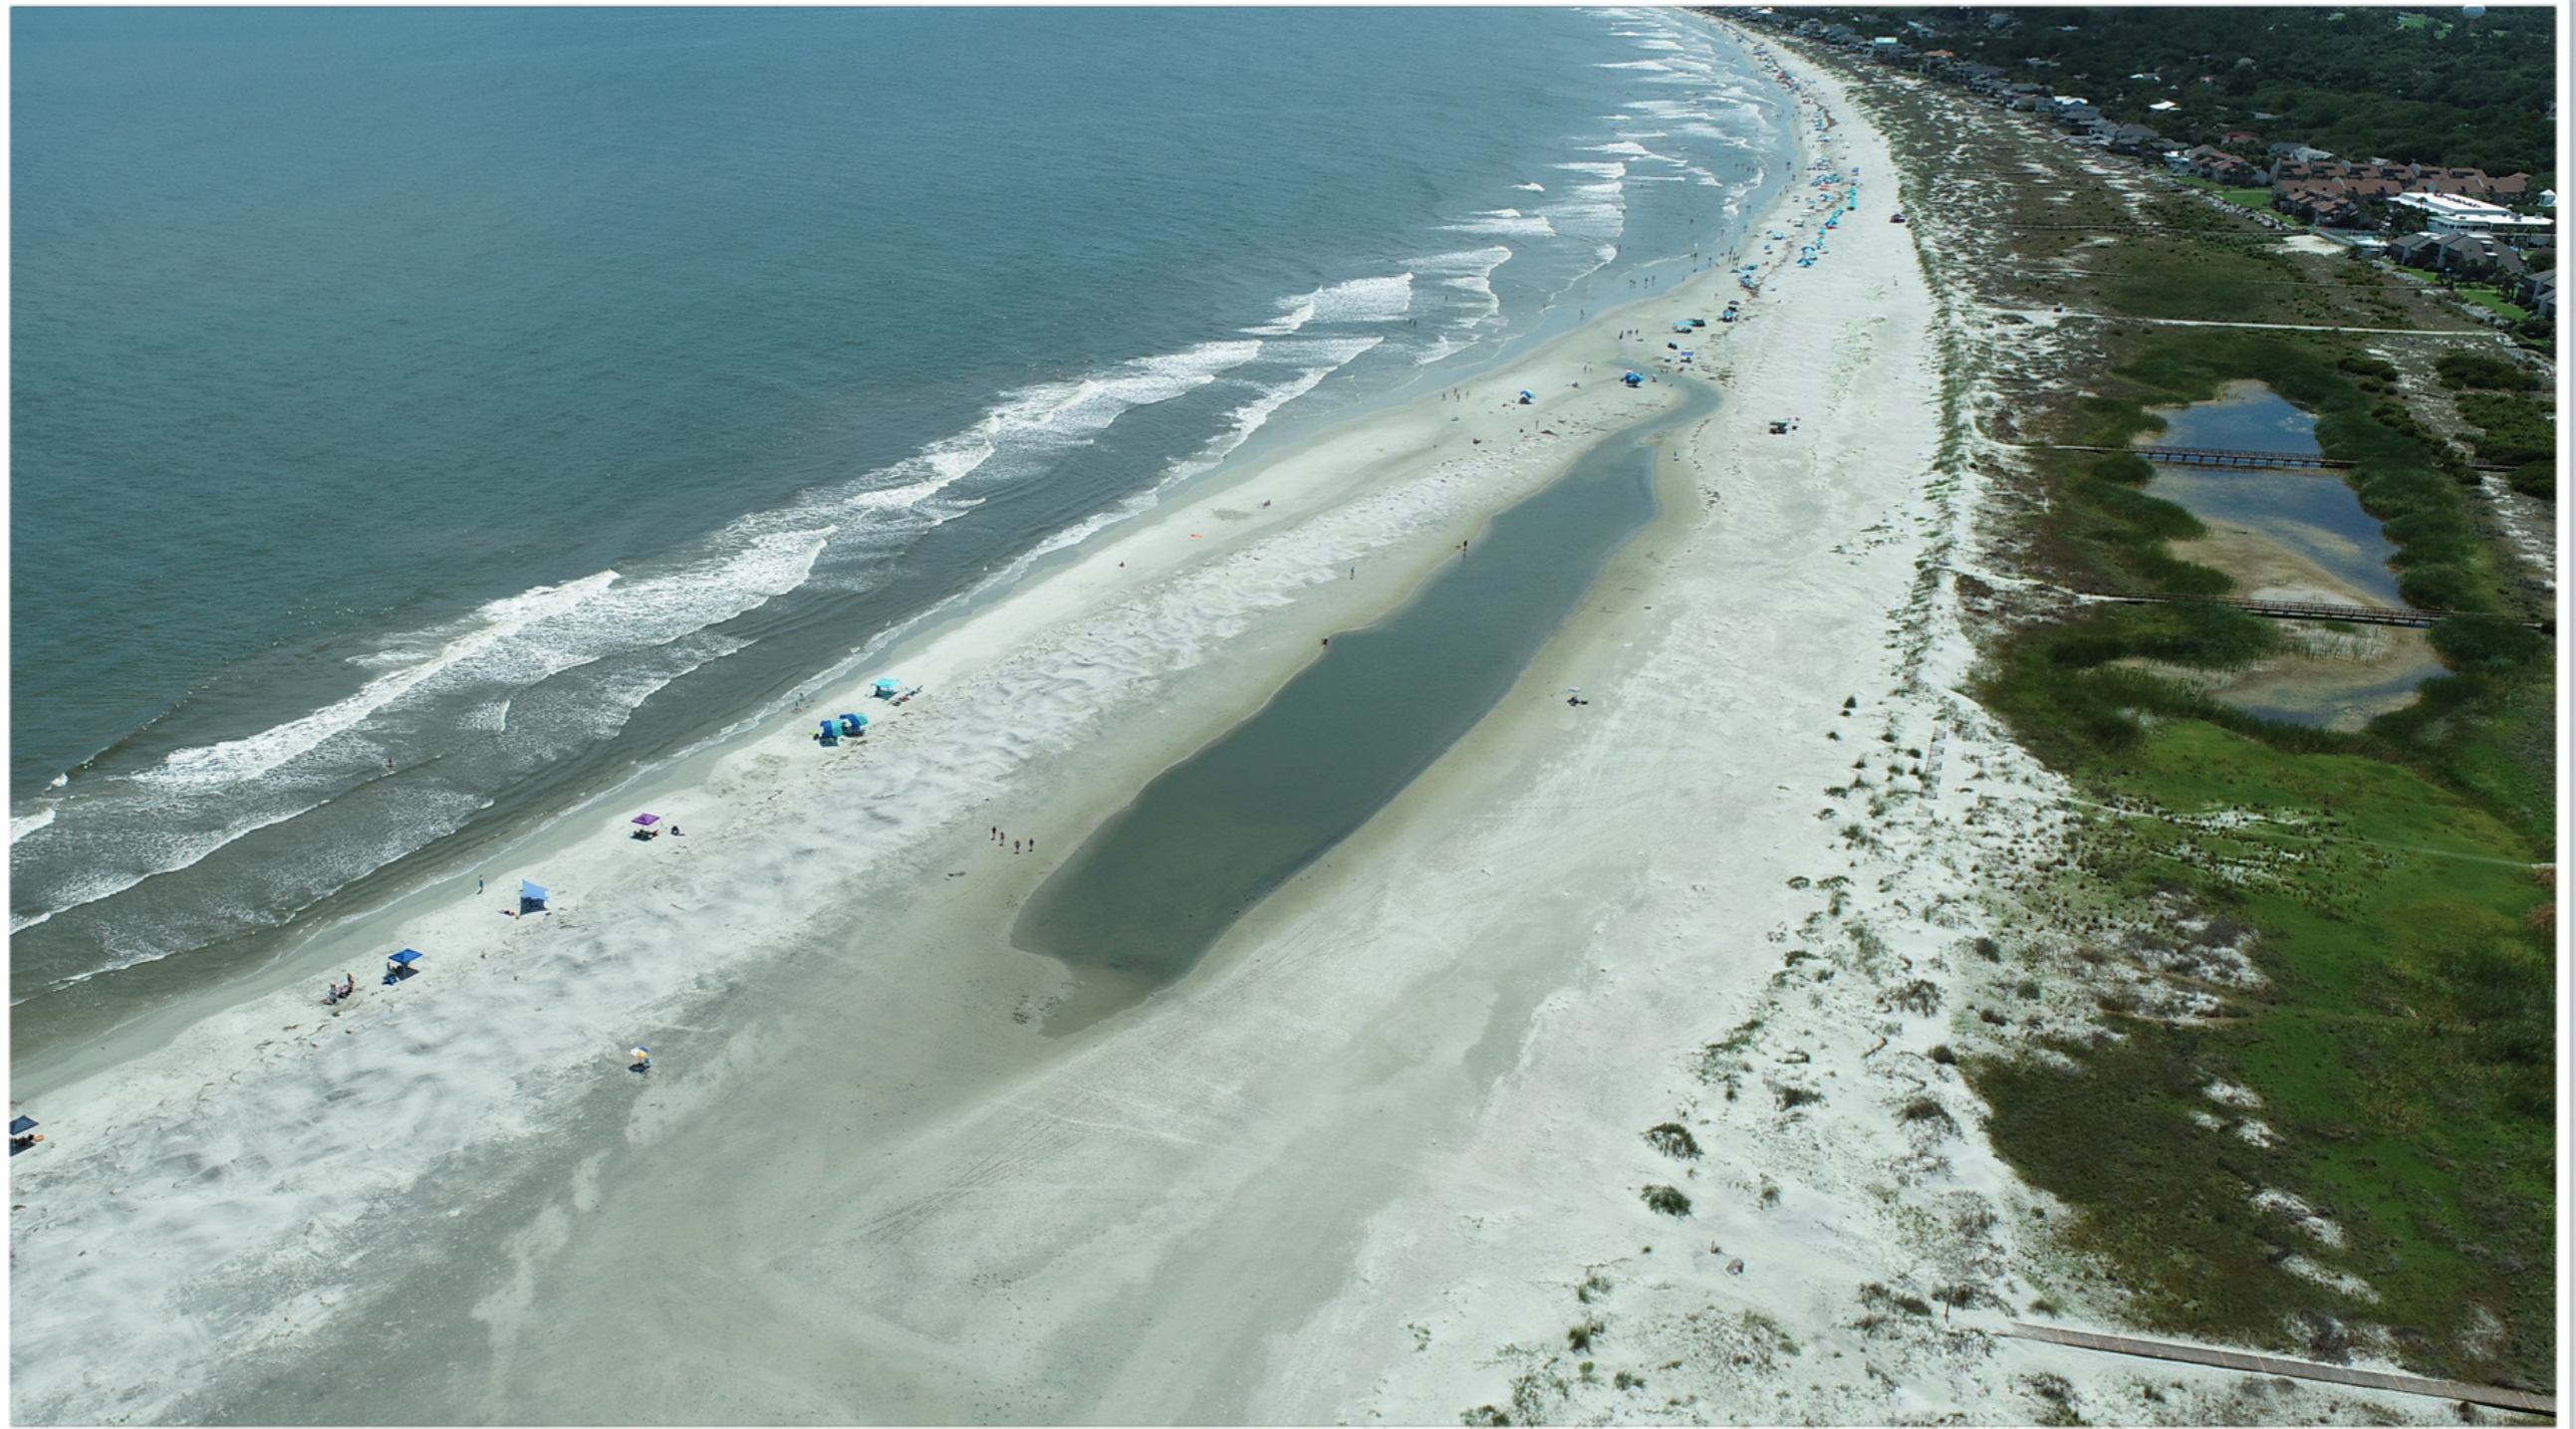
The second of the two large tide pools. This pool was formed by water draining down the beach from the first pool. The volume of water eventually overwhelmed the low spot and the excess carved a channel at the far end, back out to sea.
