BEACH STATUS

Aerial Observations - high tide
June 8, 2022

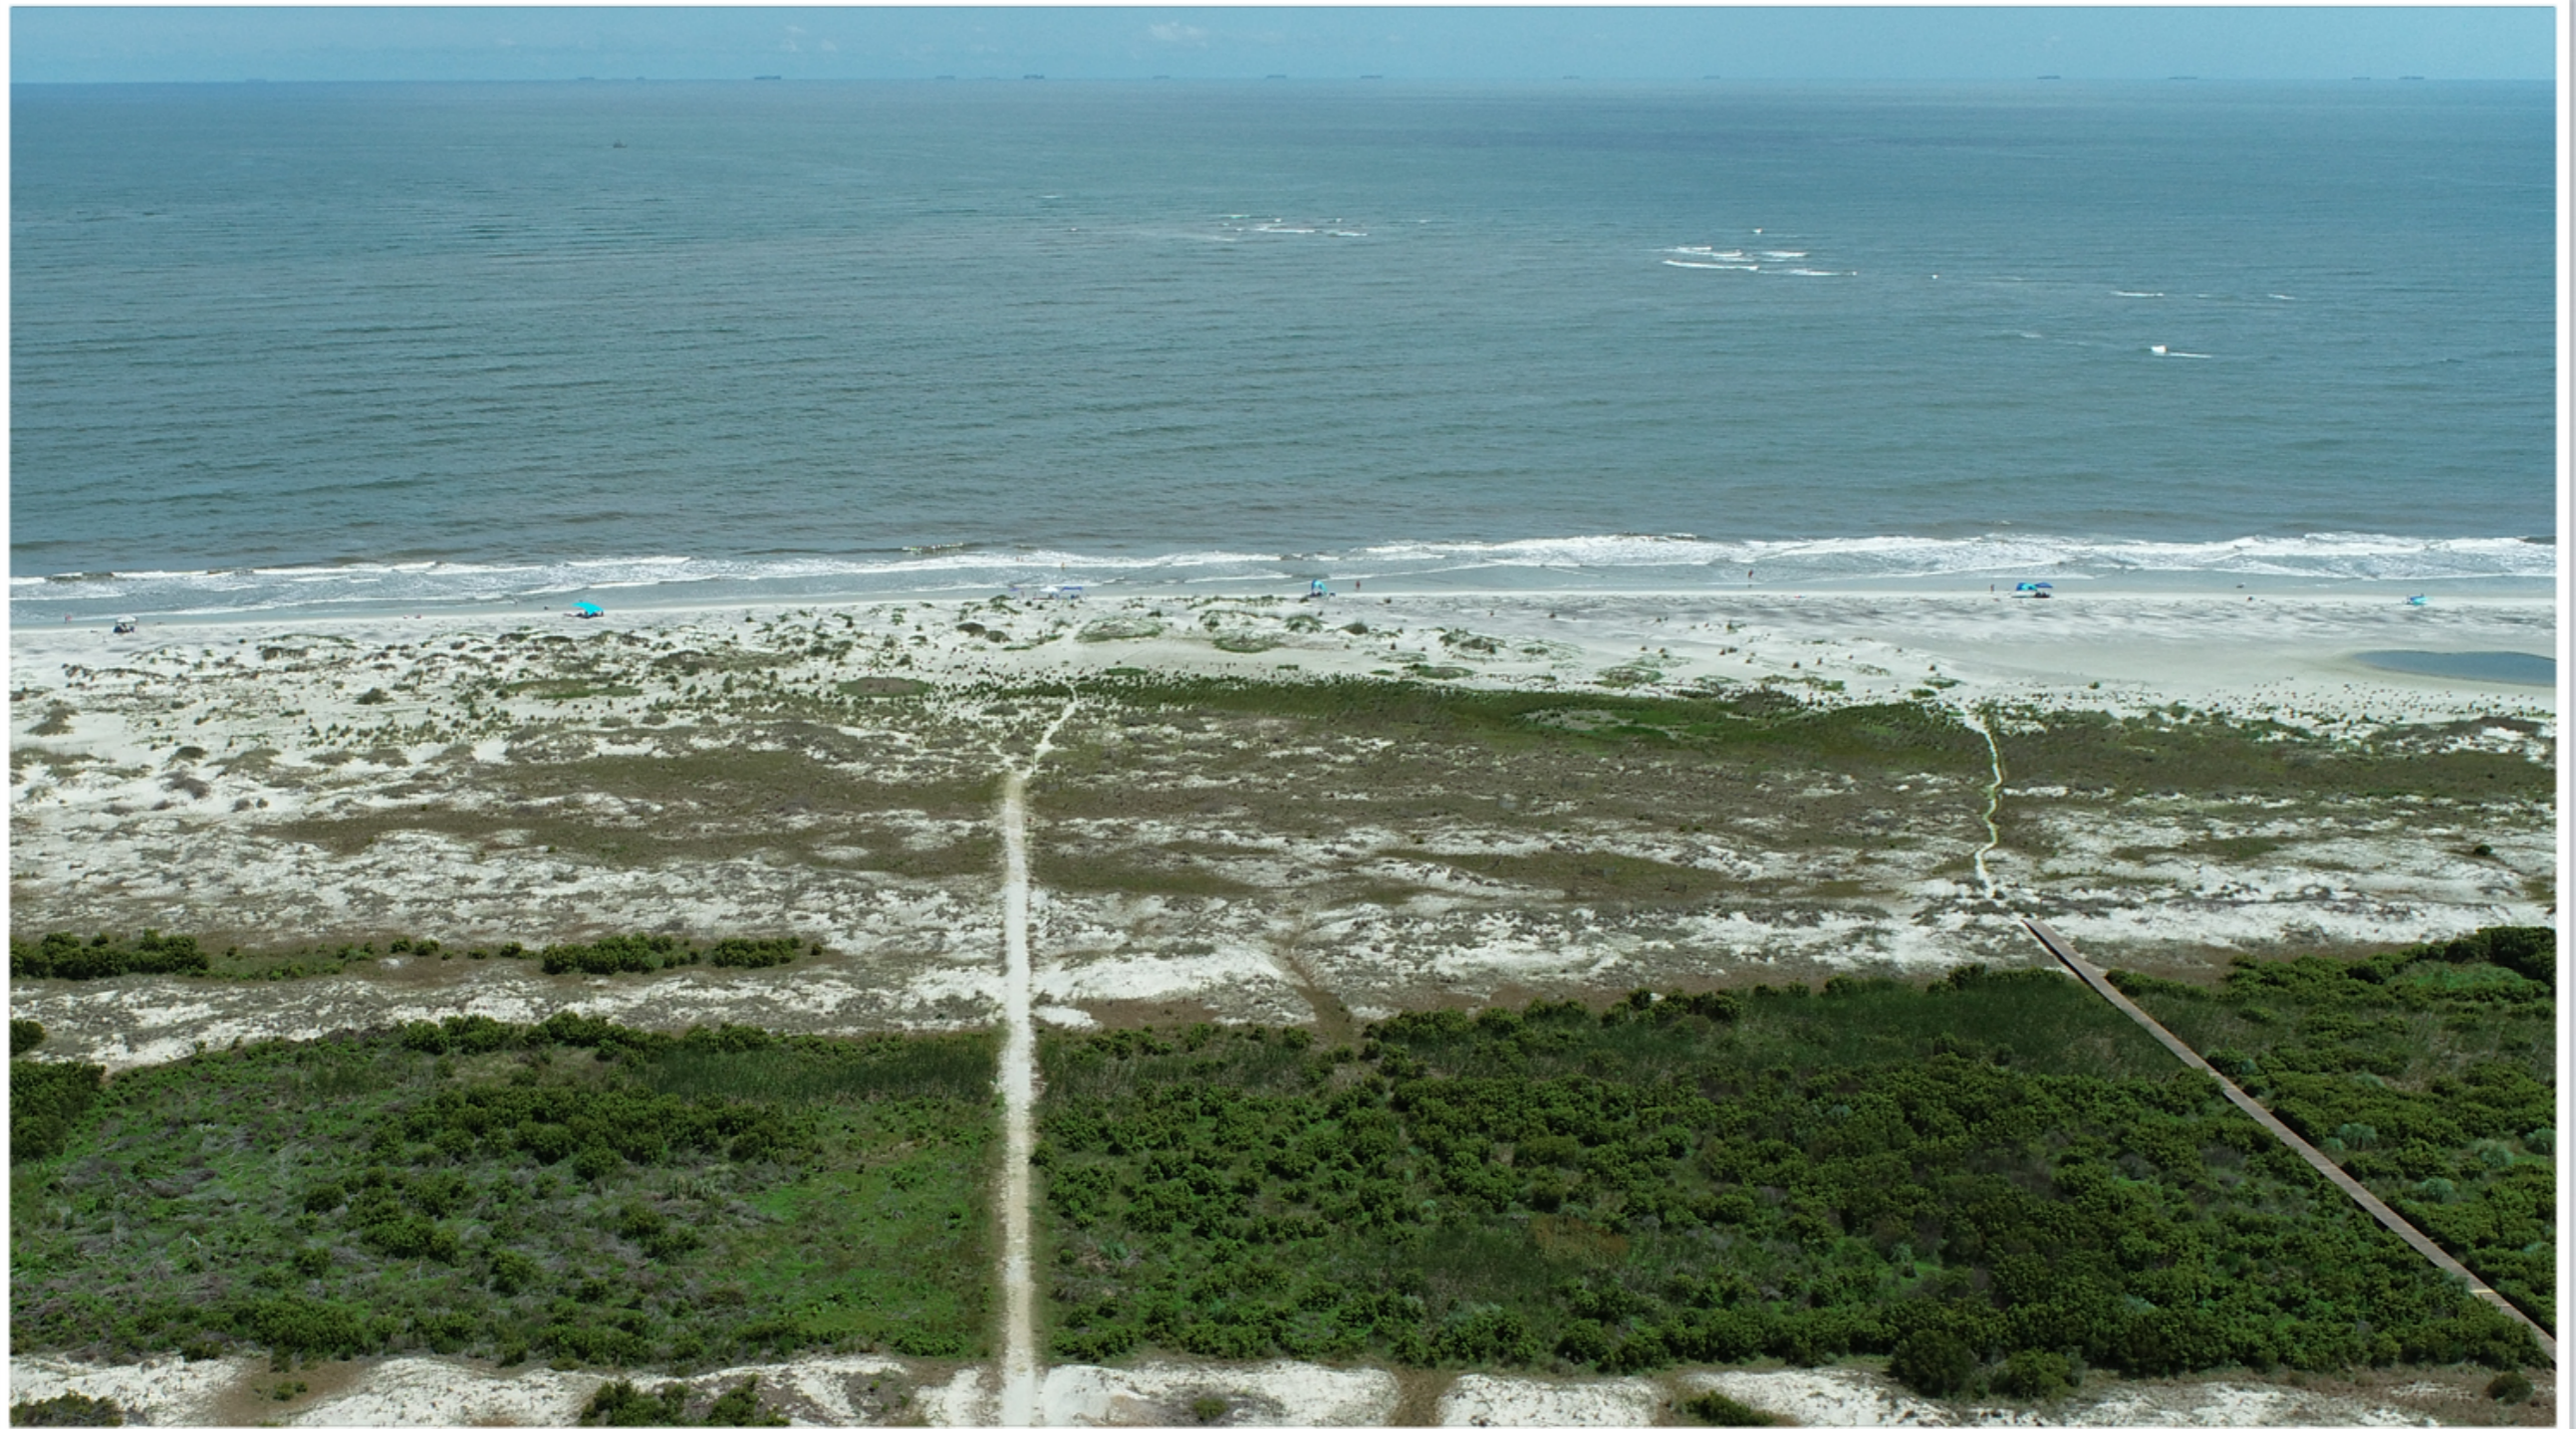
The view directly over access #4. The last shoal that came ashore came directly in front of this access, the new one appears to be forming further down the beach, closer to access #5, but because the shoal is still below the surface, it's subject to a lot of shifting and movement, and as such, it's too early to declare for sure.

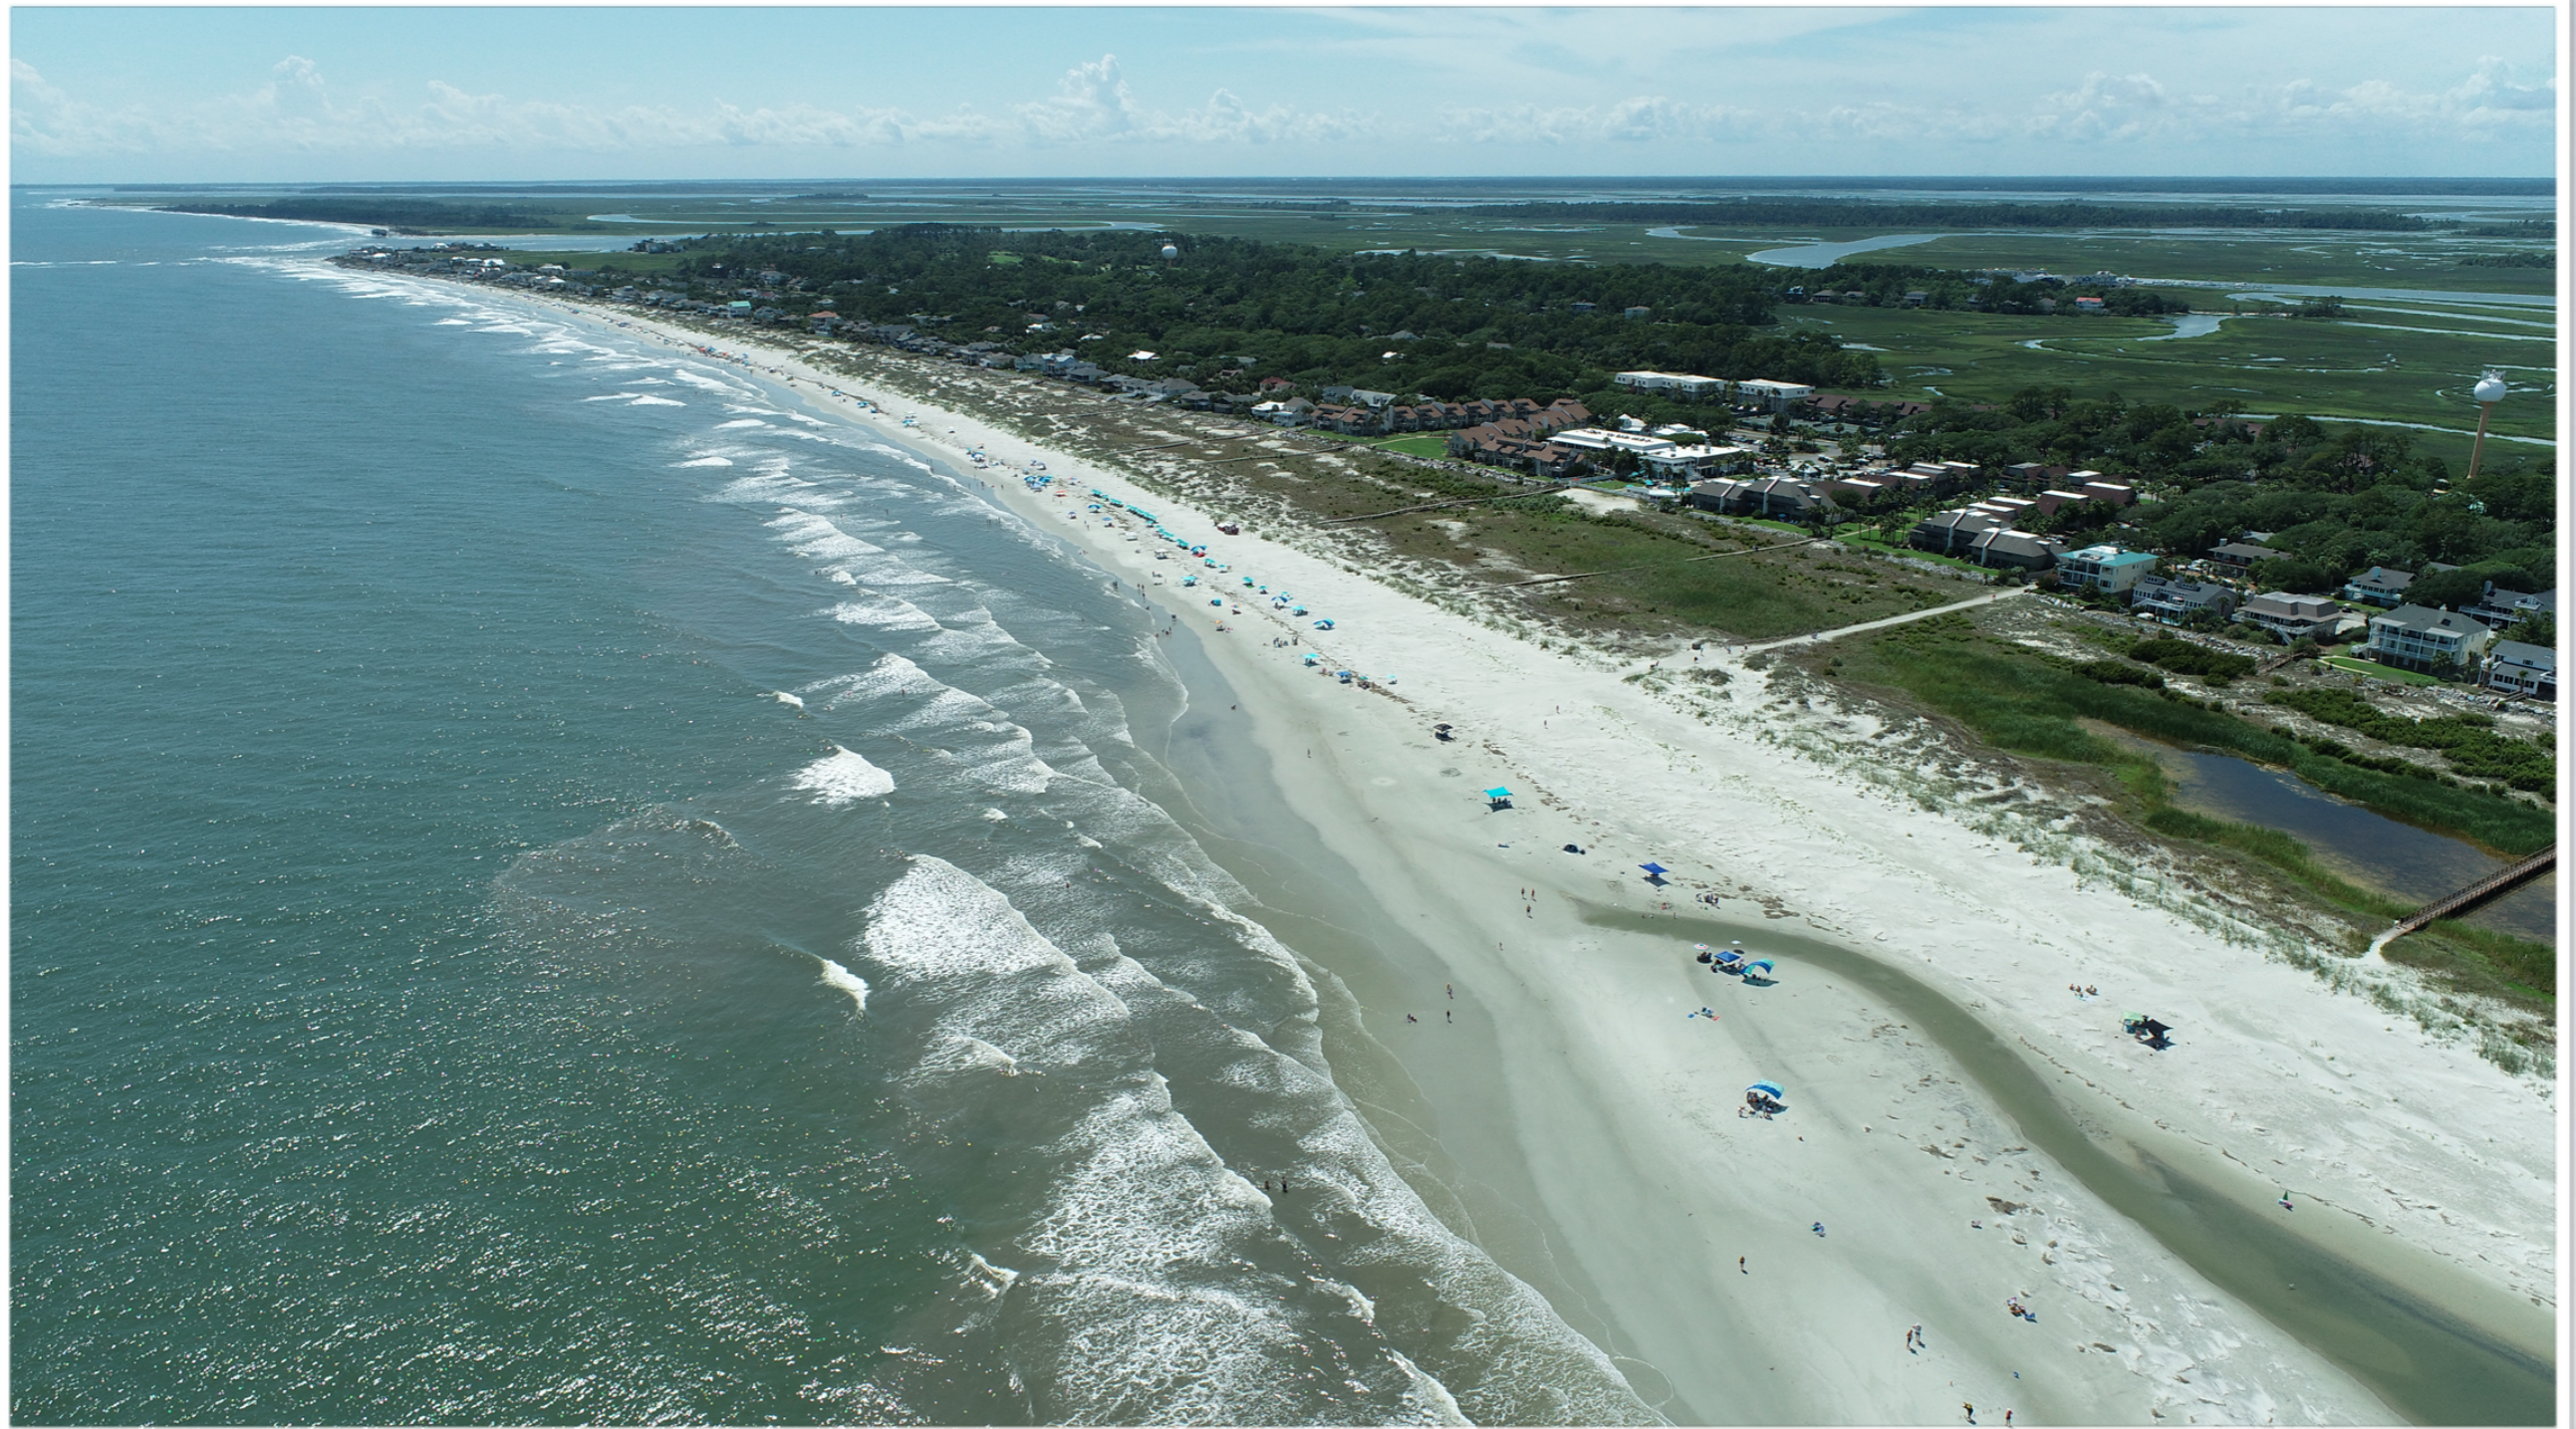
View looking towards Beach Club and Captain John Fripp Villas shows how much vegetation exists in between the beach and the rock revetment. Sand continues to migrate down the beach and build in front of these areas.

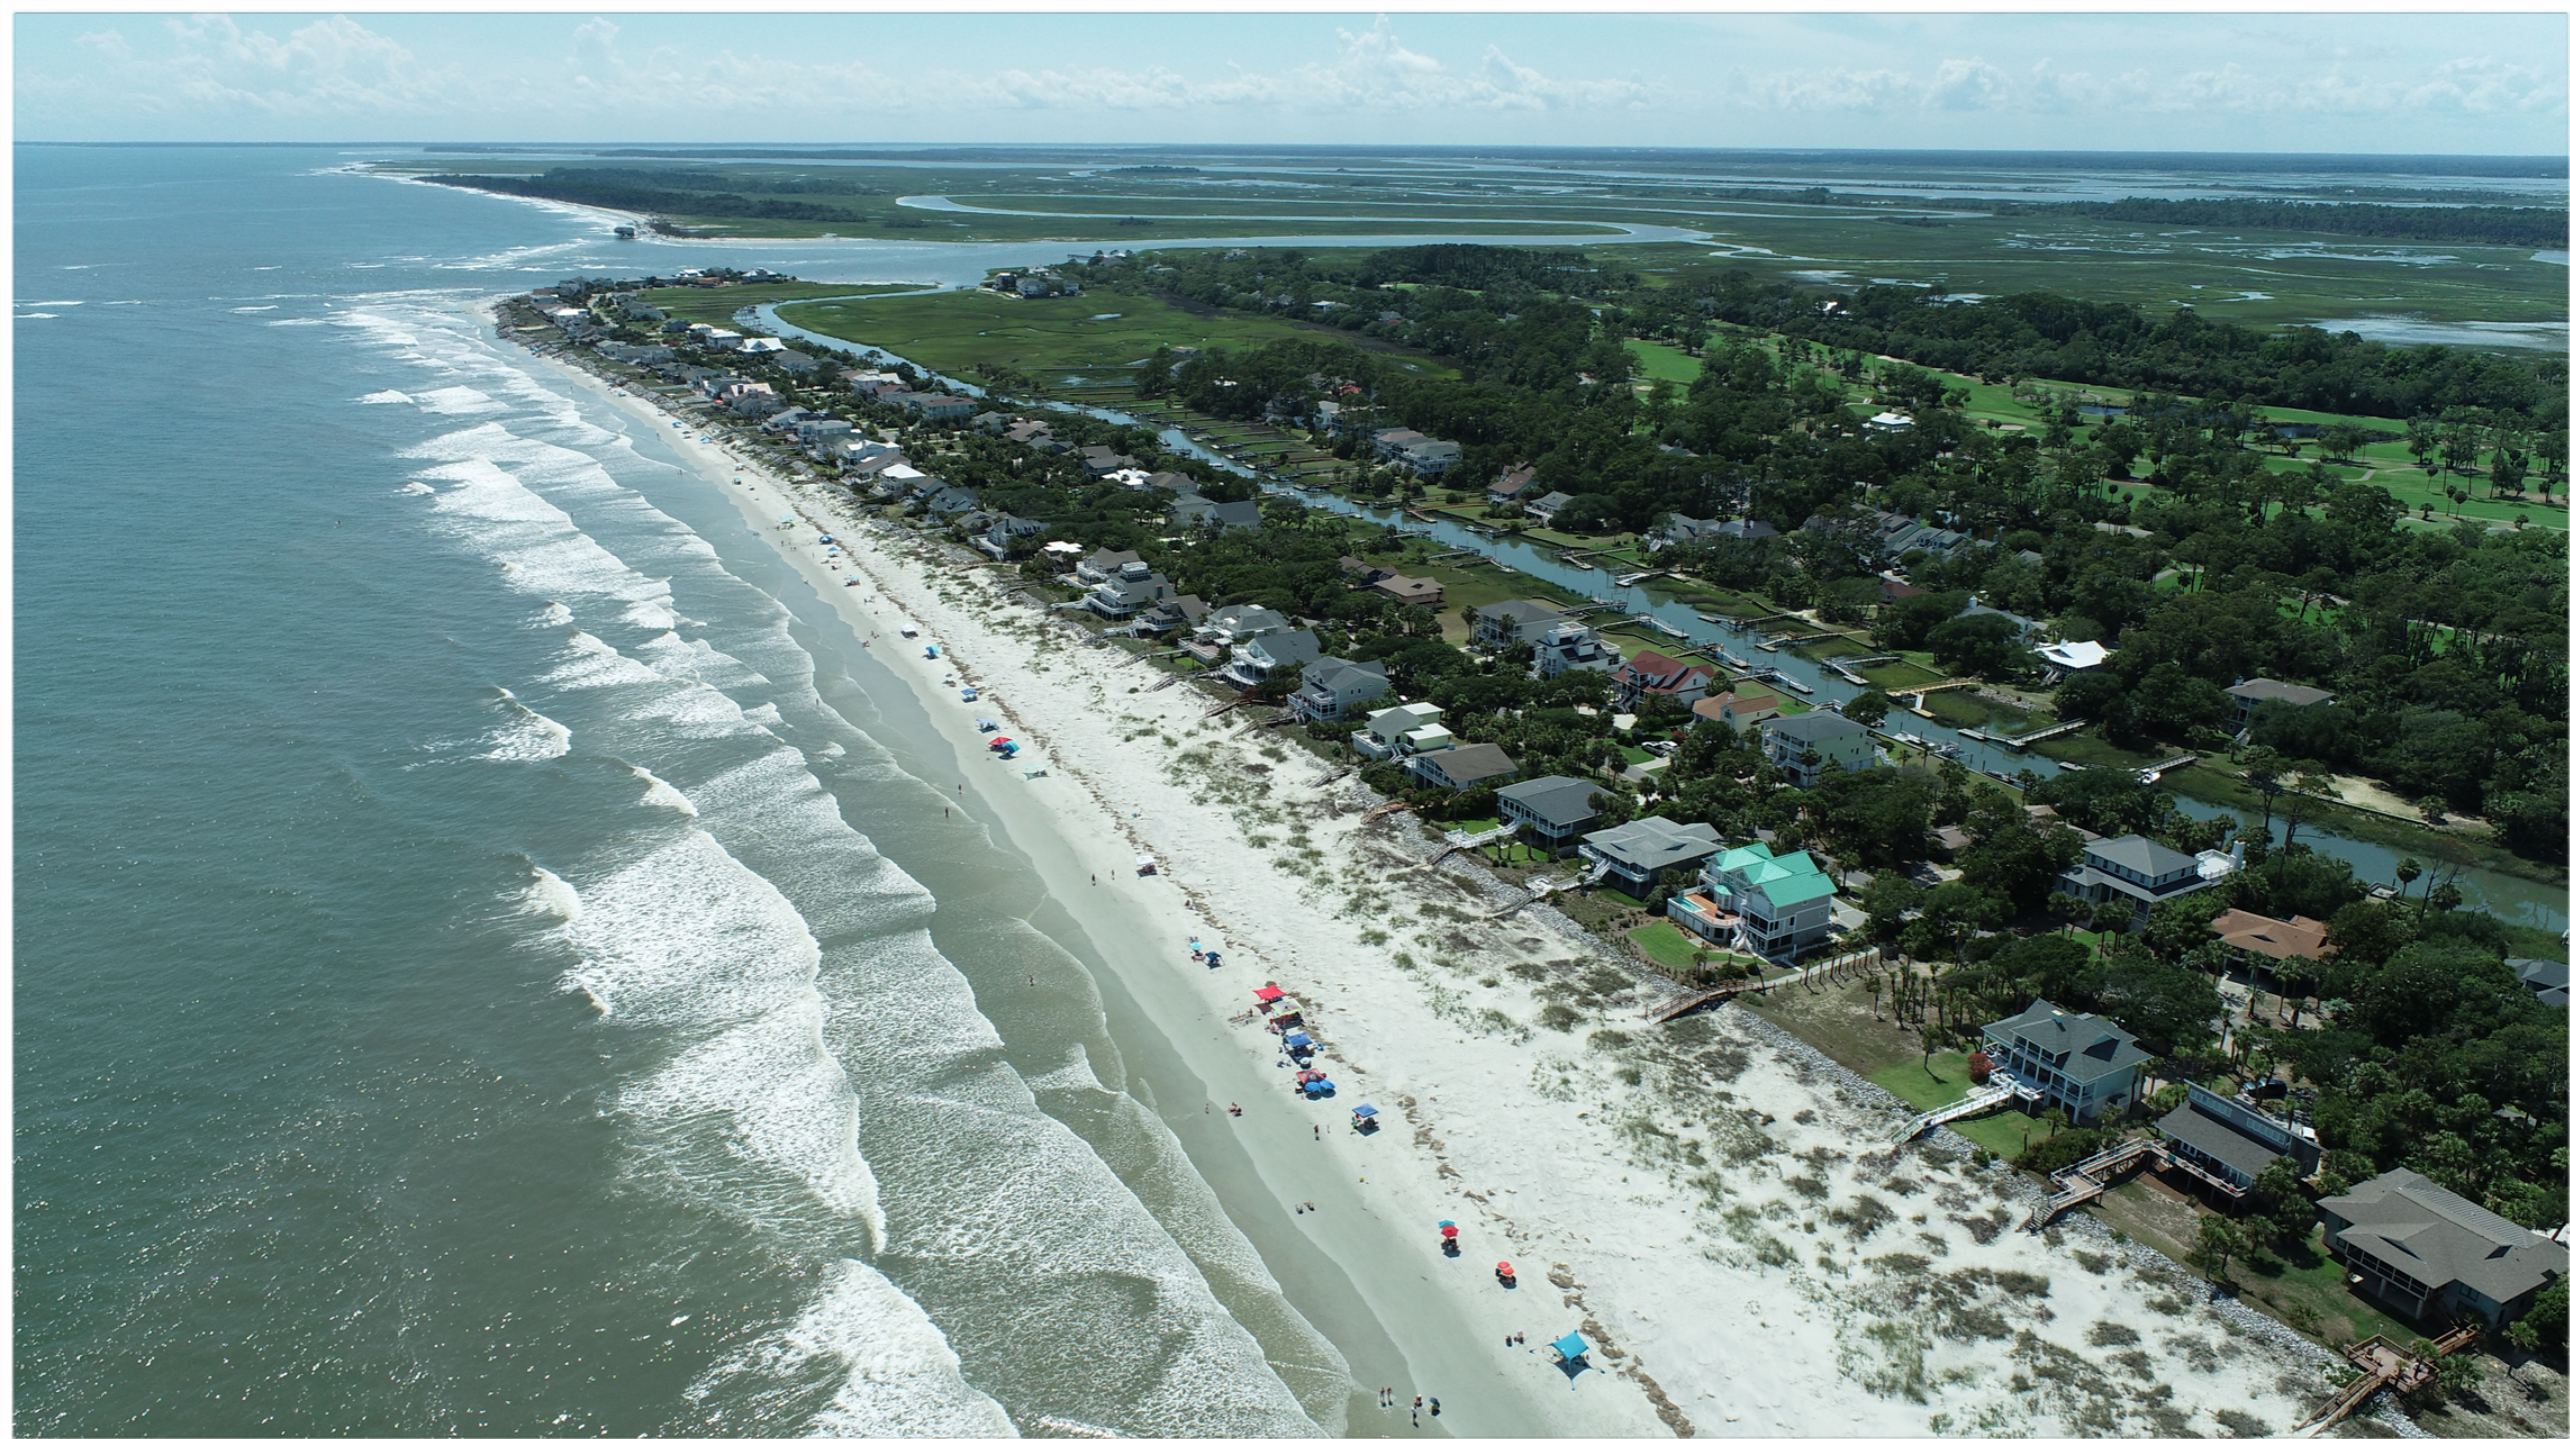
Sand and dunes are forming almost to the south end. The wrack line continues to inch its way down to the corner.

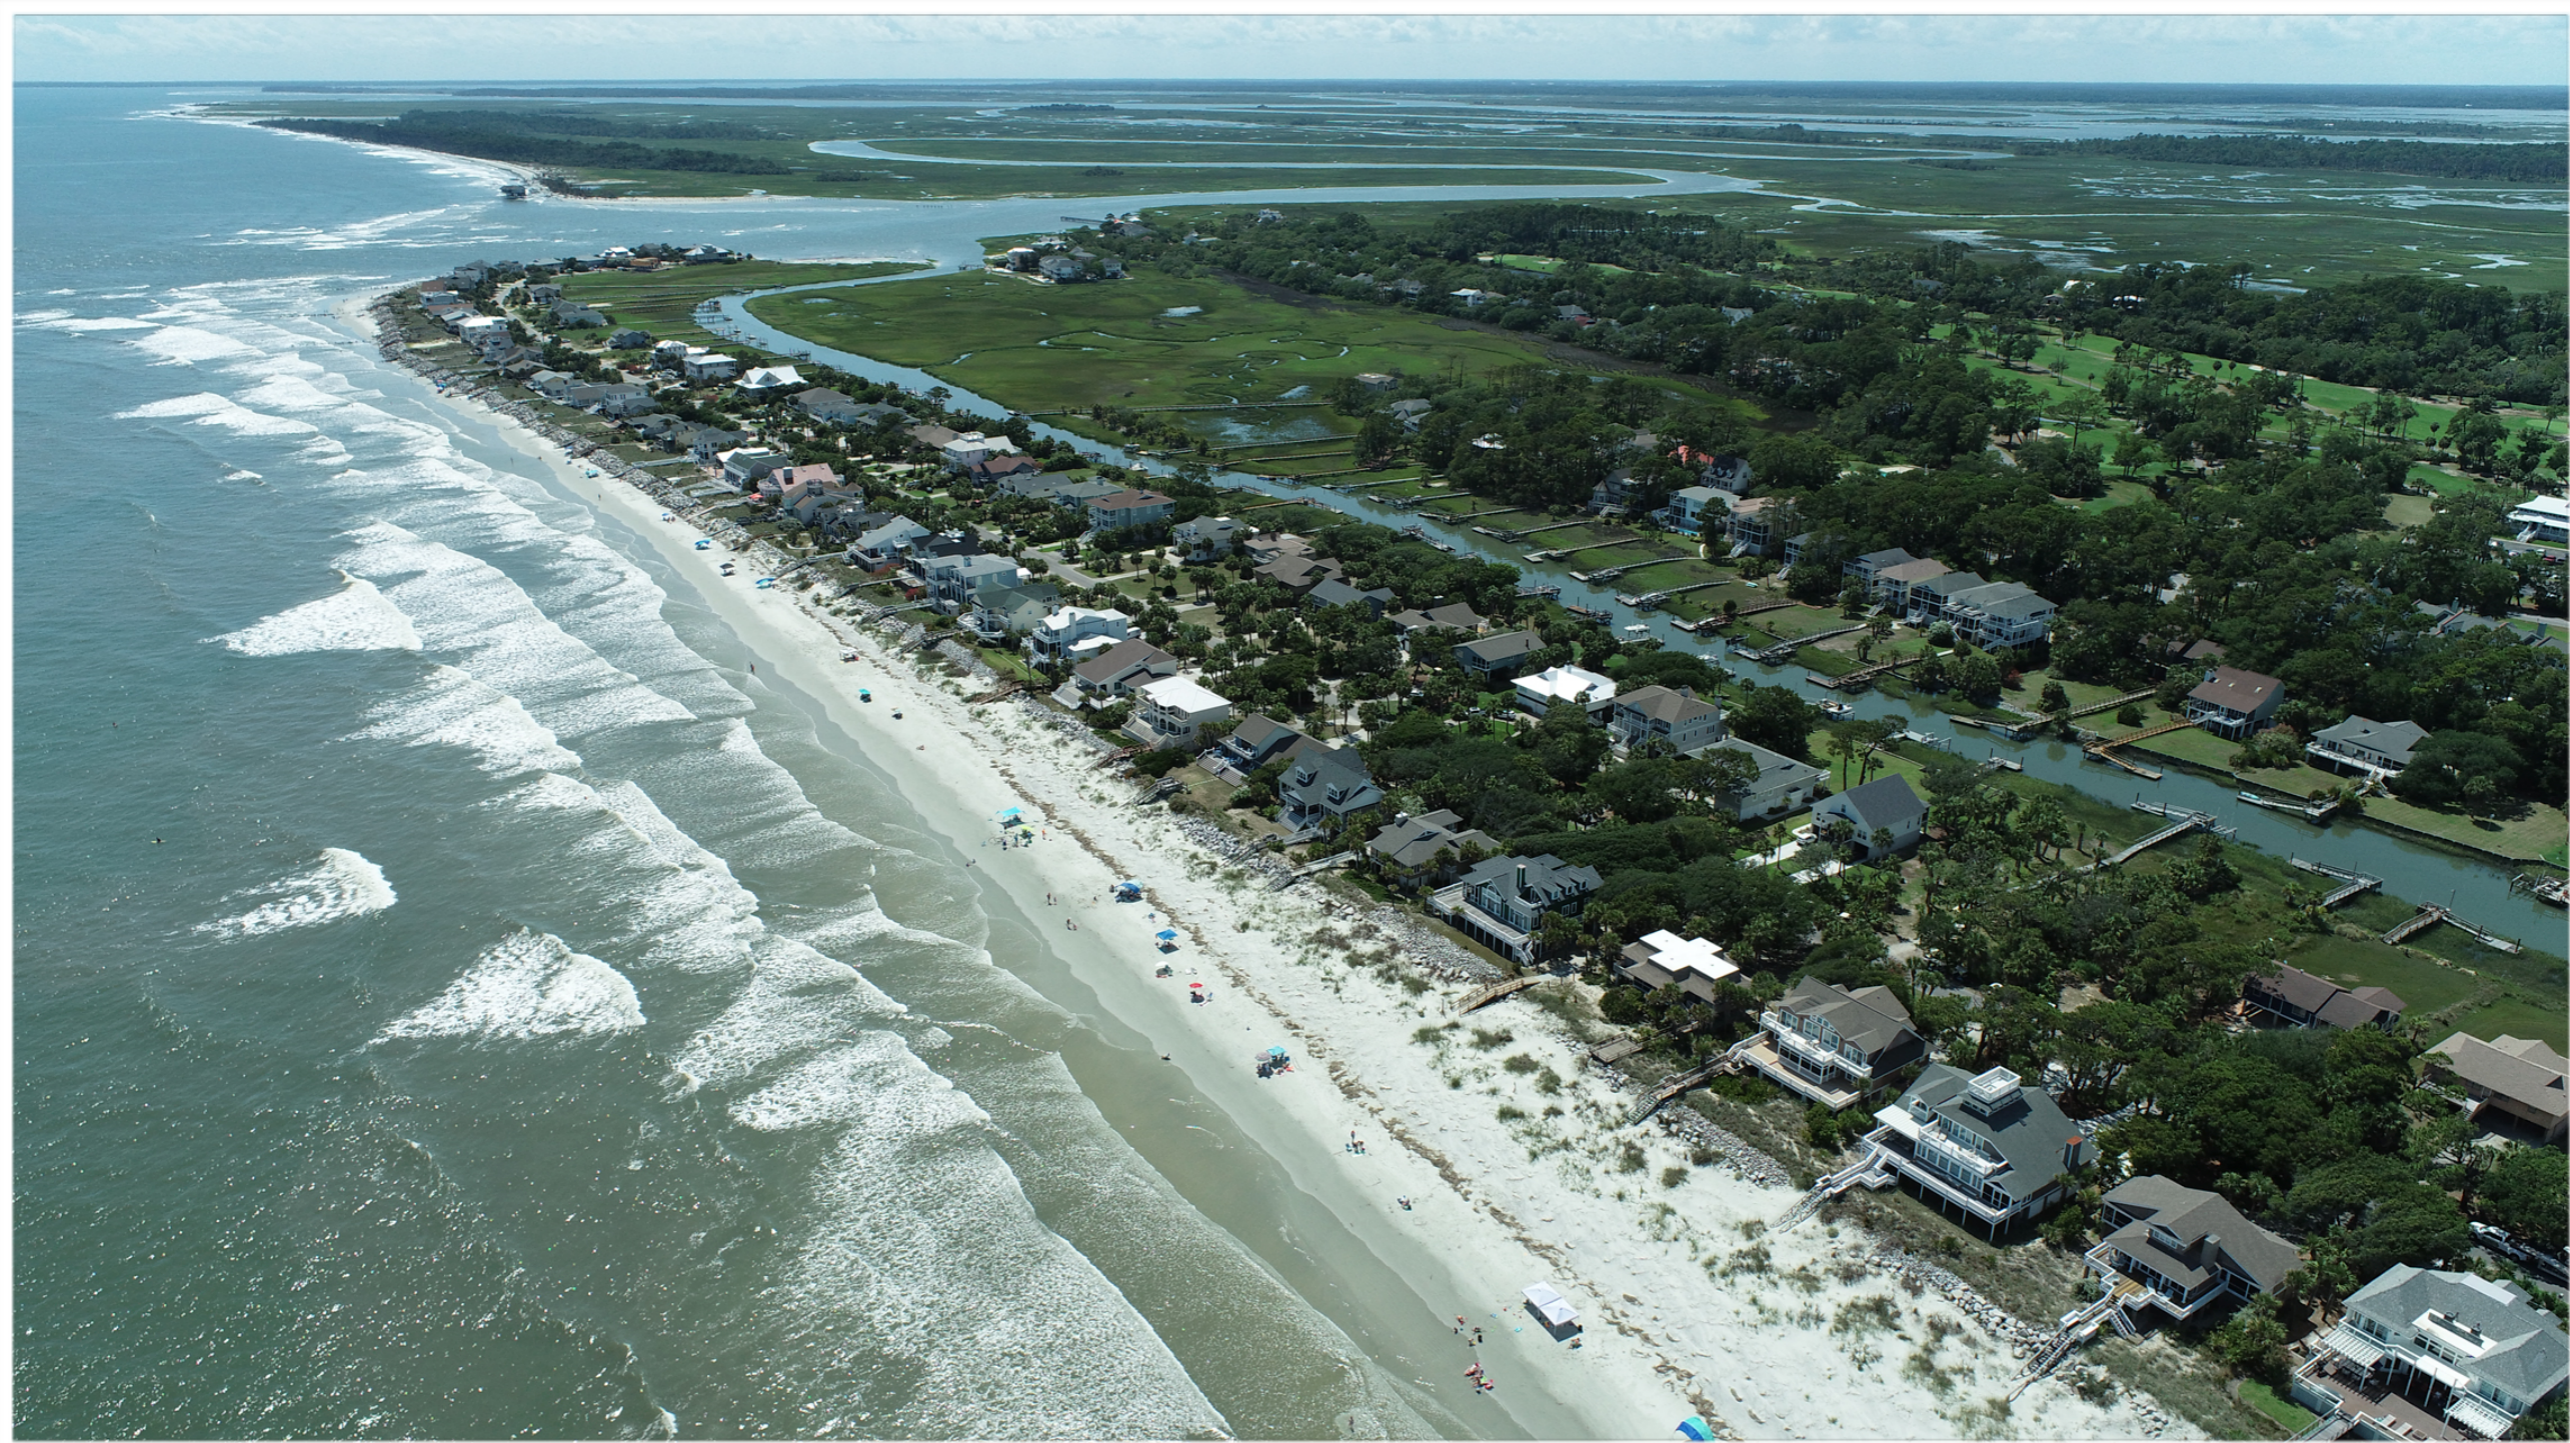
These photos were taken at high tide. A person can walk all the way to the corner of Skull Creek Inlet and experience only a small area of damp sand, but no depth to the surf coming ashore.

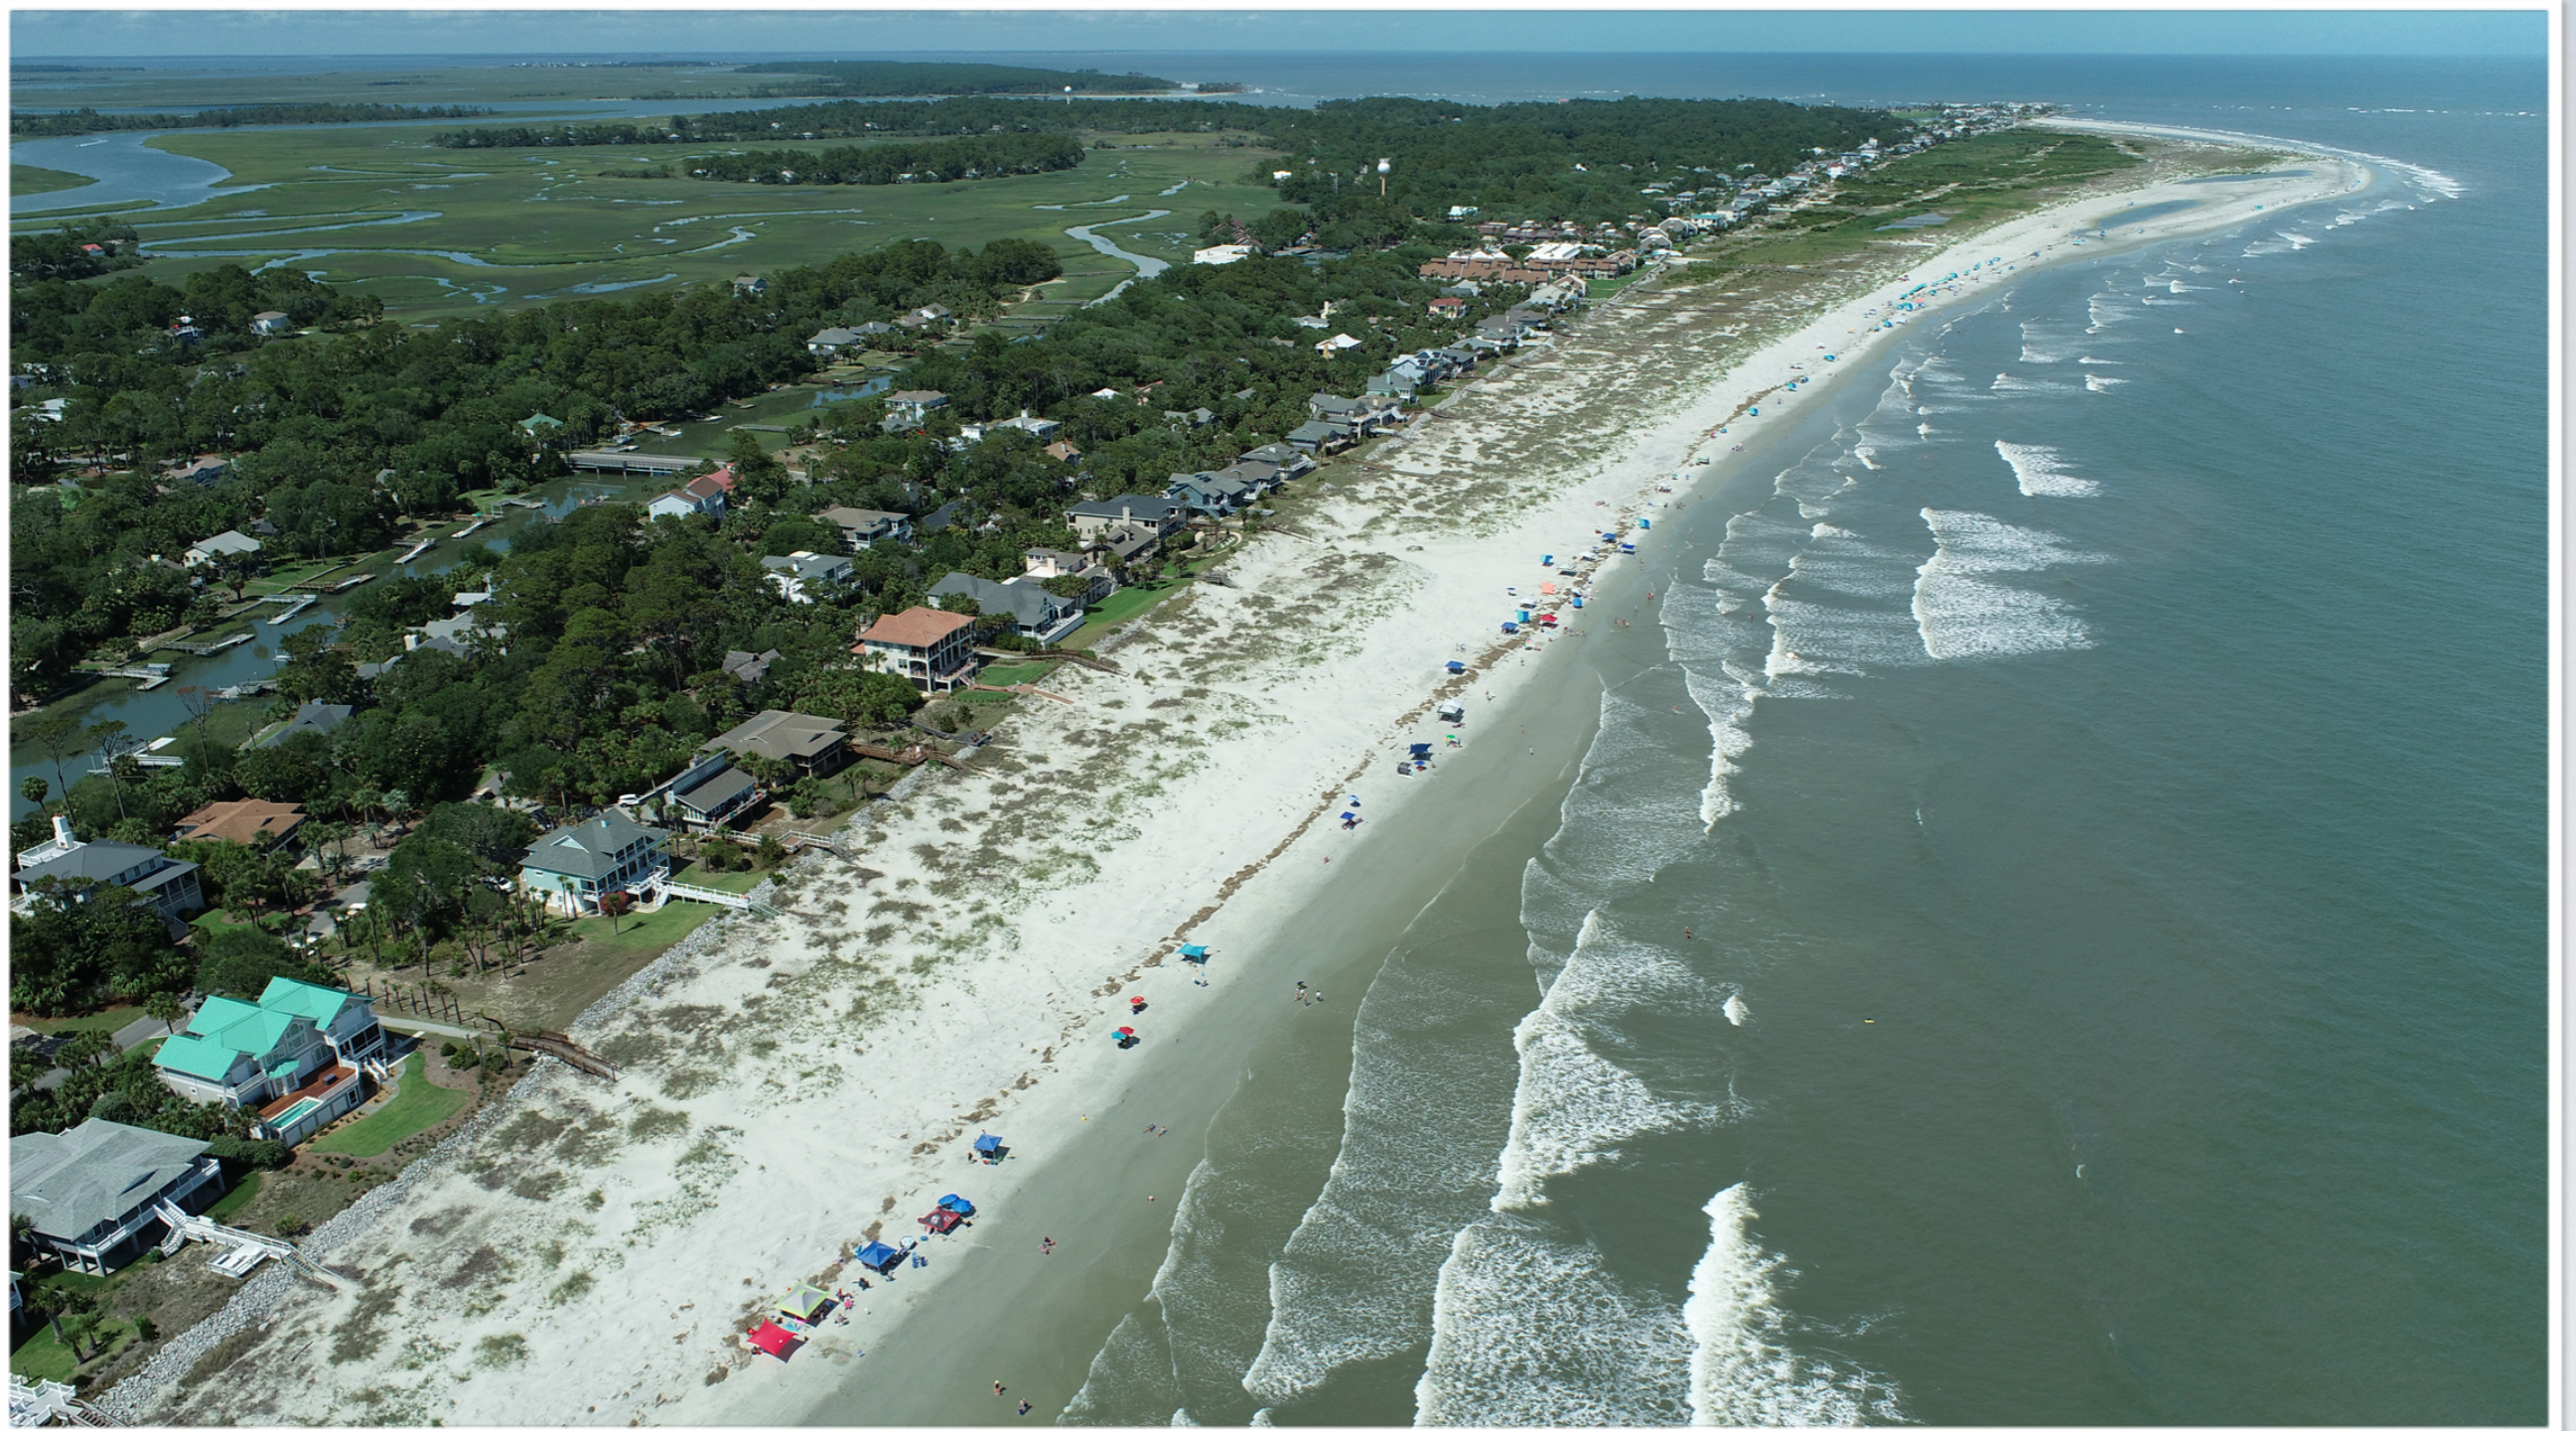
Looking back up the beach reveals areas where sand dunes are converting to lush-green vegetation areas. Also, pockets of high traffic areas can be seen along the beach.

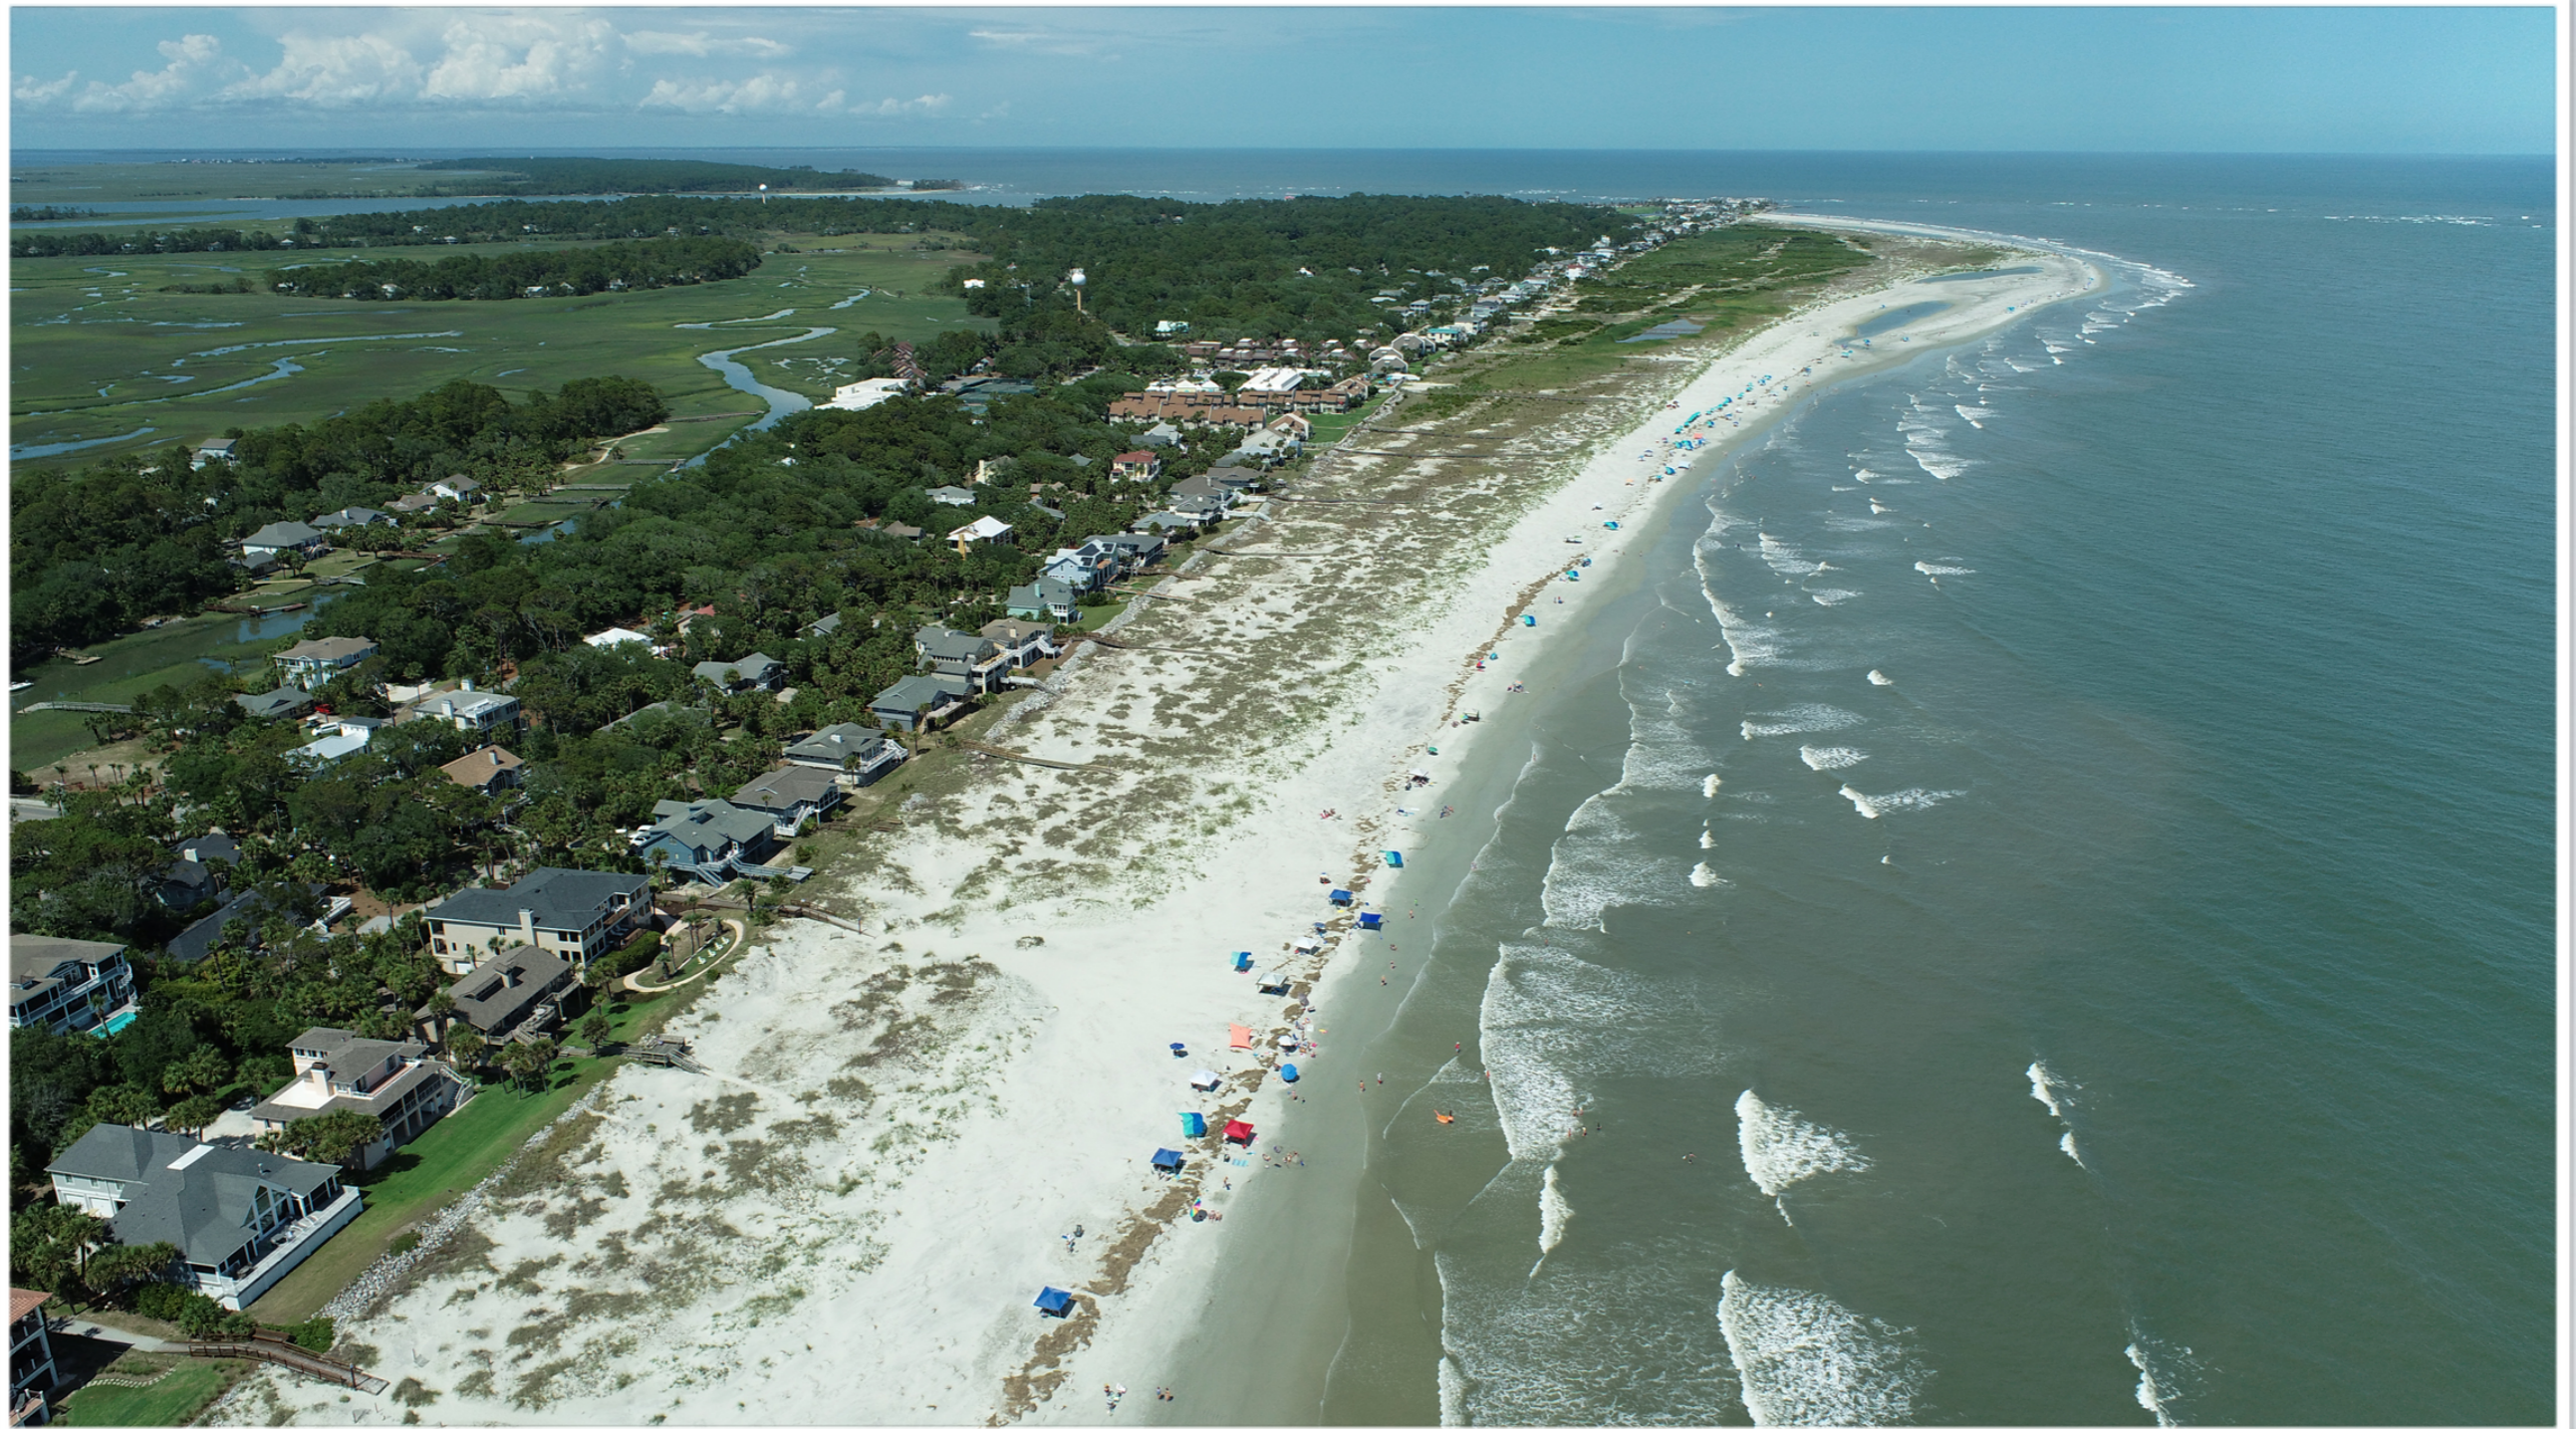
Bonito Road (access #21) in foreground, is the heaviest area of concentration. Note how heavy the sand trail through the dune is. The other high traffic area is Beach Club/Captain John Fripp Villas.
