BEACH STATUS

Aerial Observations - high tide
June 8, 2022

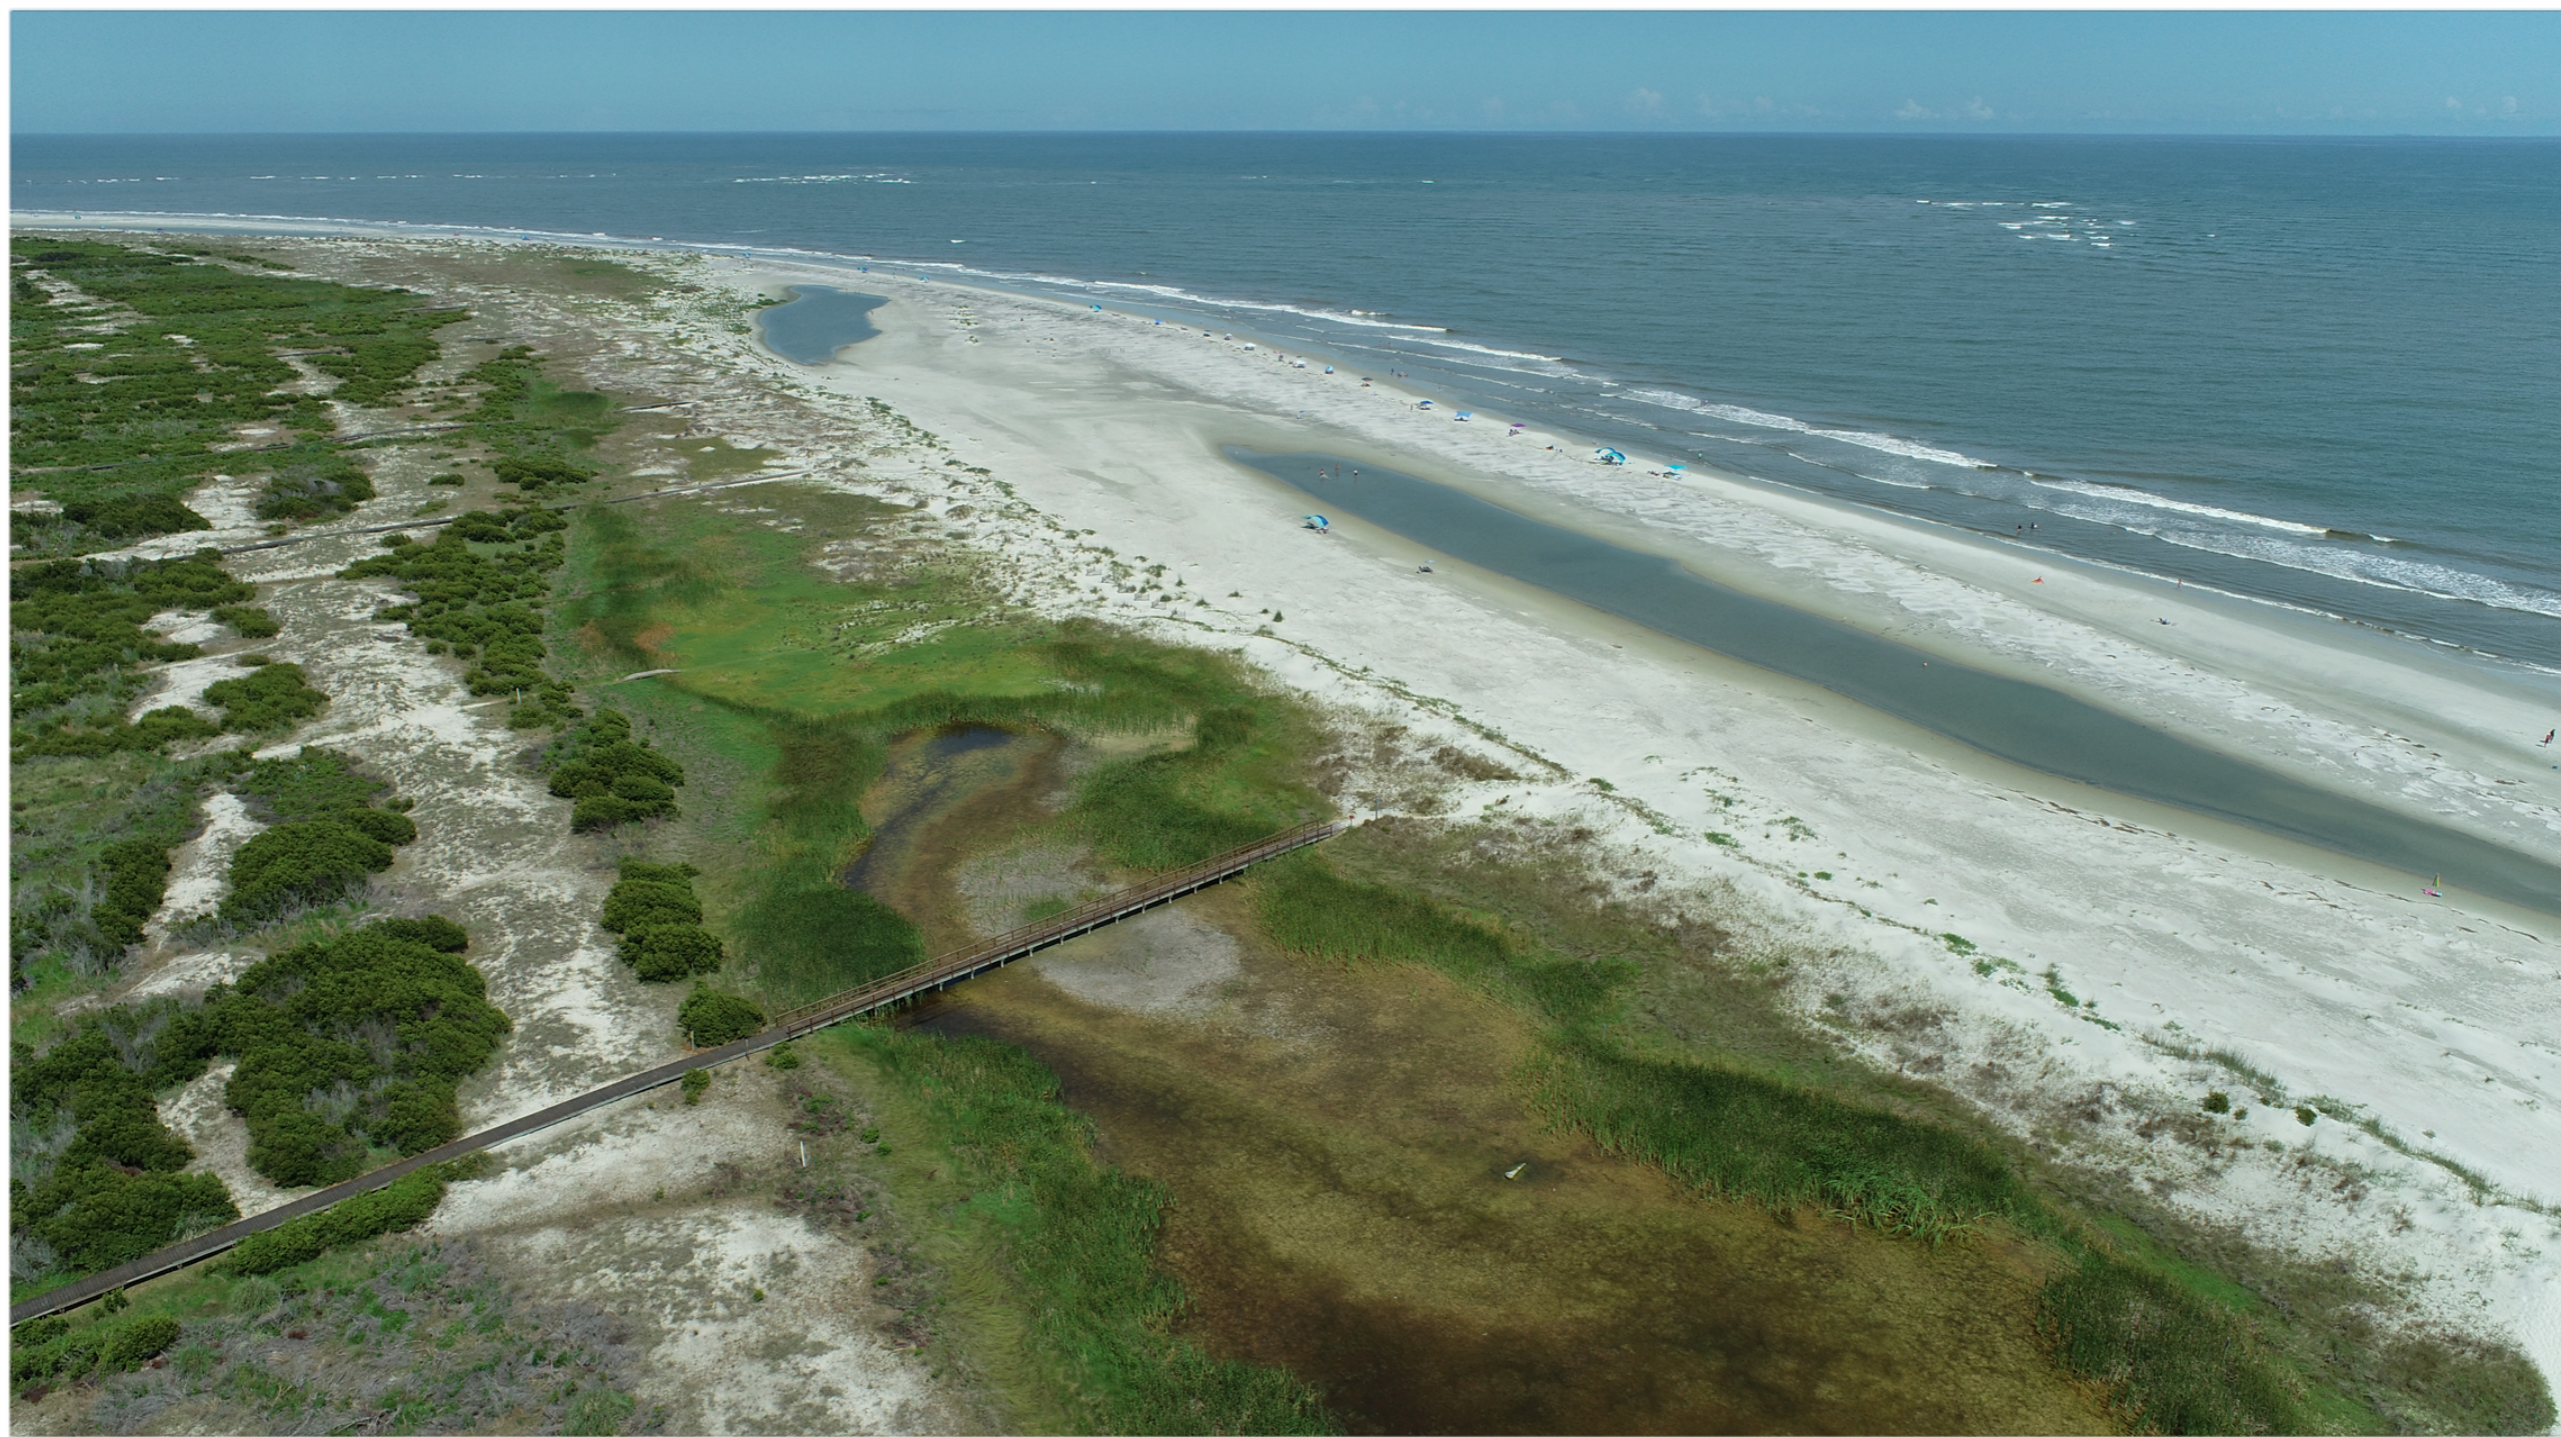
Access #13 and #14 bridge an older tide pool that has long been cut off from the sea. This area used to be all sand, with very little vegetation.

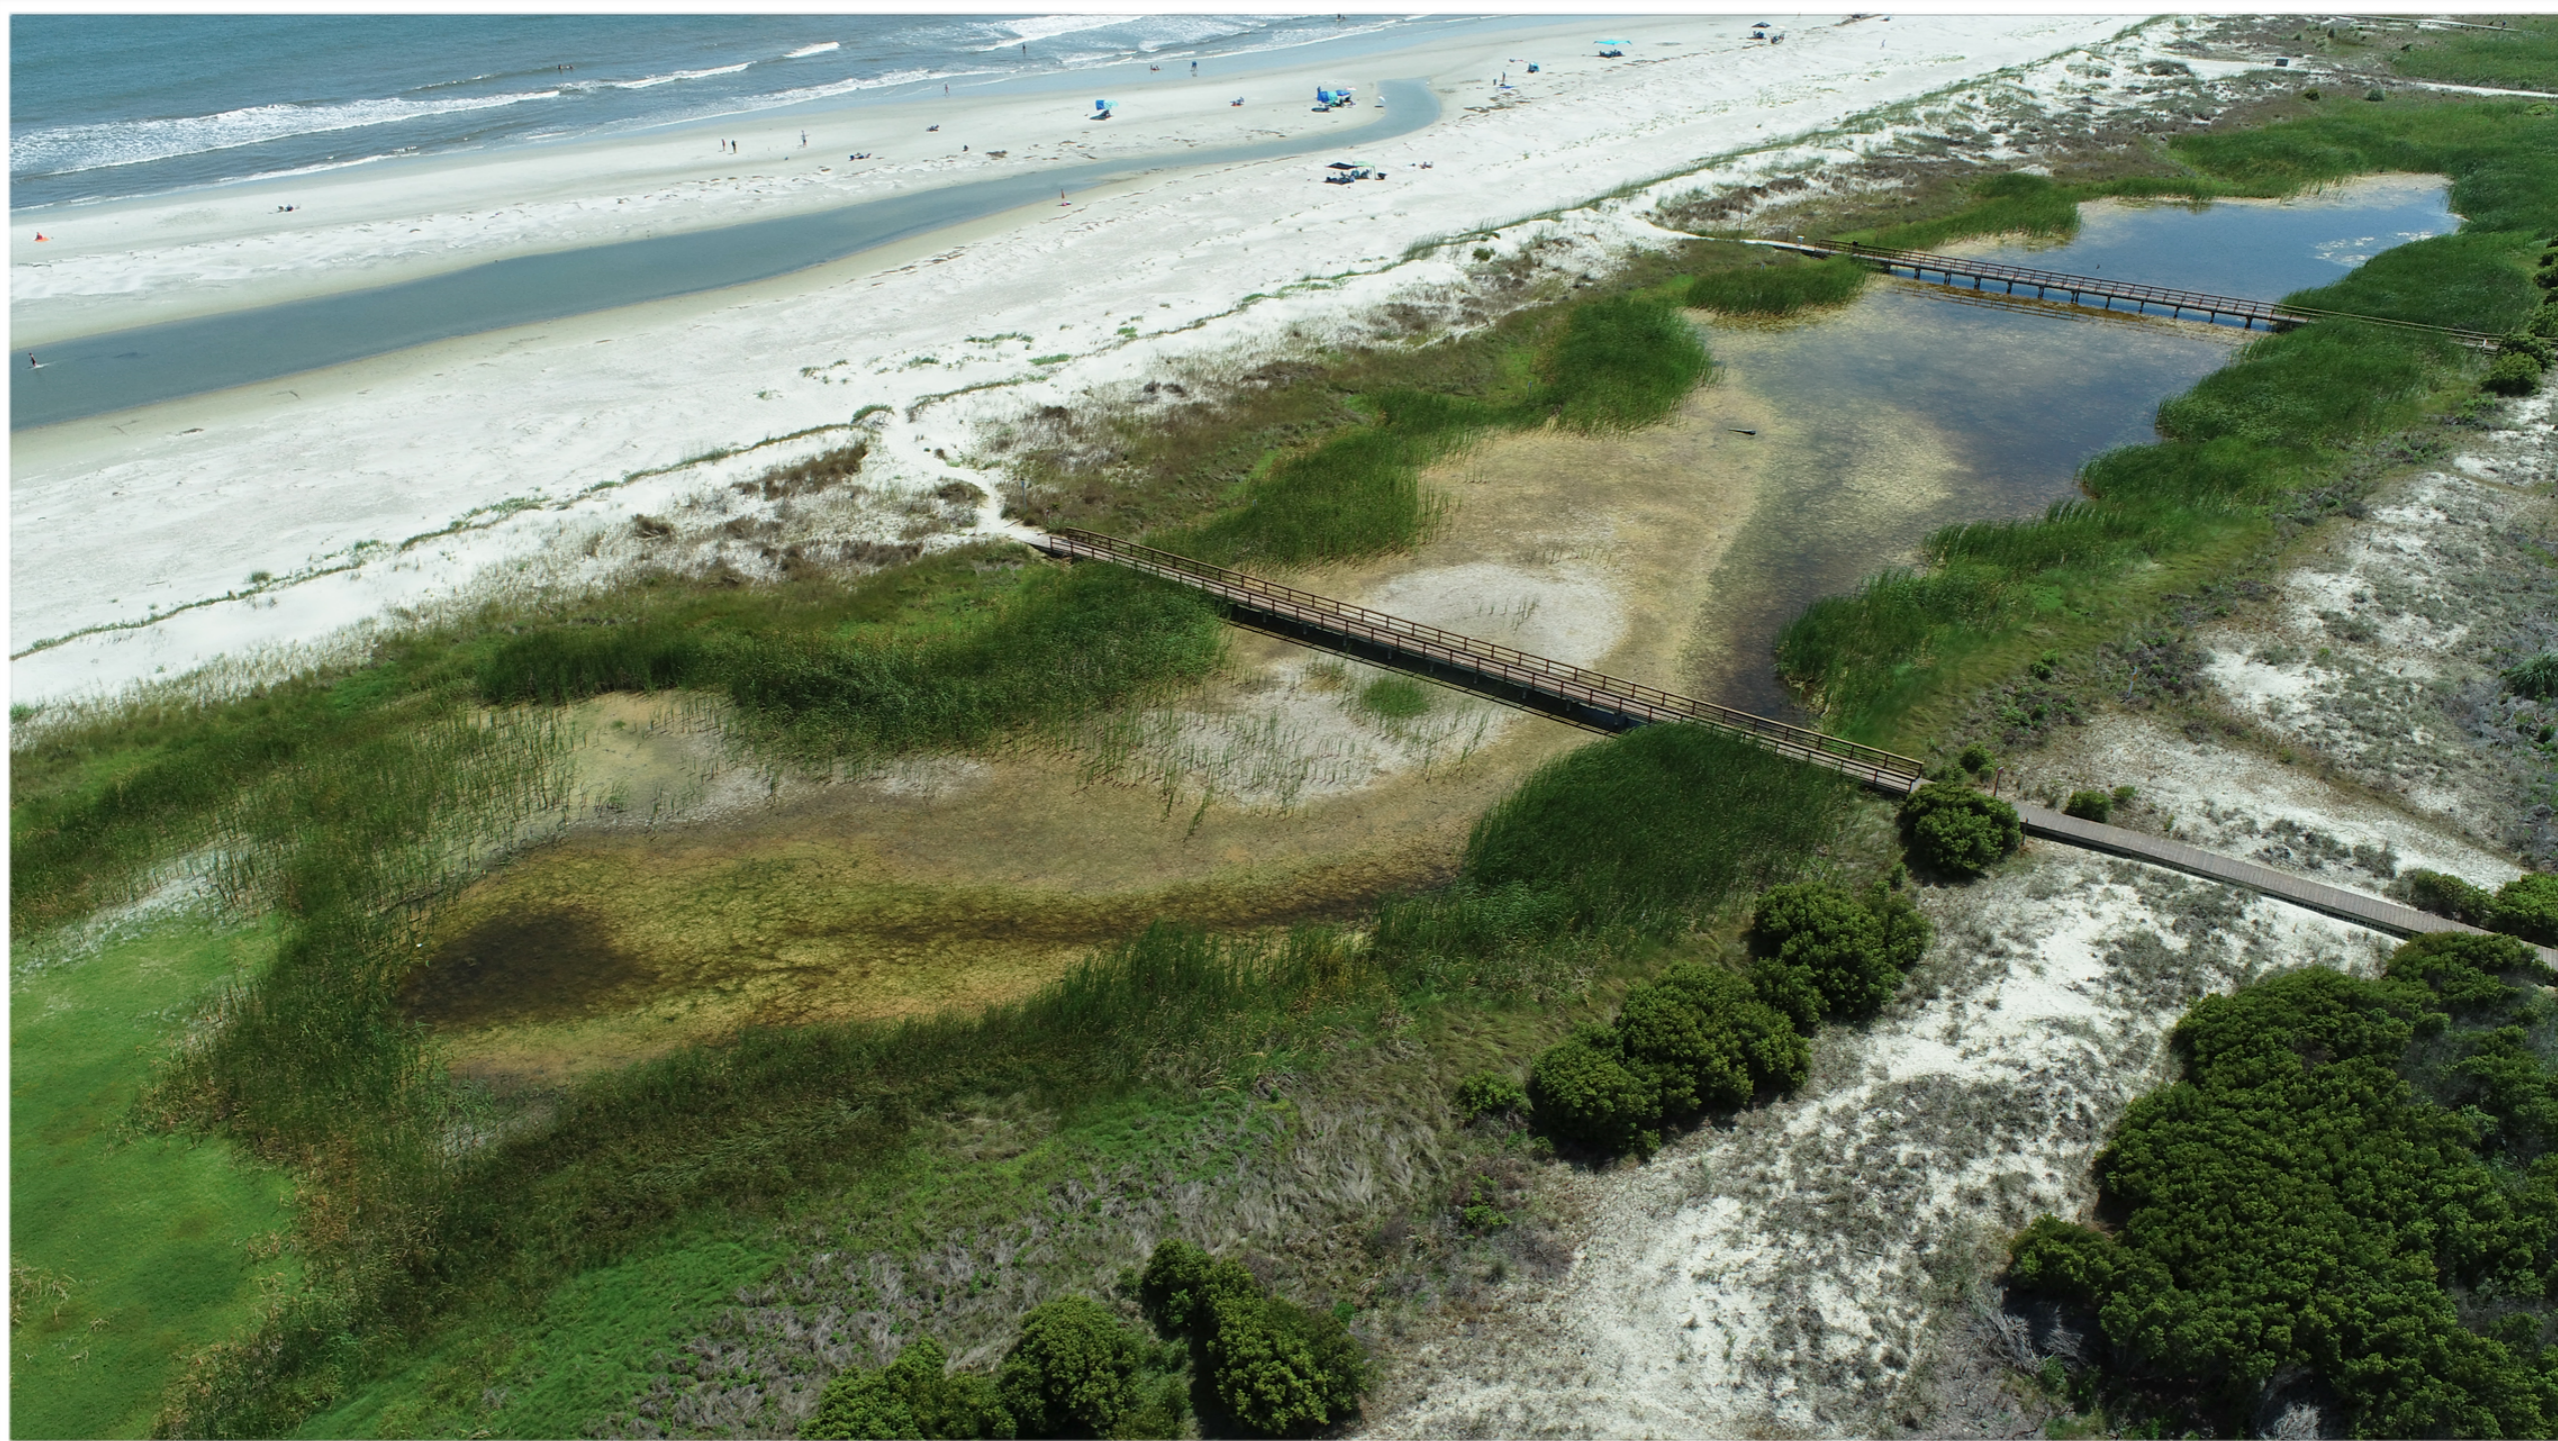
Another view shows the entirety of the water and the almost oasis-like condition of the vegetation around it in contrast to the stark beach.

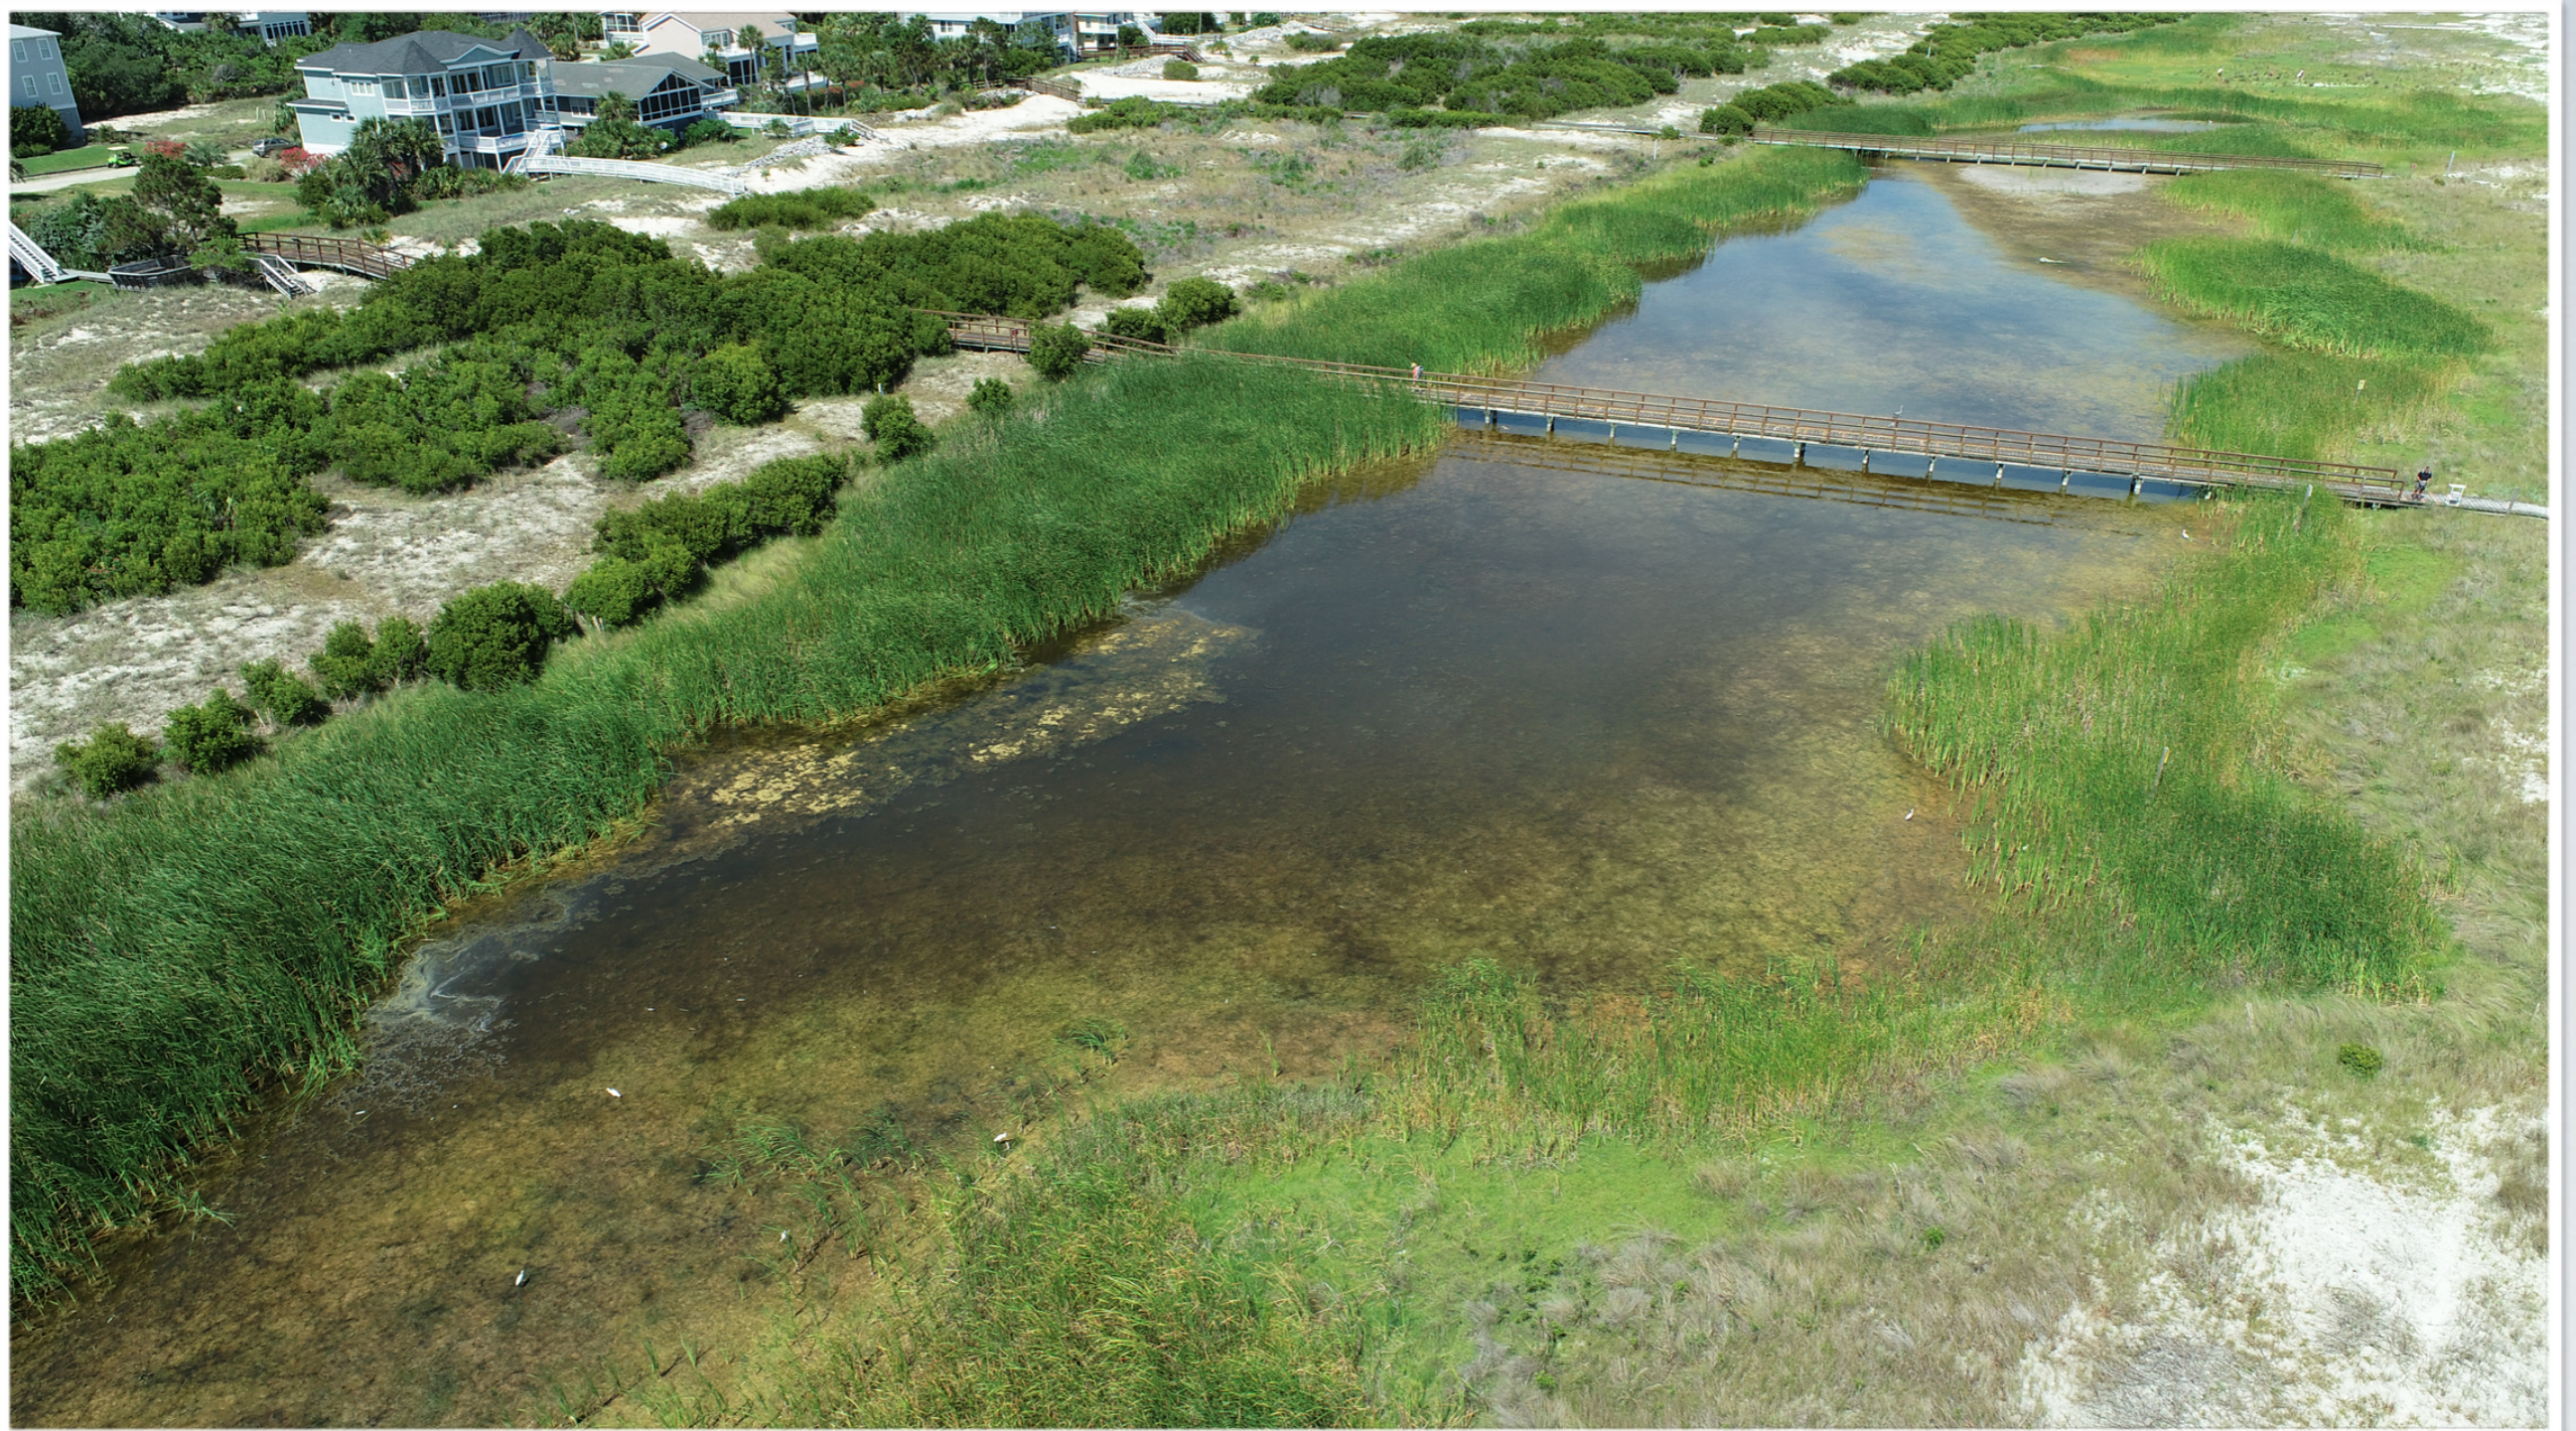
Access #14. The water is concentrated on this end and is very shallow. It's conceivable that this whole area may be dry soon because of evaporation and water usage by the vegetation.

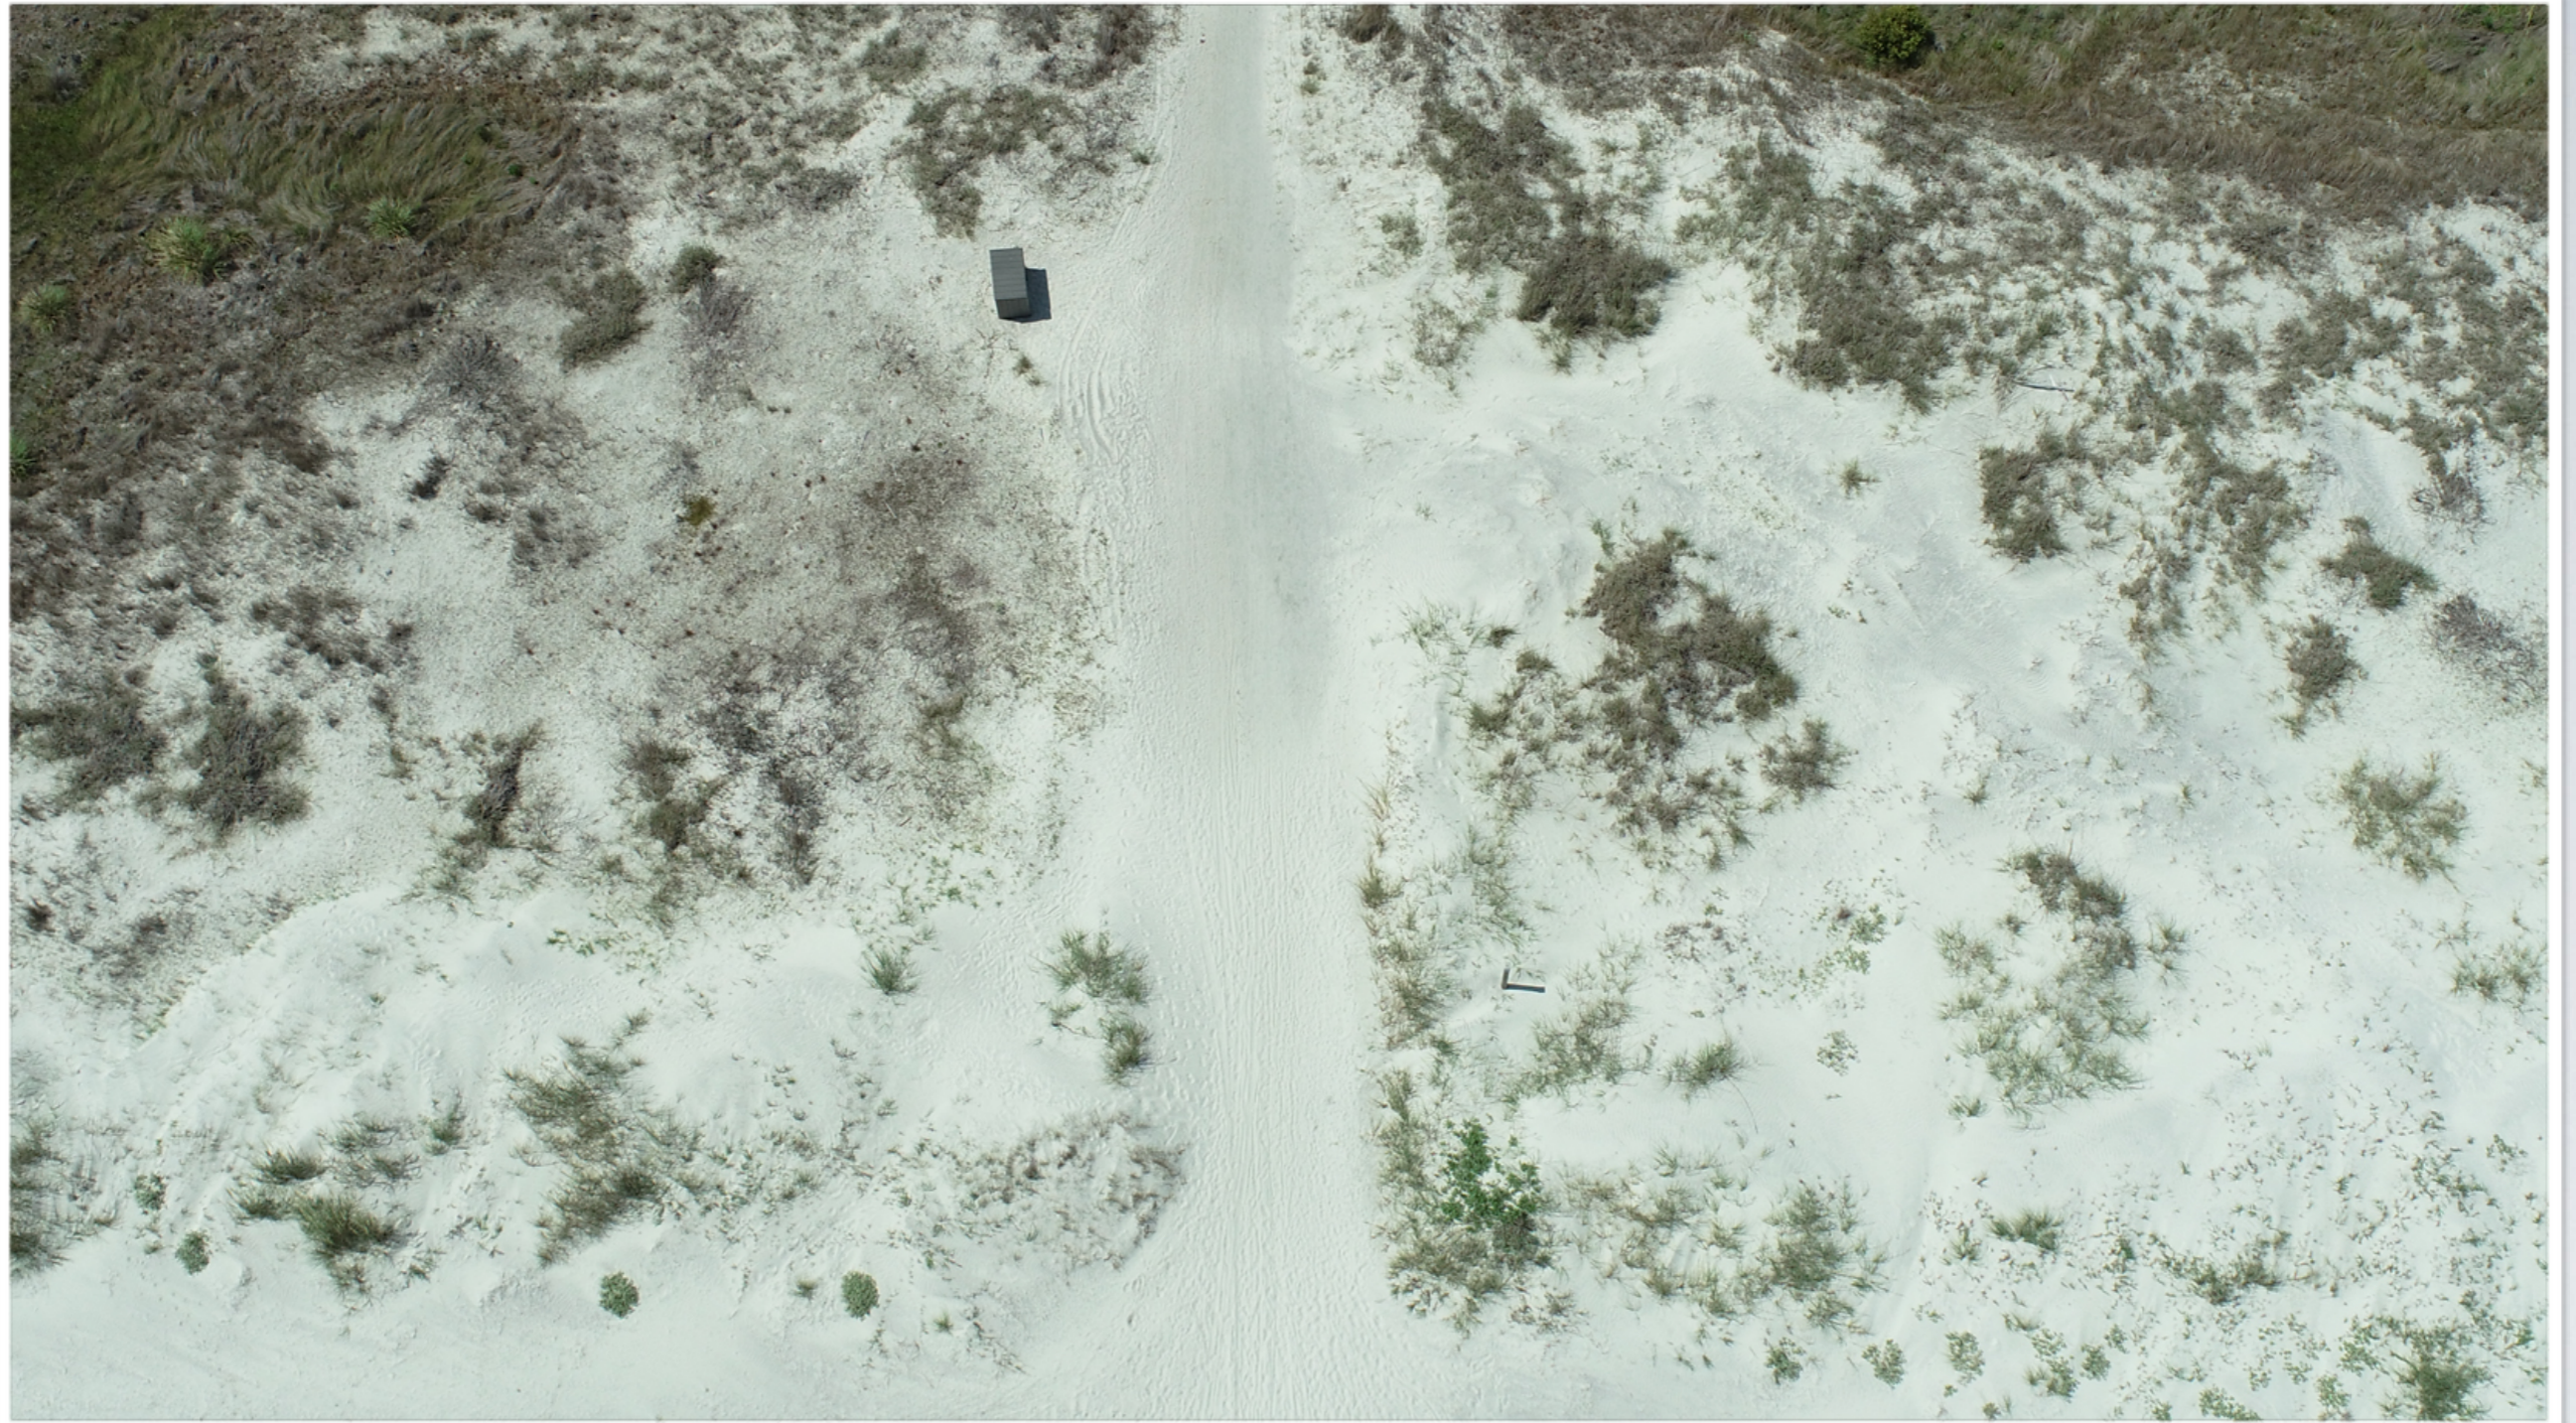
Access # 15. Closeup view. New sand dunes are forming at the end of the geo-webbing expanding the distance from the end of the access to the beach.

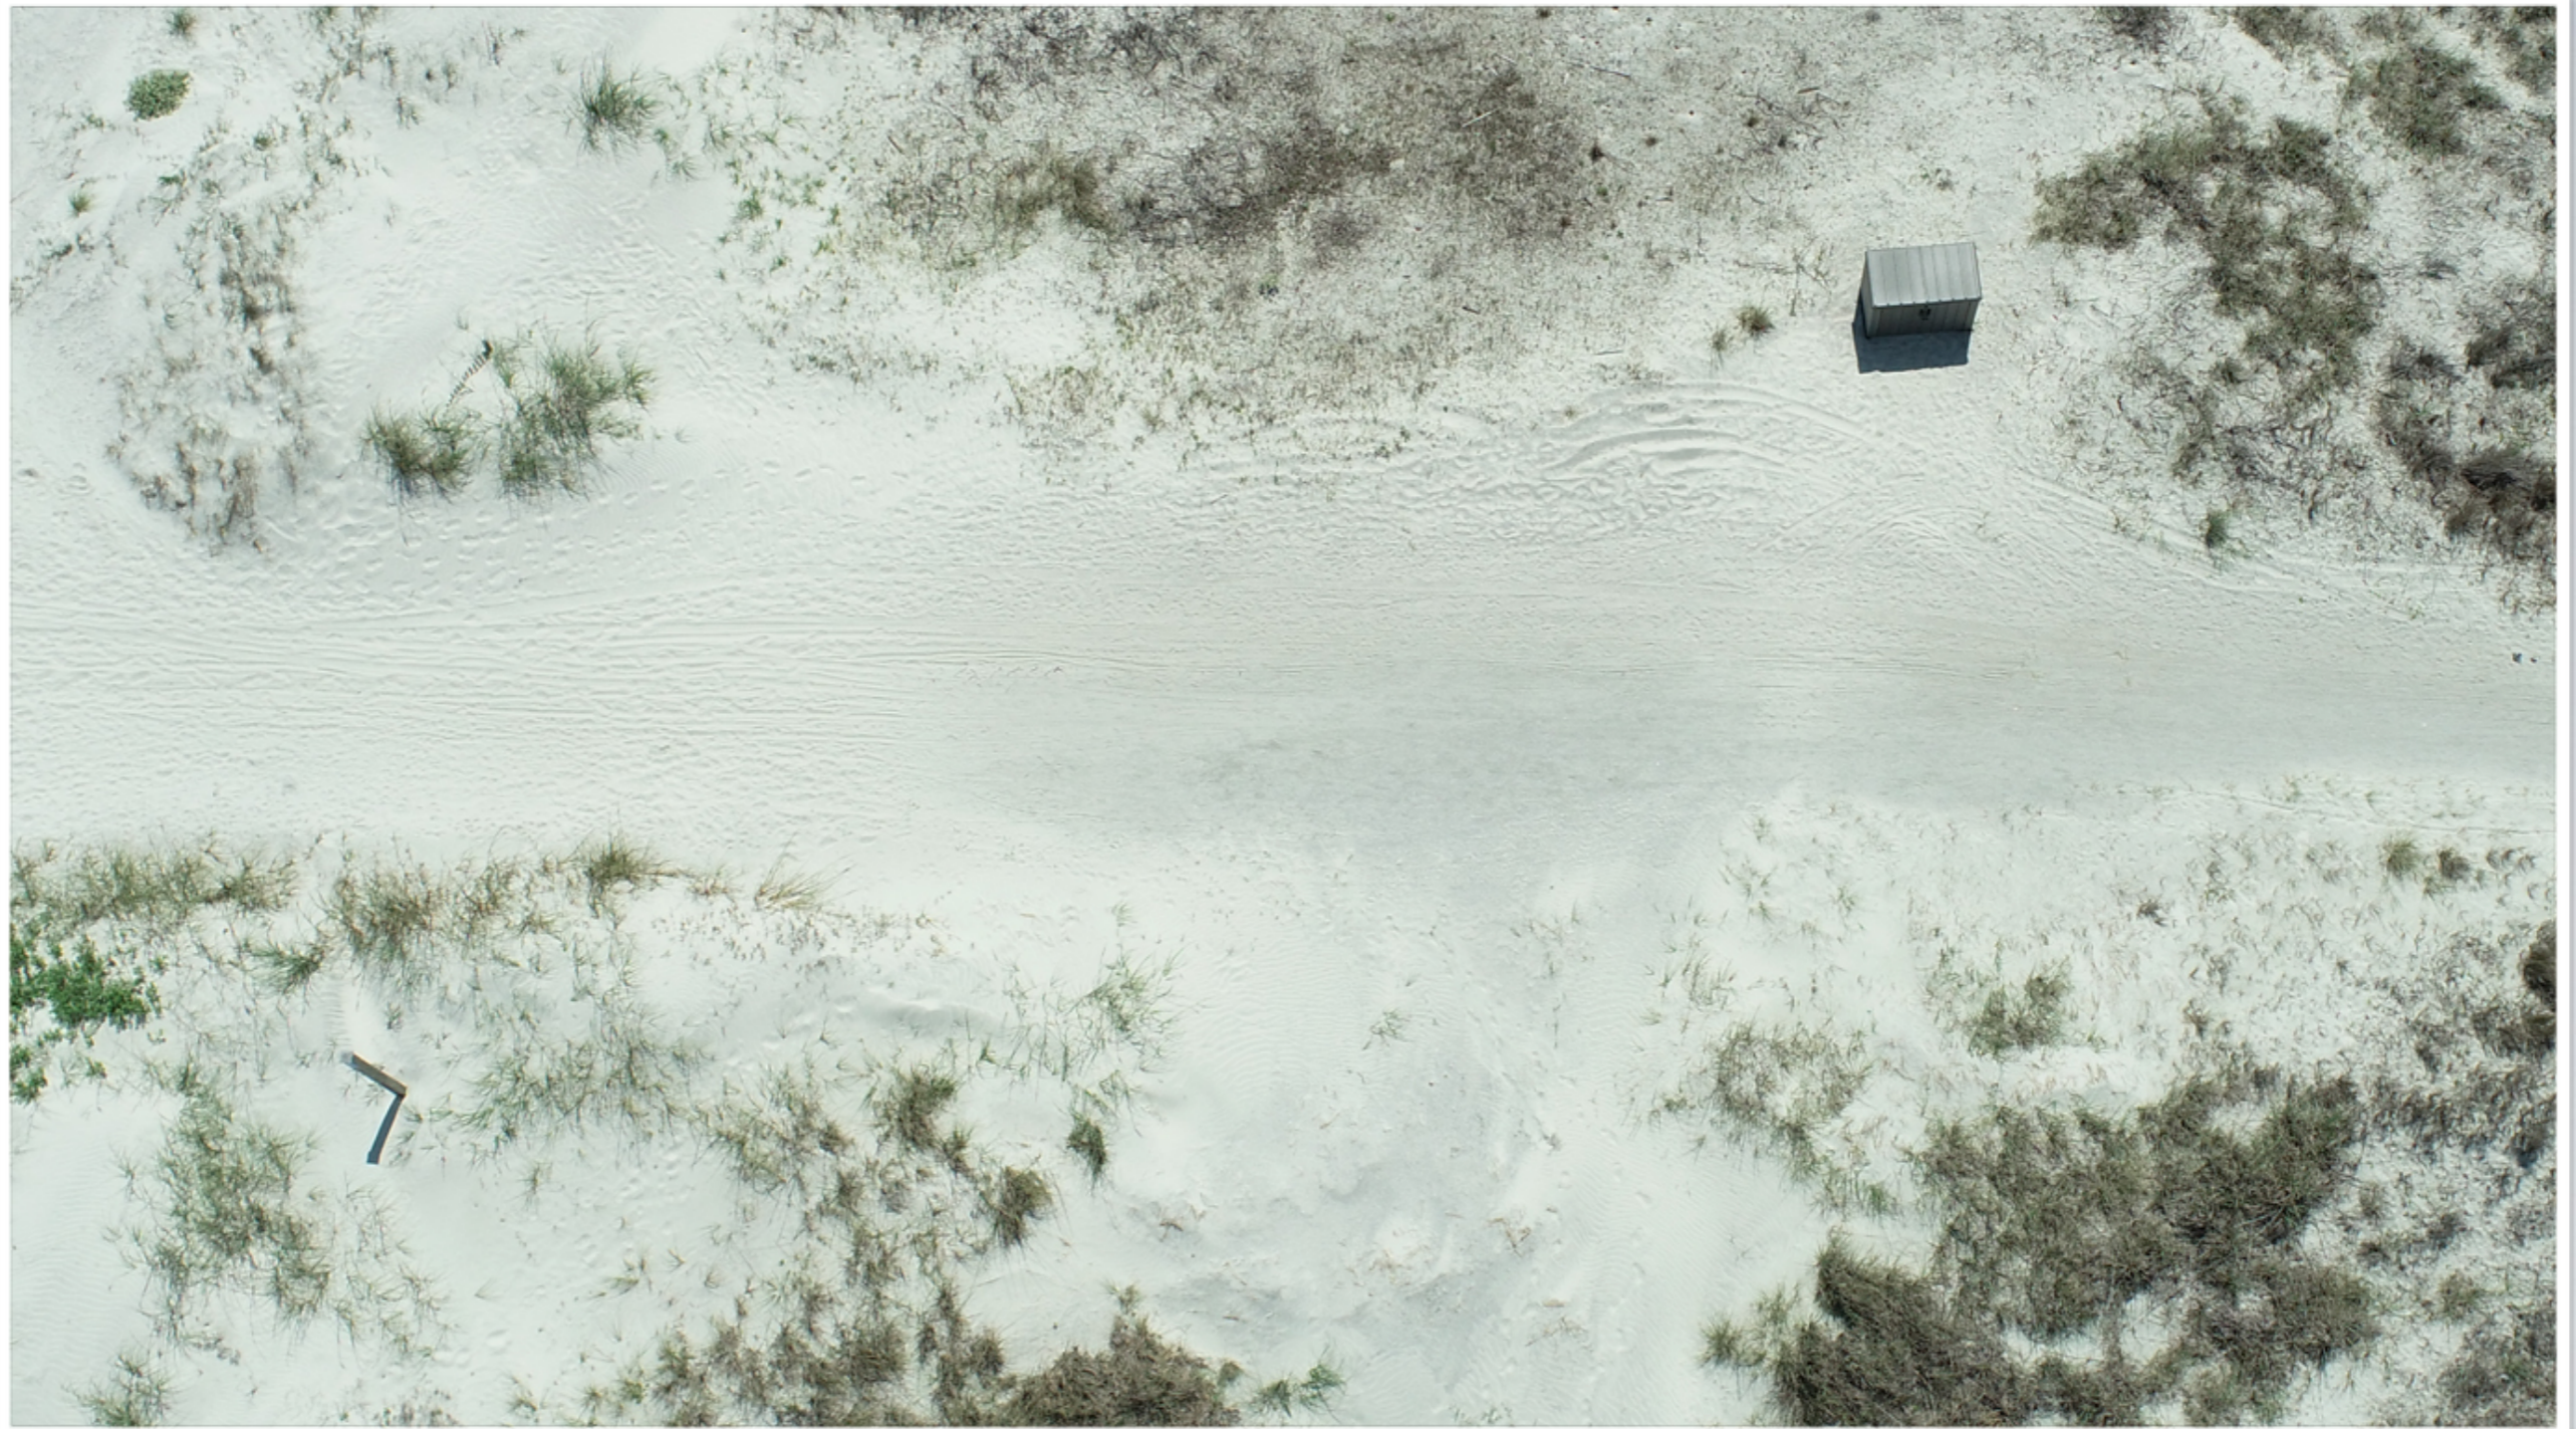
Access #15. Closeup view. People are walking/driving along the side of the geo-webbing for the last 100 feet or so. Less foot traffic on the webbing allows it to be taken over by encroaching sand dunes.
