Shoreline Status

Fripp Island - Shoreline Committee

January 24, 2022

A visual look at both sides of the Fripp Island bridge abutment and the salt marsh.

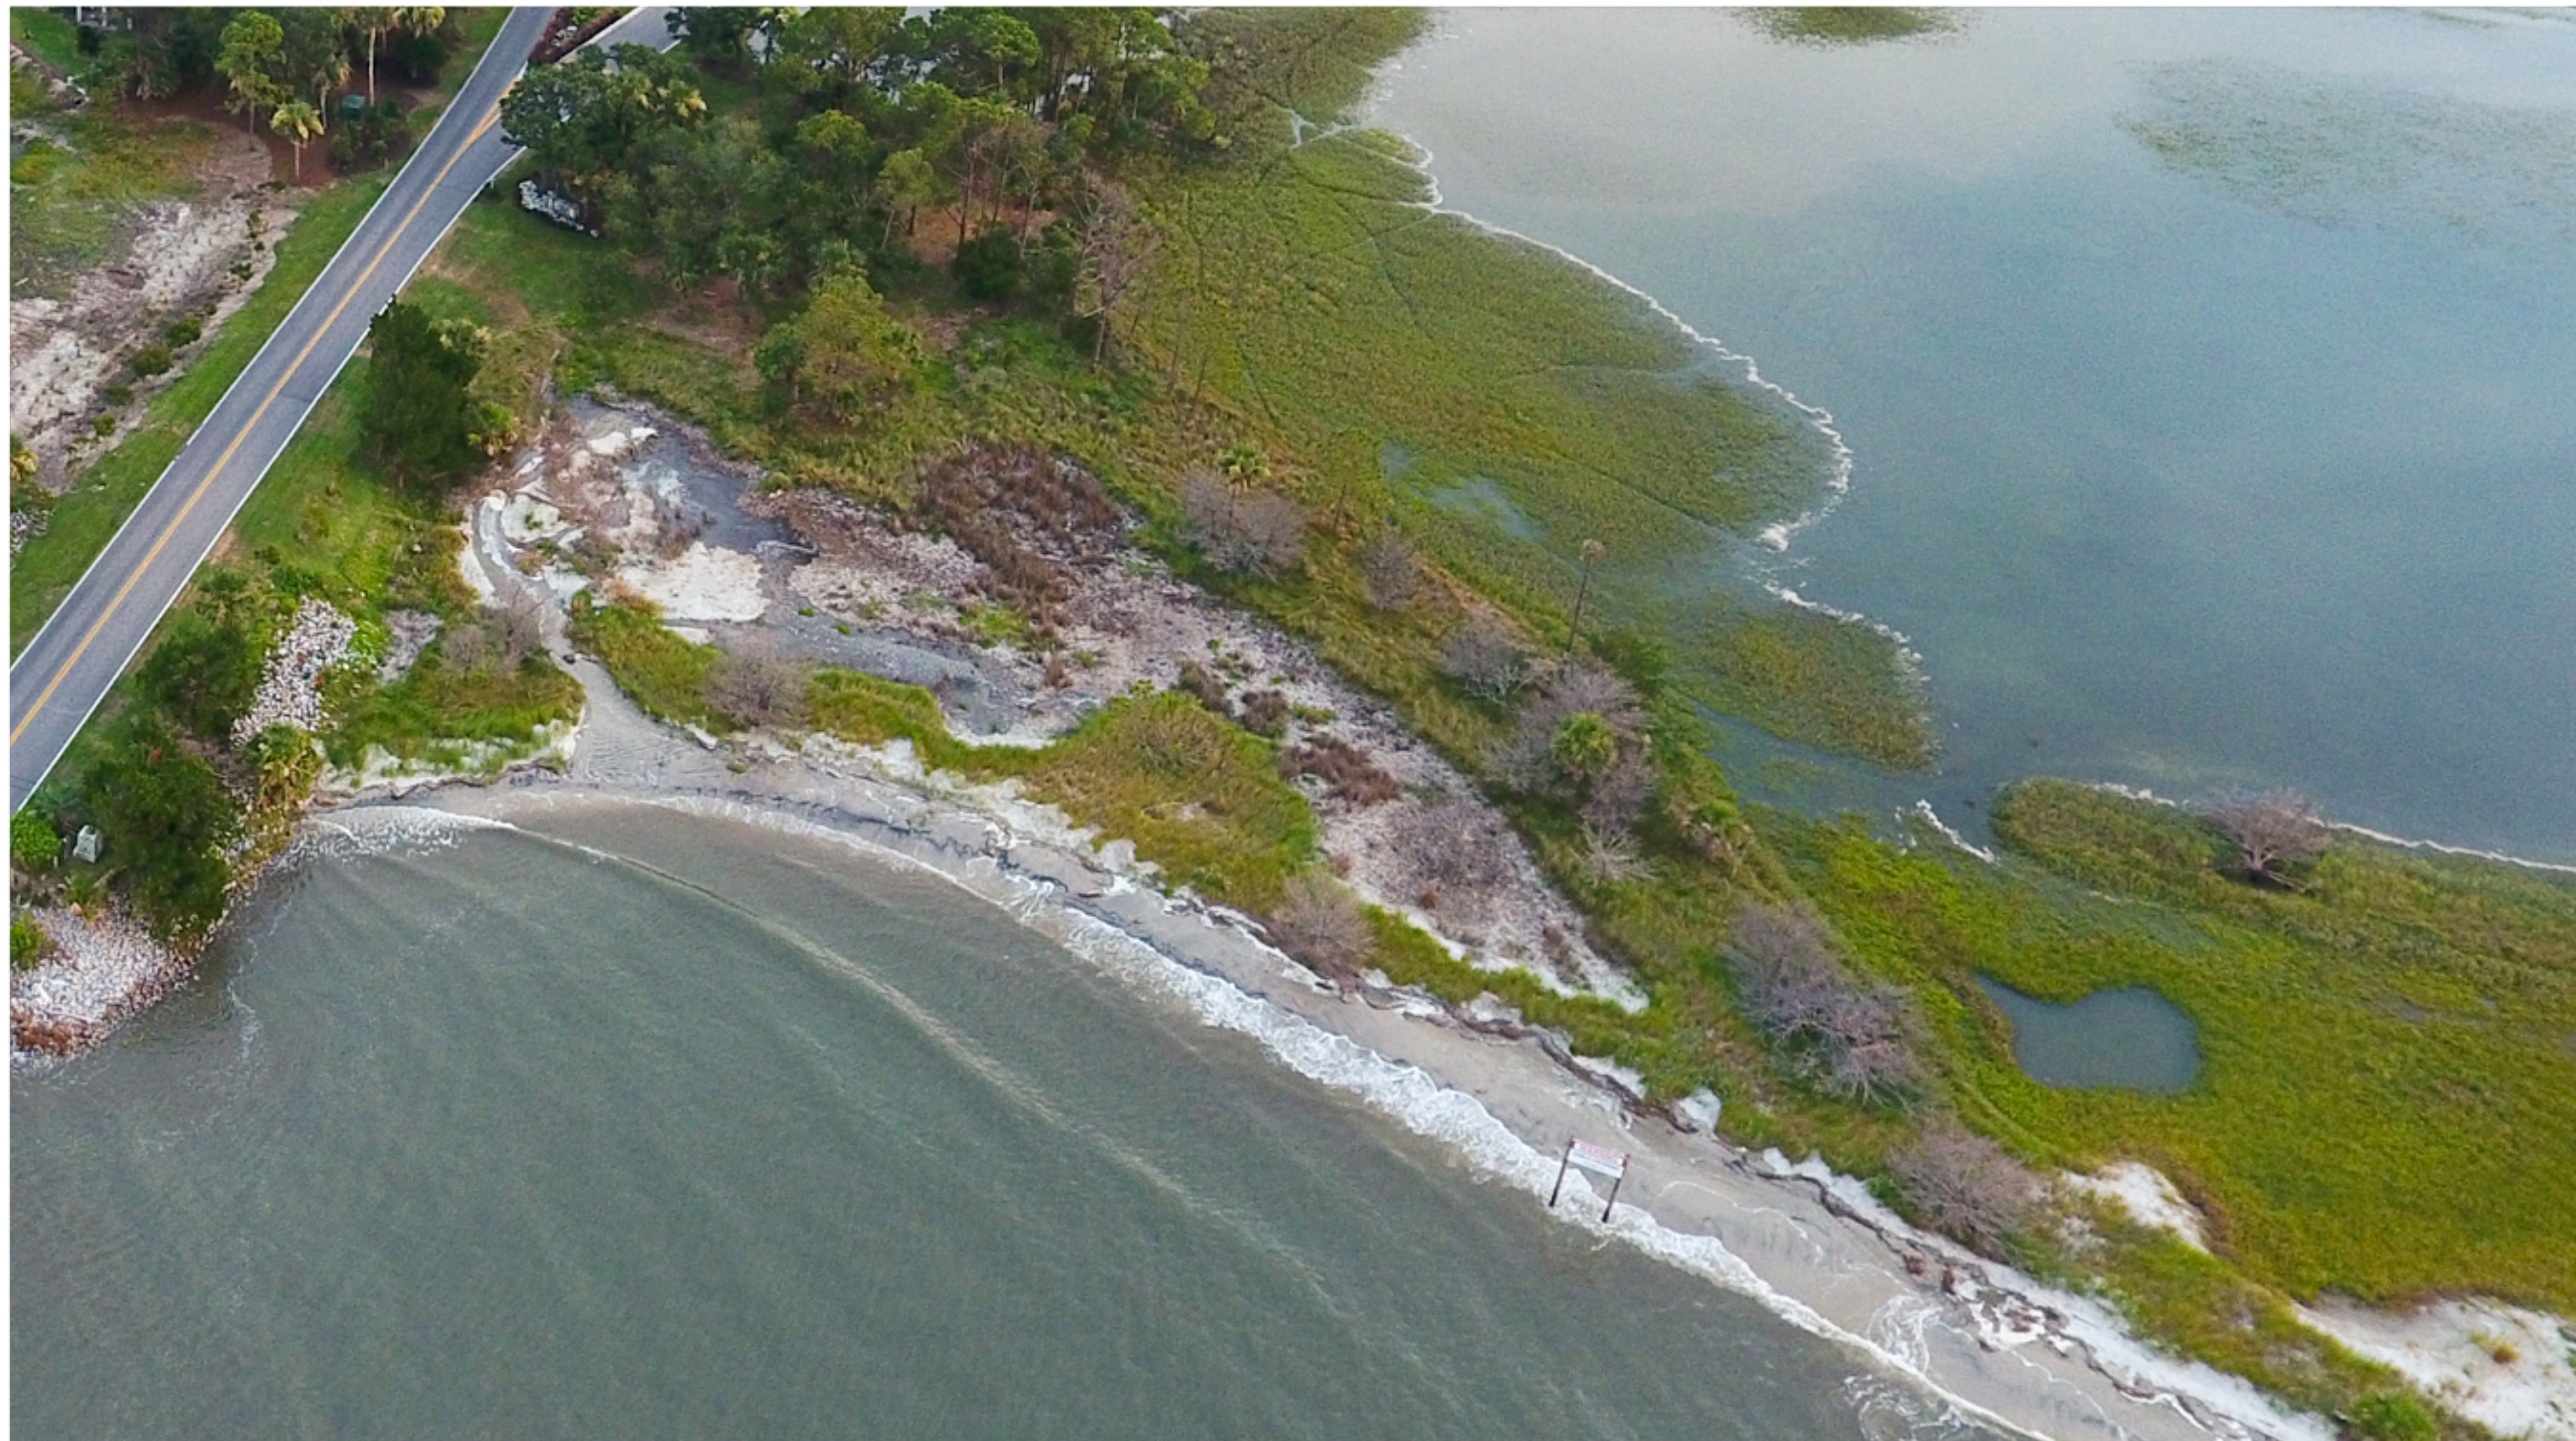
This aerial photo, taken during a king tide event on **July 13, 2018**, shows the large amount of vegetation still visible in the area around to the bridge approach in spite of the flood-like conditions.

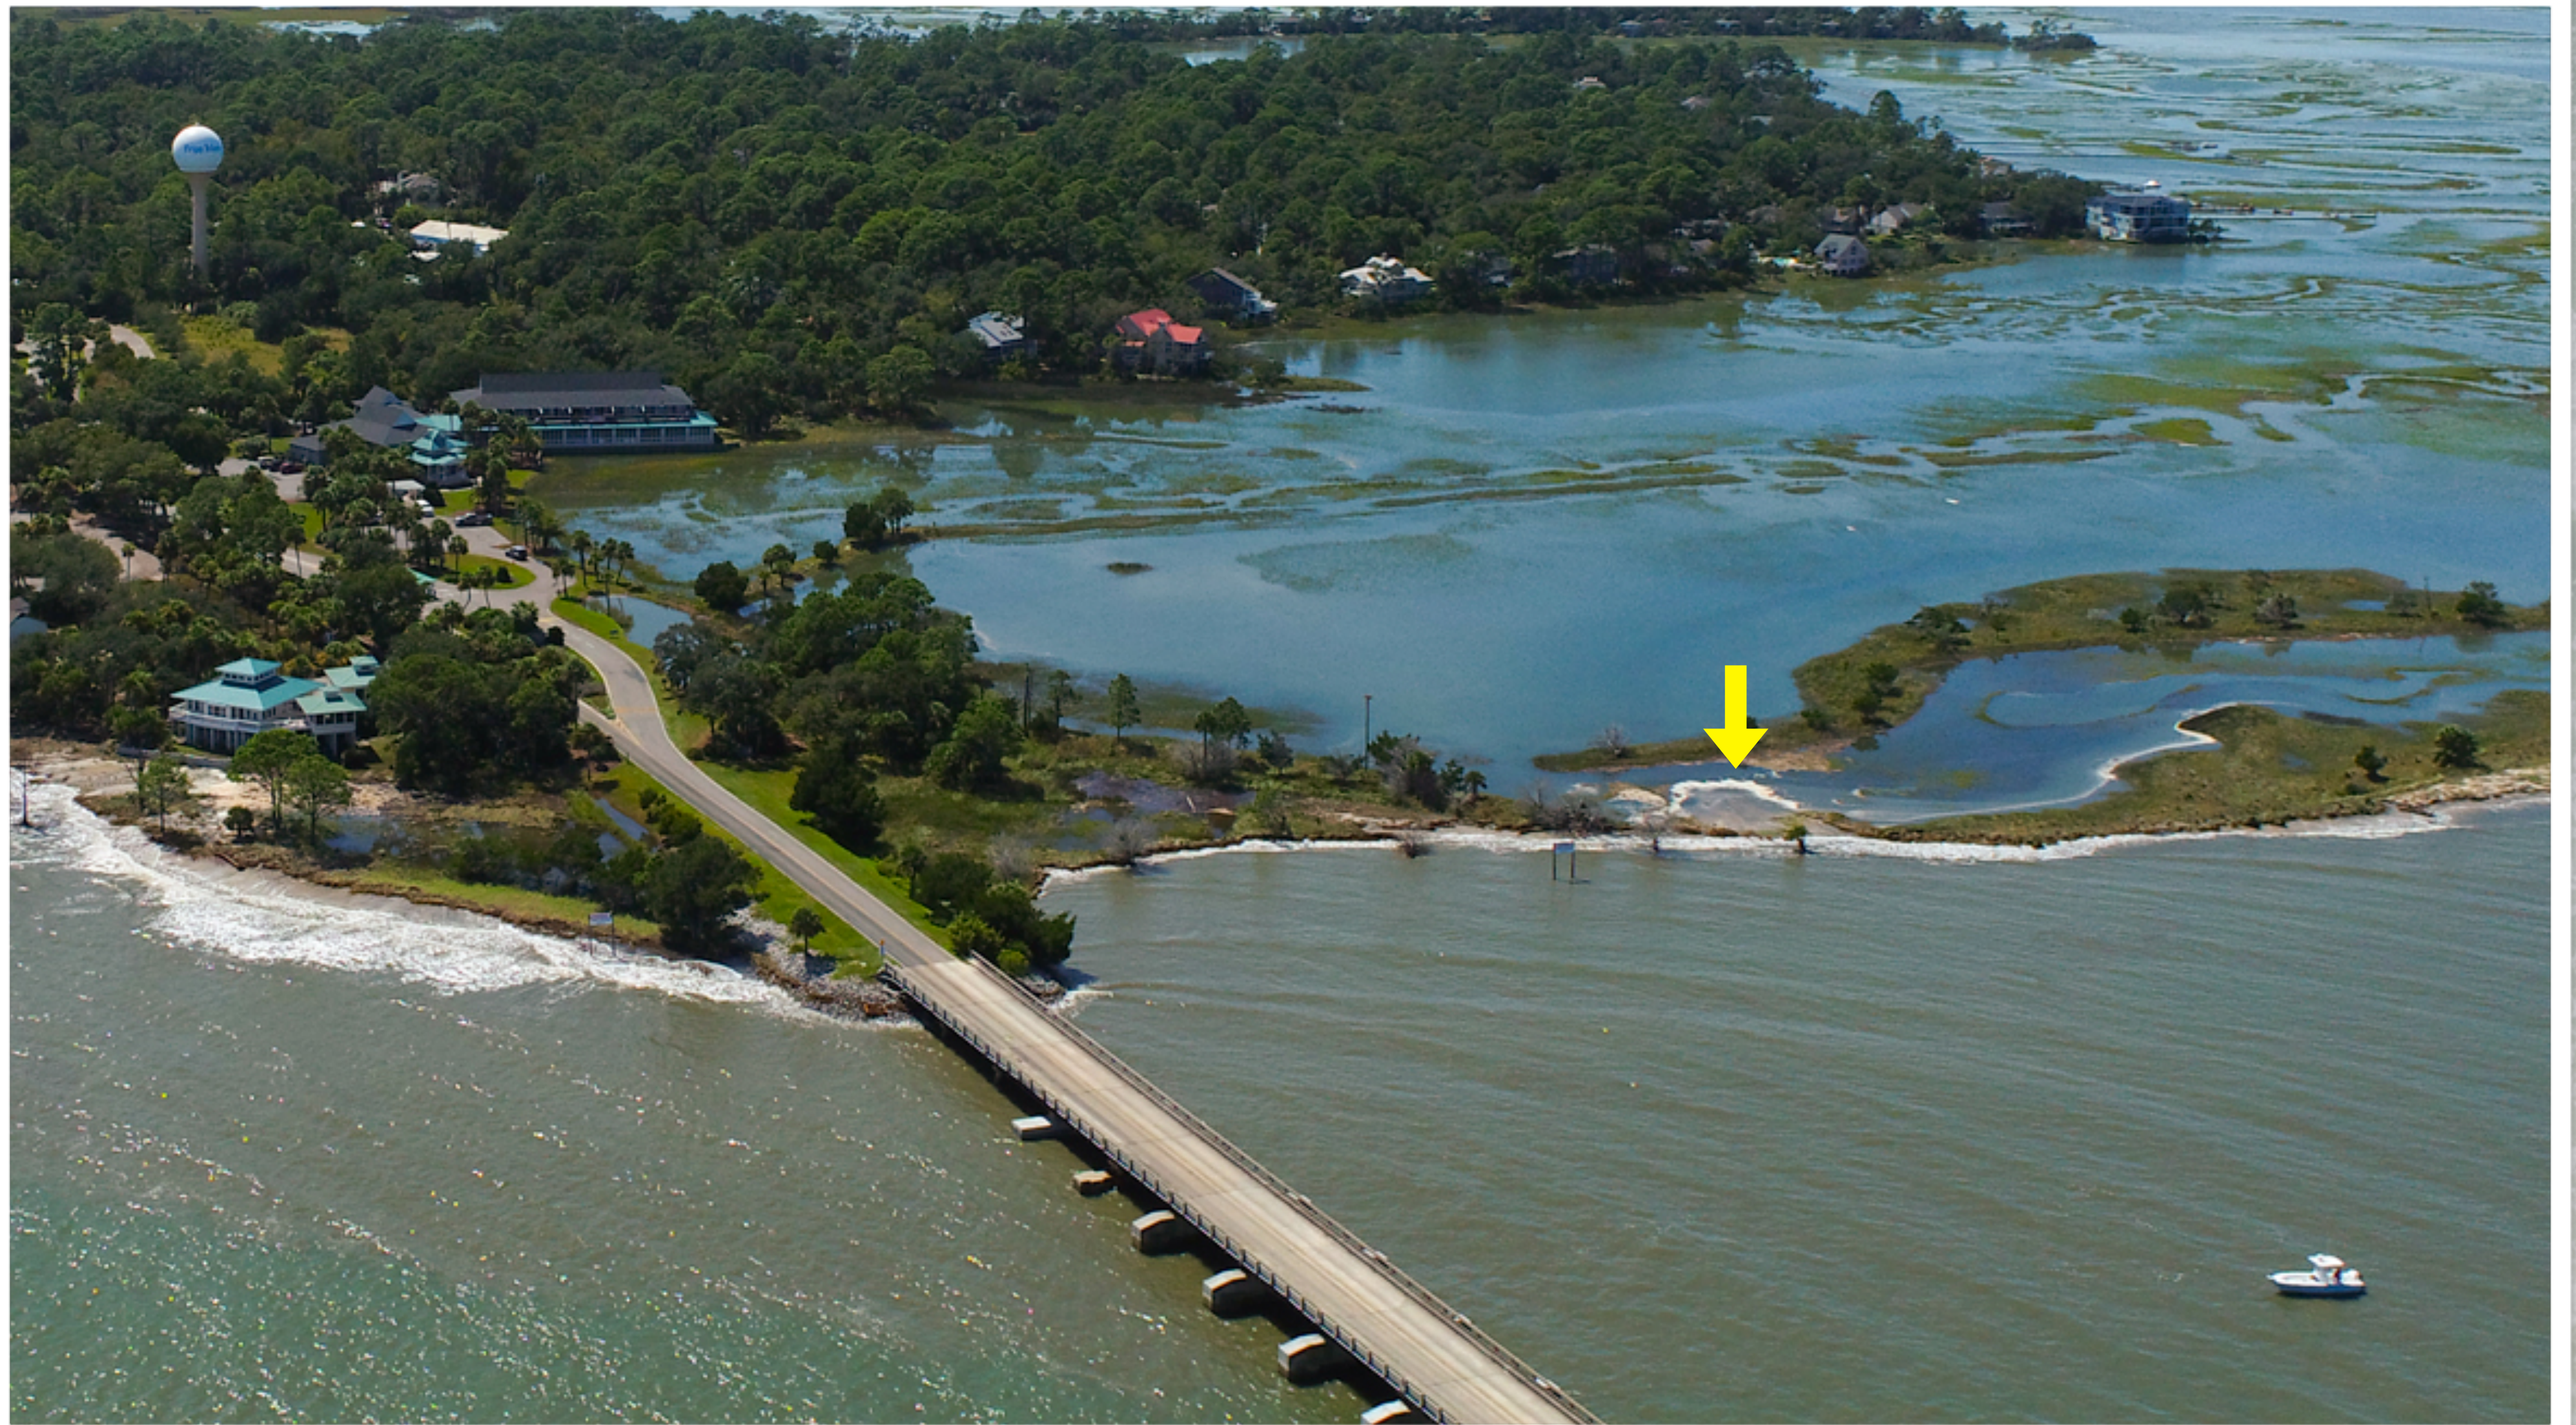
This photo, taken during a king tide event on **September 22, 2020**, shows a break in the vegetation boundary where sea water broke through from the inlet into the flooded salt marsh area.

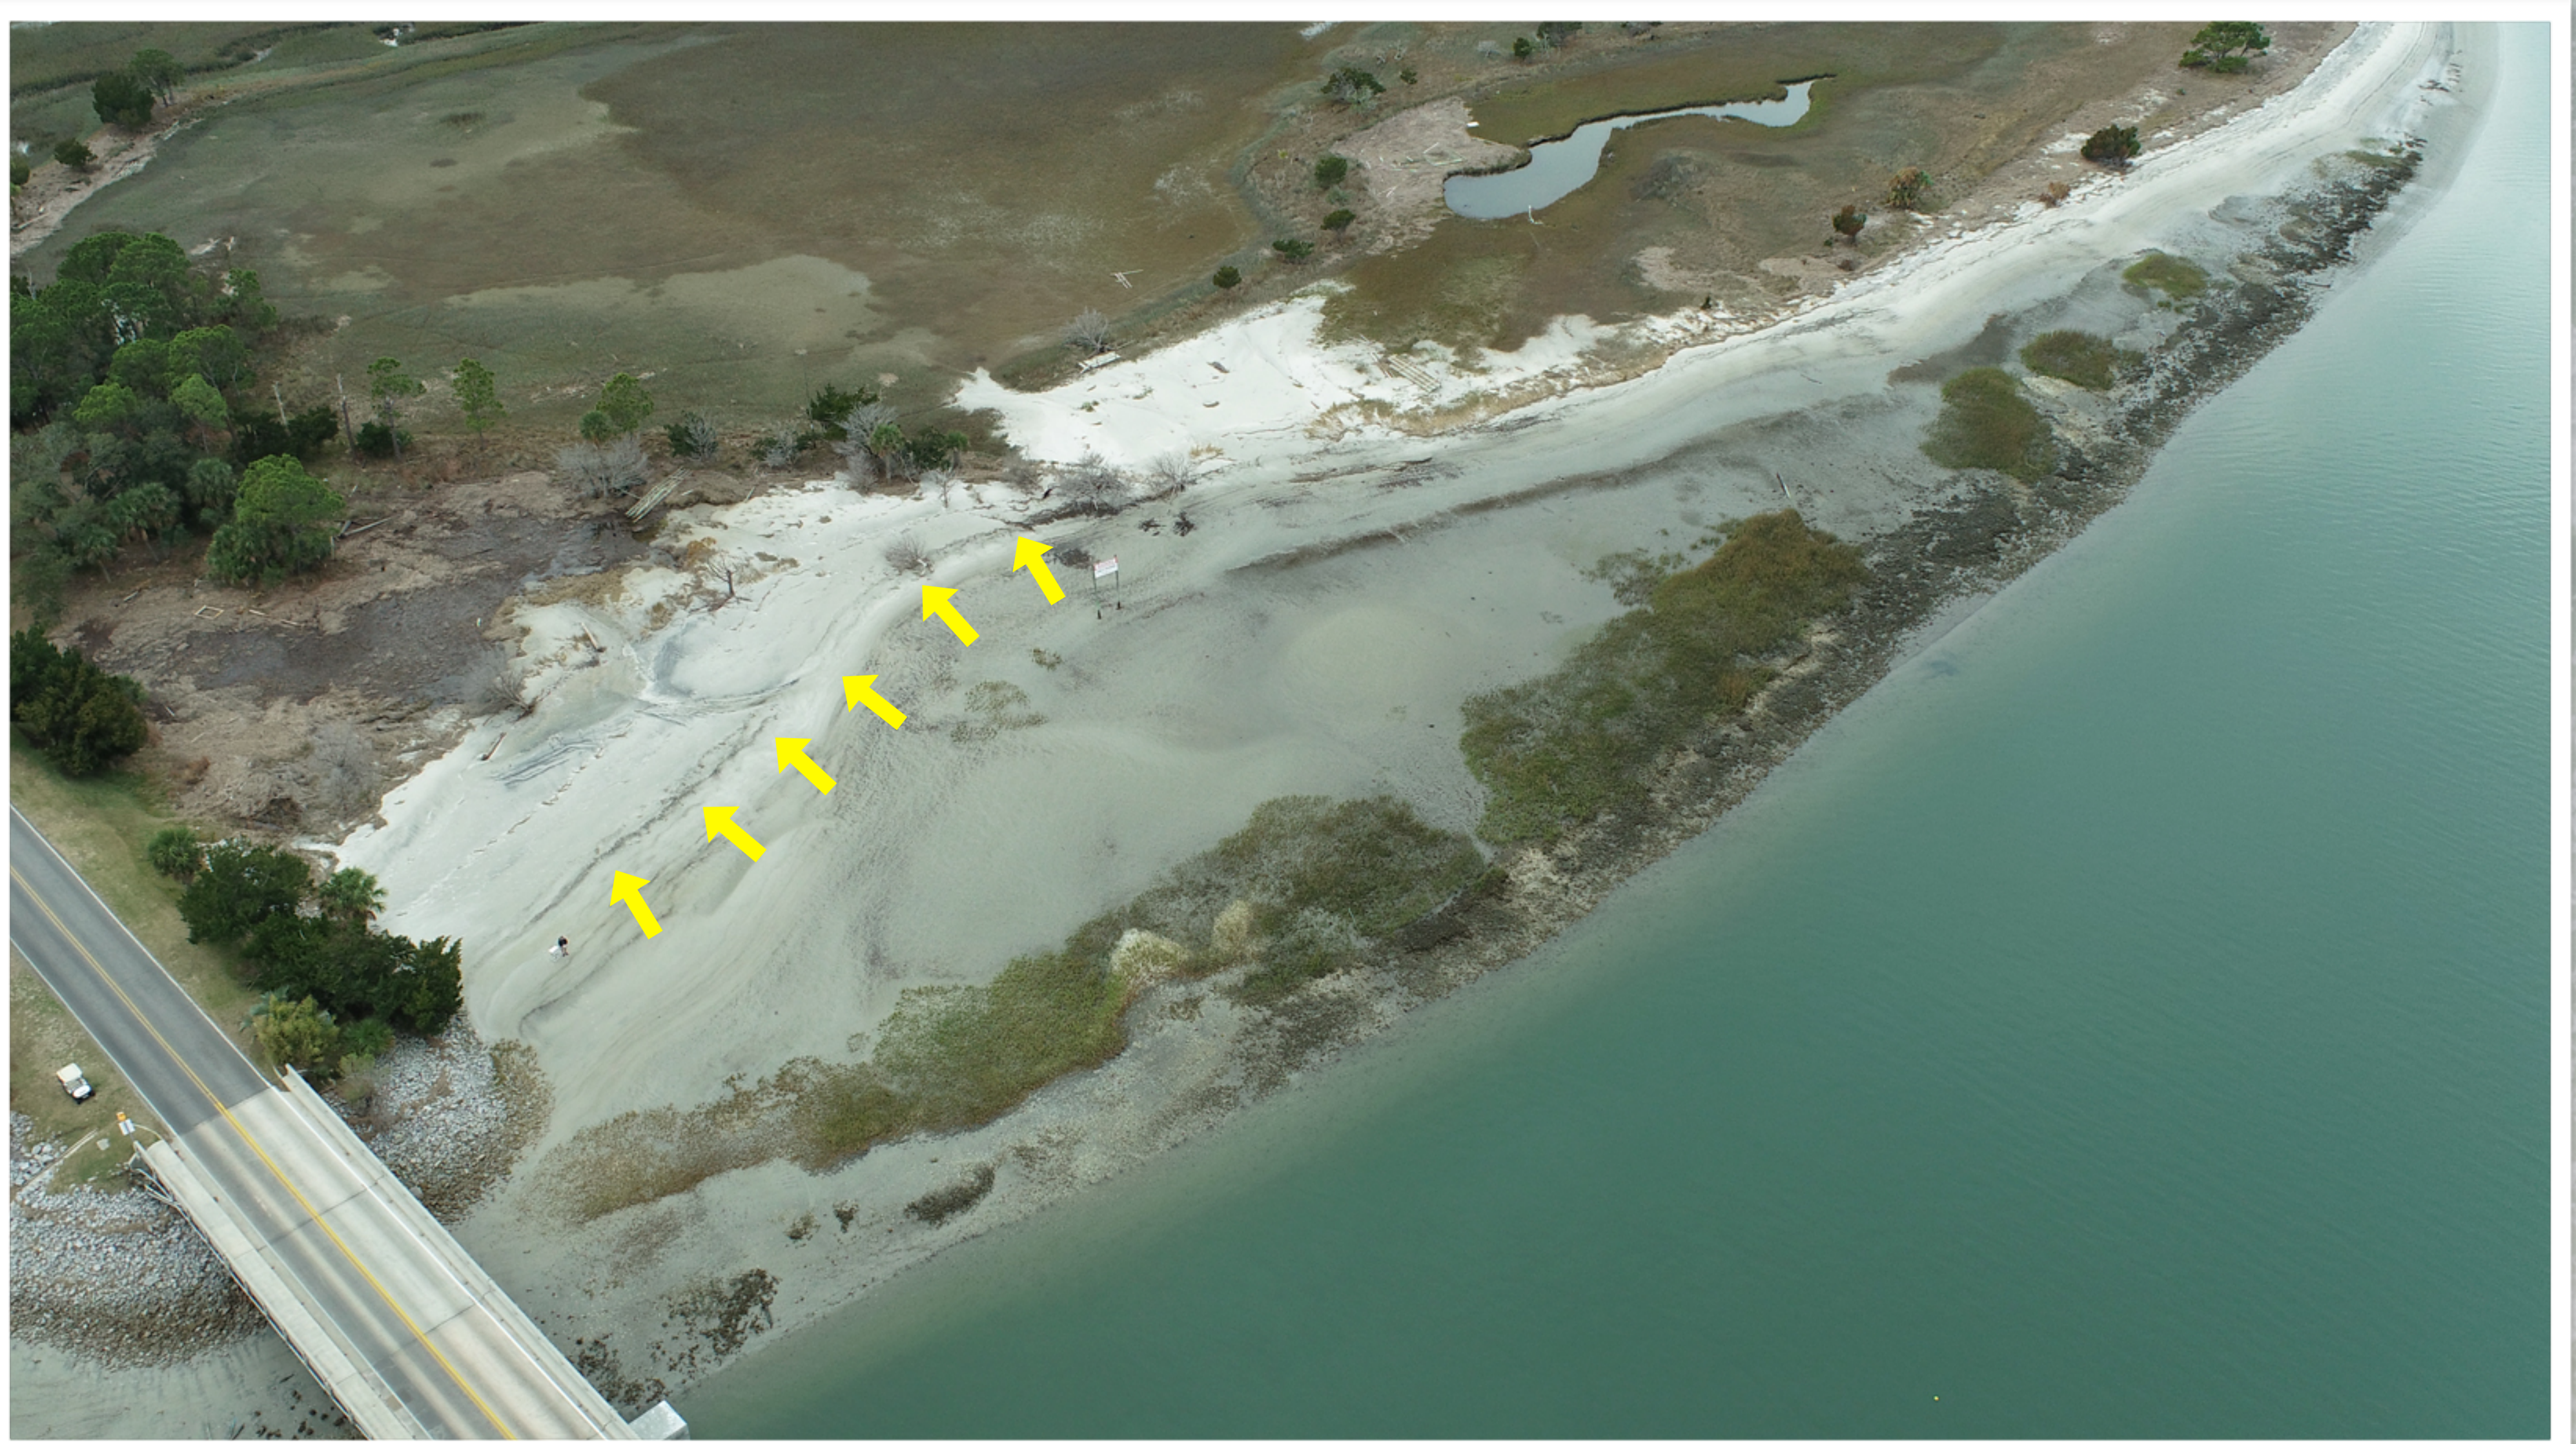
This photo, taken at low tide taken on **January 20, 2022**, shows the breached area has joined the existing eroded area next to it, creating a larger sand-only footprint that continues to expand along the bridge approach and throughout the whole area.

The same photo shows wrack is being pushed further and further towards Tarpon Boulevard indicating there is less vegetation available to slow the waves and halt the floating debris.

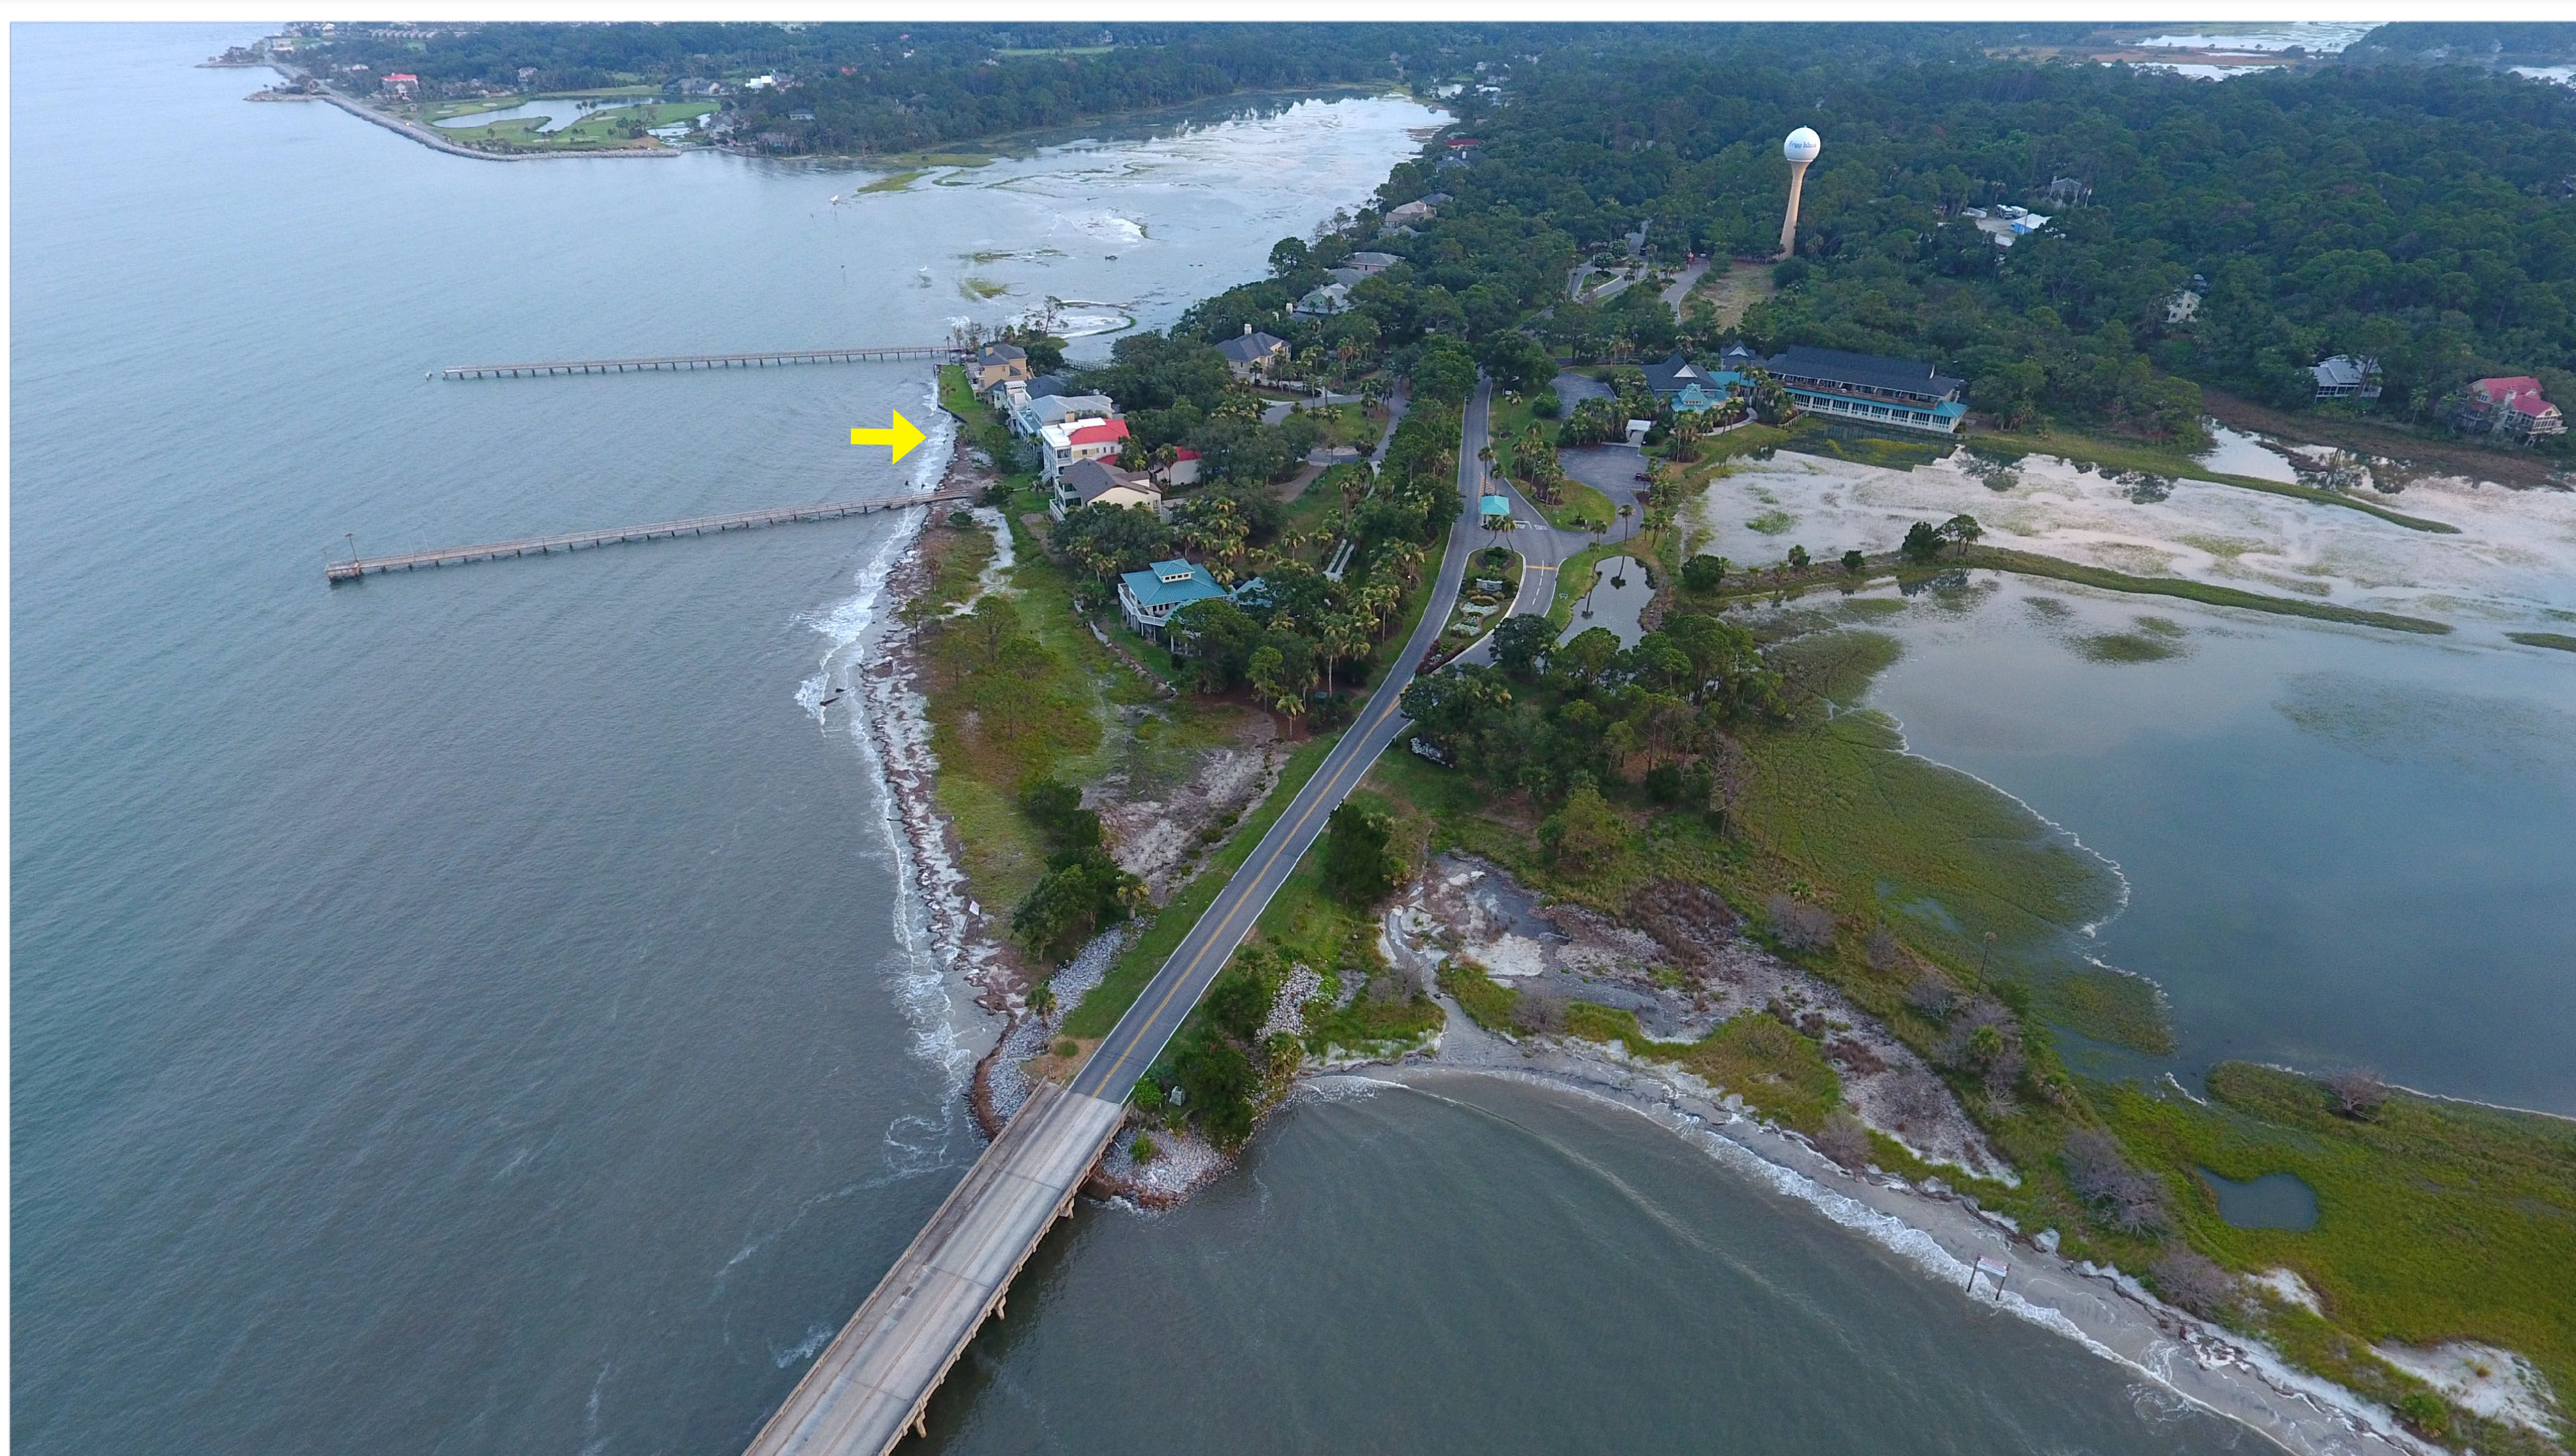
This aerial photo, taken during a king tide event on **July 13, 2018**, shows the grassy area in front of the homes remains for-the-most-part, dry and intact even during higher than normal flooding.

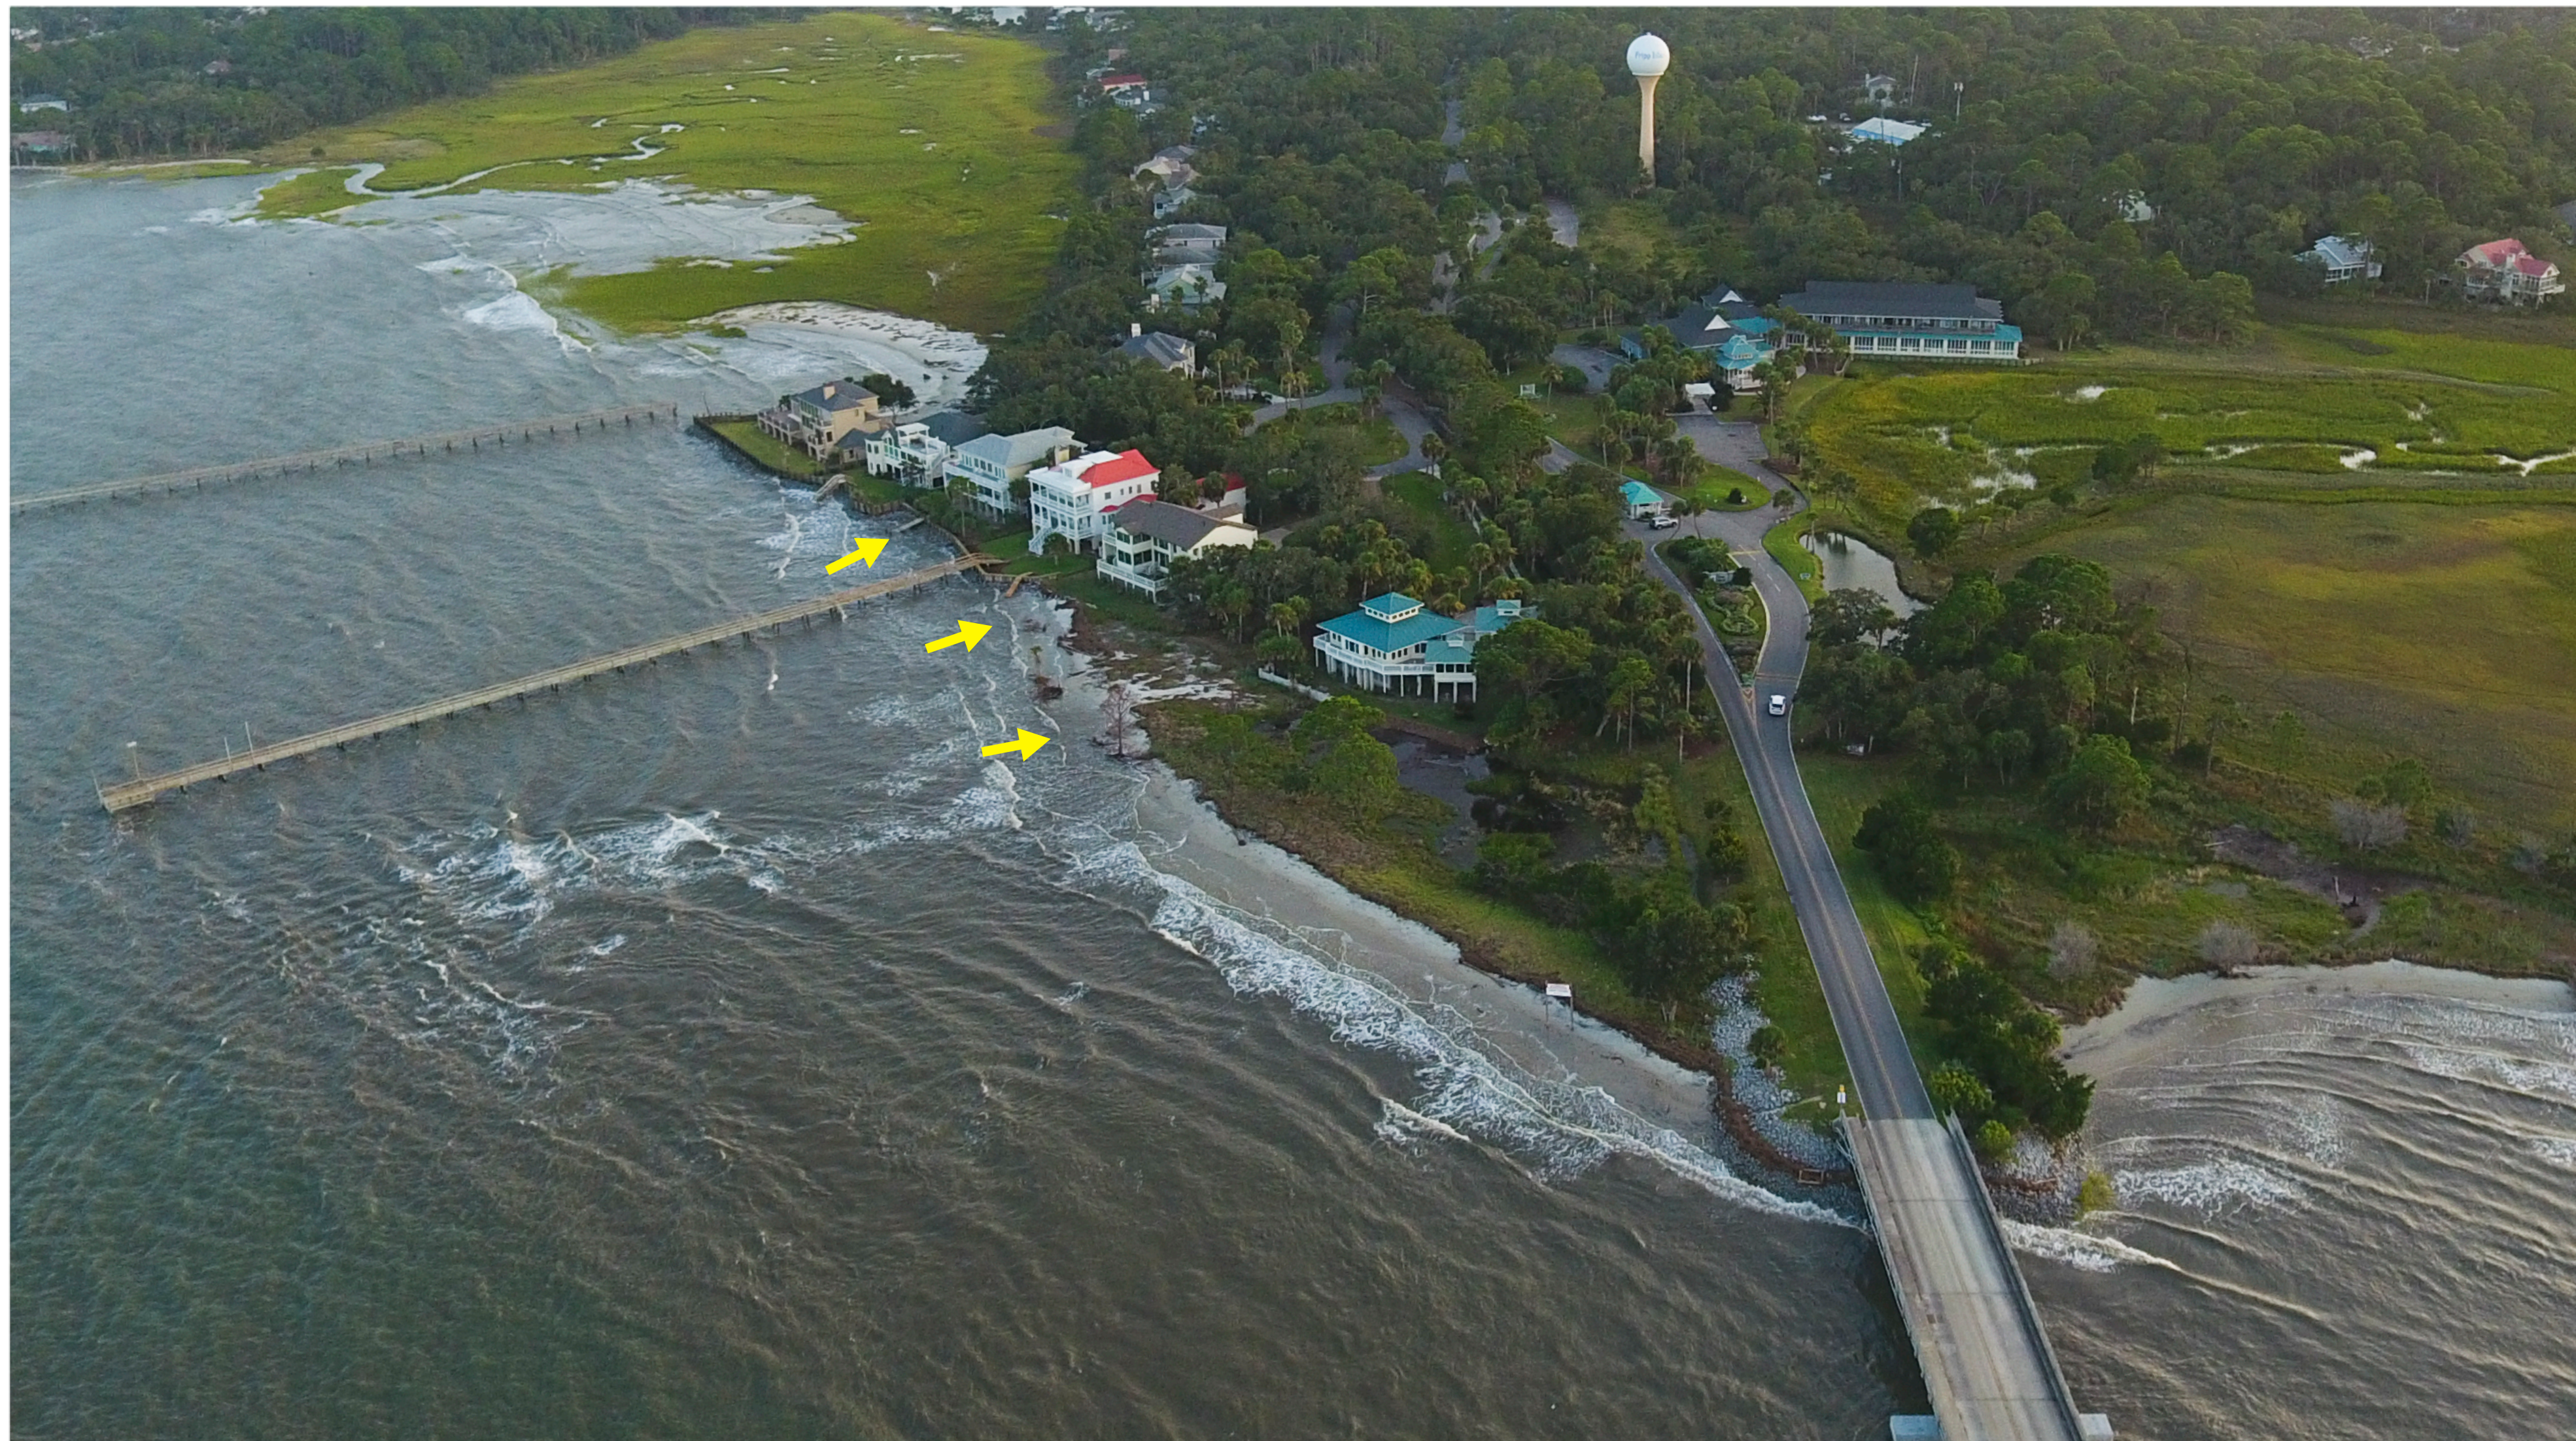
This photo, taken two years later on **September 17, 2020**, during a normal high tide, shows the eroded area has expanded along the front of the River Club homes and towards the bridge approach area.

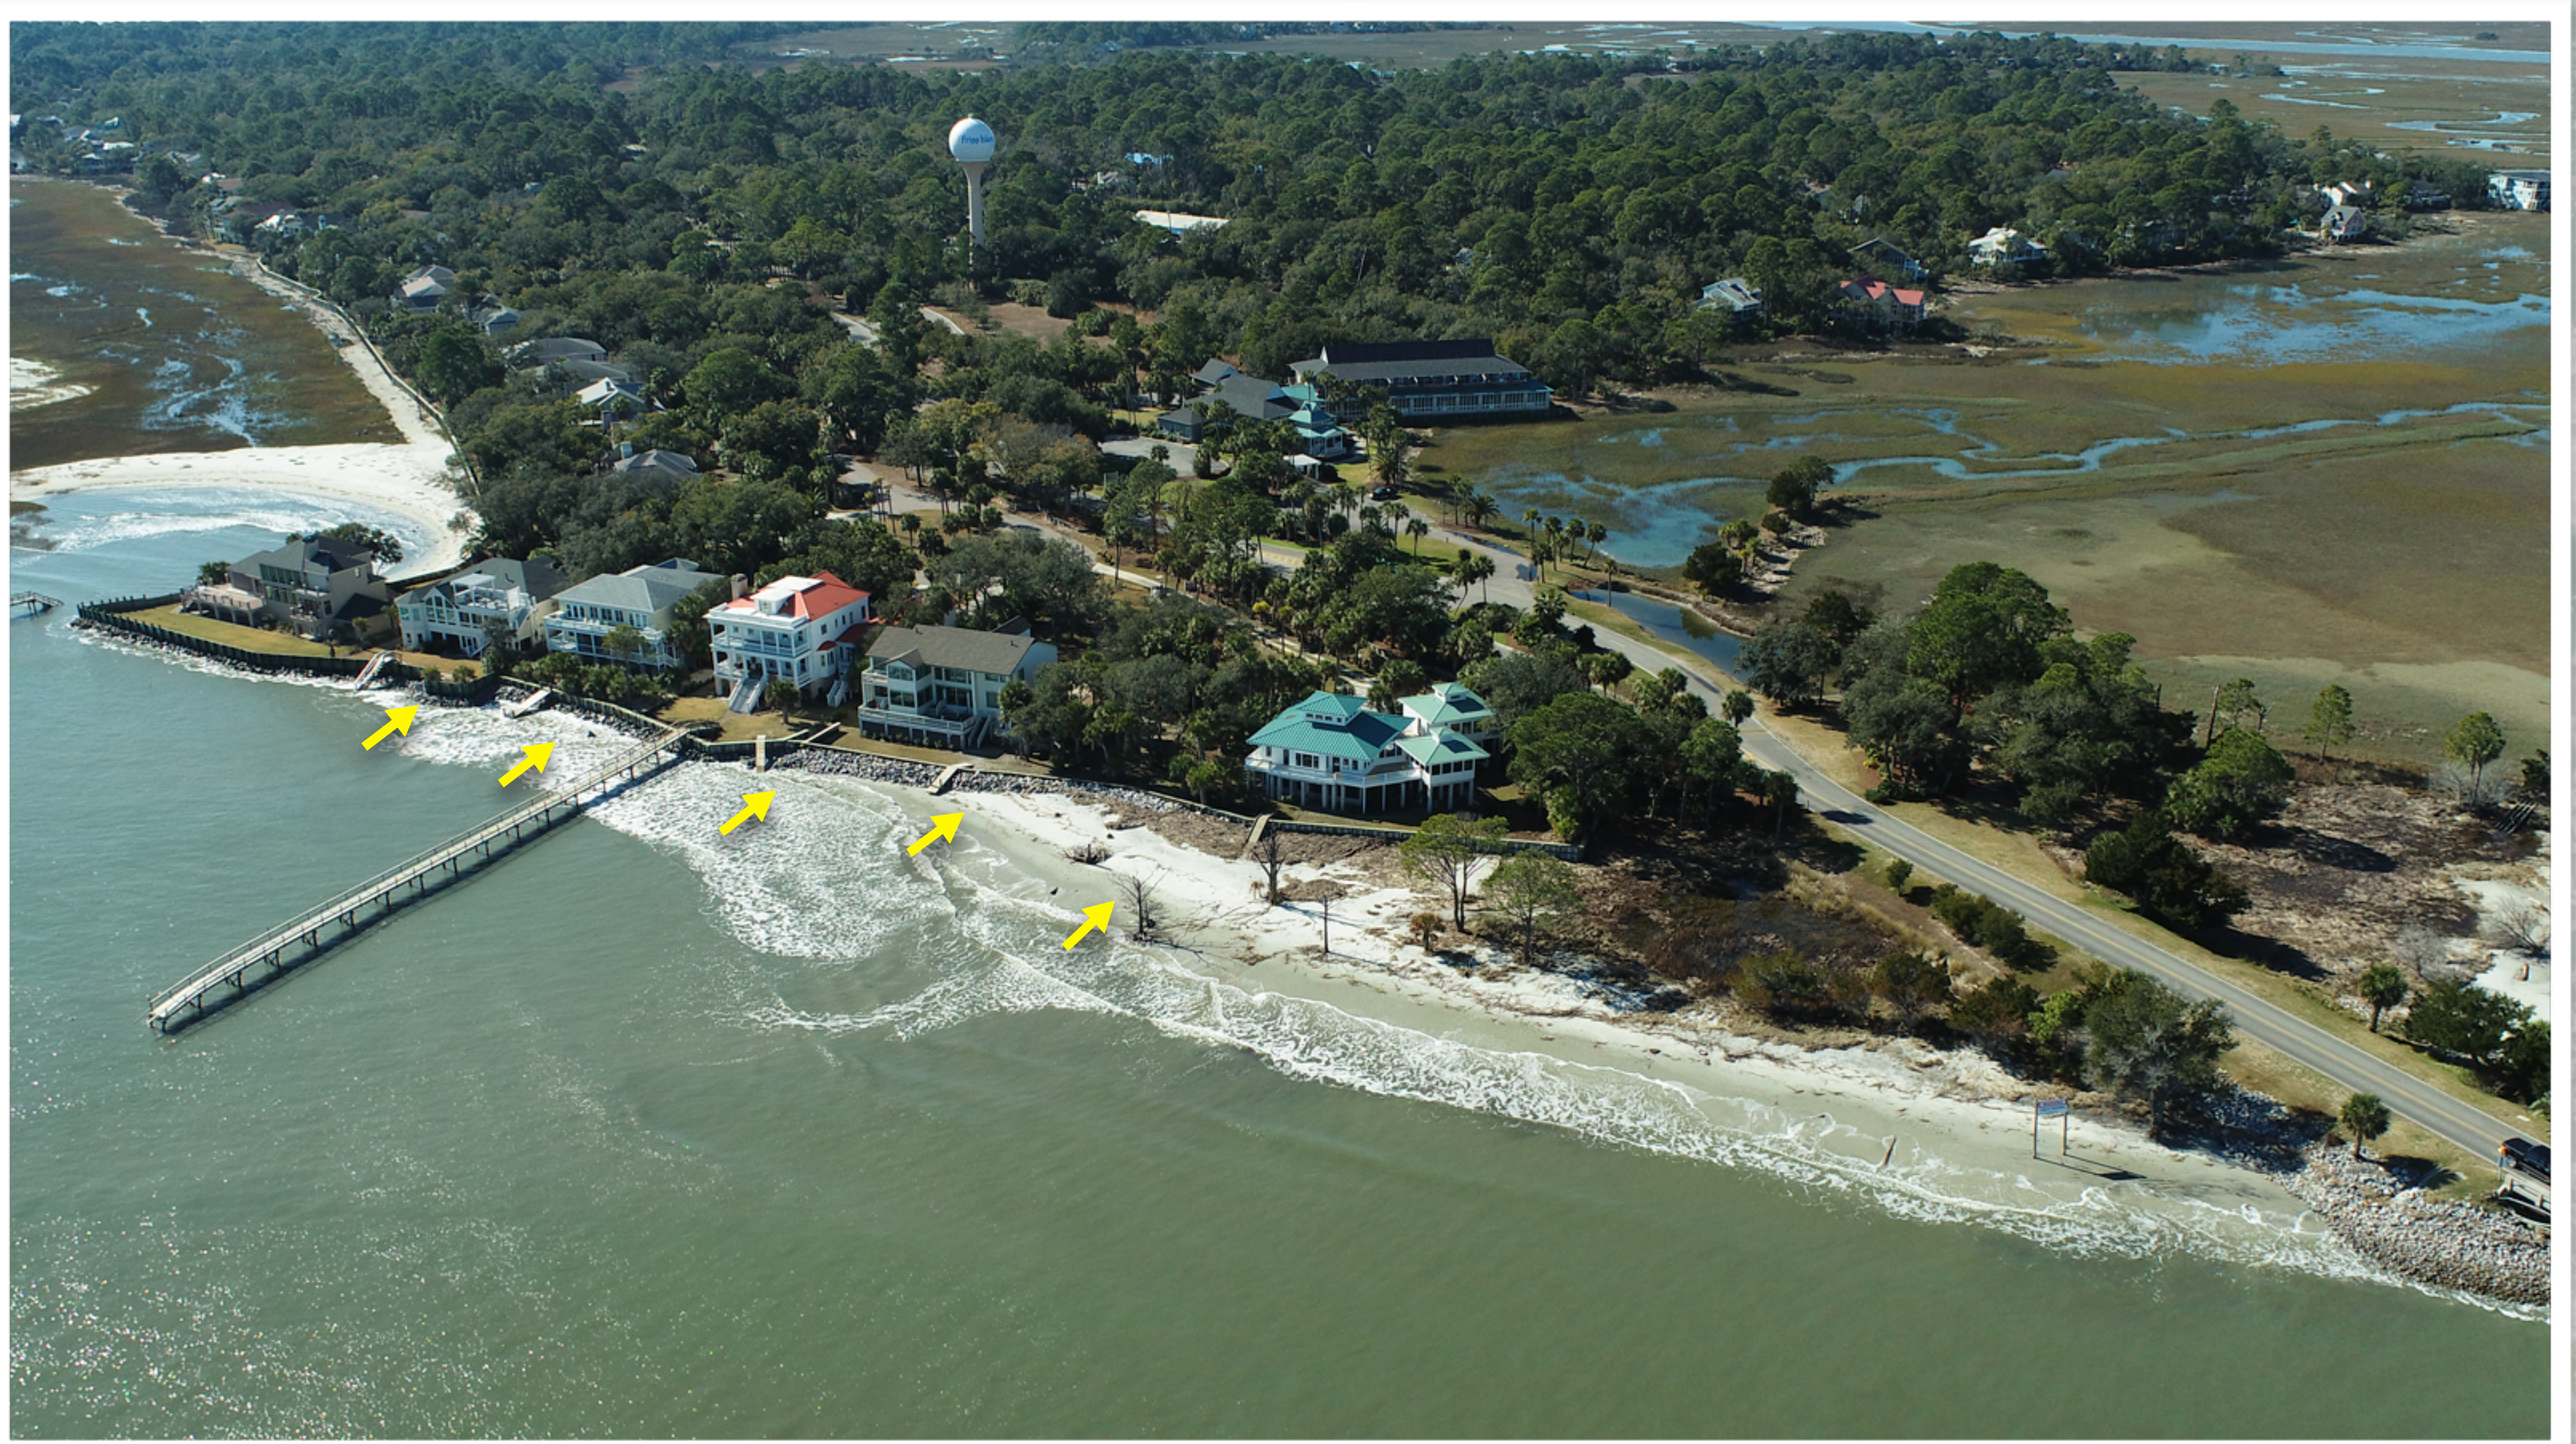
This photo, taken at high tide on **January 23, 2022**, shows the eroded area has extended along almost the entire front of the homes in River Club and regularly floods the small land area near the bridge approach.
