Shoreline Status

Fripp Island - Shoreline Committee

January 24, 2022

A visual look at both sides of the Fripp Island bridge abutment and the salt marsh.

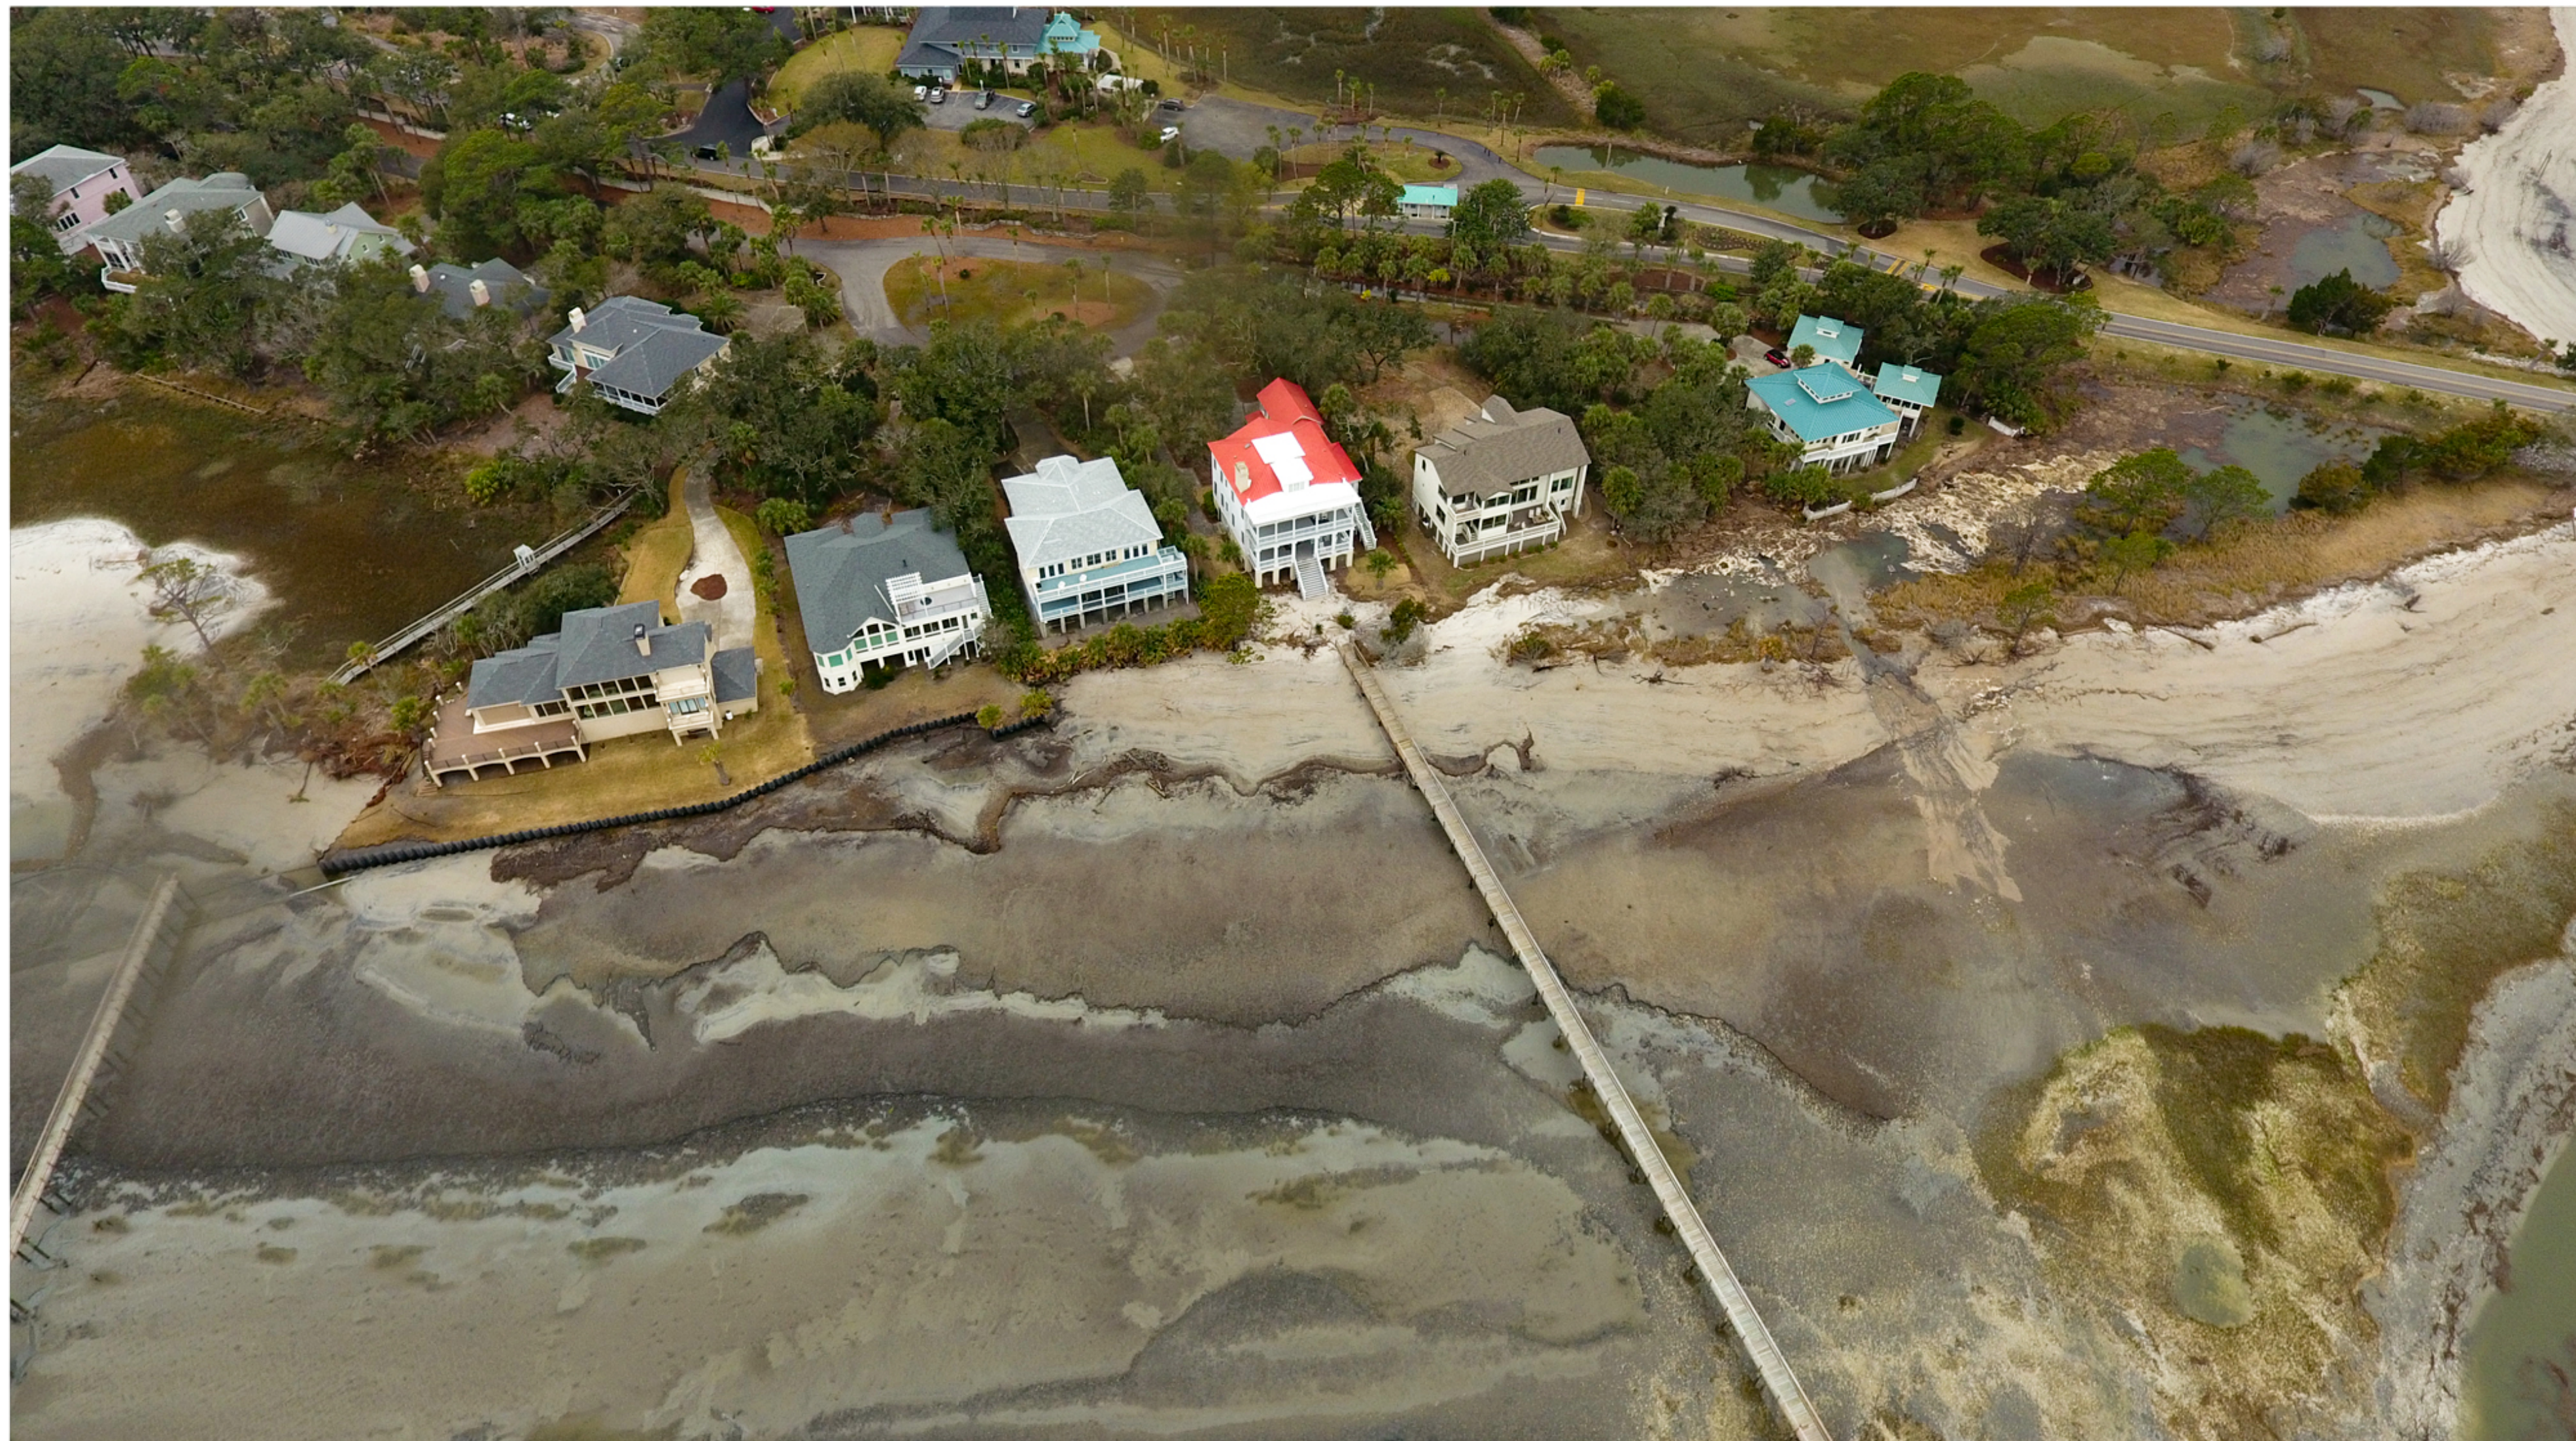
This photo, taken at an extreme low tide (during a king tide cycle) on **February 20, 2019**, shows several layers of underlying soil. The sea-facing hard edge of the layers indicates fresh erosion with each flood cycle, which can be seen in the next slide.

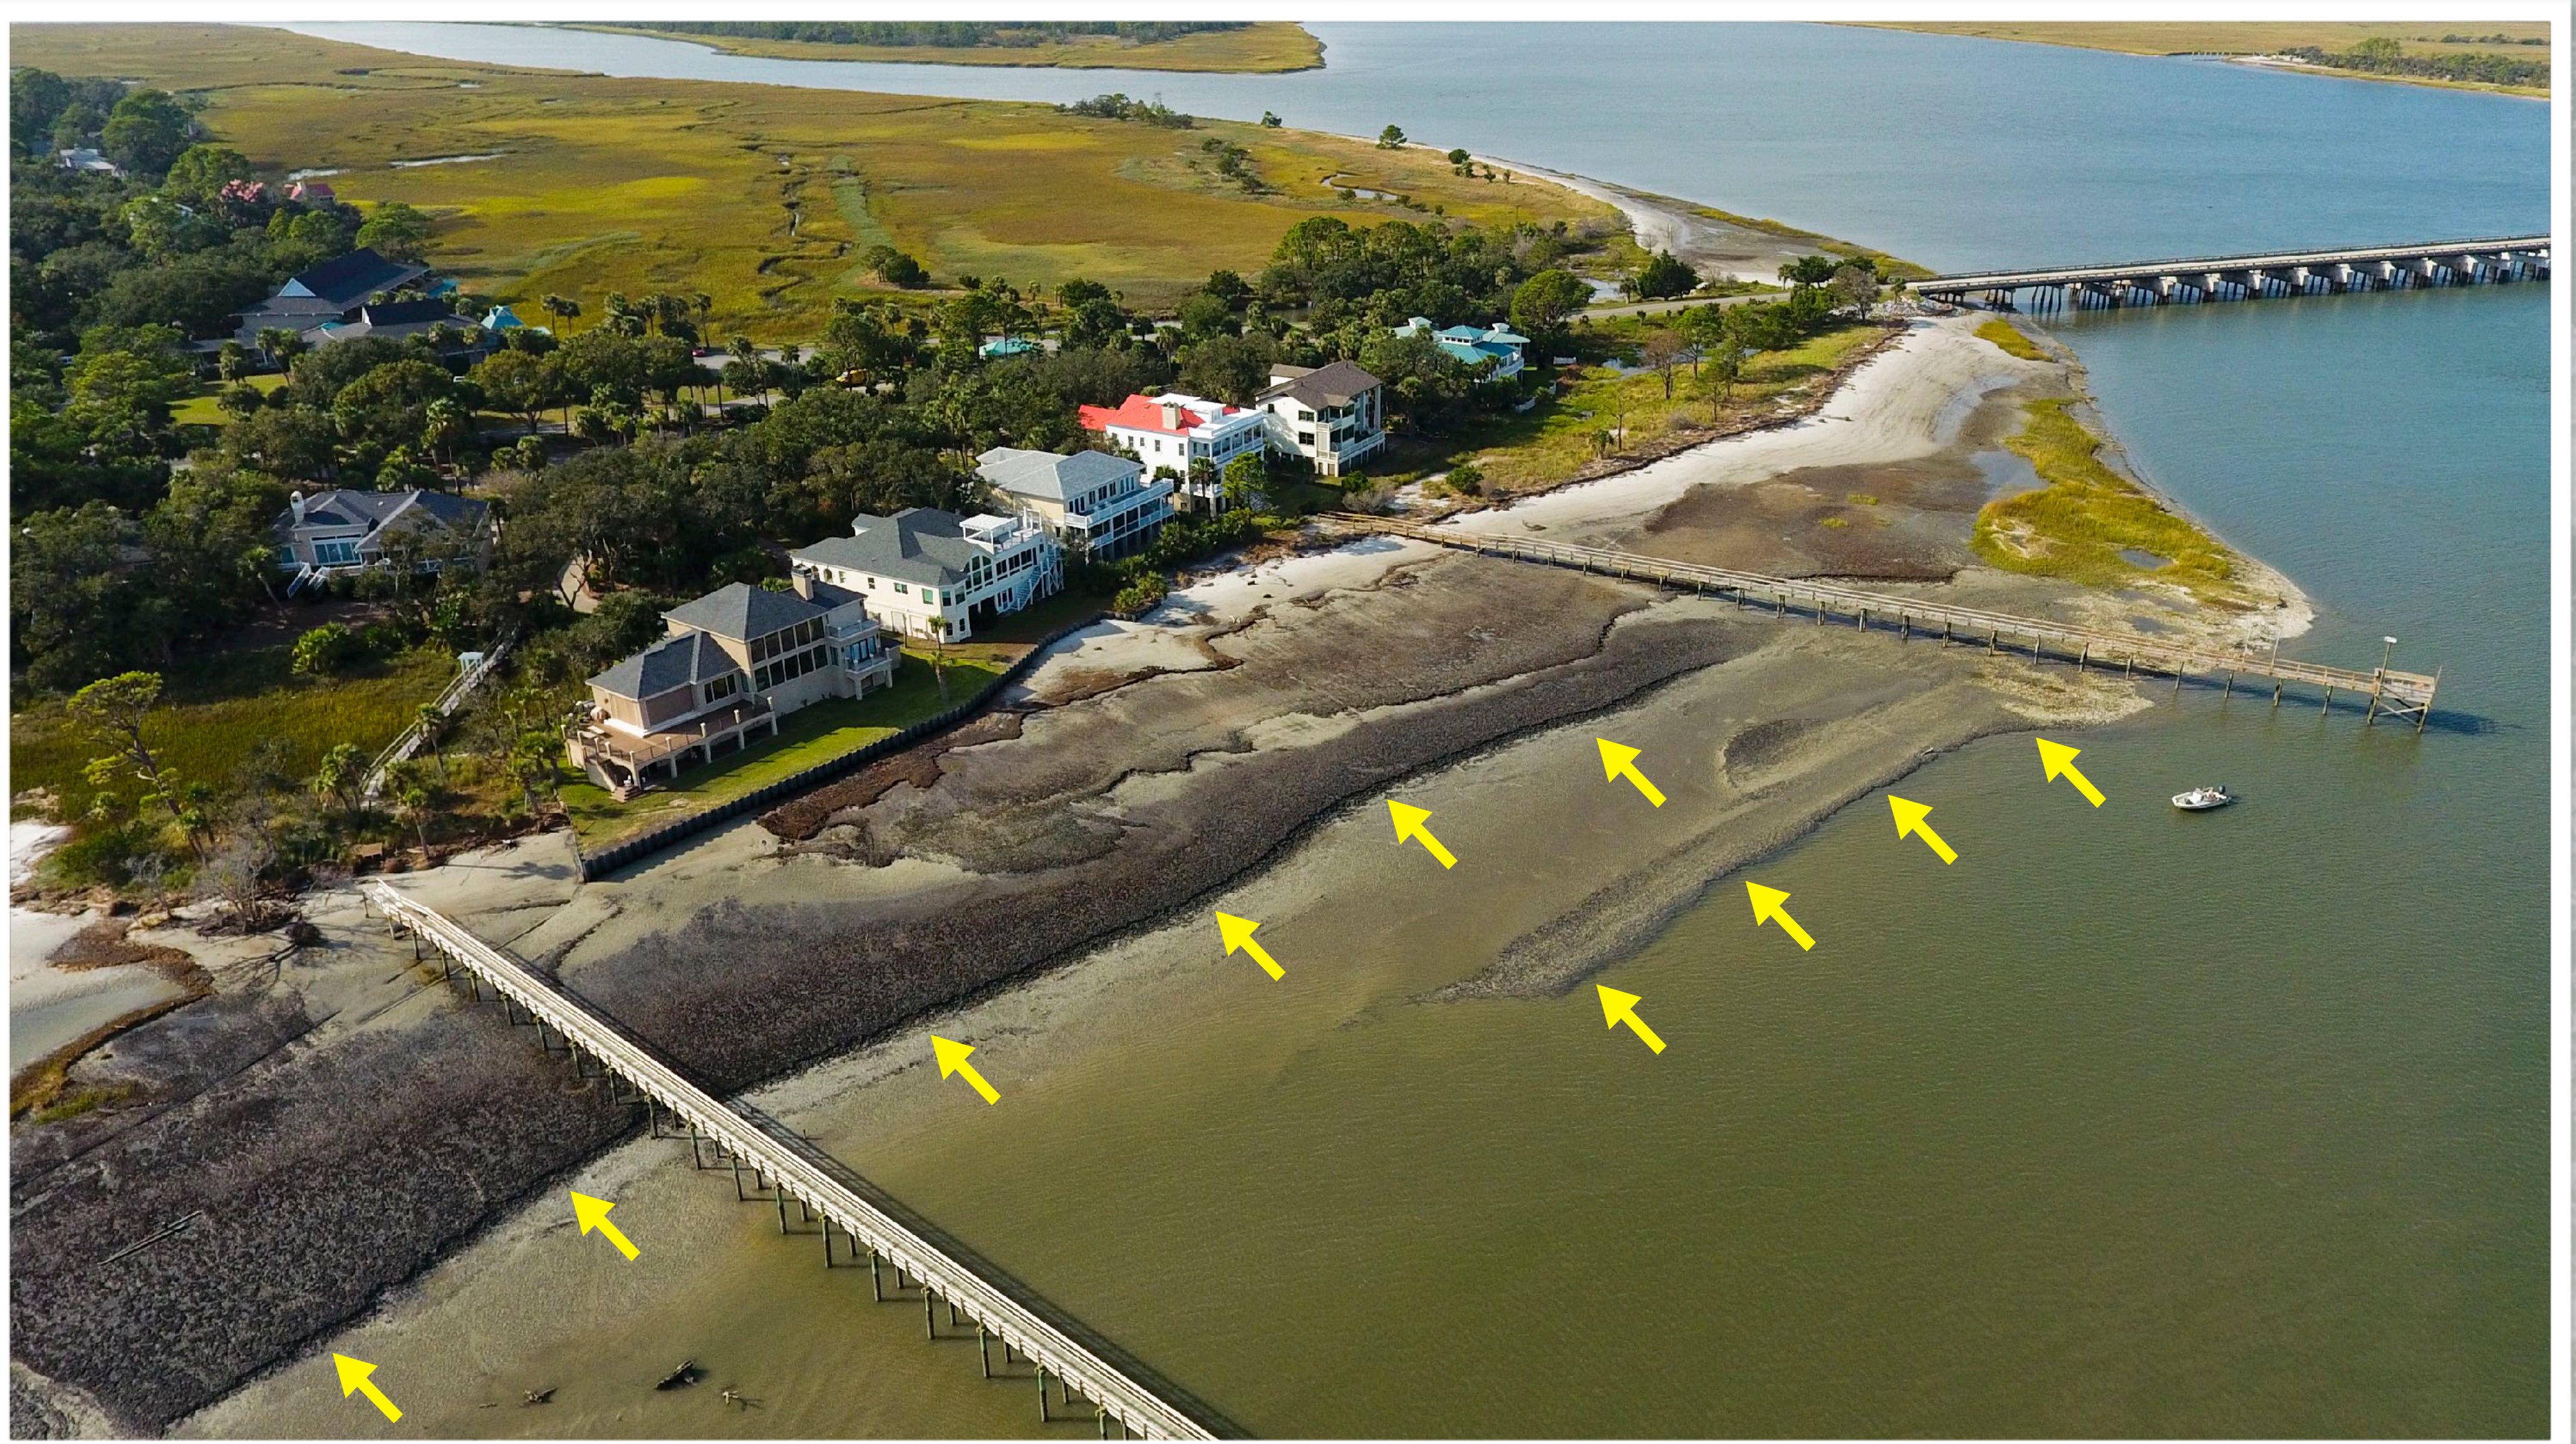
In this view, taken at low tide on **November 6, 2018**, the line of soil minus the vegetation is visible. Much of the vegetation had already been eroded away leaving only the soil footprint remaining. Left unprotected, the soil is quickly eroded by both wave action and the tidal flow that occurs in the inlet.

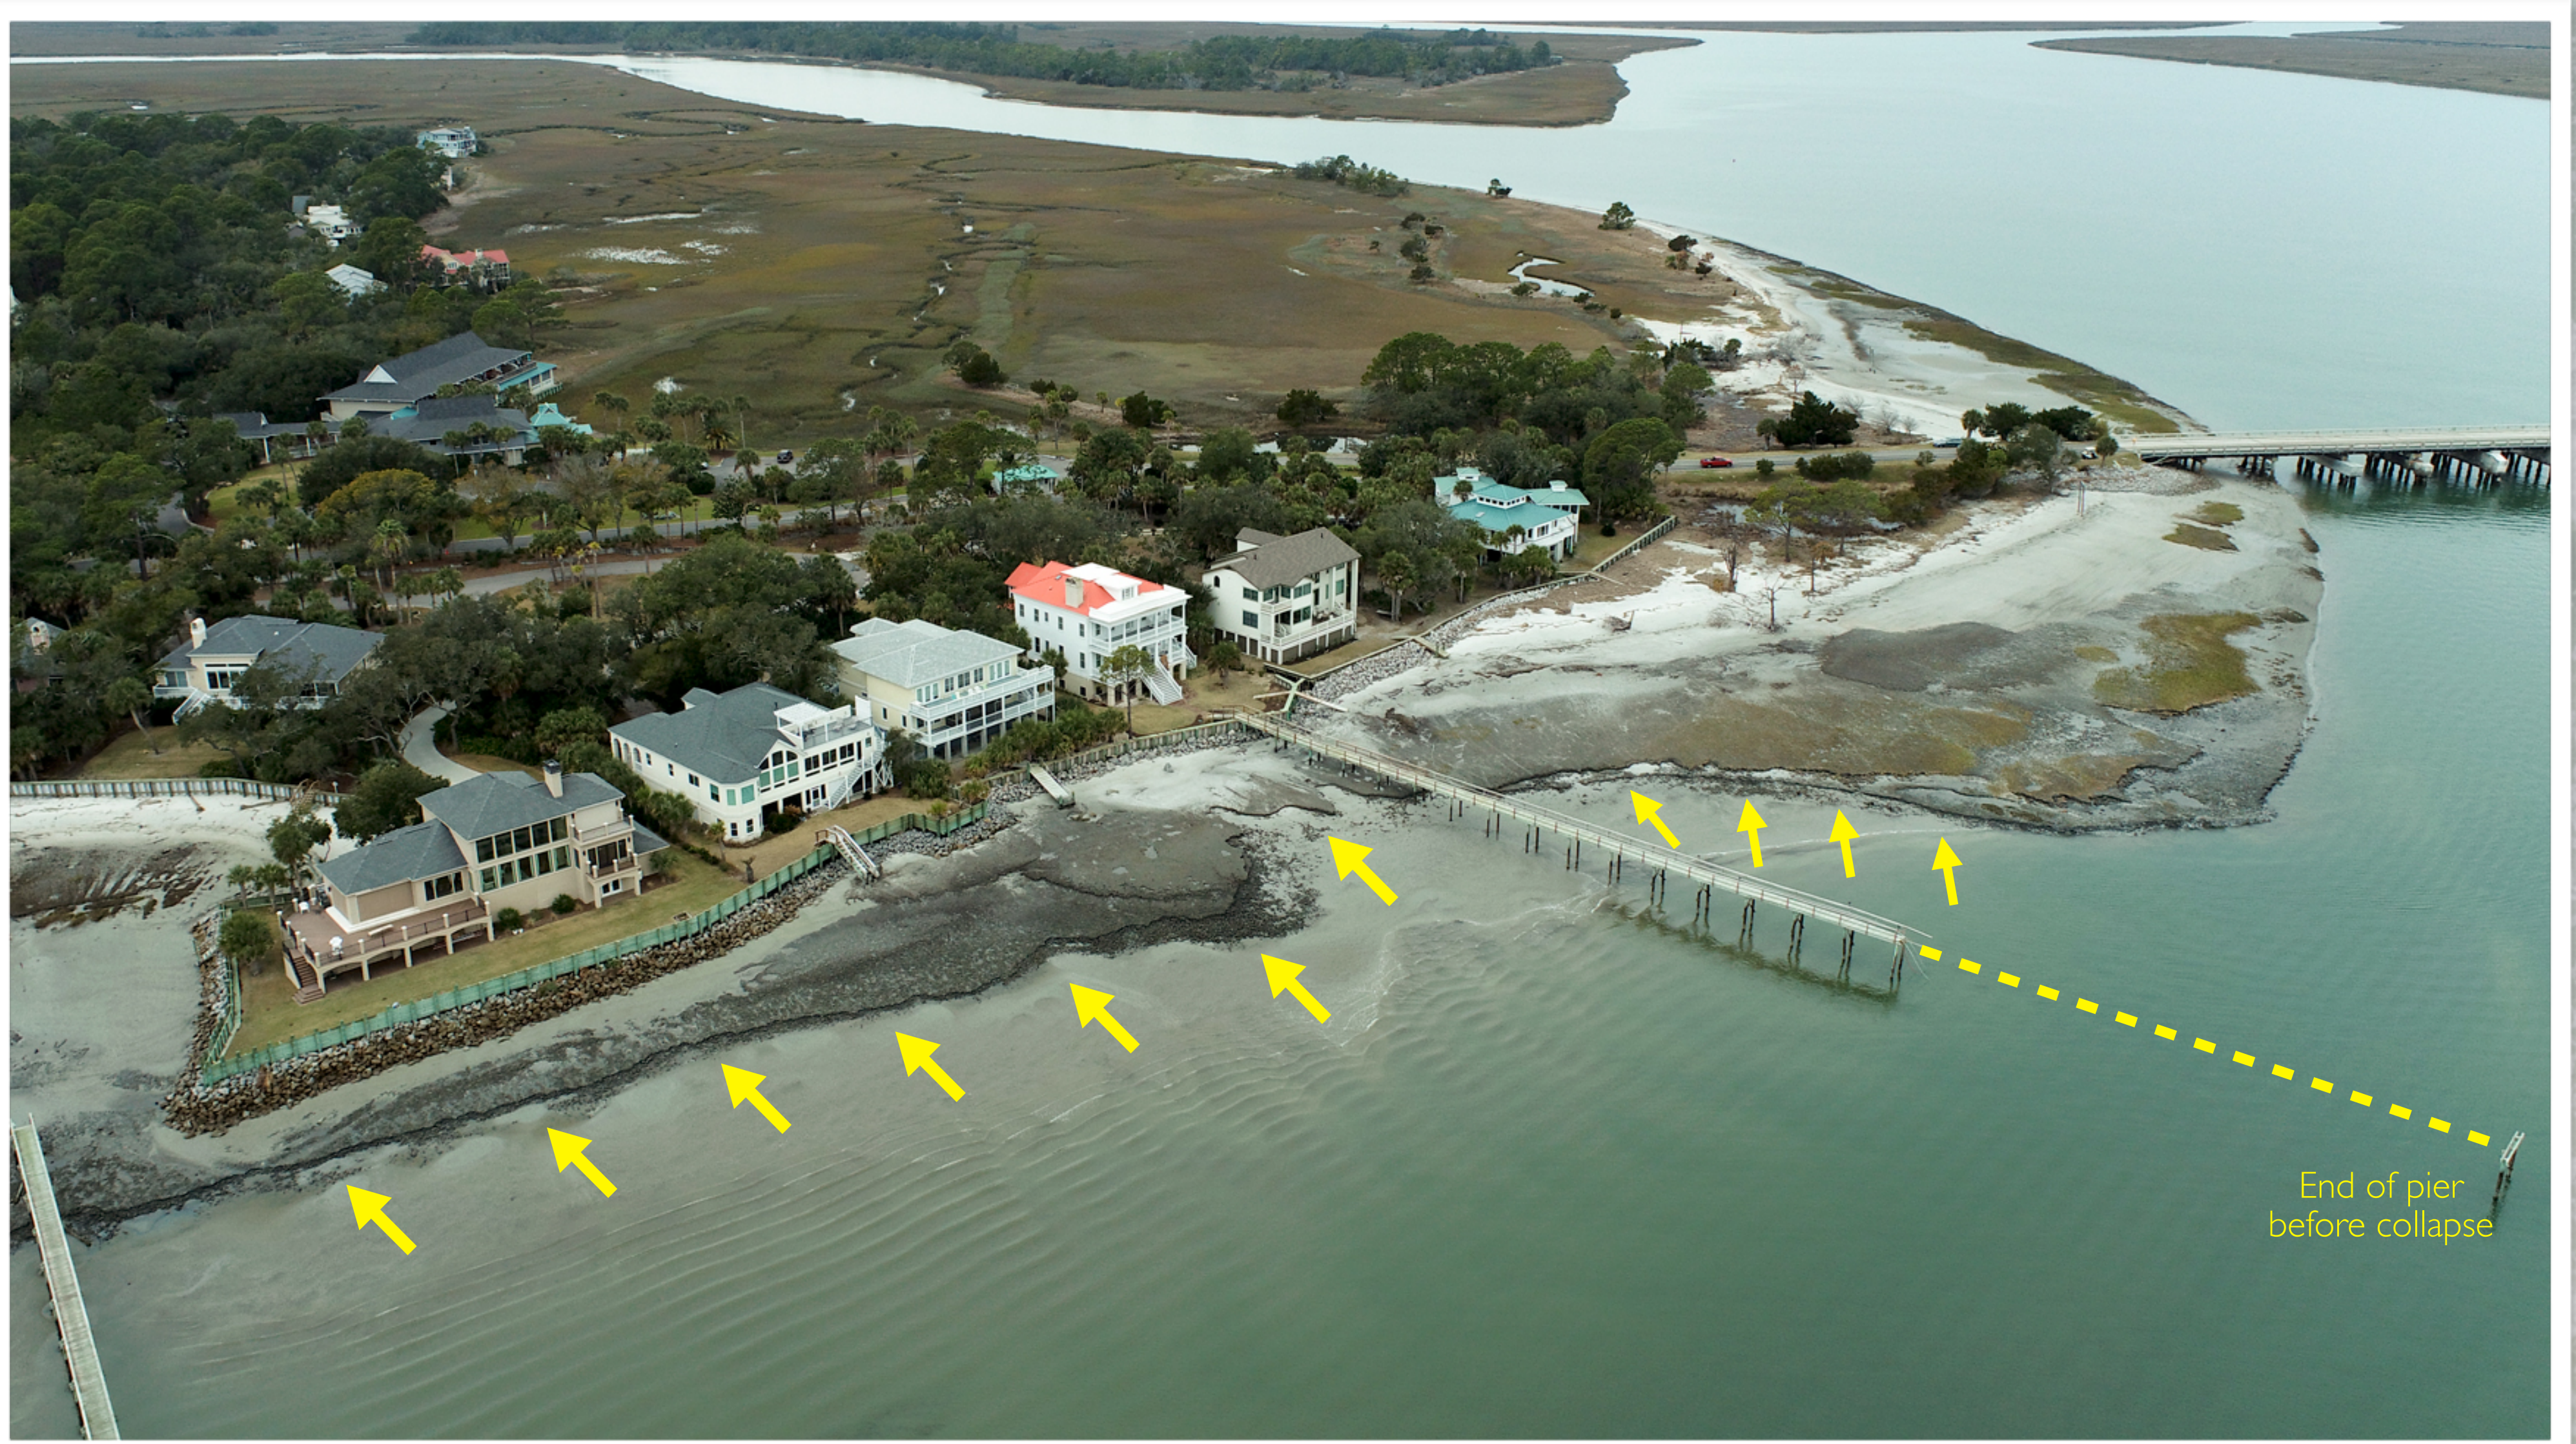
This photo taken three years later, on **January 23, 2022**, shows the extent of the erosion of the unprotected soil starting at Wardle's pier and moving past the River Club pier towards the front of the salt marsh. This area gets hit by both wave action and tidal currents.

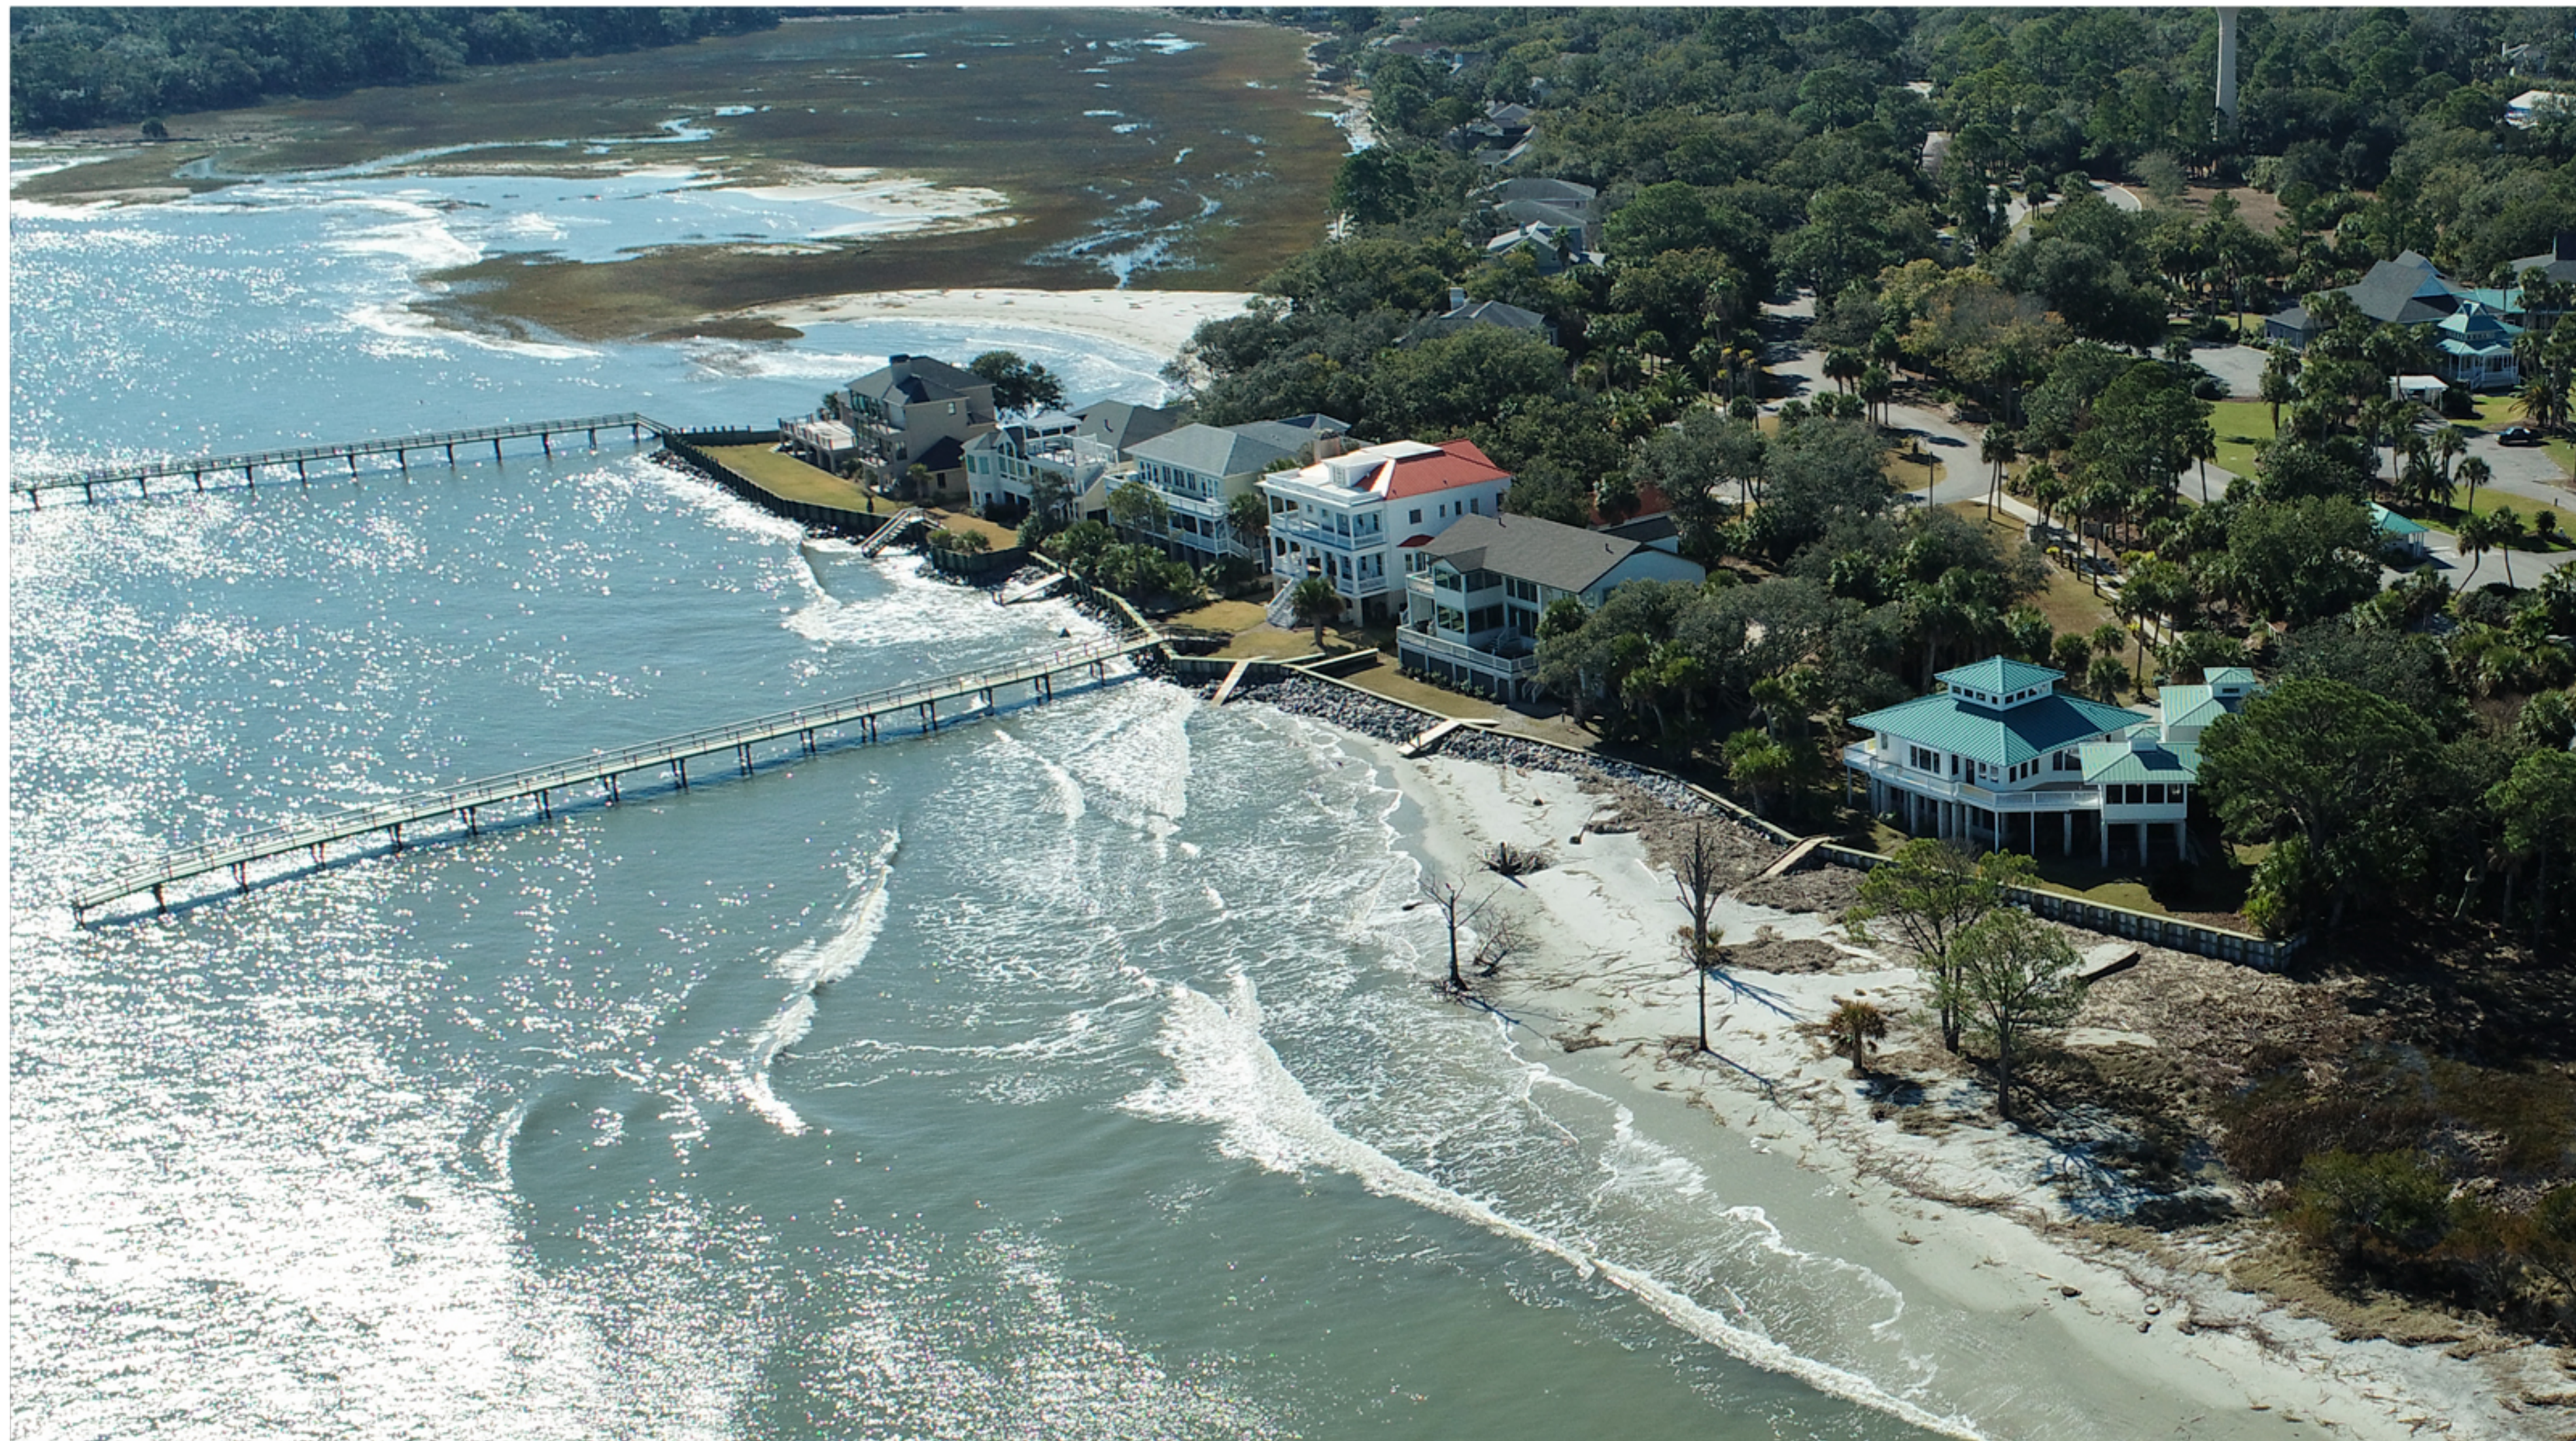
This aerial photo, taken at high tide on **January 23, 2022**, shows the typical wave action that occurs against the shoreline. The winds were steady at the time, between 5-10mph with gusts around 15mph (flyable with the drone, but windy)

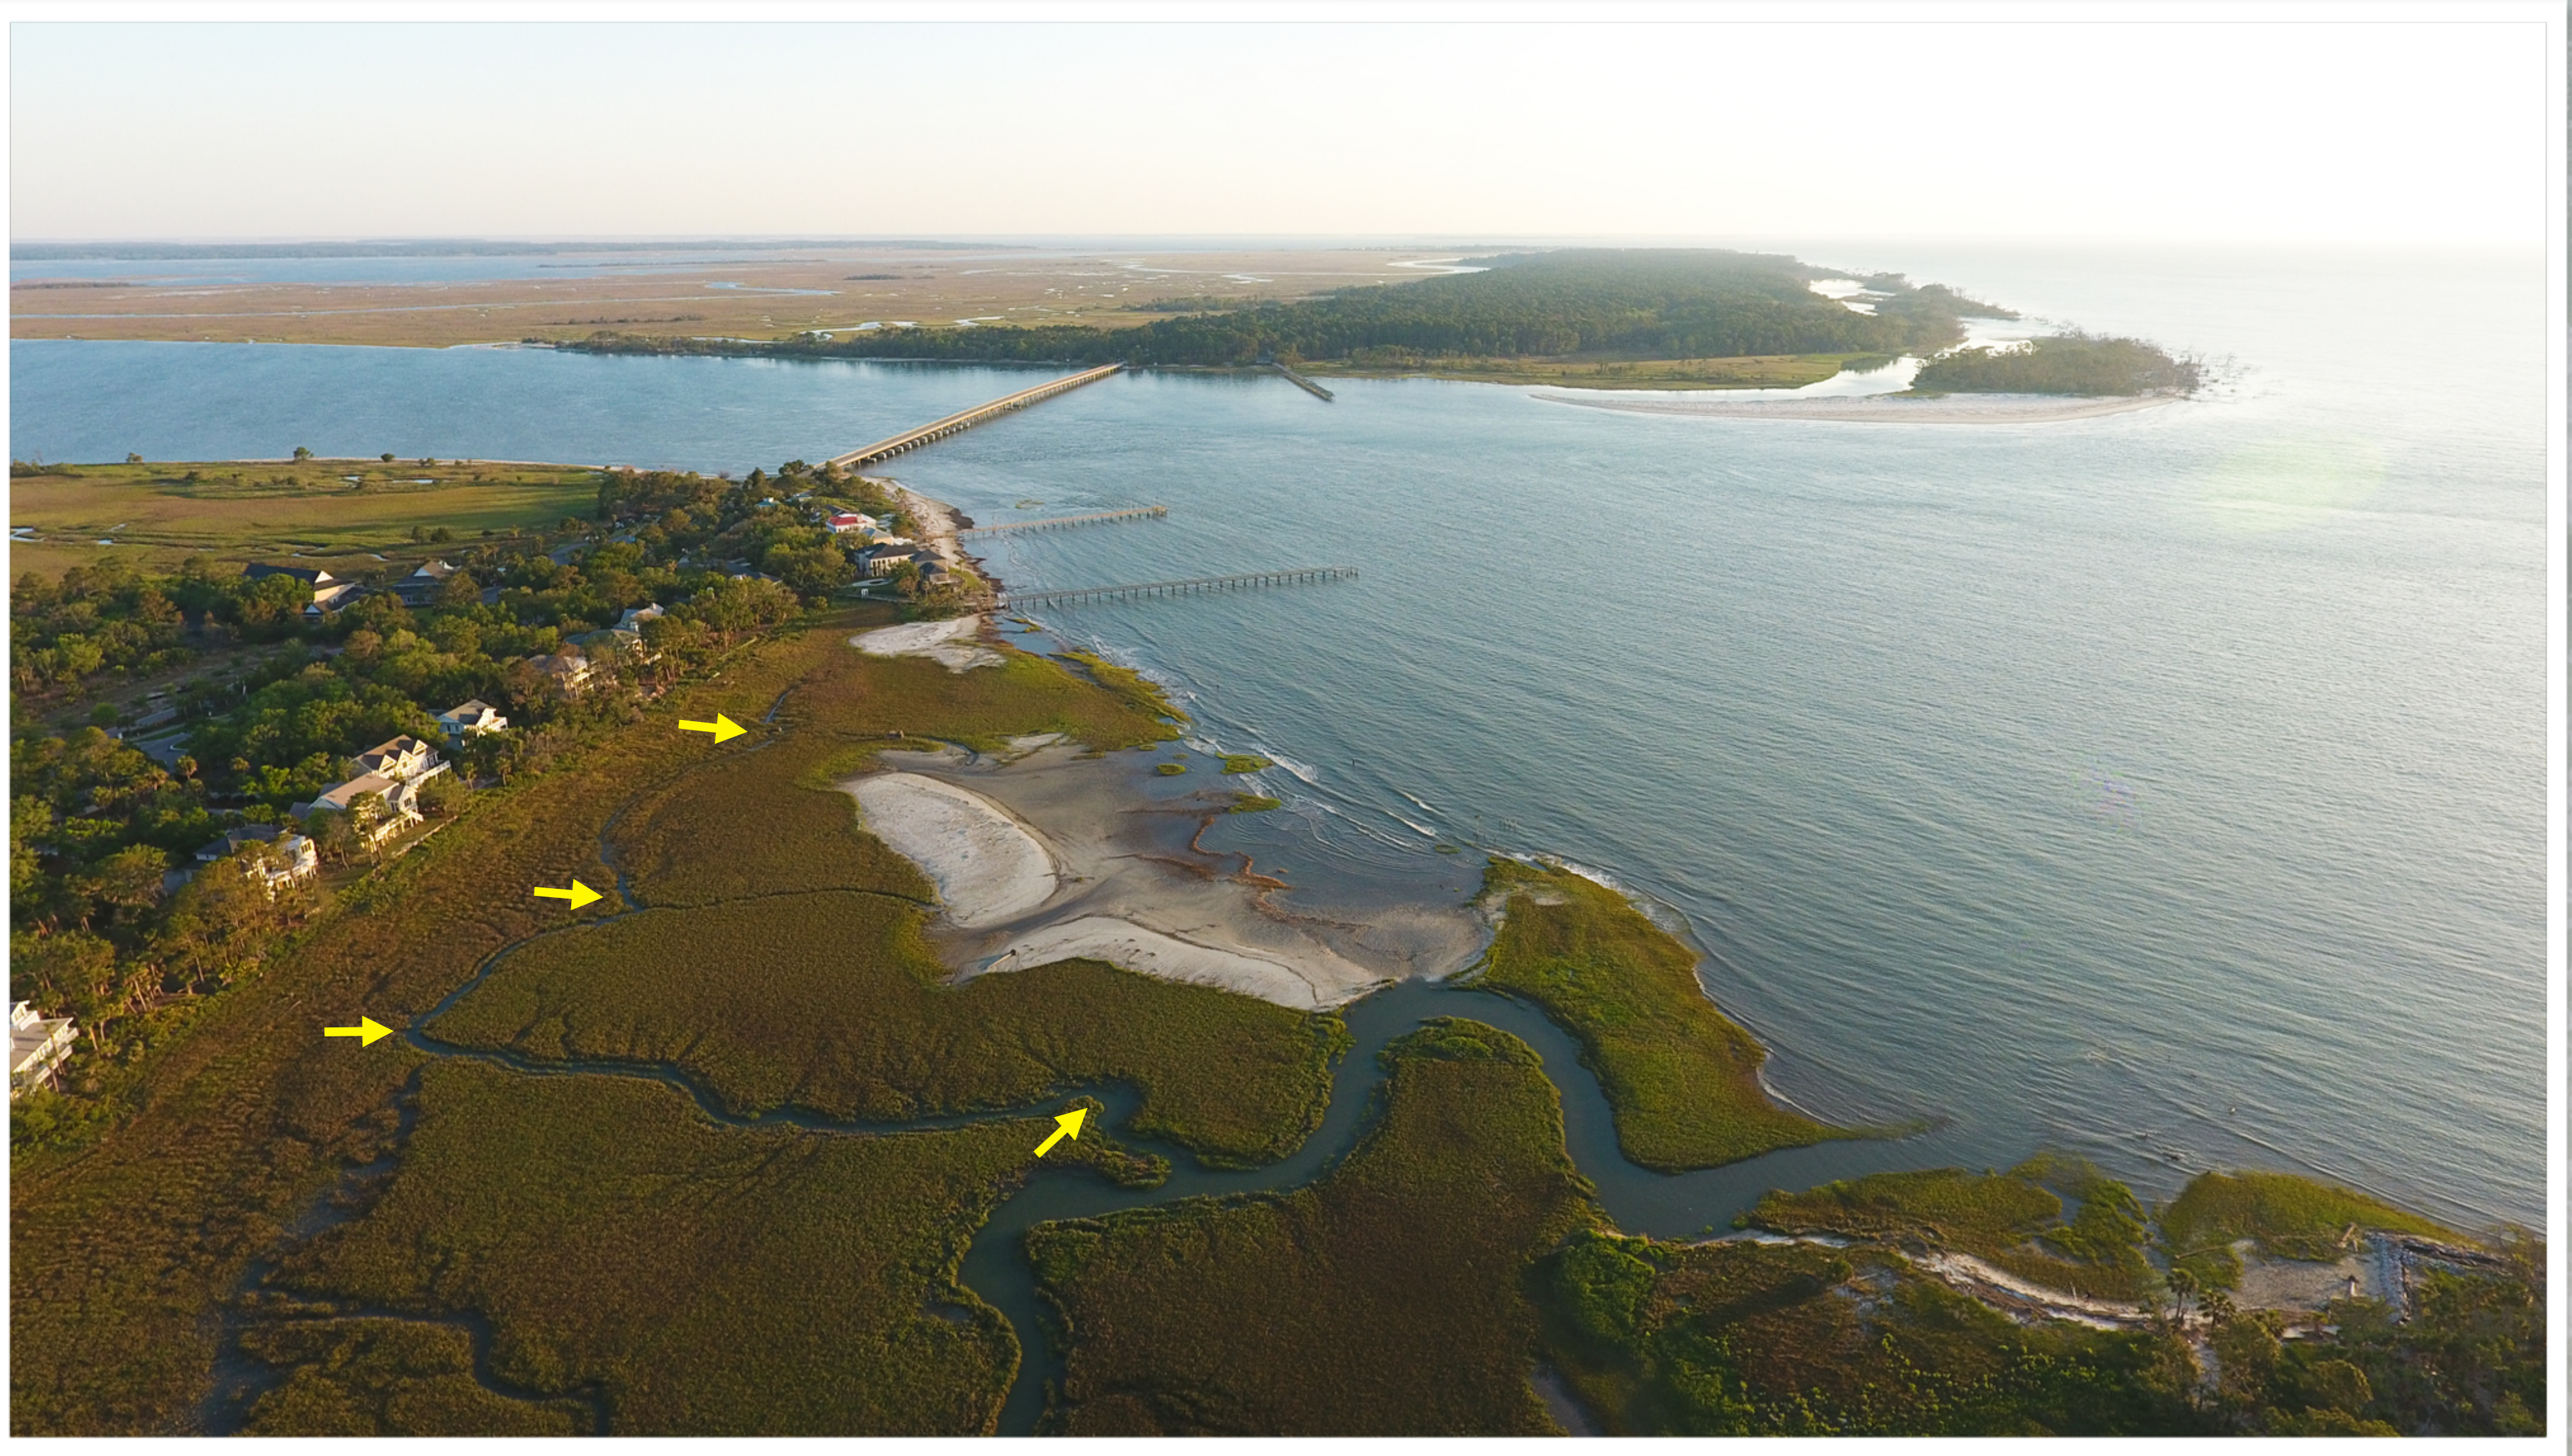
This photo, taken on **April 29, 2018**, shows the salt marsh had already begun to erode. By using points of reference along the tidal creek, one can get a good idea of how far the erosion has spread. (See next slide)

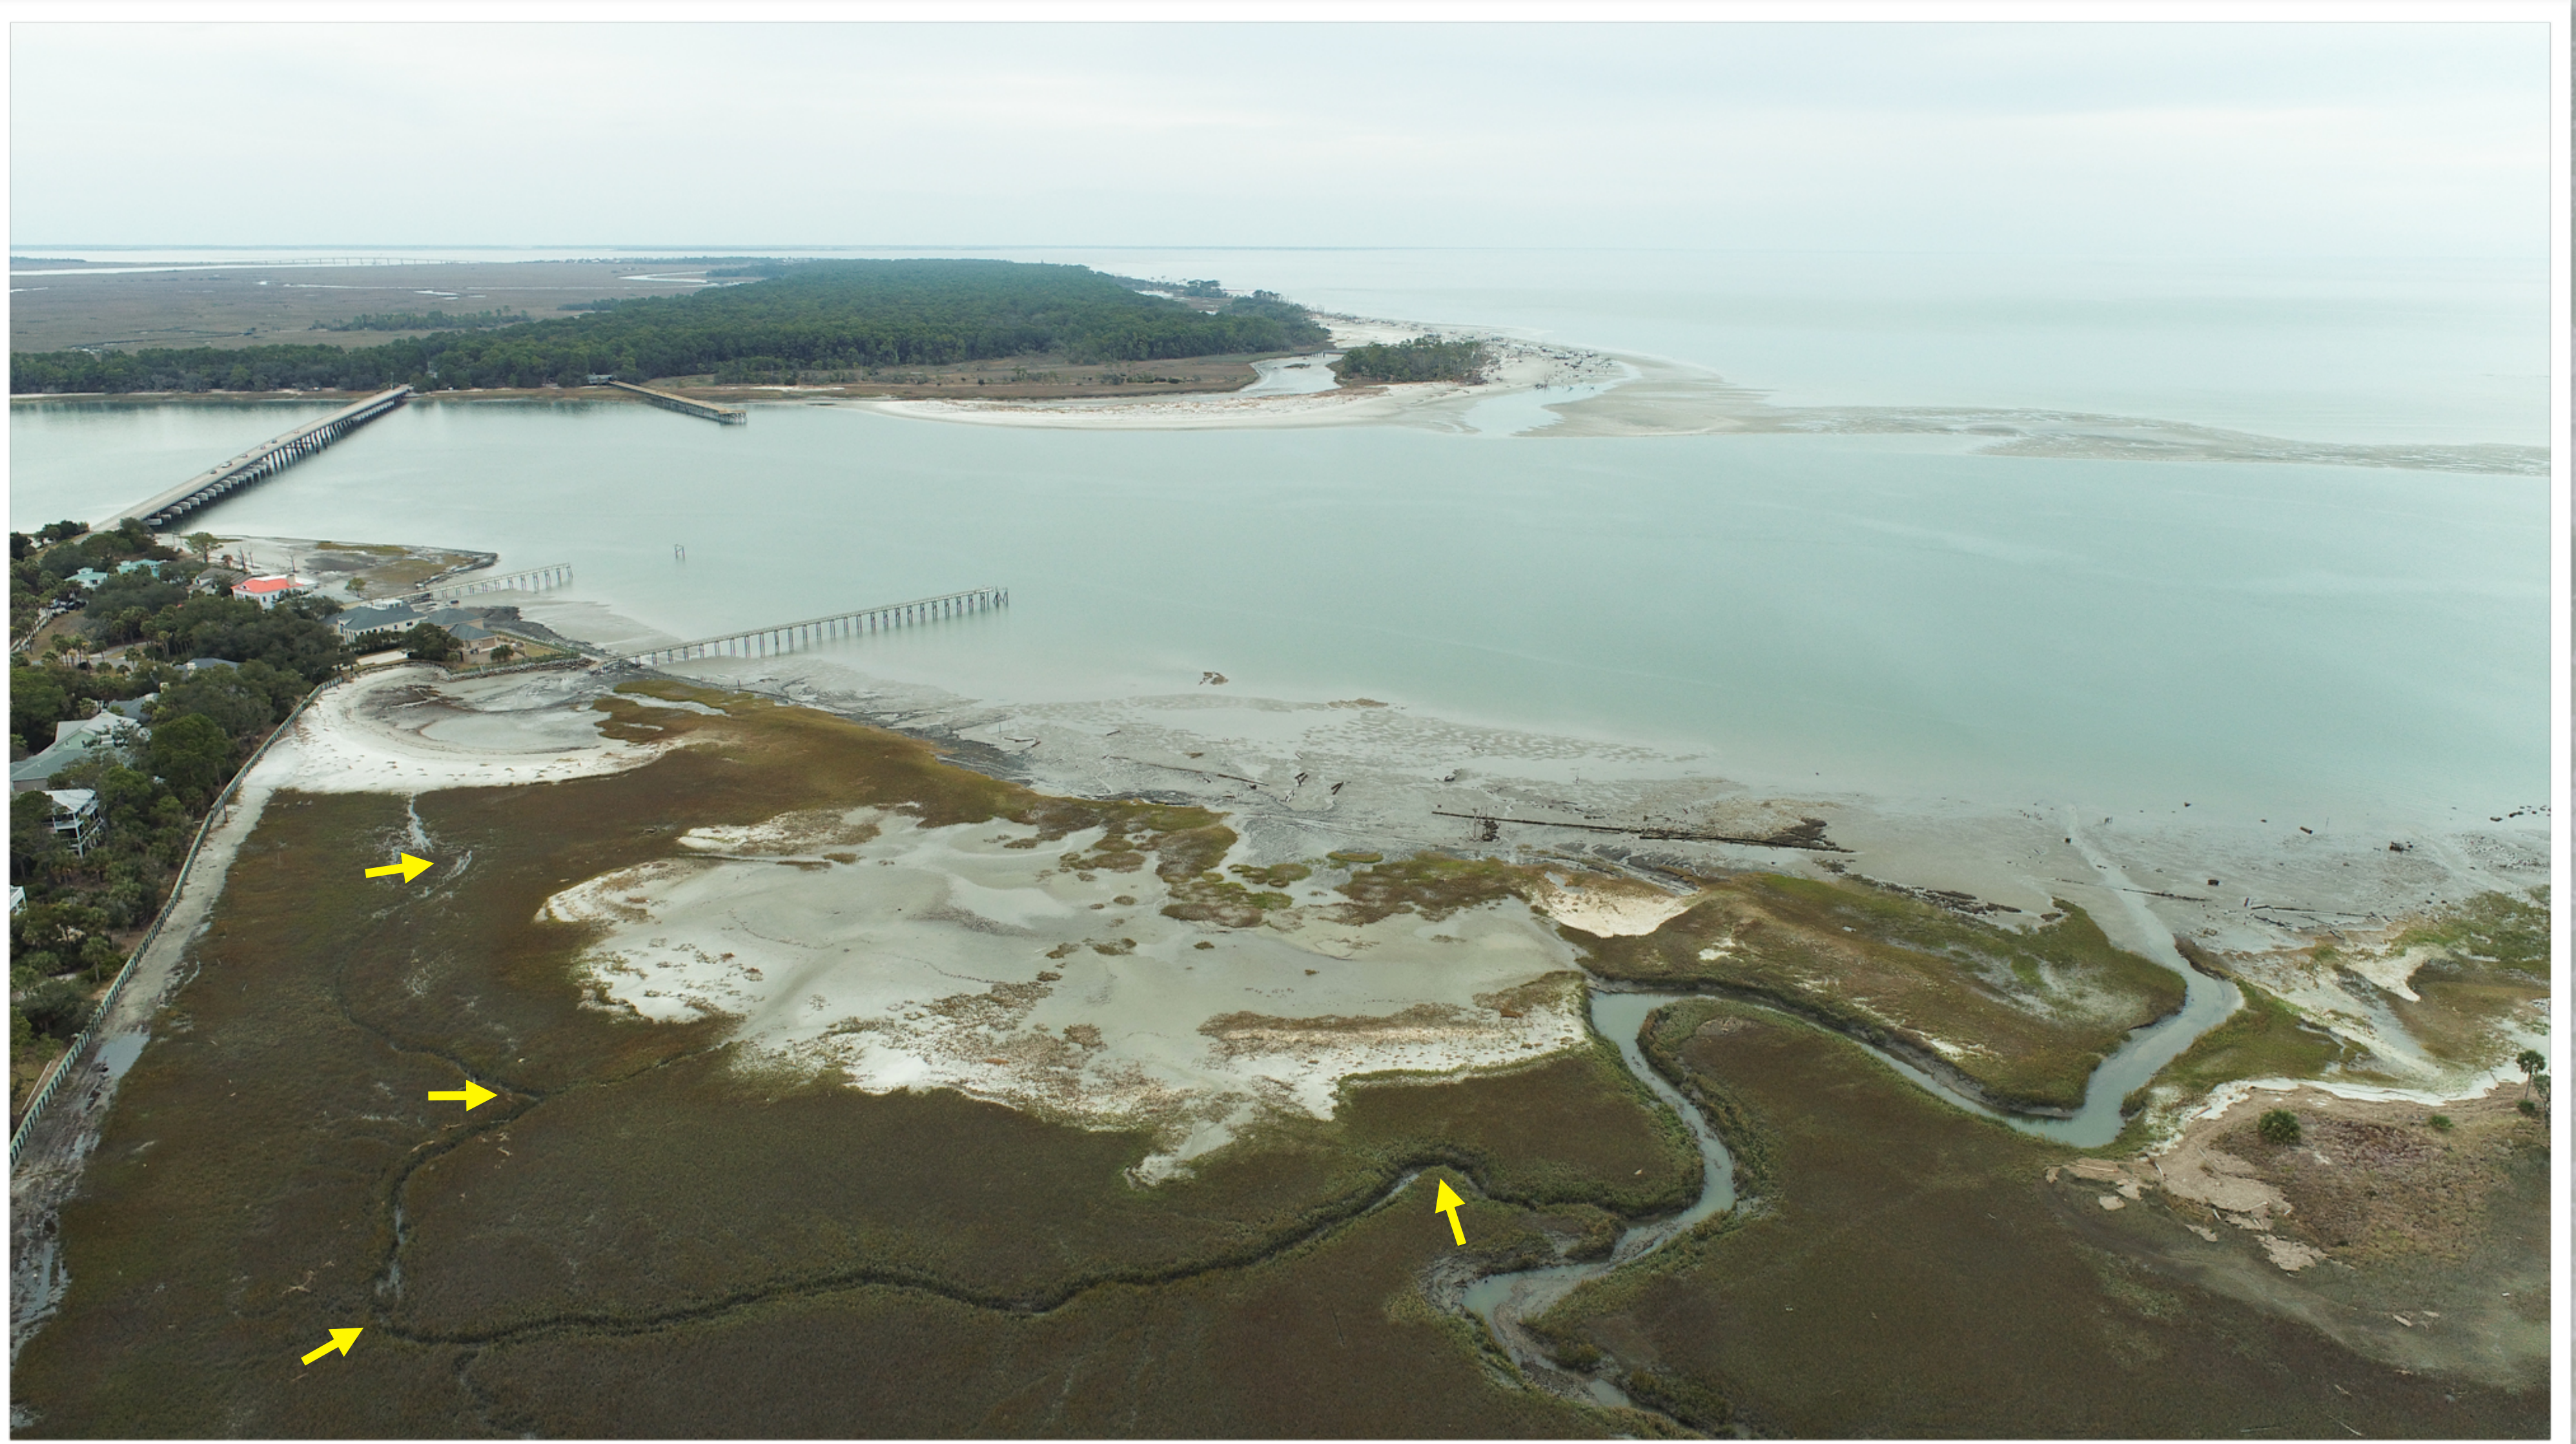
This photo, taken on **January 20, 2022**, shows the mouth of the salt marsh as it stands today. Erosion has spread, but vegetation is trying to make a comeback. Slowing the wave action that negatively affects the marsh would greatly help any natural recovery.
