Shoreline Status

Fripp Island - Shoreline Committee

January 24, 2022

A visual look at both sides of the Fripp Island bridge abutment and the salt marsh.

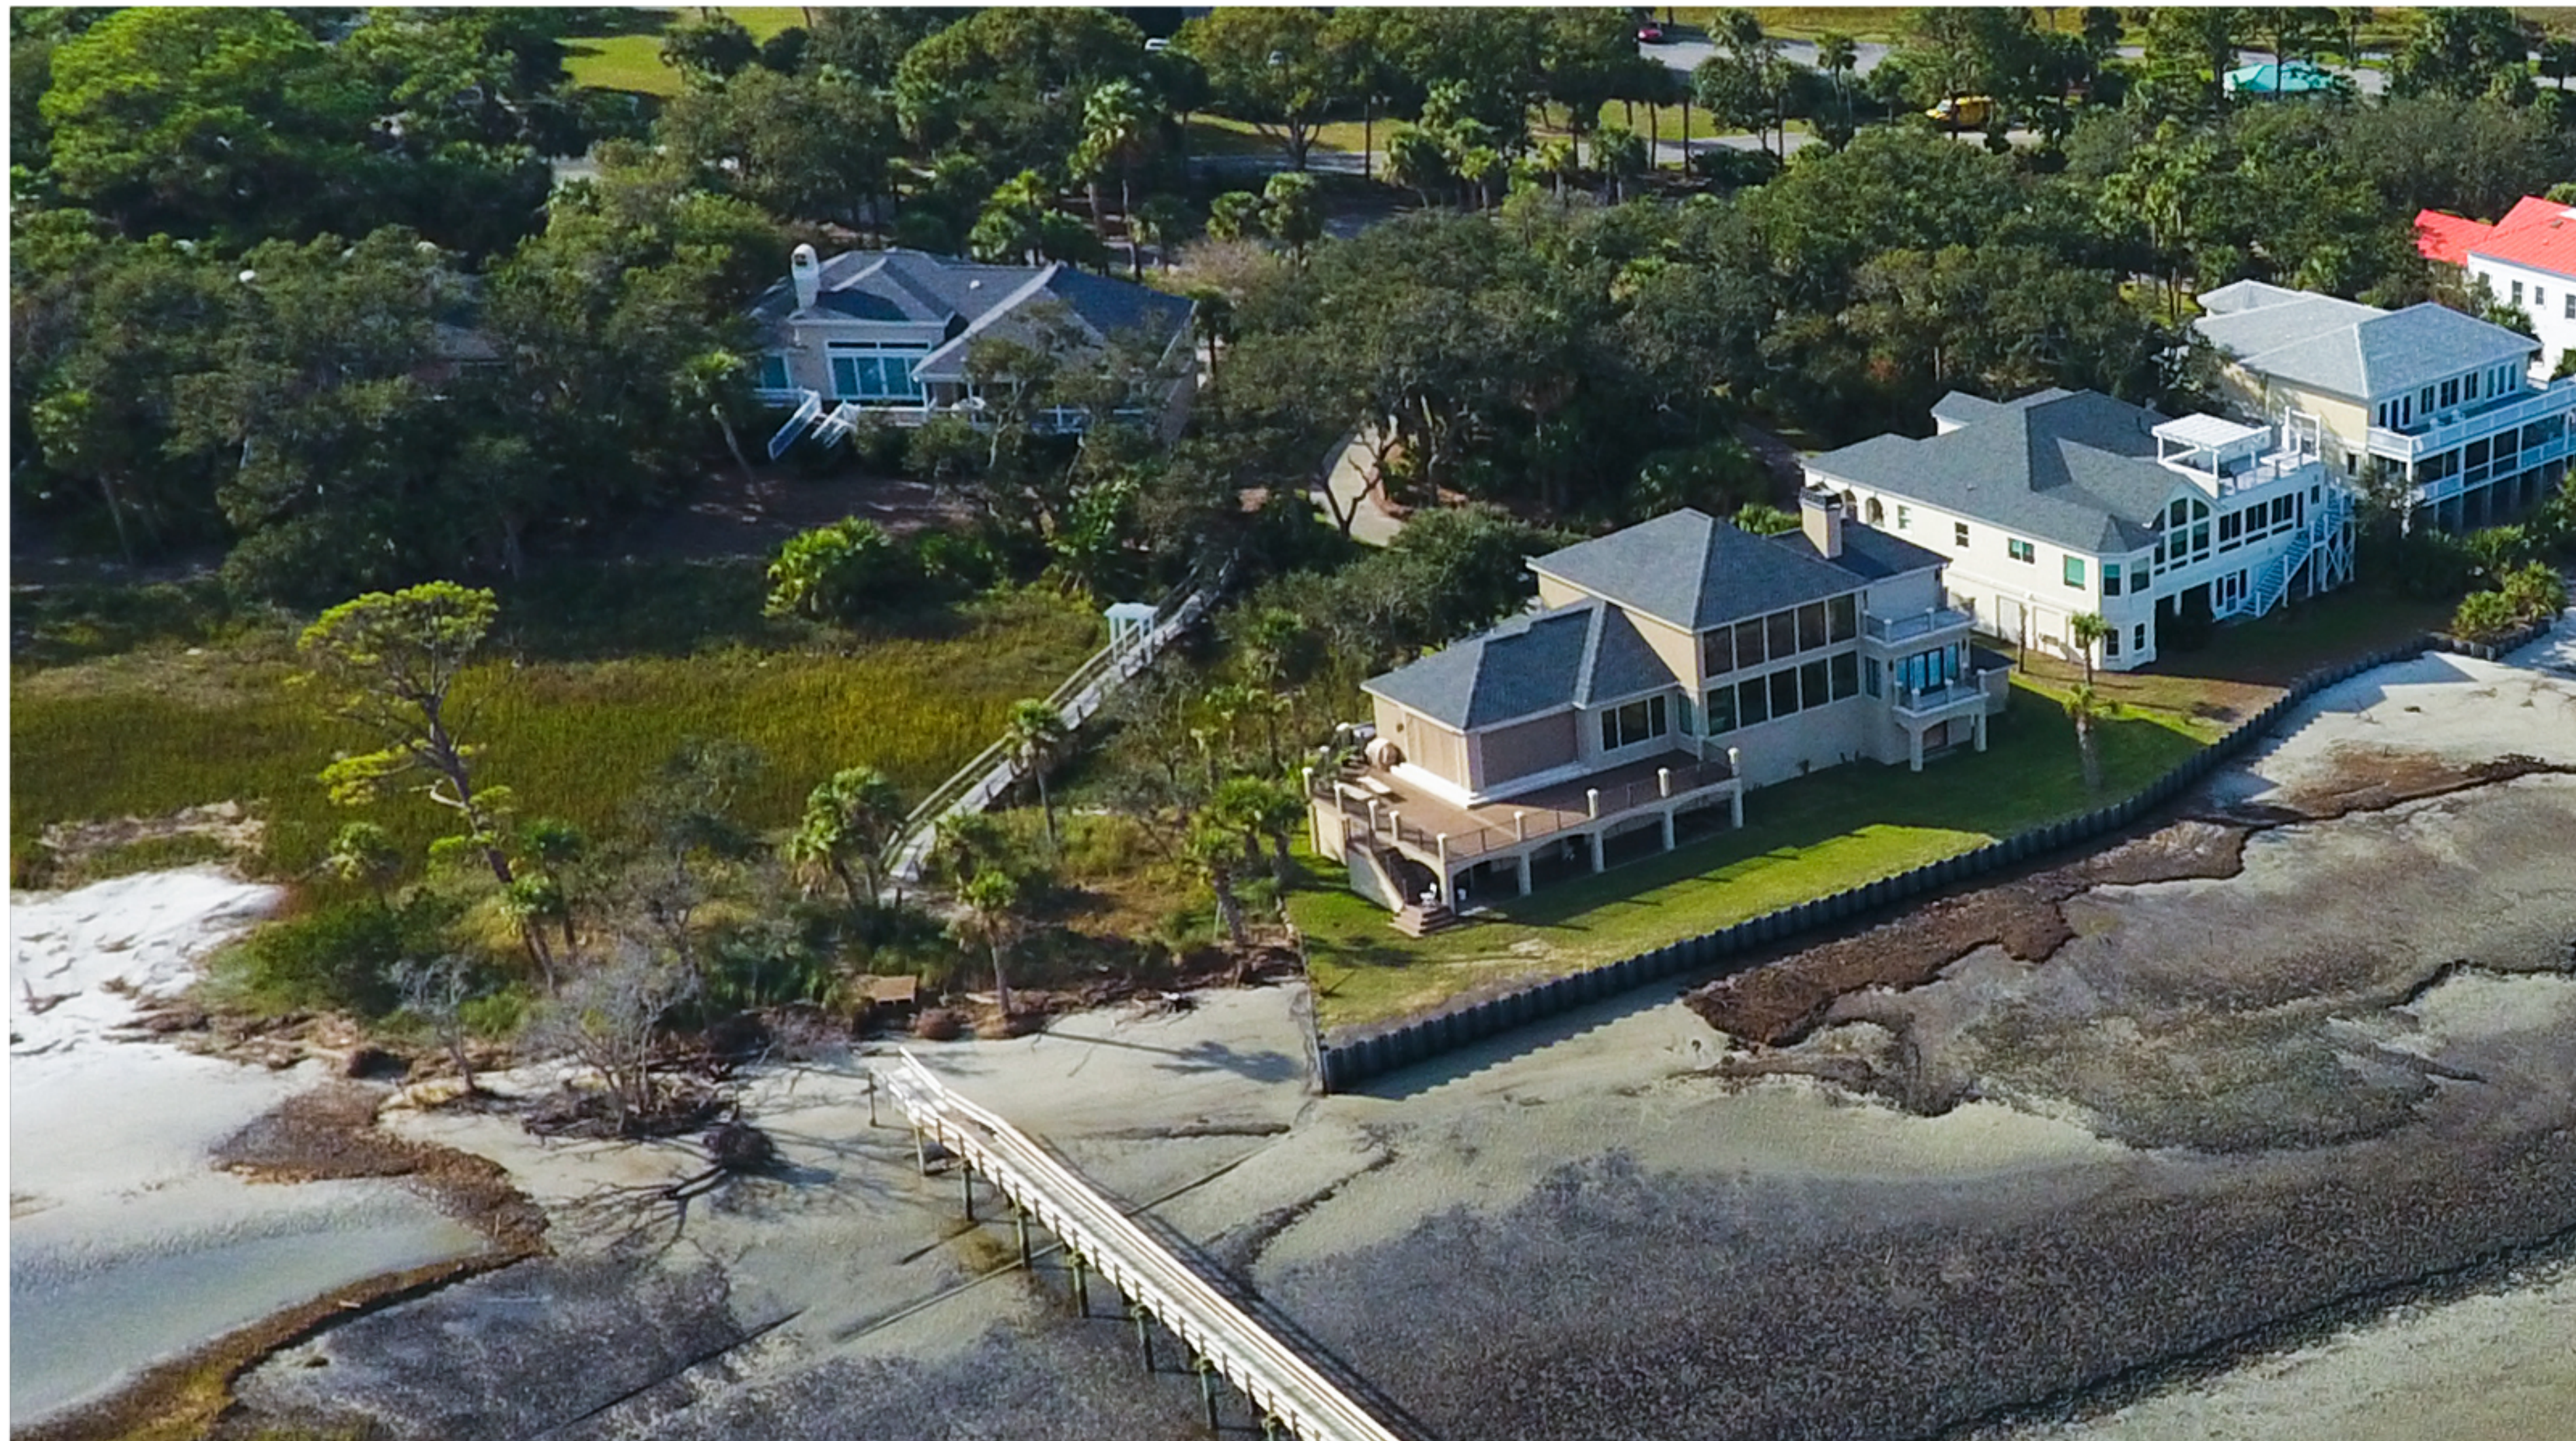
This aerial photo, taken at low tide on **November 6, 2018**, shows the salt marsh area next to the Mollura residence on River Club Drive. Trees existed and were surrounded by a large grassy area that was spanned by the first leg of a 2-pier walkway.

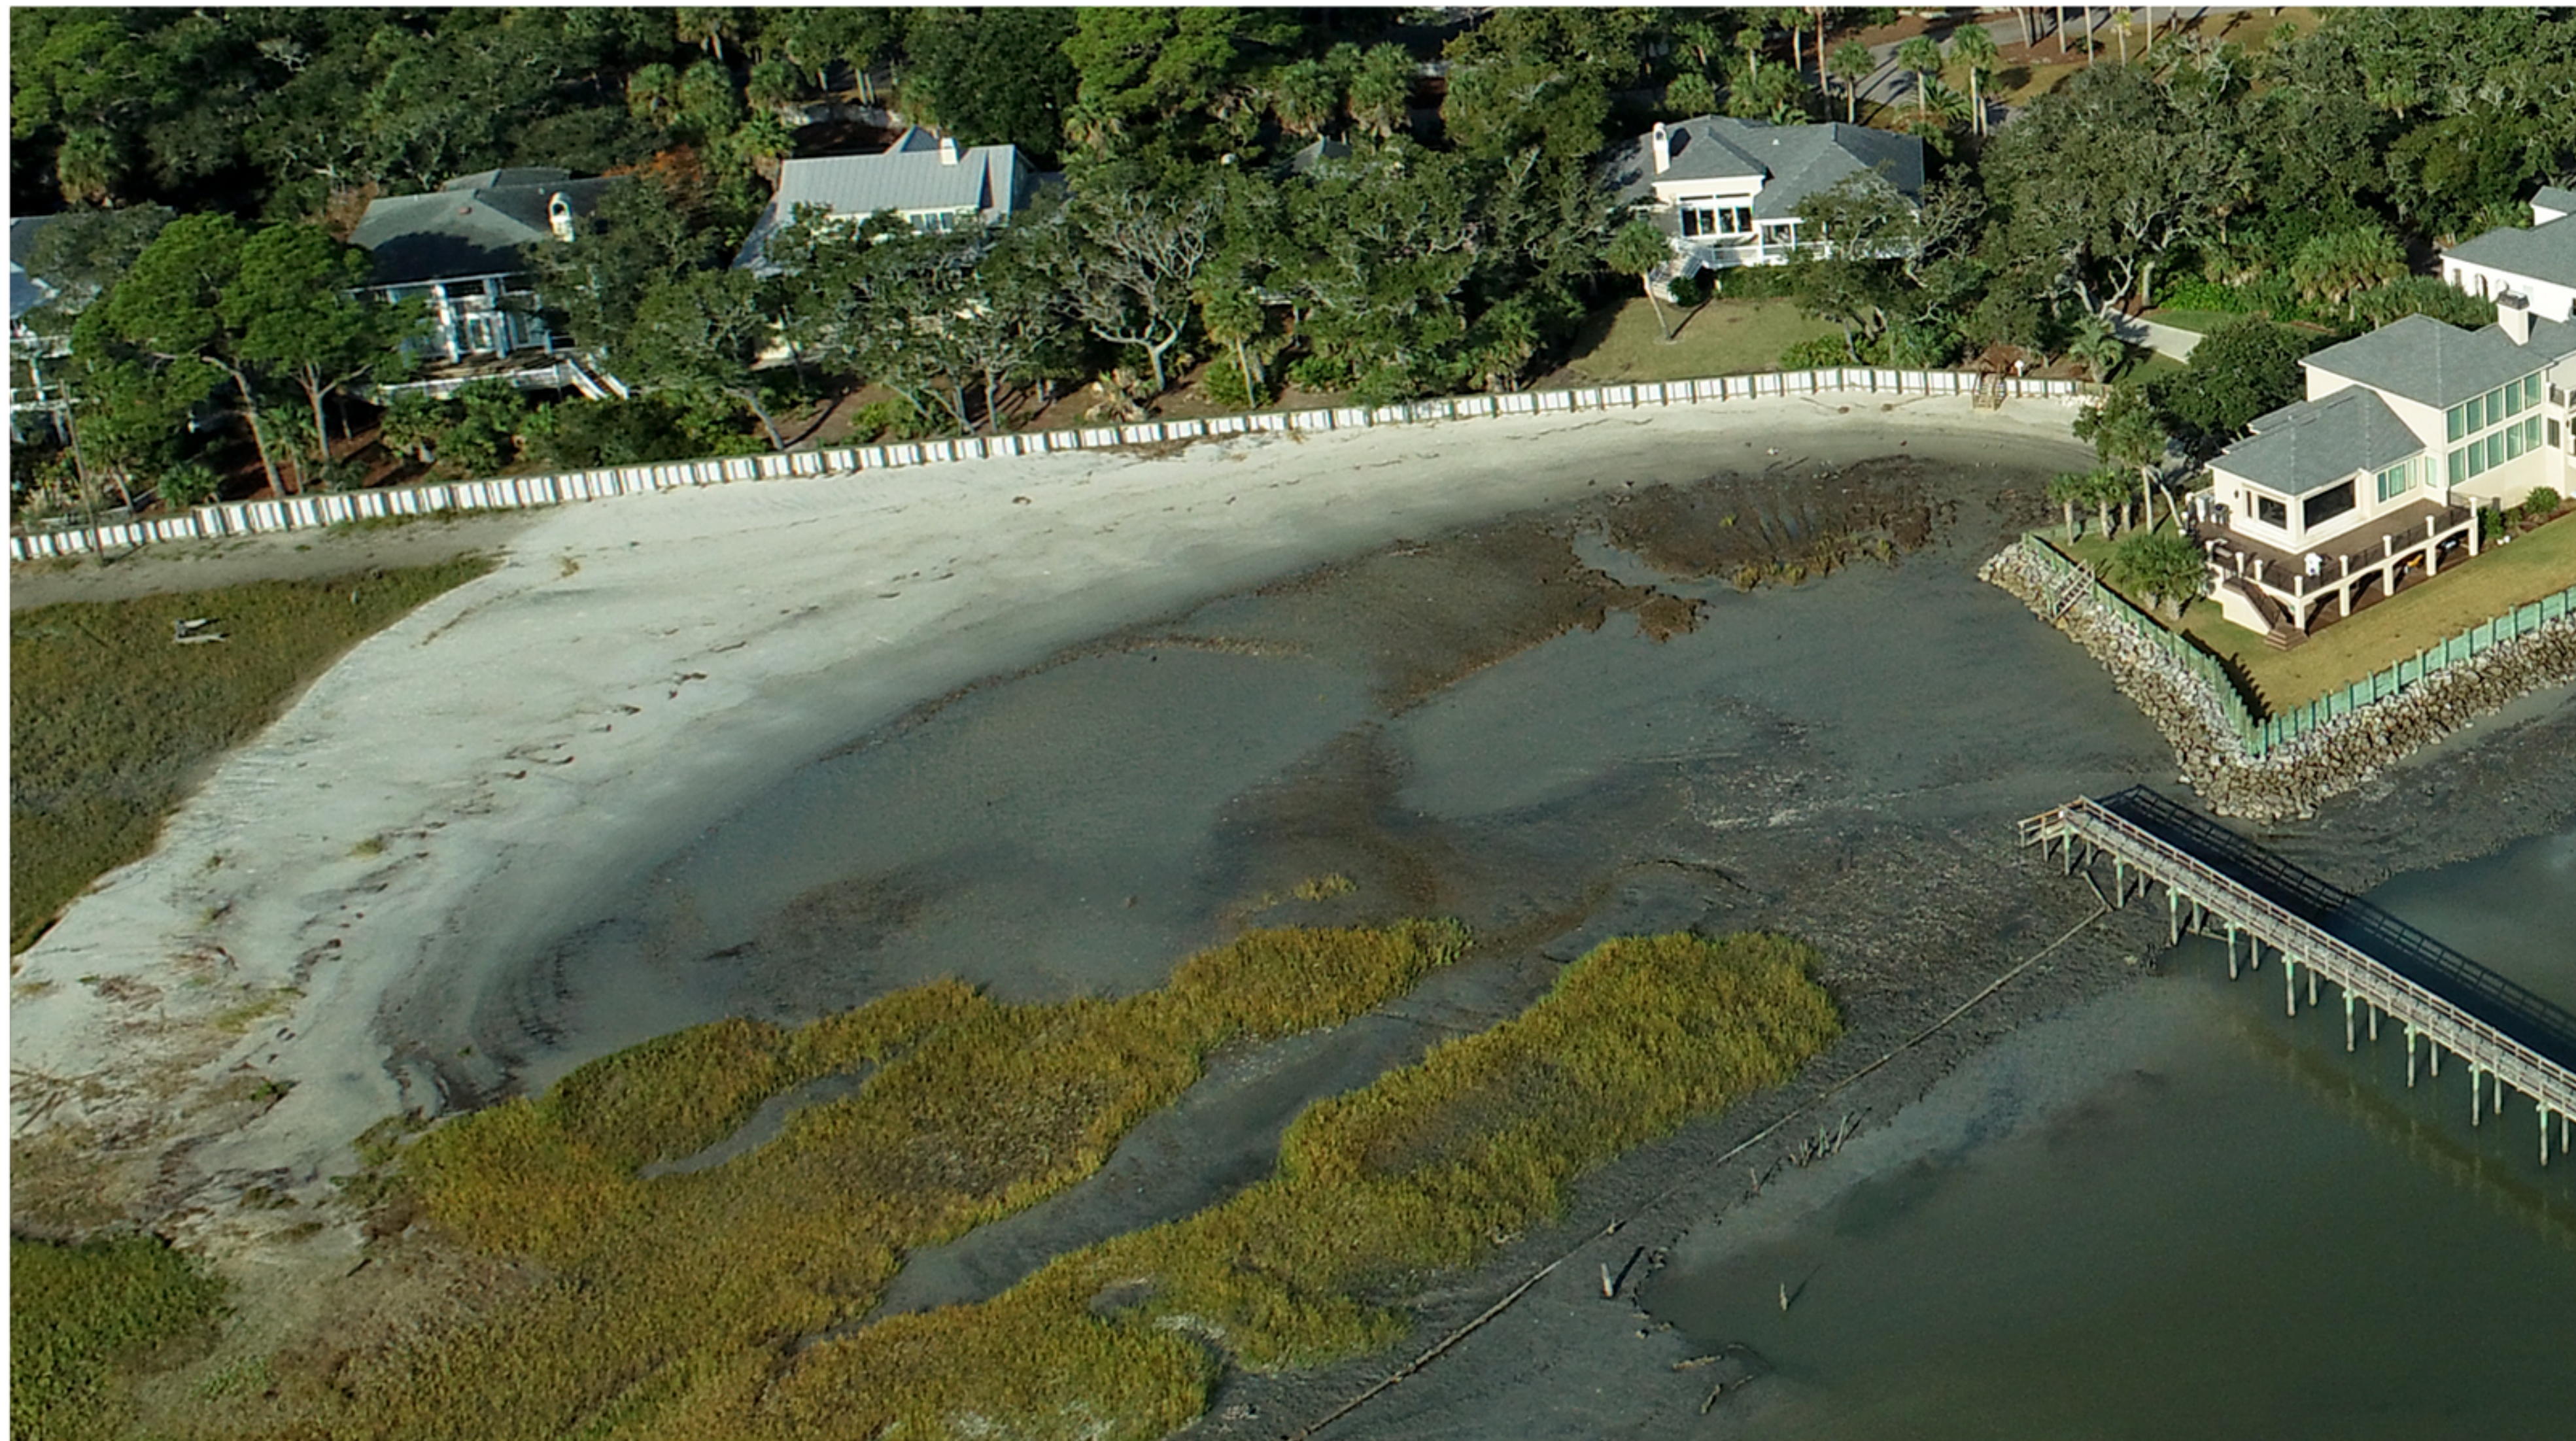
Just three years later on **November 15, 2021**, the trees, the grassy area, and the walkway are long gone. A sea wall was added starting at River Club and extending along Cardinal Crest Lane. This has become a necessity to protect property owners against the sea in this area. The sea wall in this corner is all that stops the sea from reaching the homes and streets during storm events.

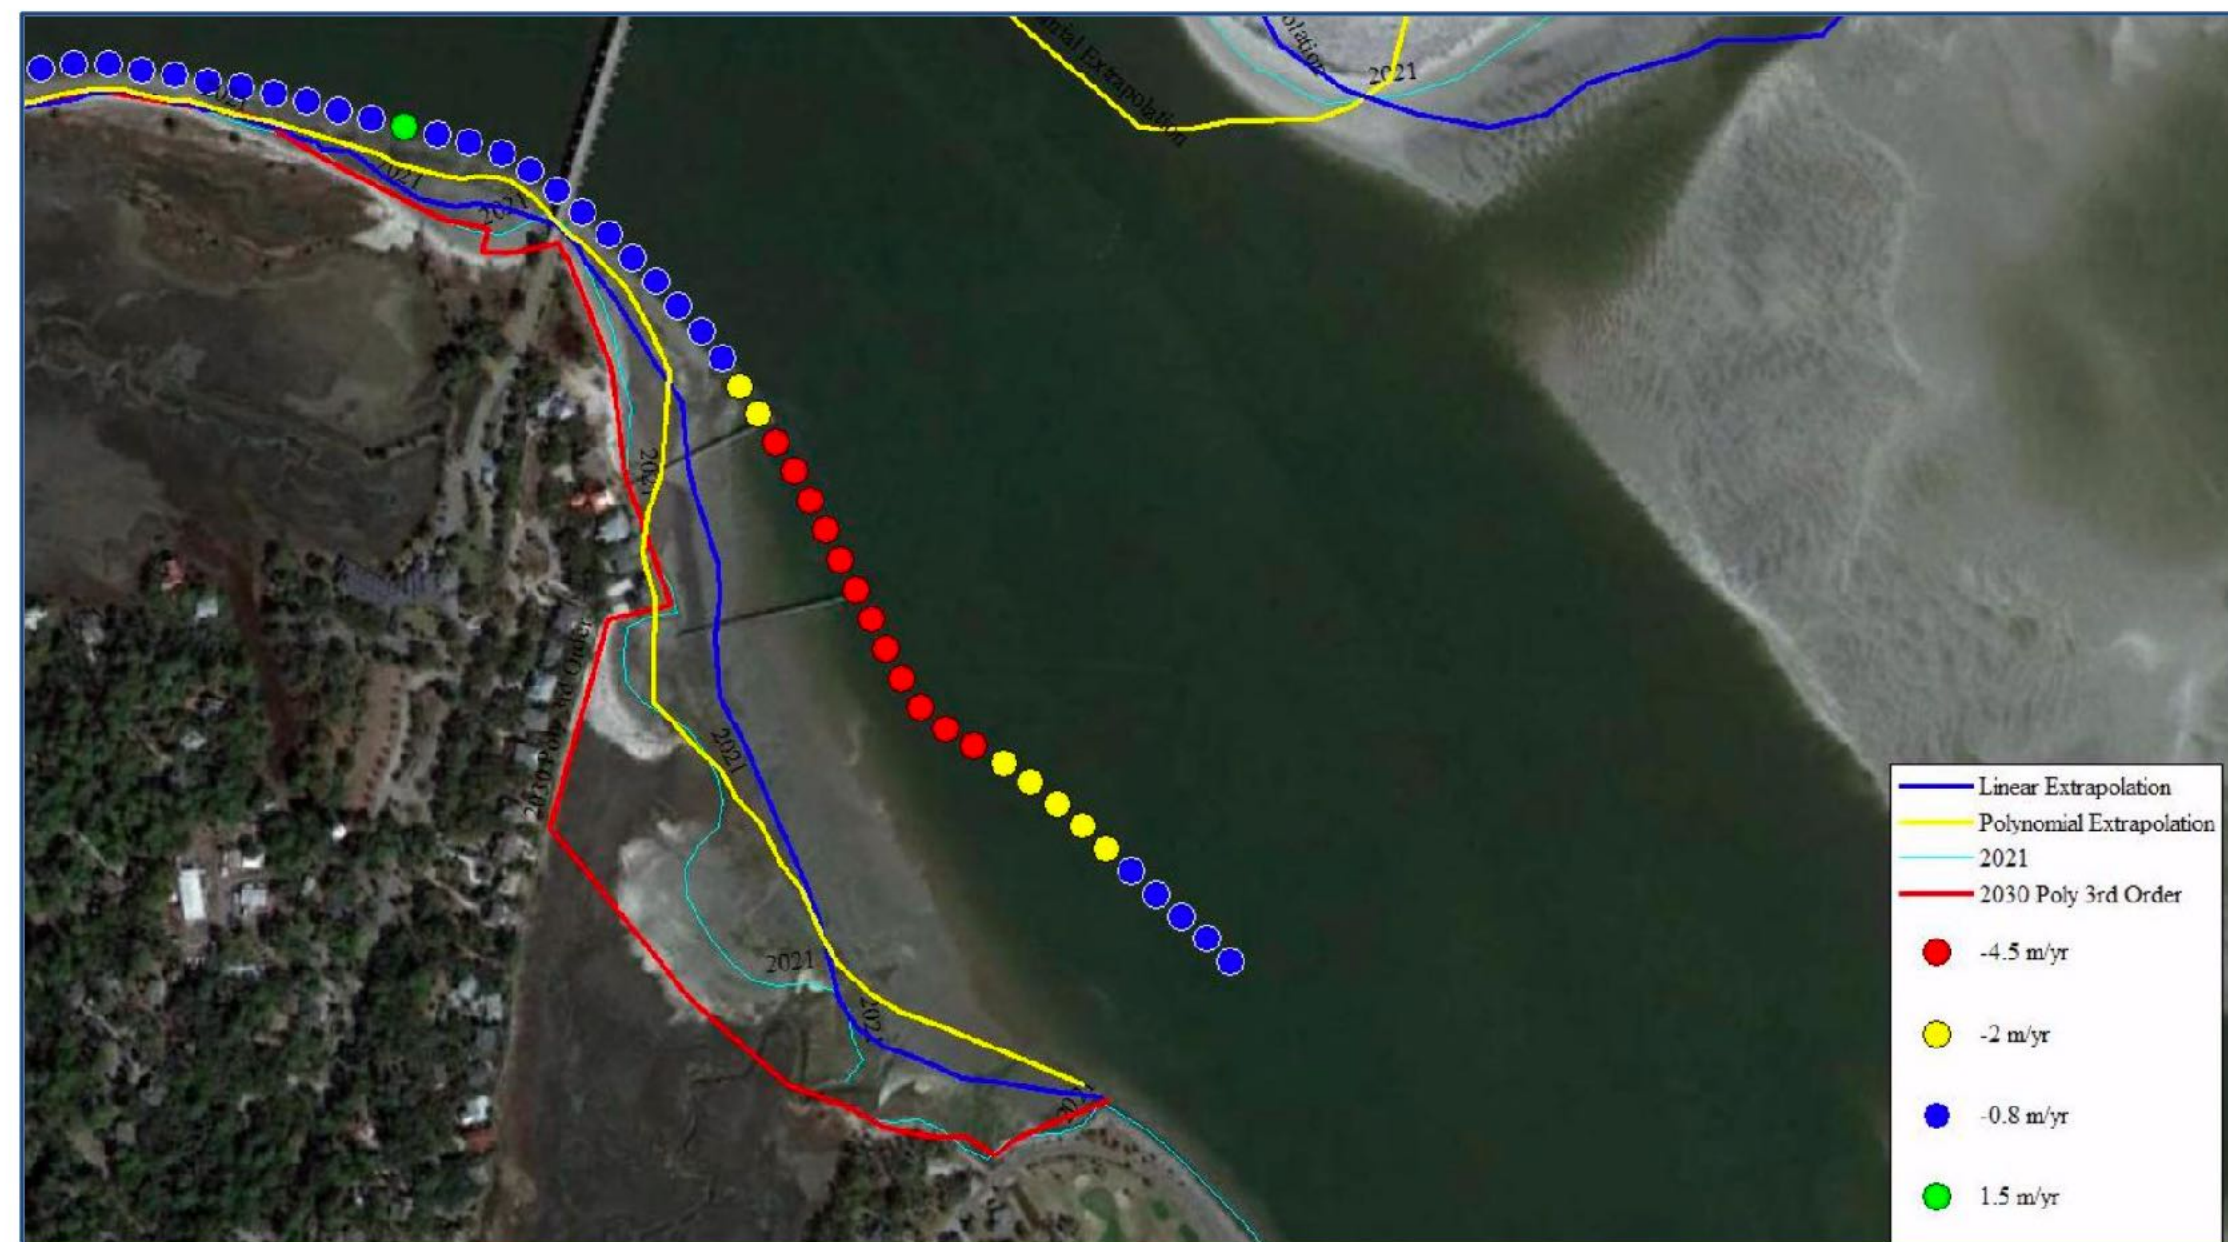
Figure 8. Shoreline Change

Note: Red line indicates projected shoreline in 2030

As shown on the information provided in Figure 8, between 2021 and 2030 the shoreline adjacent to the bridge and nook area is expected to change relatively little and significant shoreline erosion is expected between River Club and the PSD Revetment (Marsh Area). Correlating the information presented above with measurements obtained from satellite imagery, it appears that between 2021 and 2030 the shoreline has the potential to retreat between 100 and 200 ft adjacent to River Club and greater than 300 ft within the Marsh Area.

A page (8) from the McSweeney Inlet Shoreline Erosion Study shows the projected retreat of shoreline between 2021 and 2030 can be 300 feet or more in the marsh area (red line) and between 100-200 feet around the River Club area.

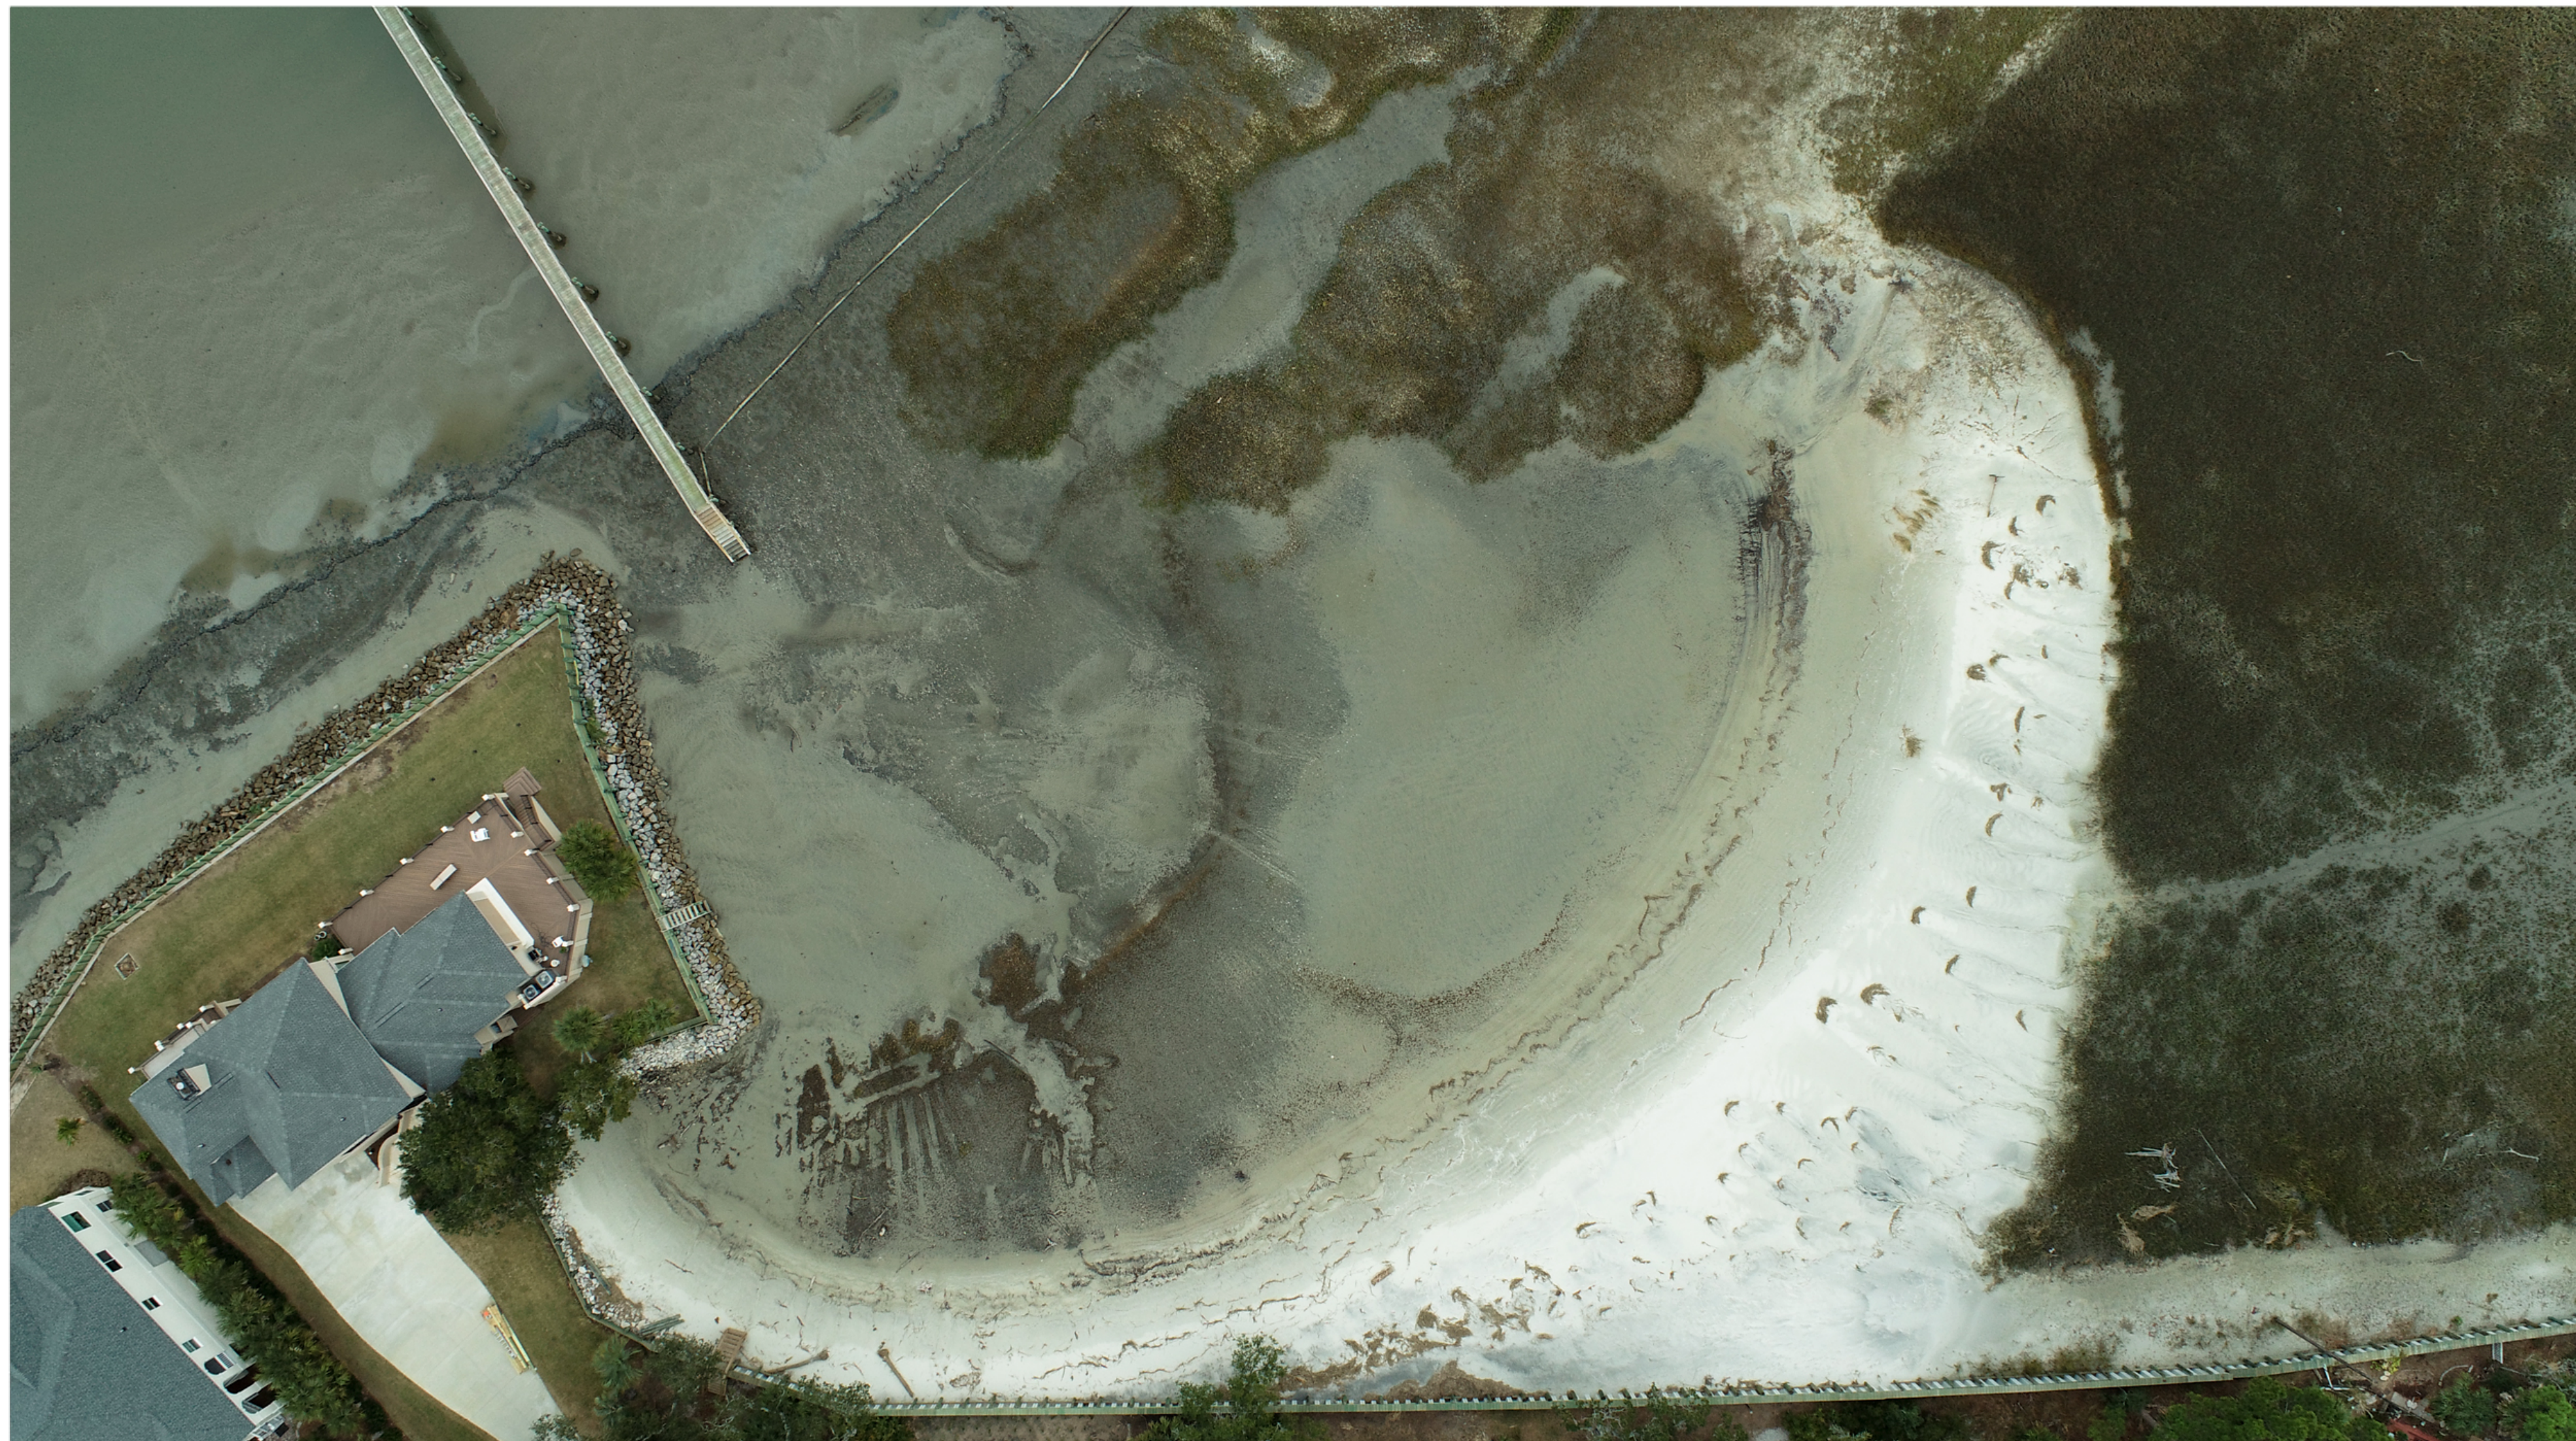
This aerial photo, taken at low tide taken on **January 21, 2022**, shows the eroded area is expanding rapidly and is now easily, two to three times the size of the entire property footprint of the Mollura residence.

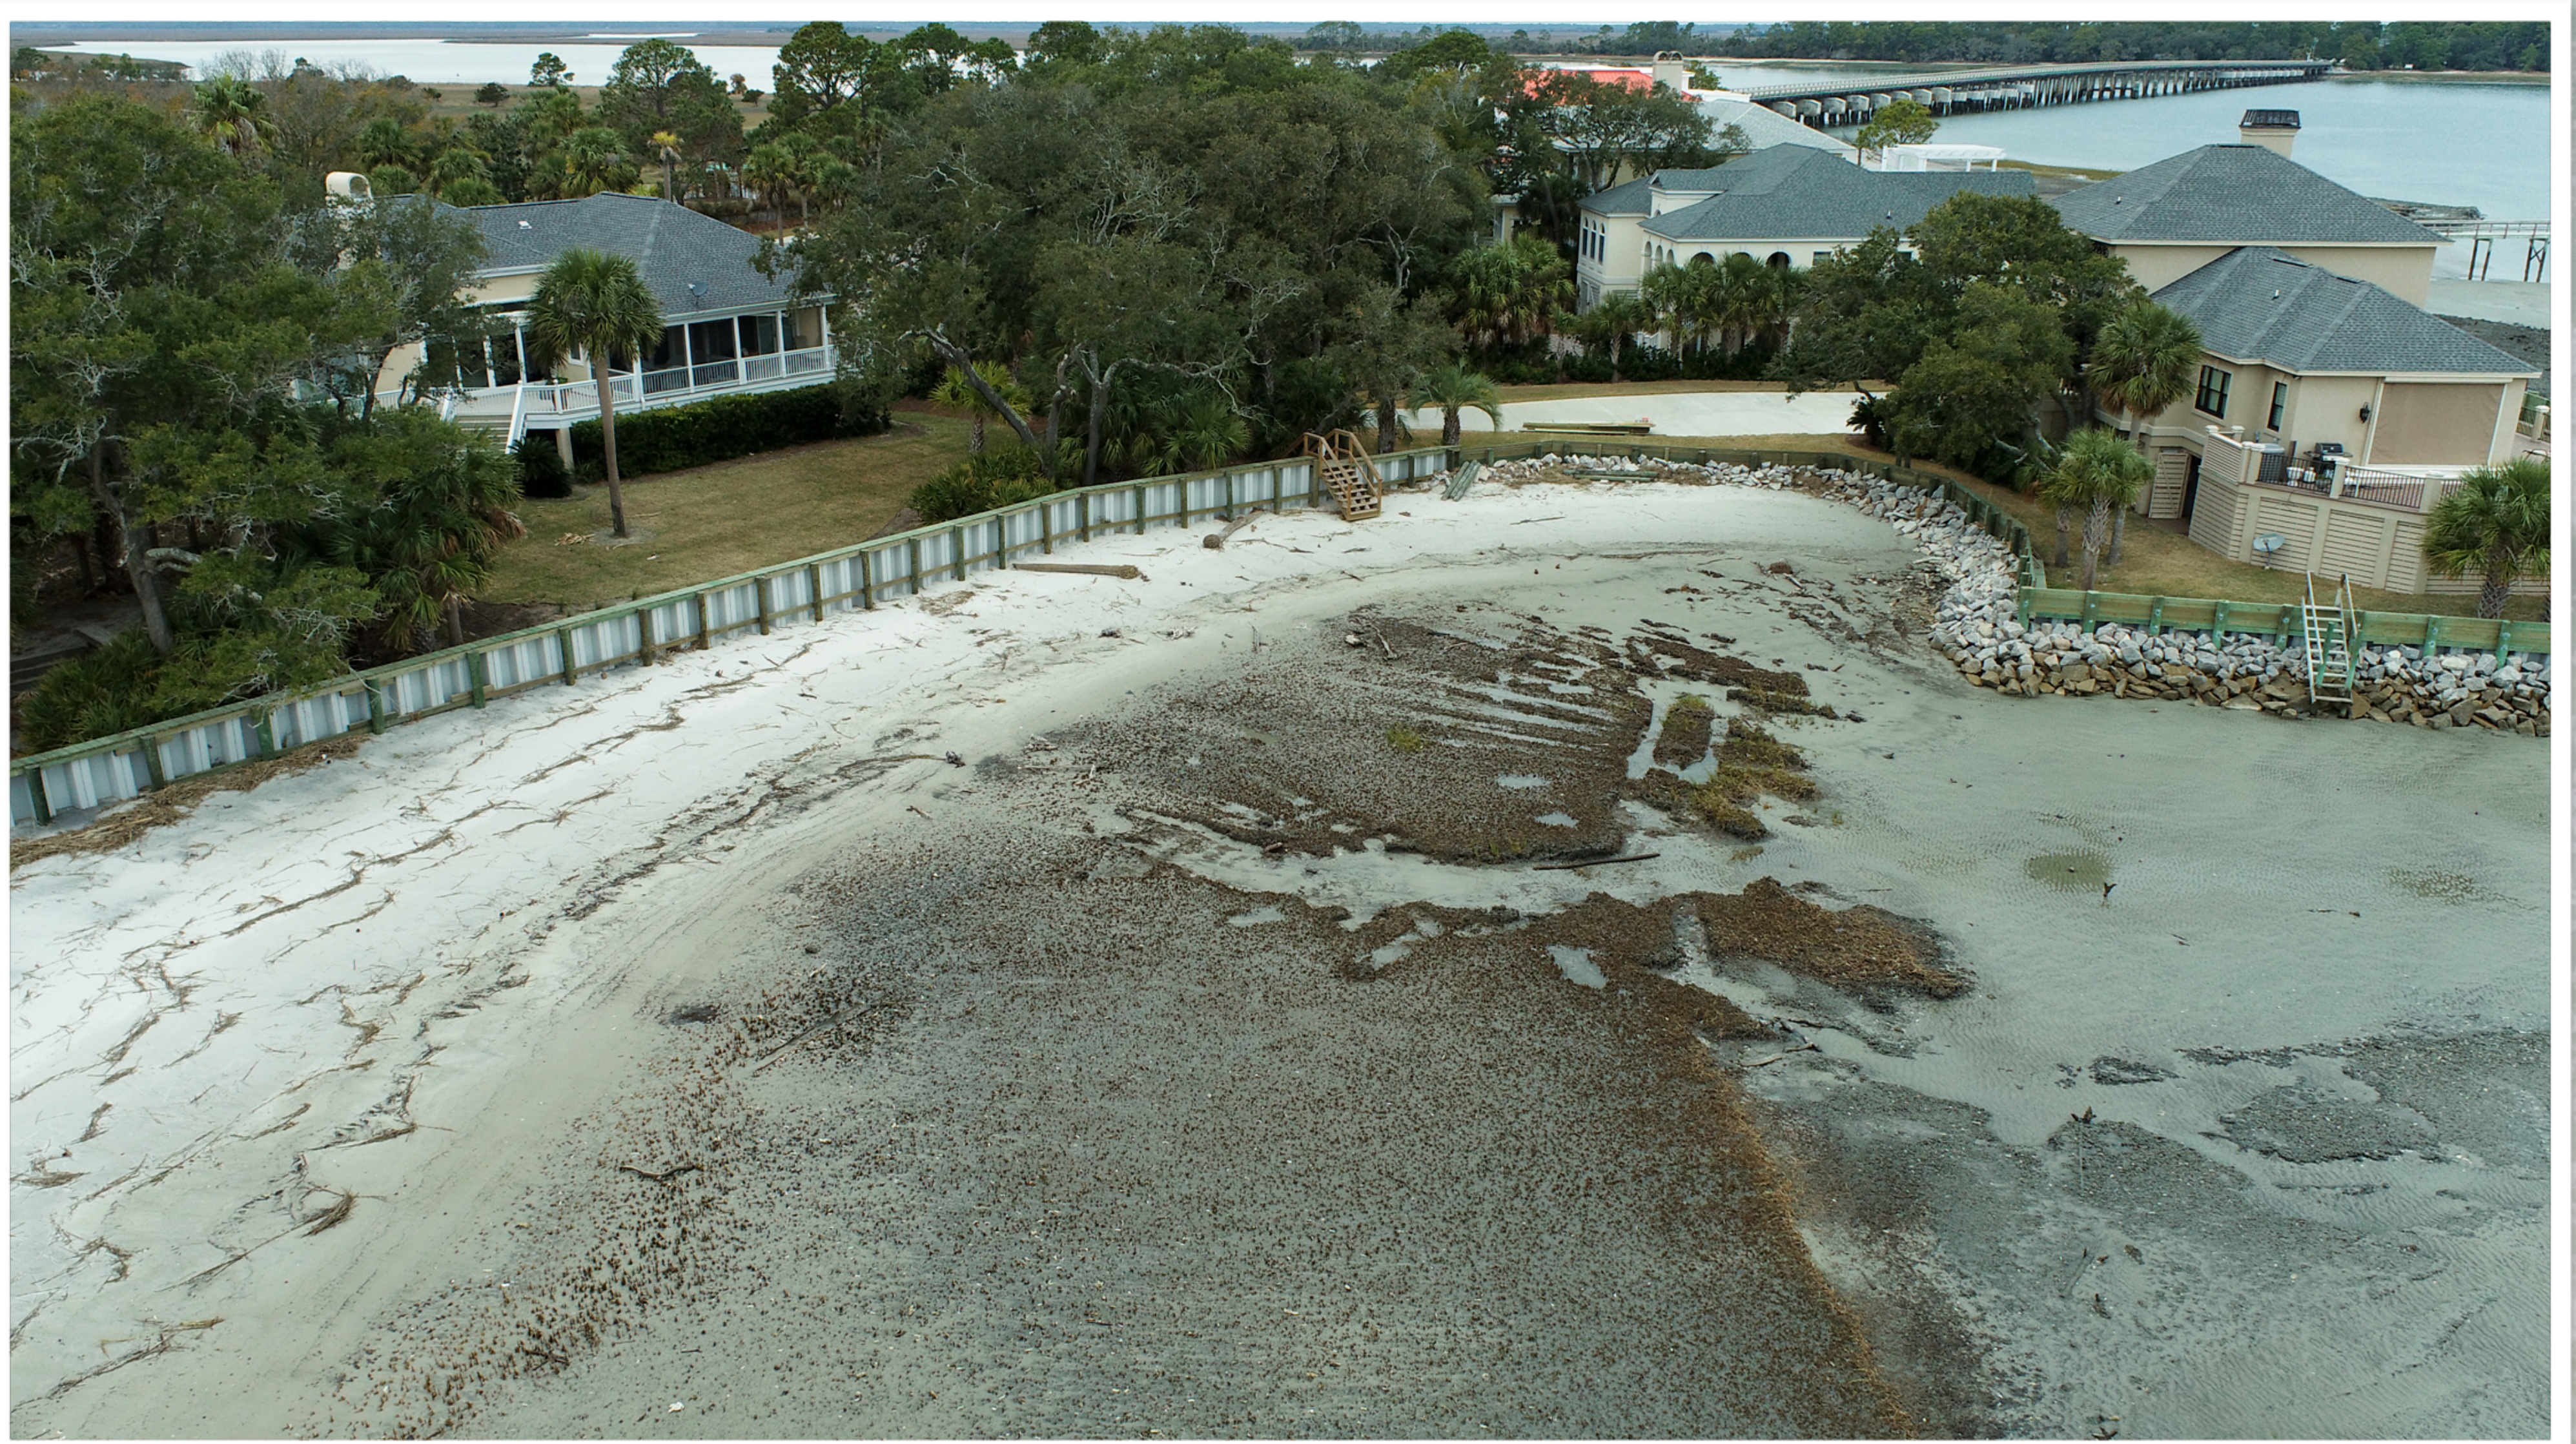
Another view of the eroded area, taken on **January 21, 2022**. The sea wall in this corner is the main barrier that prevents sea water from flooding the River Club neighborhood and Tarpon Boulevard during king tides or storm events.

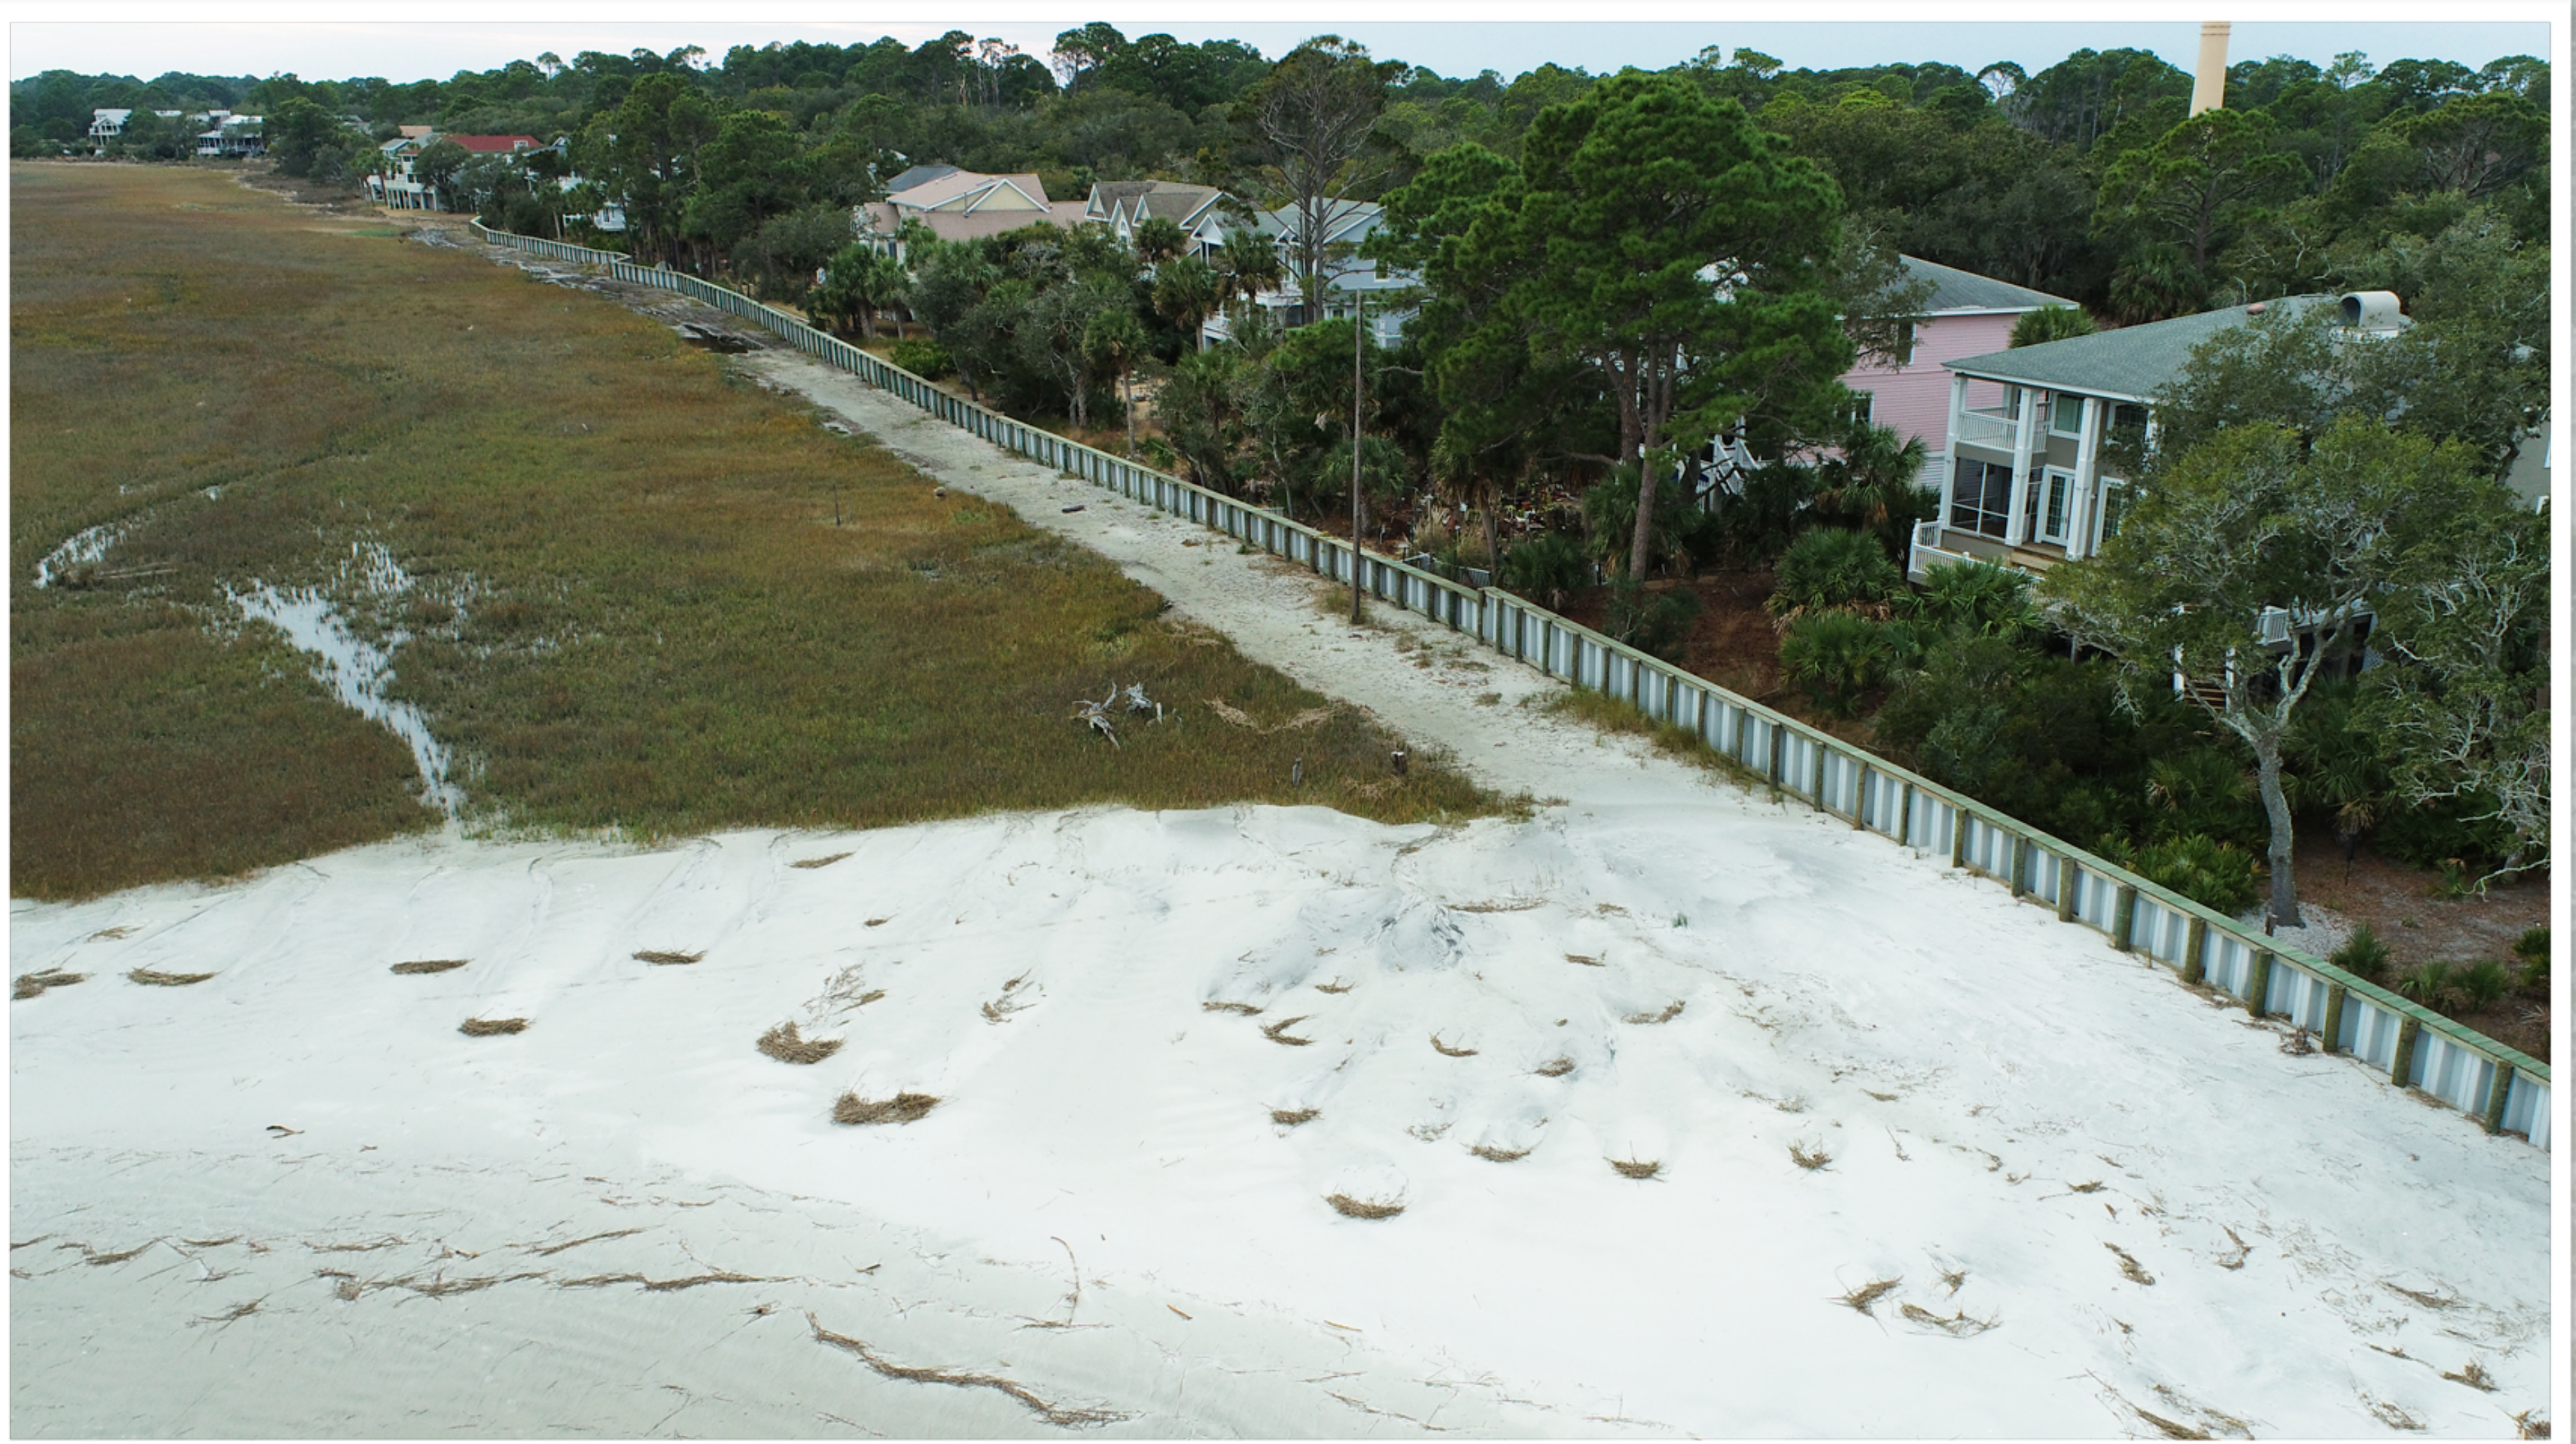
Another view, taken on **January 21, 2022**, shows the sea wall extends down Cardinal Crest Lane, but does not go the full length of the marsh. Eventually it will have to if the marsh continues to deteriorate or any opening will become a weak link in the chain.
