Shoreline Status

Fripp Island - Shoreline Committee

January 24, 2022

A visual look at both sides of the Fripp Island bridge abutment and the salt marsh.

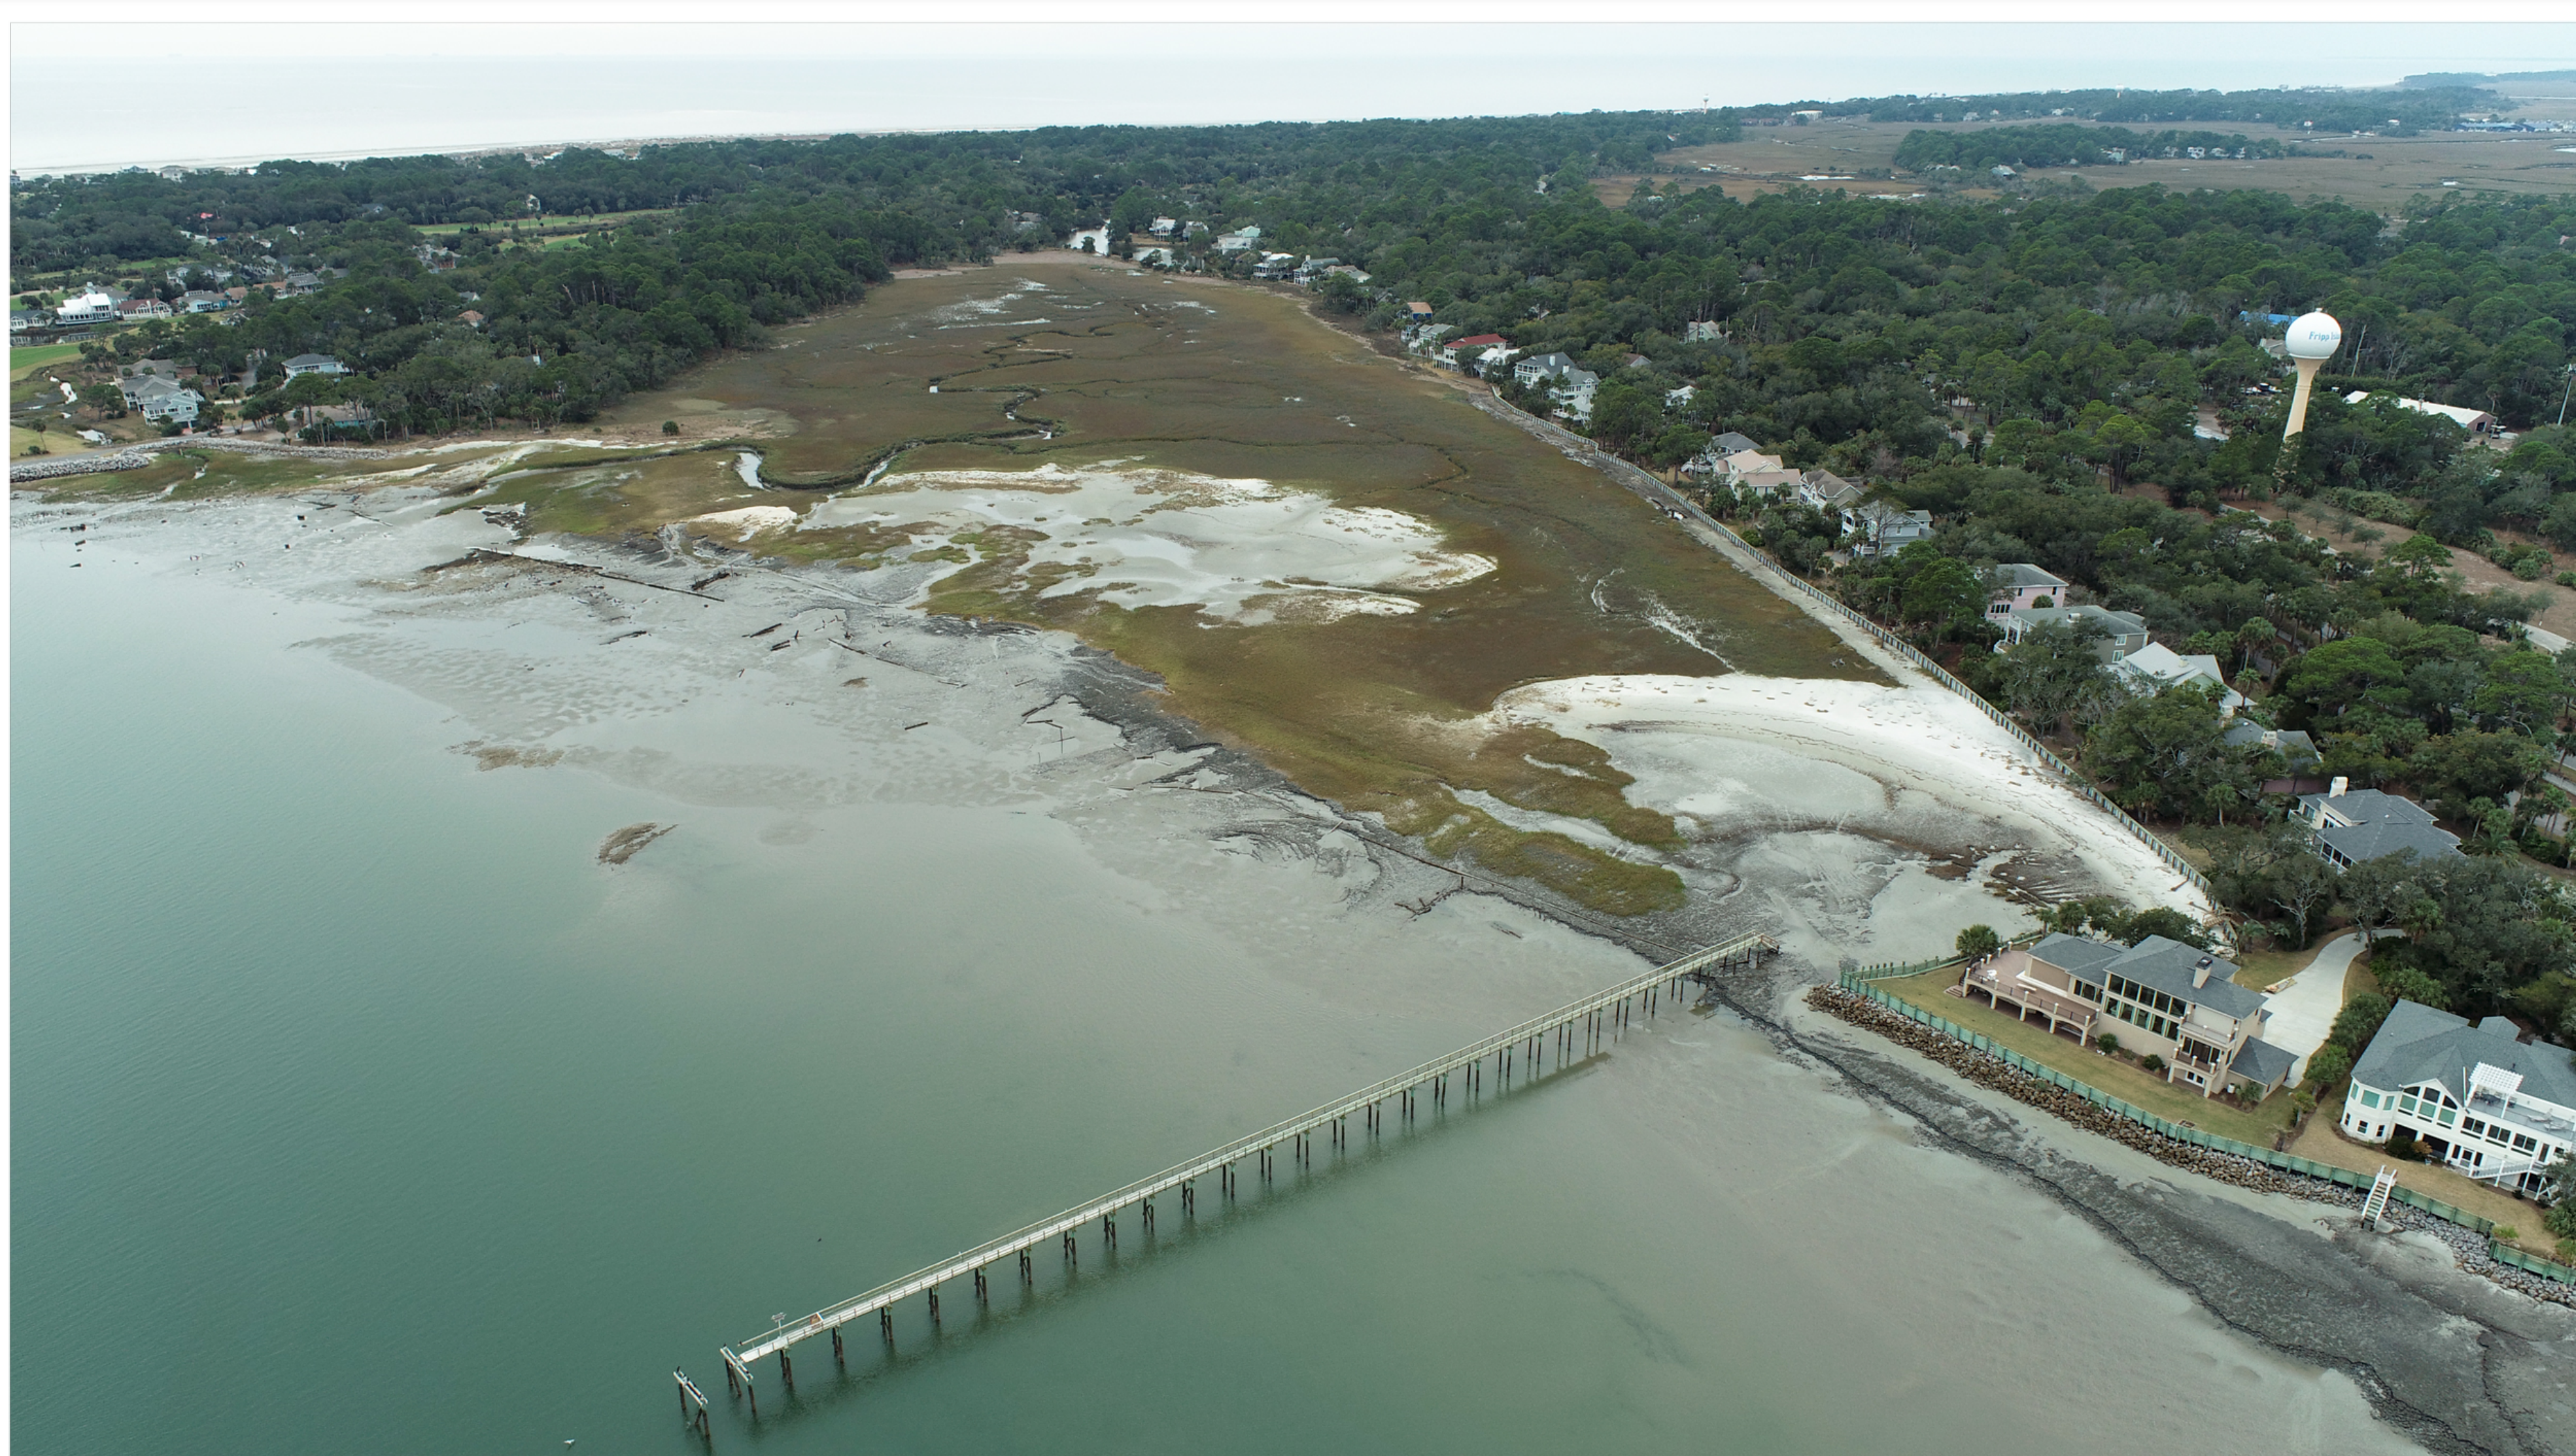
January 21, 2022 - An overall view of the salt marsh as it stands today showing the two main areas of erosion at the mouth of the salt marsh. As the southern tip of Hunting Island deteriorates, this area is more and more subject to the direct forces of the ocean.

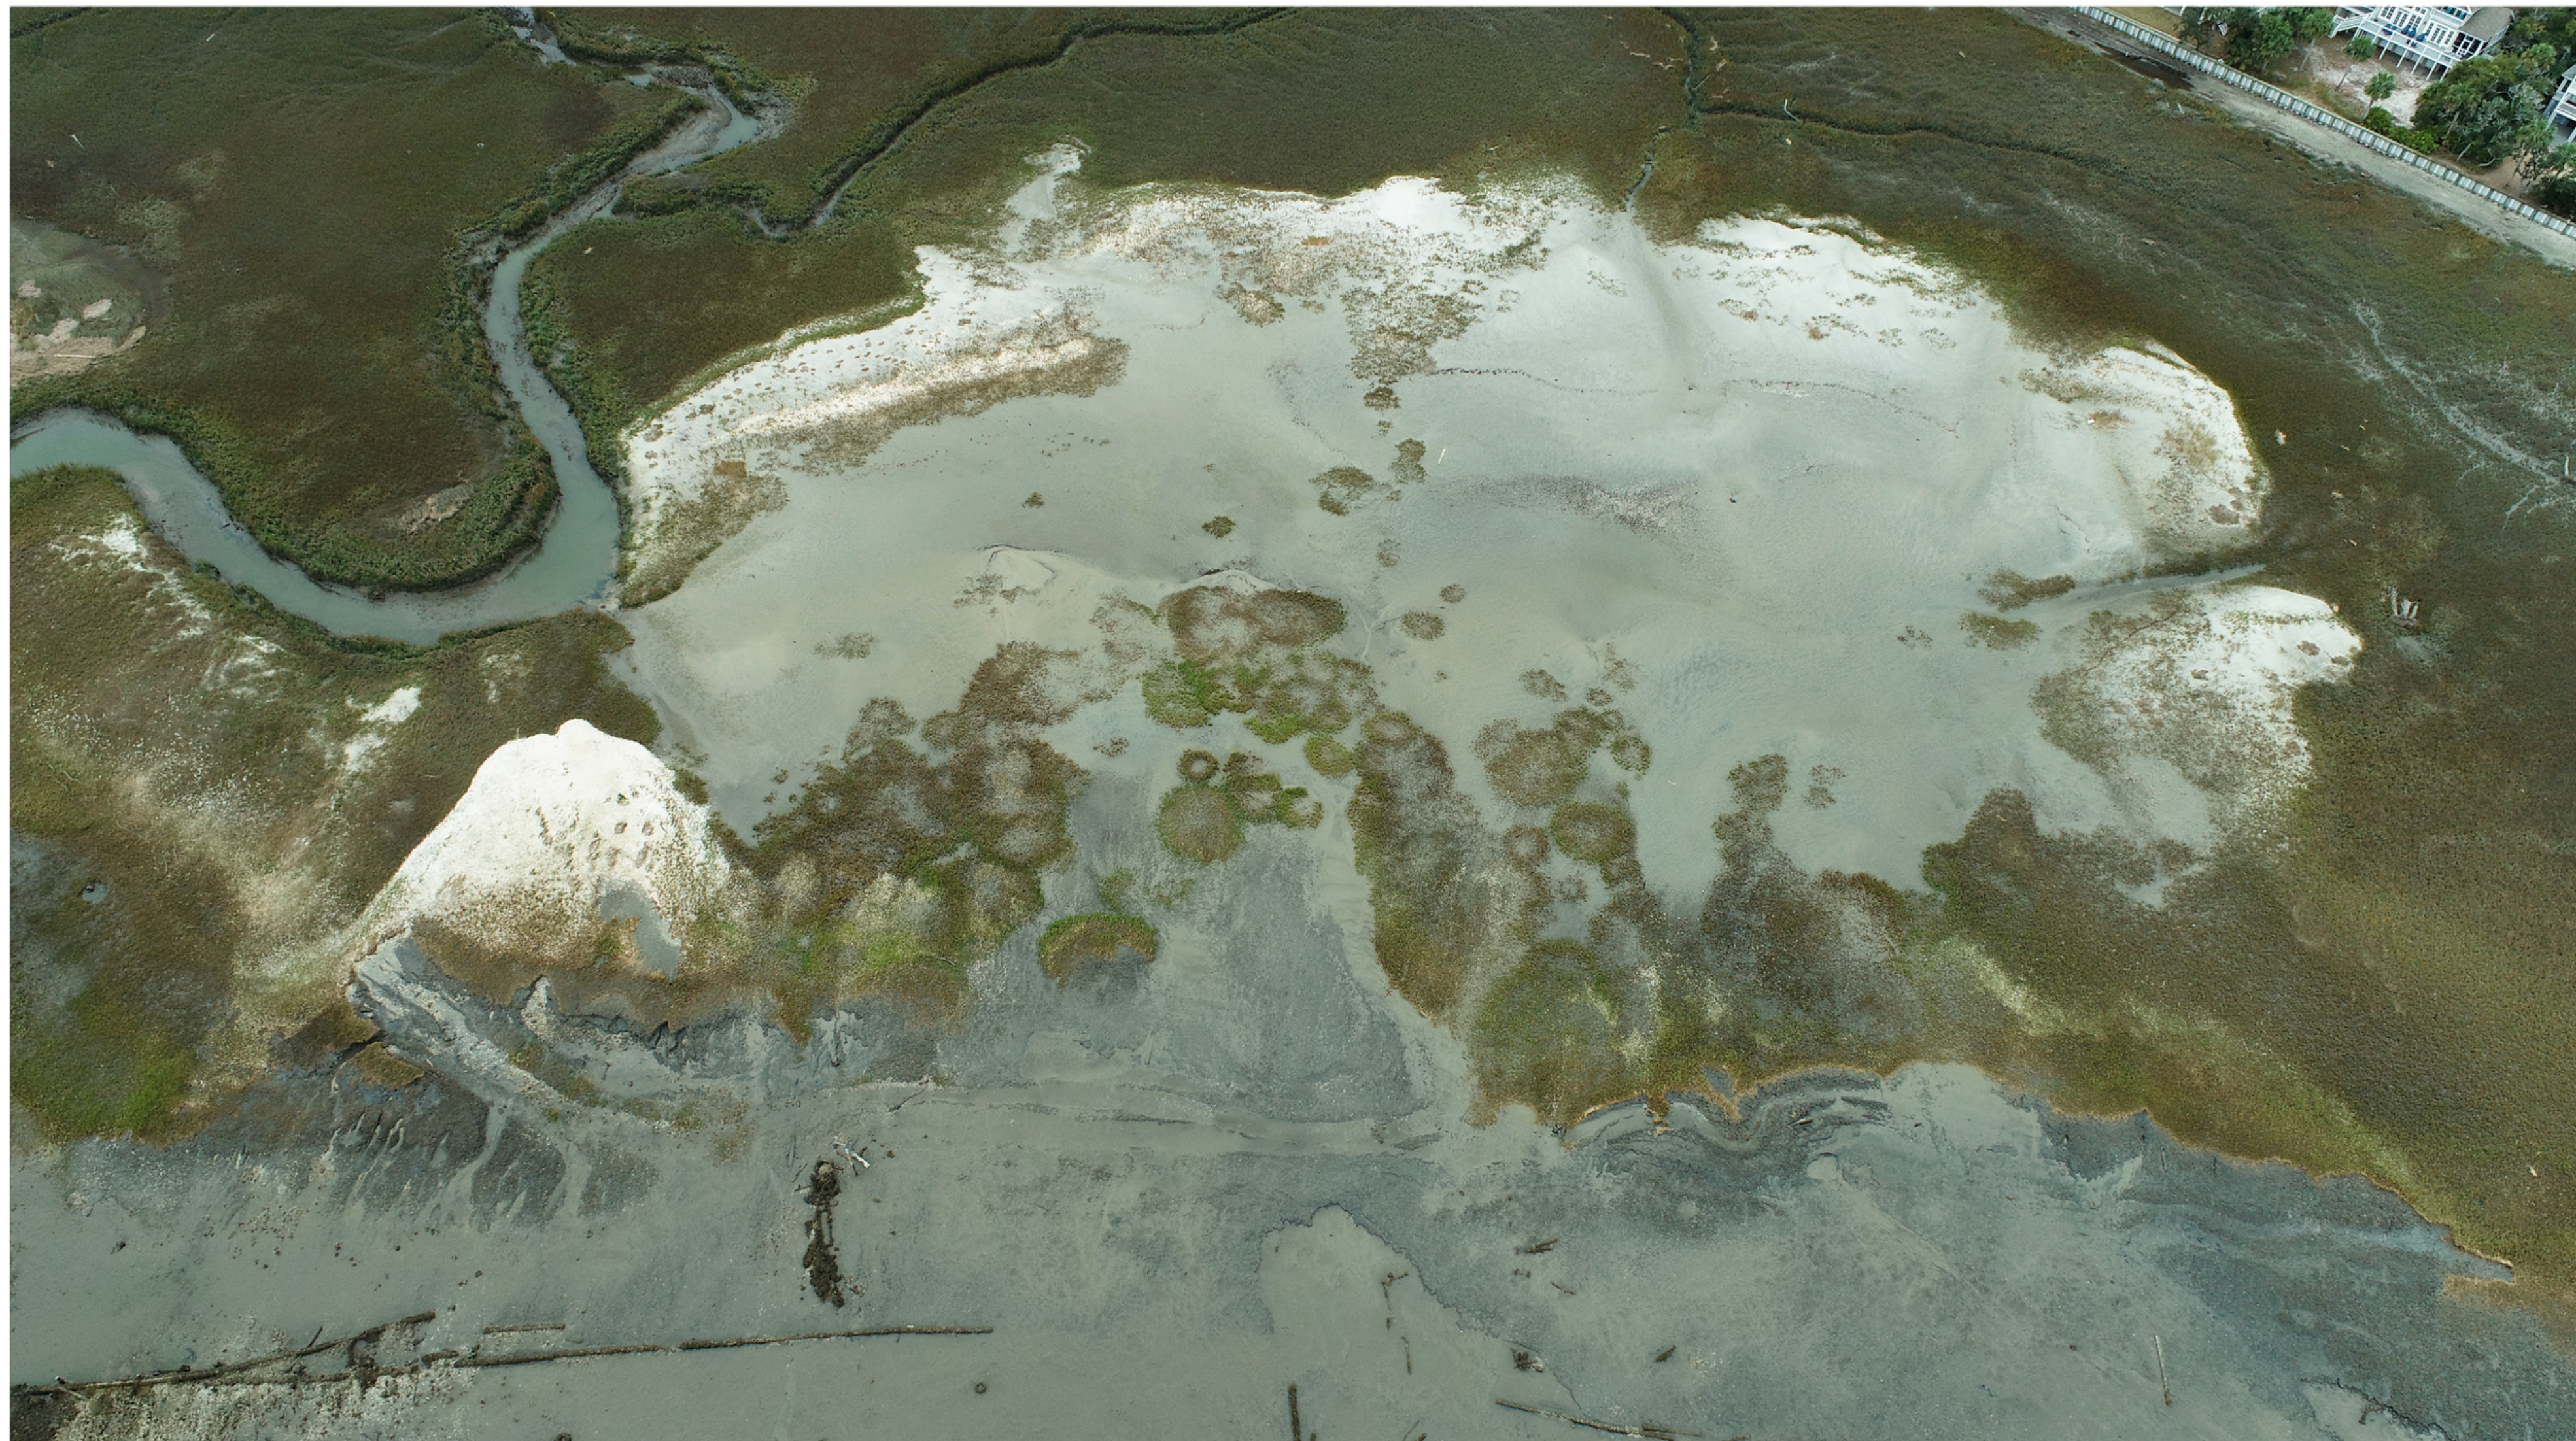
An overhead view of eroded area at the center of the salt marsh. To get a scale of how big this area is, note the house in the upper right hand corner of the photograph. The bright white area at the lower left is a pile of oysters. I'm not sure why they were placed there, but if the purpose was for erosion and/or to encourage new oyster beds, the attempt does not appear successful.

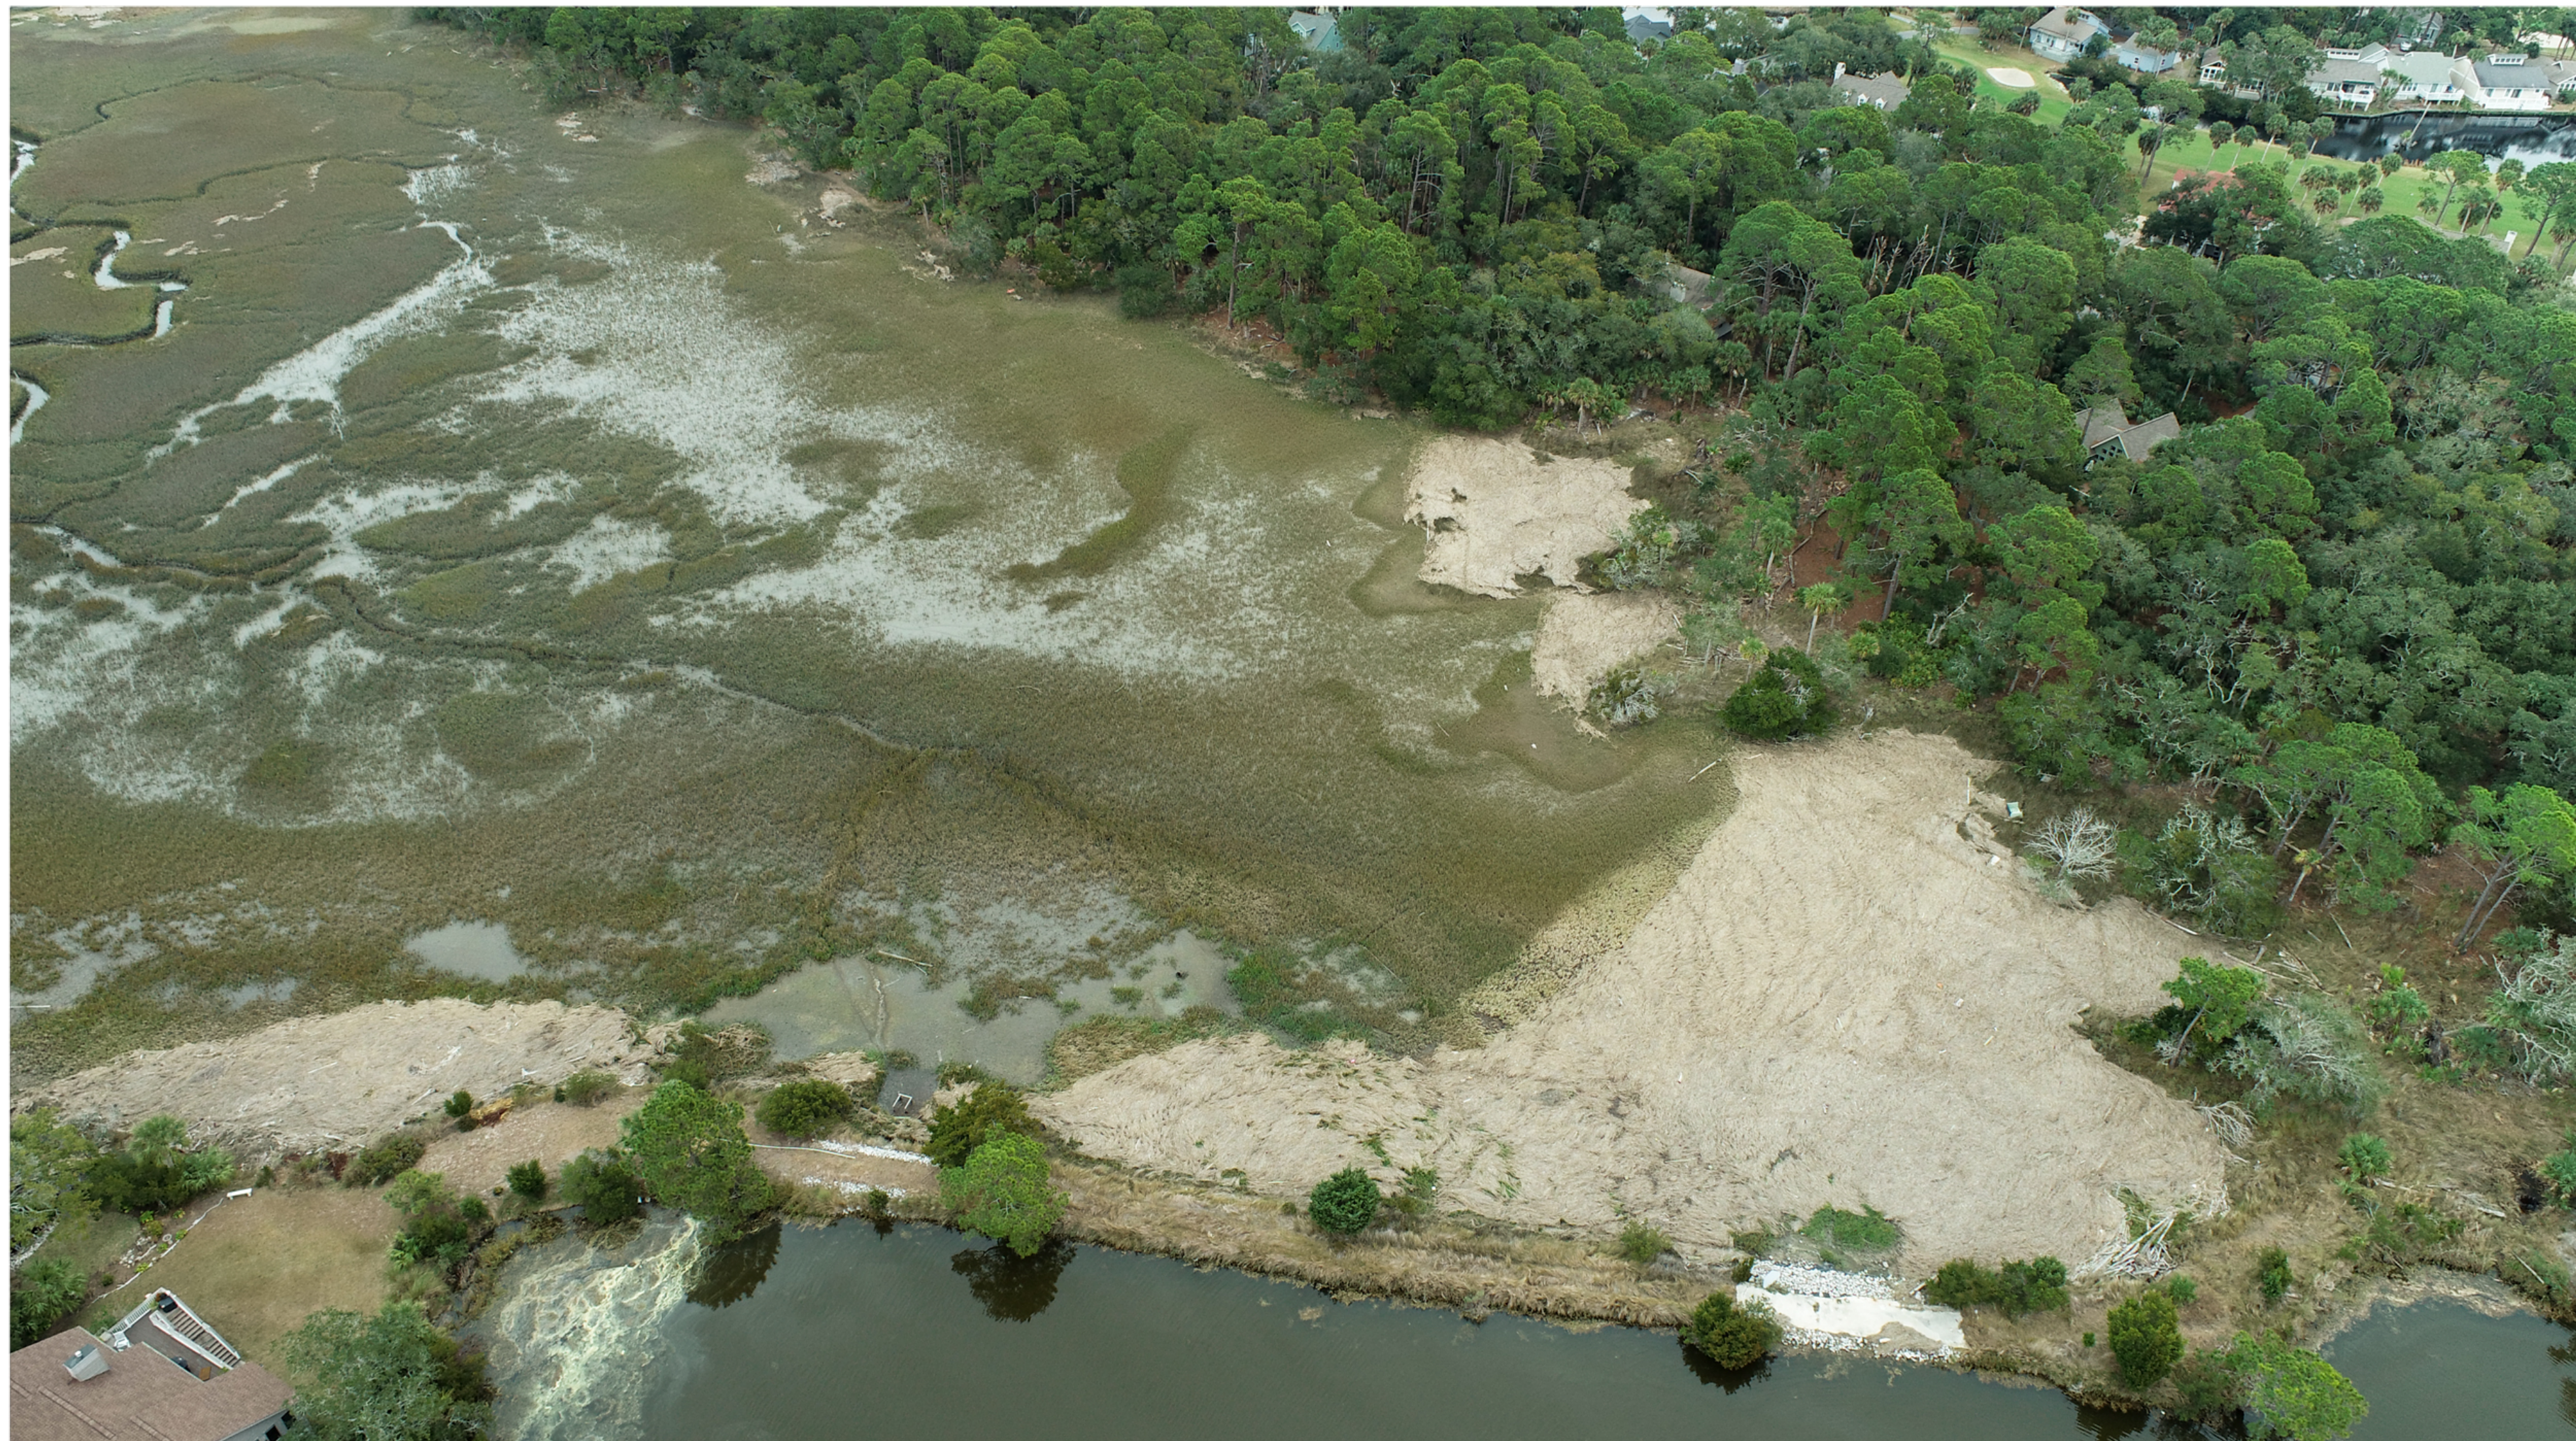
January 21, 2022 - At the end of the salt marsh is a spillway that overflows into Deer/Blue Heron lake. Because the eroded area has expanded so far into the marsh, it leaves huge quantities of wrack piled up at the end of the marsh's boundary during flood events.

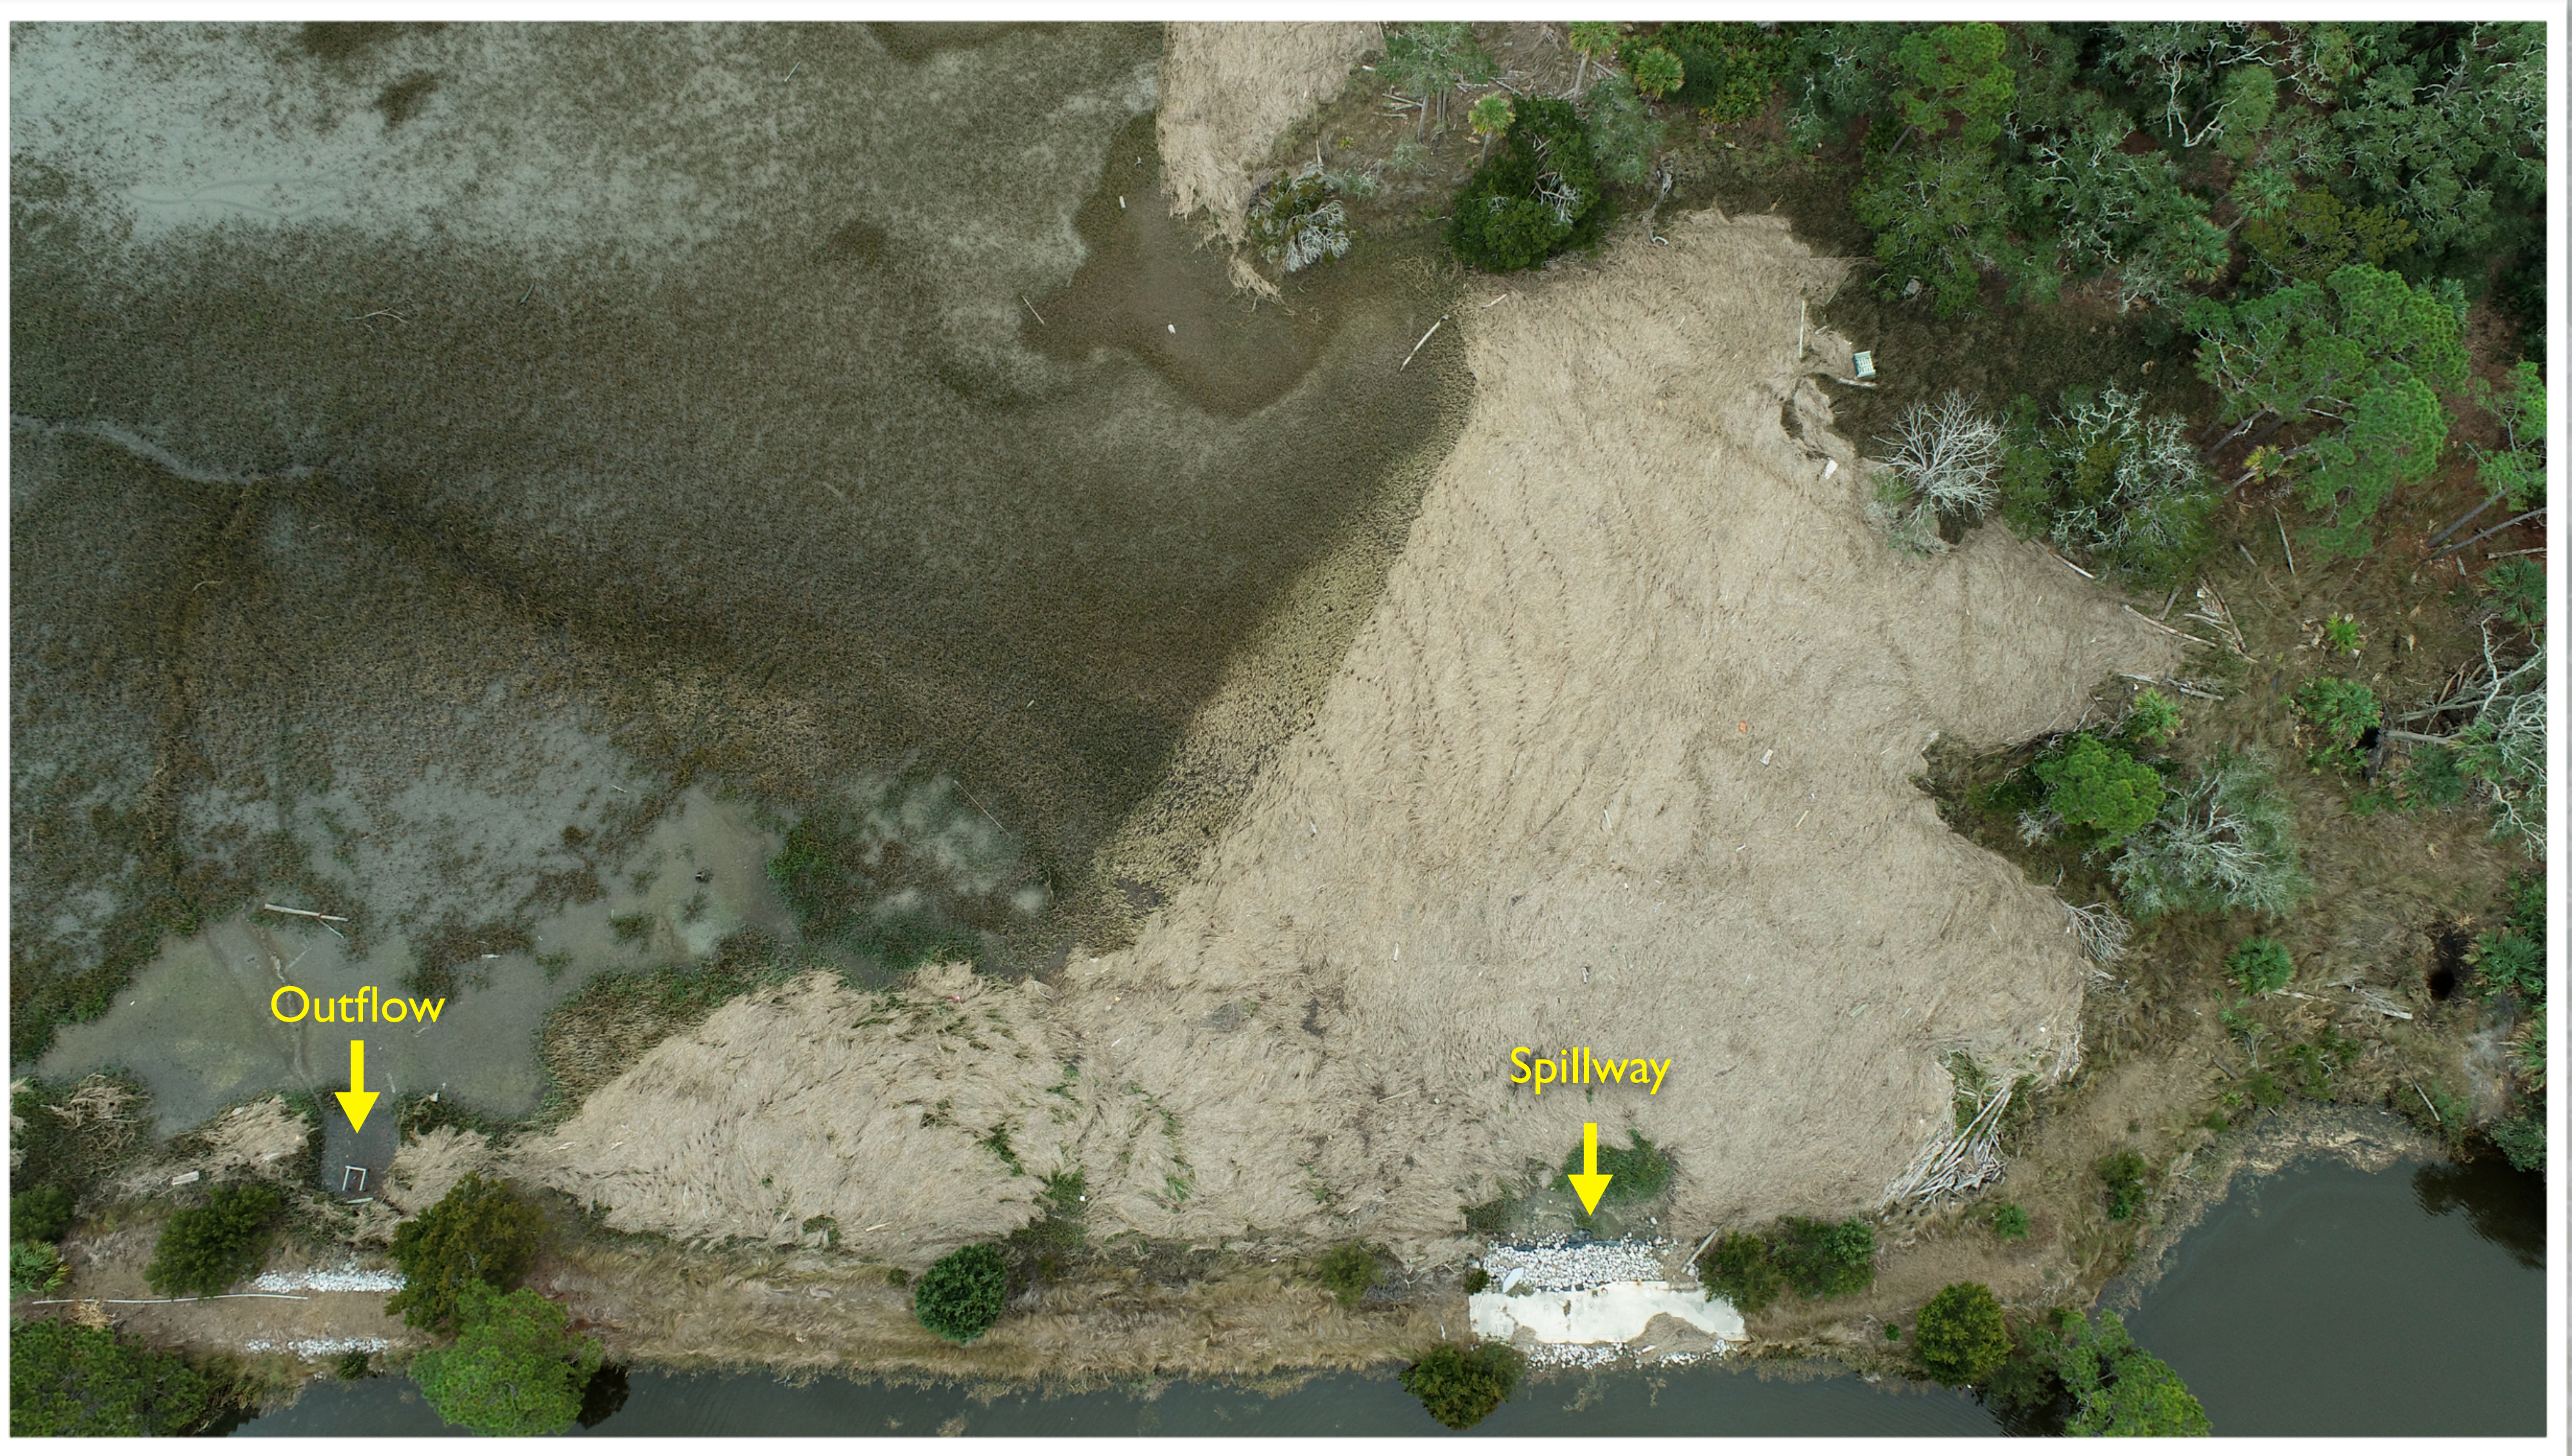
The amount of wrack piled up against the spillway and surrounding area could ultimately act like a dam in front of the spillway causing flooding in other areas during higher than normal tide events. A large amount of wrack gets pushed into the interior lakes, which causes them to become shallower, effecting the amount of runoff drainage that can occur within the interior of the island.

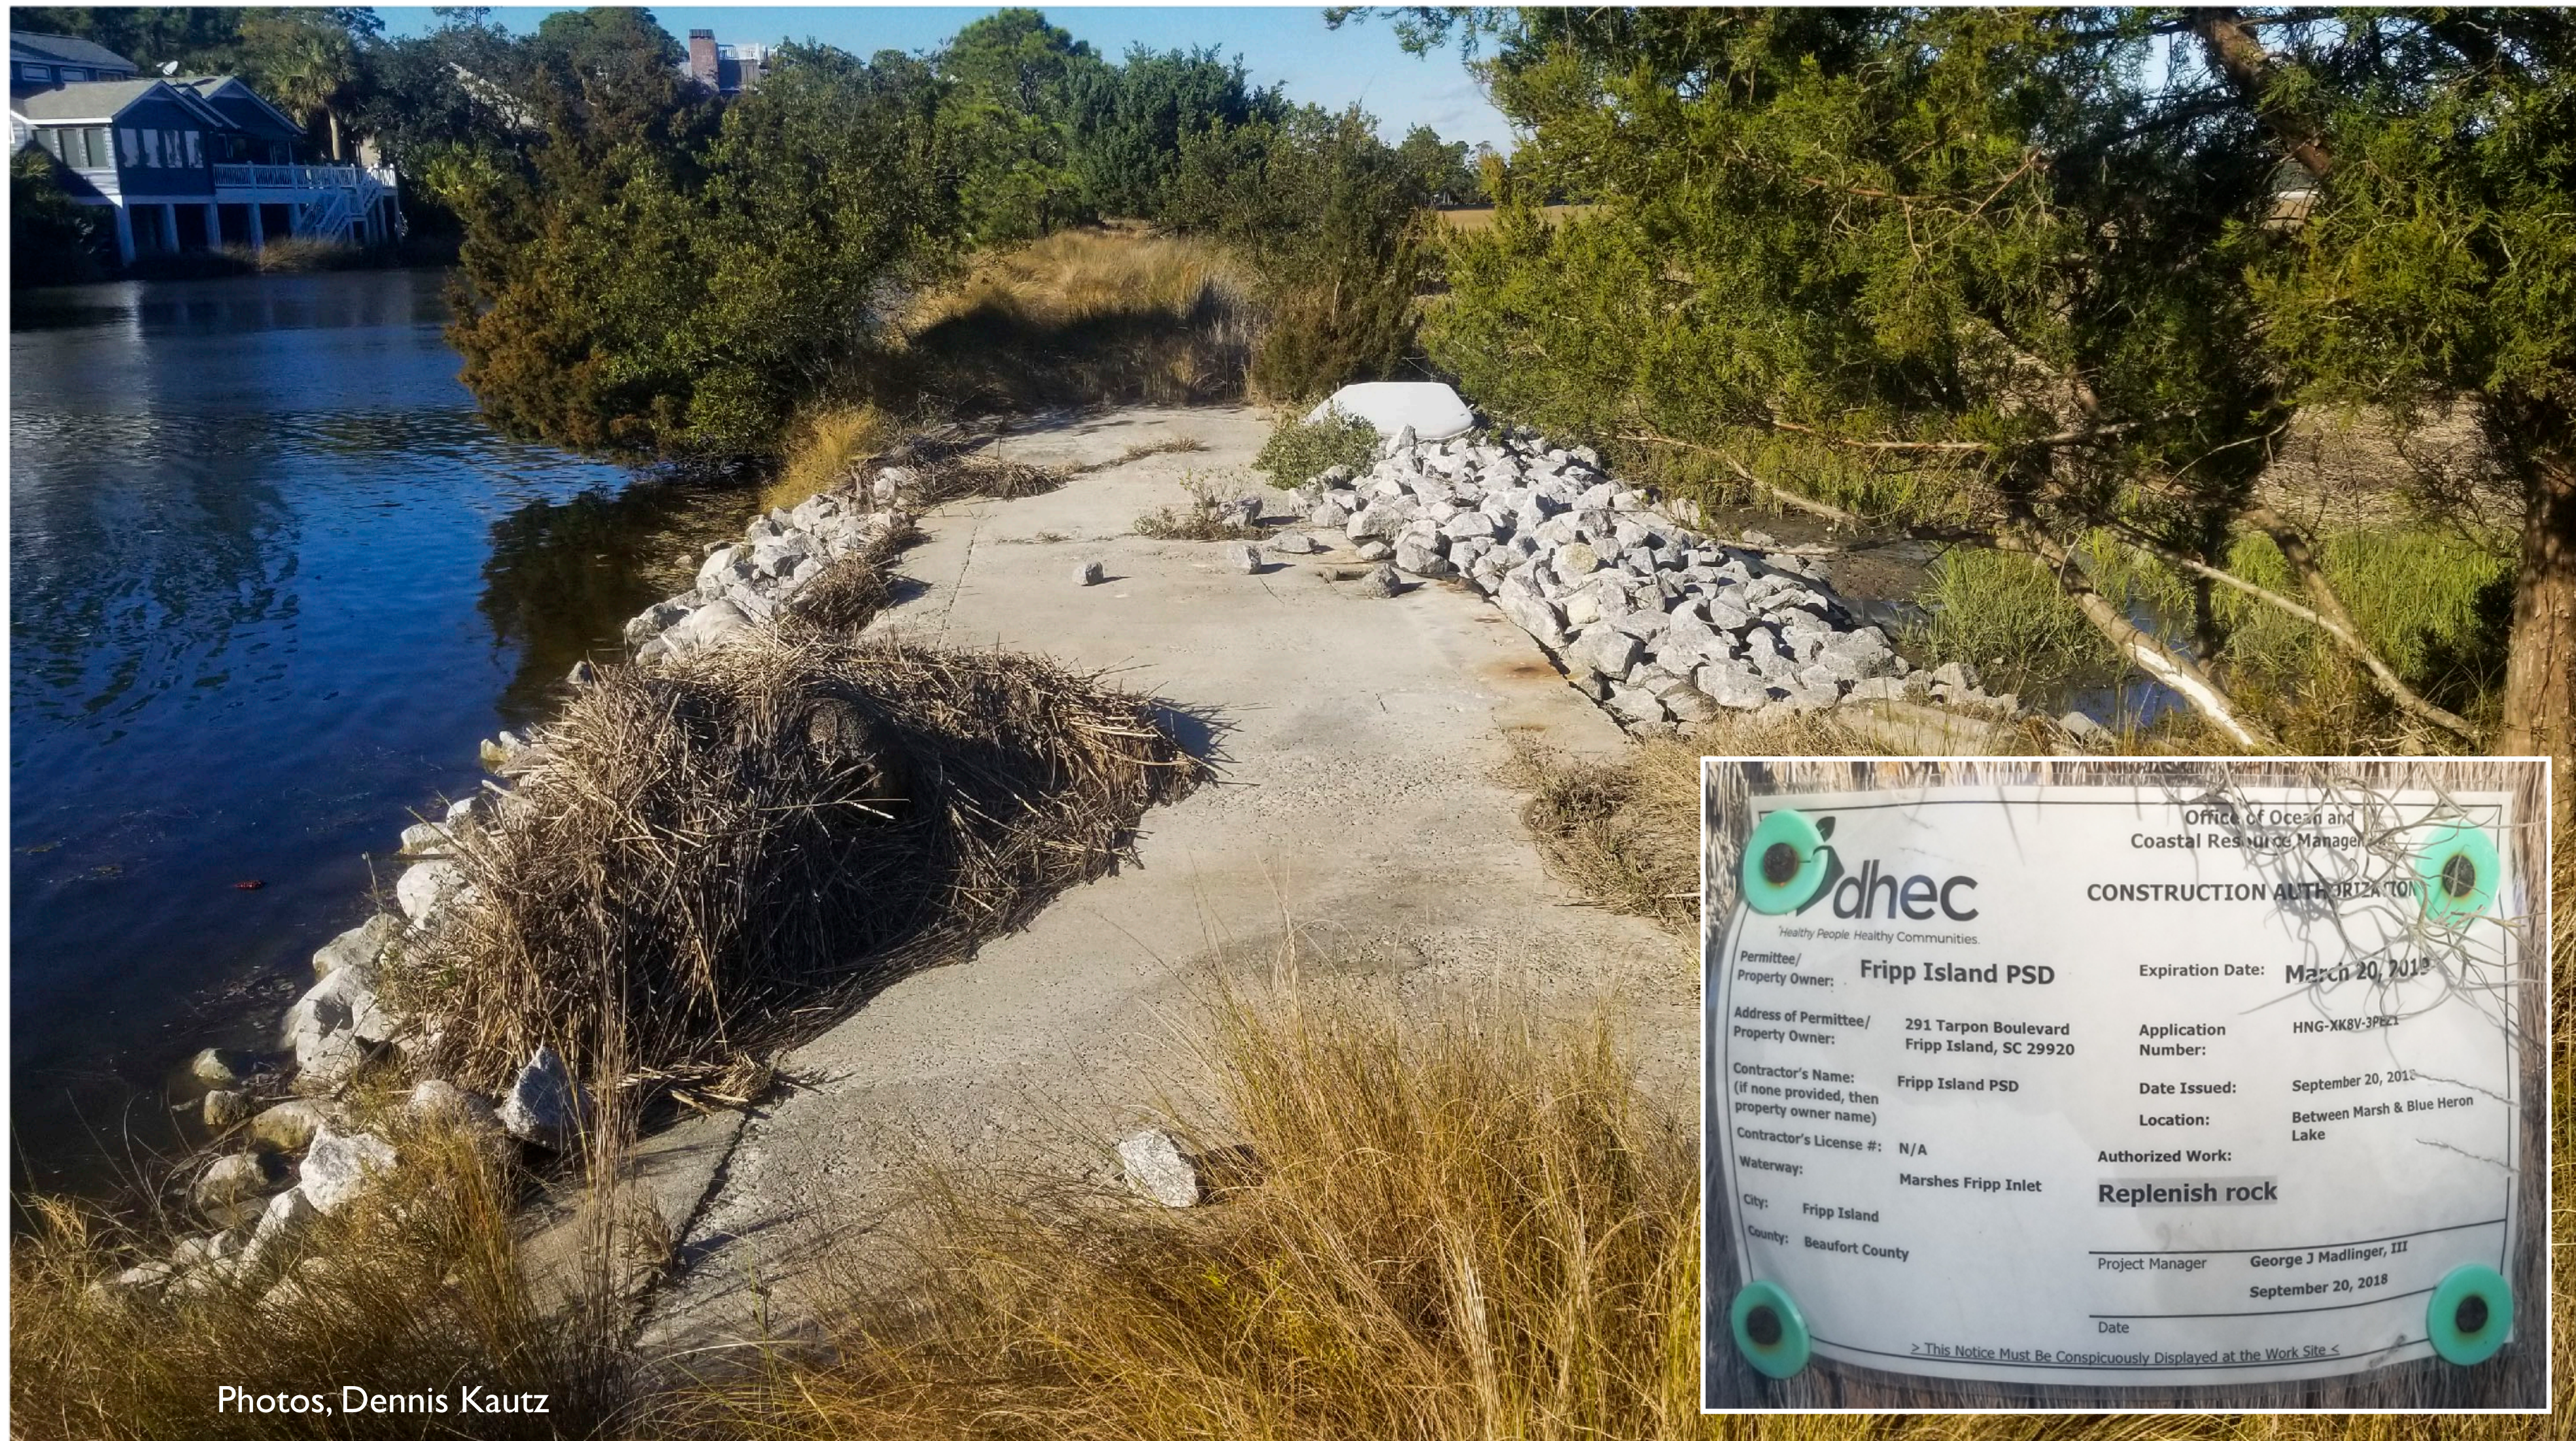
On the spillway at ground level, evidence of the wrack being pushed into Deer/Blue Heron lake is visible. The spillway itself appears to be in good condition, and a sign posted from OCRM is for rock replenishment by the PSD in 2018-19.

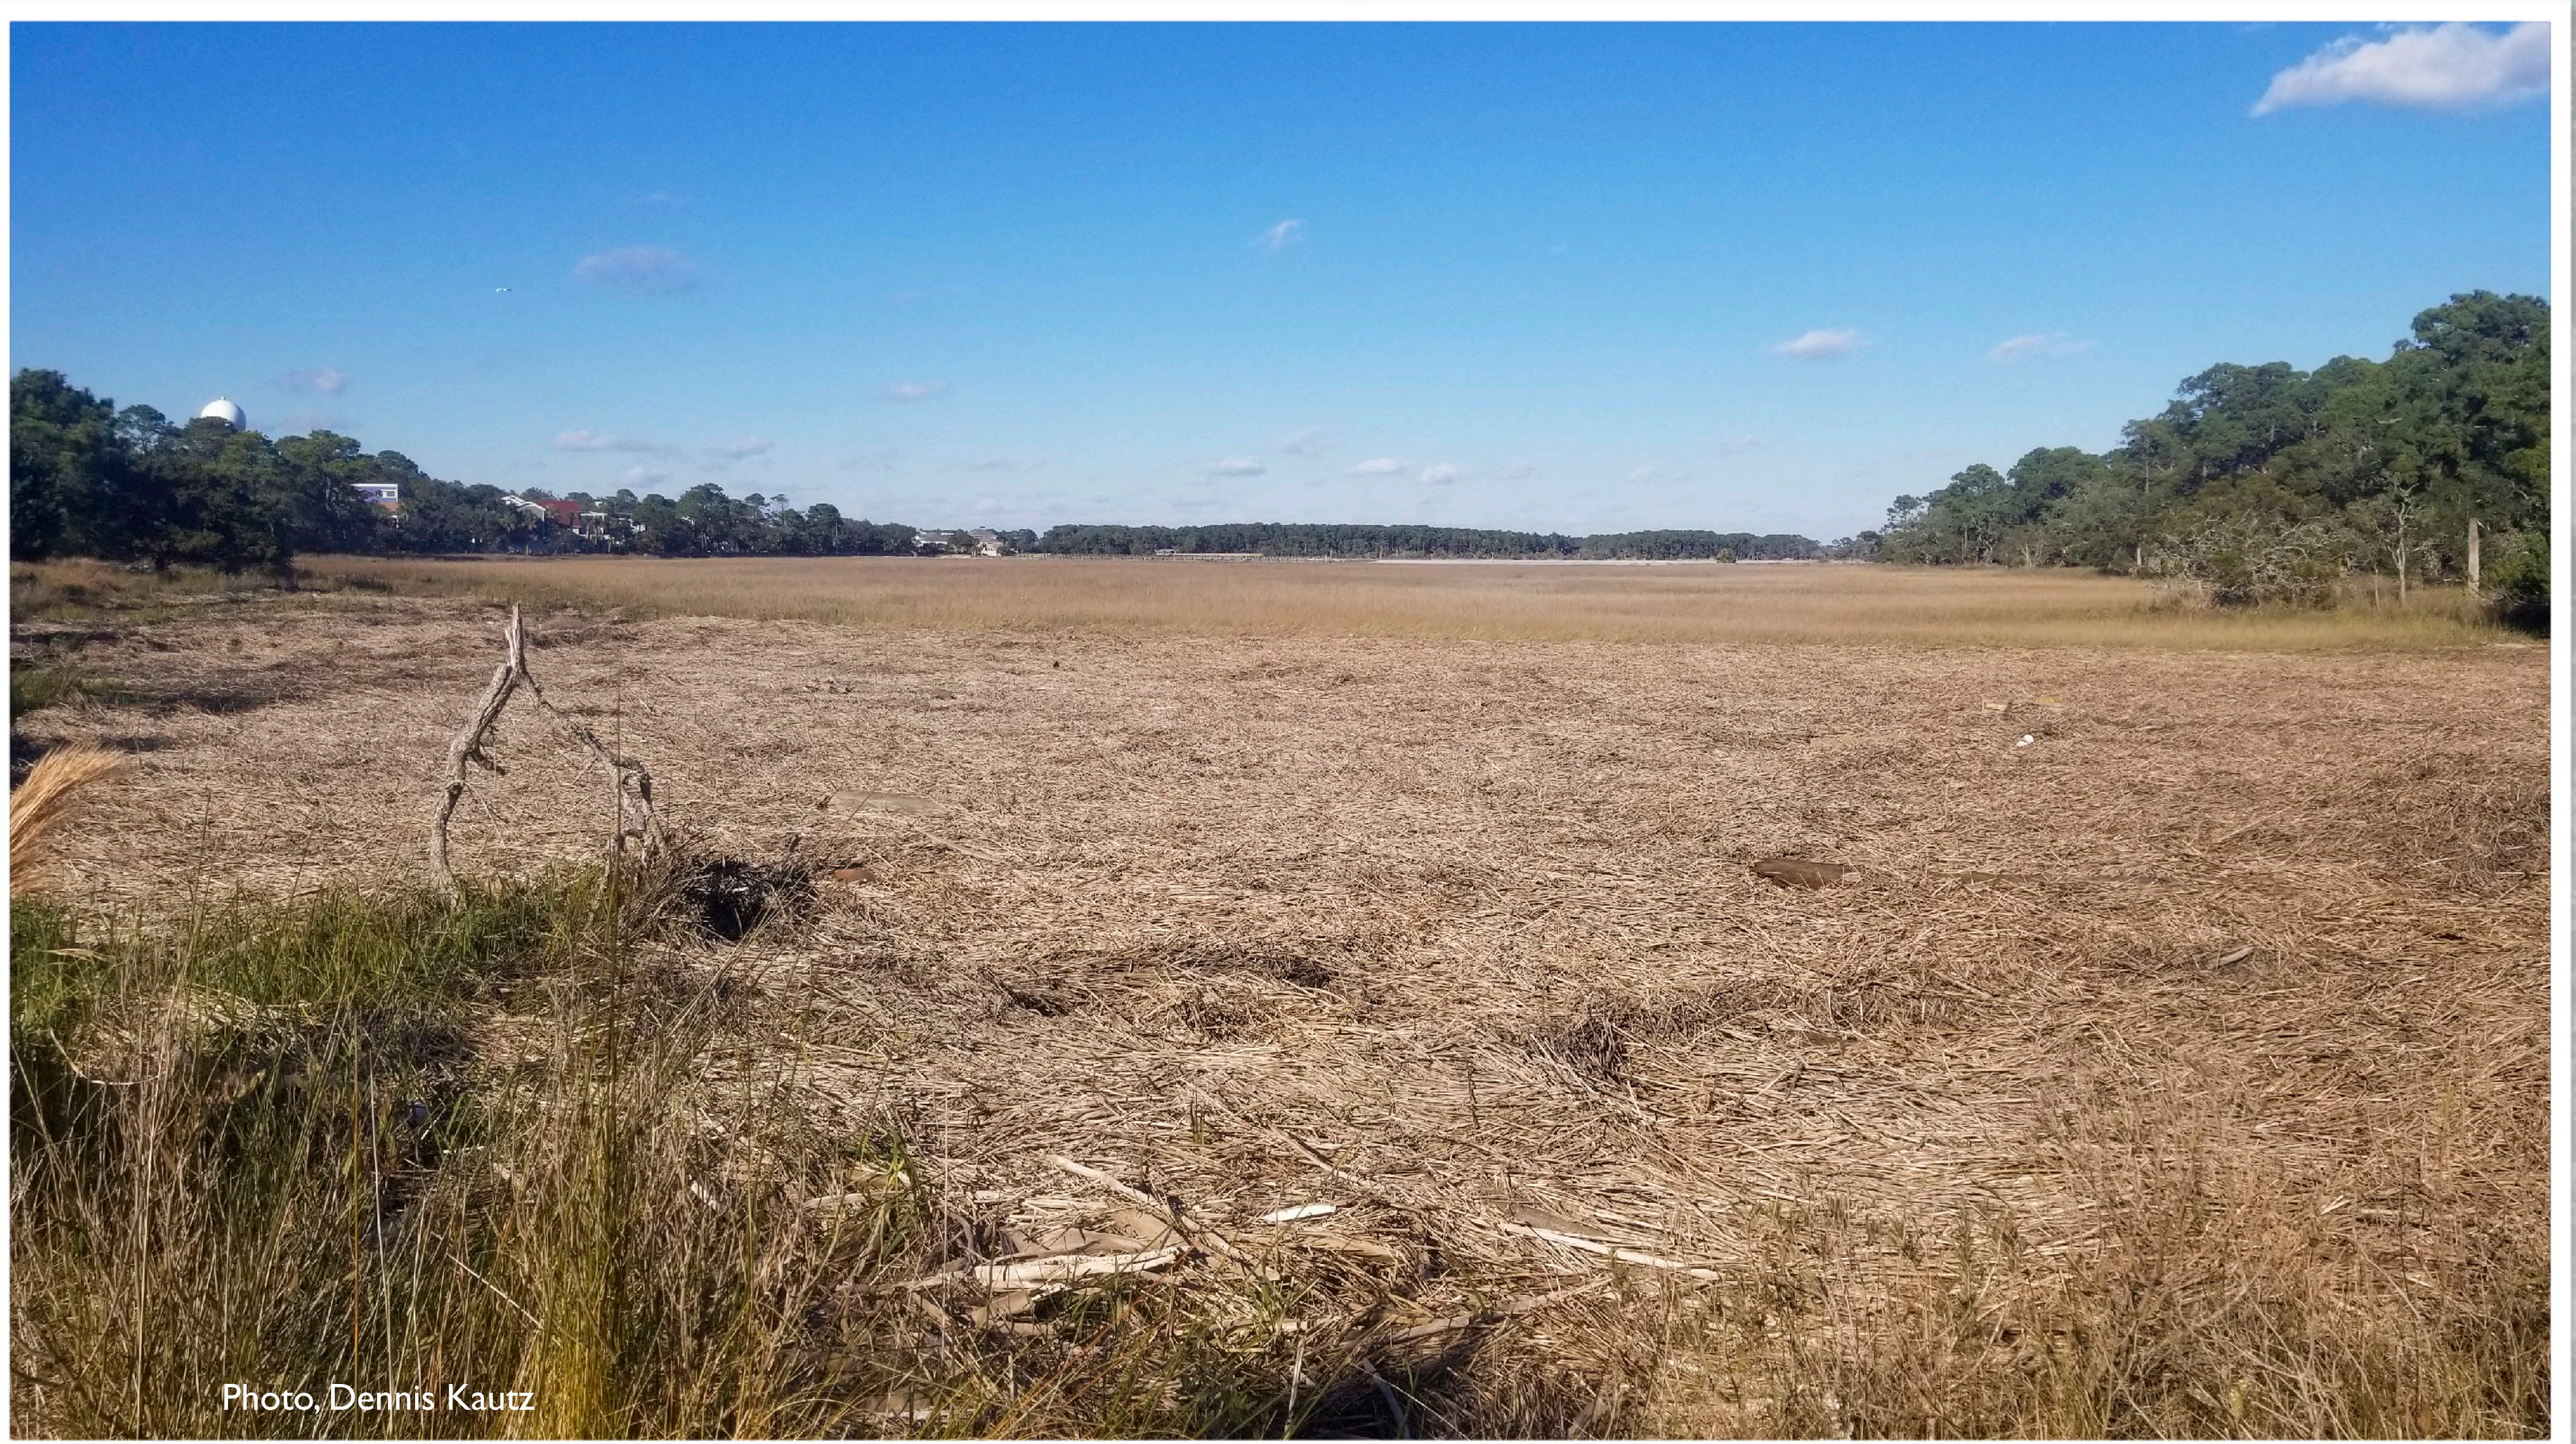
Looking out towards the salt marsh from the spillway shows the huge amount of wrack that has built up at the end of the salt marsh.
