Shoreline Status

Fripp Island - Shoreline Committee

January 24, 2022

A visual look at both sides of the Fripp Island bridge abutment and the salt marsh.

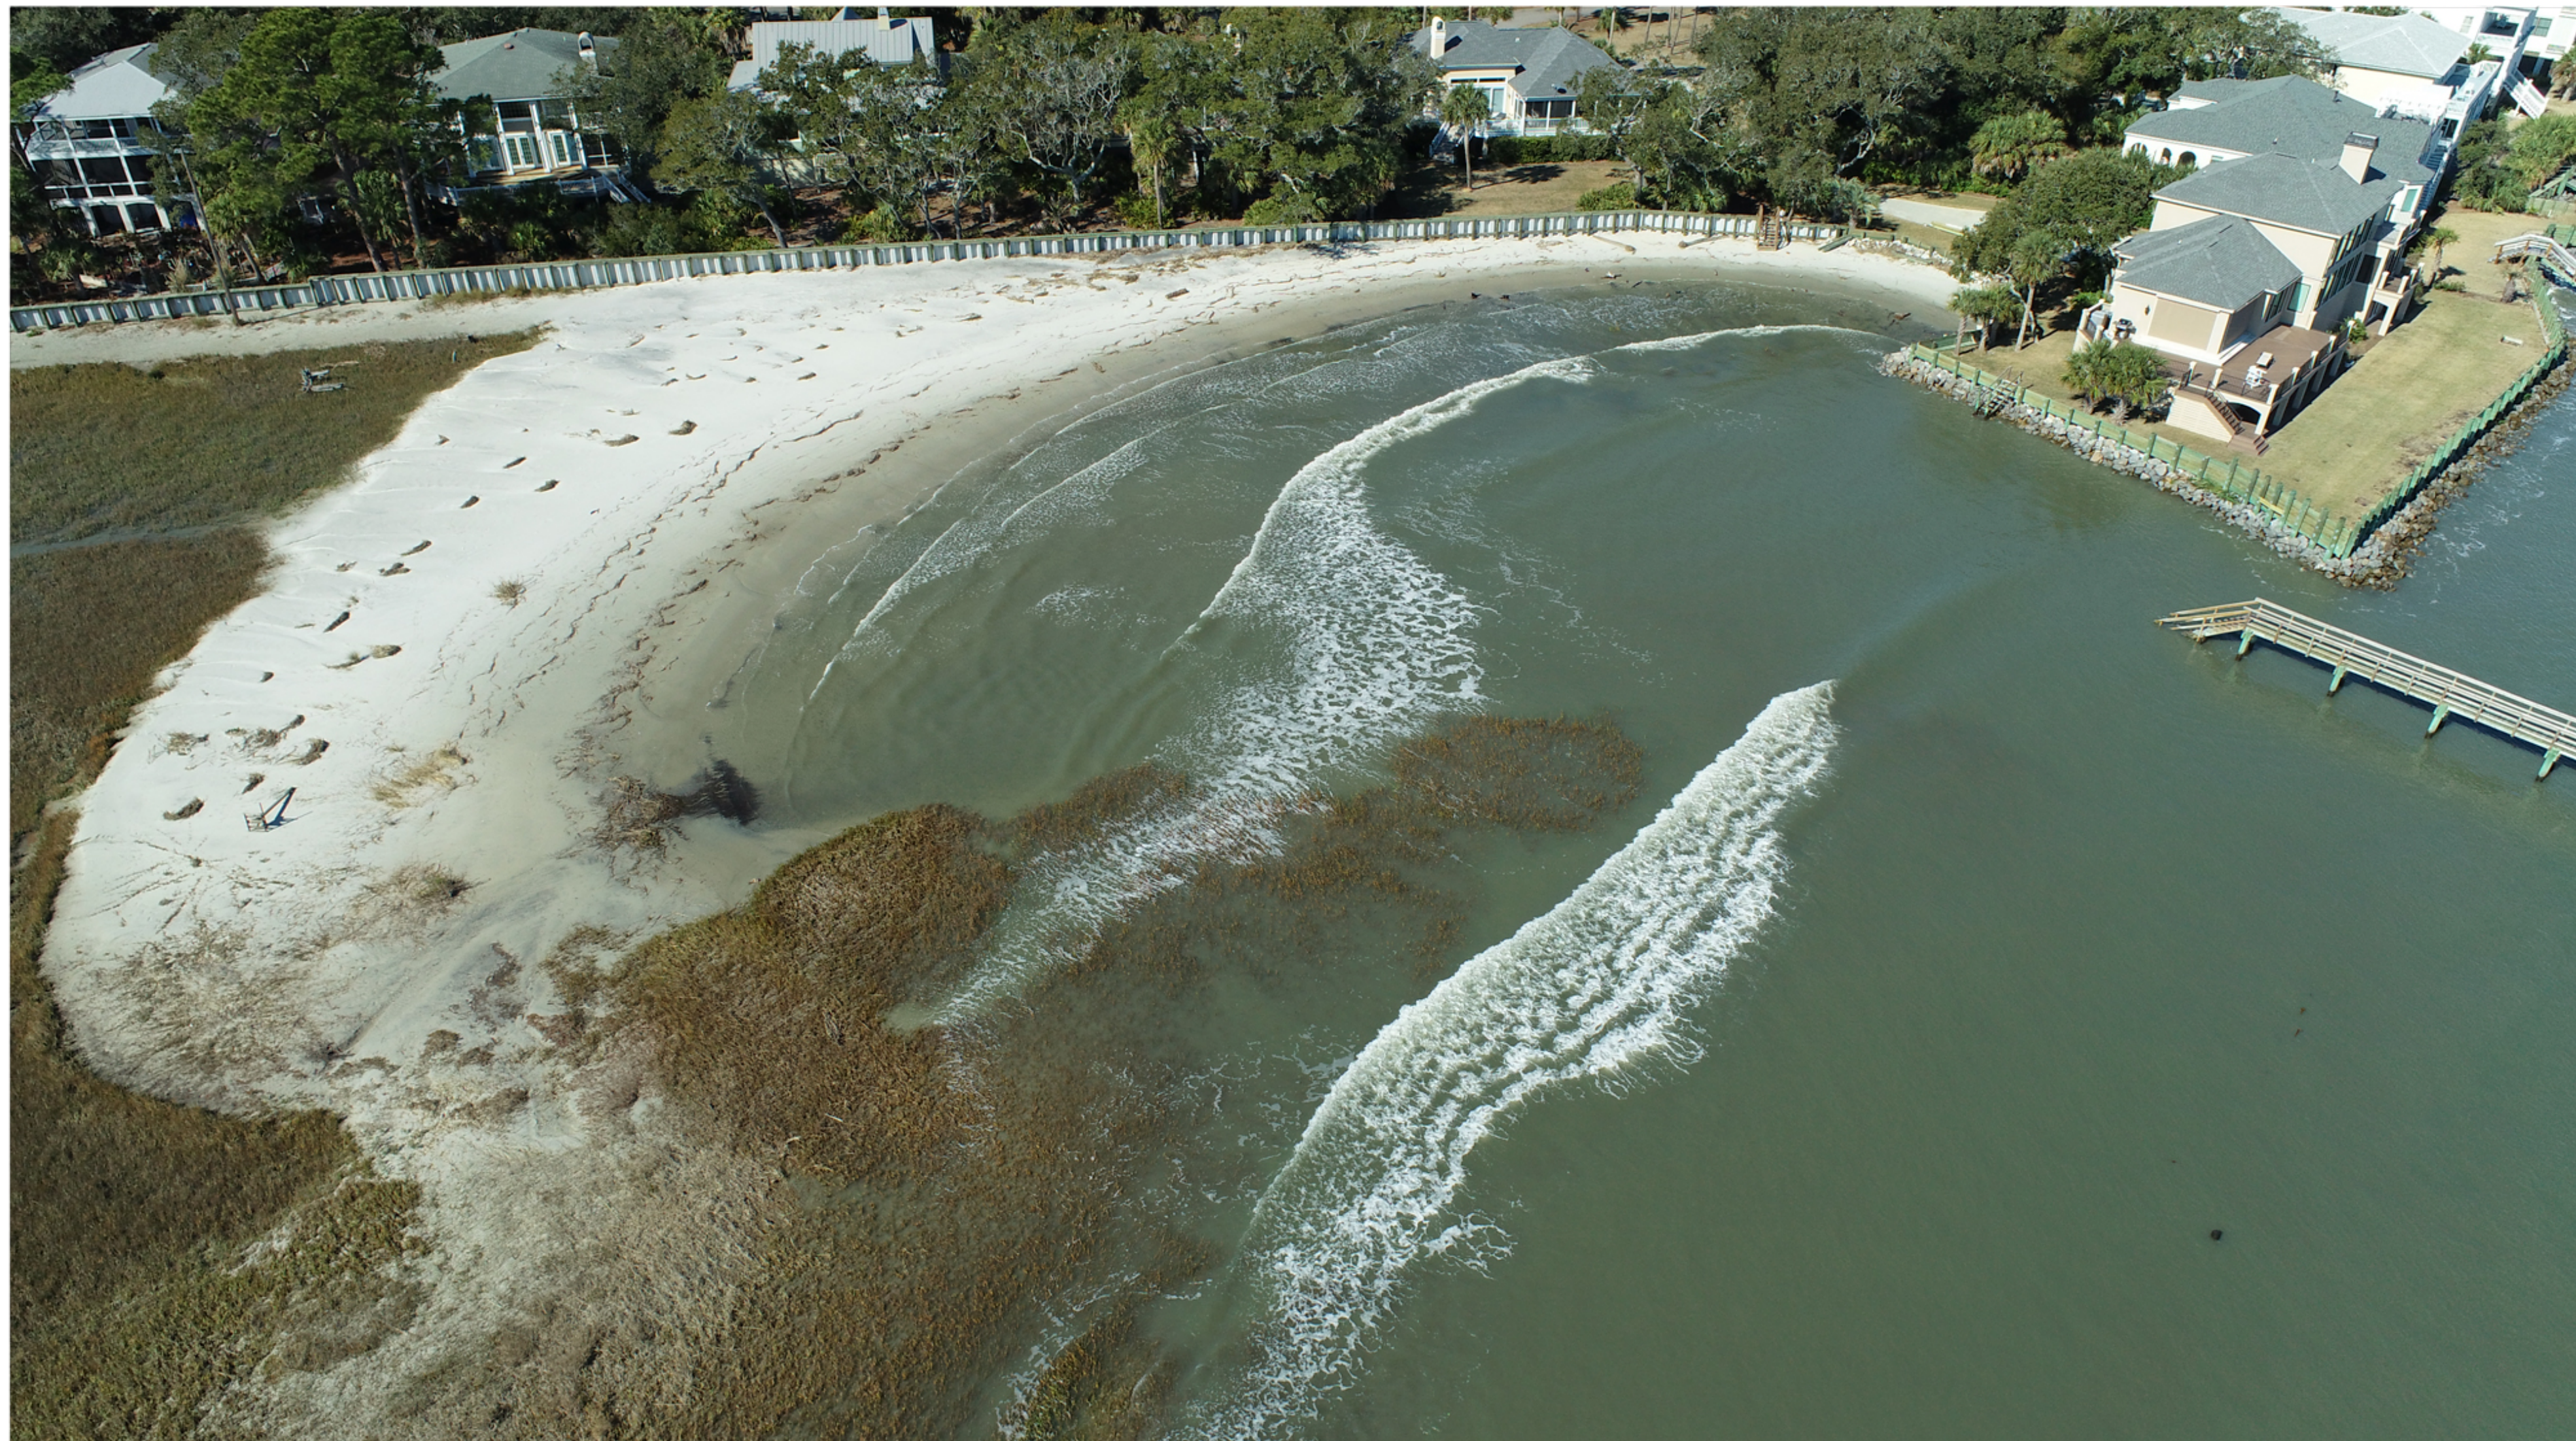
A good illustration of how spartina grass in the salt marsh helps control wave action. In the large opening, waves reach the sandy area at or near full strength, but the wave energy flowing through the grass is dispersed quickly and has almost no force left shortly through the grass.
