Shoreline Status

Fripp Island - Shoreline Committee

Darryl Zoekler - November 10, 2021

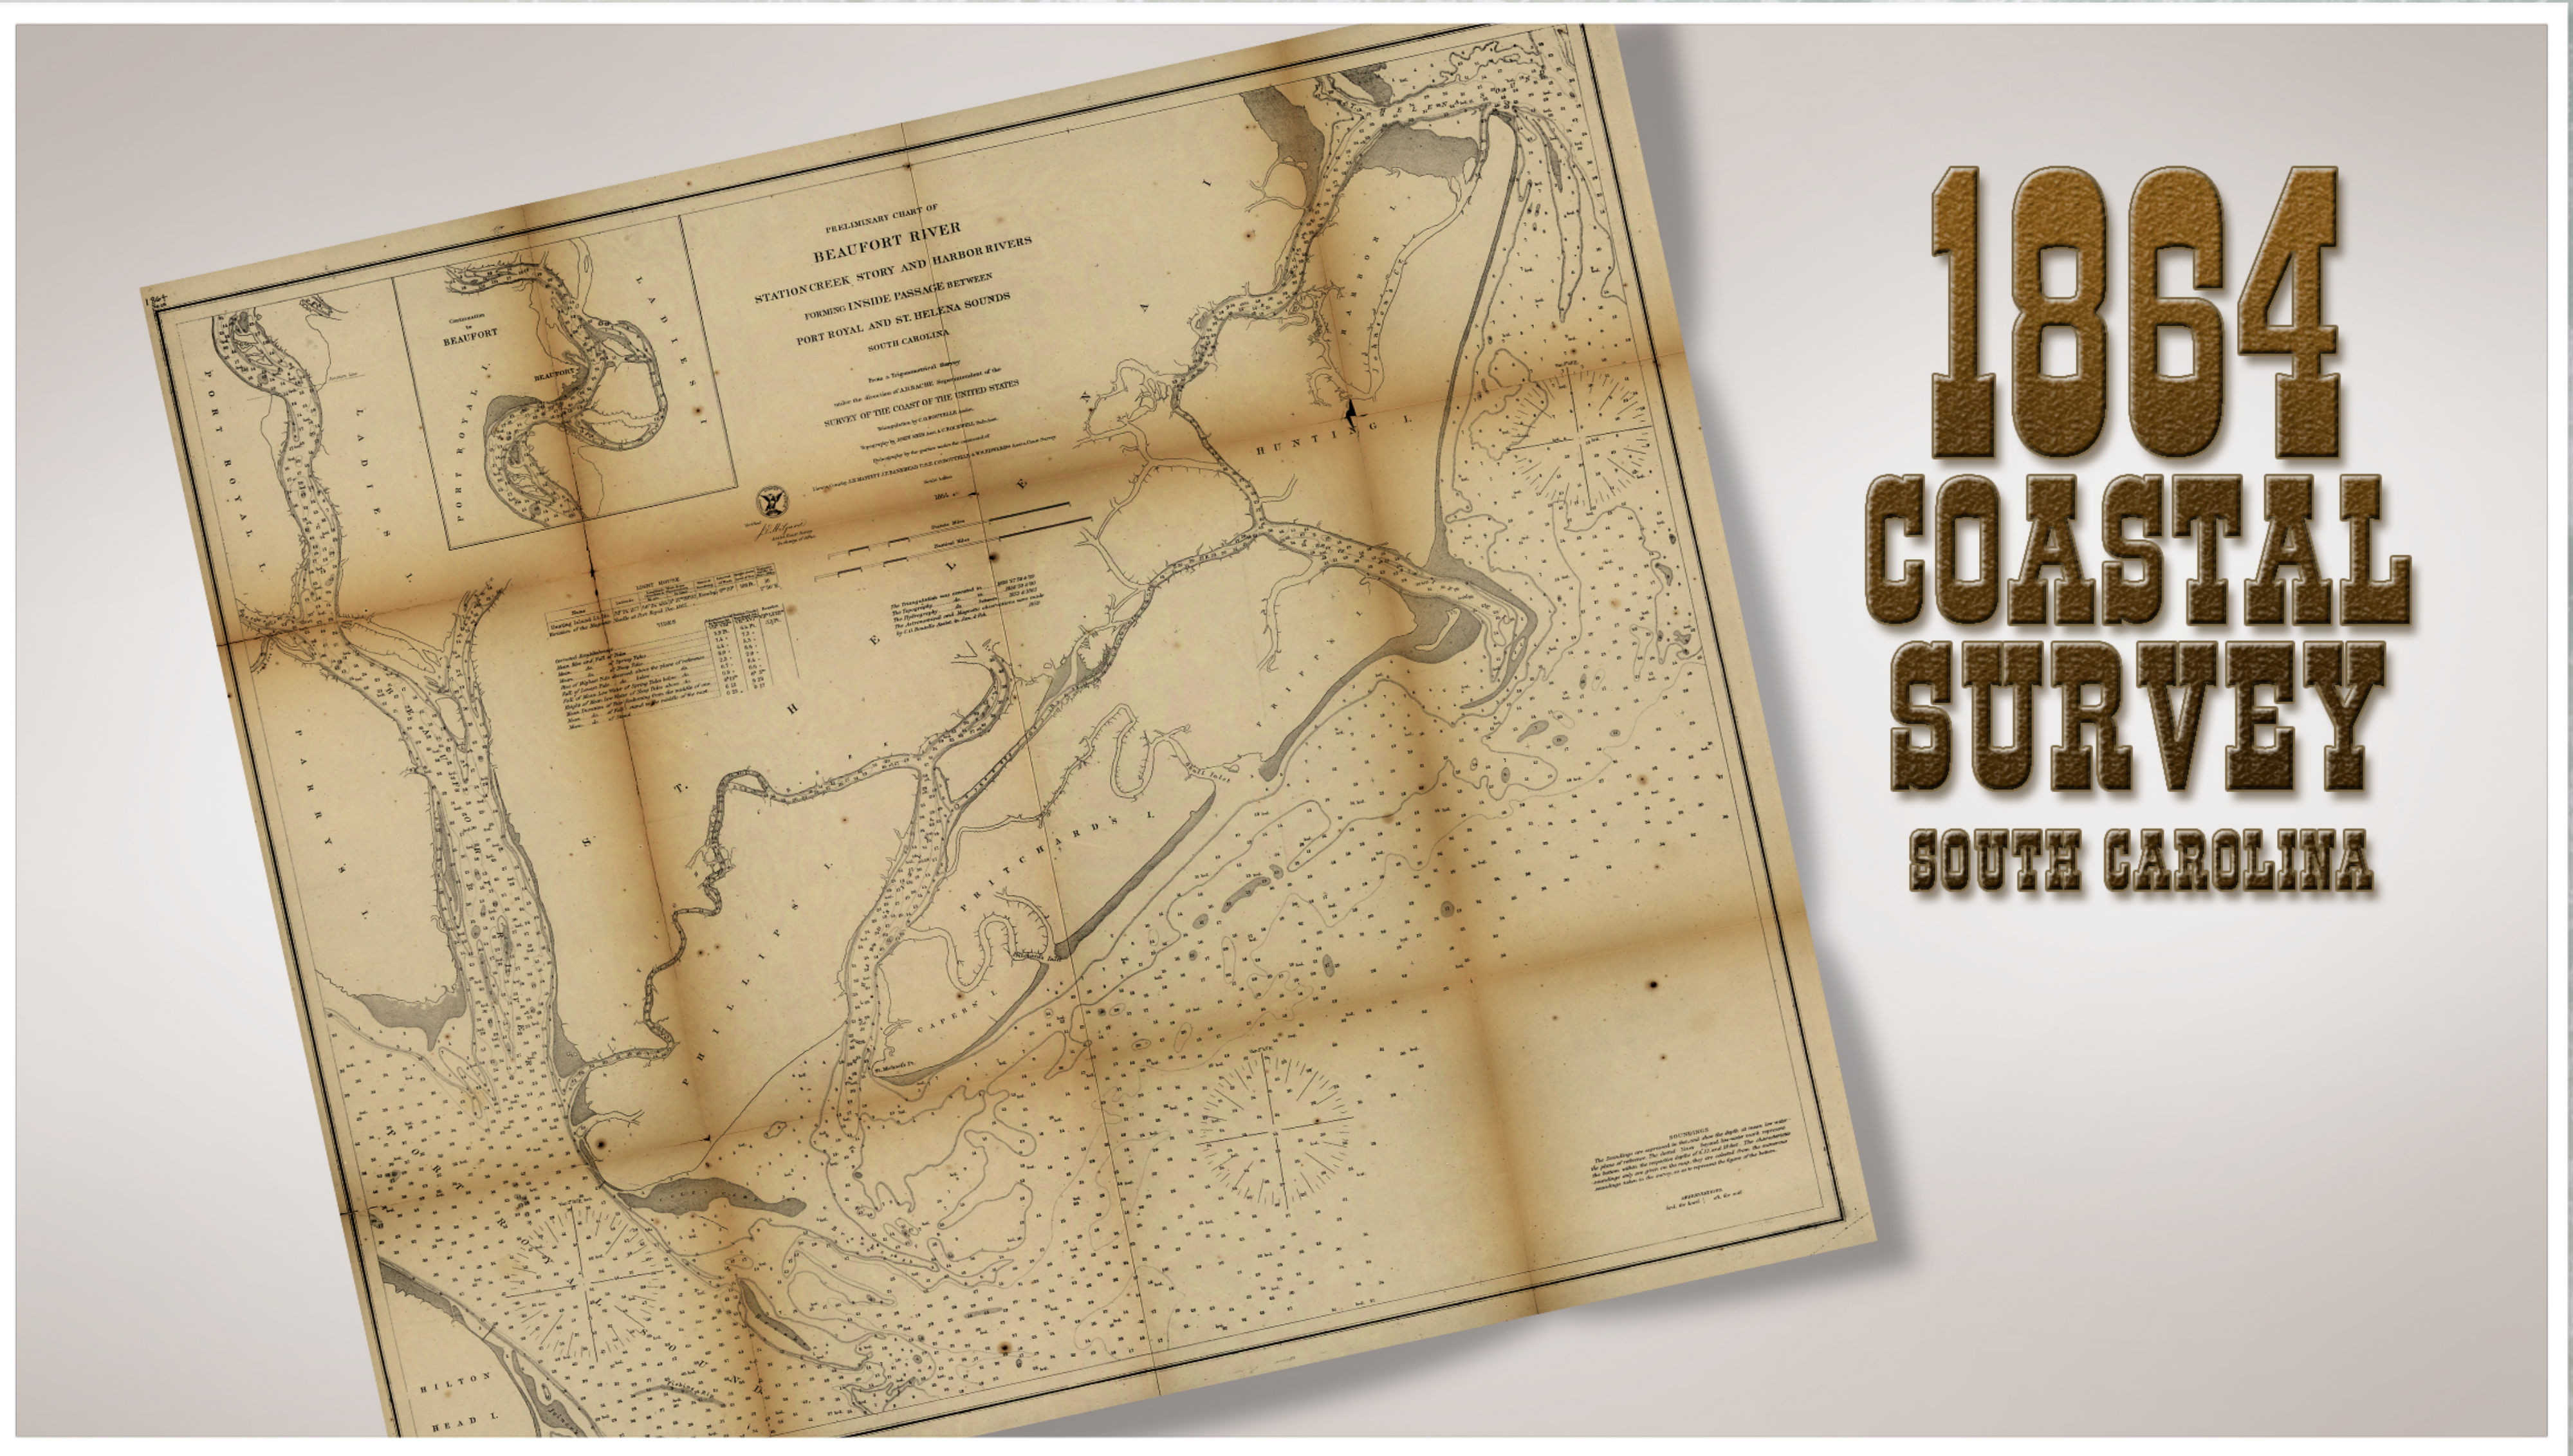
1864 COASTAL SURVEY SOUTH CAROLINA

“Grandpa, did you get that from Netscape?” - I started my comparison by examining an old coastal survey of Fripp Island, Hunting Island, and Harbor Island to see what the shoreline looked like in 1864. (download: <http://darrylzoekler.com/1864/1864CoastalSurvey.jpg.zip>)

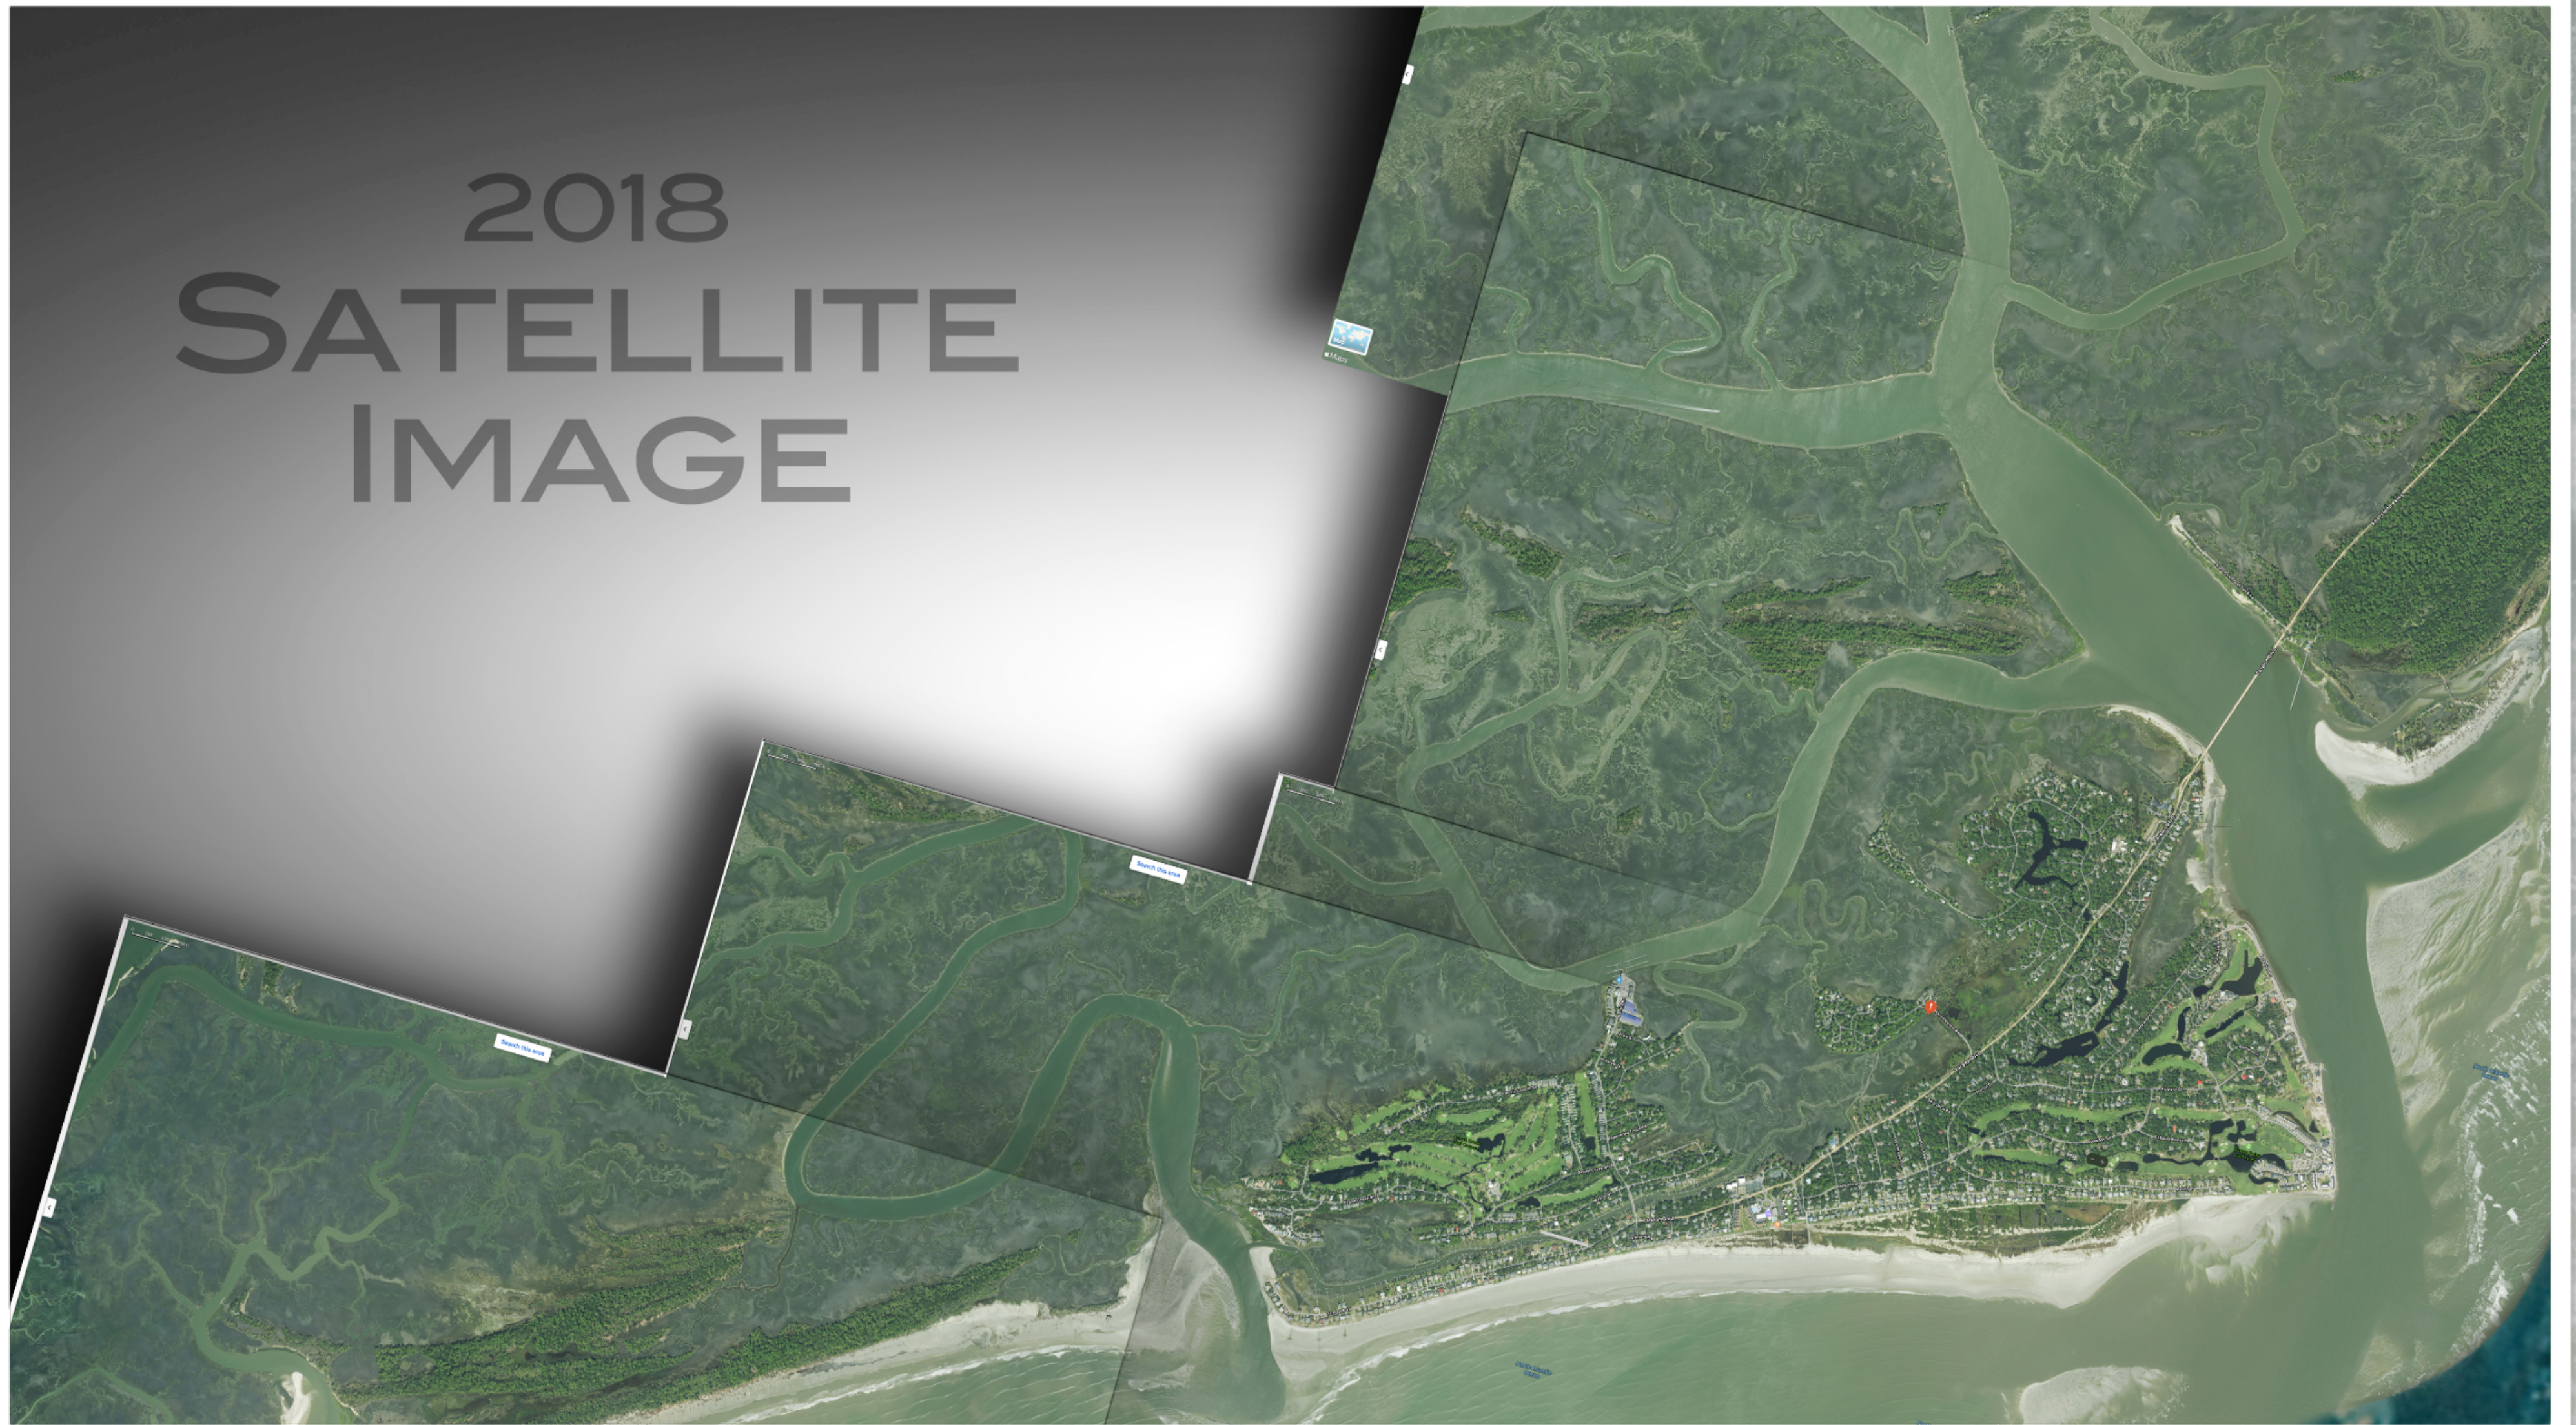
2018 SATELLITE IMAGE

"A stitch in time.." - I pieced together 29 individual screen shots of satellite images, taken in 2018, into a single large photographic mosaic to create an accurate map that can be used to compare the data of the 1864 chart. (download: <http://darrylzoekler.com/1864/2018SatelliteImage.jpg.zip>)

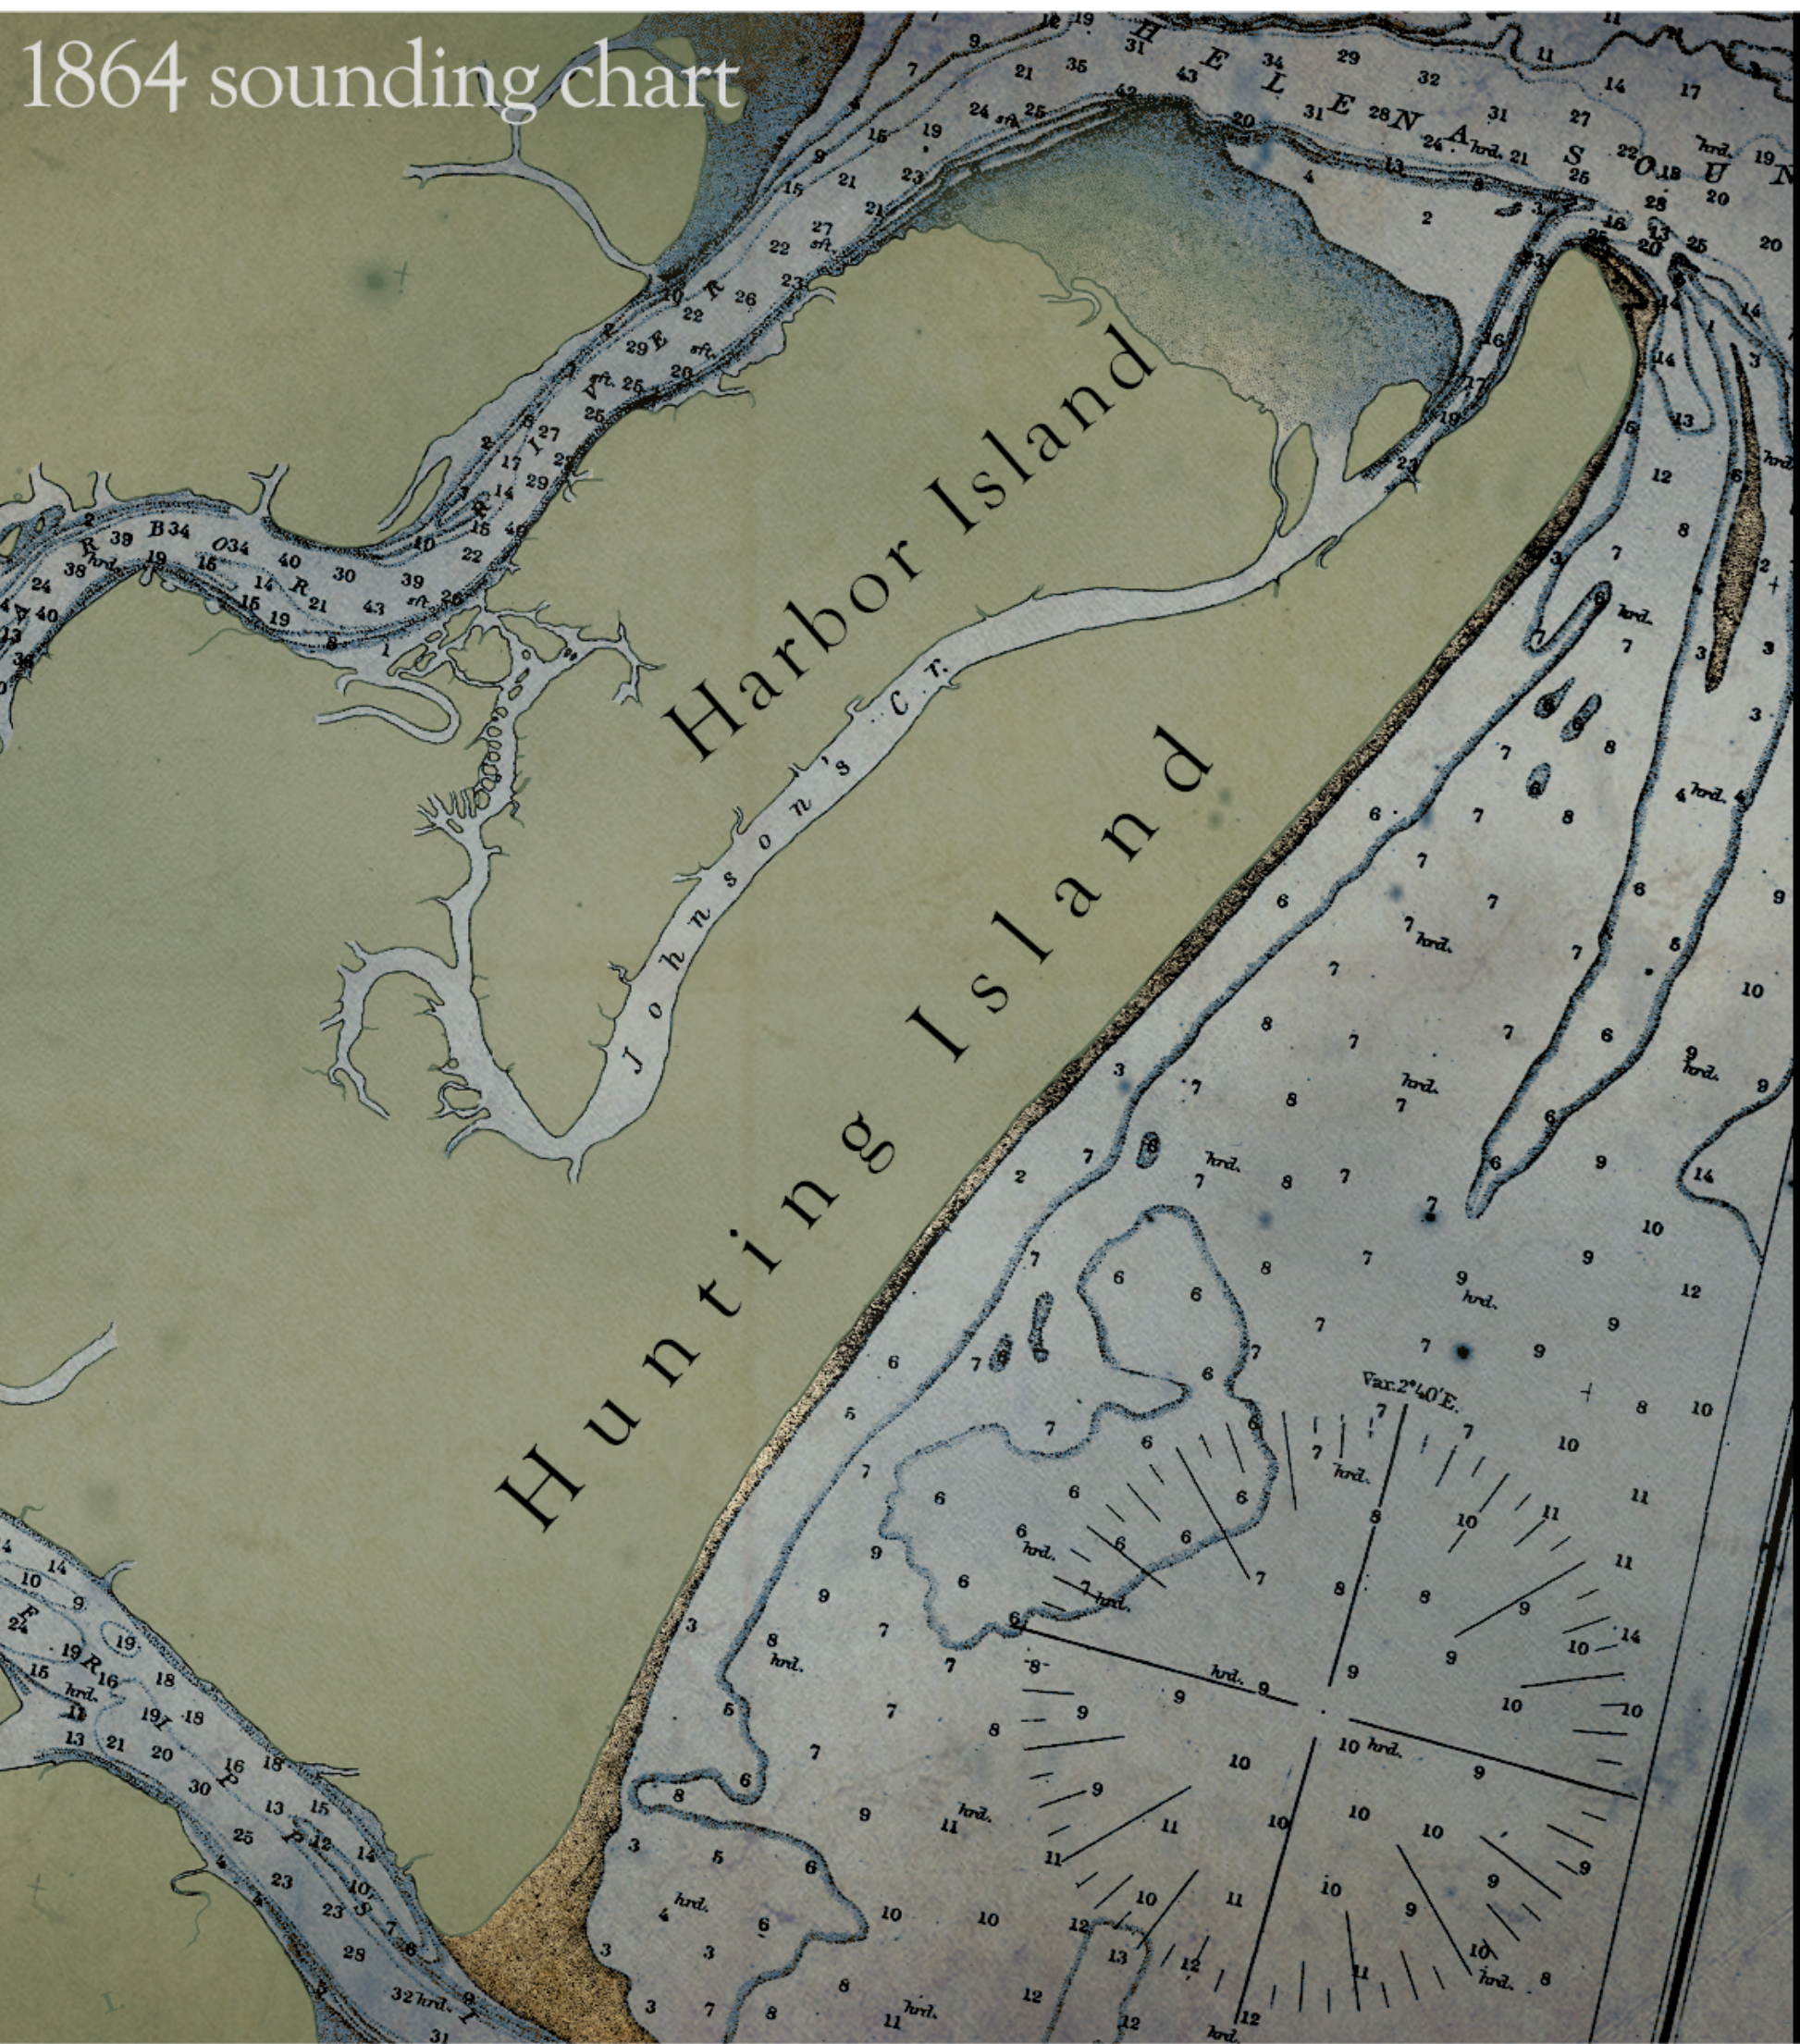
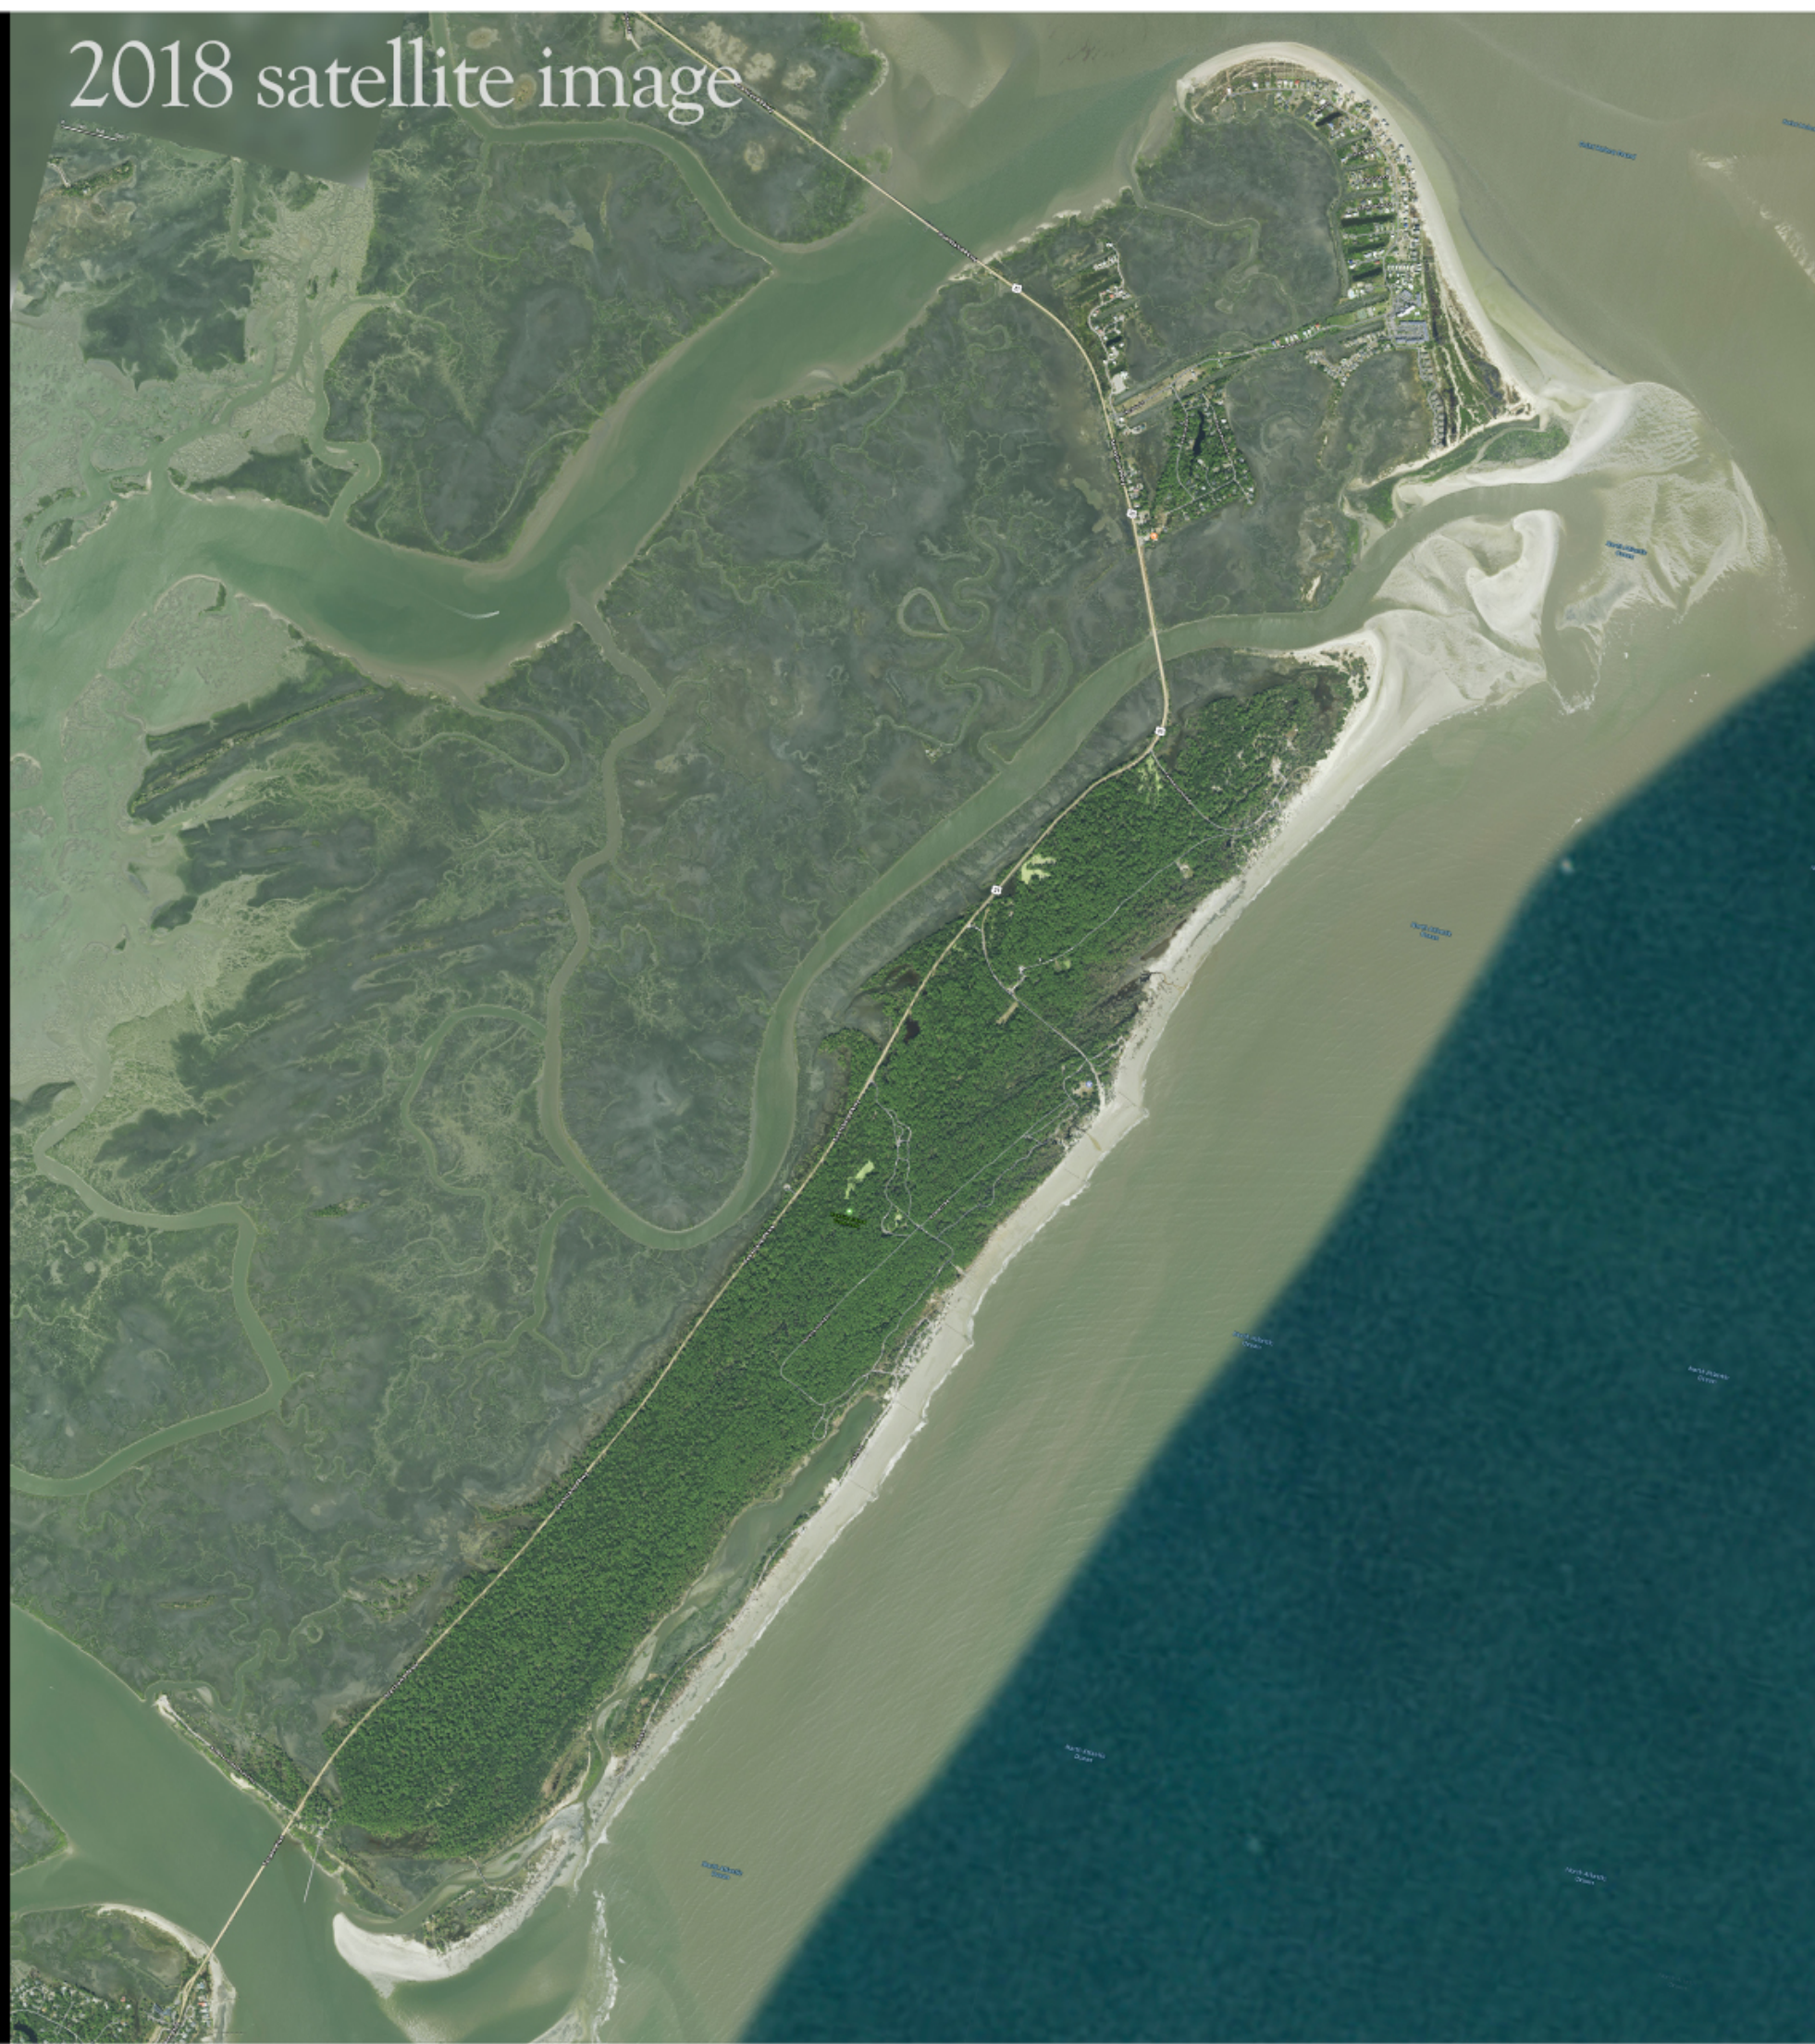
Spot the differences - By placing the 1864 chart, next to a modern satellite image of the area, a pretty substantial difference appears on Hunting Island's north end where Johnson's Creek meets the sea. On Harbor Island, the faded area on the chart represents a salt marsh and the triangle tip is a sandbar that may not be above water at high tide. The chart lacks land detail but the tidal creeks look fairly proportional to the satellite image.

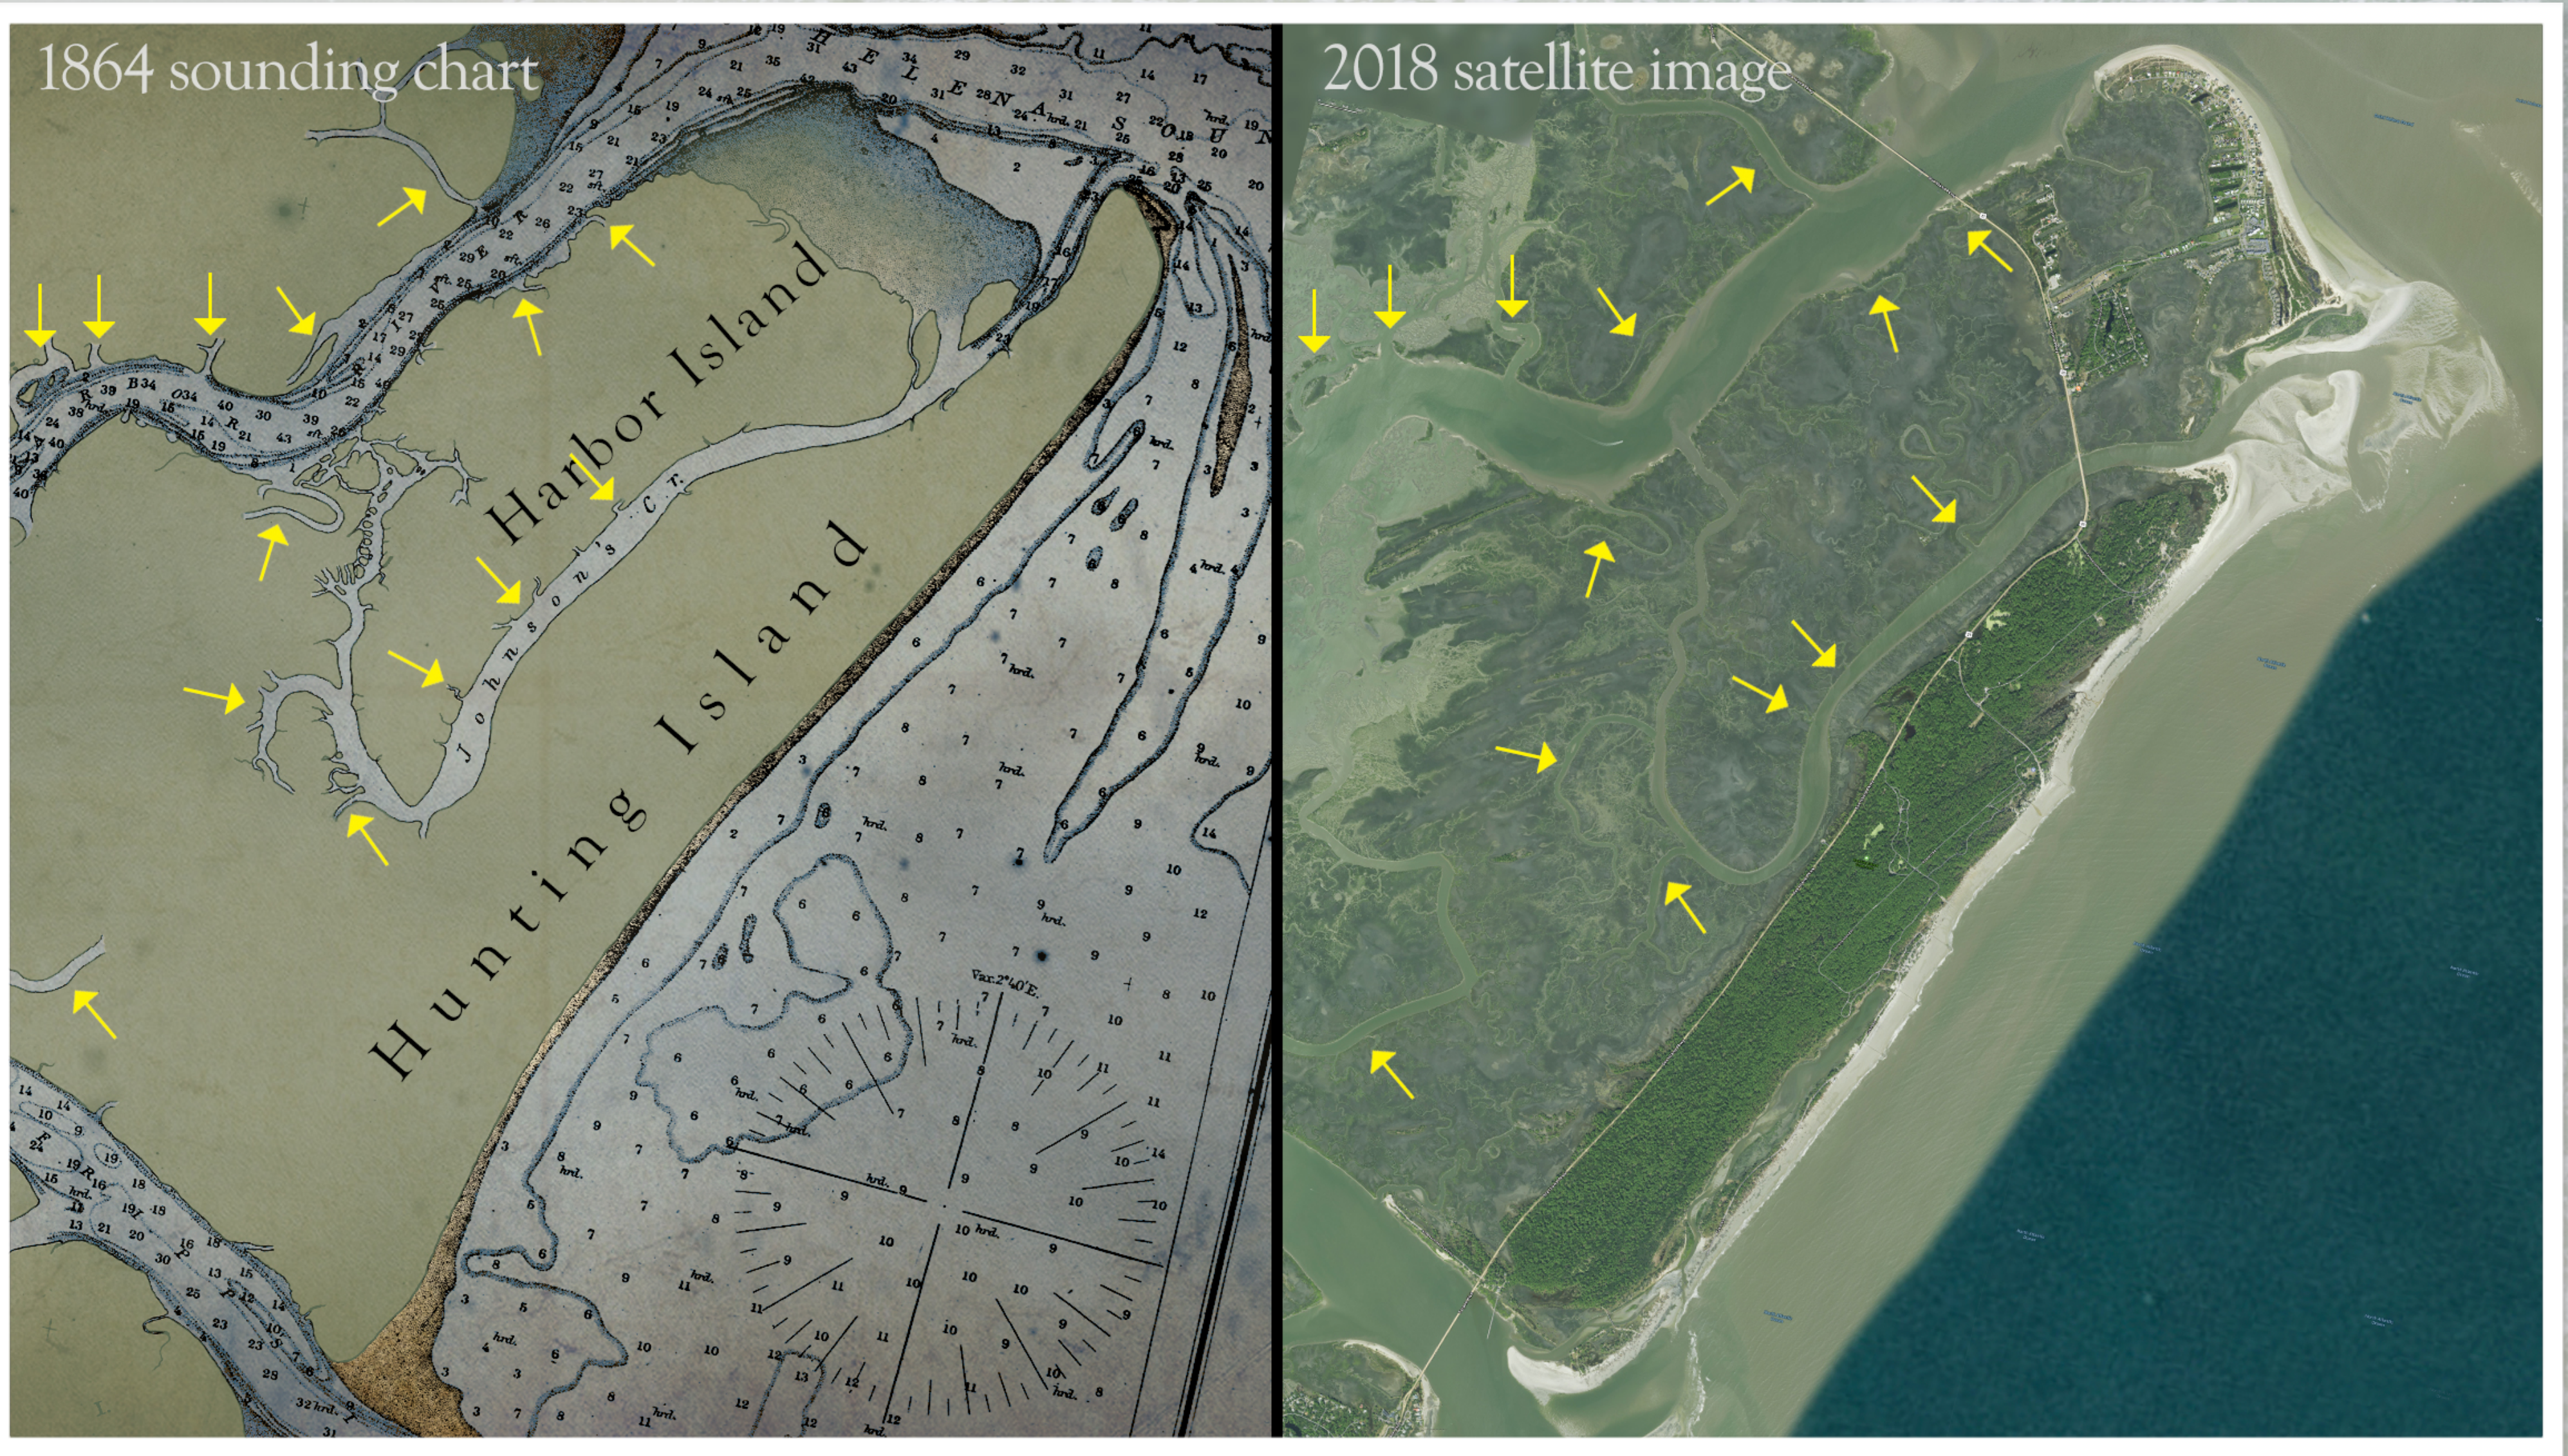
The search for clues - Many of the small feeder creeks were not drawn in completely on the 1864 chart, but the locations where they branch off from the main tidal creeks have been illustrated and are still visible on the satellite image after 157 years of changes to the area. These can be used to identify locational characteristics between the two maps.
