Shoreline Status

Fripp Island - Shoreline Committee

Darryl Zoekler - November 10, 2021

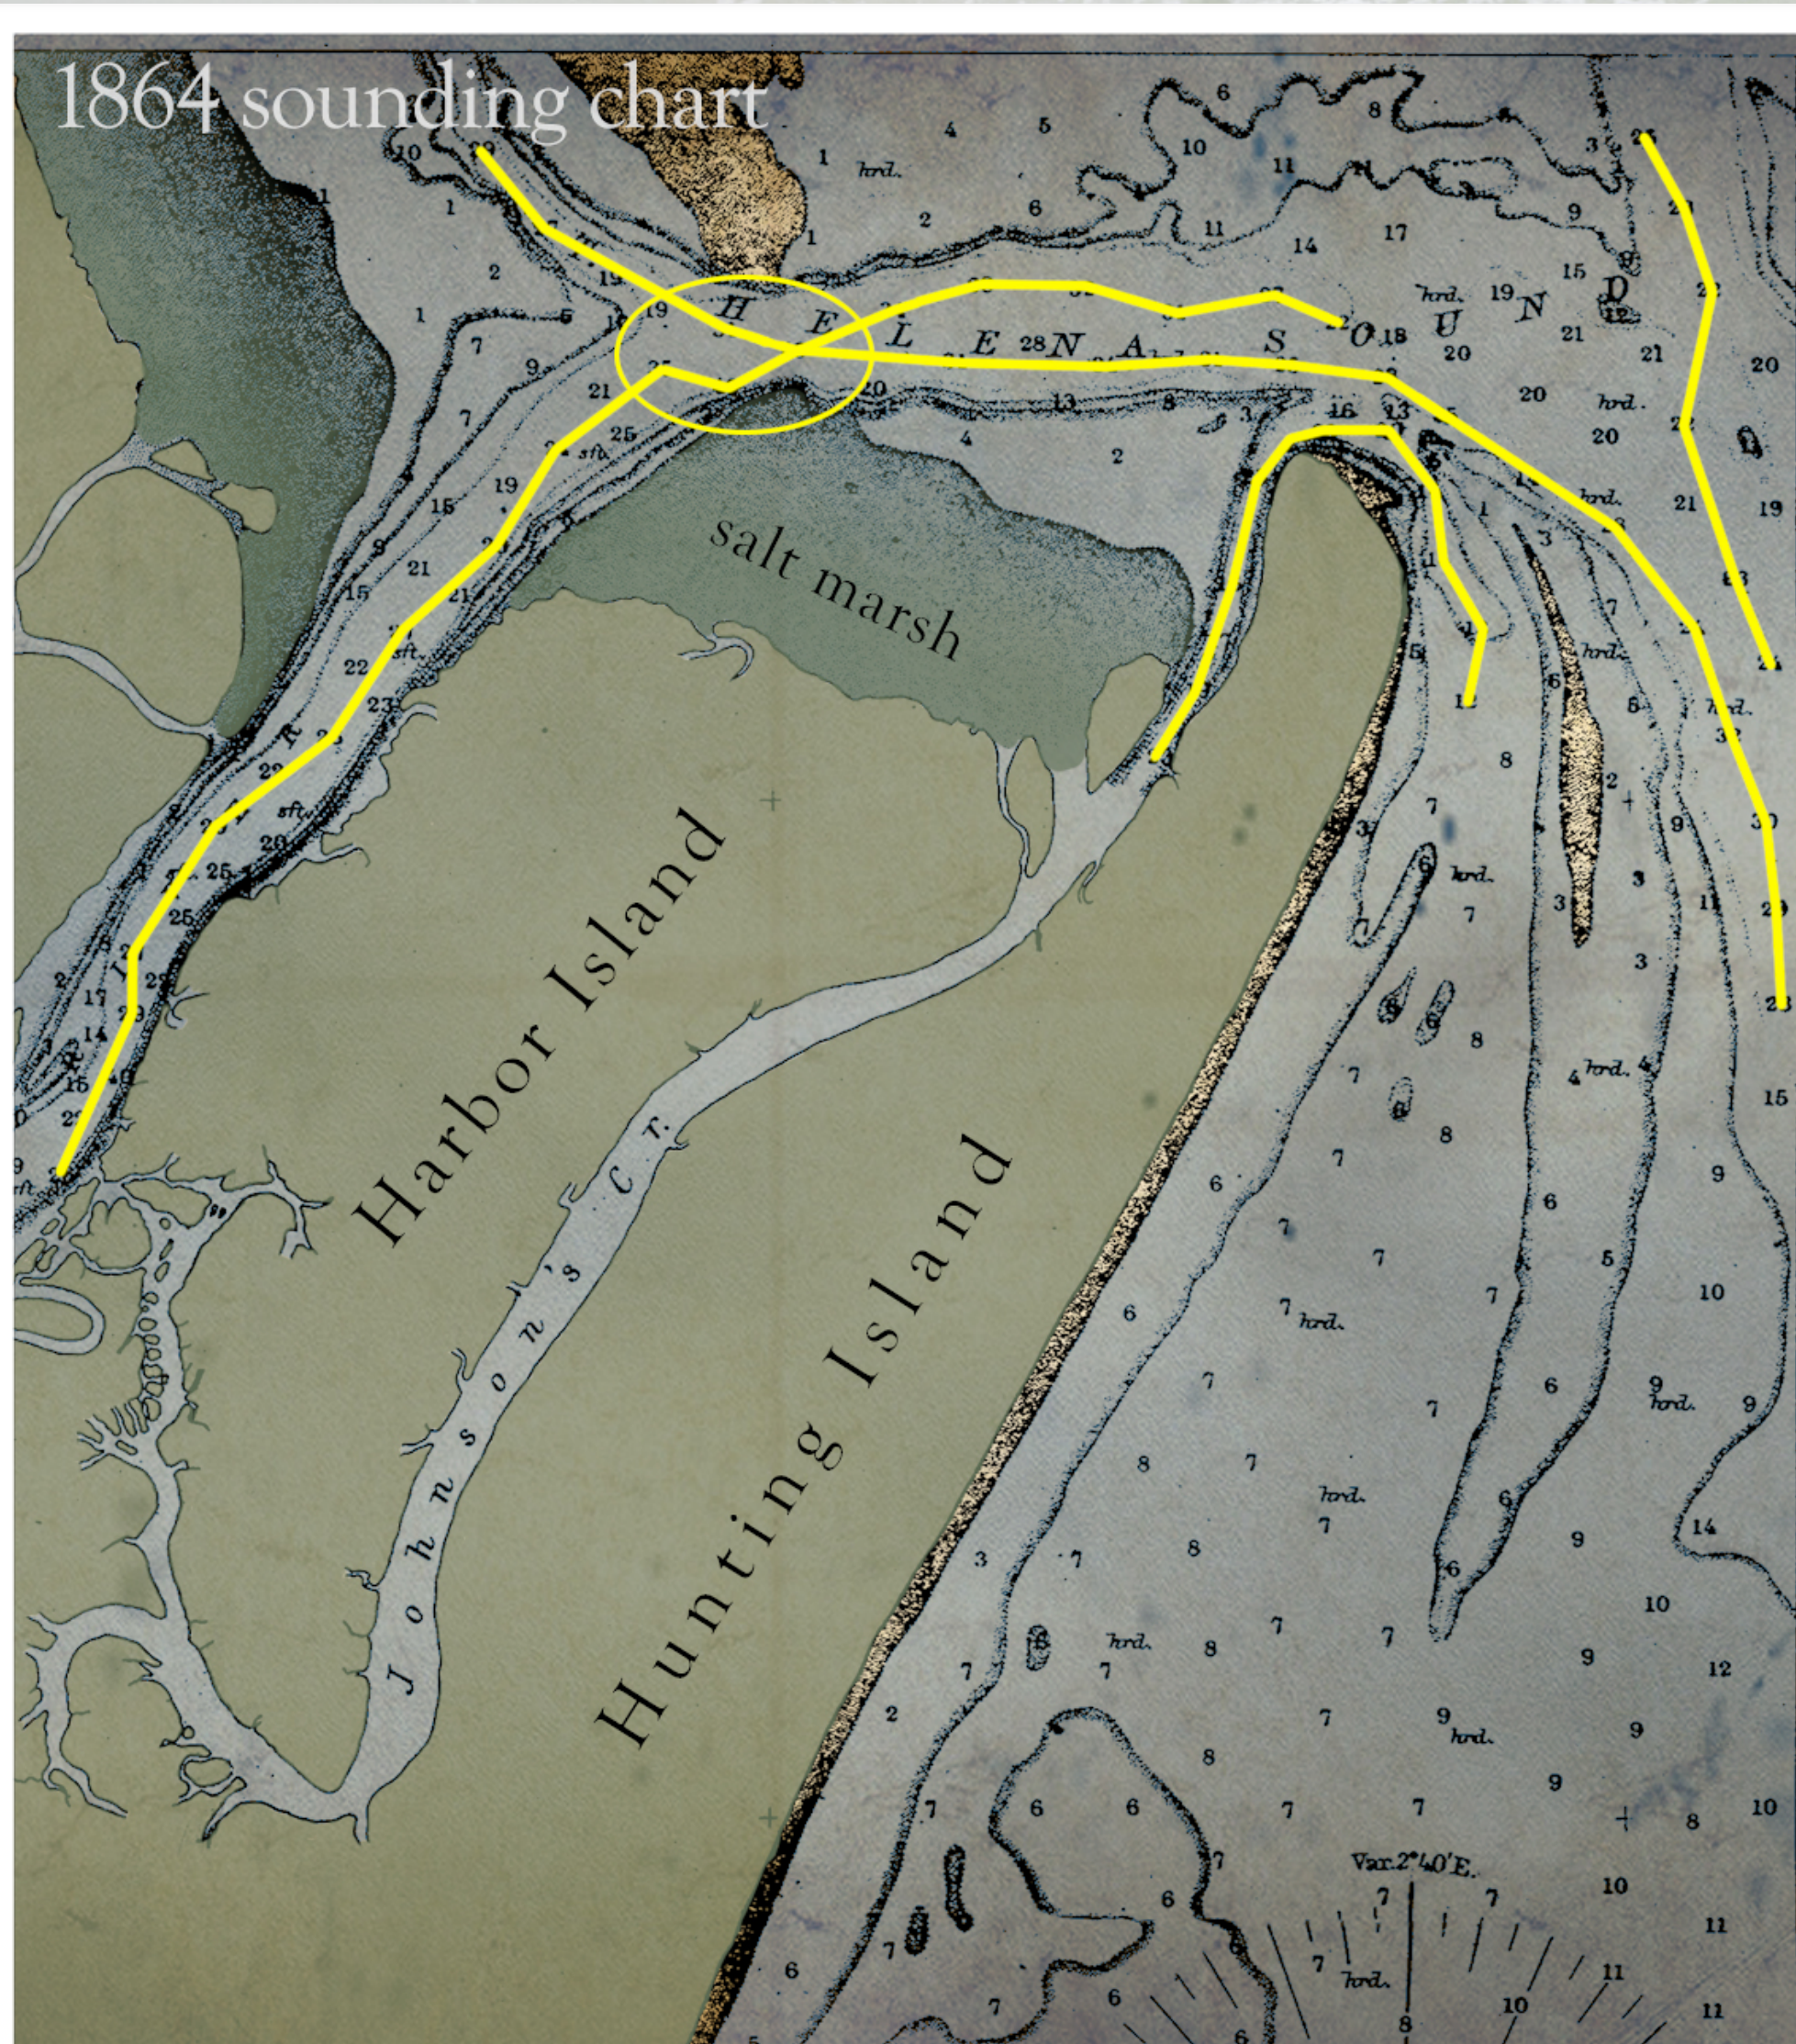
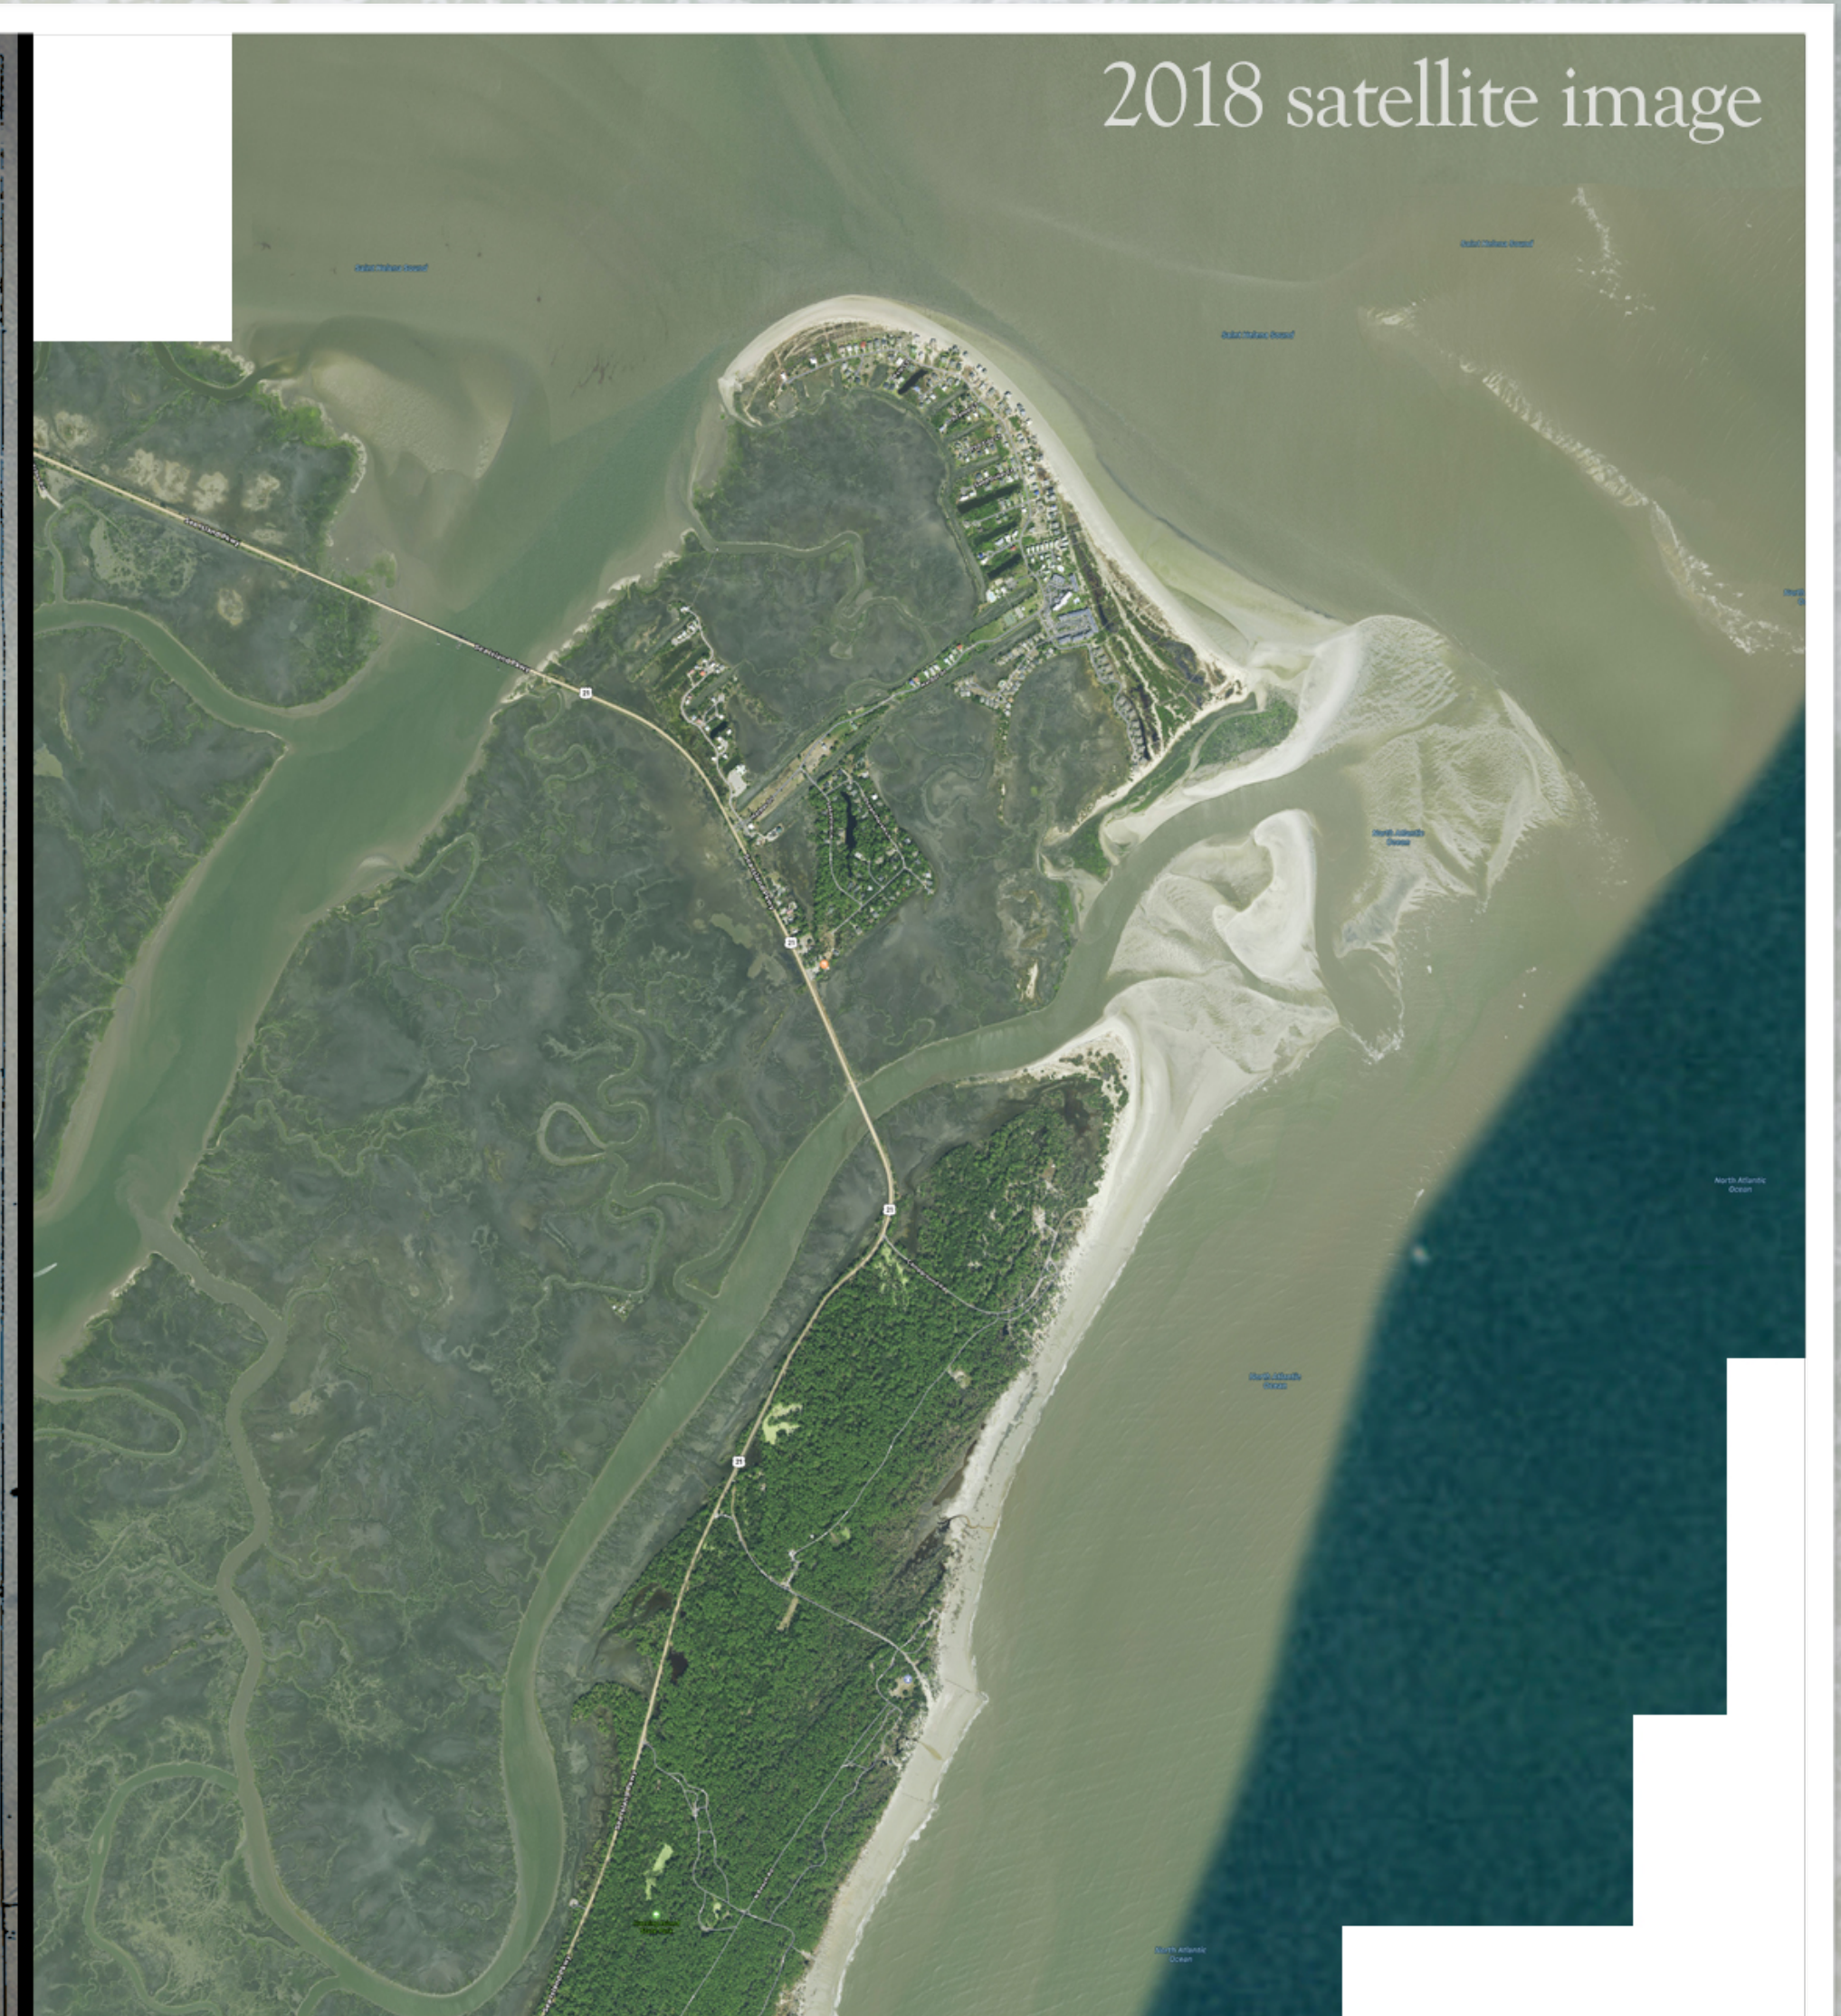
Connecting the dots - If we draw a line through the deepest parts of St. Helena sound we can identify the main channels. The channels flow “upward” past the islands in 1864, but “downward” today. The circled area is the deepest area of the chart measuring 35, 42, 43, and 34 feet of water and also, the mouth of Johnson’s Creek was quite deep in 1864, measuring 23, 19, 16, 23, and 25 feet as it enters the sound.

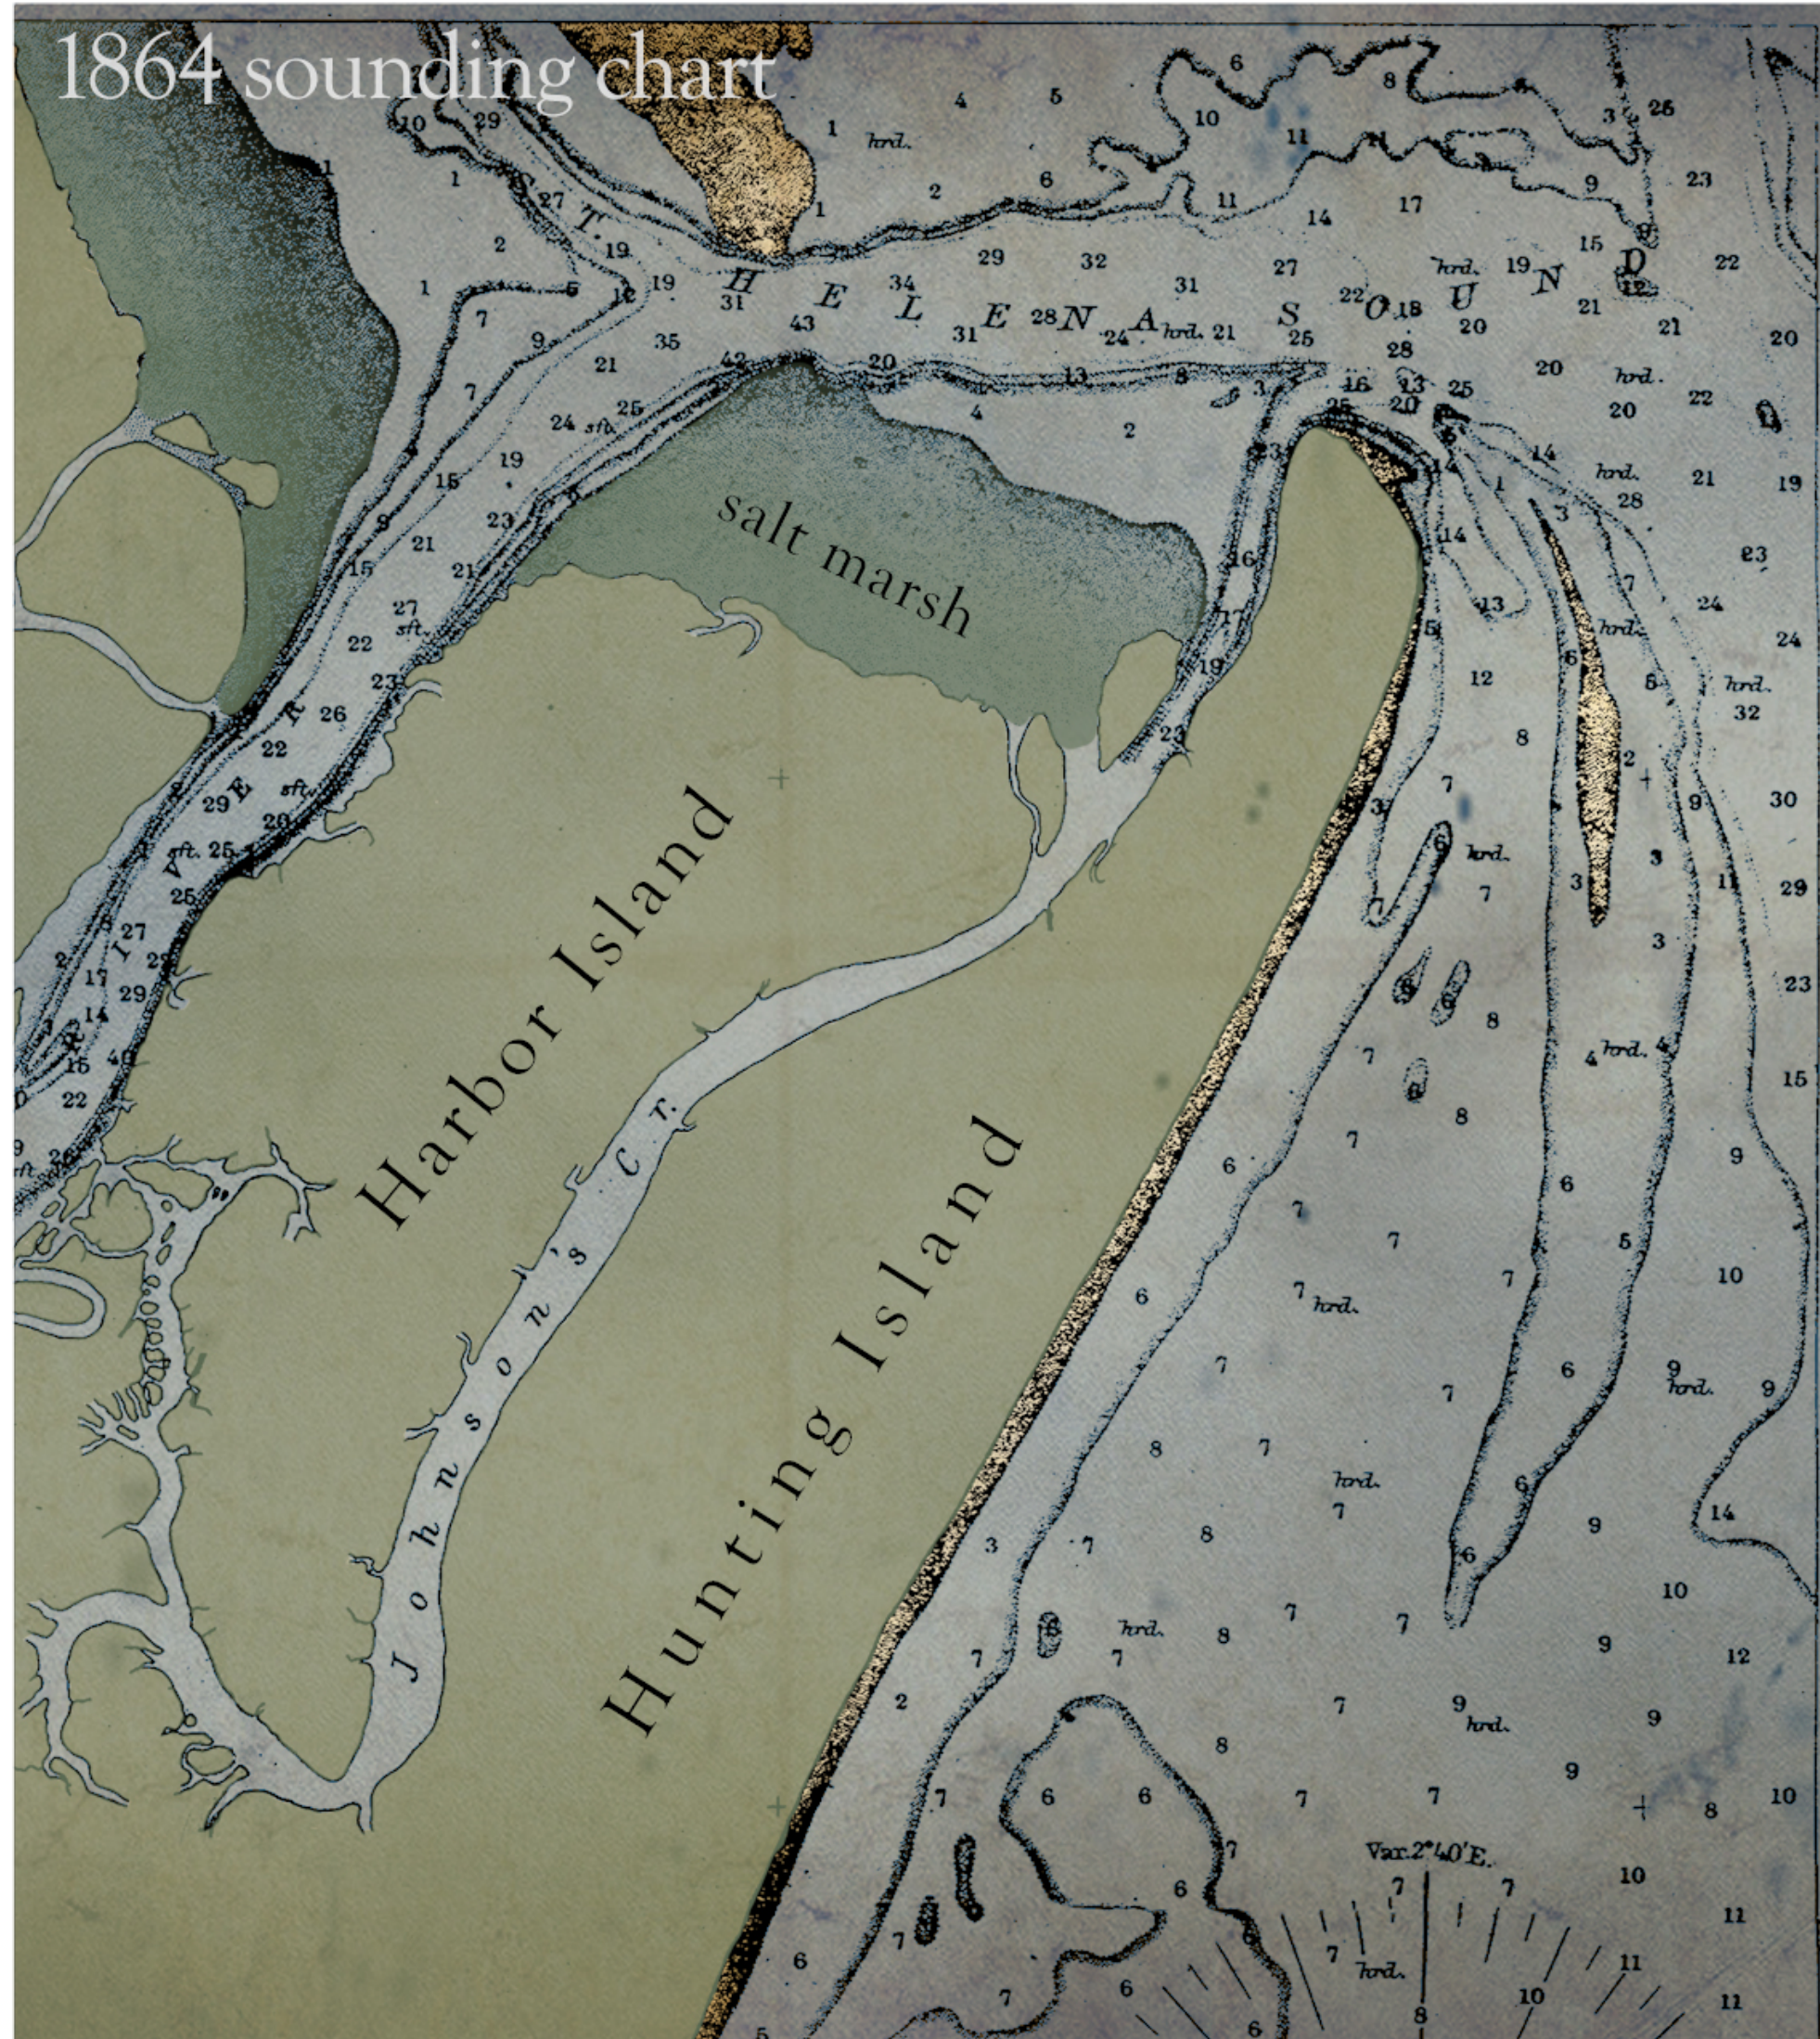
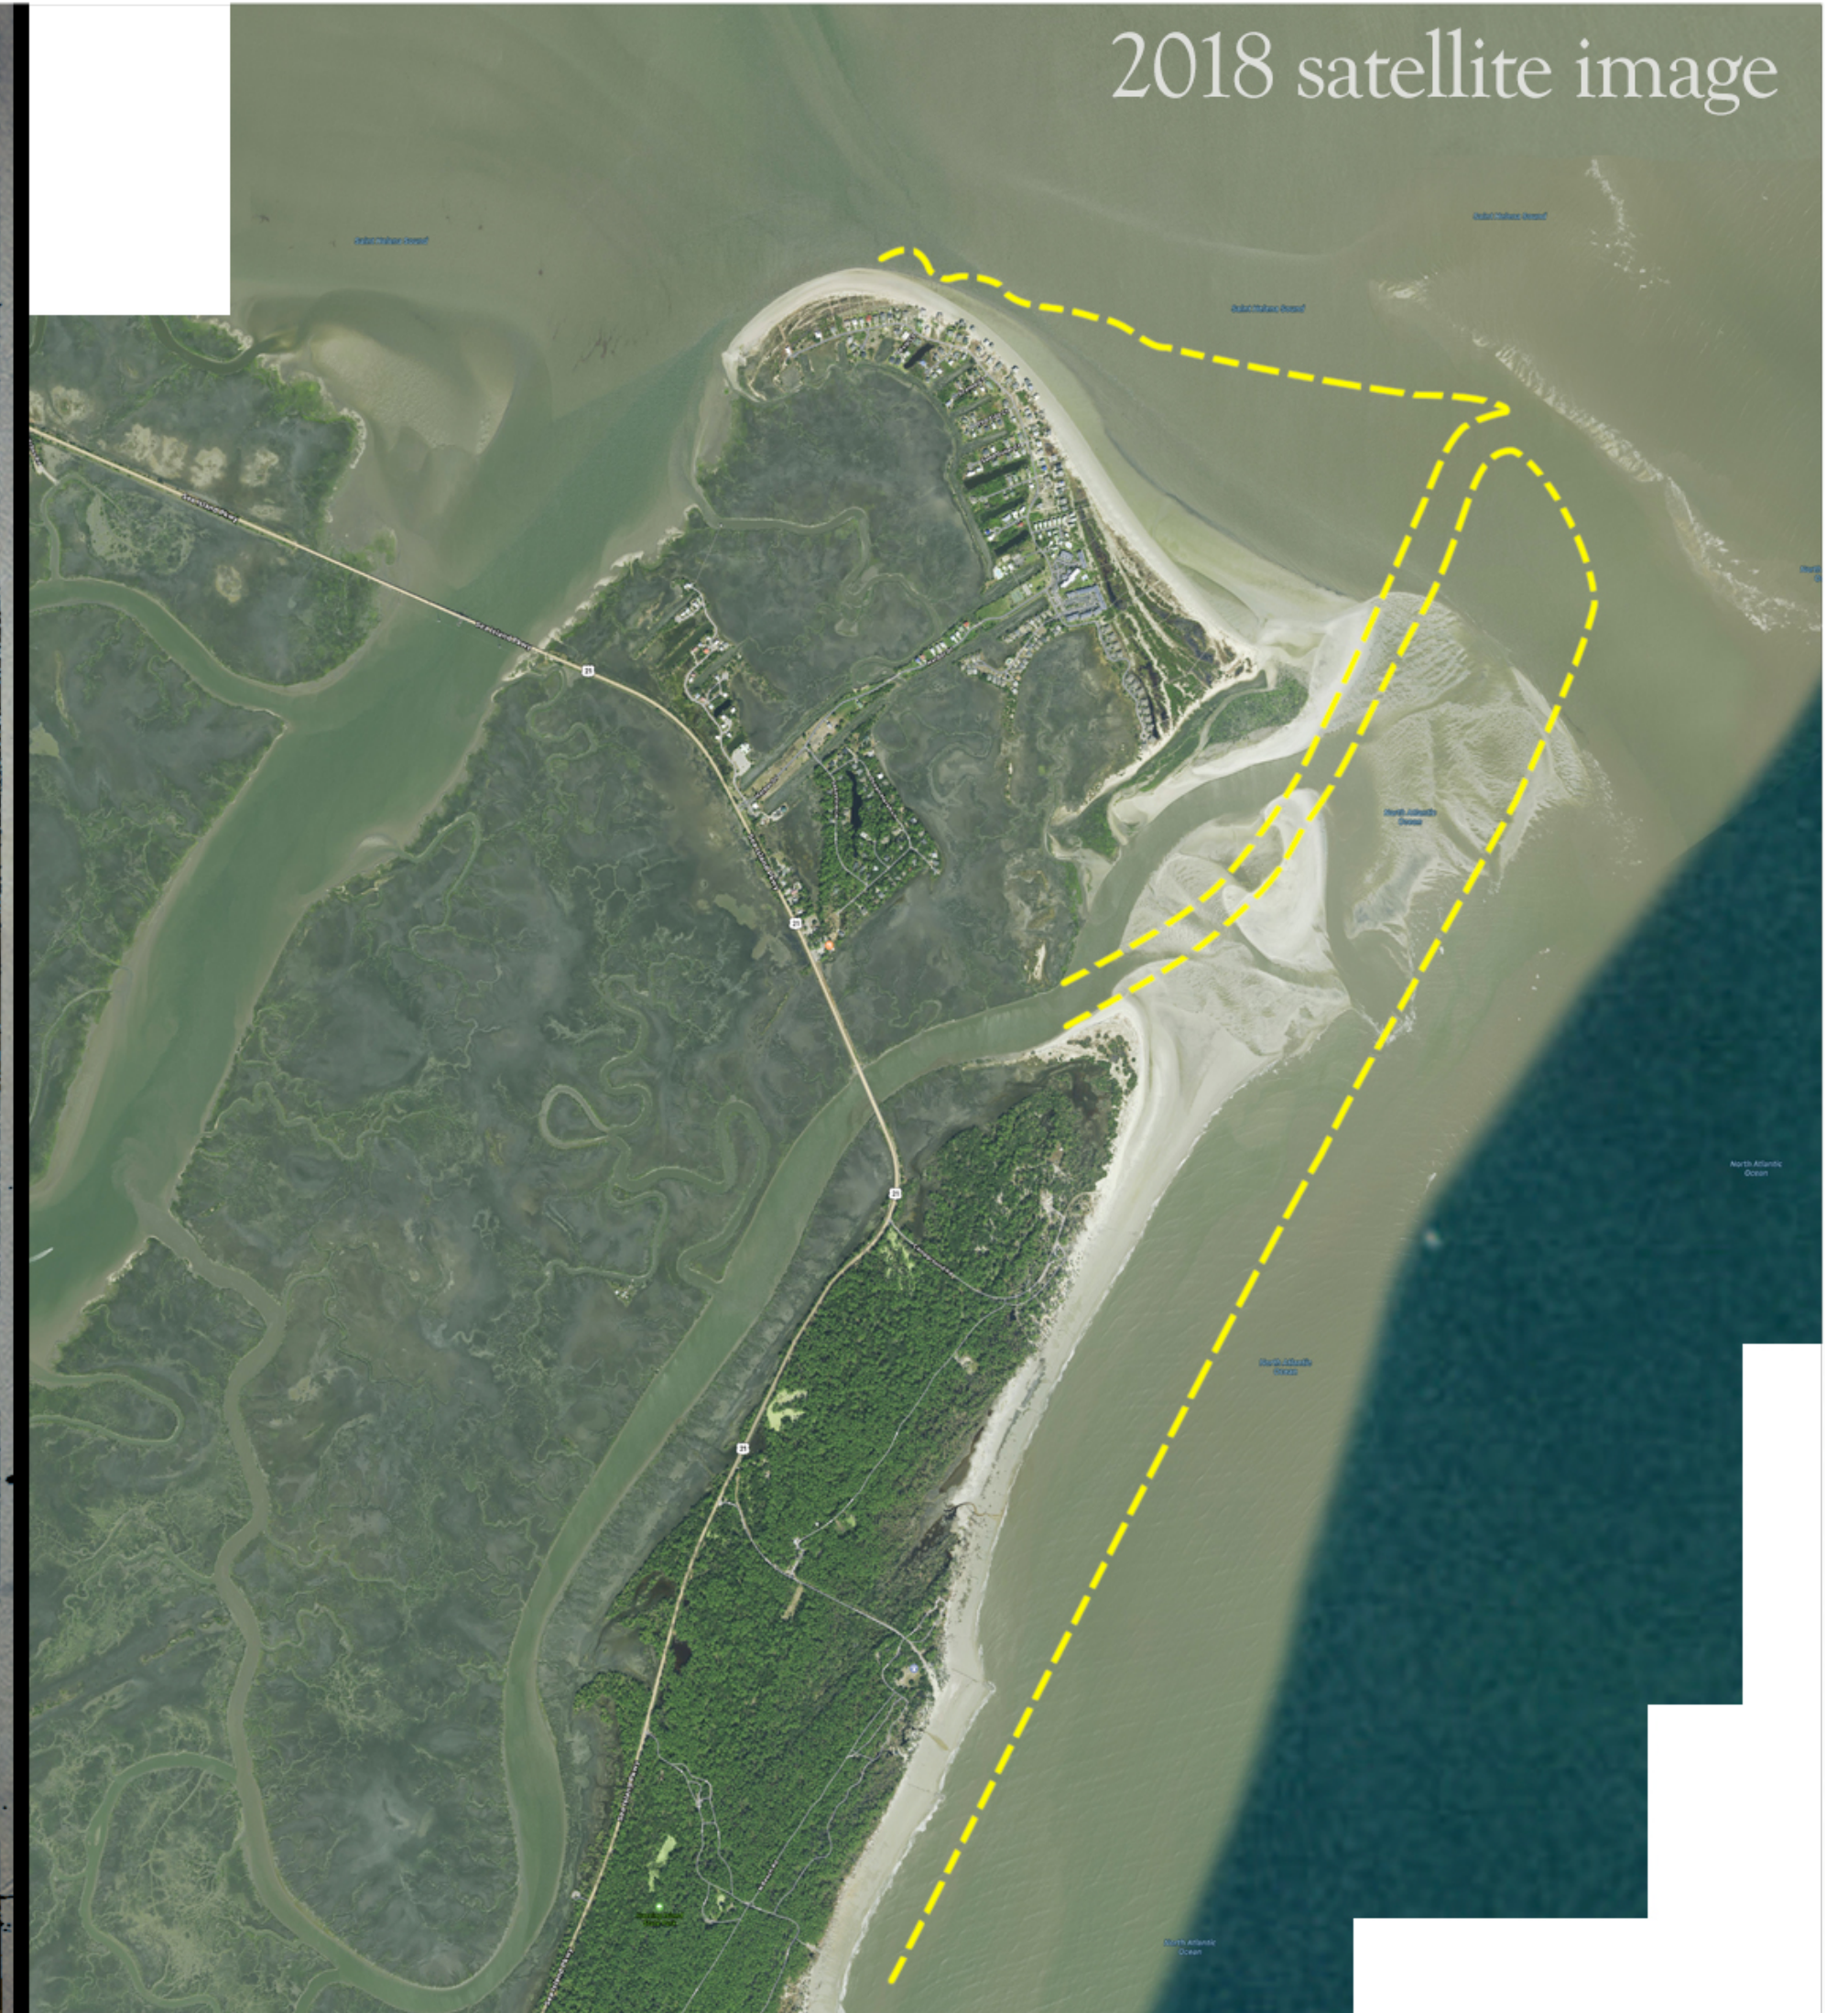
"Mama, say it isn't so!" - Even if the survey chart is not in perfect proportion because it's a drawing instead of a photograph, it's hard to imagine that the overall shoreline could be drawn so incorrectly and yet the complex detail of the feeder creeks be so accurate. I believe the chart is fairly accurate and can give a realistic idea of how much Hunting Island has changed since 1864.

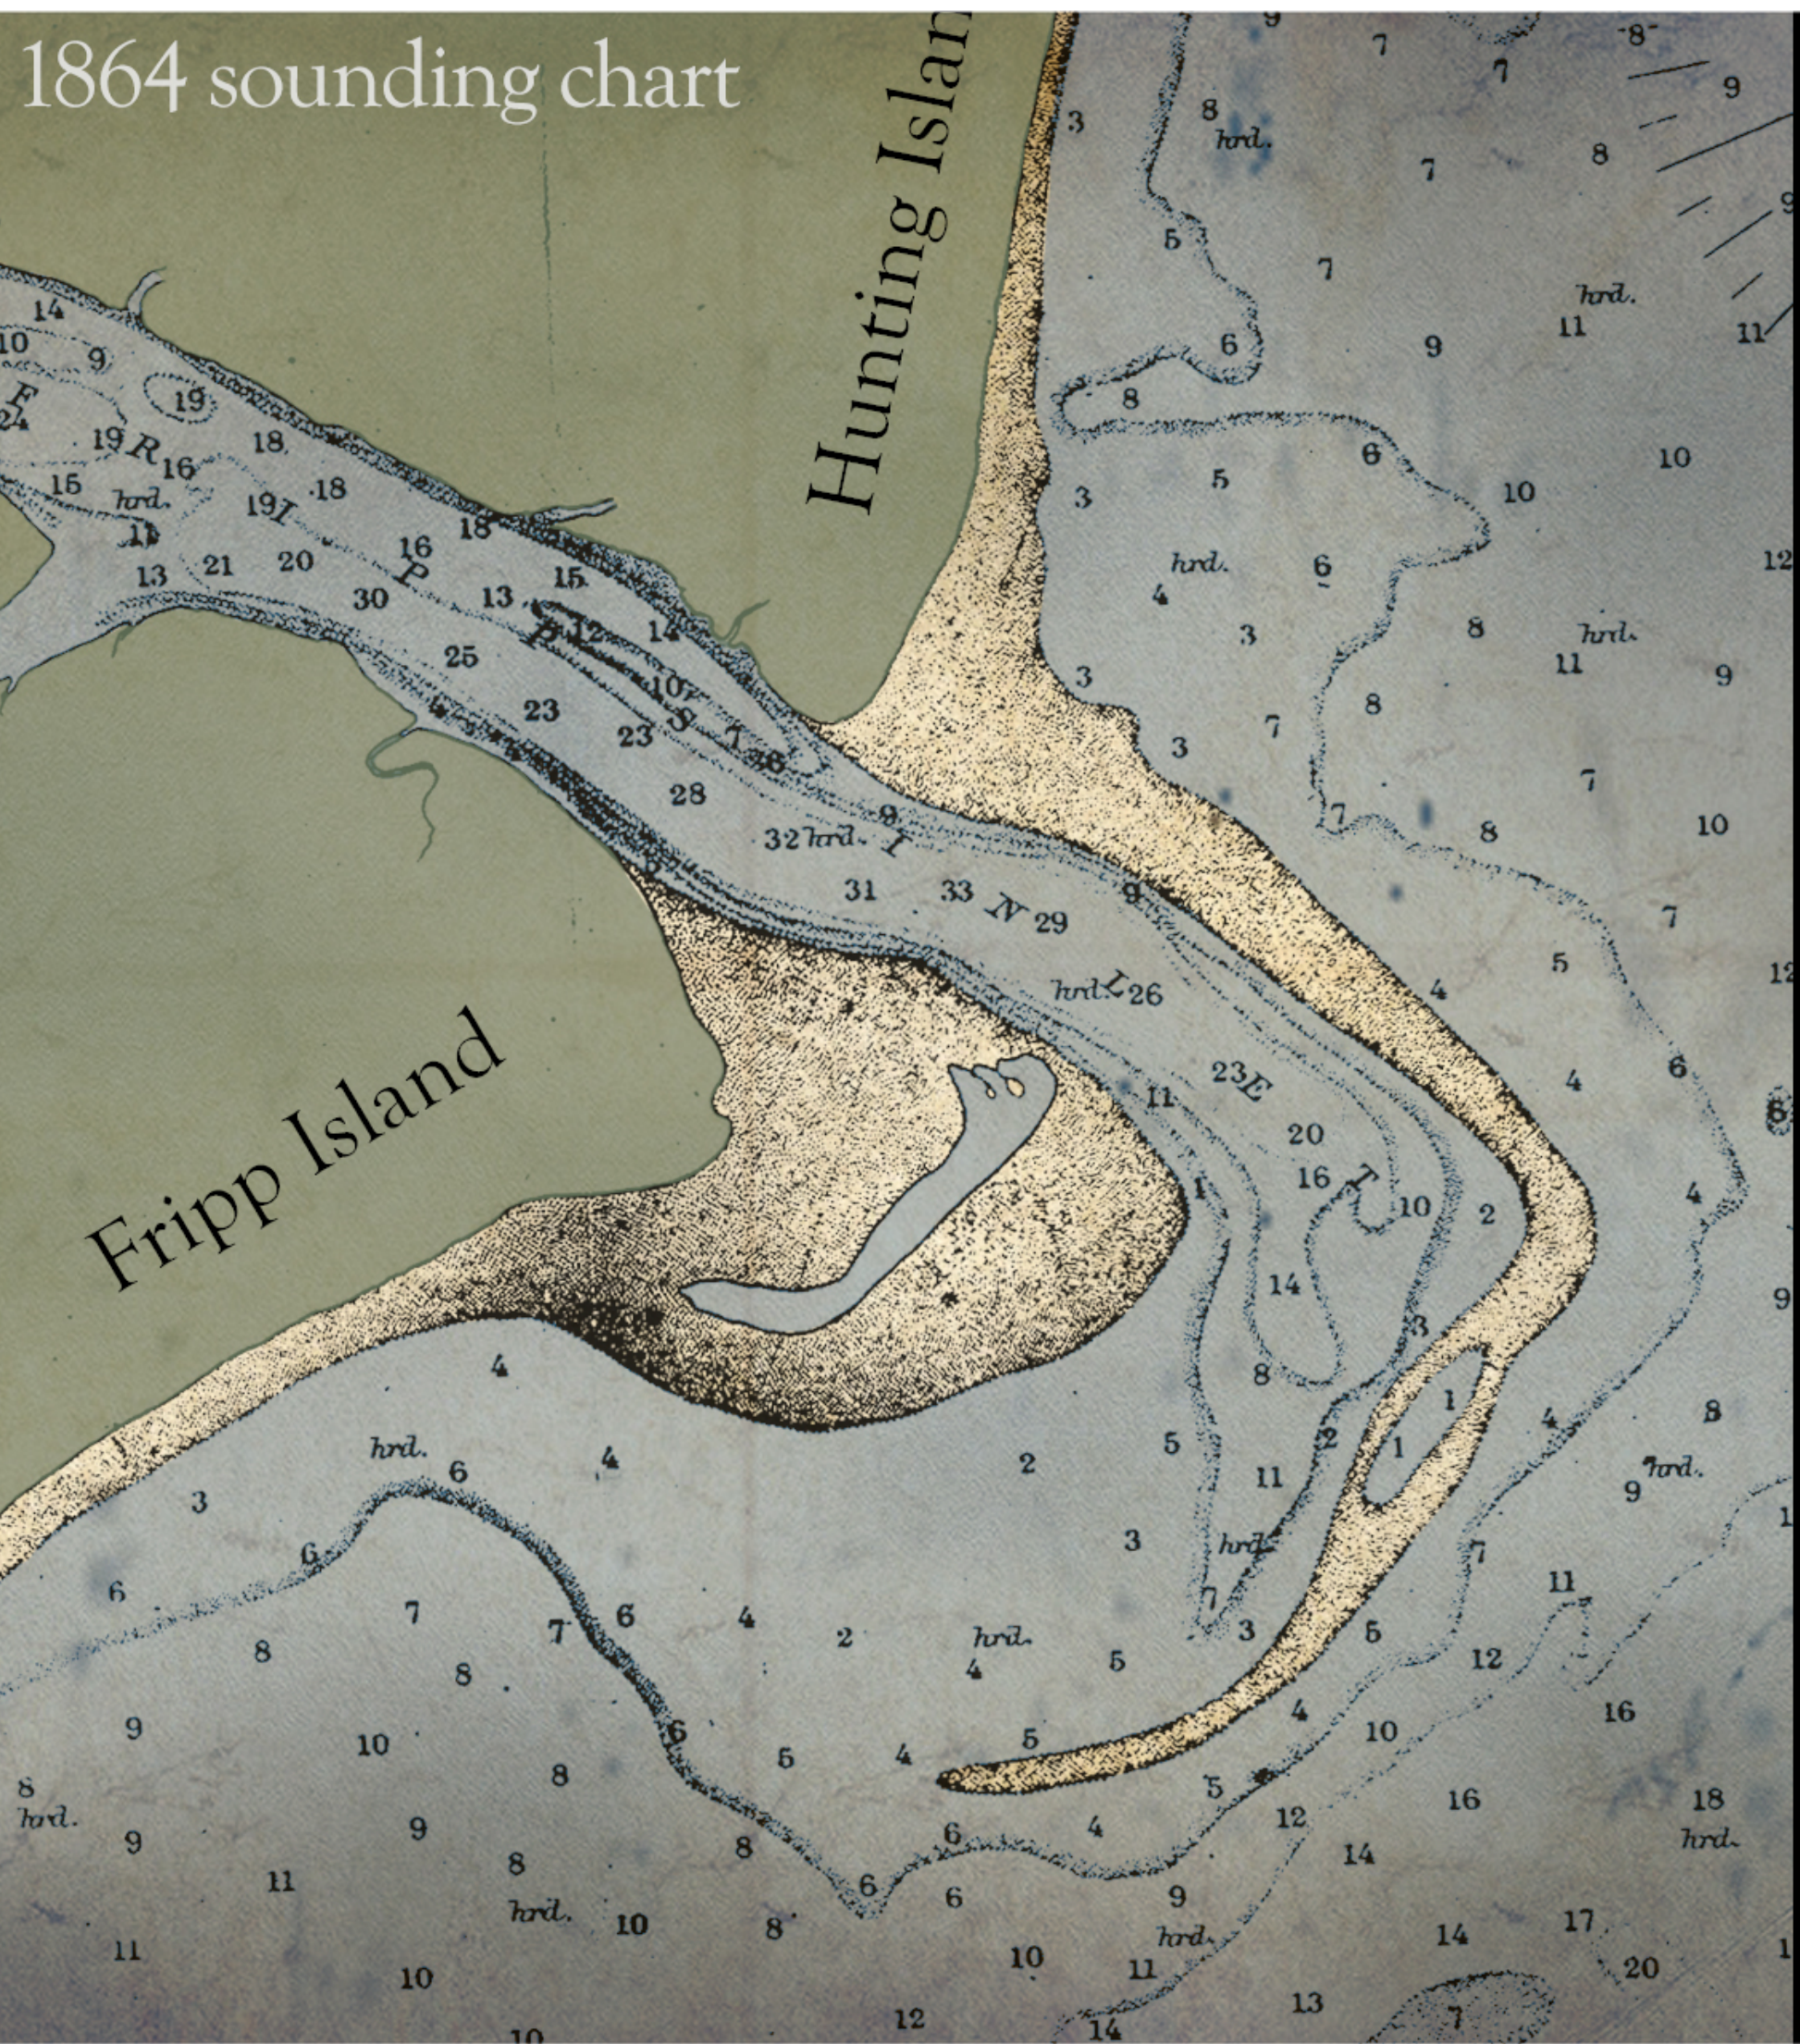
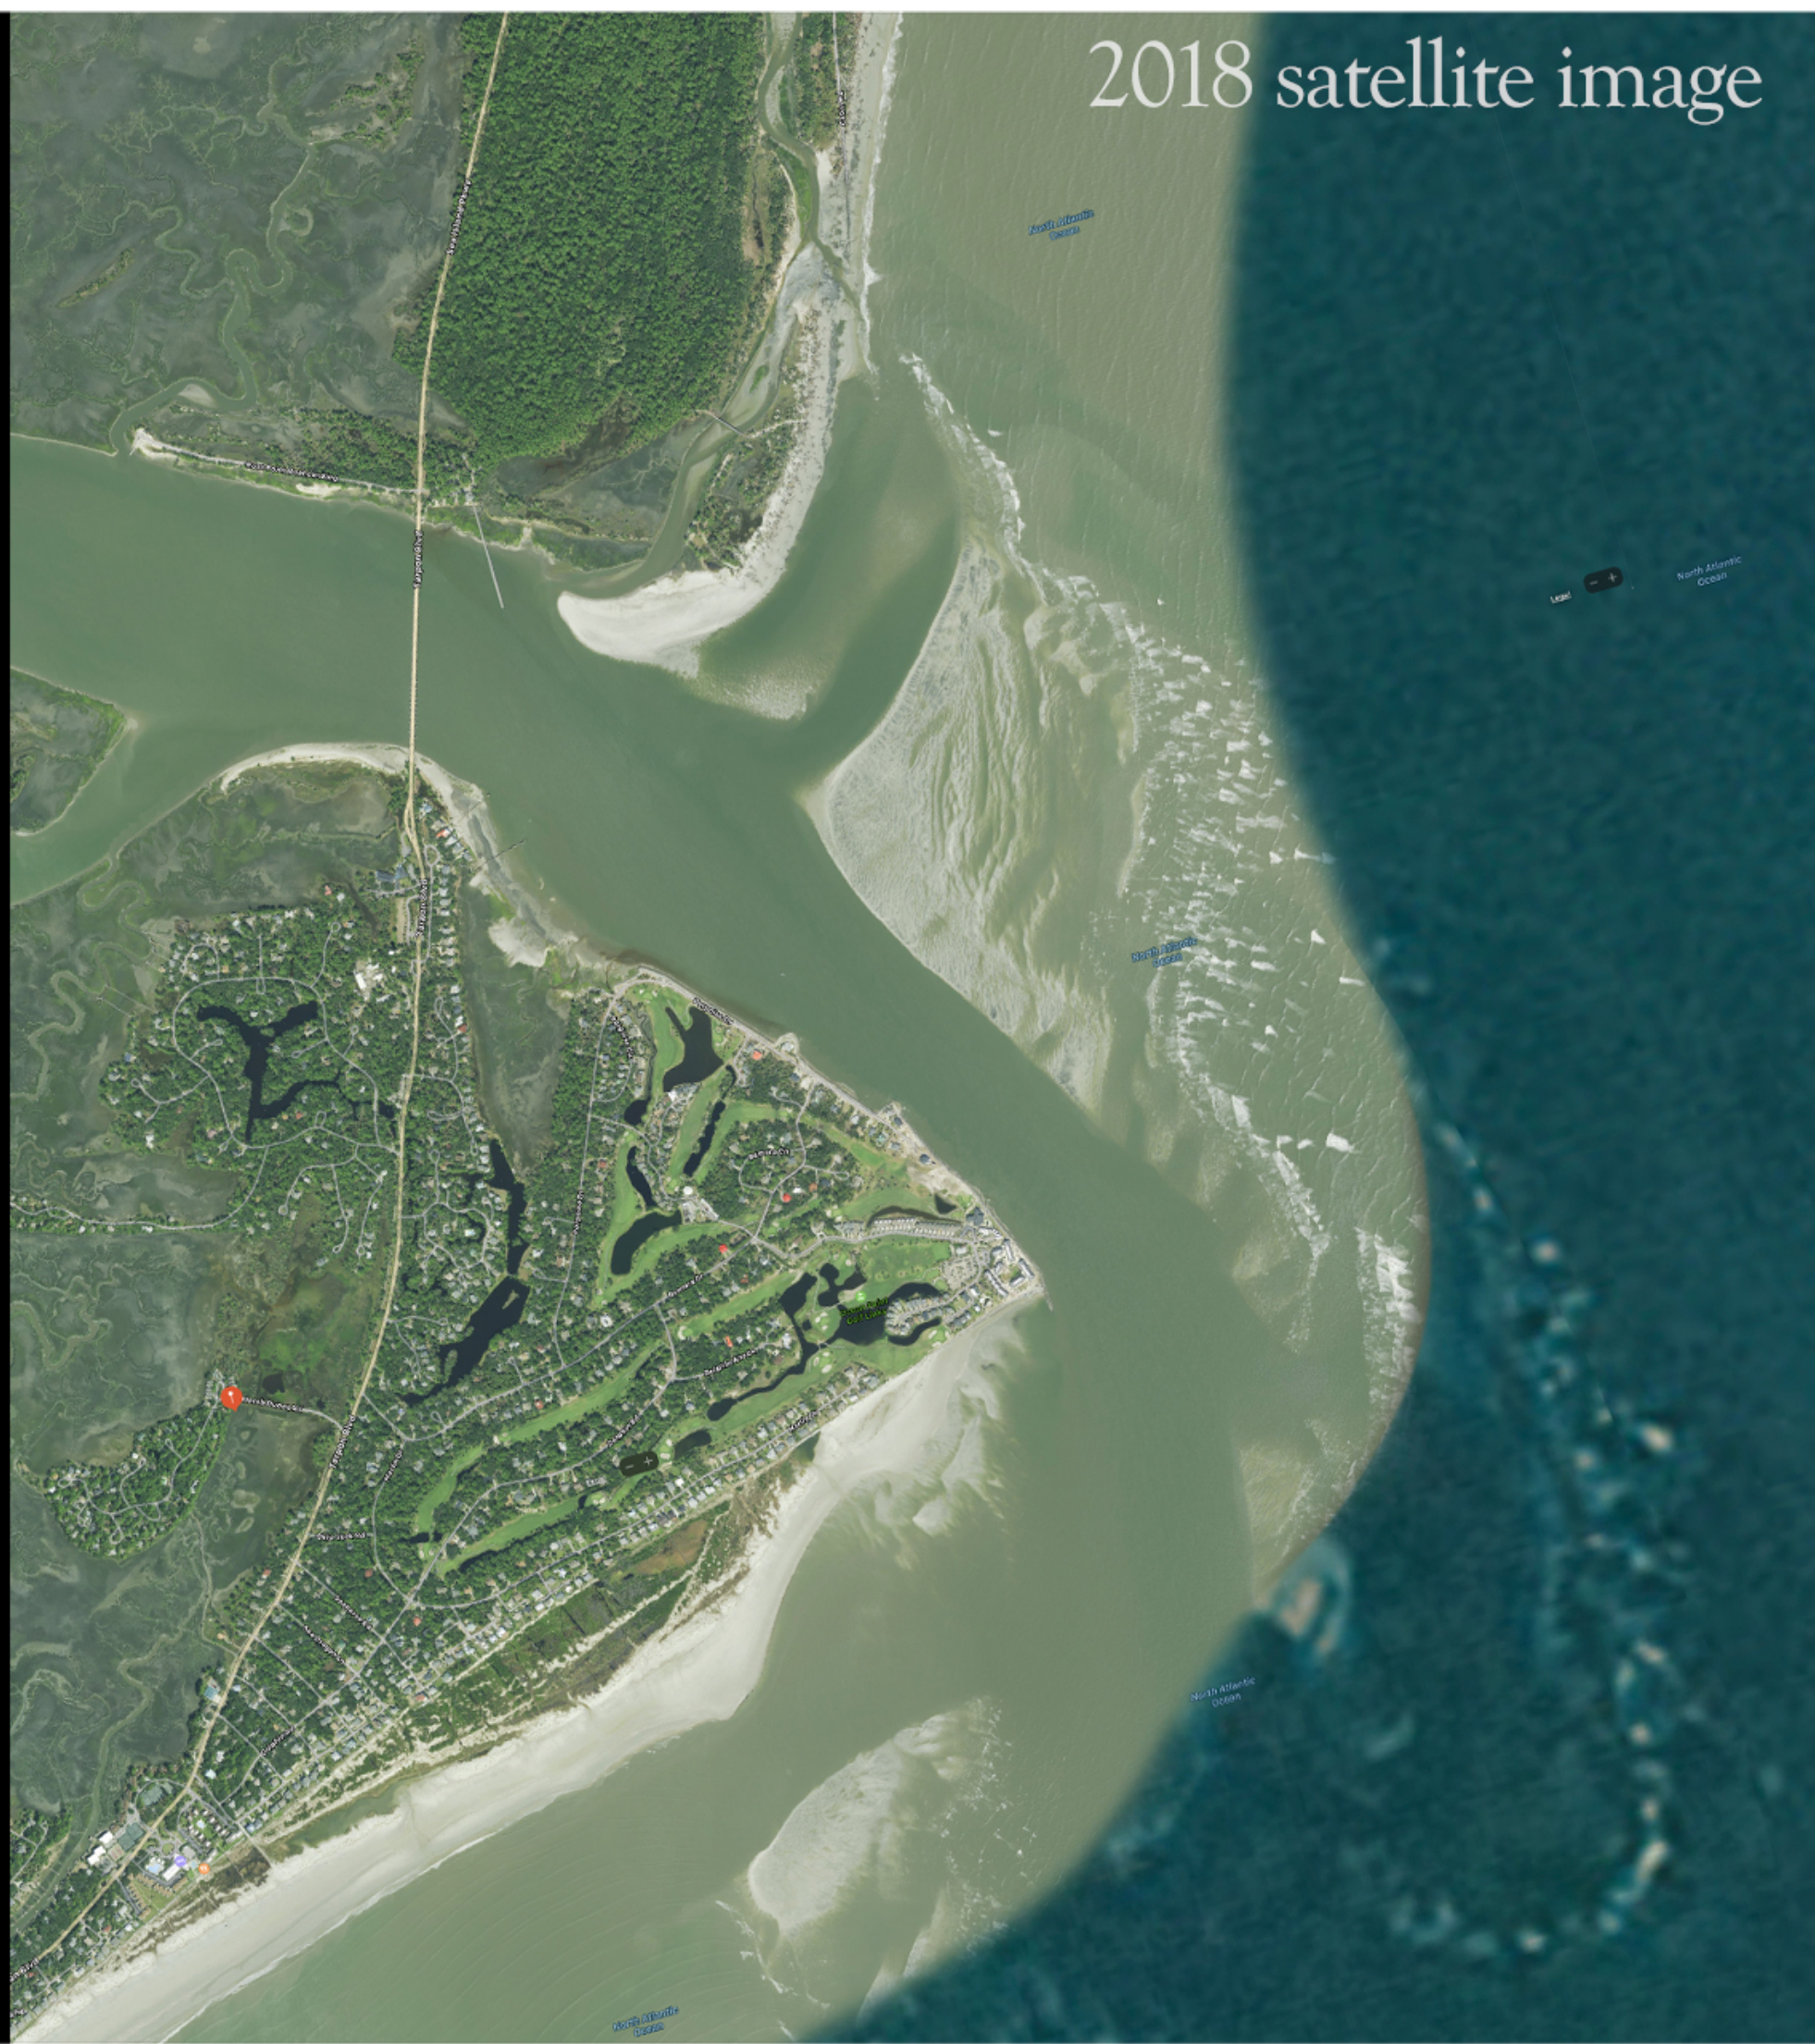
Fripp Inlet - On the 1864 chart, the massive sand shoal with the large tide pool on Fripp Island is probably most of the golf course today and the small creek detail is probably the tidal creek that feeds the salt marsh behind River Club. The long, flowing sand bar that starts at Hunting Island and goes around the northern tip of Fripp Island is still there today, but in a very different configuration.
