Shoreline Status

Fripp Island - Shoreline Committee

Darryl Zoekler - November 10, 2021

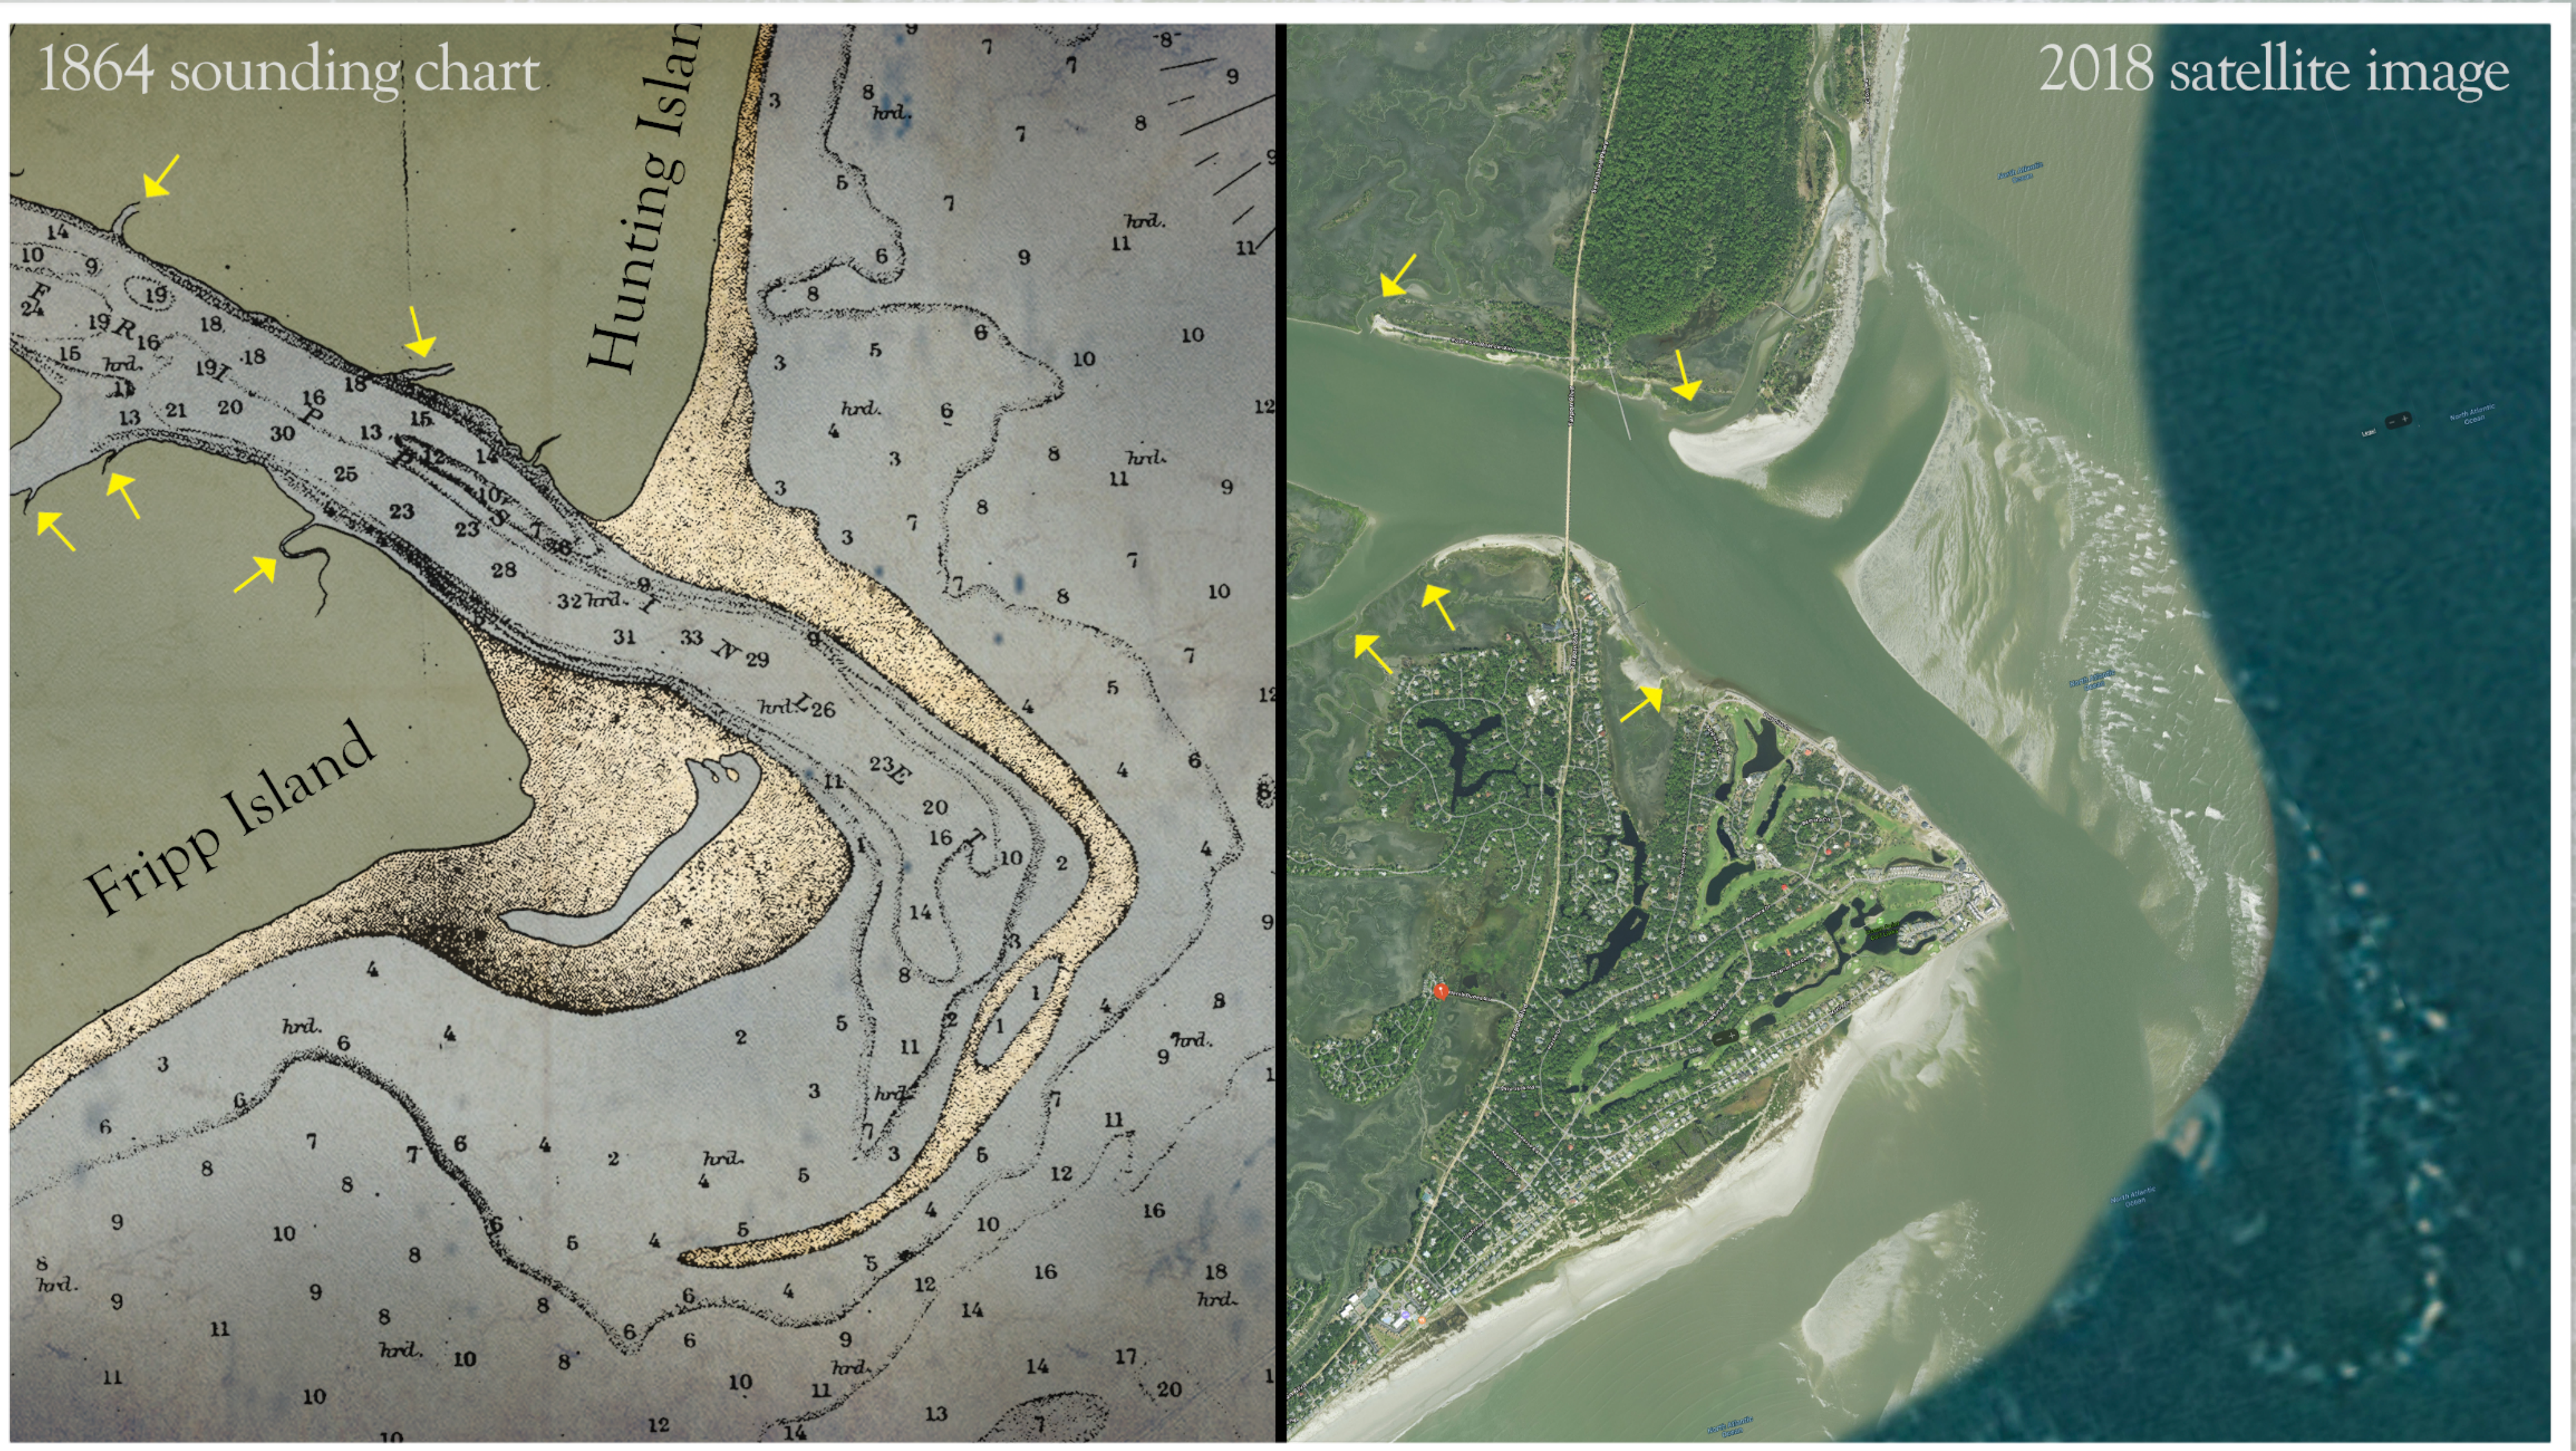
Same day, different story - Being able to identify the same feeder creeks on the satellite image that are illustrated on the old chart shows a remarkable stability to the inland creeks area. But notice the radical difference to the ocean side of the shoreline as depicted on the chart versus the satellite image. A big reason for this difference is that the shoreline is exposed to wave action, the inland creeks are not.

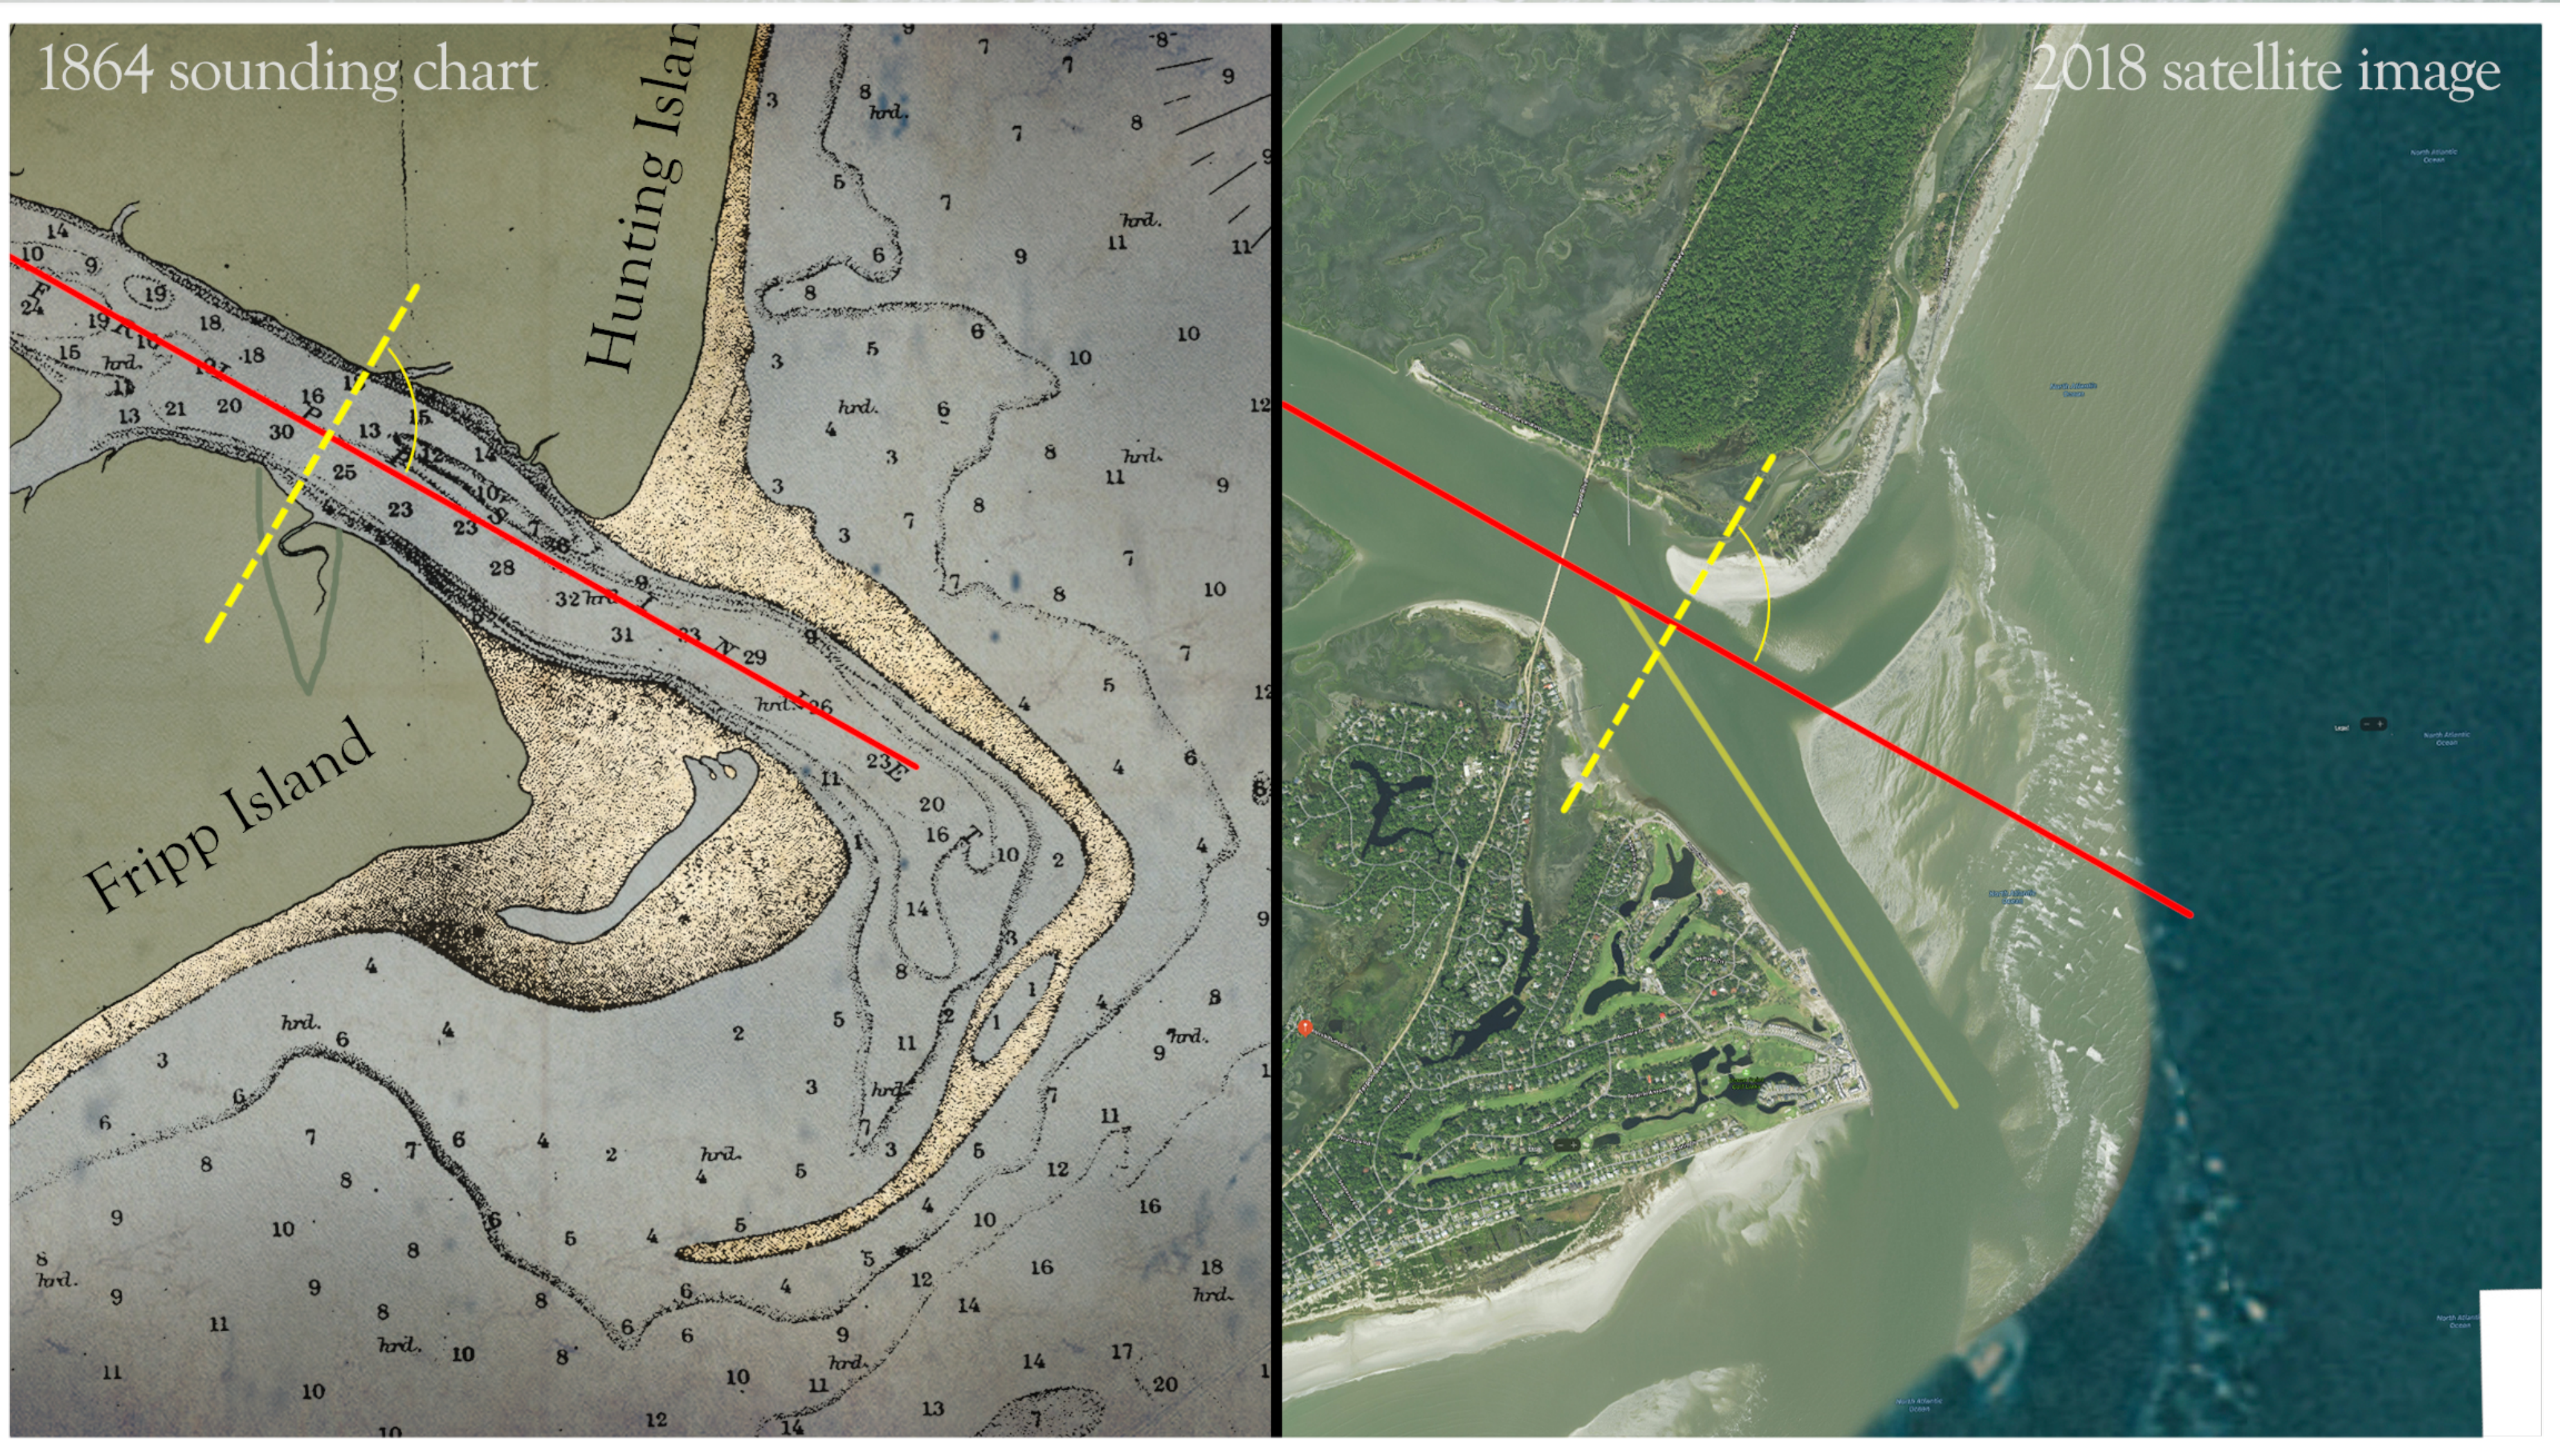
There was a crooked man... - If a line is drawn down the center of the Fripp Inlet on the chart (red line) and a 90 degree line (yellow dotted) intersecting the red line is added, you can get the salt marsh creek on Fripp to line up with the pedestrian bridge creek on Hunting Island. If you move those two lines over to the satellite image, you can get them to line up almost exactly in the same spot with one big difference, the whole inlet turns to the right at Hunting Island (yellow fade line)

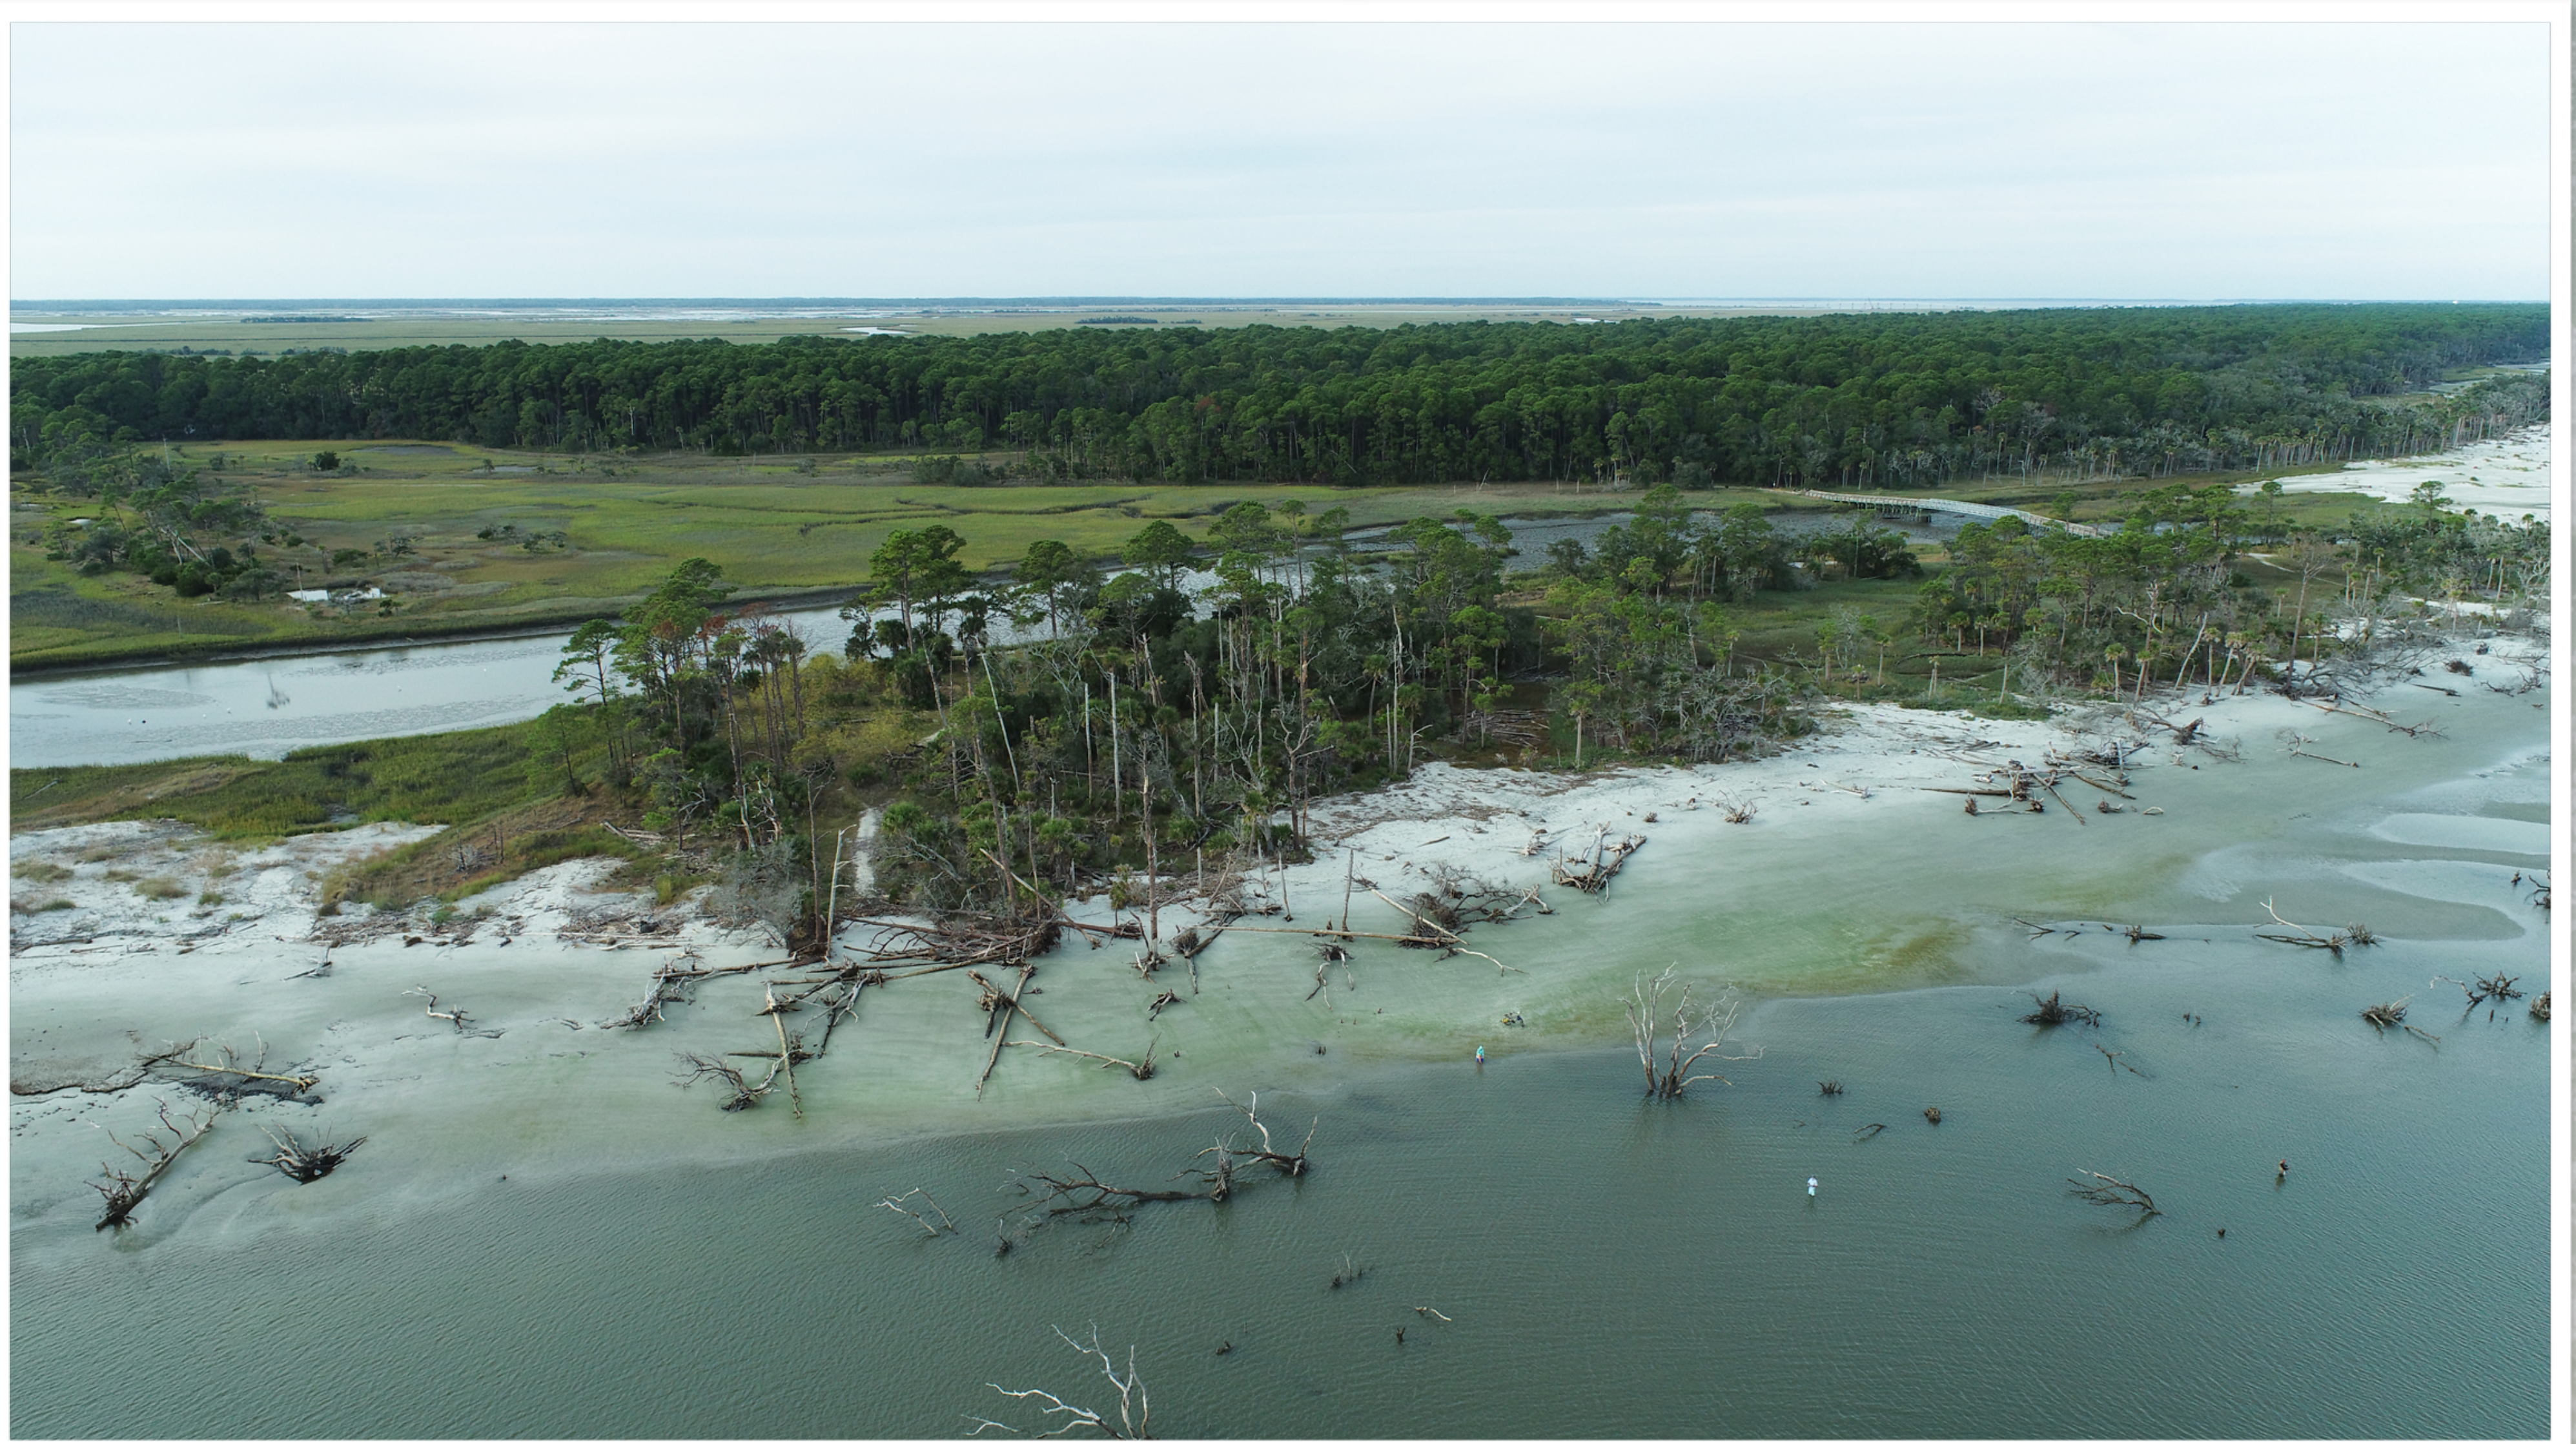
The south end of Hunting Island - The land mass continues to erode as each row of trees succumb to the invading sand, salt, and sea. As this happens, the overall shape of the south end of the island has begun to change.

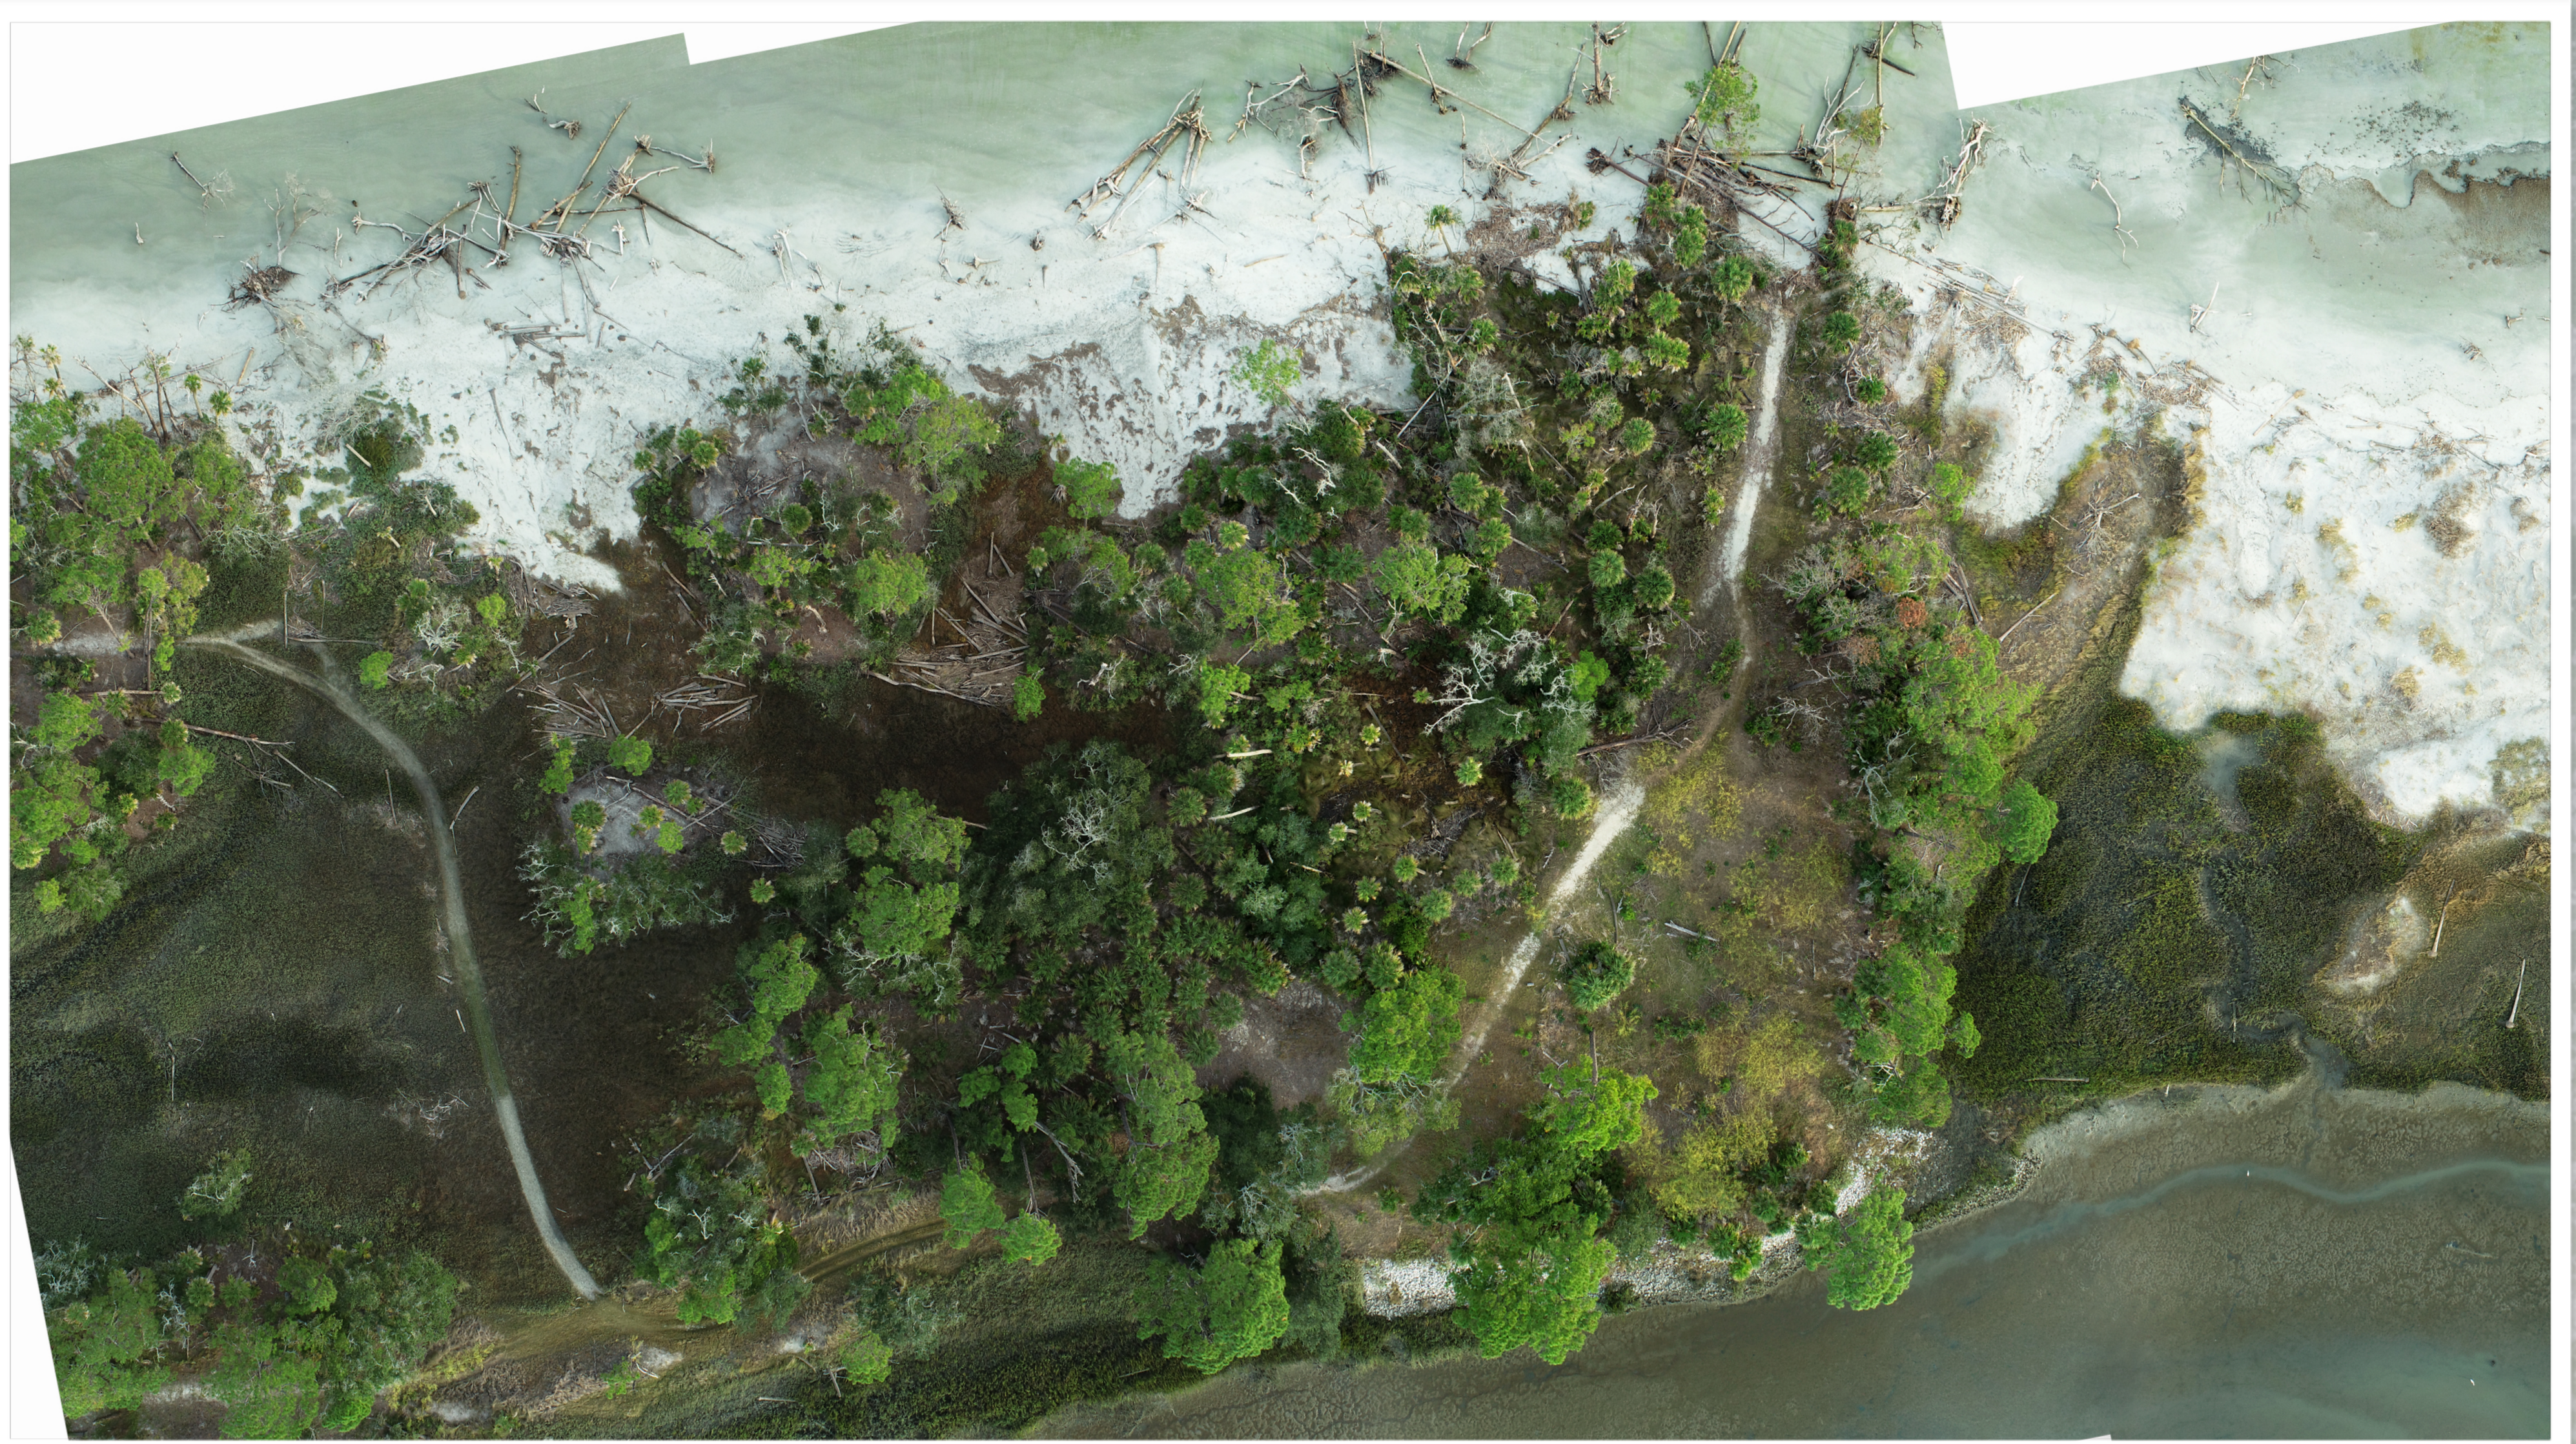
“Can't see the forest for the trees.” - In this montage image, made up of a series of individual photos stitched together, the trees can be counted and the erosion into the remaining woods on the south end of Hunting Island becomes obvious.

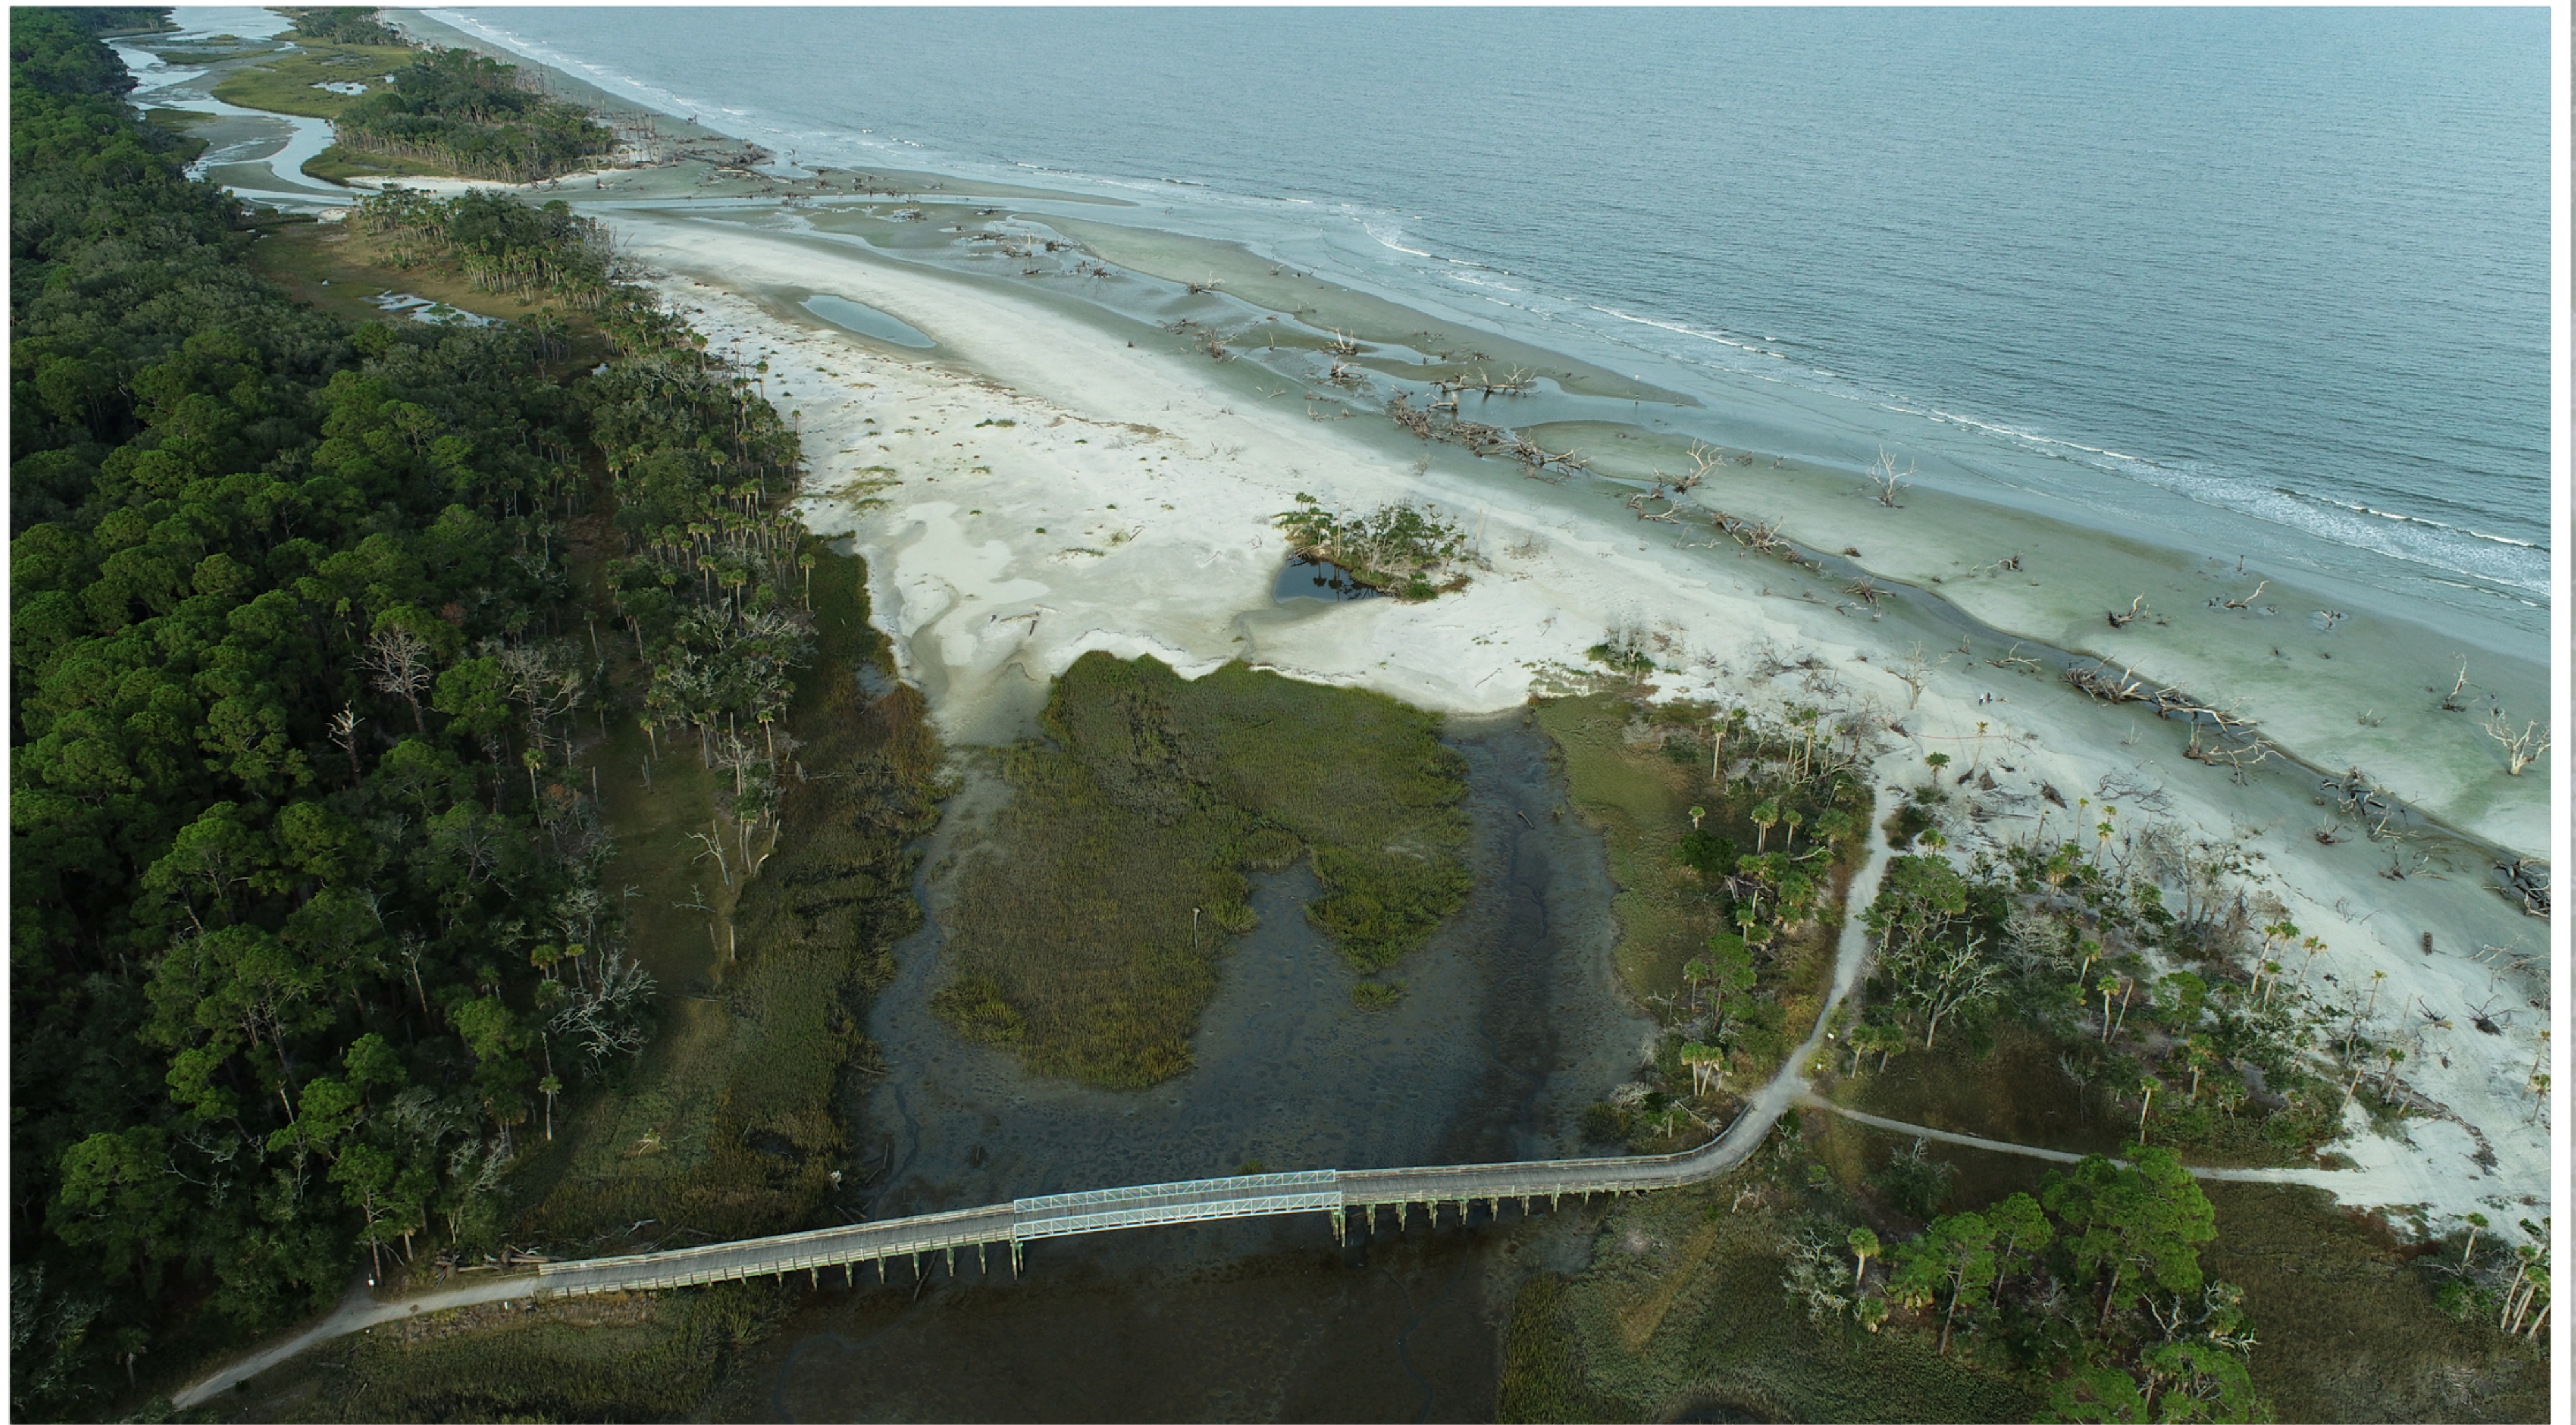
The New Boundary - As the sand pushes towards the pedestrian bridge, it slowly covers over the existing vegetation and forms a new beach boundary along the main land mass of Hunting island.

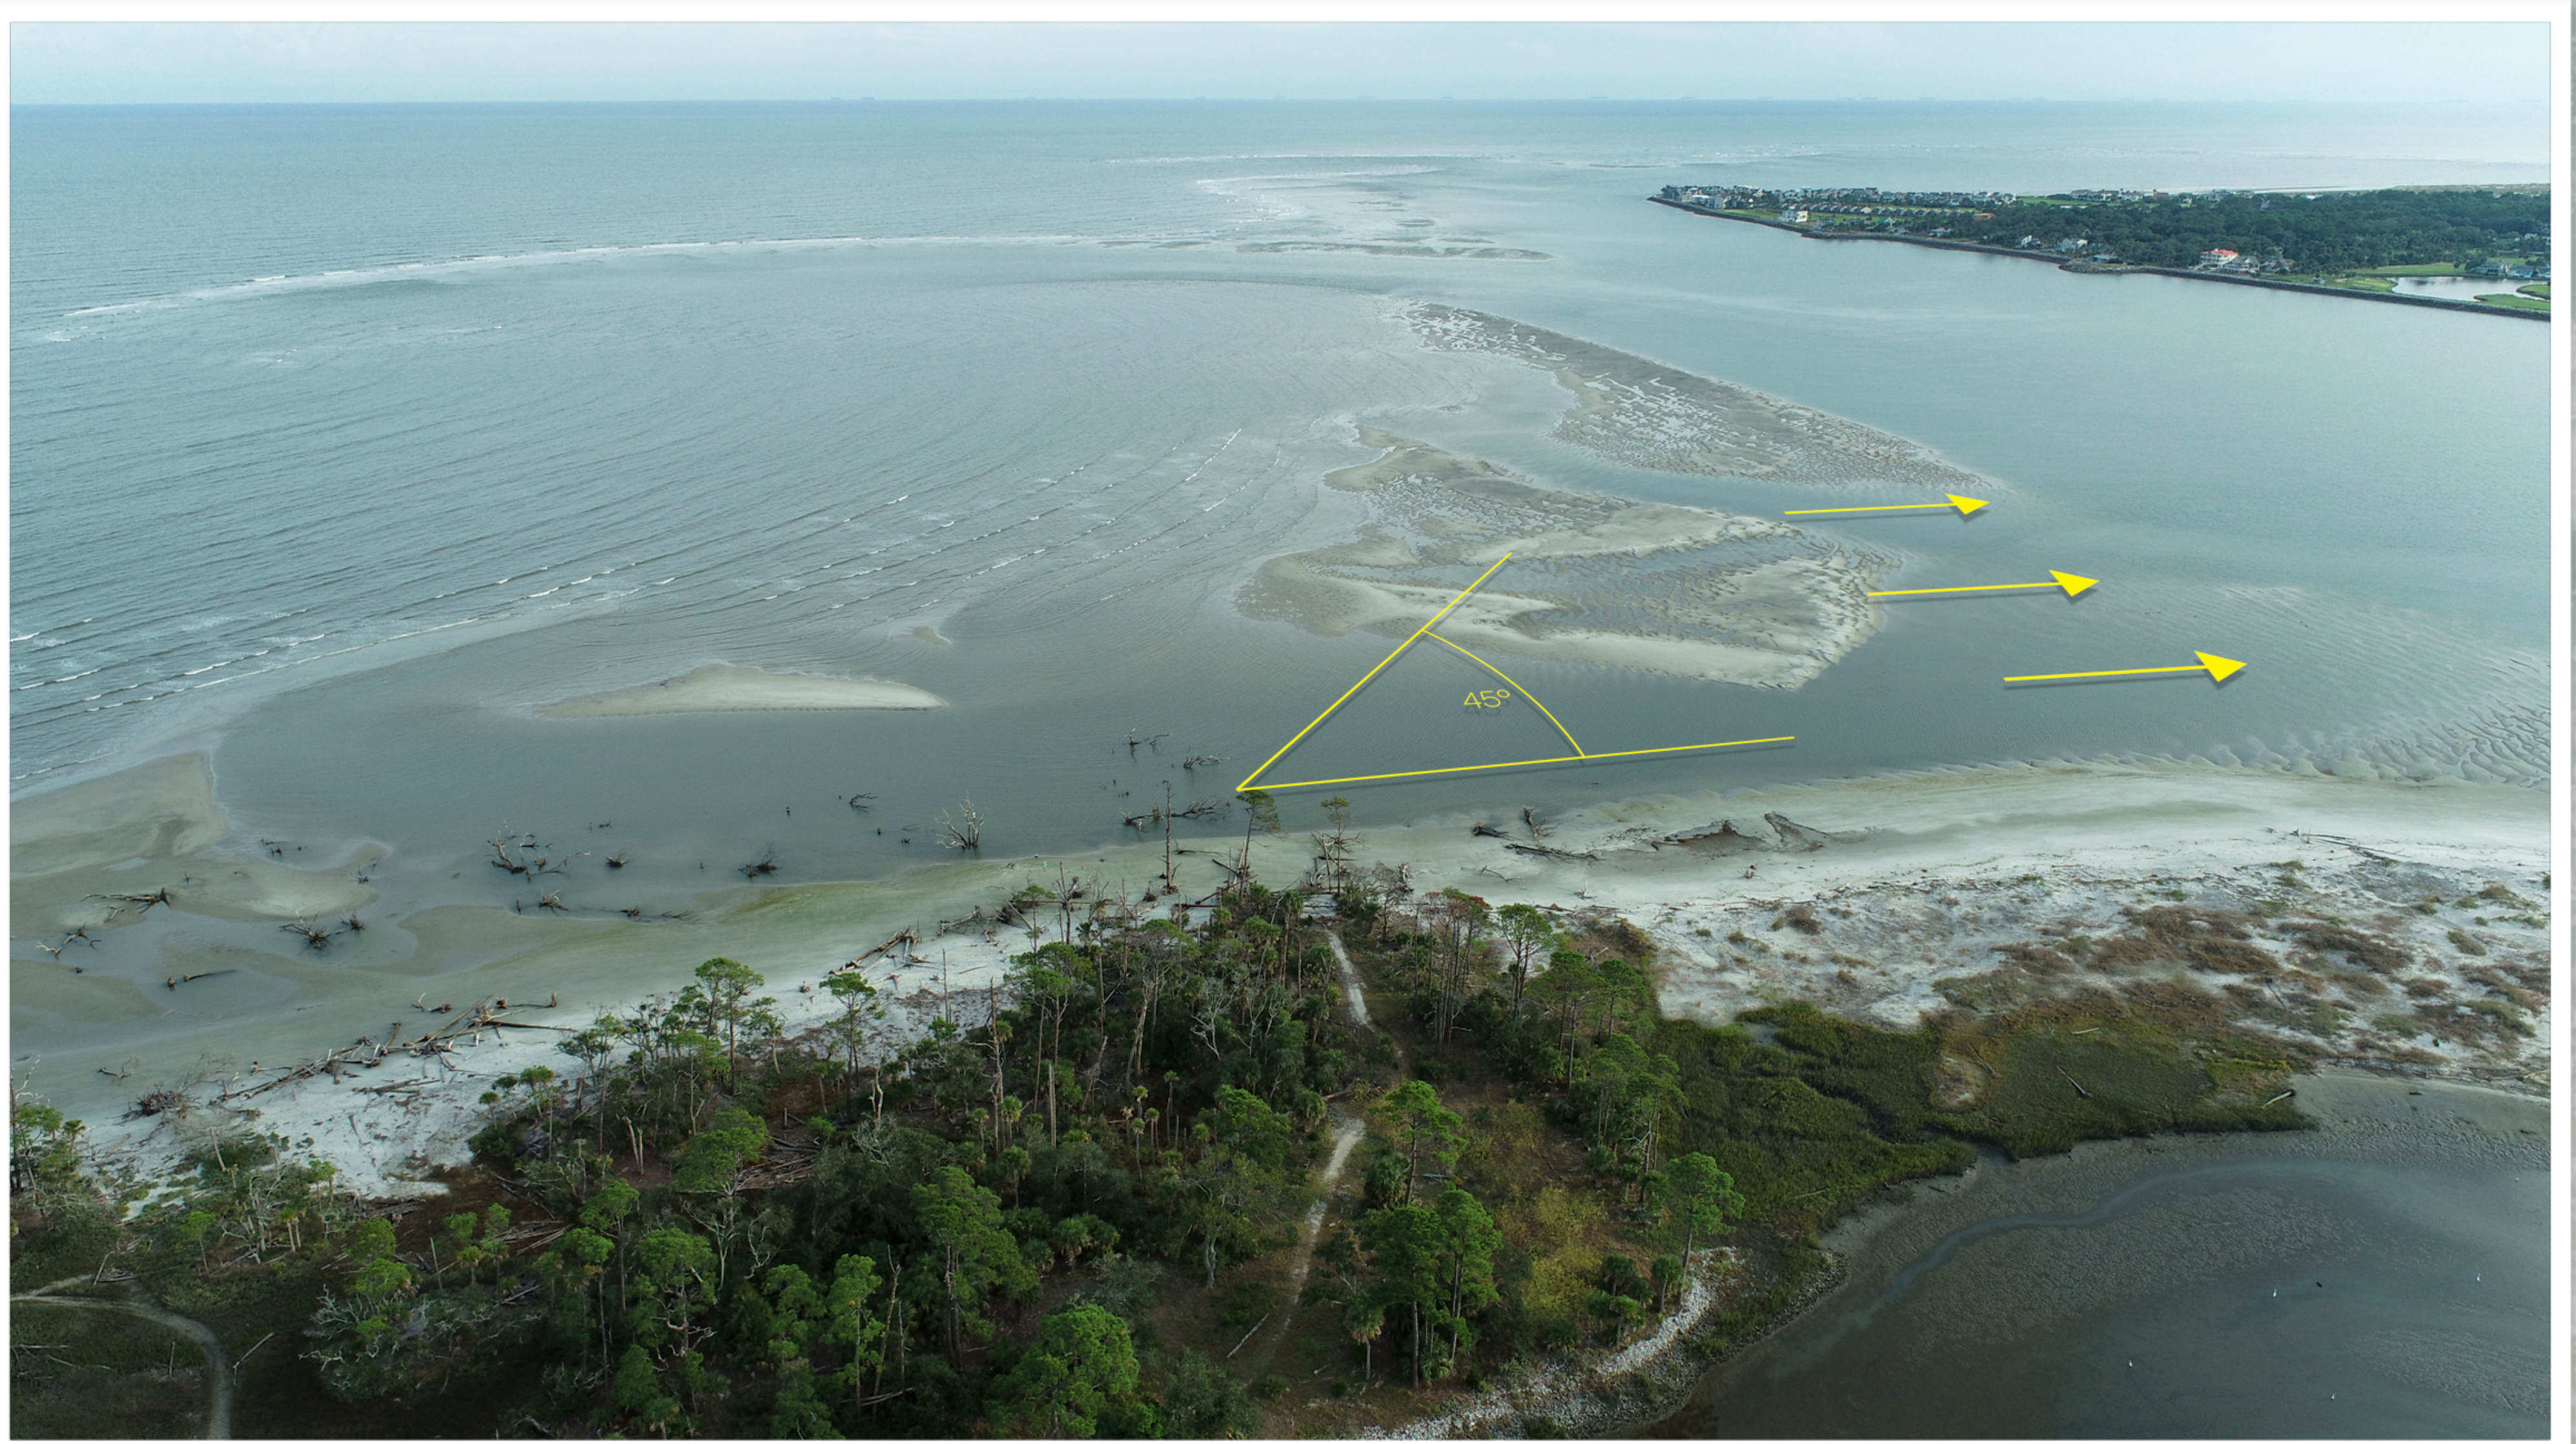
The Littoral Current - When waves strike the land mass at an angle, as seen here, it creates a flow called a littoral current that runs parallel to the shoreline. This is a natural distribution of sediment along a beach. Here, the sand is being pushed into the inlet and the current carries it out around the front of Fripp Island.
