Shoreline Status

Fripp Island - Shoreline Committee

Darryl Zoekler - November 10, 2021

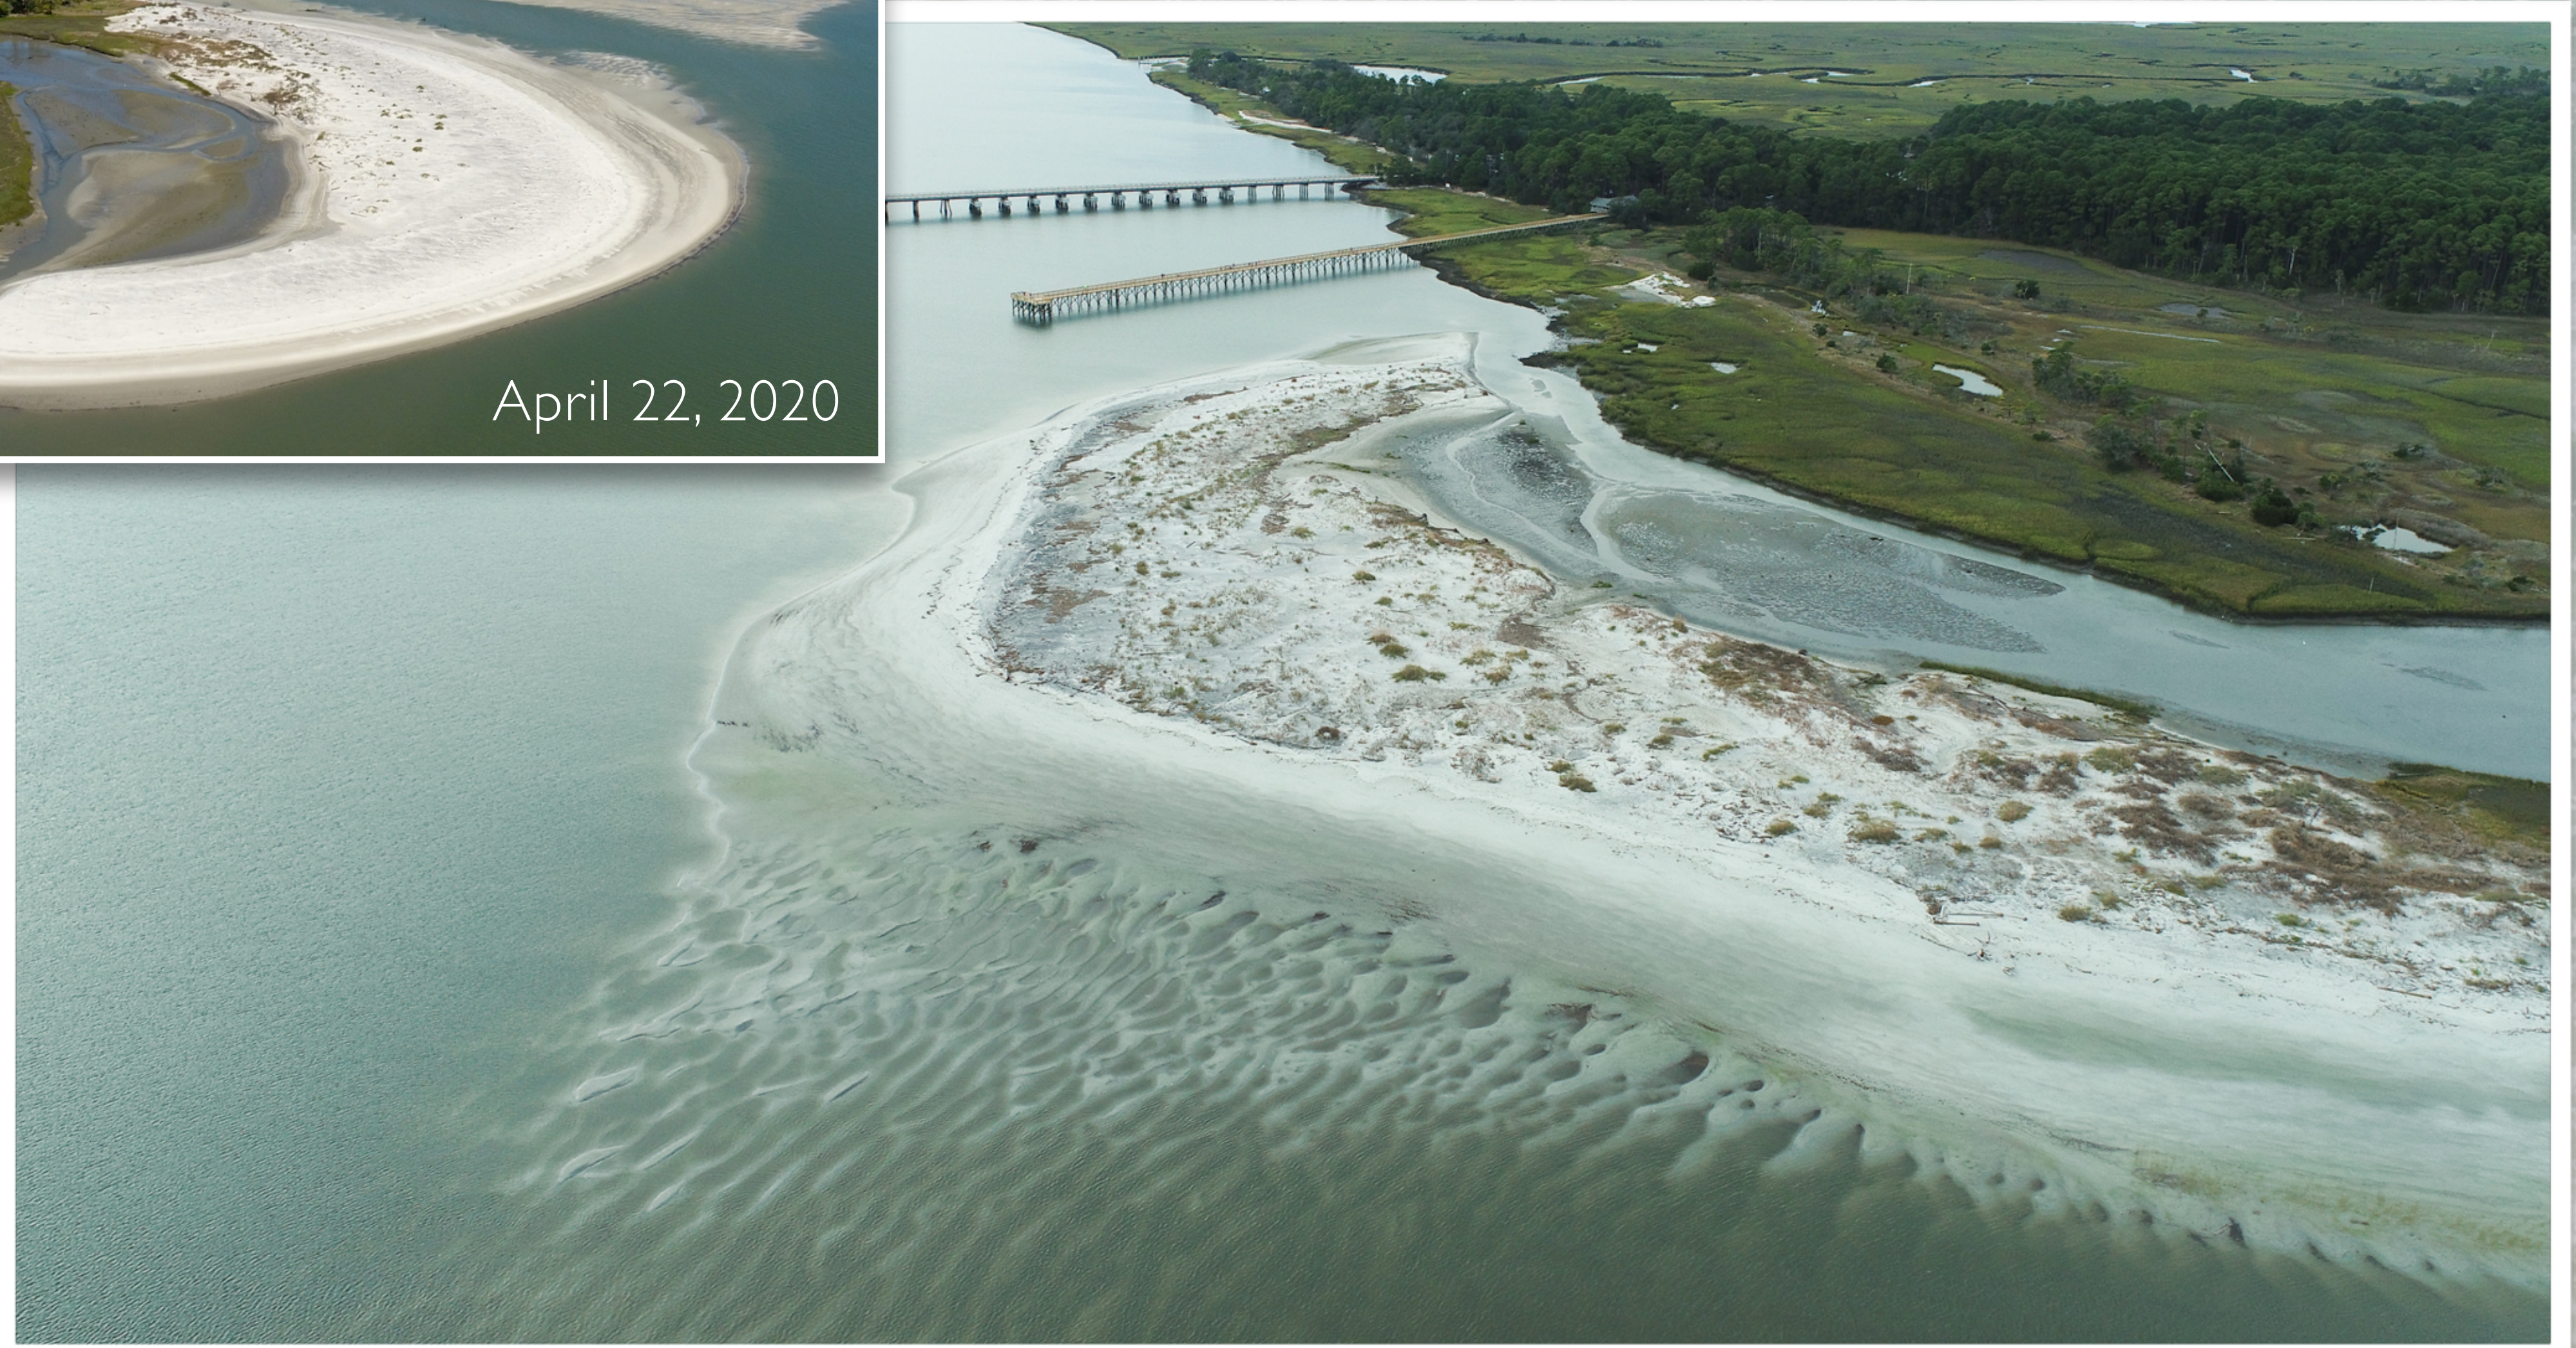
The flat tire - The littoral current has carved a channel in front of the sand bar at the southern tip of Hunting Island that has eroded a flat spot into the side of the sand bar where it was once very round.

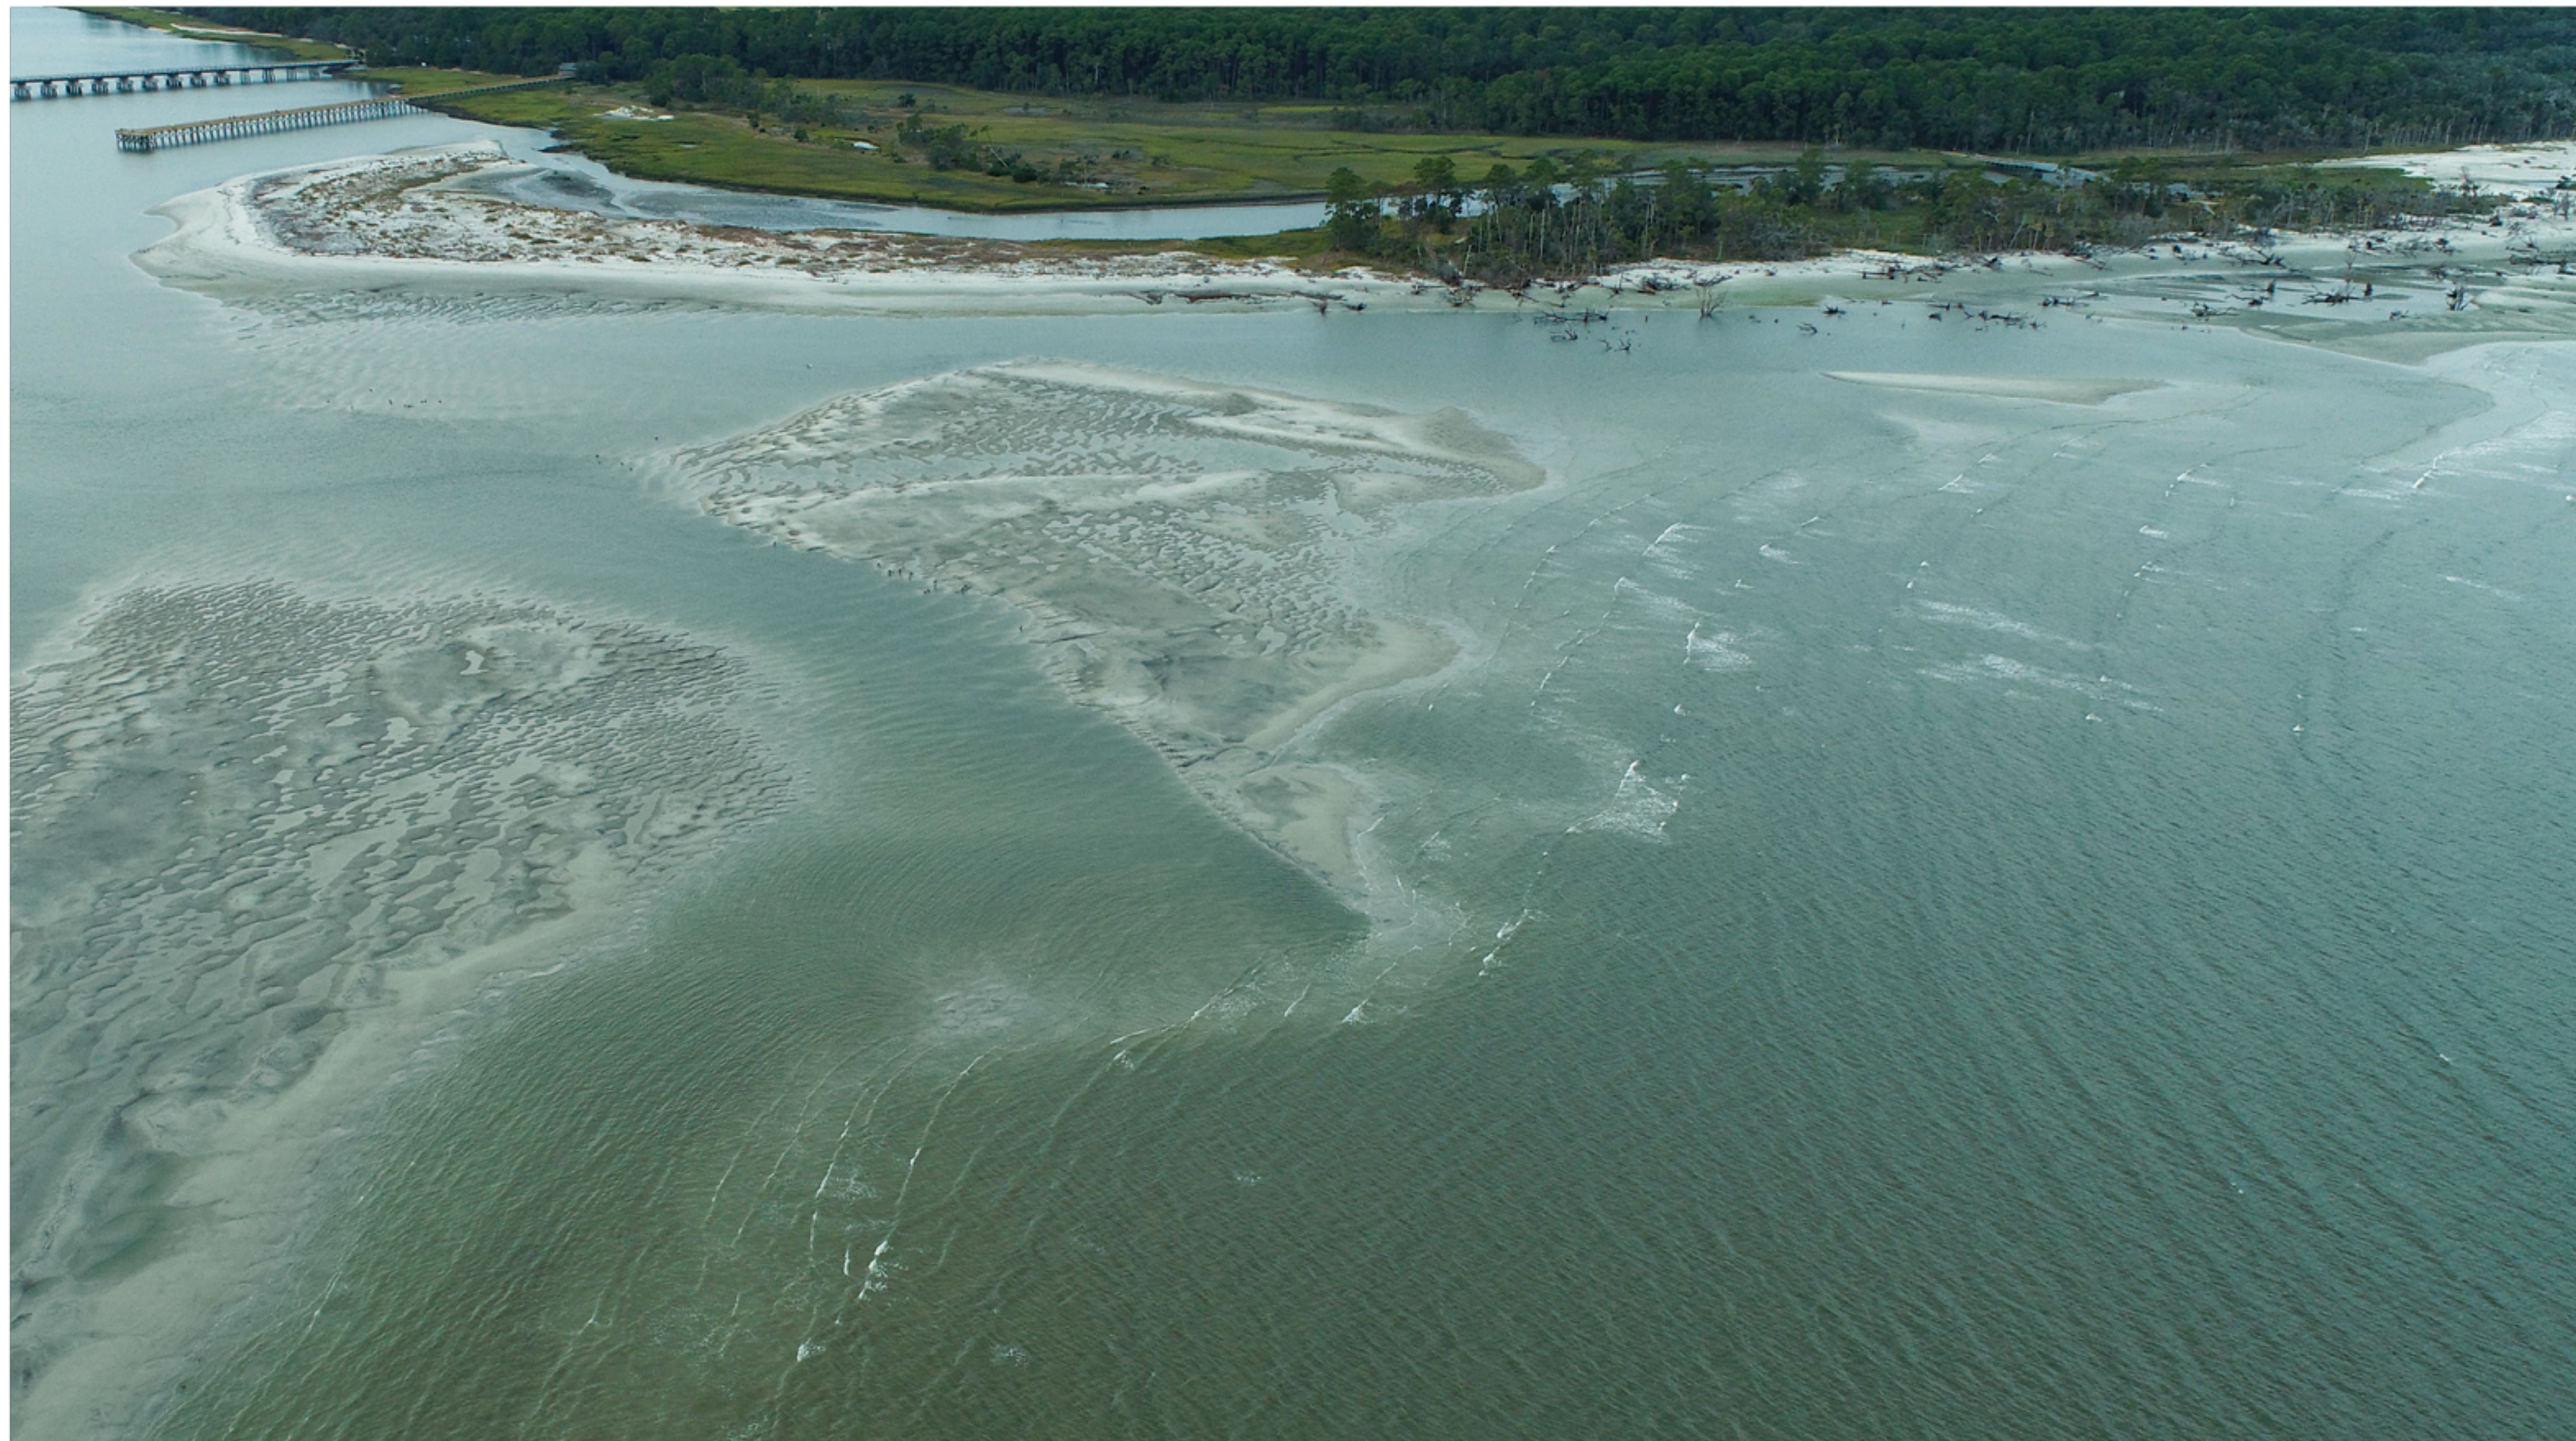
The trail of sand - This aerial photo is an overall view looking back over the area and shows the angled waves, the channel parallel to the shore, and the flattened area of the sand bar.

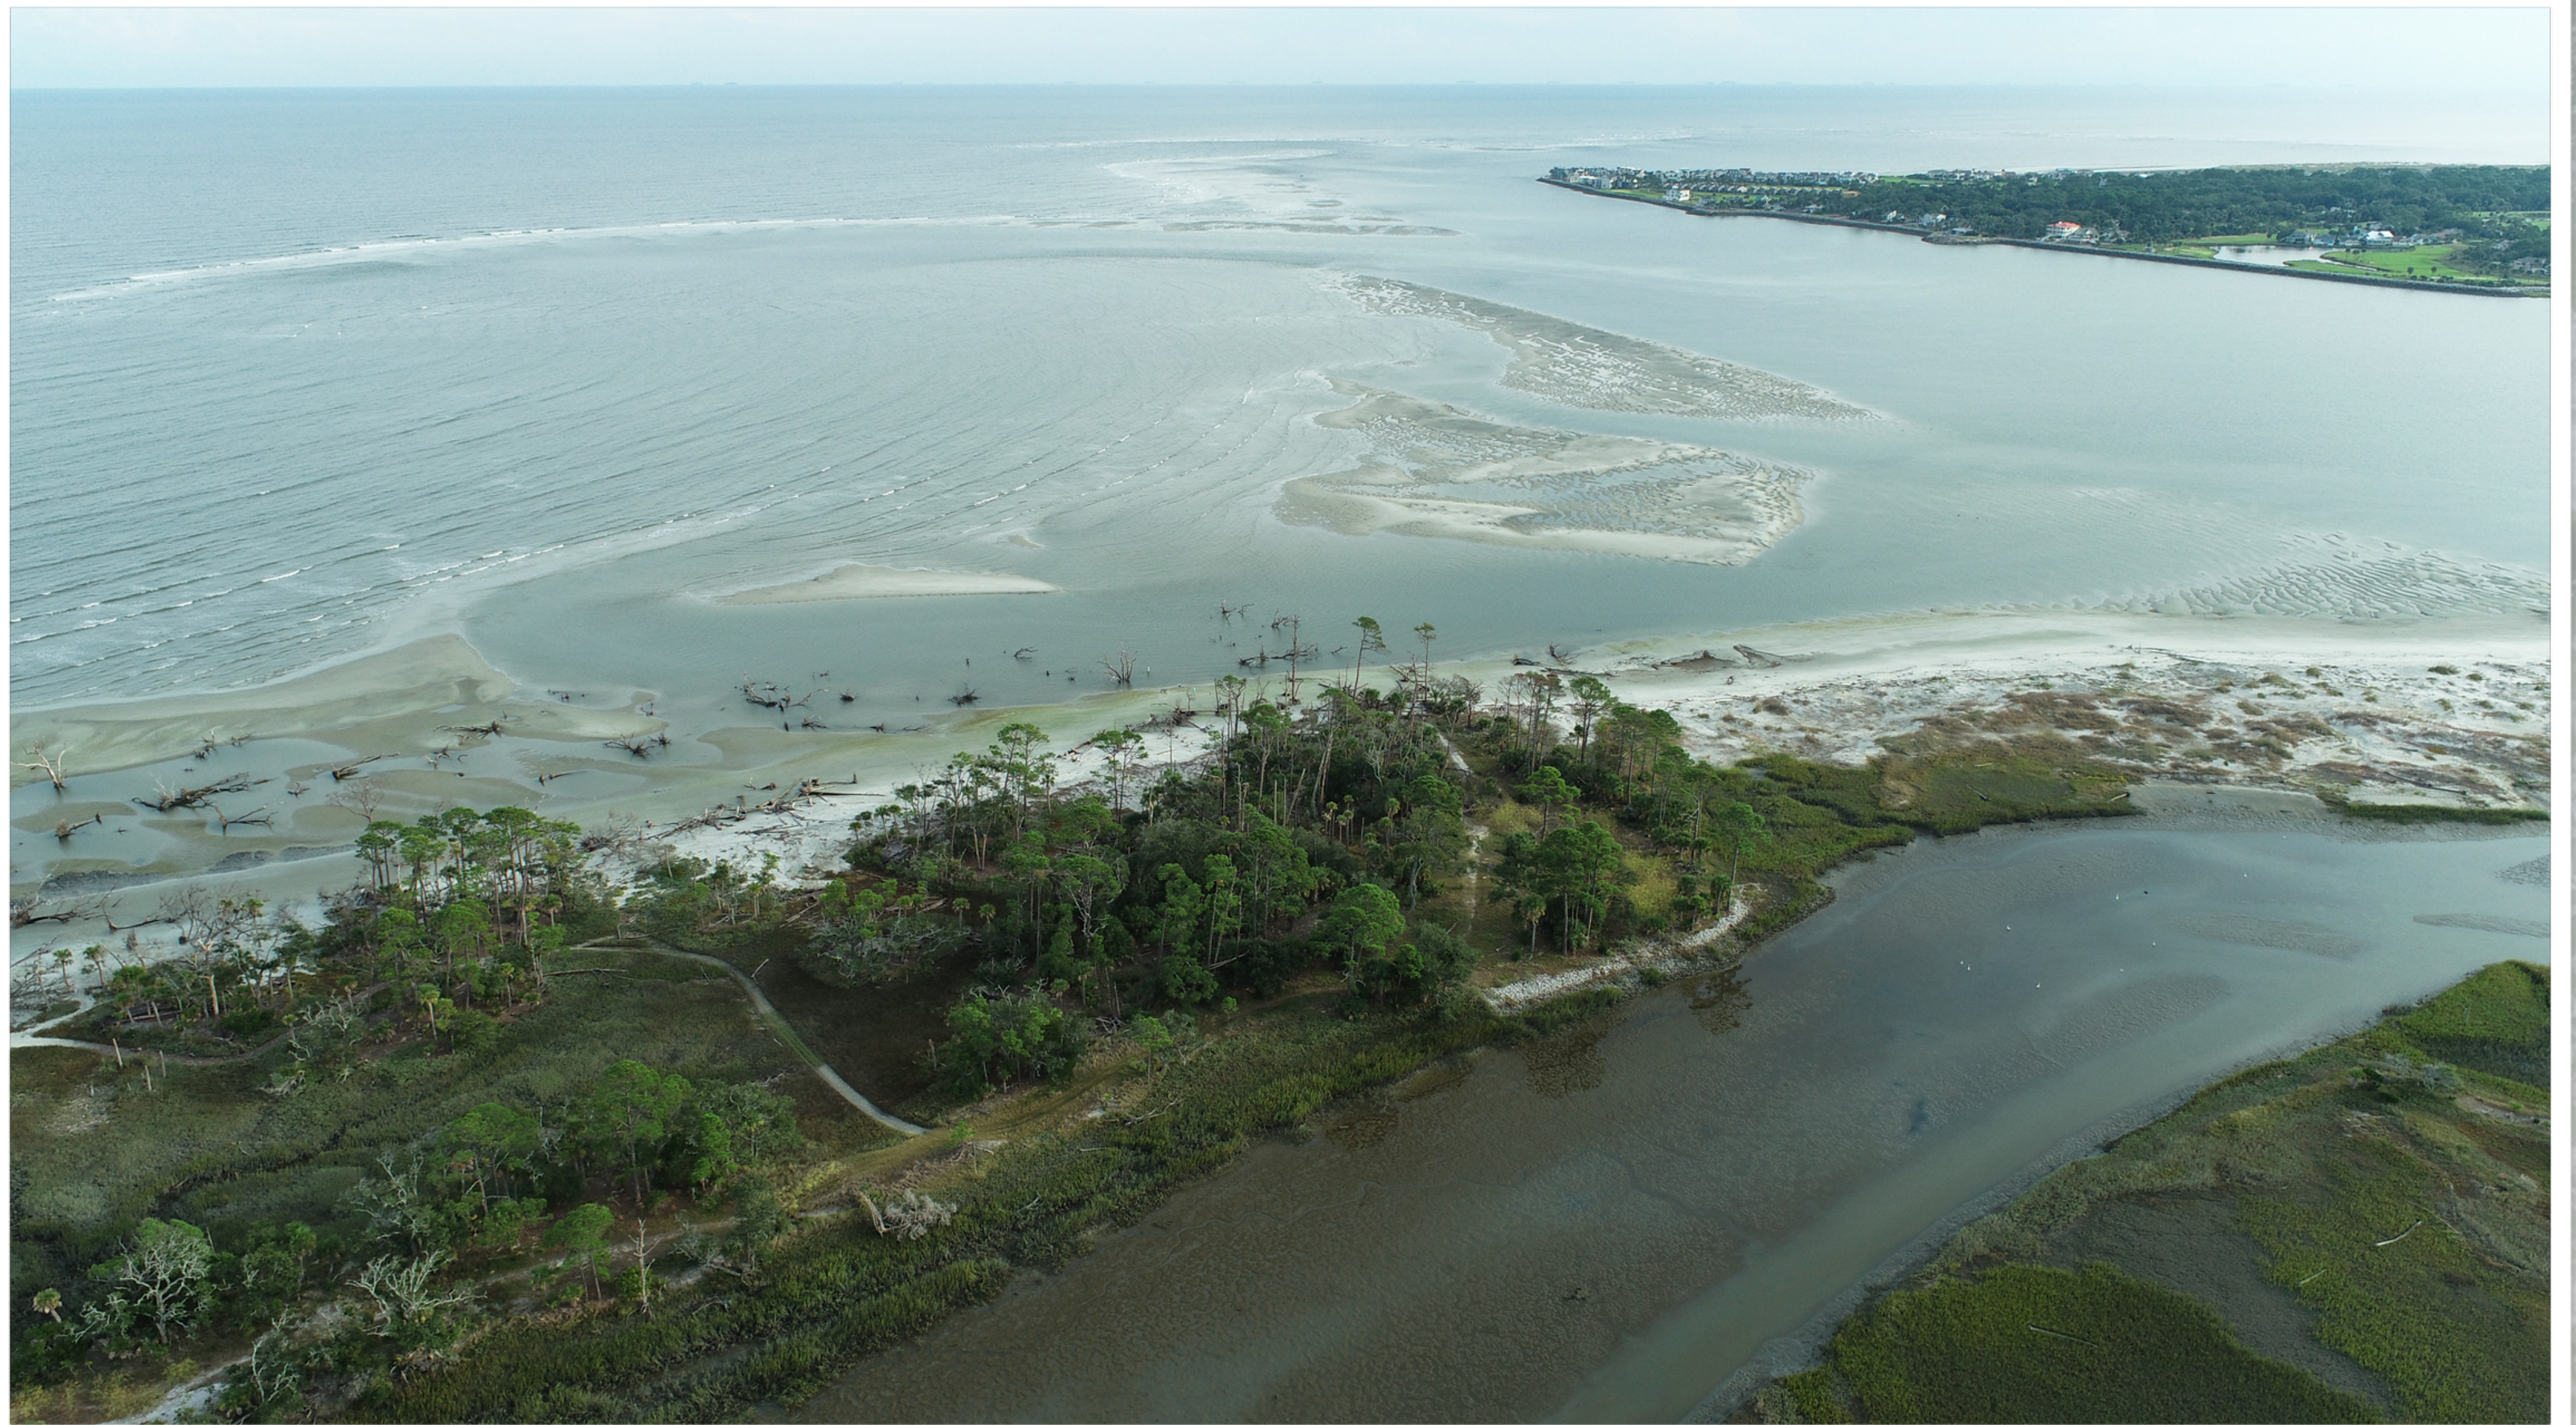
The trail of sand - Looking seaward from the south end of Hunting Island, the vast sand shoal is visible along the side of the Fripp Inlet and wraps around the northern tip of Fripp Island.

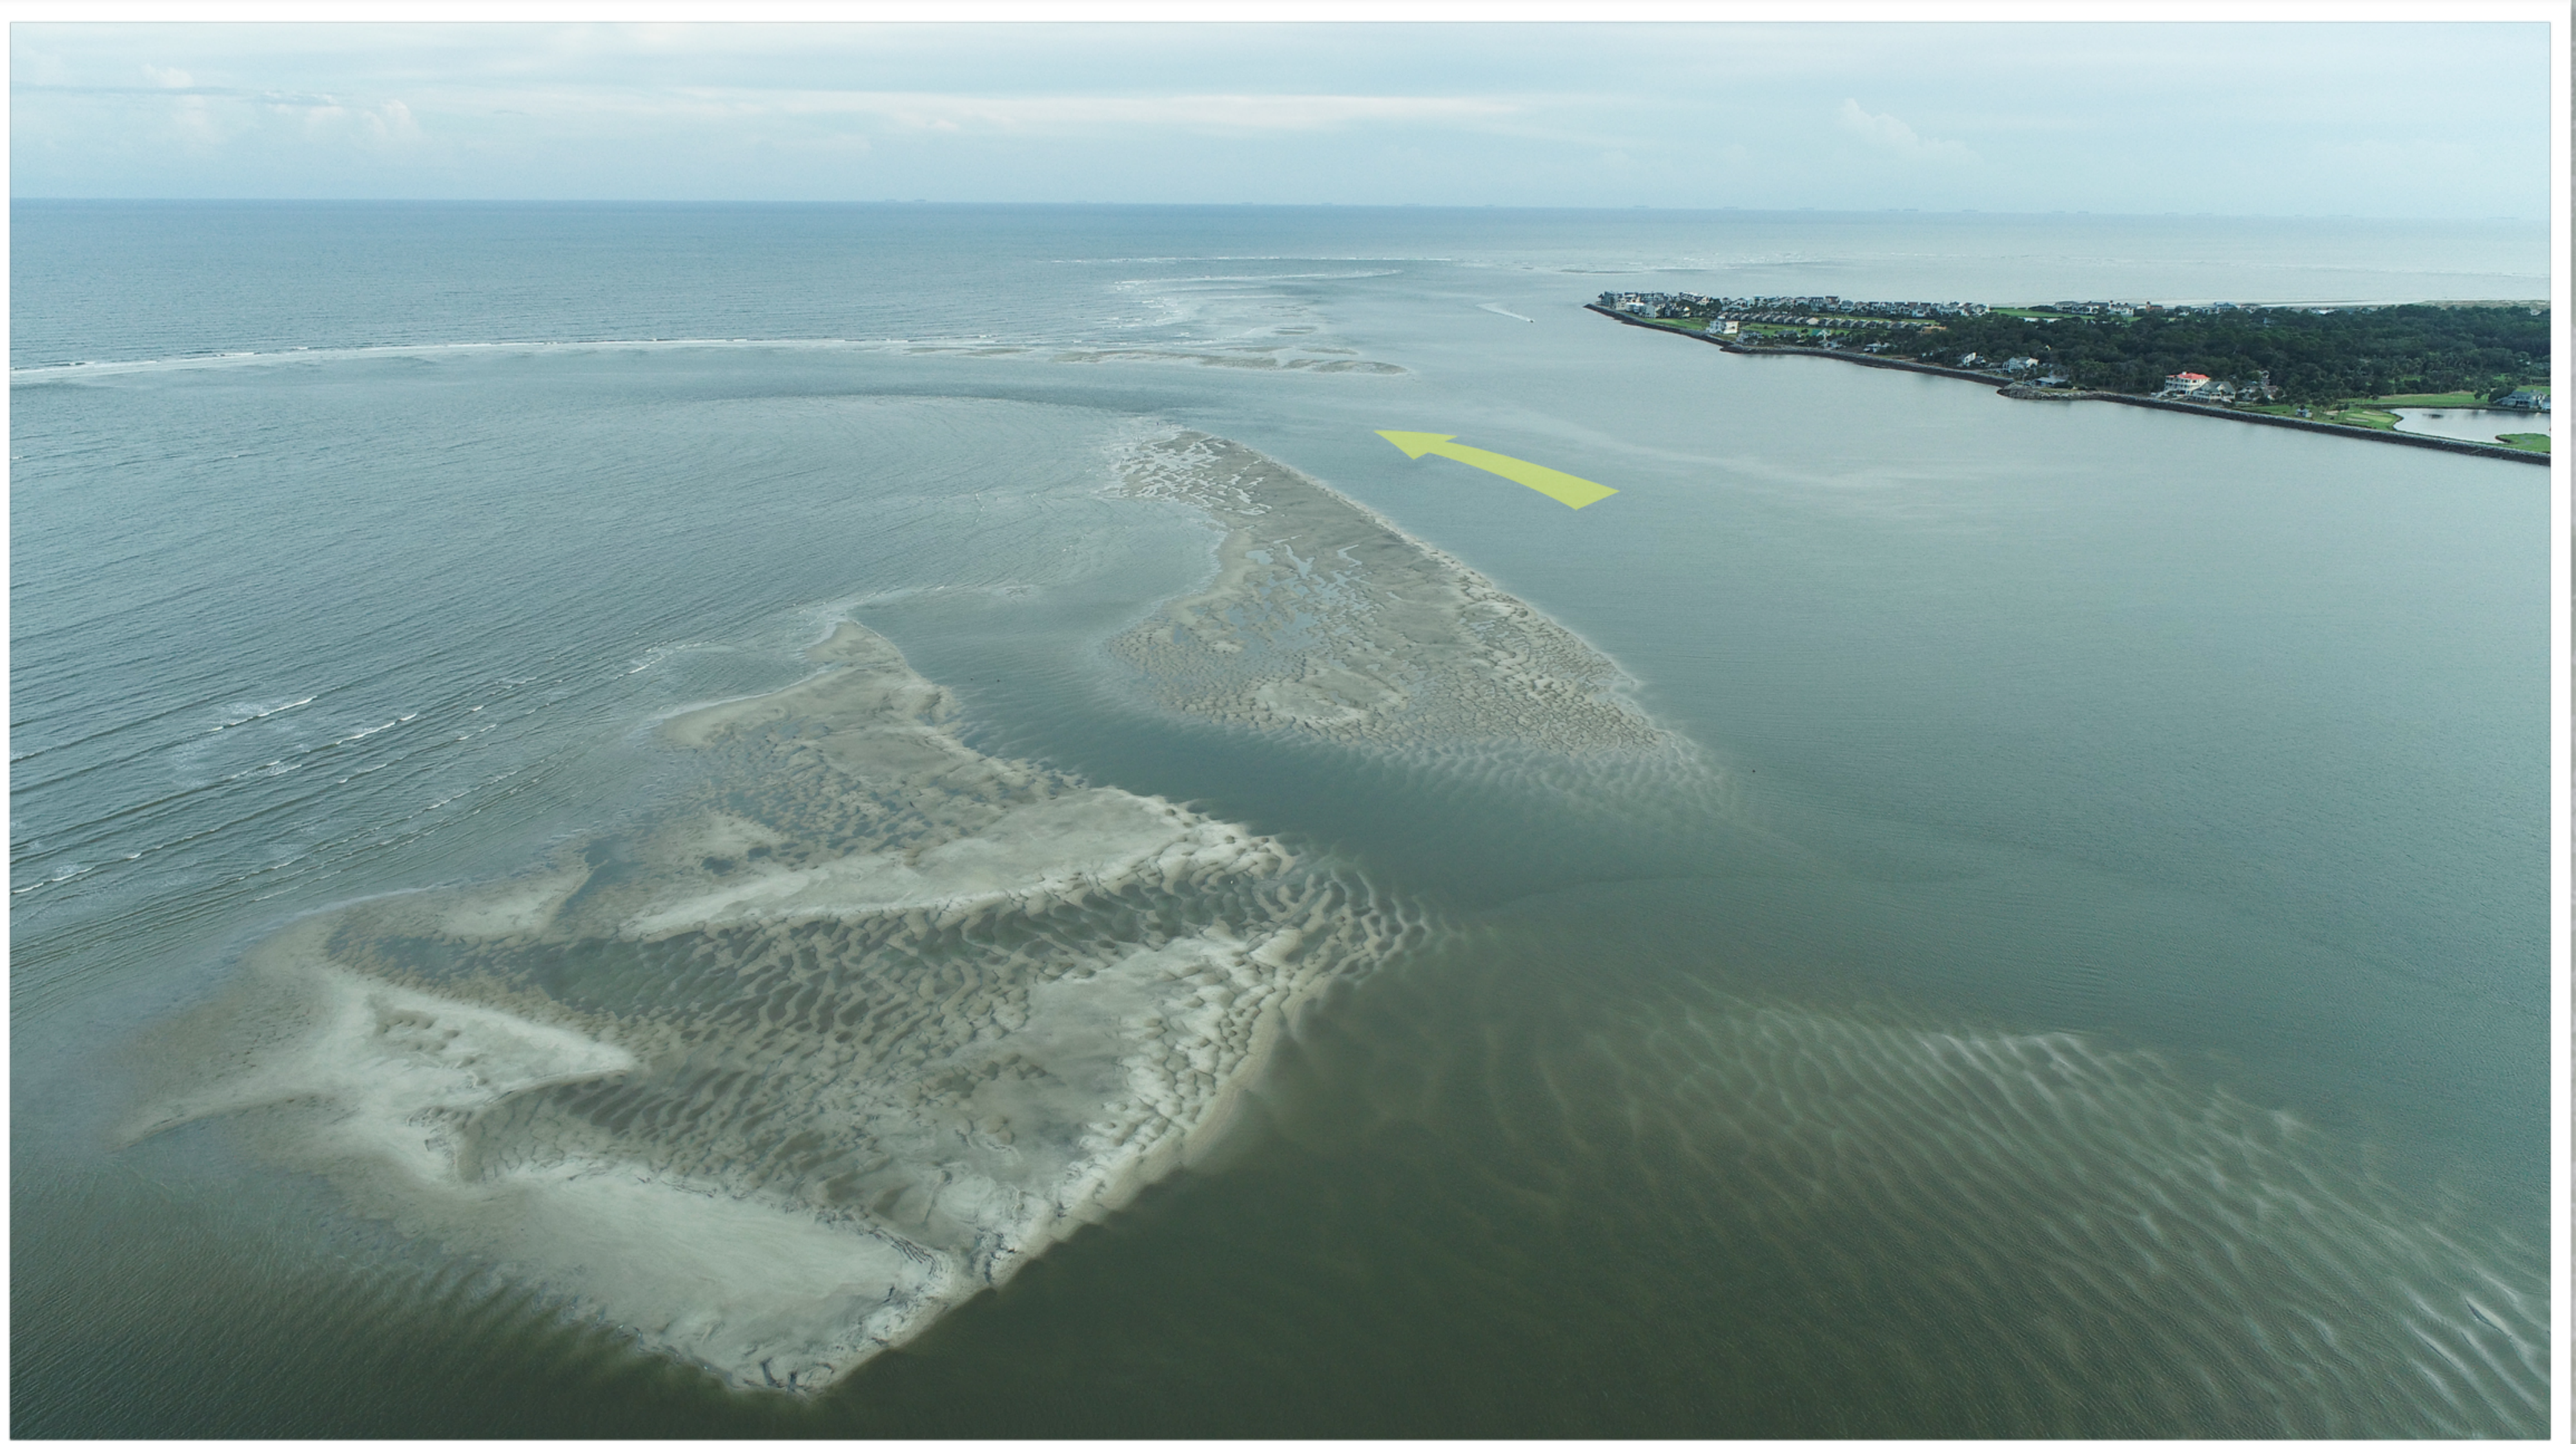
The trail of sand - About midway down the trail of sand, there is a large break in the shoal where a channel has carved an almost perfect curve through the sand and a portion of the sea flows in and out of this channel during the tide cycle.

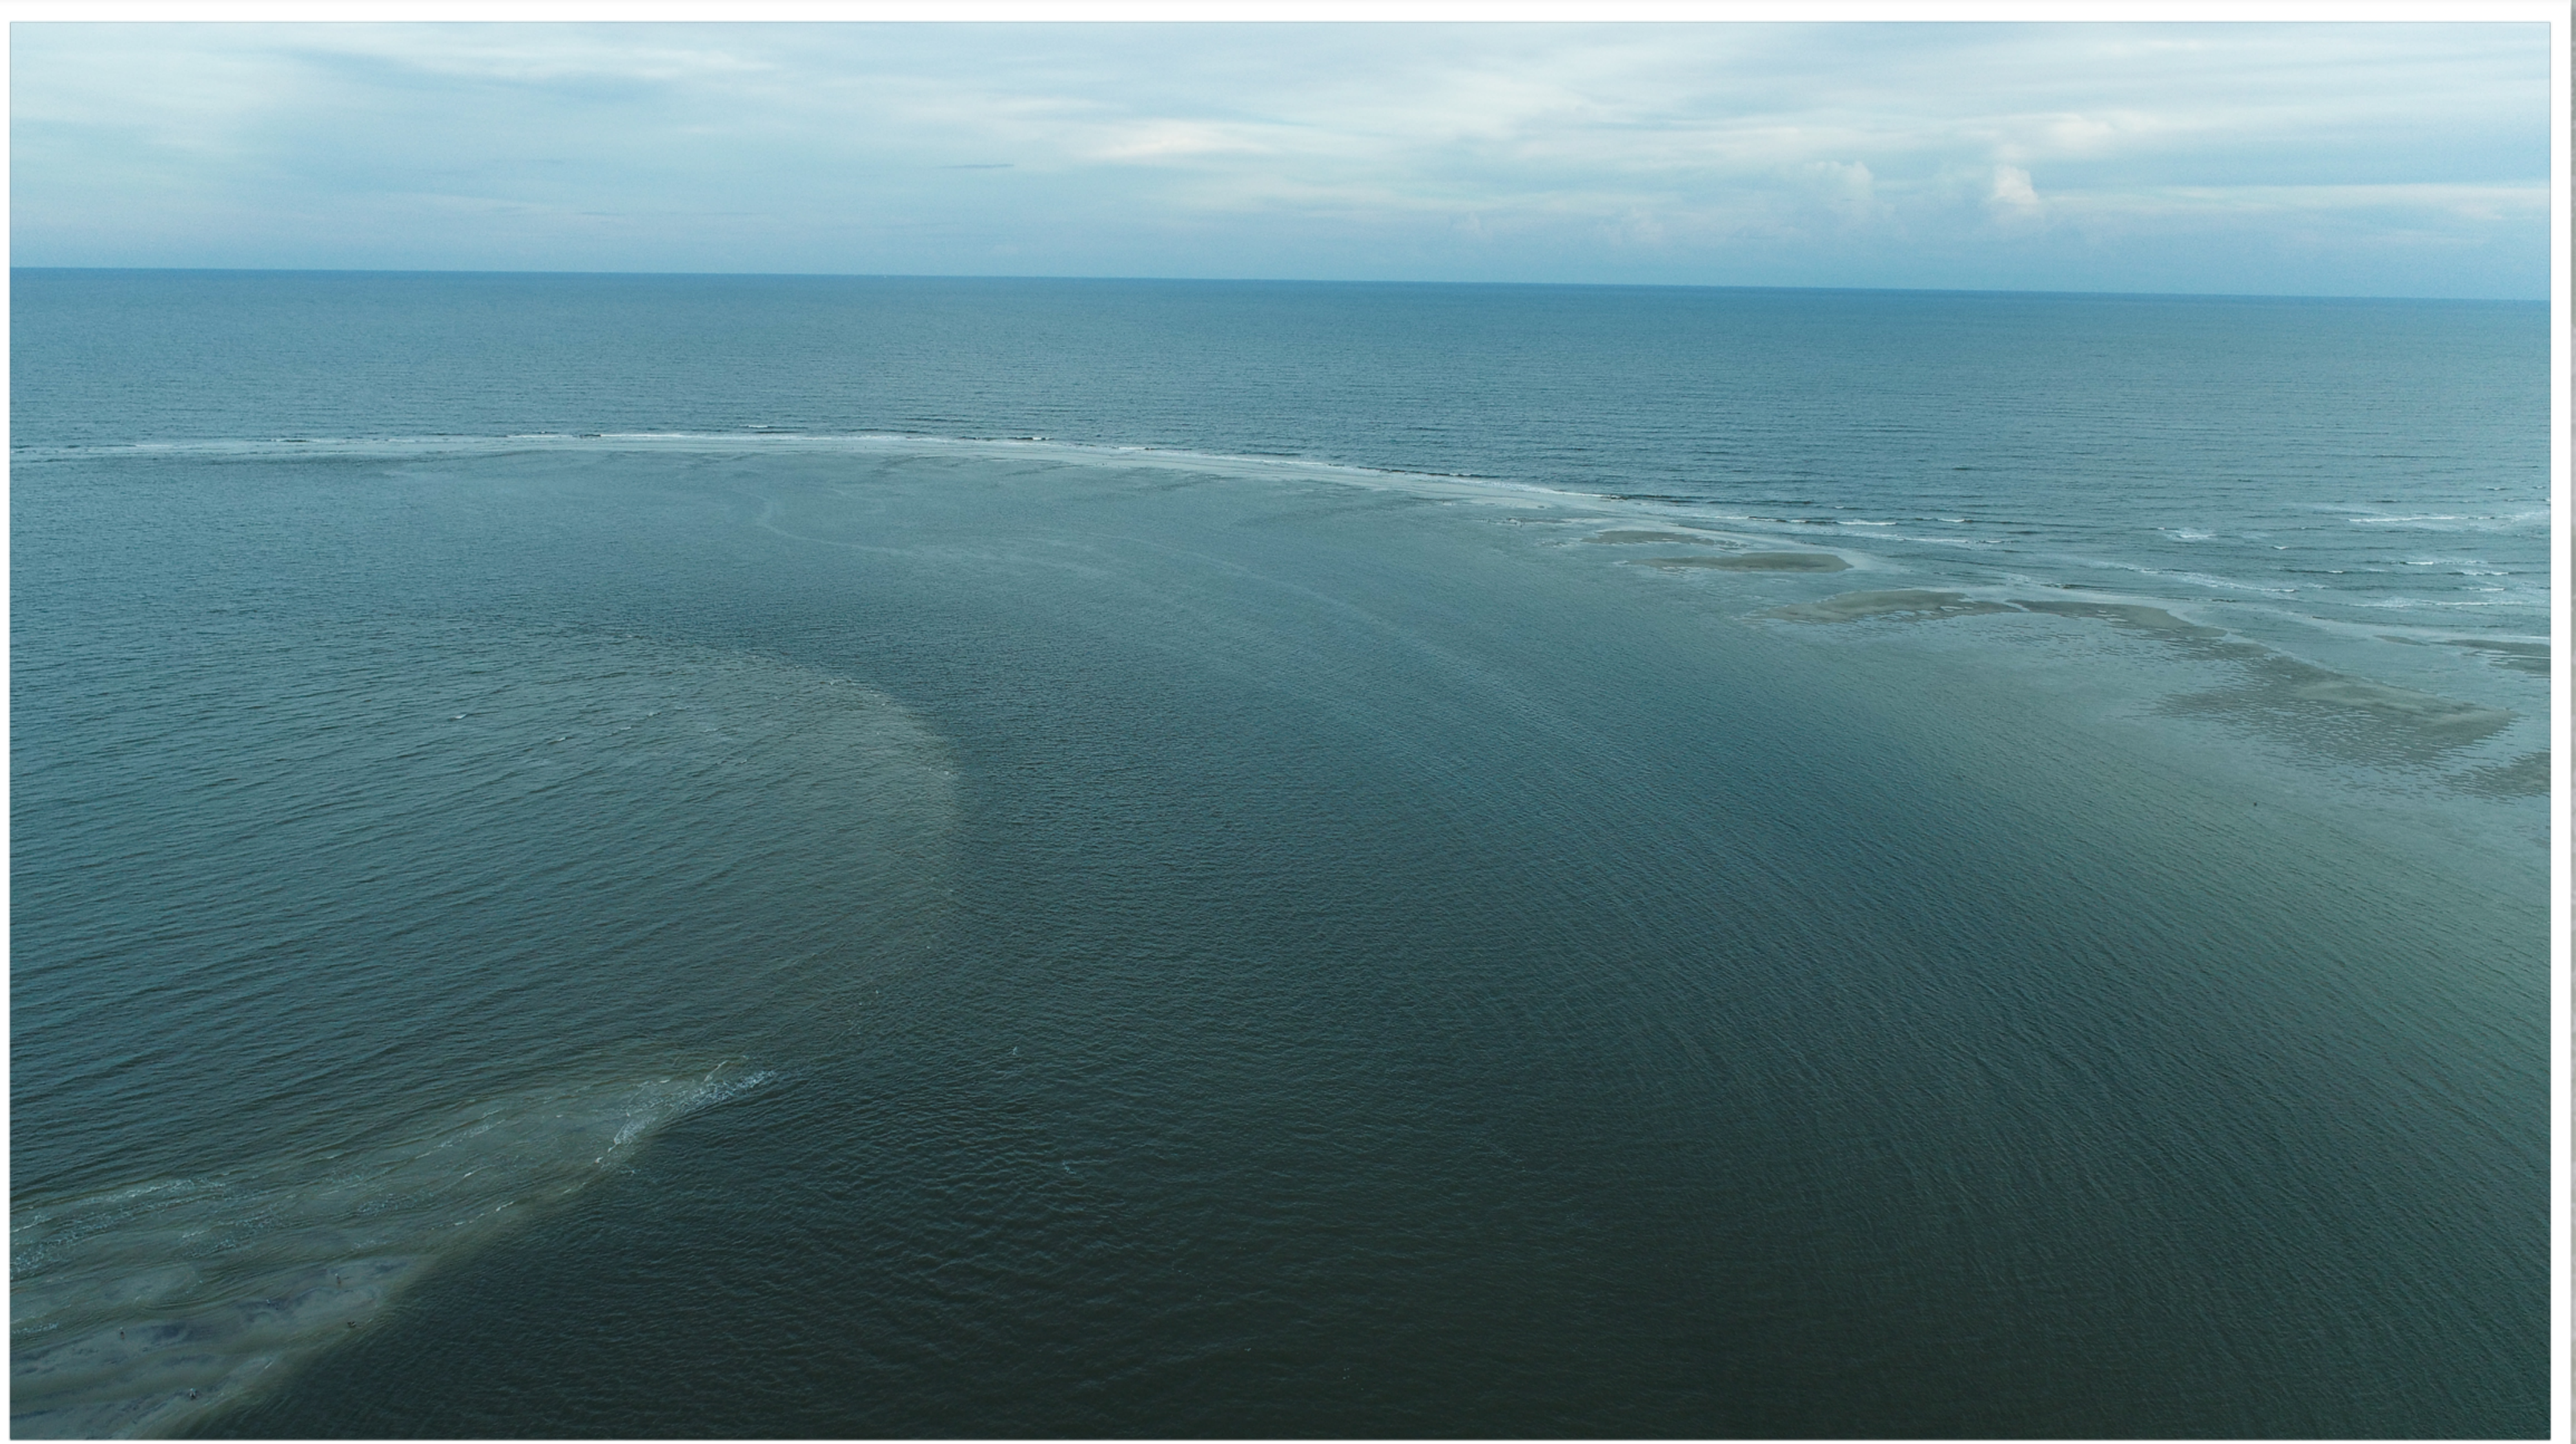
The Channel - Looking down the channel carved in the sand, is an almost perfect curve. This photo was taken at low tide and shows the channel has some depth to it.

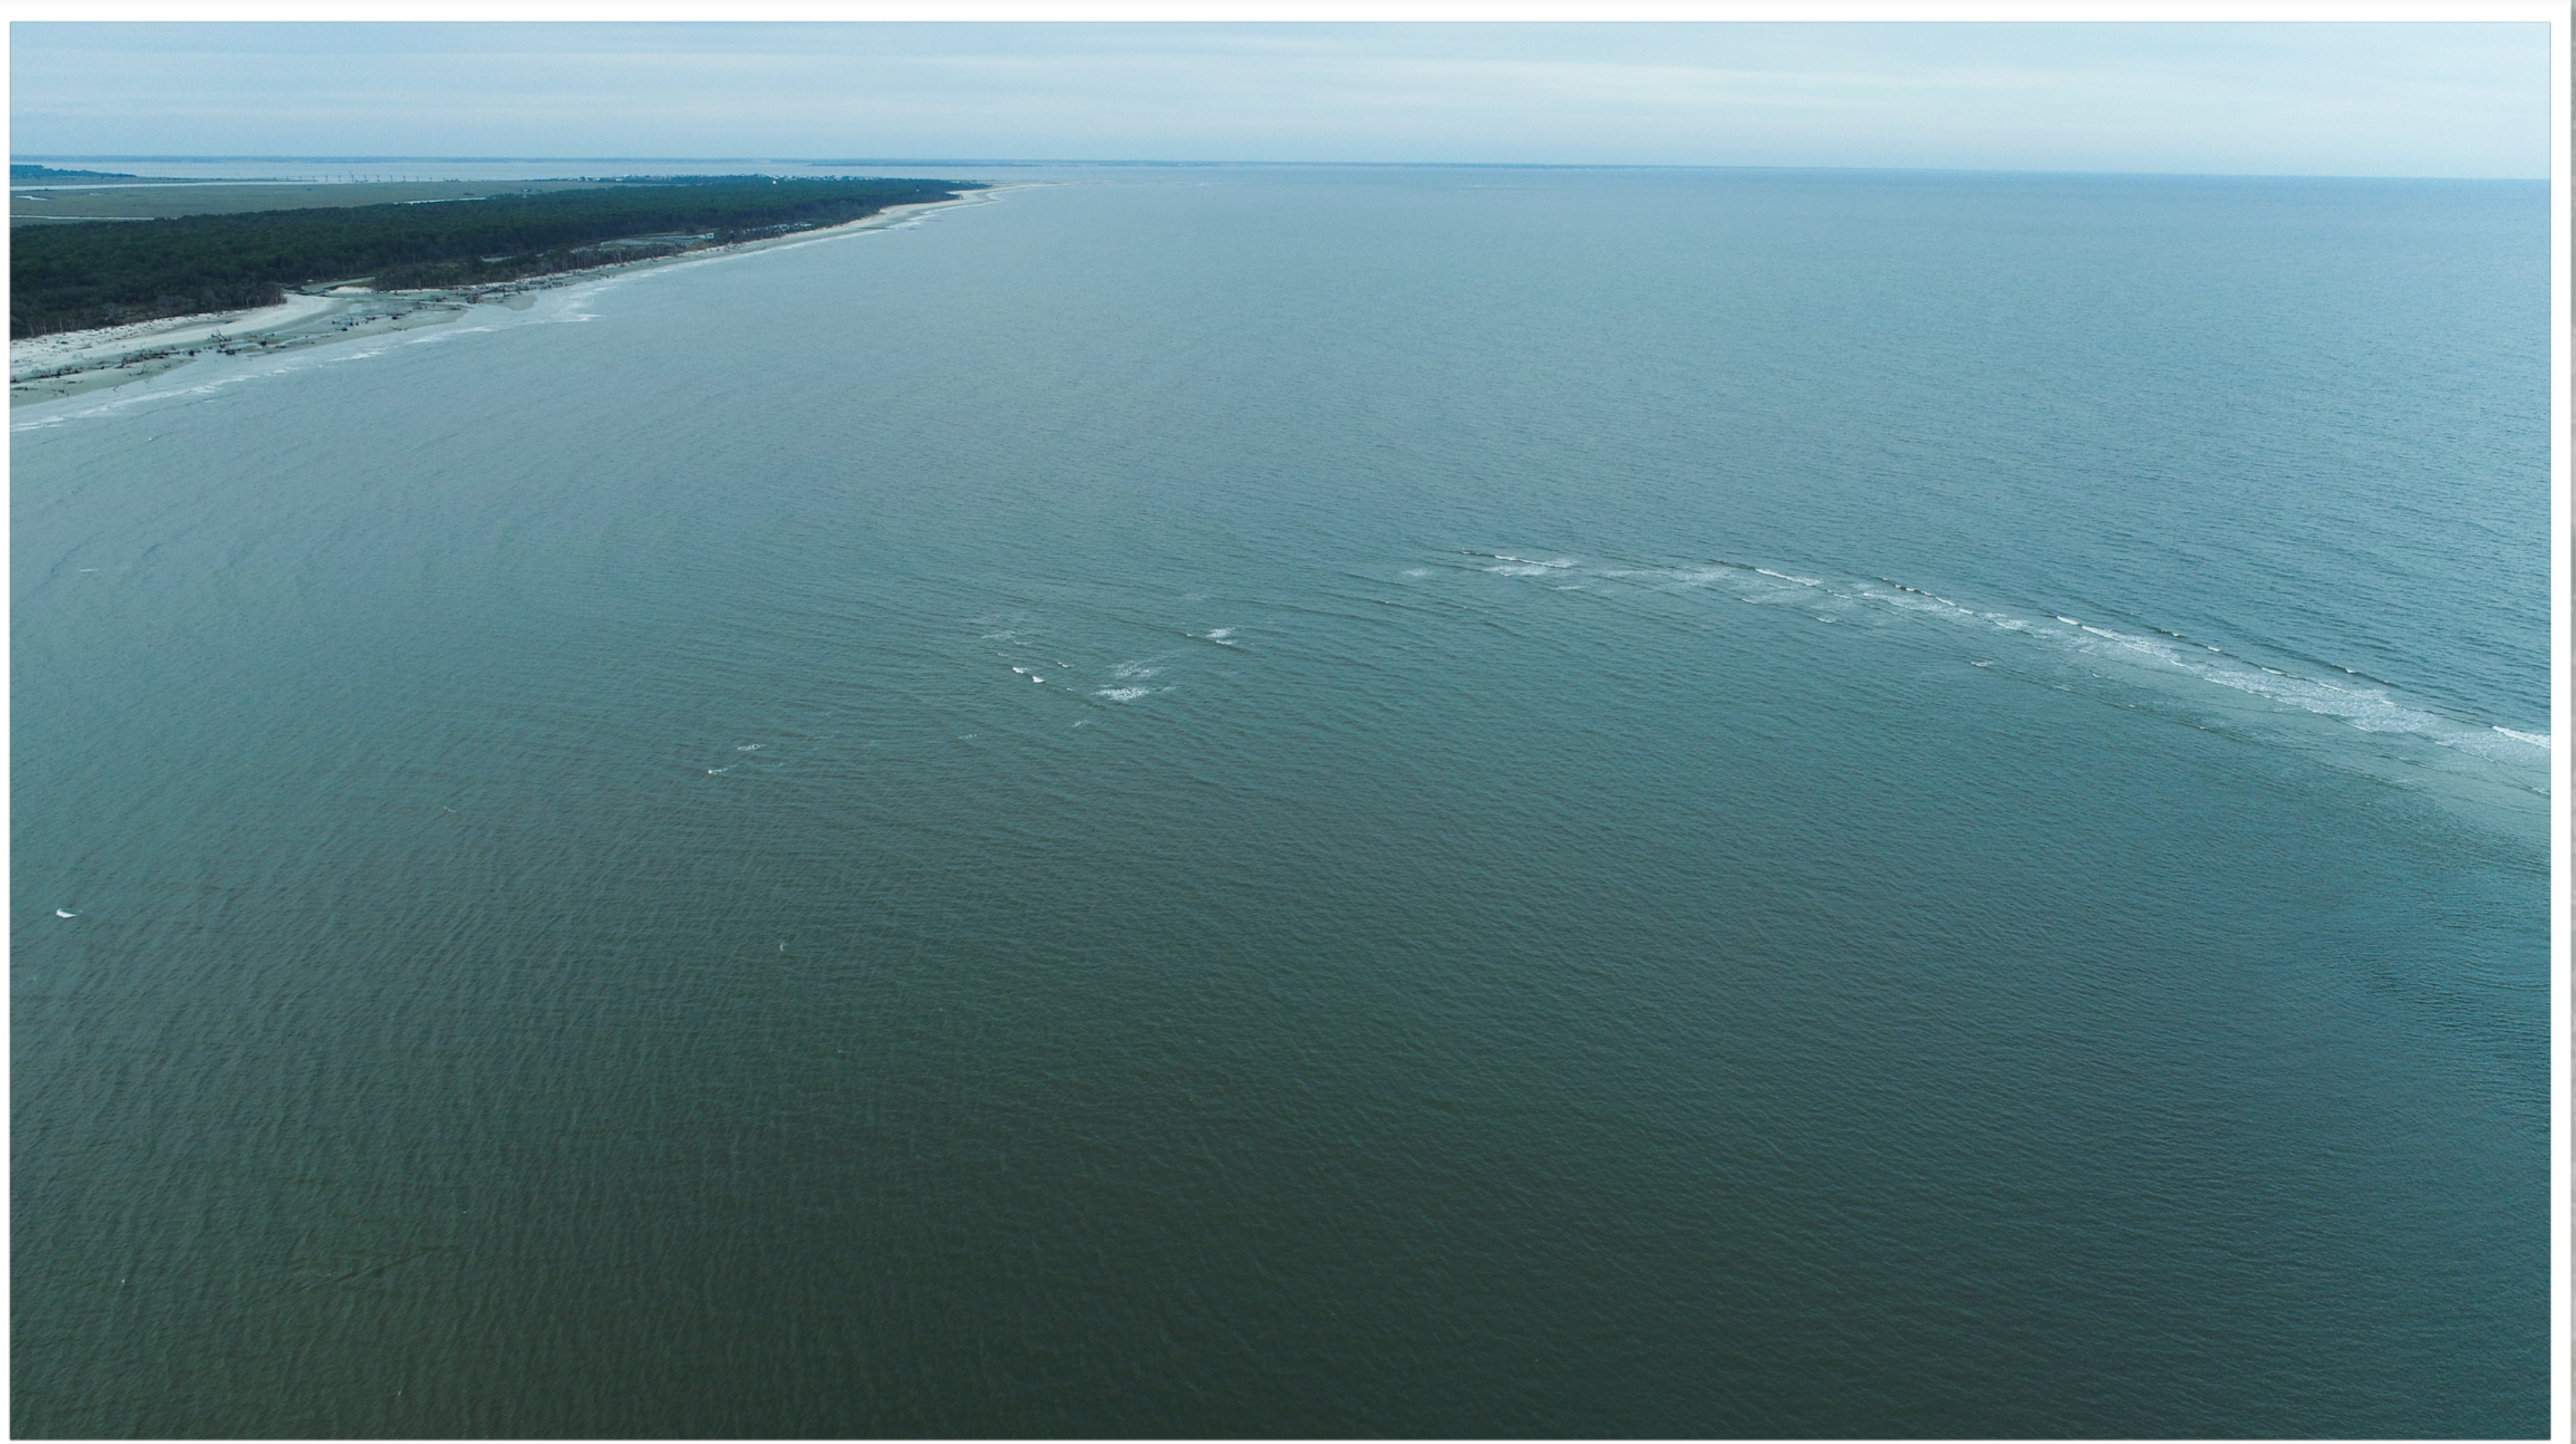
The Channel - But at low tide, the opening of the channel on Hunting Island's side is still quite shallow and would probably be a risk to navigate for most vessels.
