Shoreline Status

Fripp Island - Shoreline Committee

Darryl Zoekler - November 10, 2021

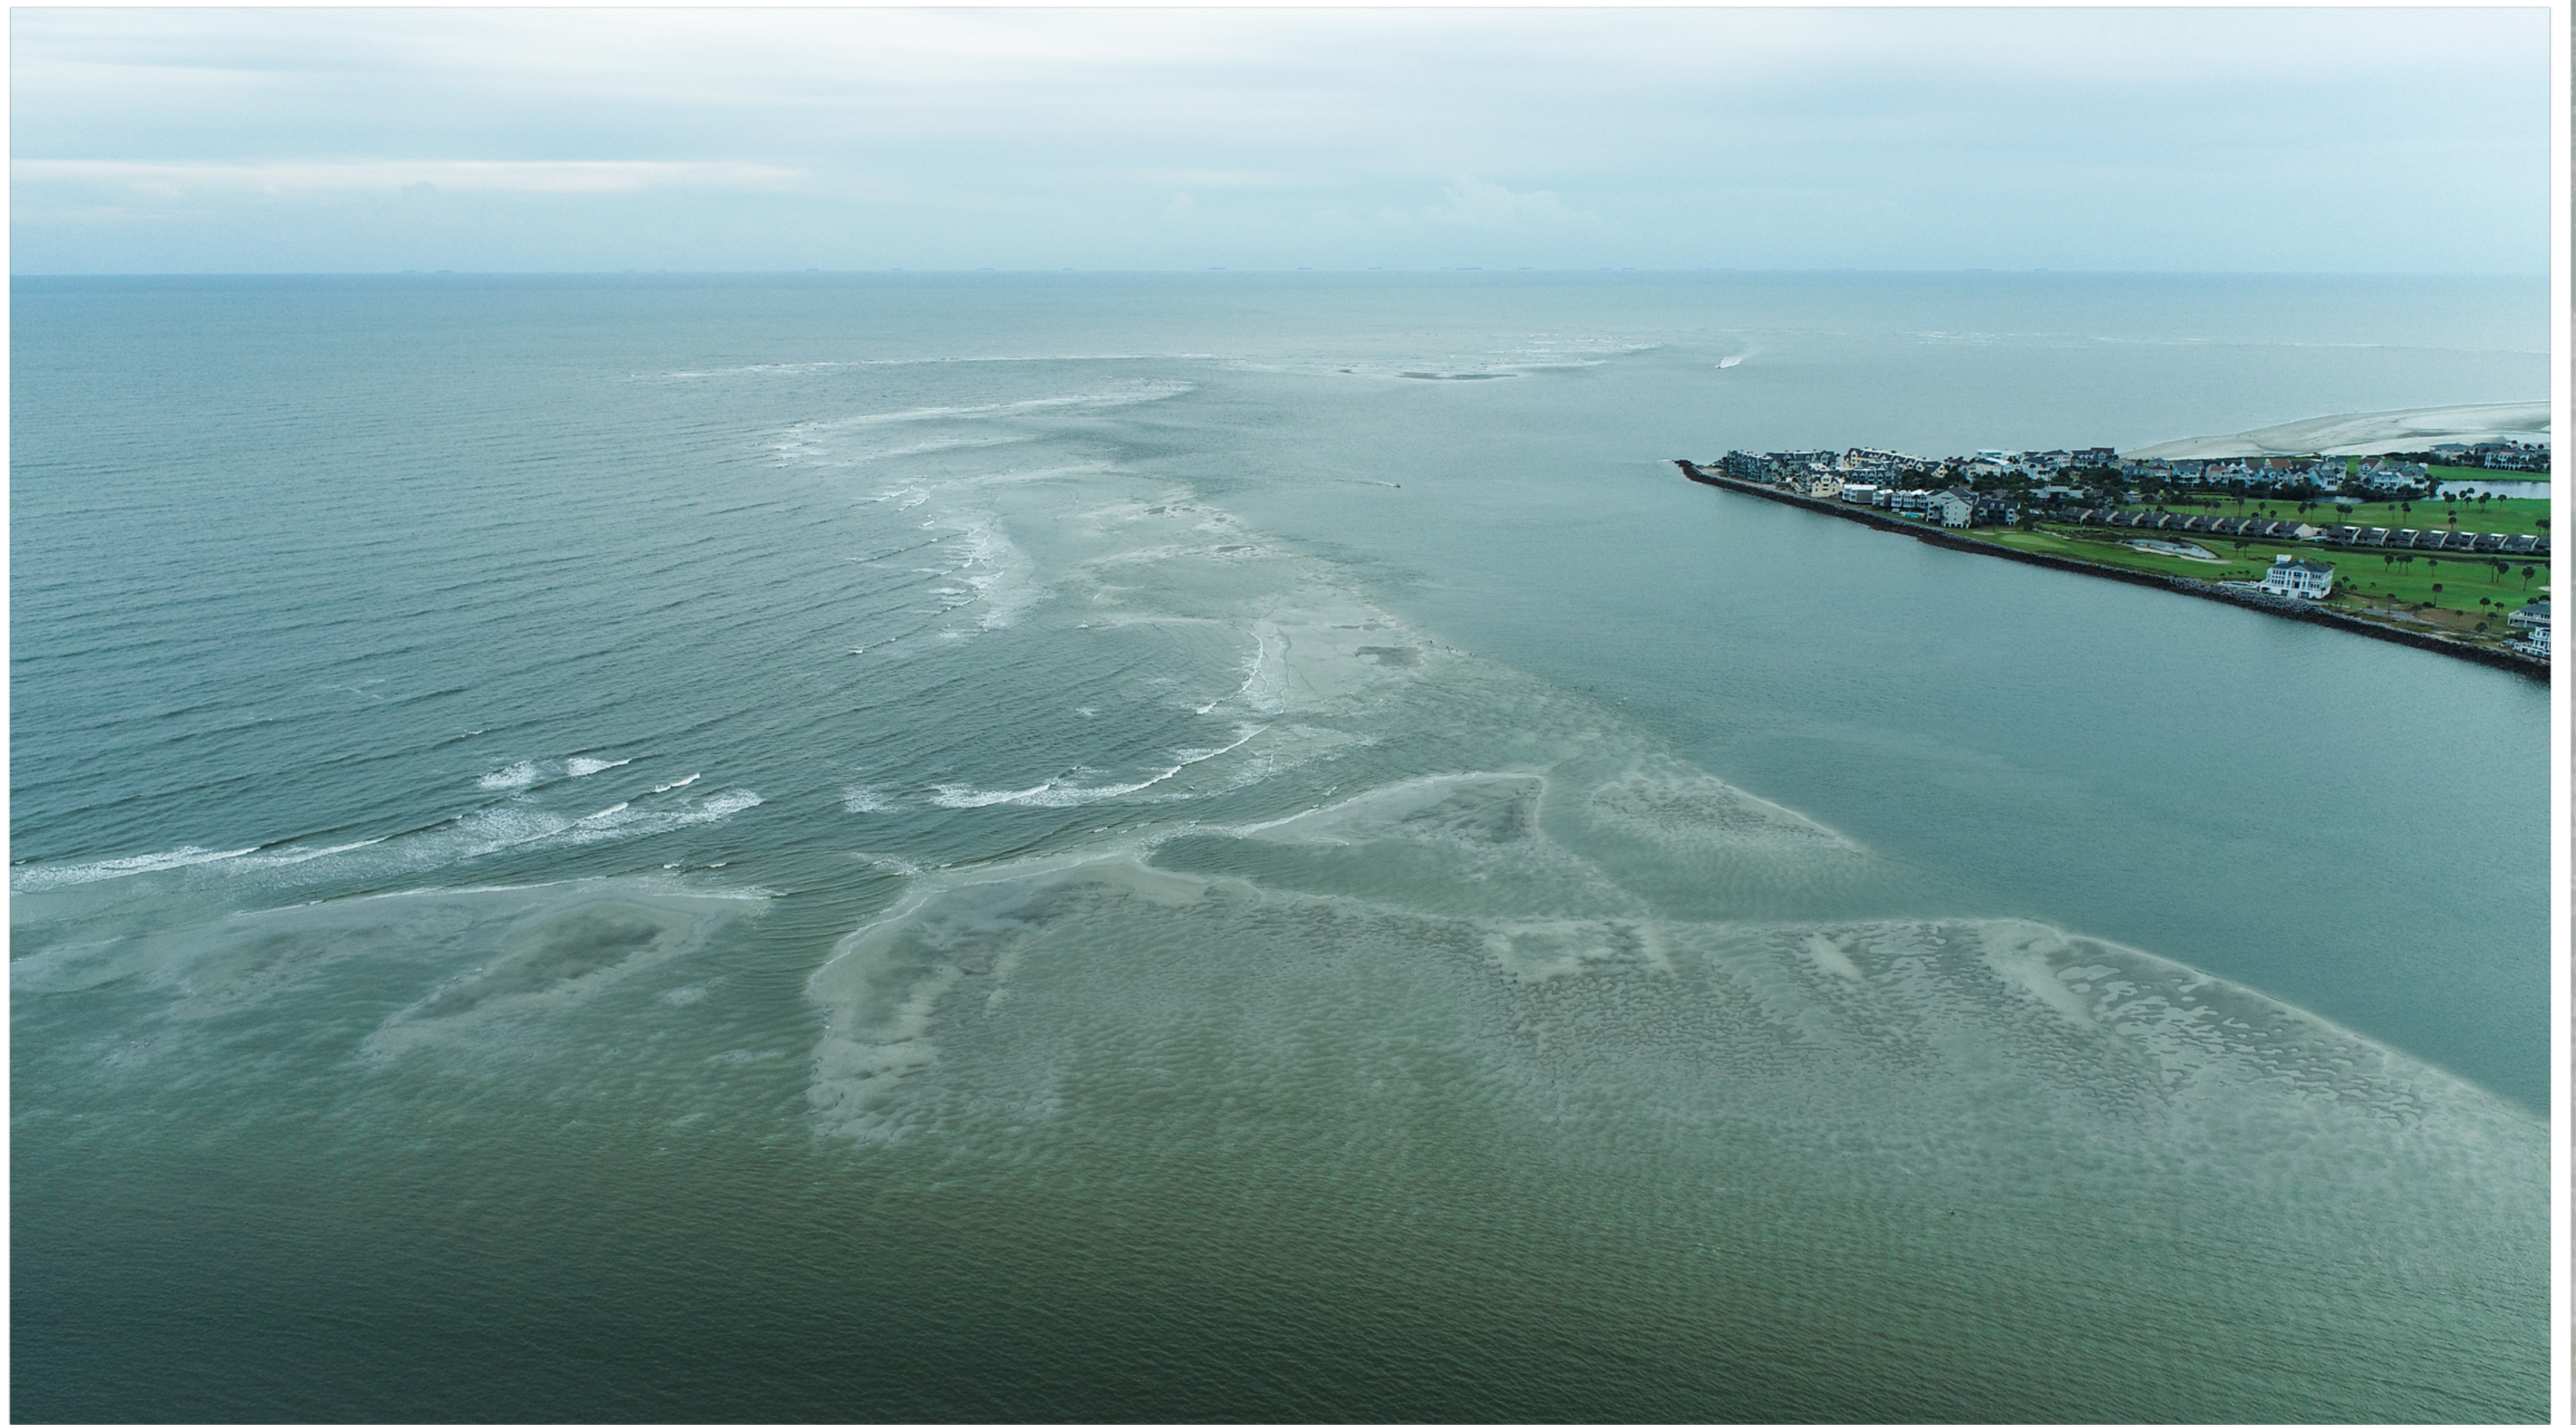
The trail of sand - Moving past the channel, an almost straight line runs parallel to the rock revetment. The straightness of this sand line mirrors the straightness of the revetment as though the sand can only compress the channel so much due to the force of the current in the inlet.

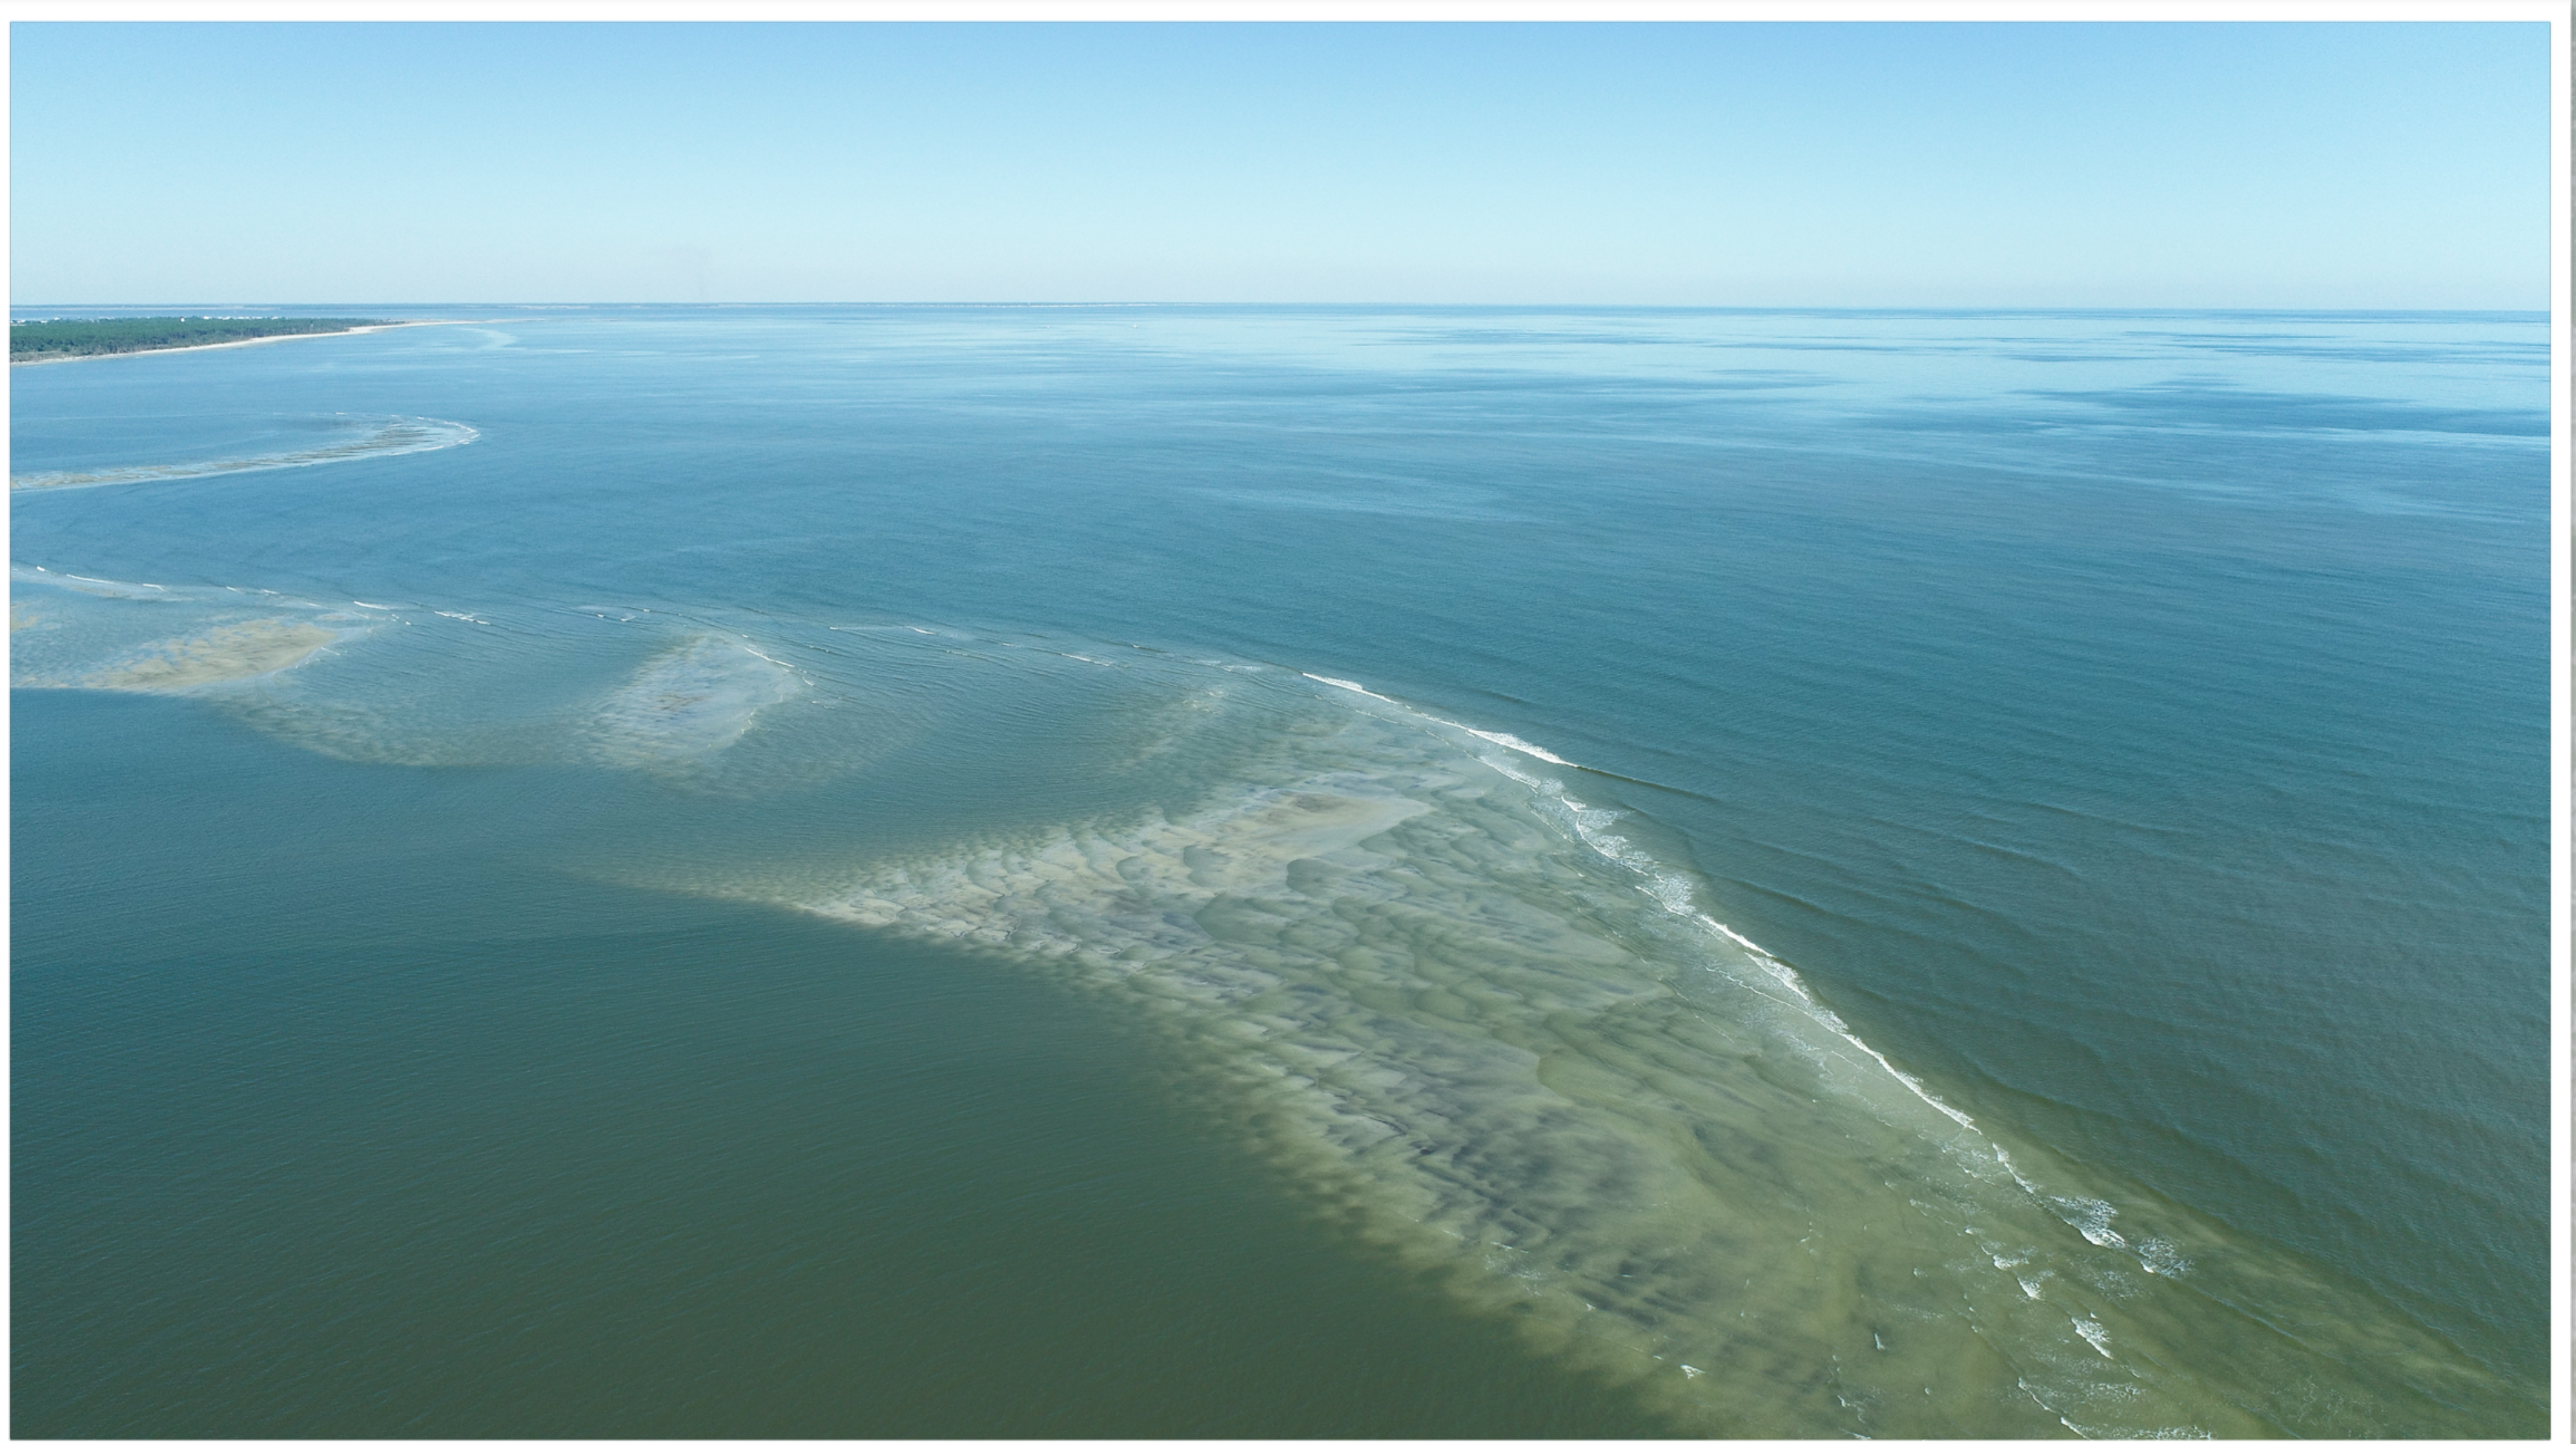
The trail of sand - A view of the dog-leg or bend in the shoal where it turns and wraps around Ocean Point running along the front of Fripp Island.

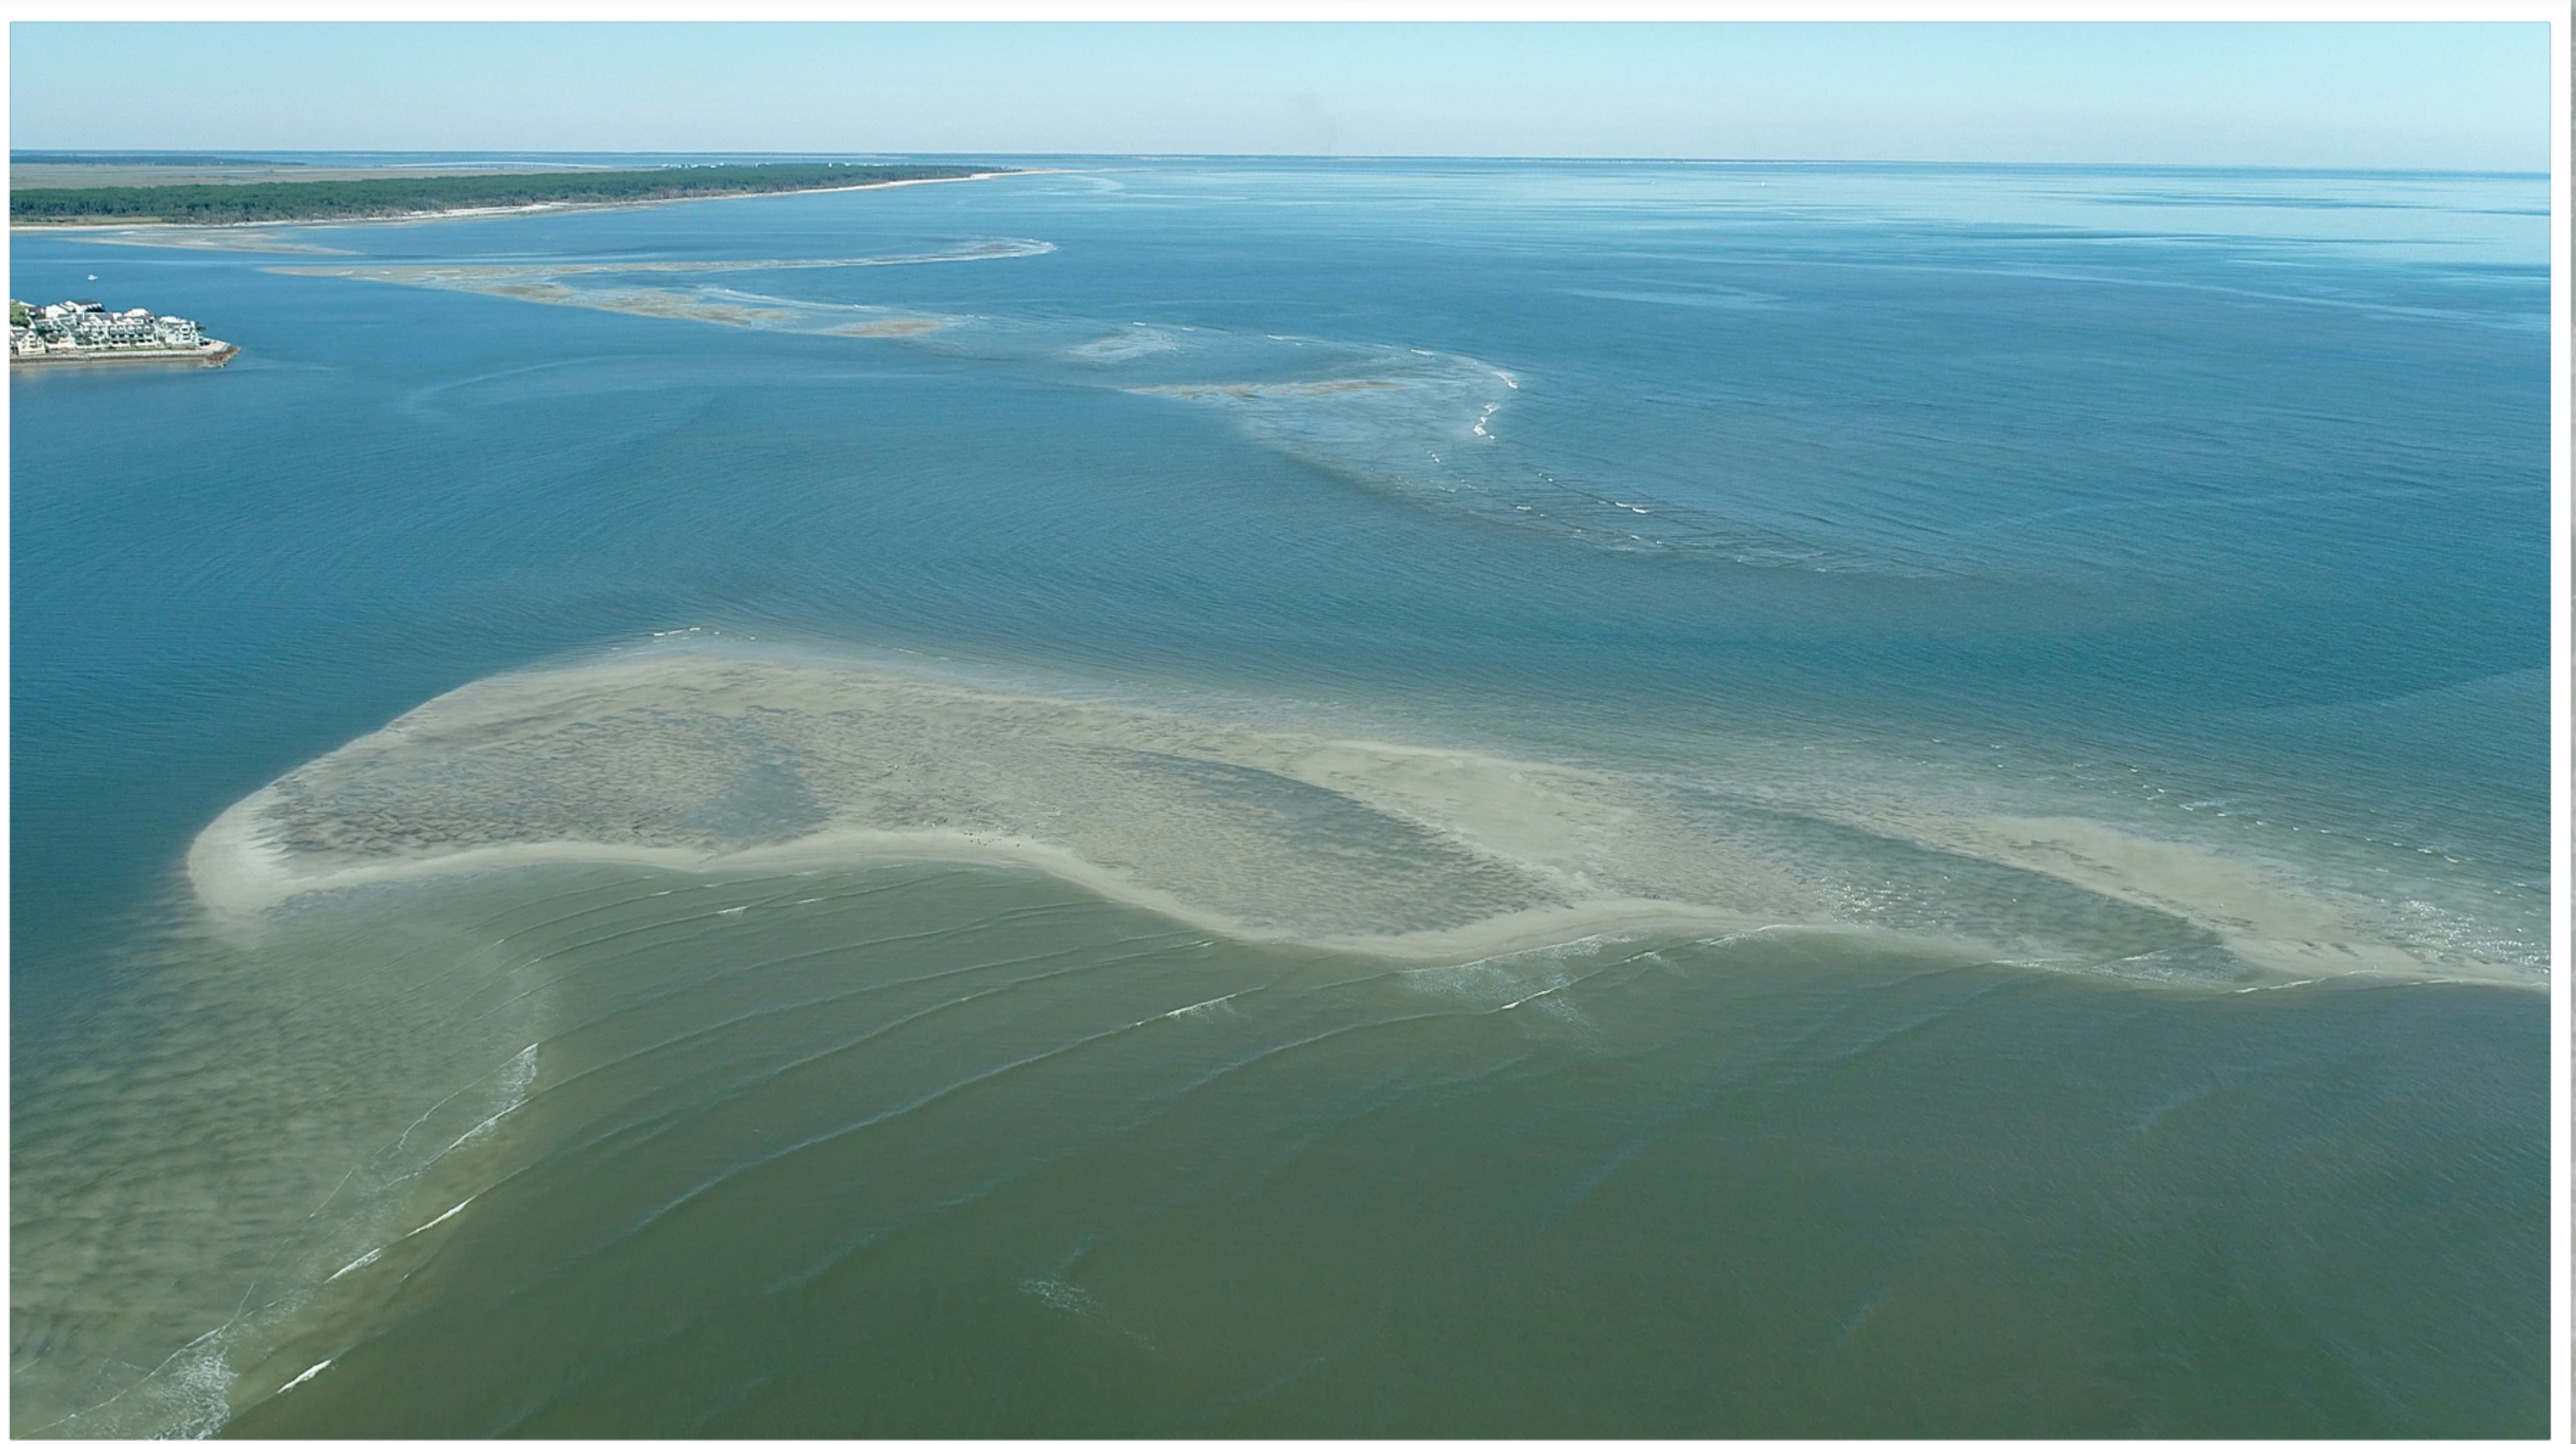
The trail of sand - Just past the dog-leg is another channel. This is the channel most vessels navigate to get to the ocean from the inlet. On the southern side of the channel is a build up of sand that acts like a reserve for the sand that continues southward.

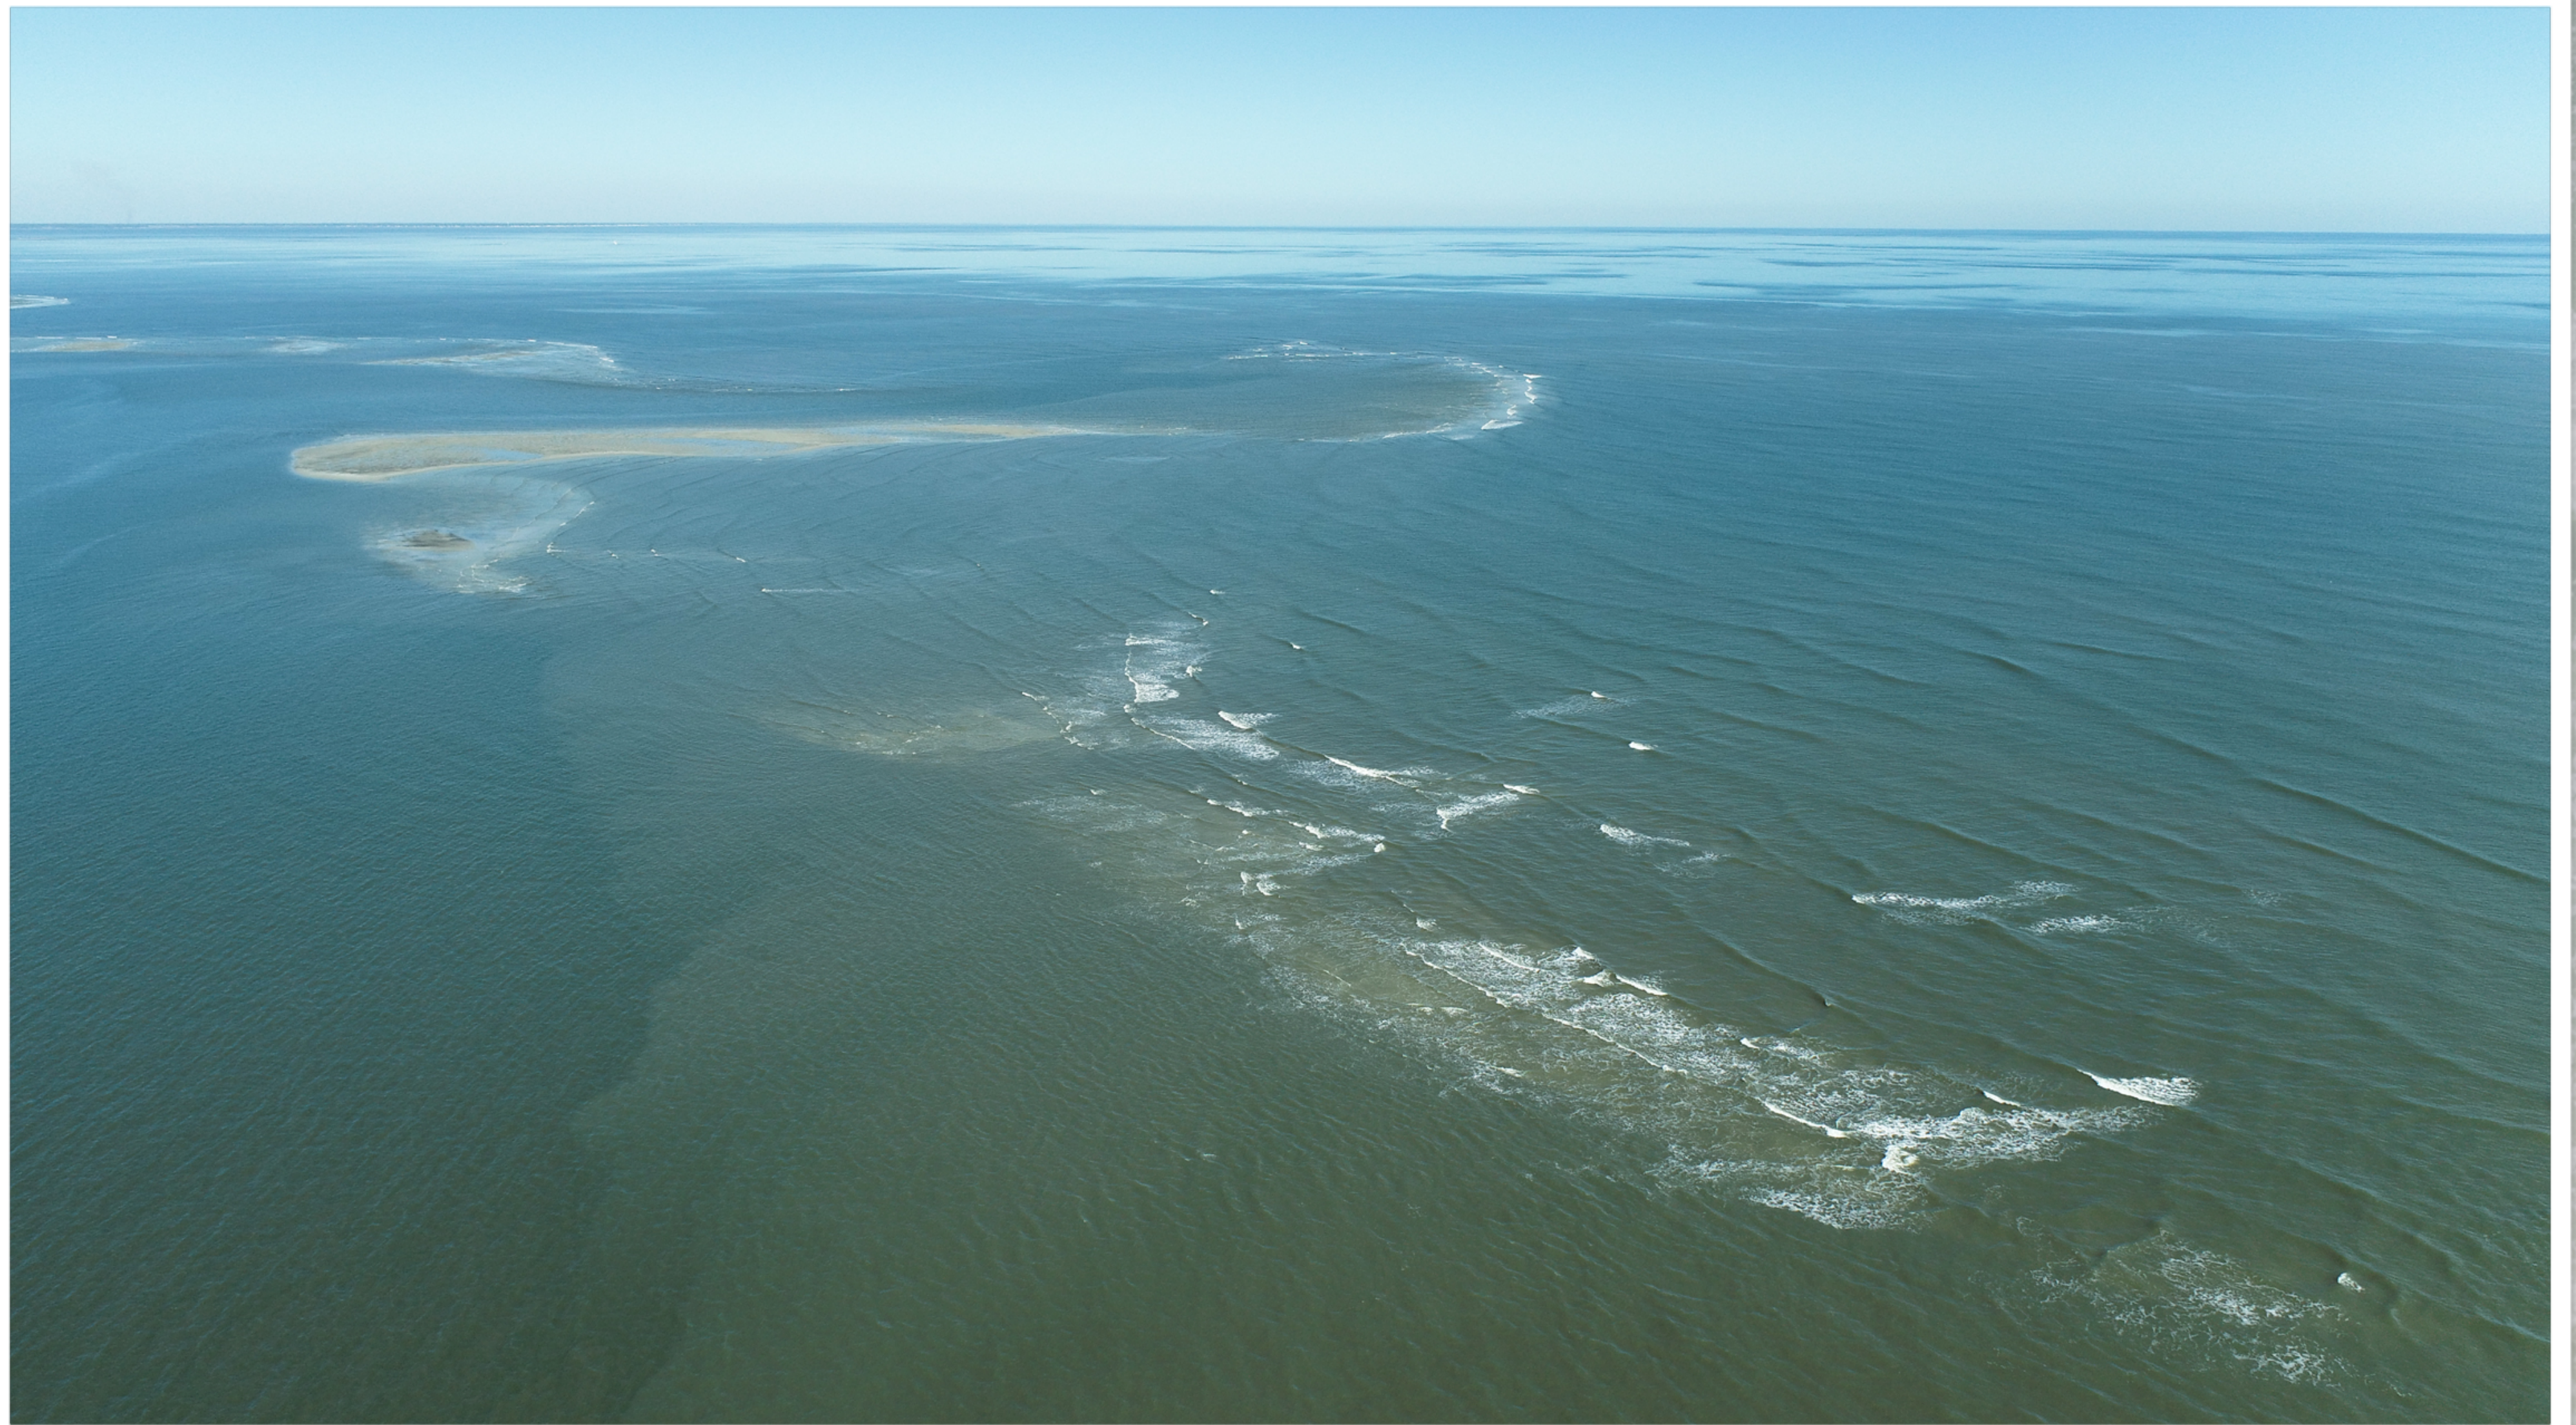
The trail of sand - Past the reserve sand pile, the trail of sand continues. This is where the shoal formed in 2017 before attaching to the beach in 2020 and becoming an established extension of the beach today.

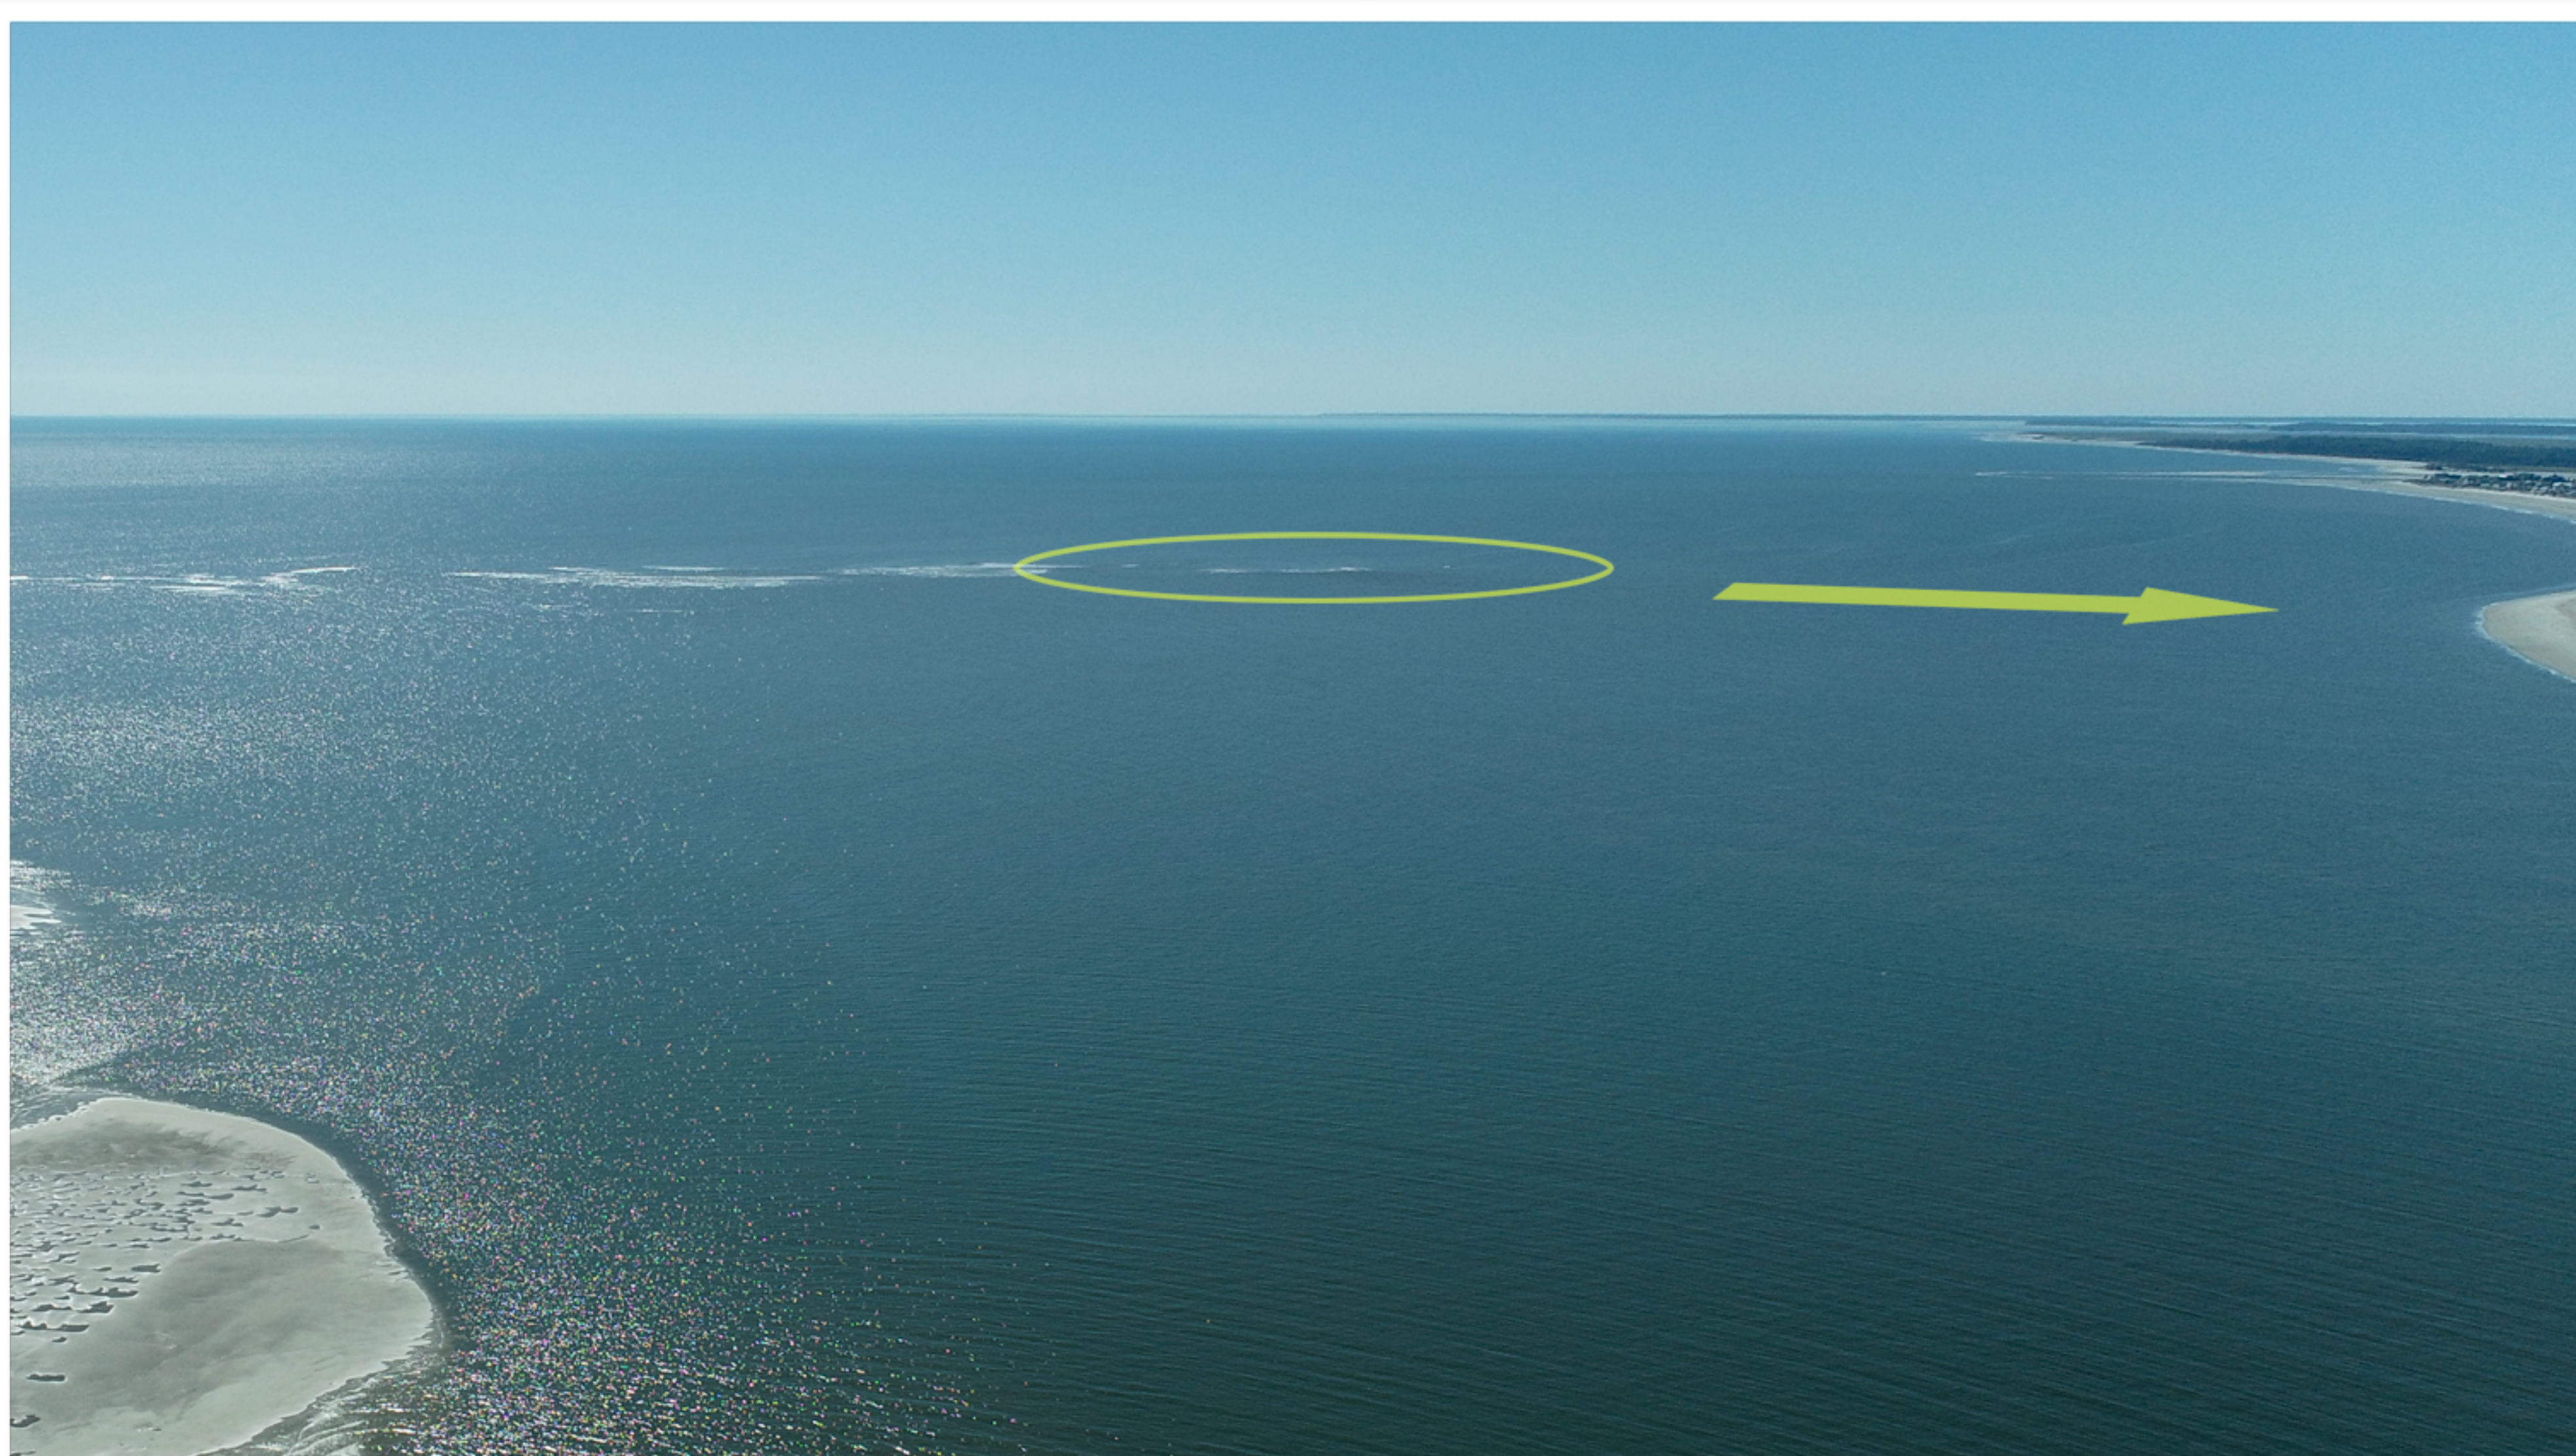
The end of the trail - The visible outer shoal ends where the circle is drawn. This is the same spot where the previous shoal formed and grew in 2017. The arrow points to where the shoal attached to the beach. As of yet, there is no sand visible above the surface at low tide, but it will be the area to watch in future to see if a shoal forms there or moves further down the beach.
