Shoreline Status

Shoreline Committee - Town Hall

May 14, 2022

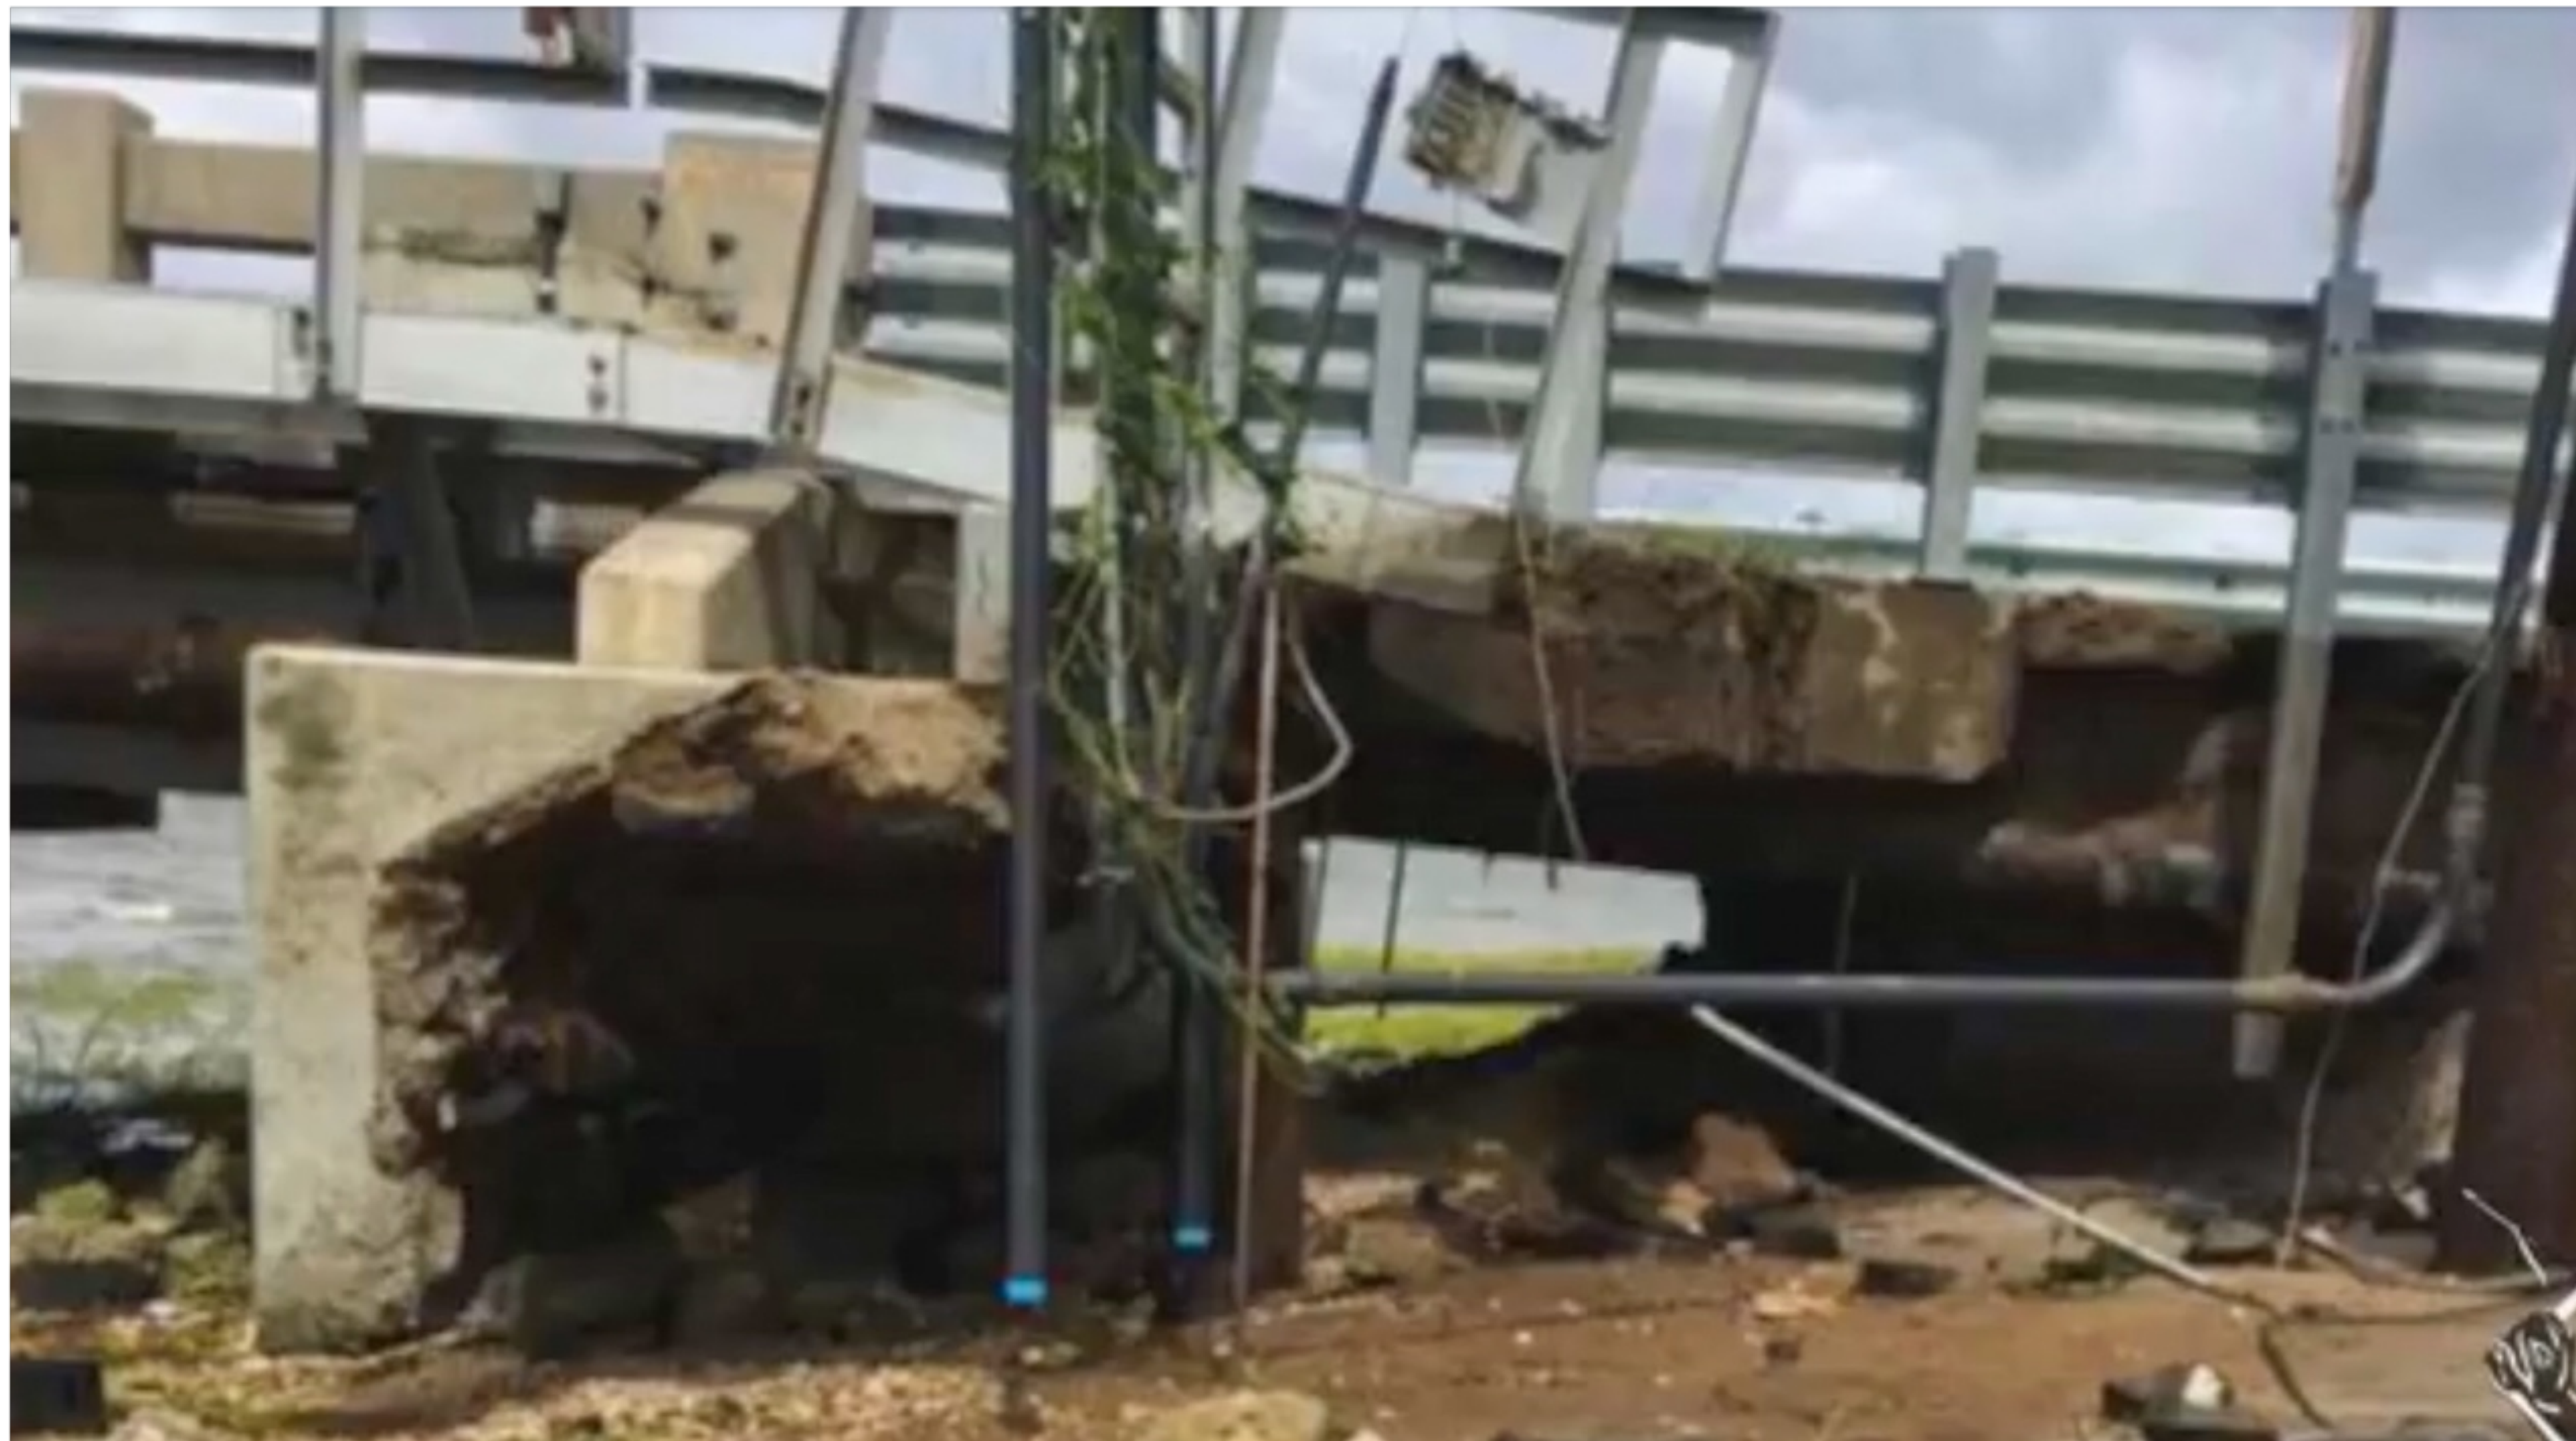
Harbor River bridge hurricane Matthew

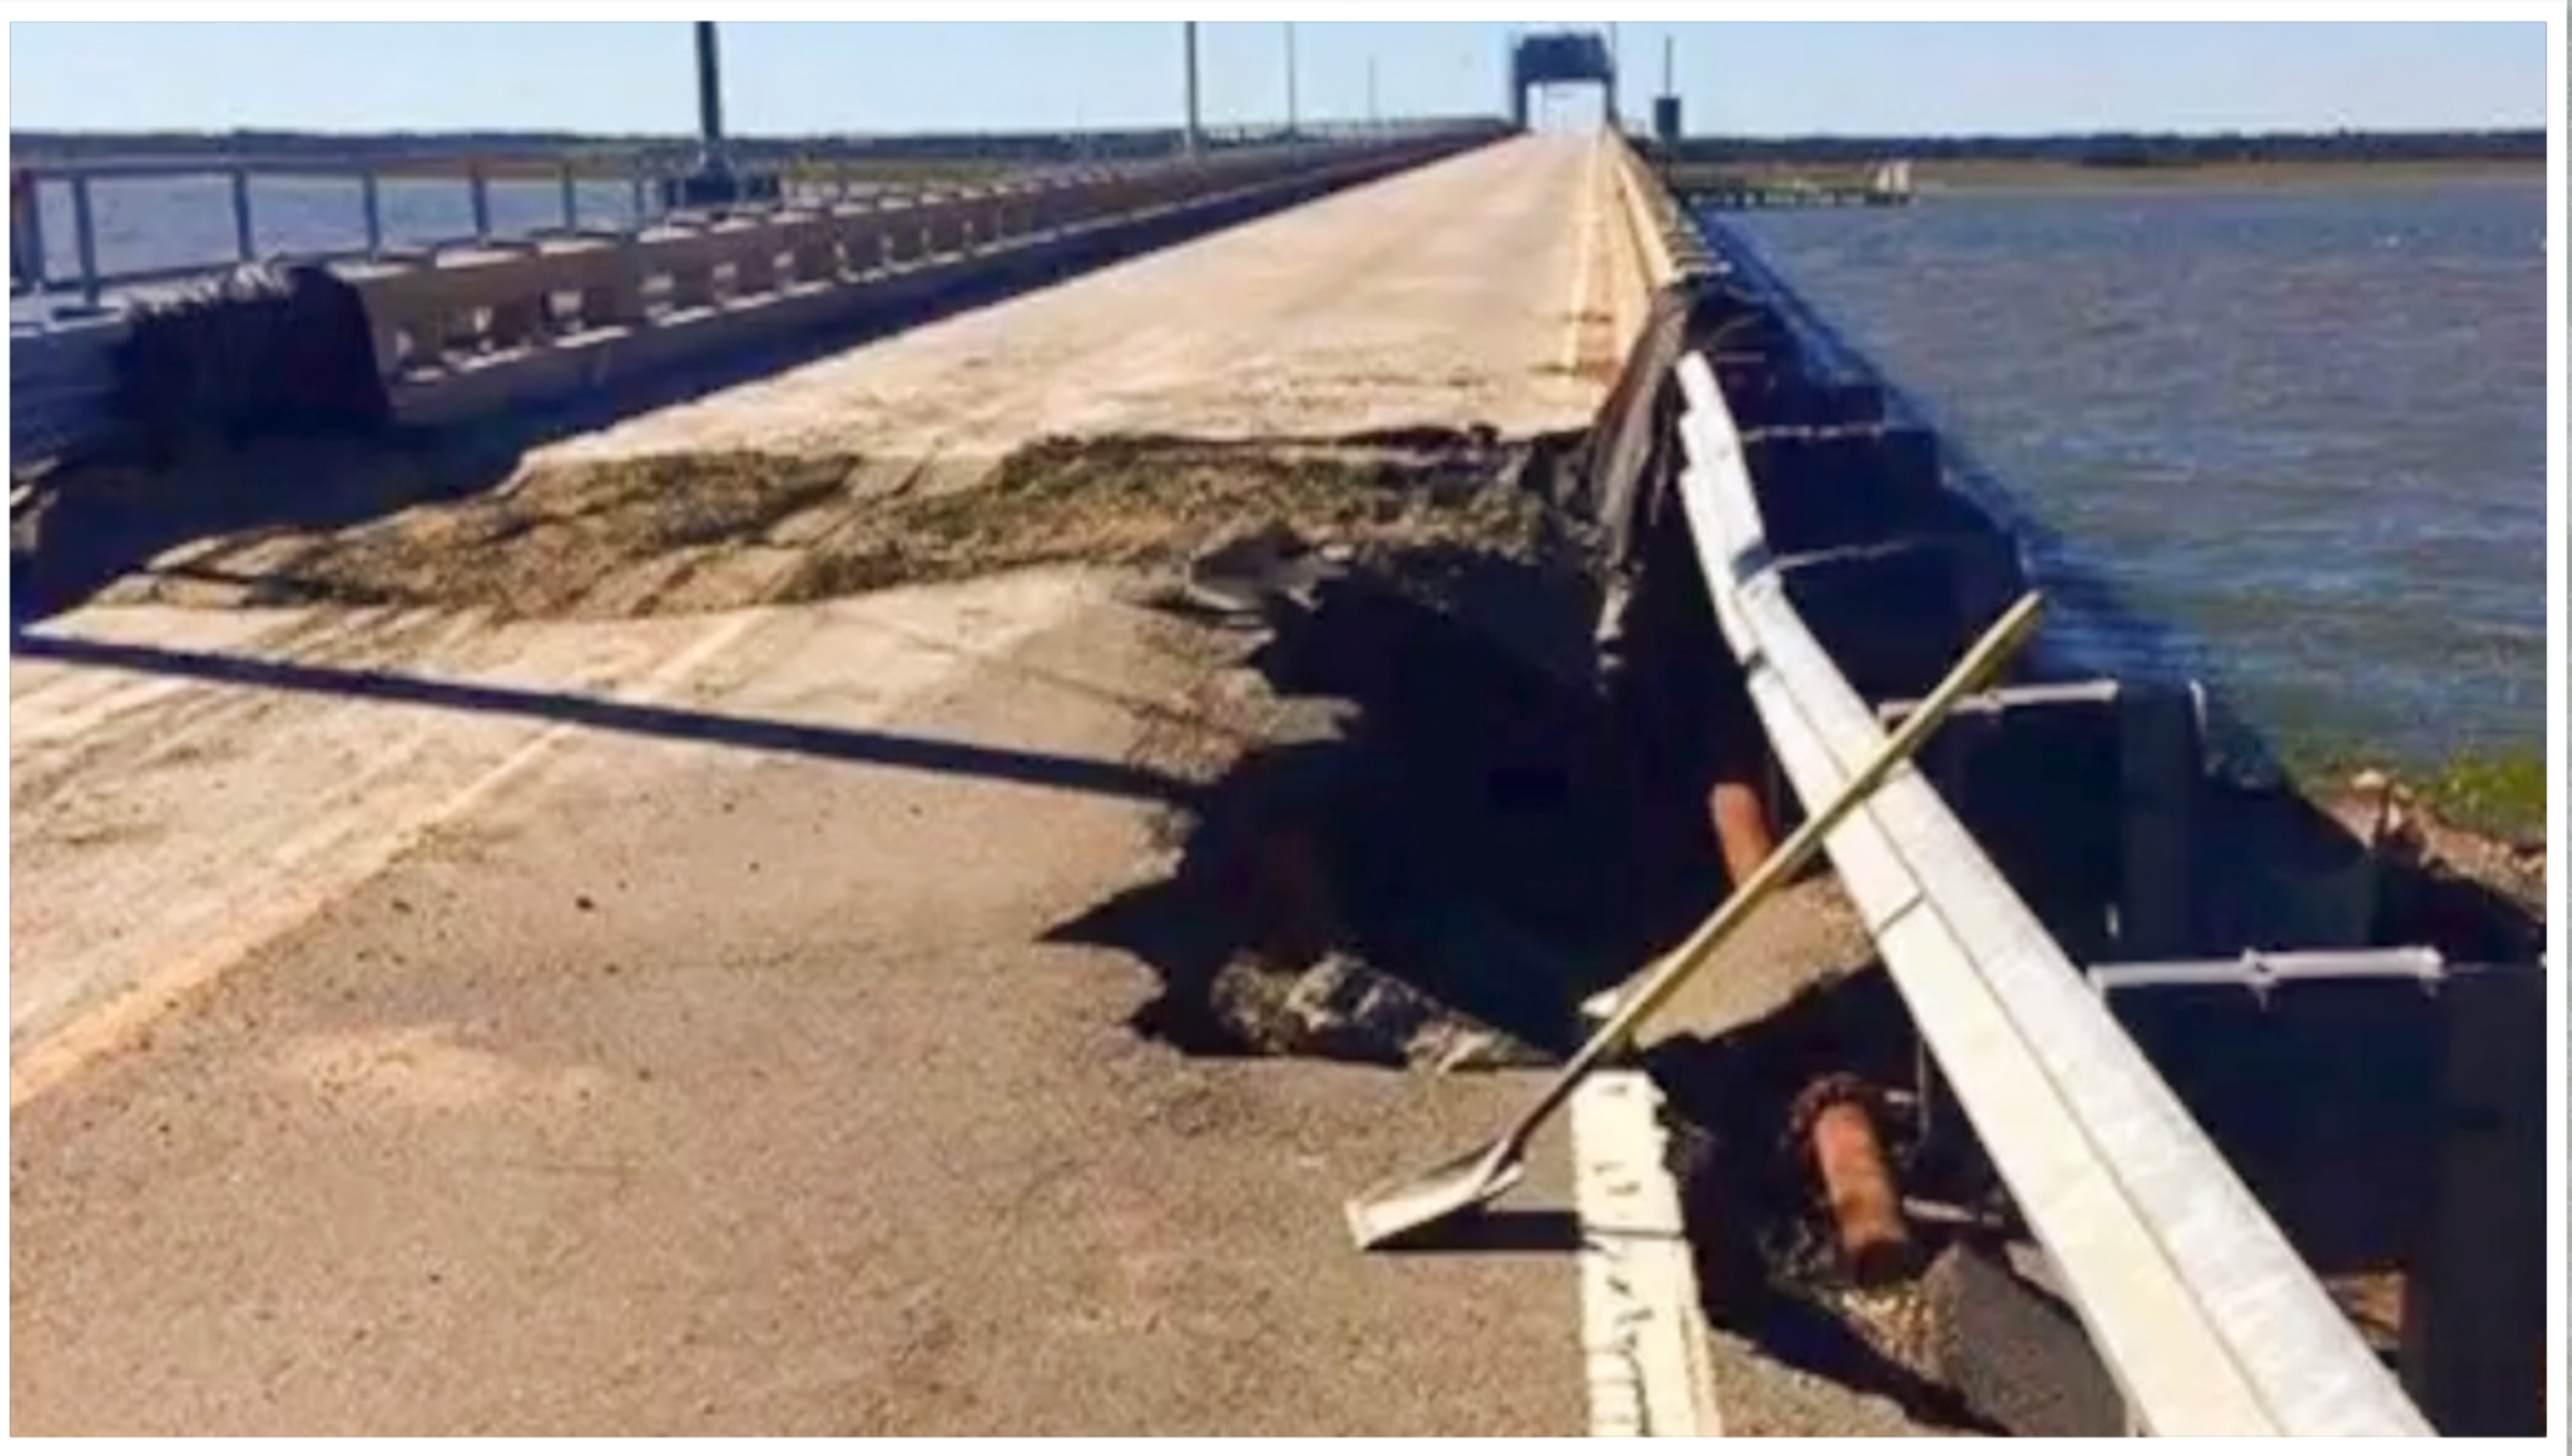
Harbor River bridge hurricane Matthew

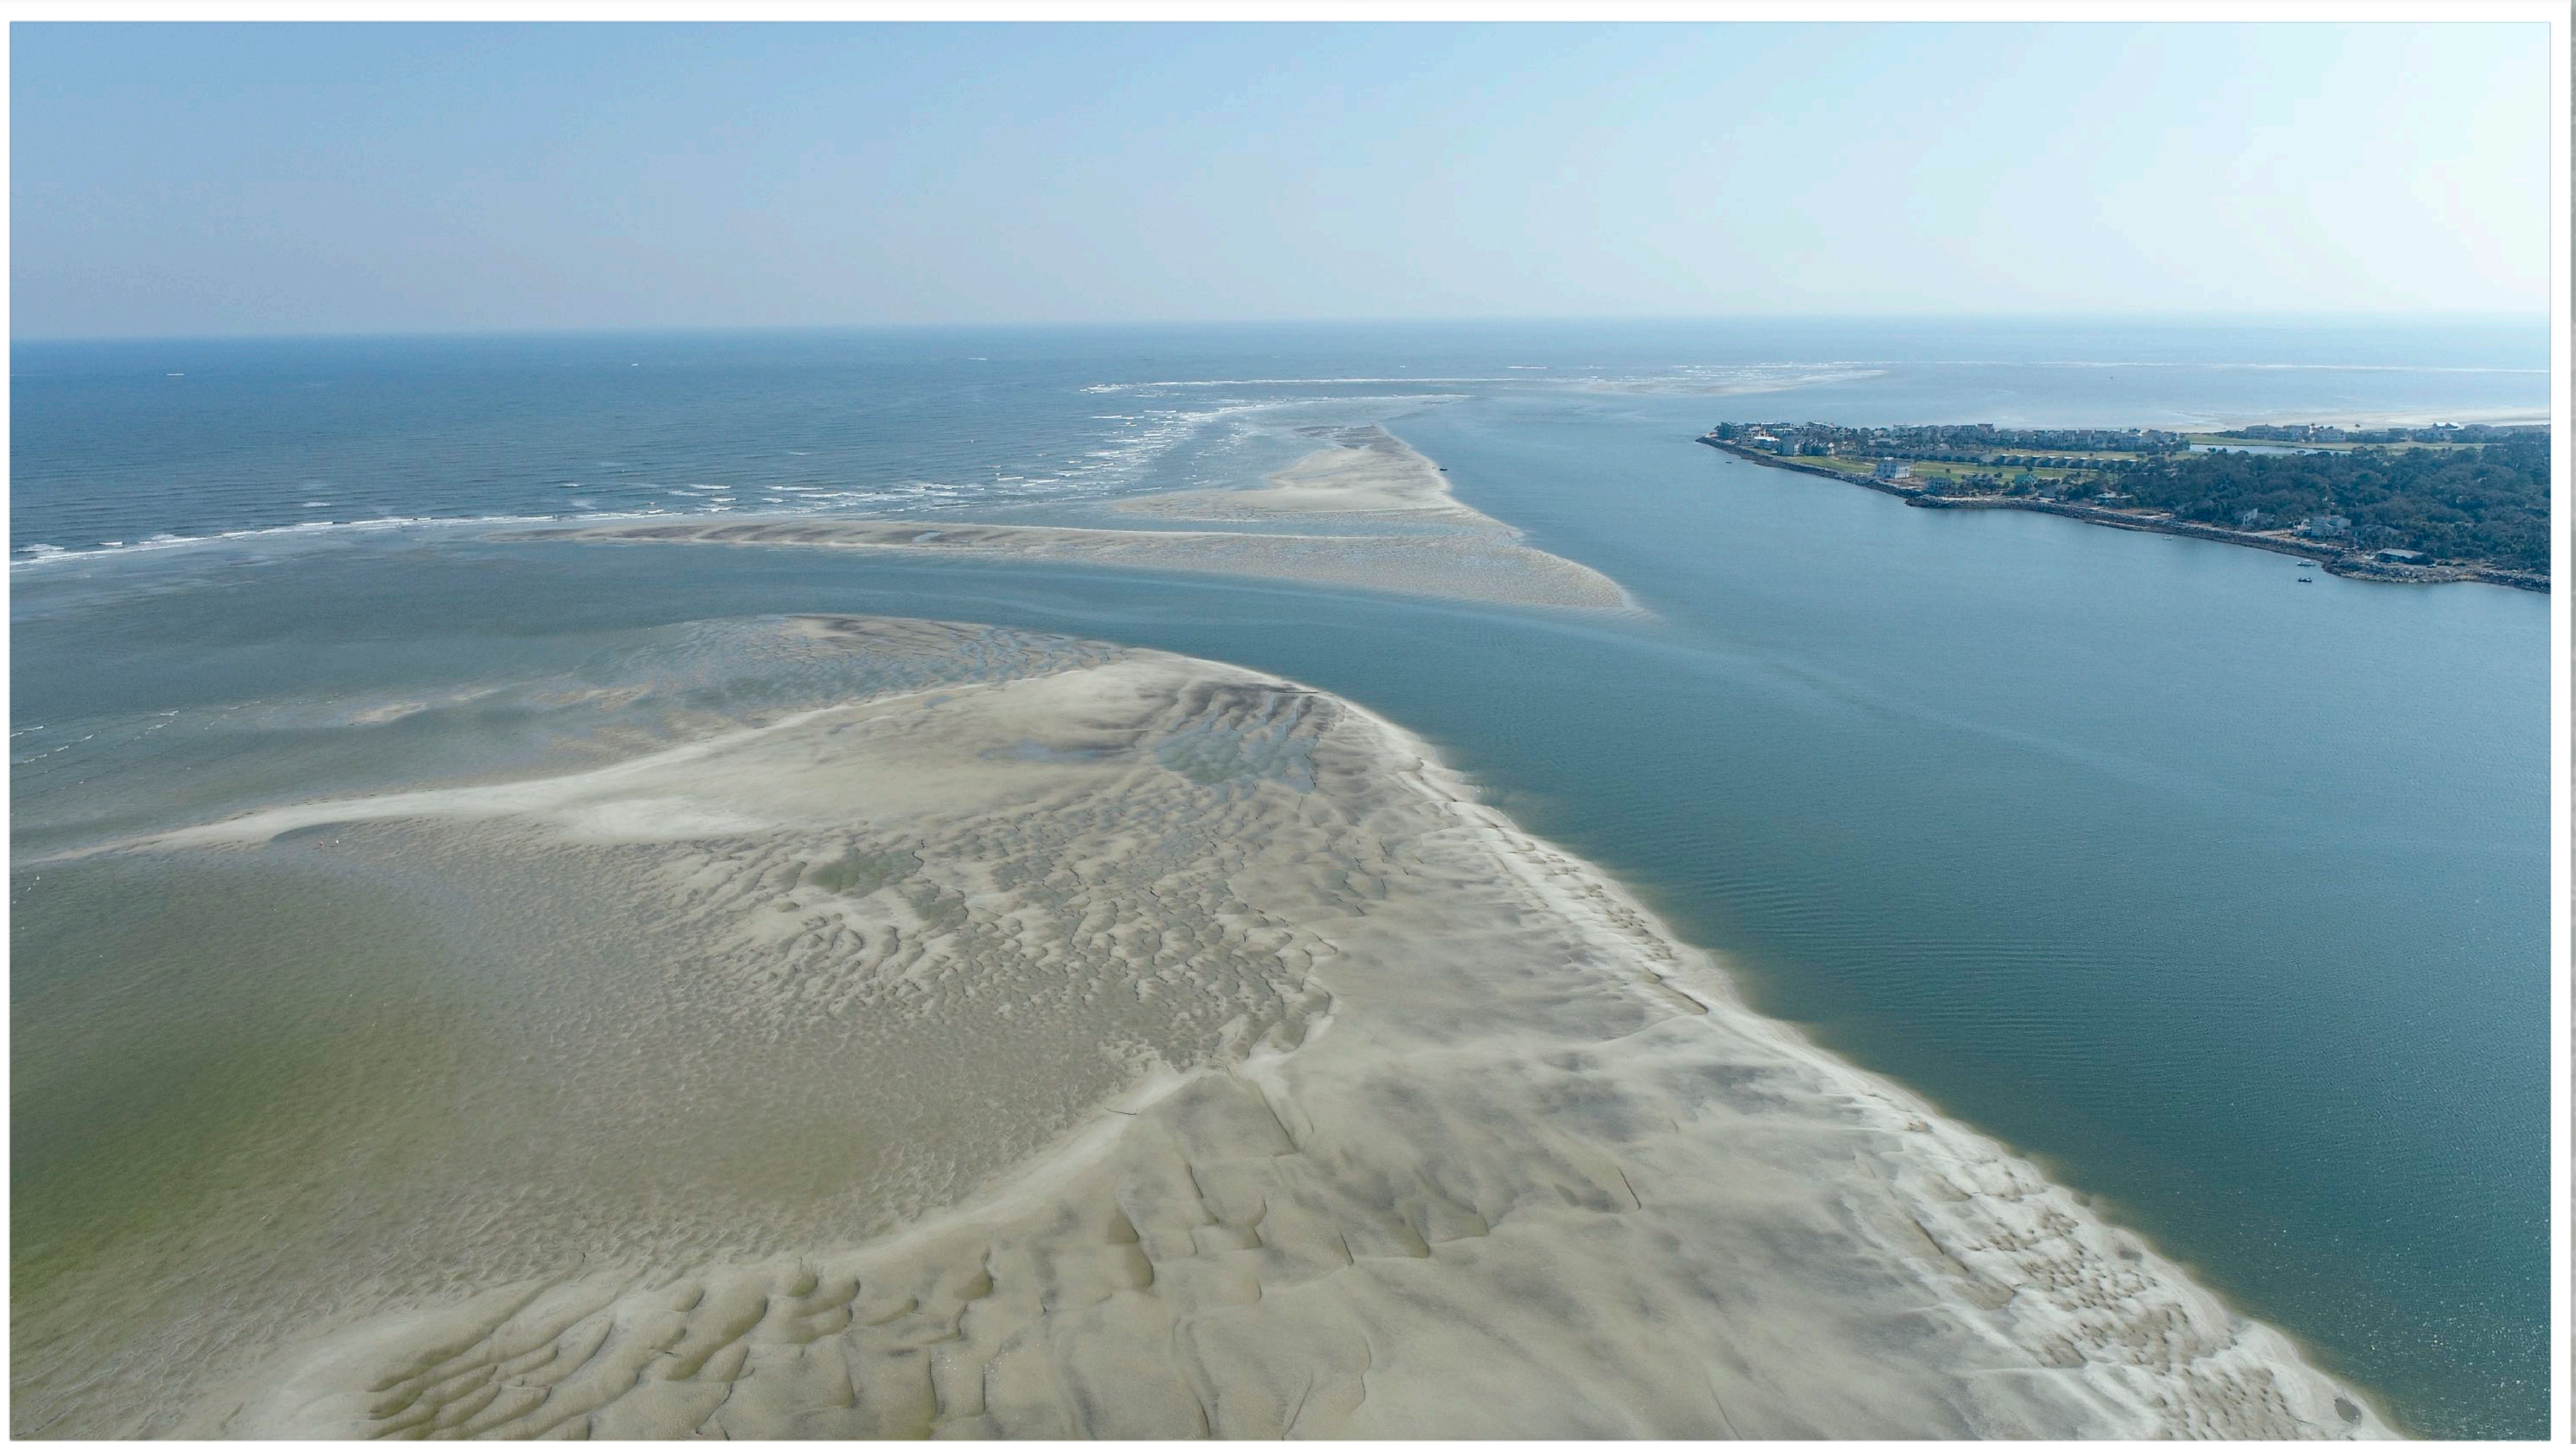
A visual scale of the amount of sand building in the Fripp Inlet.

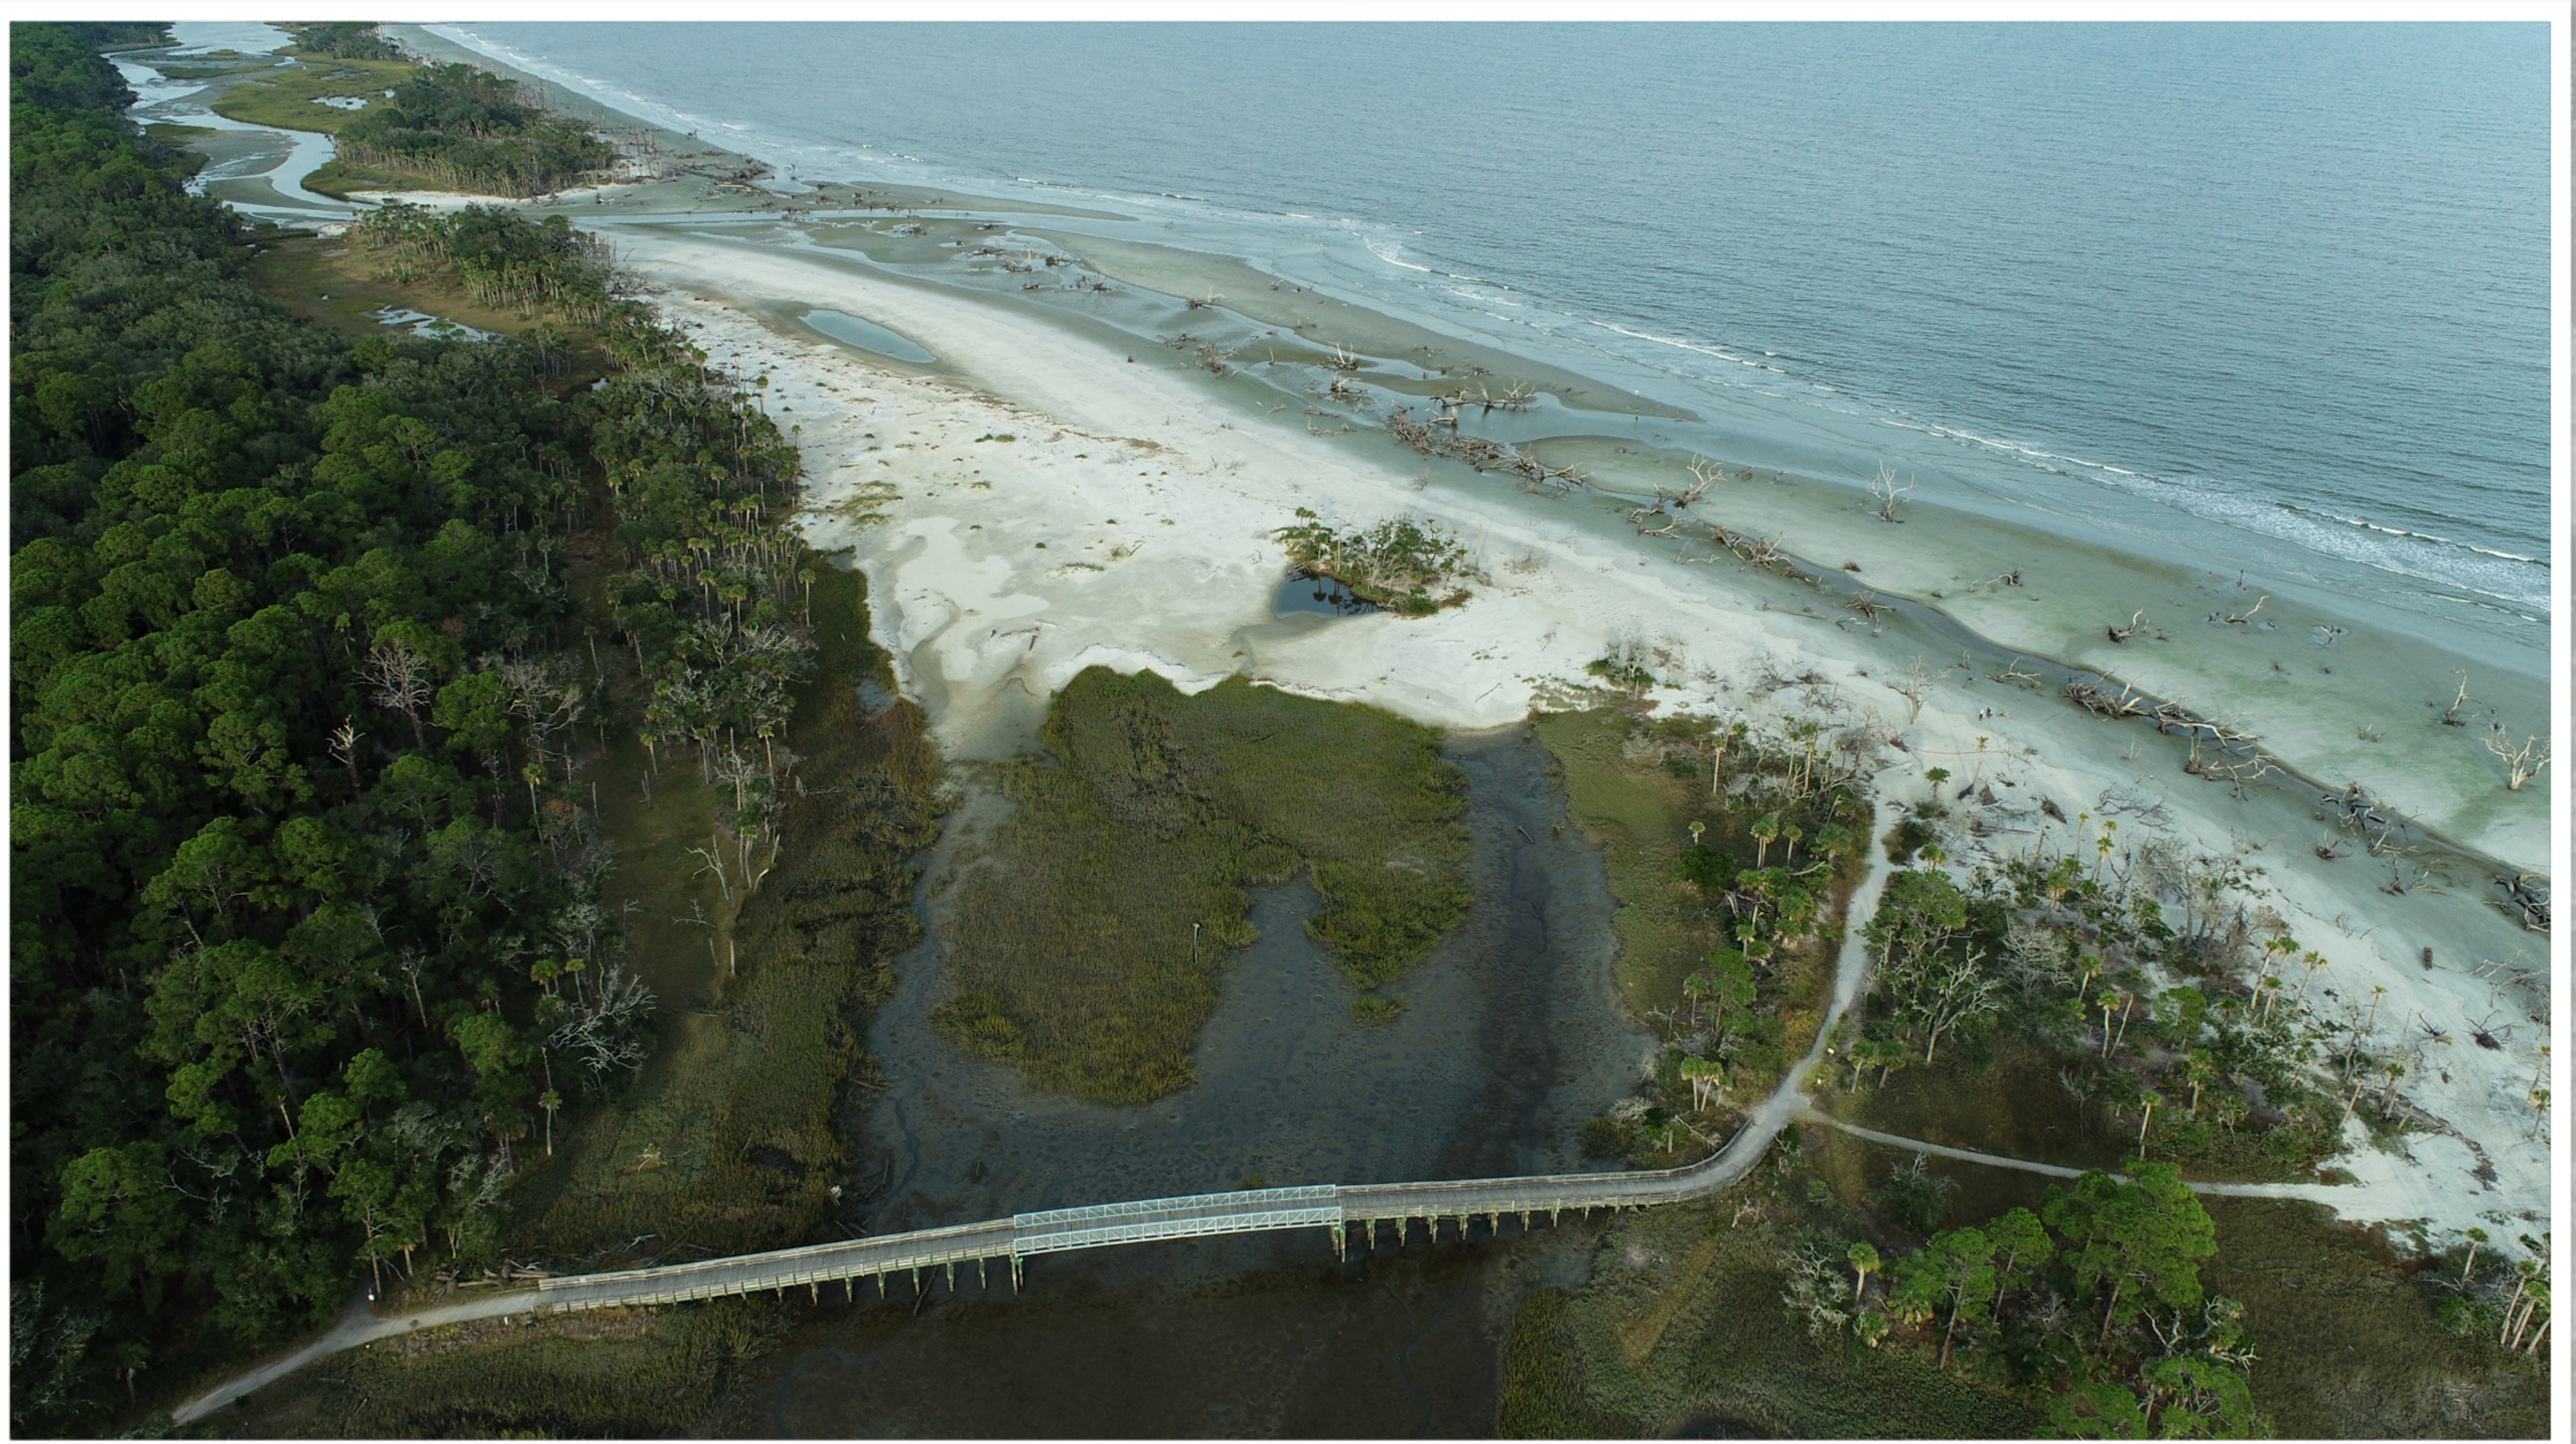
The moving beach.

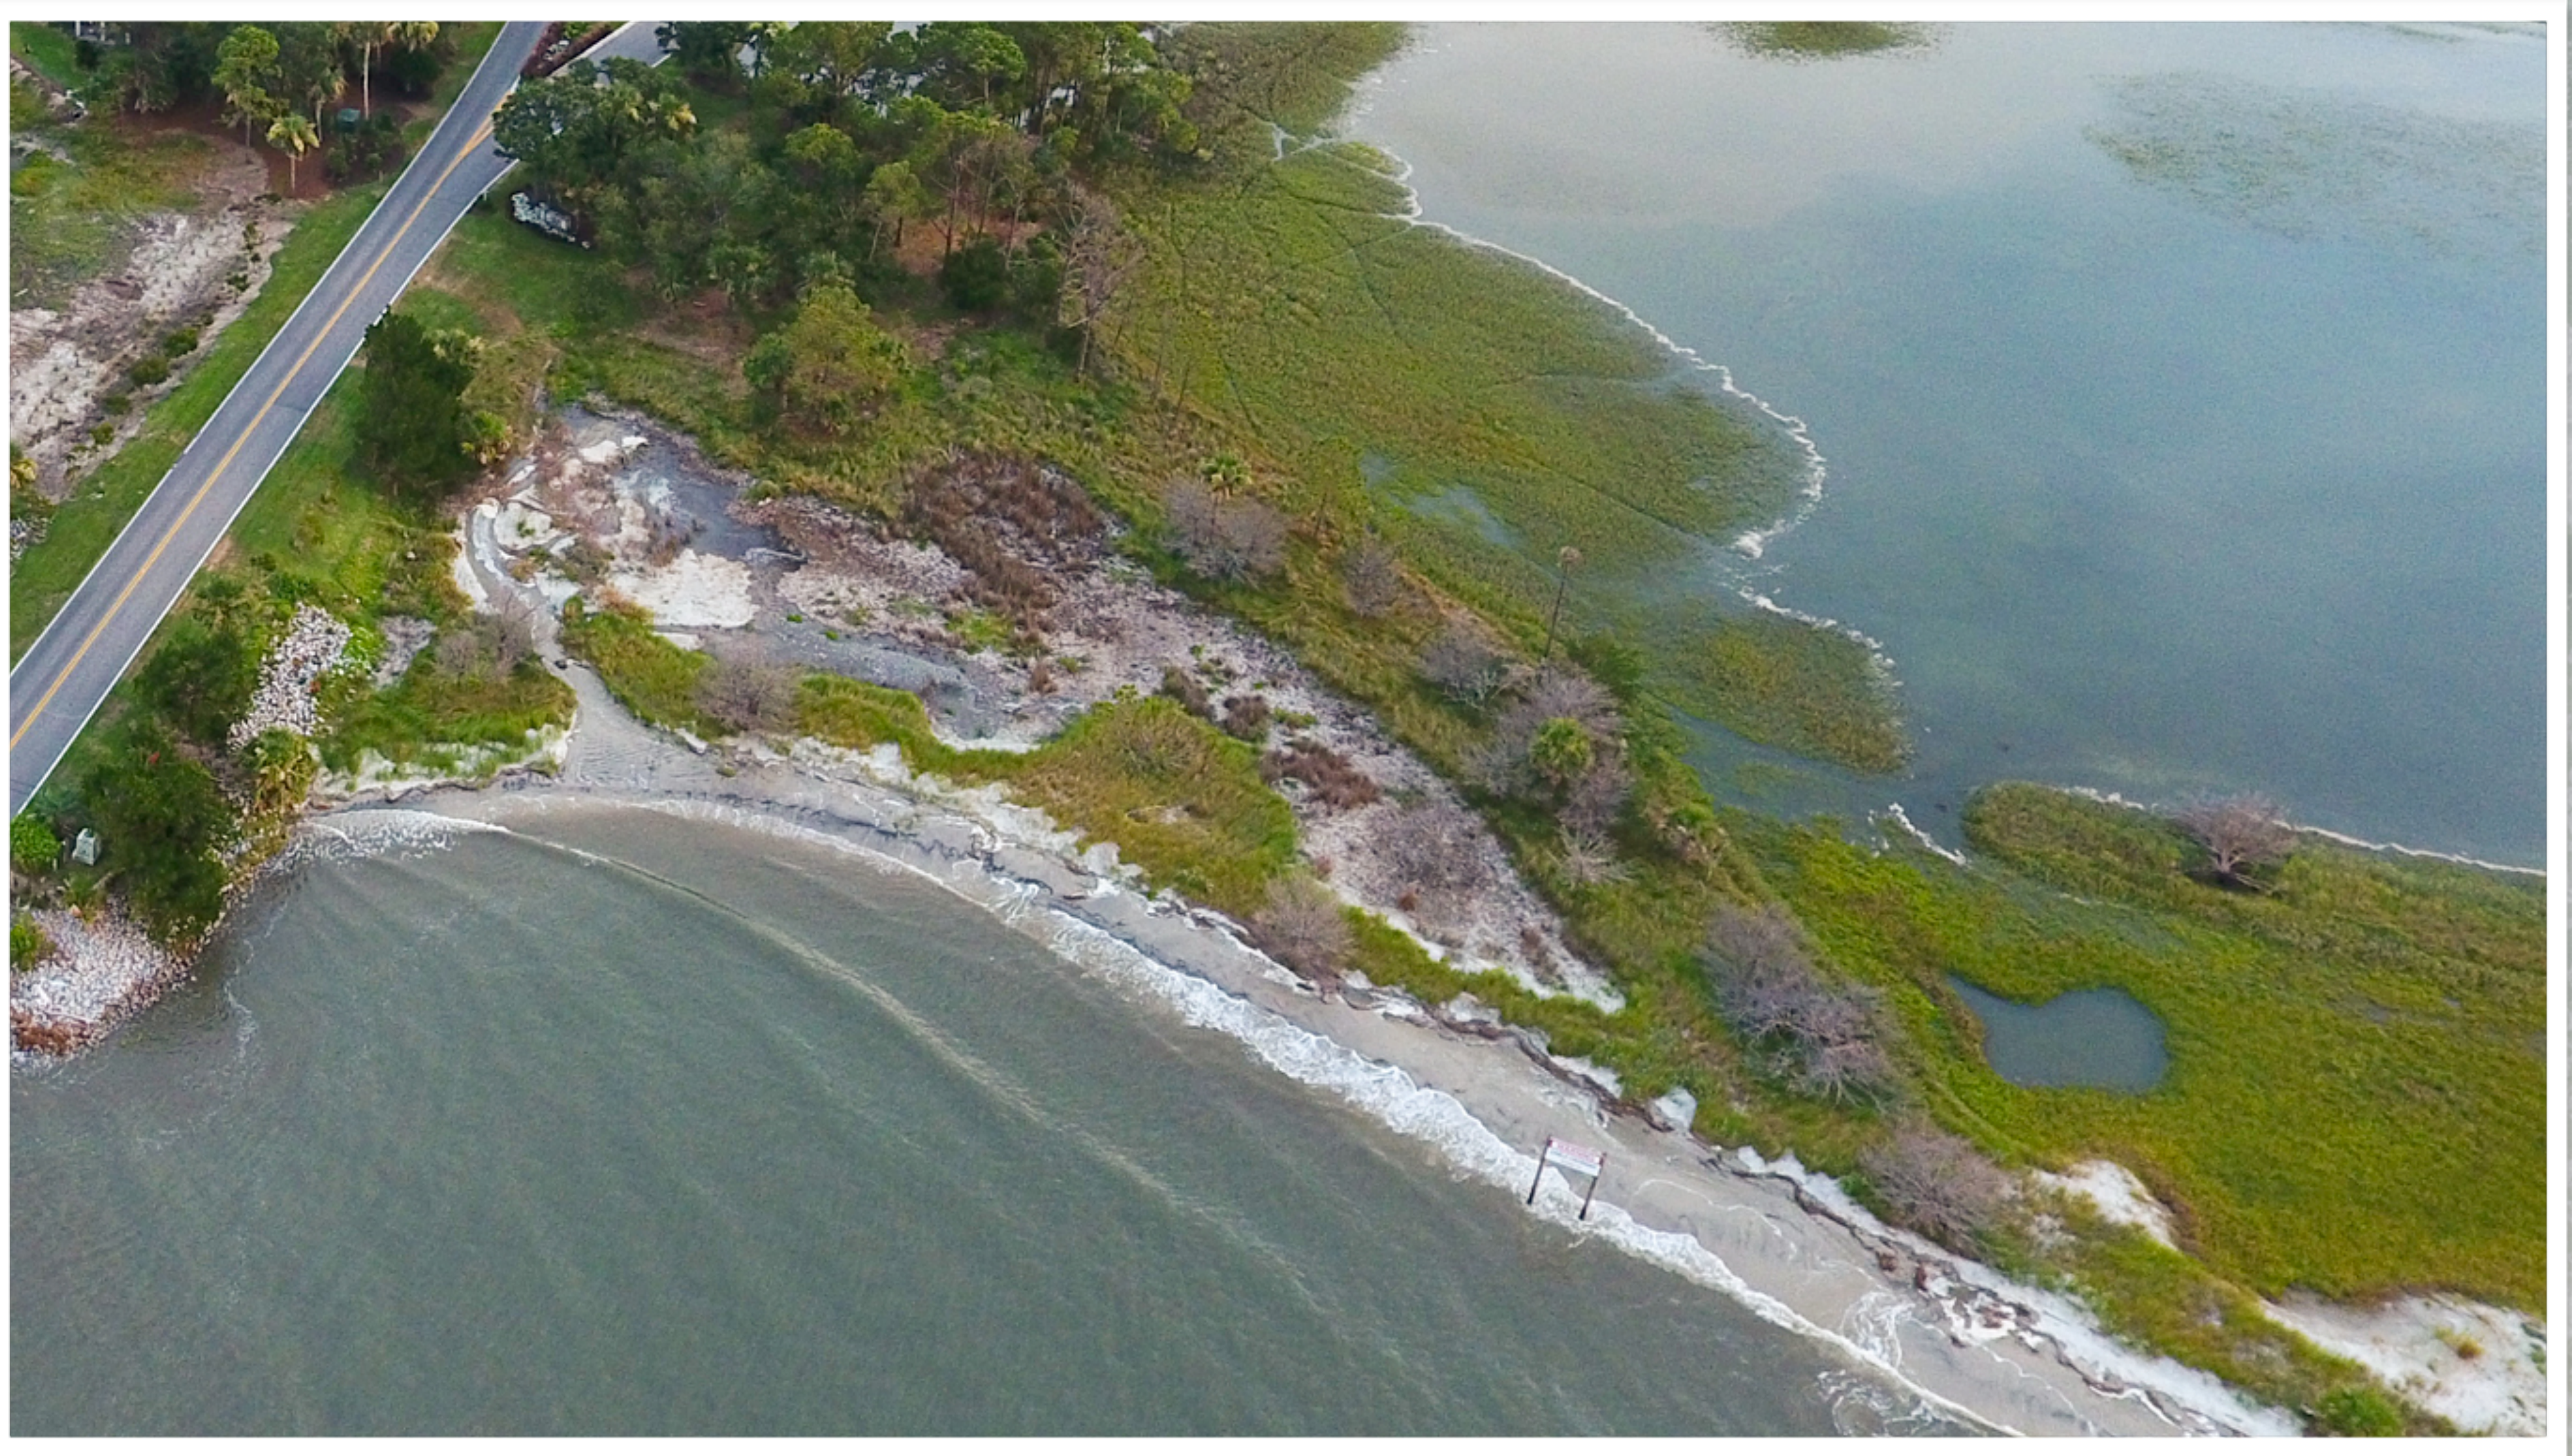
The bridge area (west)

This aerial photo, taken during a king tide event on **July 13, 2018**, shows the large amount of vegetation still visible in the area around to the bridge approach in spite of the flood-like conditions.

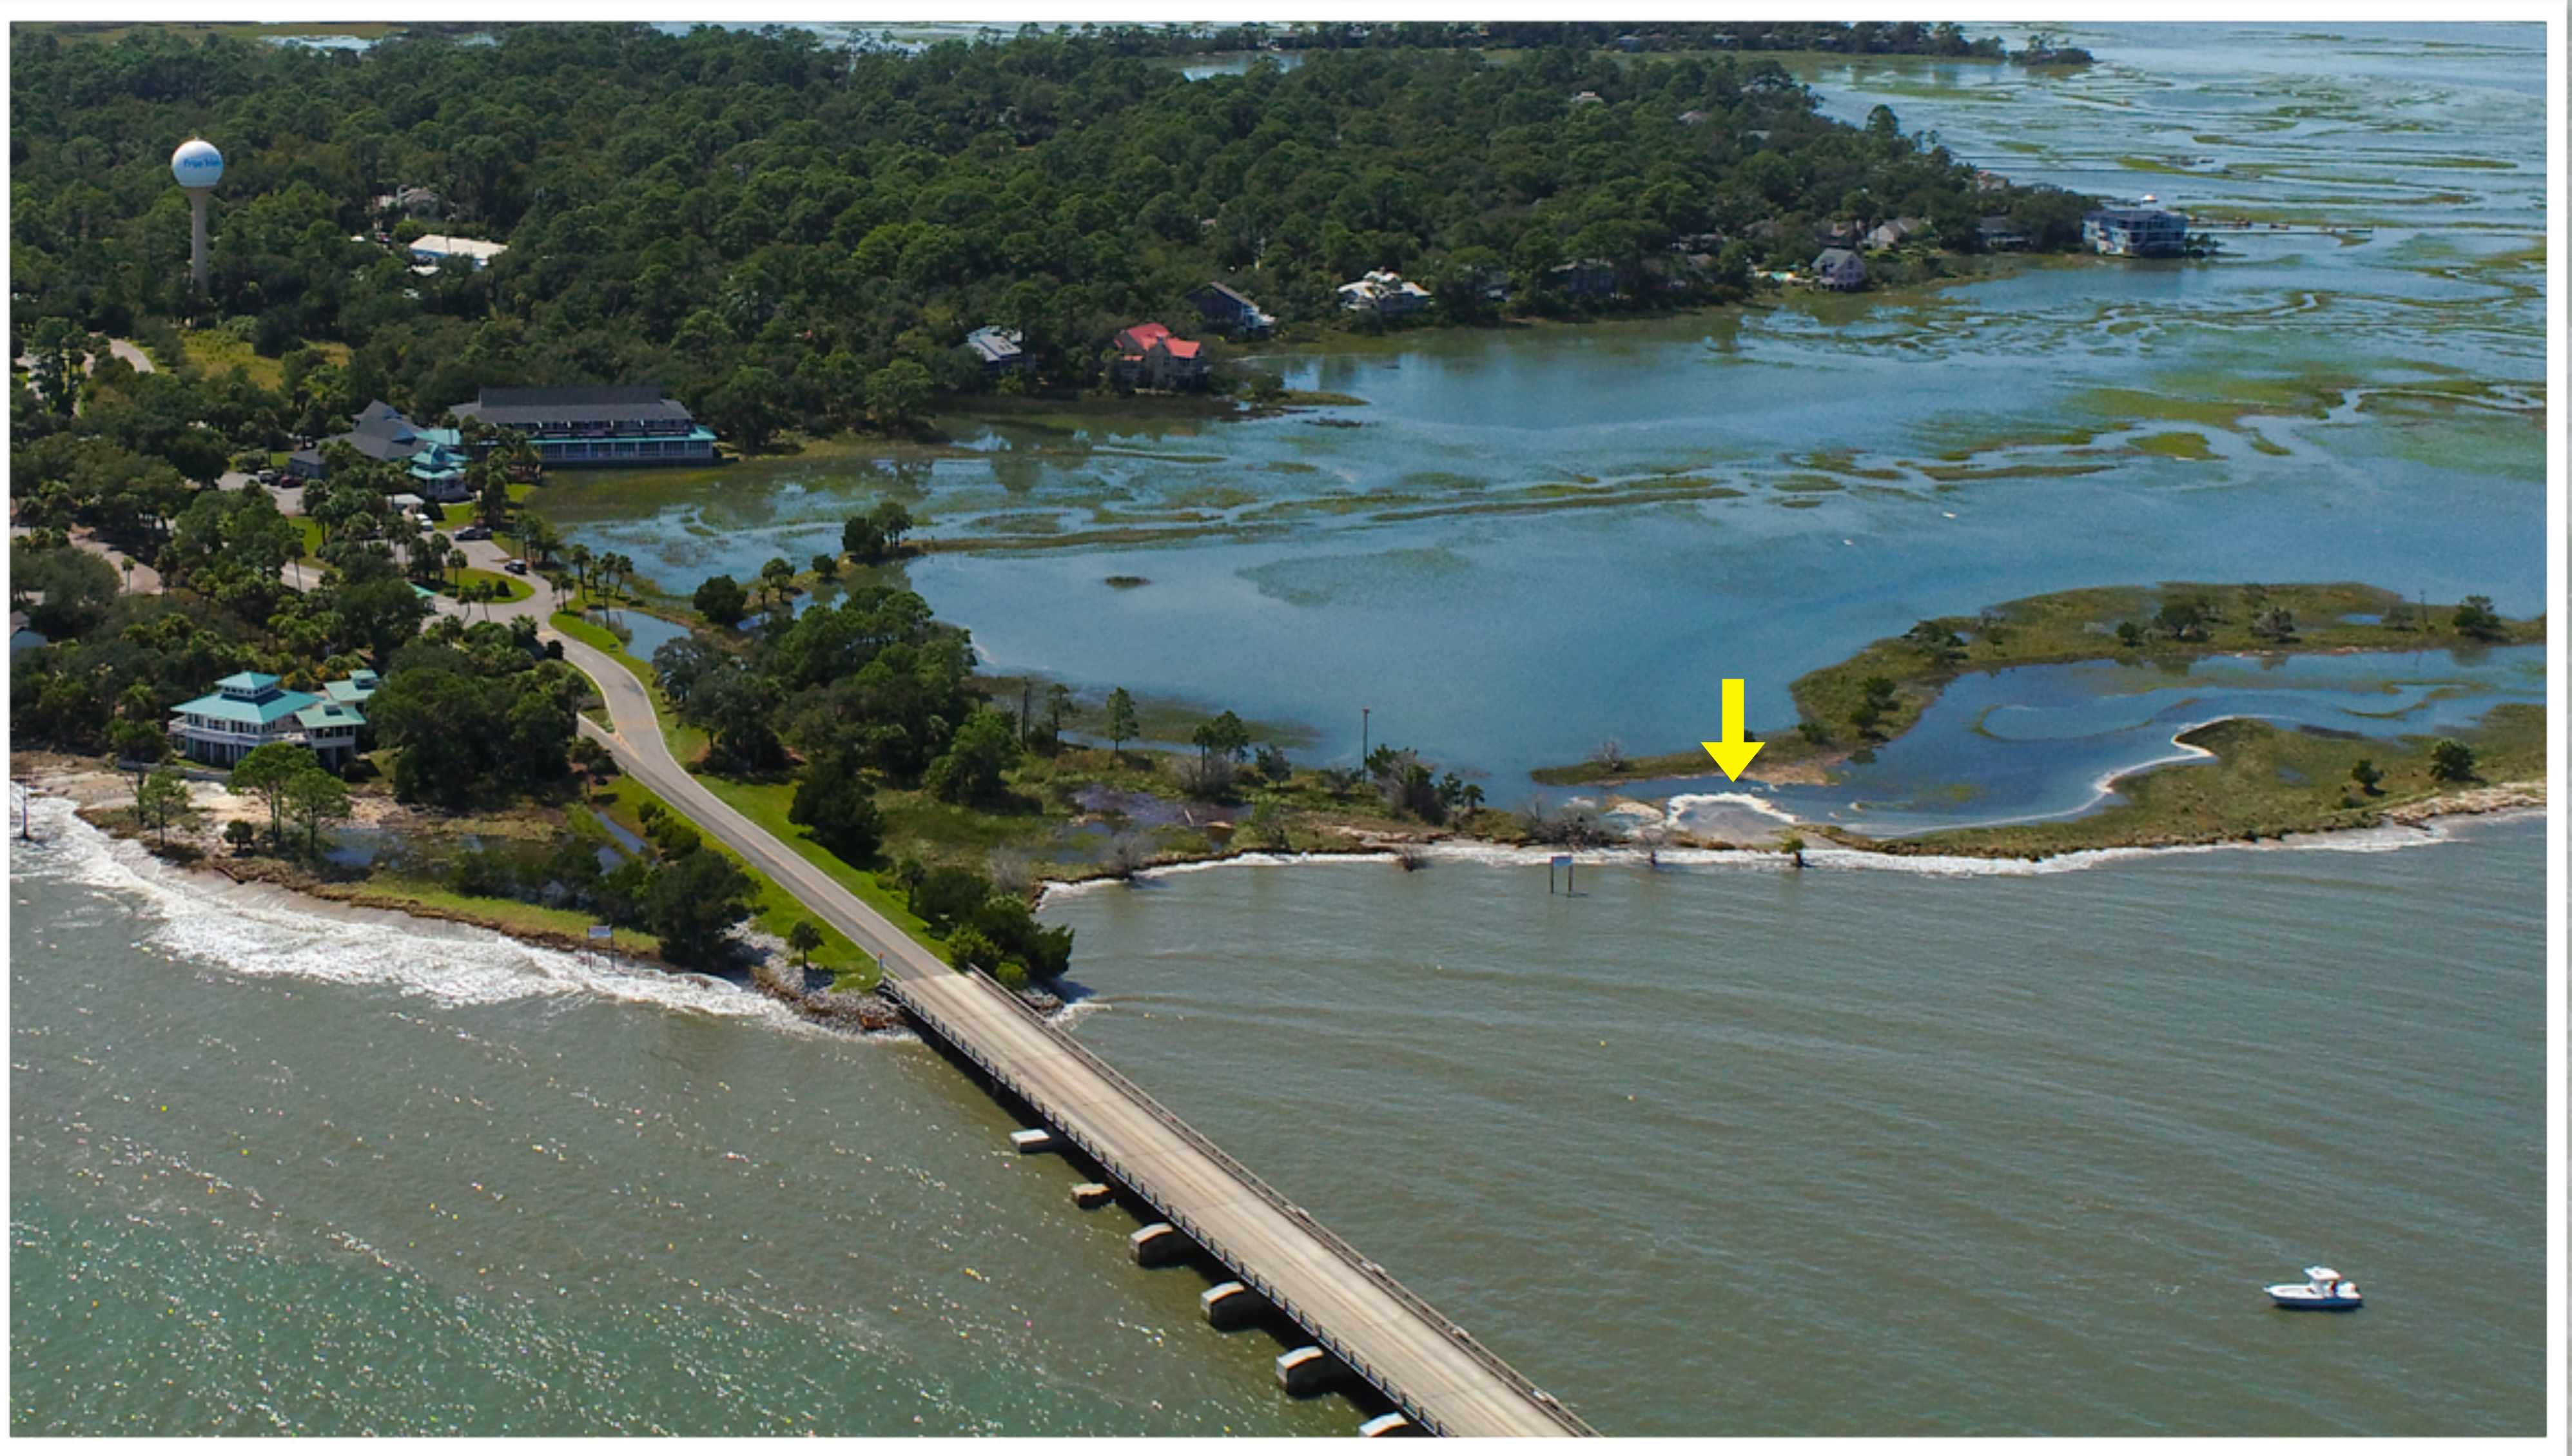
This photo, taken during a king tide event on **September 22, 2020**, shows a break in the vegetation boundary where sea water broke through from the inlet into the flooded salt marsh area.
