Shoreline Status

Shoreline Committee - Town Hall

May 14, 2022

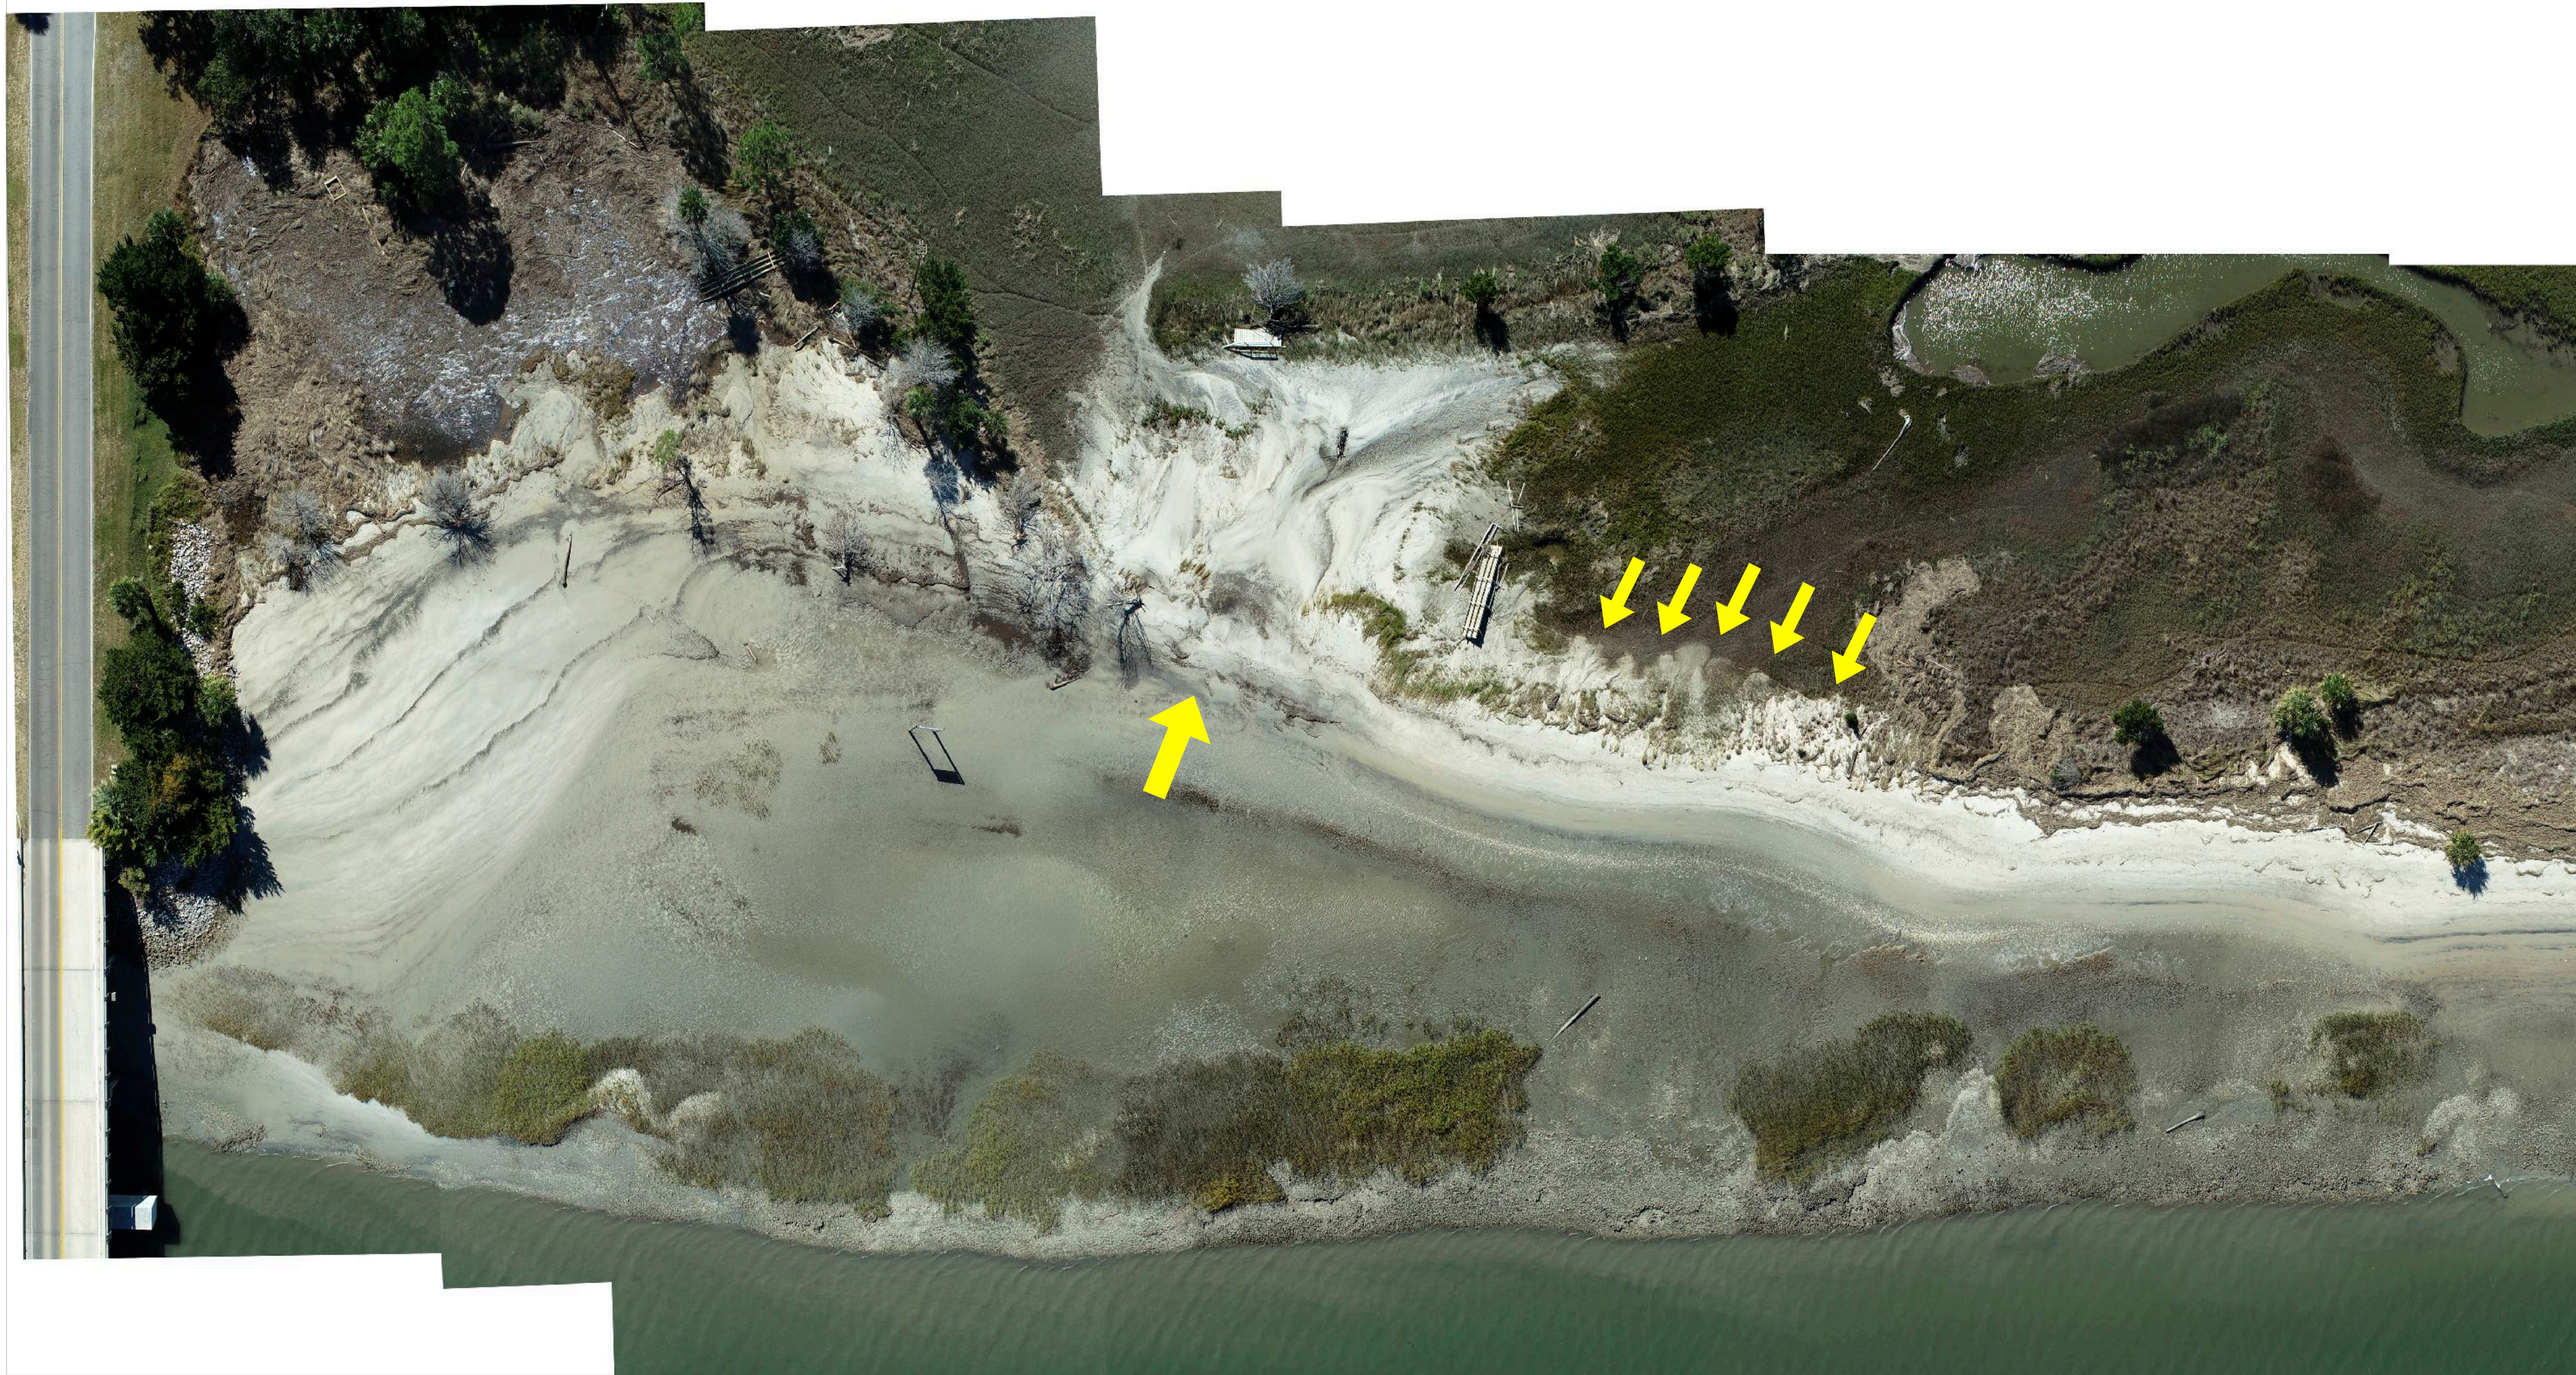
This aerial photo montage, taken a year later, at low tide on **November 15, 2021** shows the breached area has not healed and remains filled with sand. The large arrow points to the main breach, the smaller arrows point to where expanding sand has begun to bury other nearby vegetation.

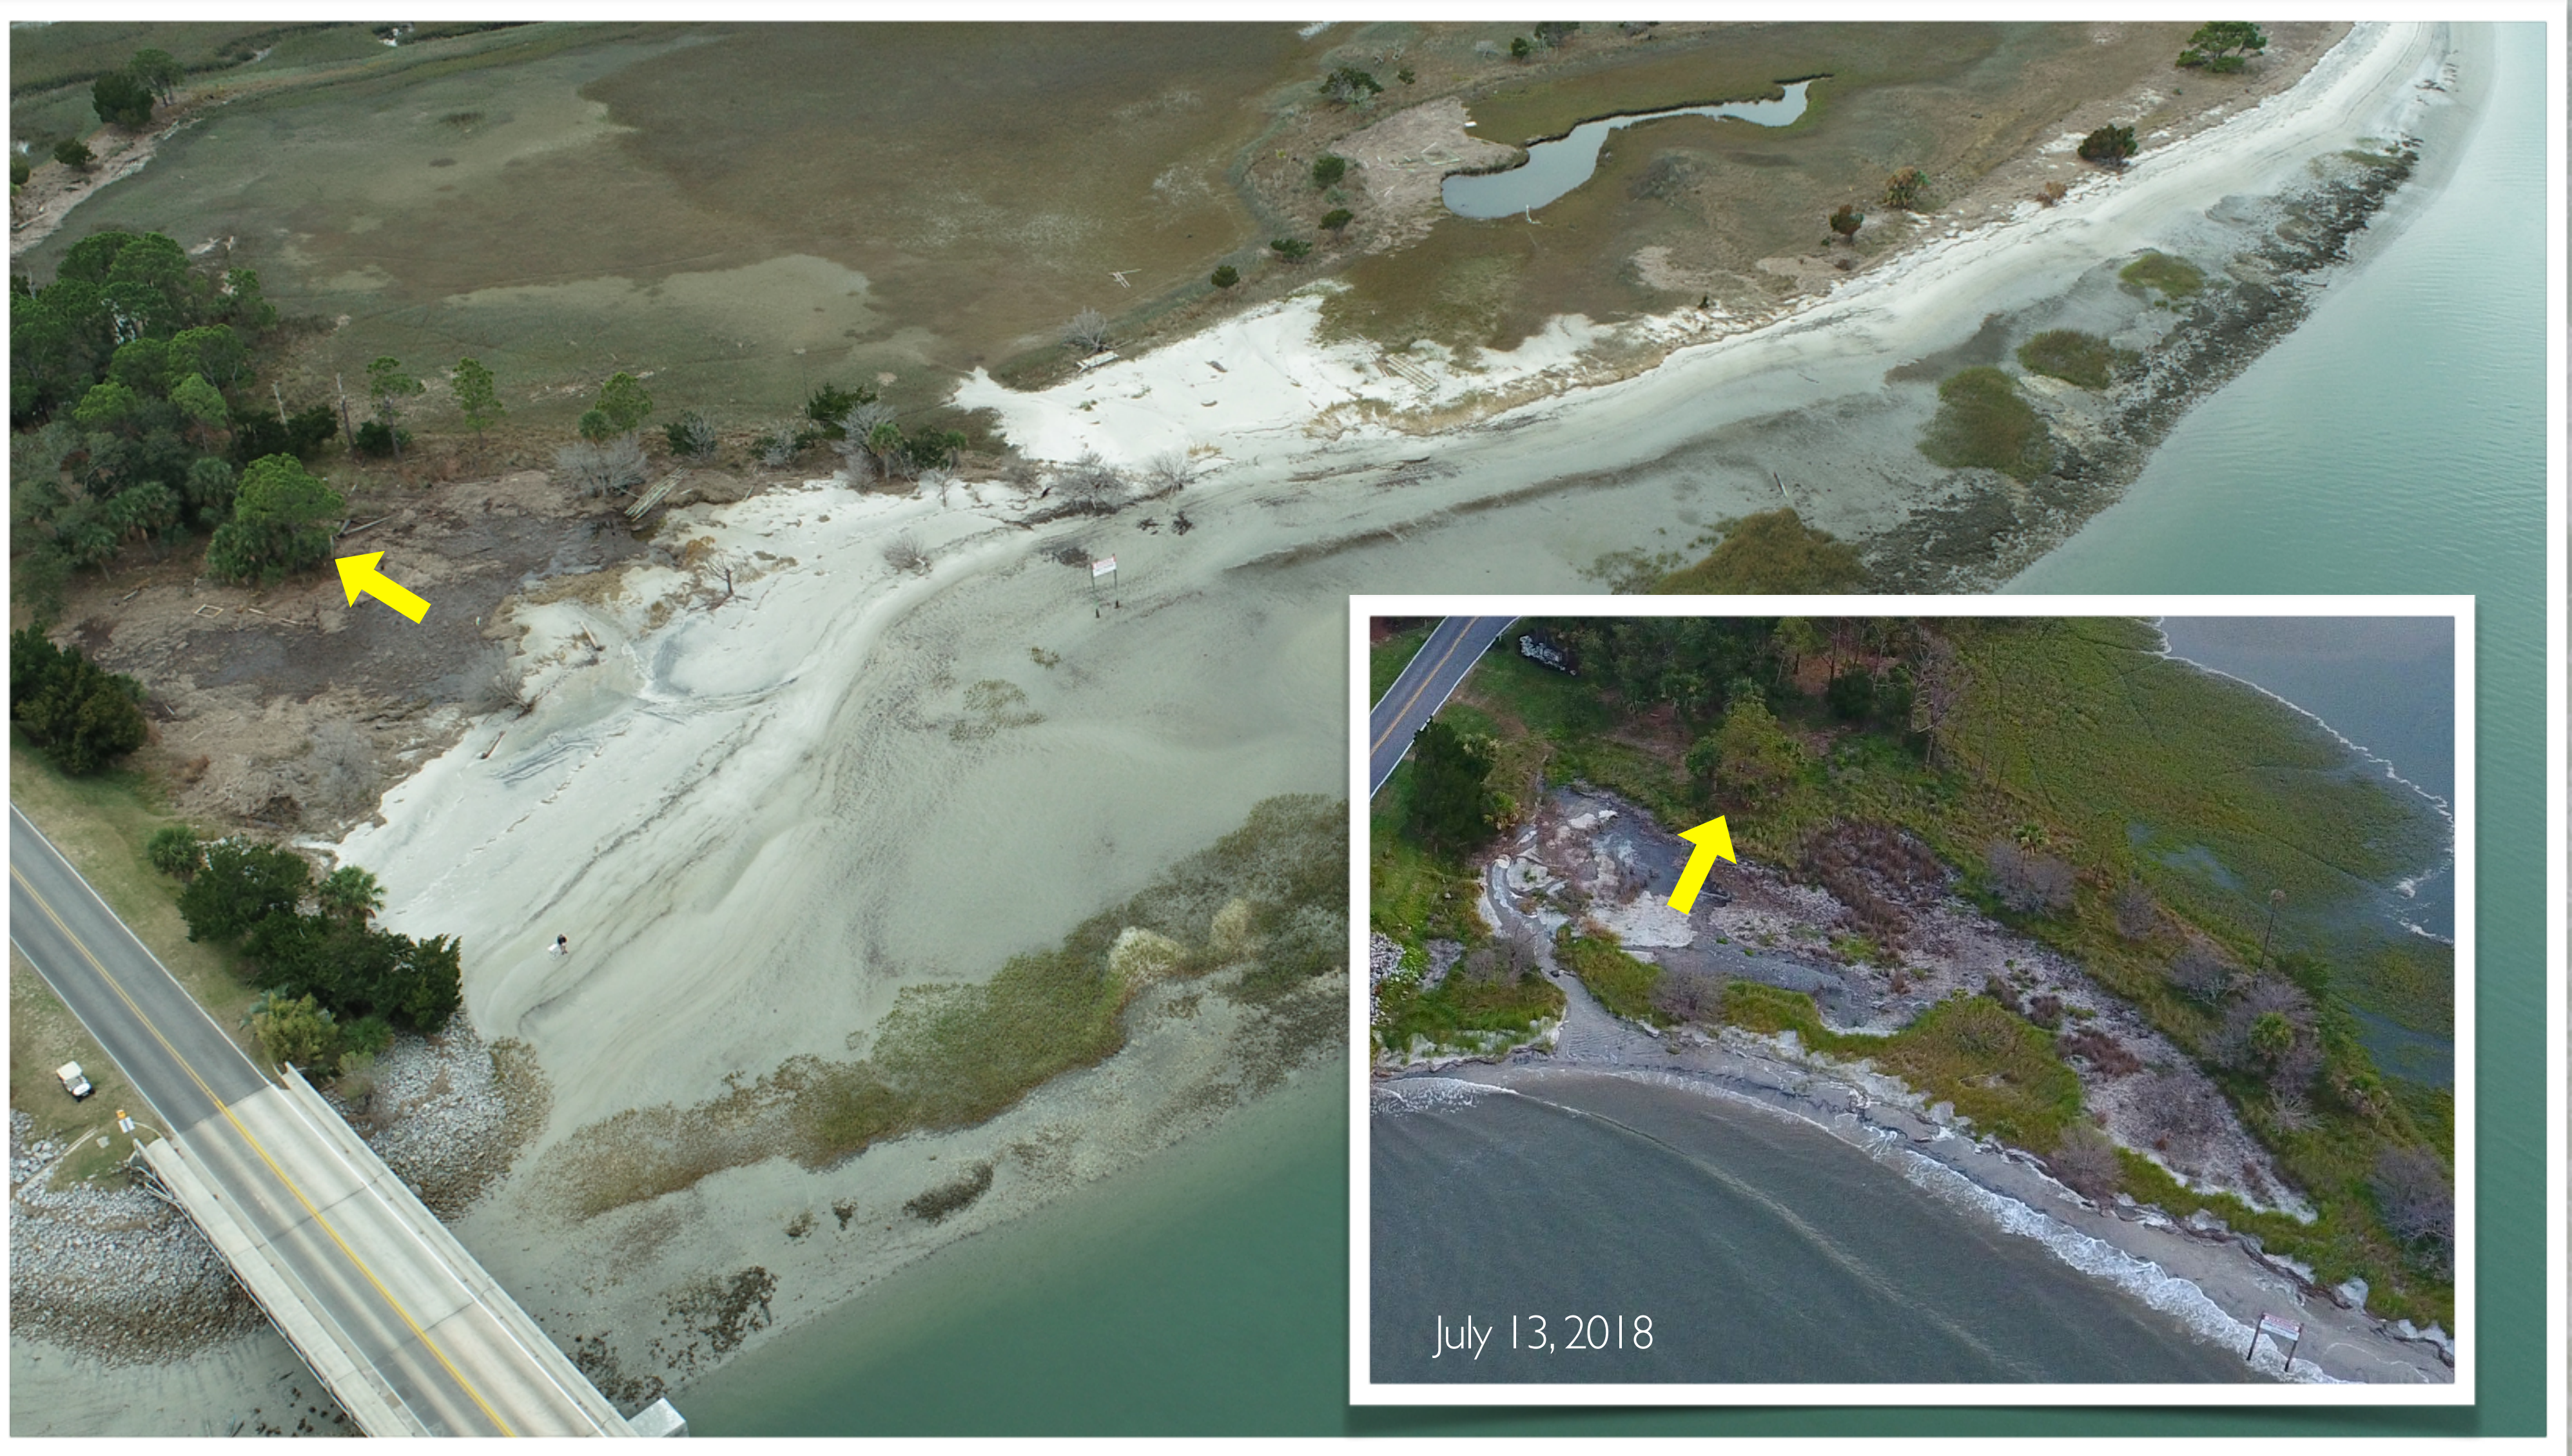
The same photo shows wrack is being pushed further and further towards Tarpon Boulevard indicating there is less vegetation available to slow the waves and halt the floating debris.

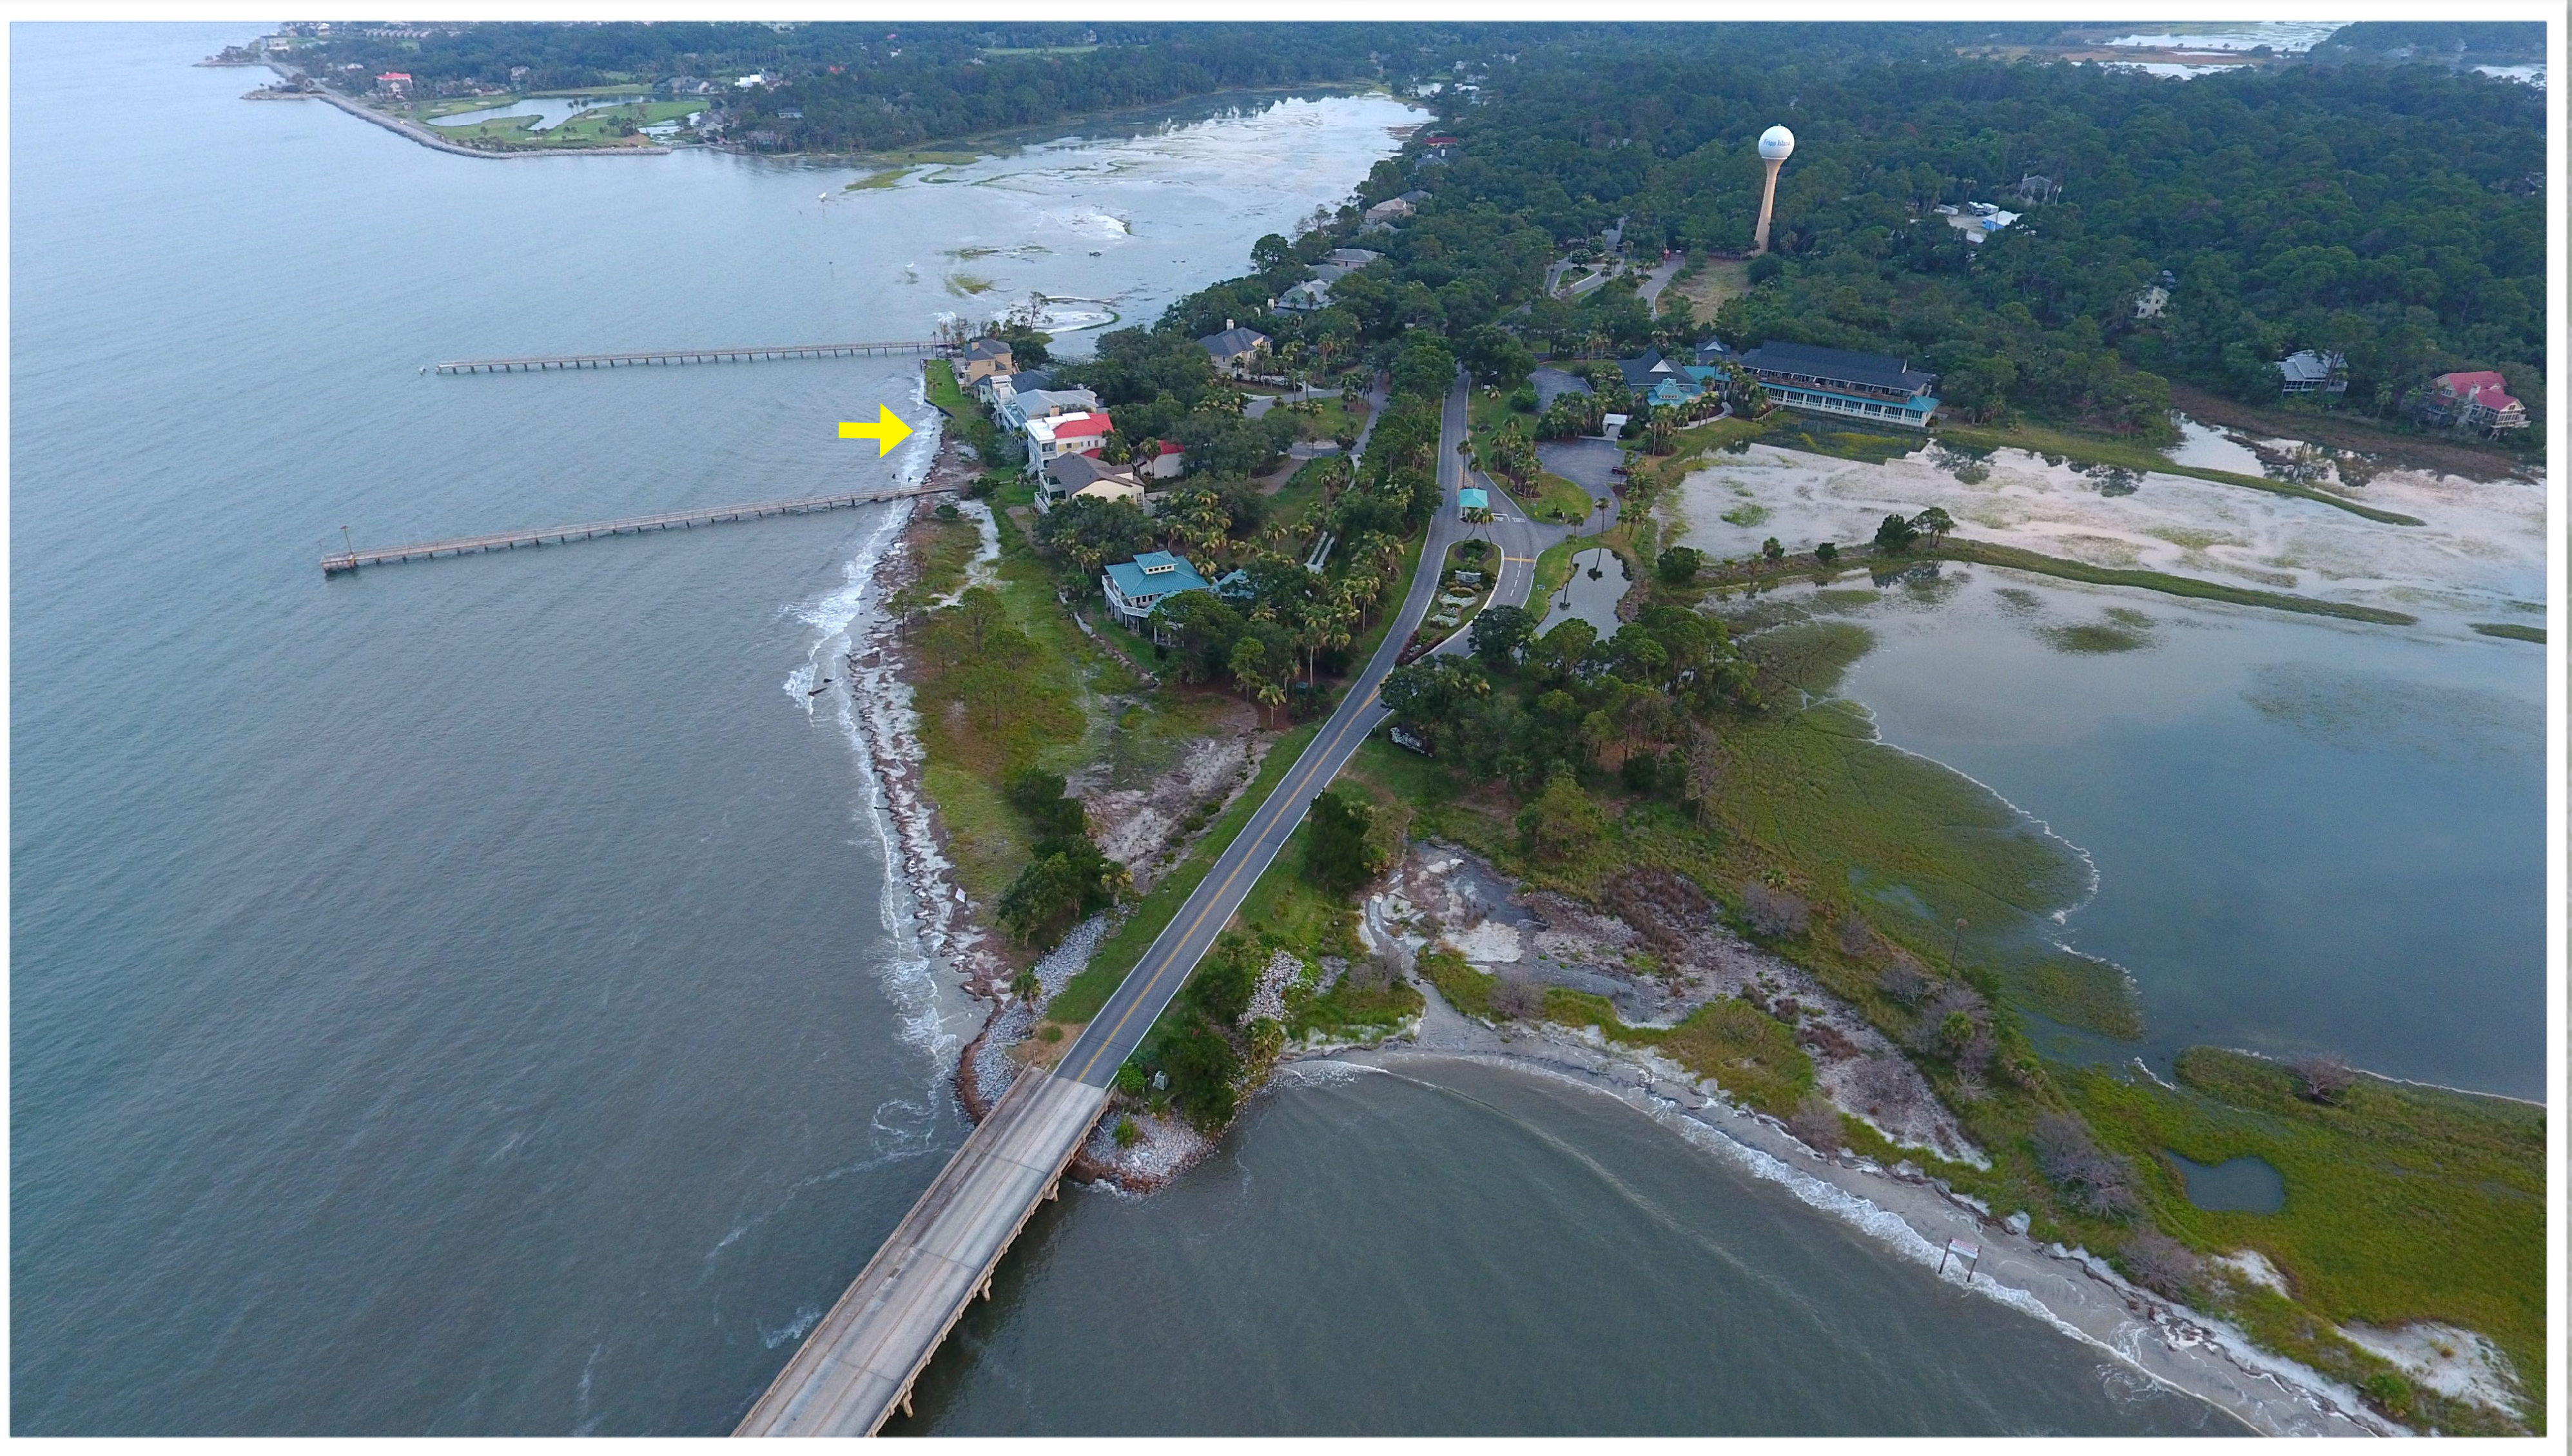
The bridge area (east)

This aerial photo, taken during a king tide event on **July 13, 2018**, shows the grassy area in front of the homes remains for-the-most-part, dry and intact even during higher than normal flooding.

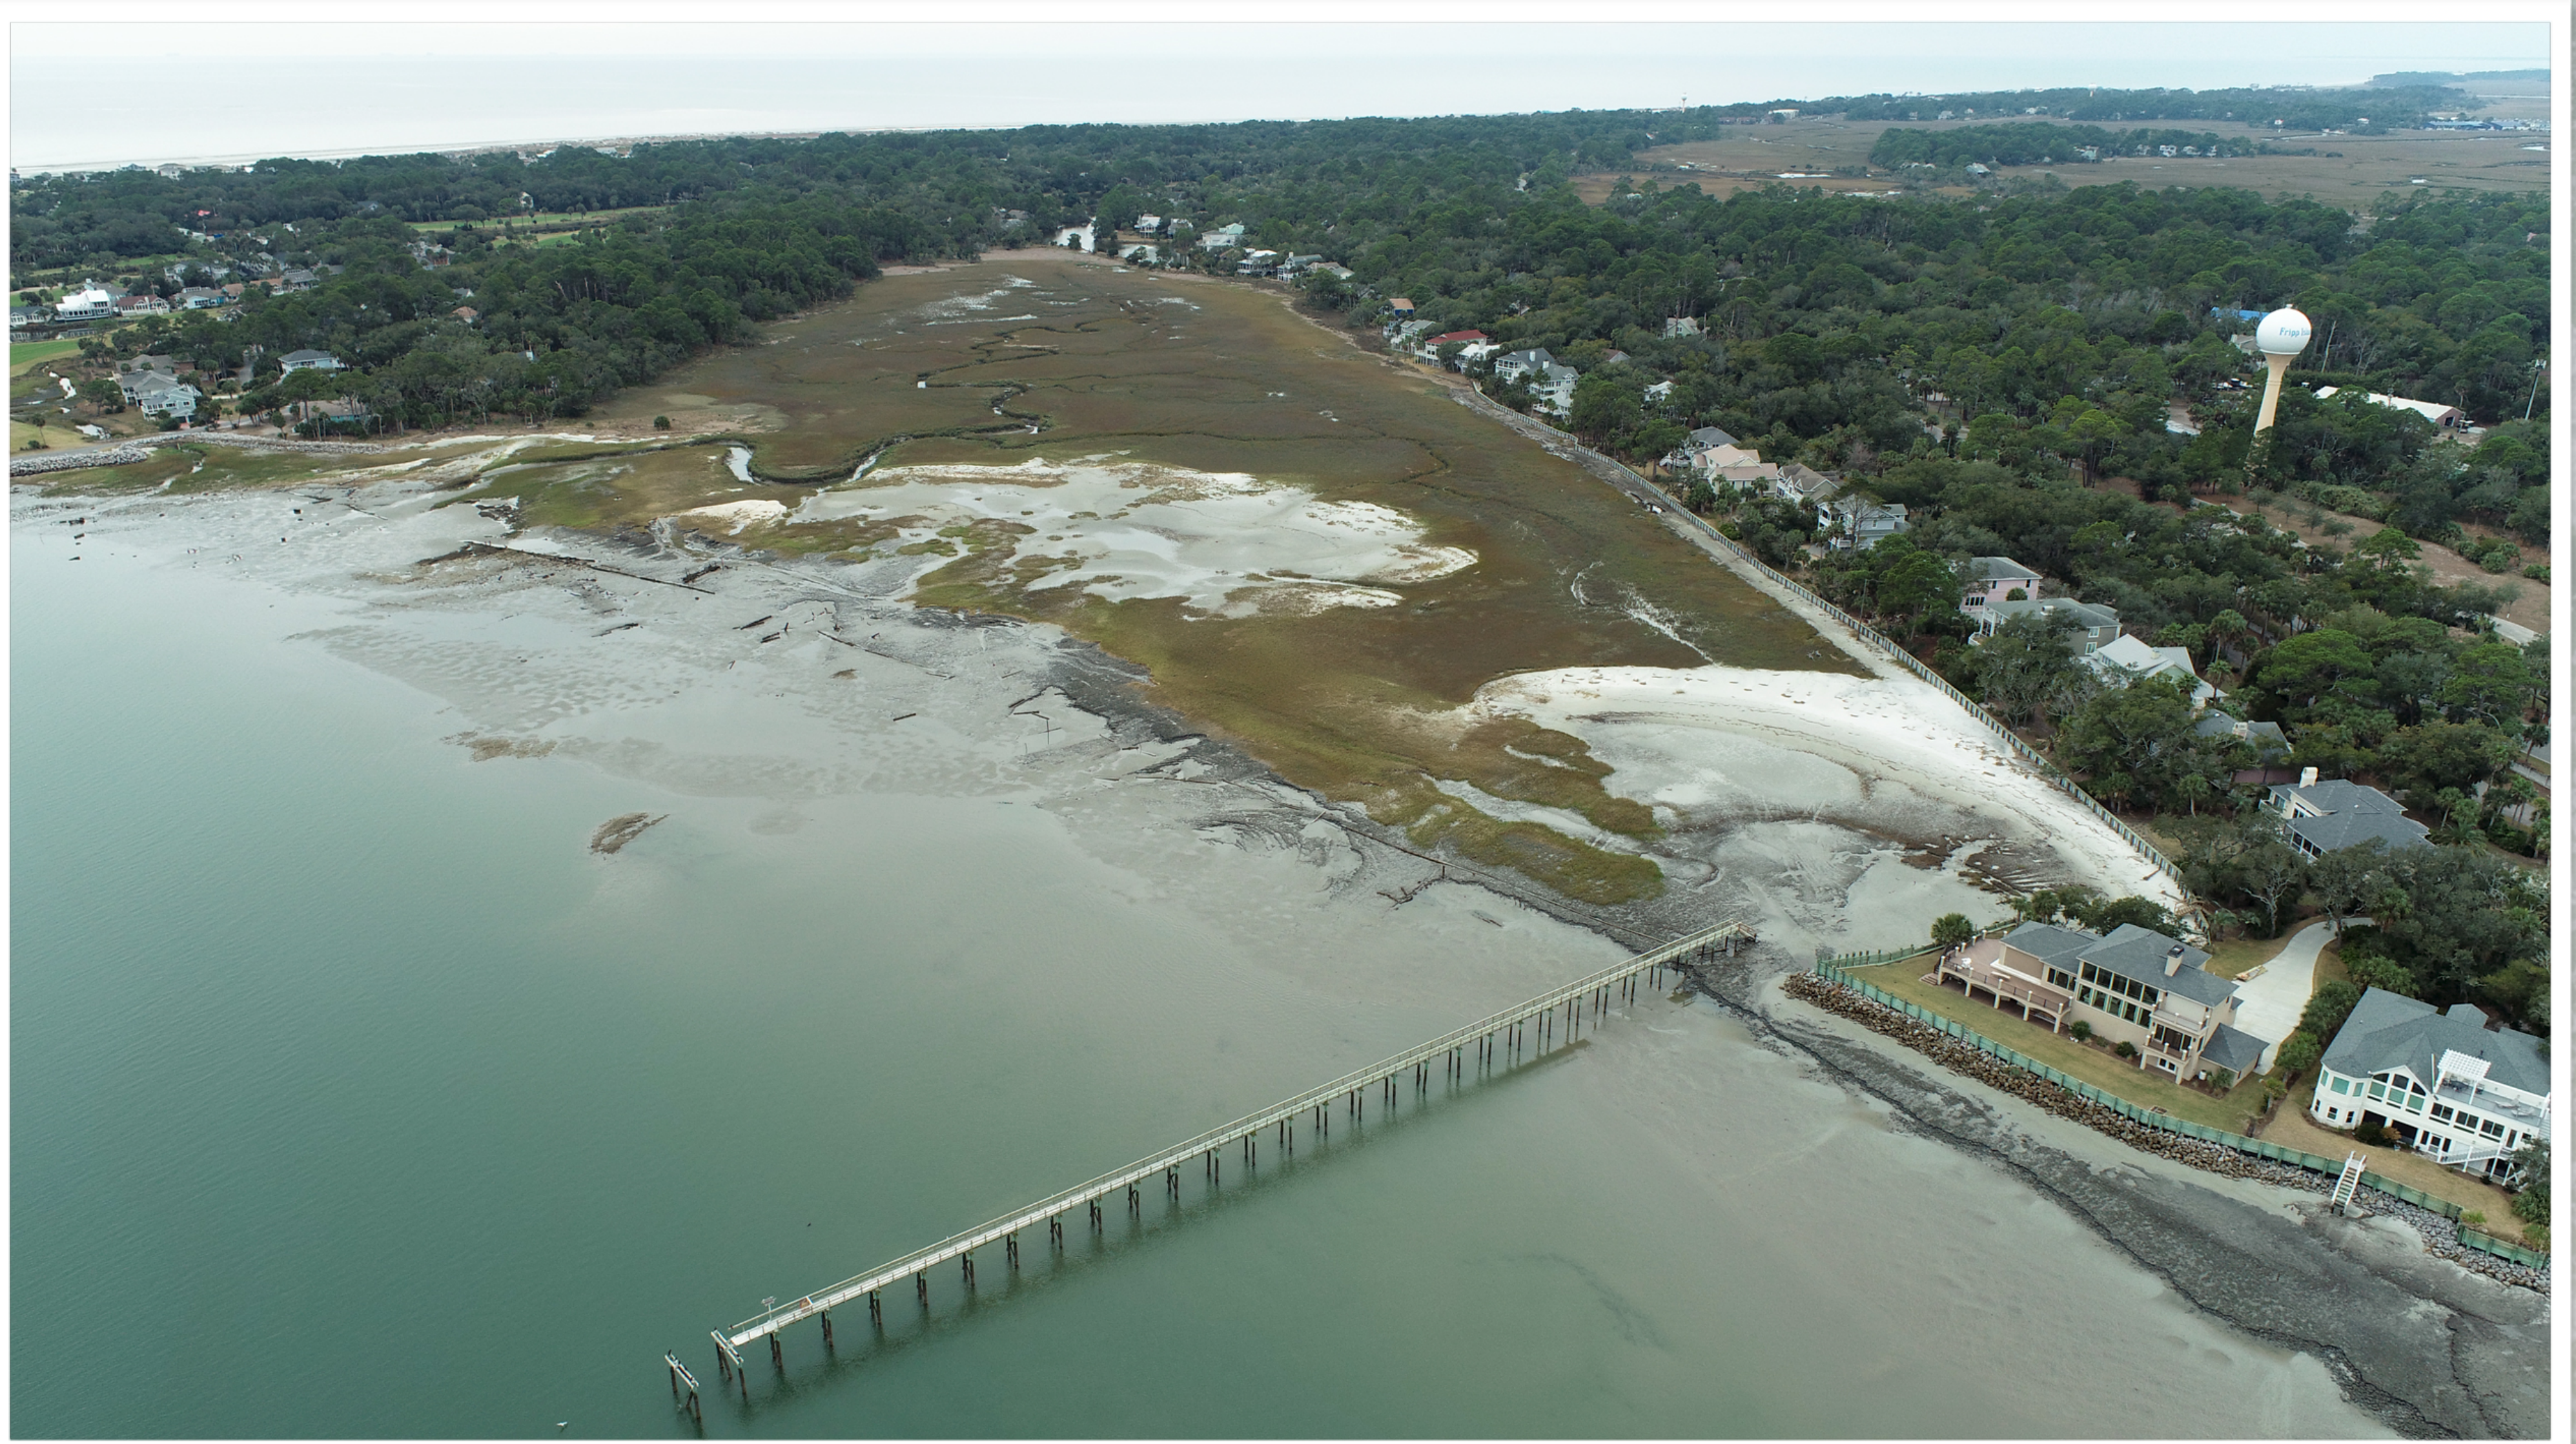
January 21, 2022 - An overall view of the salt marsh as it stands today showing the two main areas of erosion at the mouth of the salt marsh. As the southern tip of Hunting Island deteriorates, this area is more and more subject to the direct forces of the ocean.
