Fripp Island - May 16, 2020

The Changing Shoreline

Darryl Zoeckler

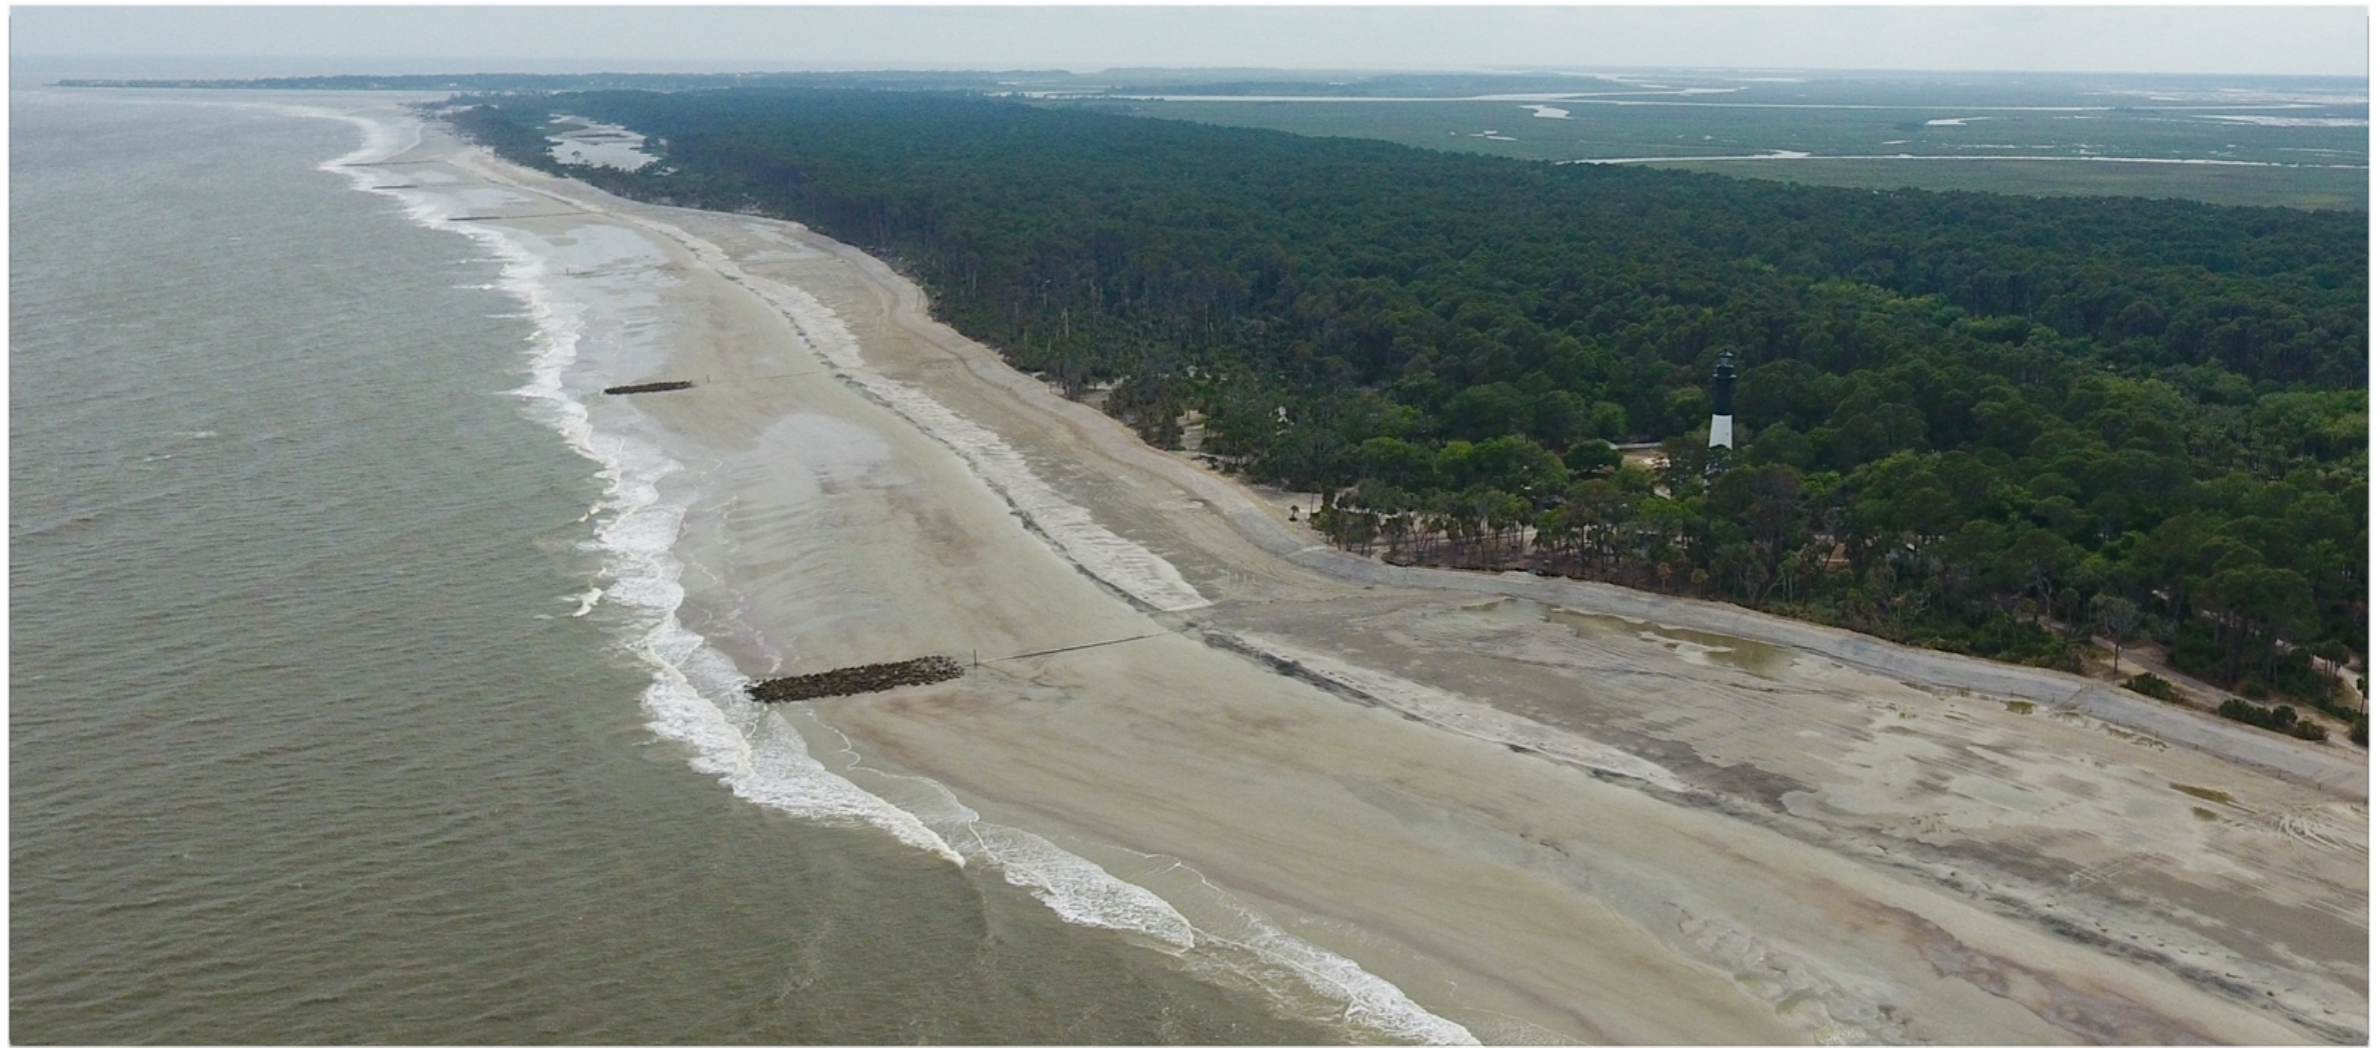
The beach renourishment

The 2020 beach renourishment project on Hunting Island State Park is complete after more than one million cubic yards of sand were added.

The beach at Hunting Island has been renourished with new sand dredged from offshore, a process repeated several times over the years as the sand continues to erode from the beach and threatens the lighthouse. The island is South Carolina's most popular state park attracting more than a million visitors each year. This fact alone could play a big part of the cost justification for the continued beach renourishment program.

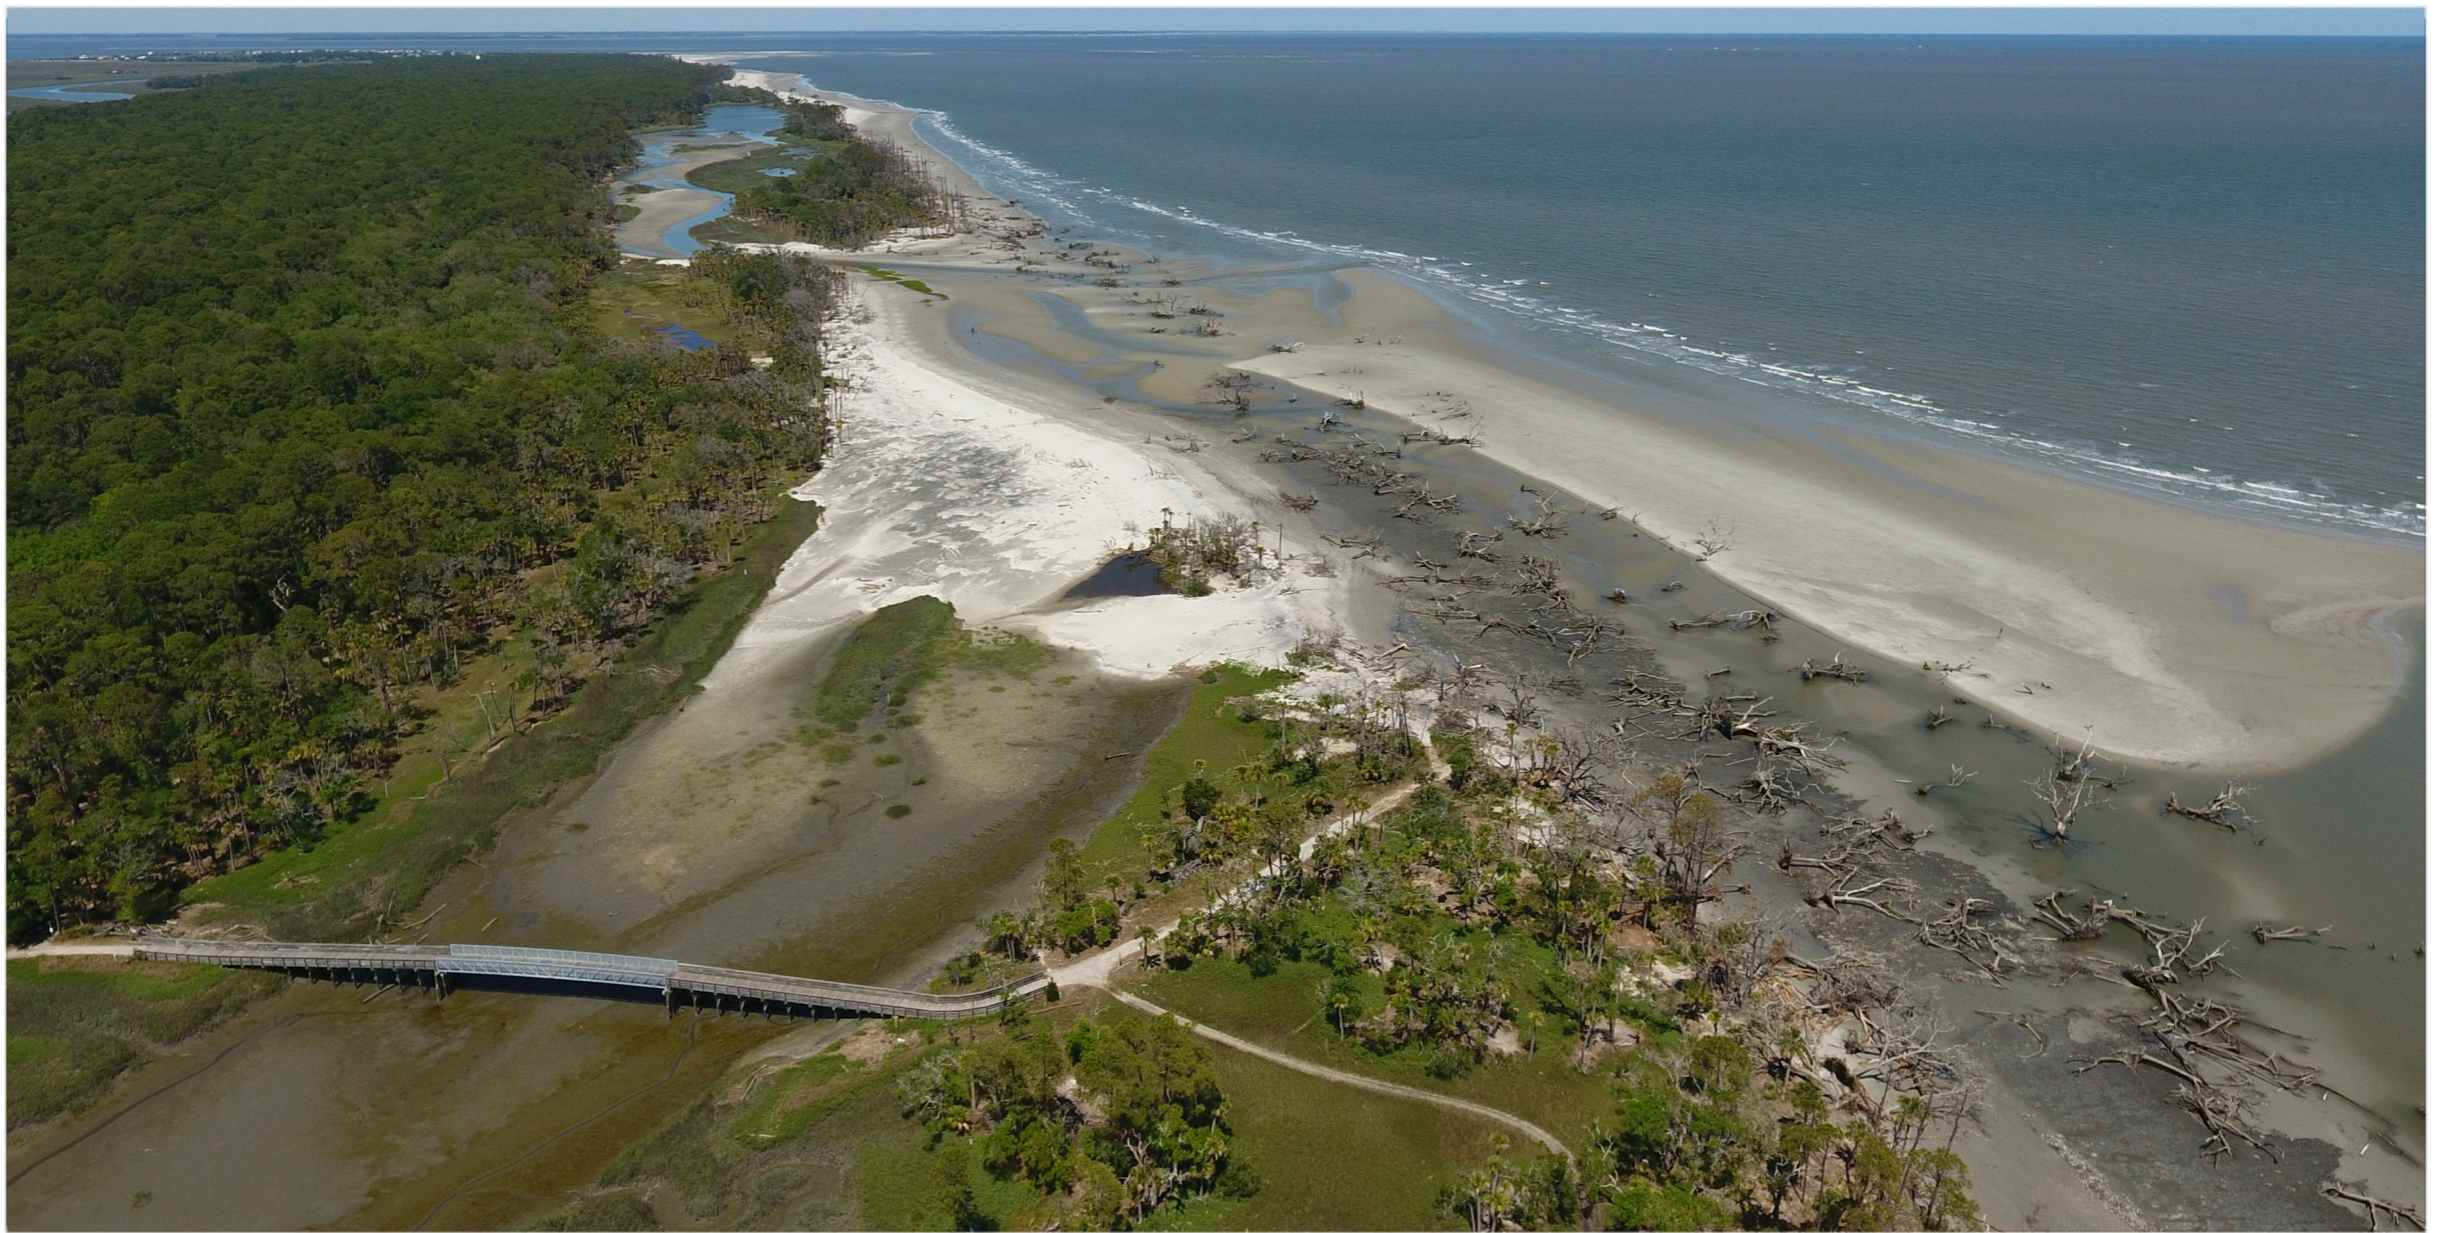
The southern end of Hunting Island continues to deteriorate as the sand and sea swallow up more of the maritime forest and beach area.

The south end of Hunting Island was not included in the 2020 beach renourishment project and continues to rapidly erode. As the encroaching saltwater kills off the remaining maritime forest, the vegetation and topsoil are replaced by sand and sea. The footpath visible in the photo was once connected to “Cabin Road” where several cabins lined both sides of it. None of the cabins remain, having either been moved or torn down due to the erosion. The pedestrian bridge once crossed a lagoon that was separated from the beach by this road.

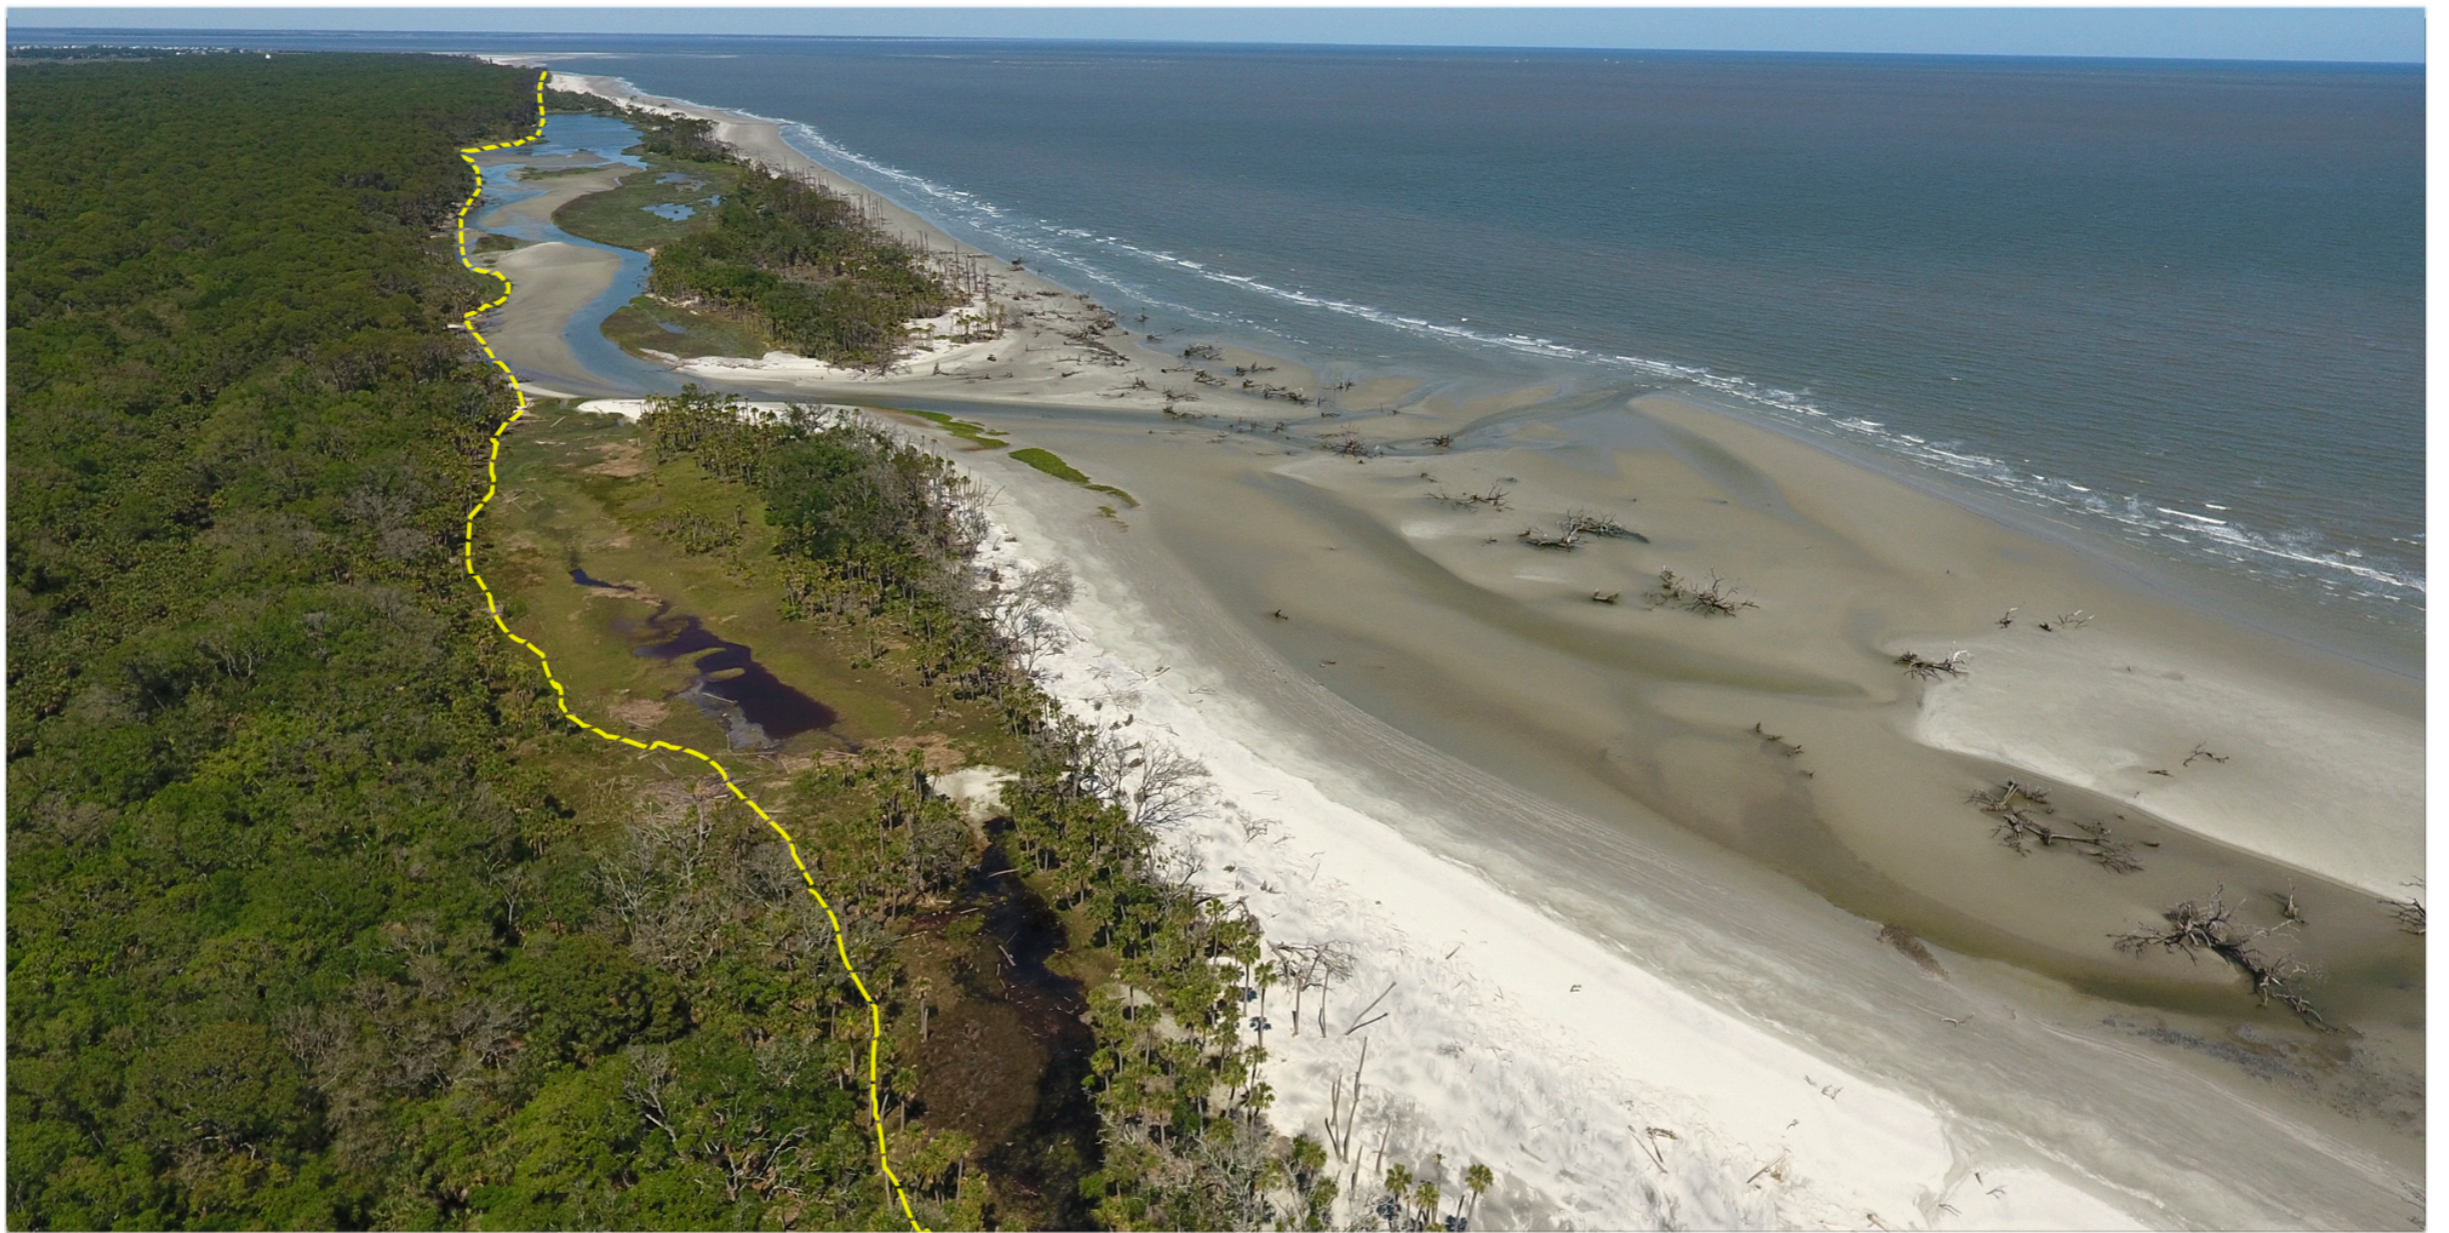
A new line in the sand

A new shoreline will be created as the sand continues to erode.

It's conceivable that as more and more of the beach and maritime forest are eroded by the ocean, the southern shoreline of Hunting Island will recede as well. Several hundred feet of beach area and maritime forest have already been erased due to the rapidly retreating shoreline and there is a good chance this process will continue into the foreseeable future.

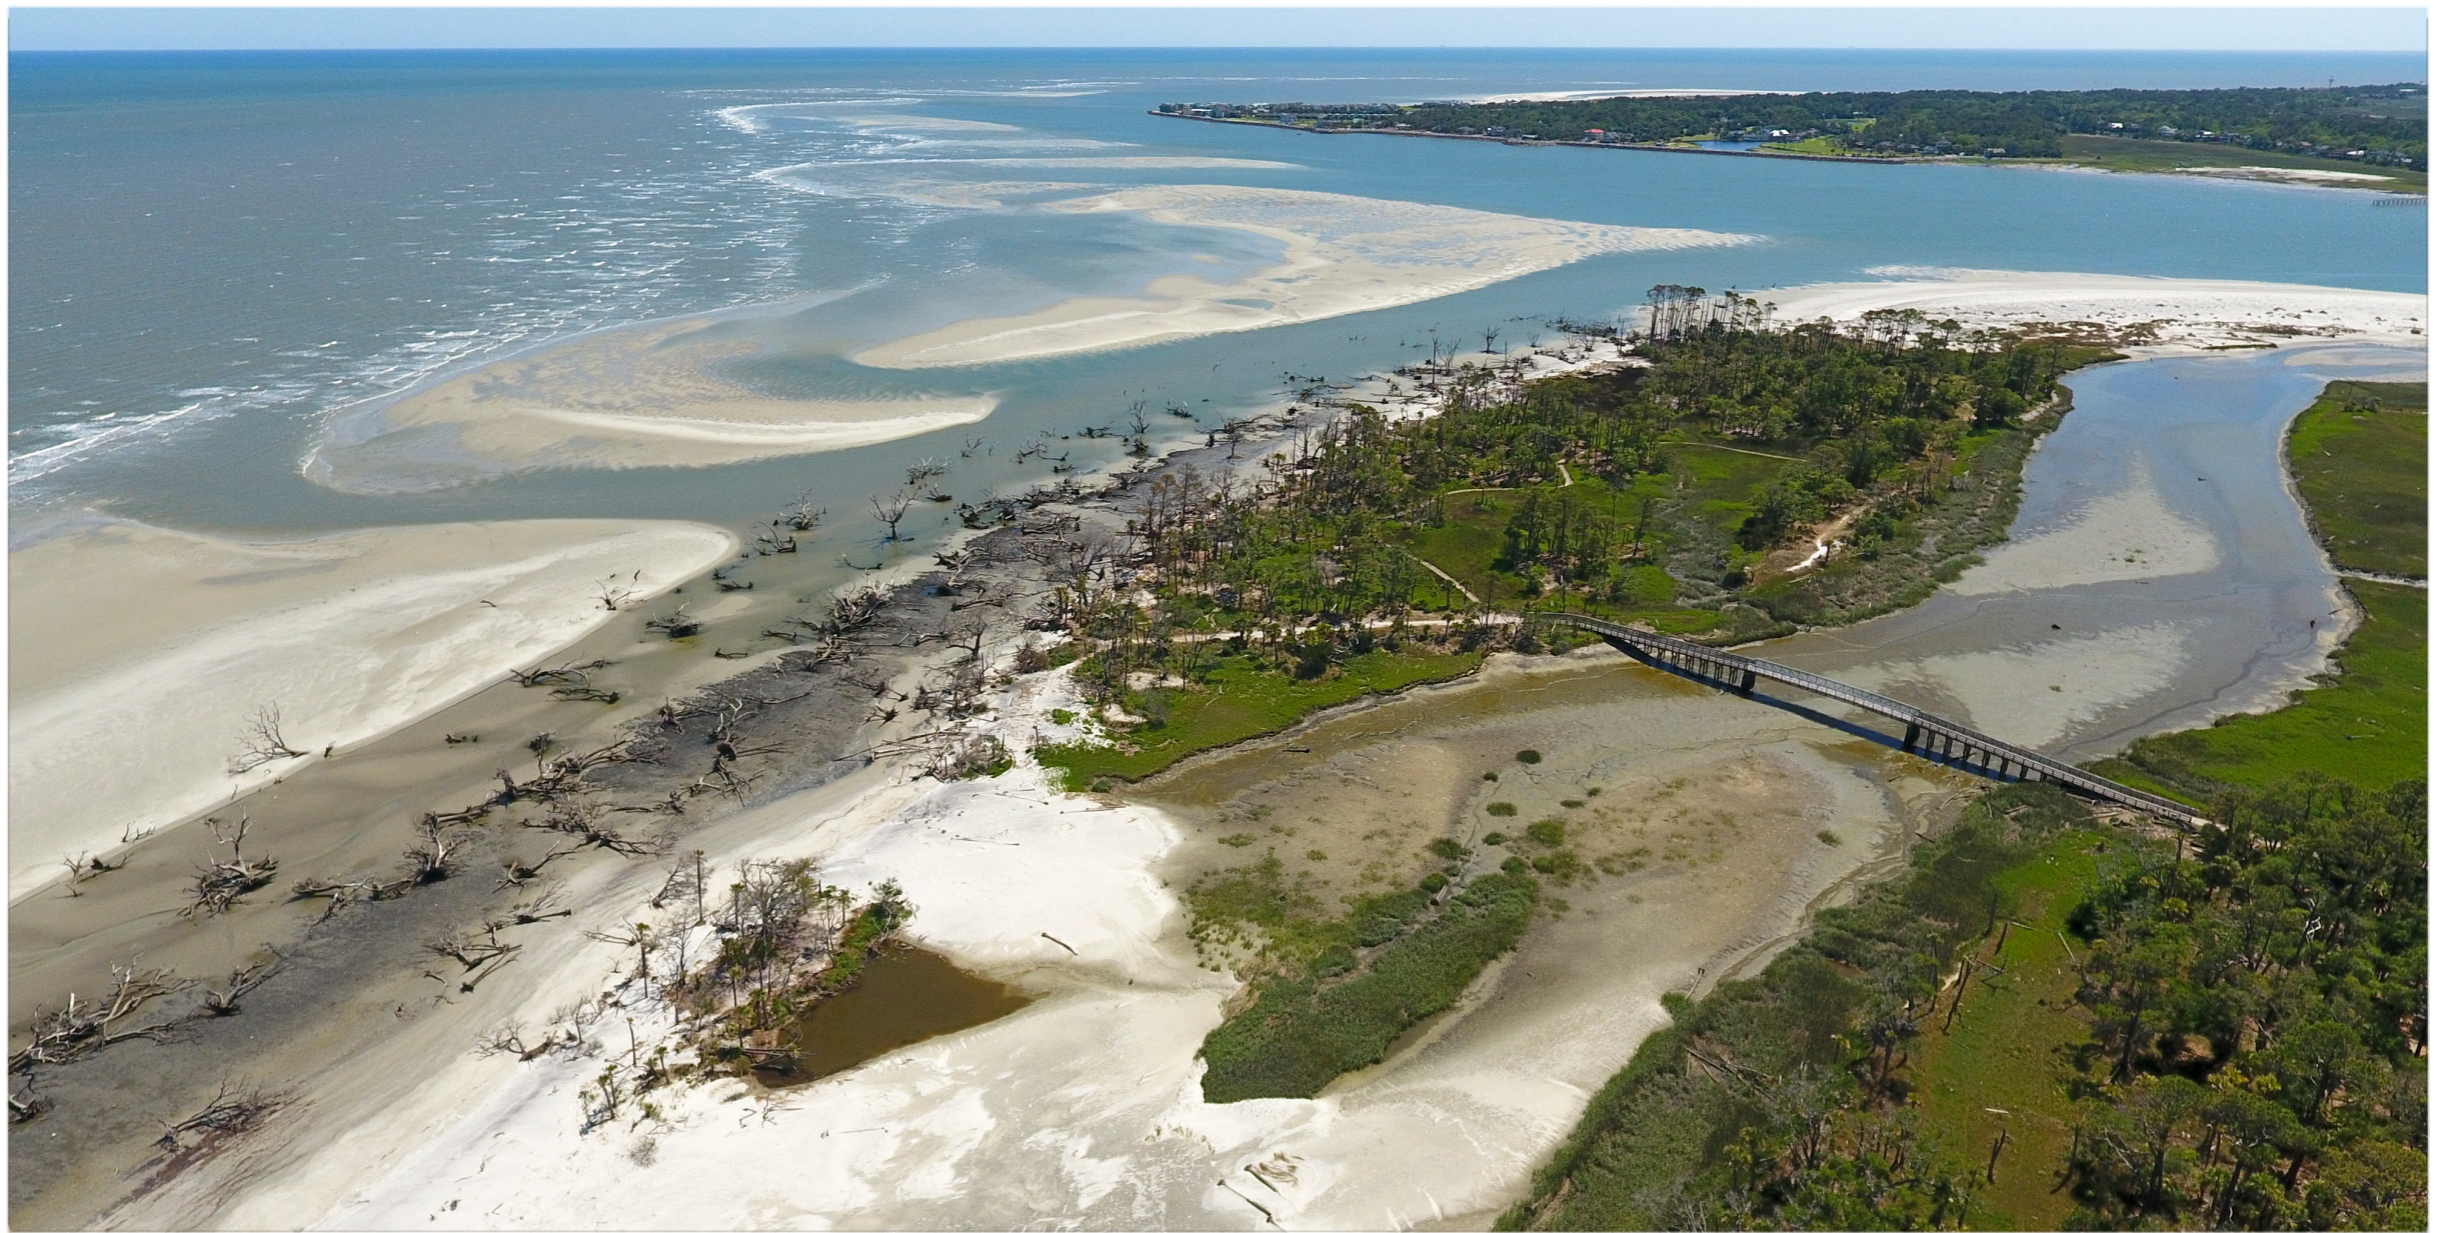
Exposing Fripp Island

As the erosion continues, the southern end of Hunting Island will no longer act as a deflection barrier.

As the south end of Hunting Island continues to erode away, more of the inlet side of Fripp Island will be exposed to the wave action and tidal forces of the open ocean. This new reality will place a greater emphasis on the strength and integrity of the rock revetment wall that lines the inlet side of Fripp Island. Areas such as the salt marsh behind the River Club and Quail Cove neighborhoods, which are not protected, already show signs of damage due to scouring and vegetation loss.

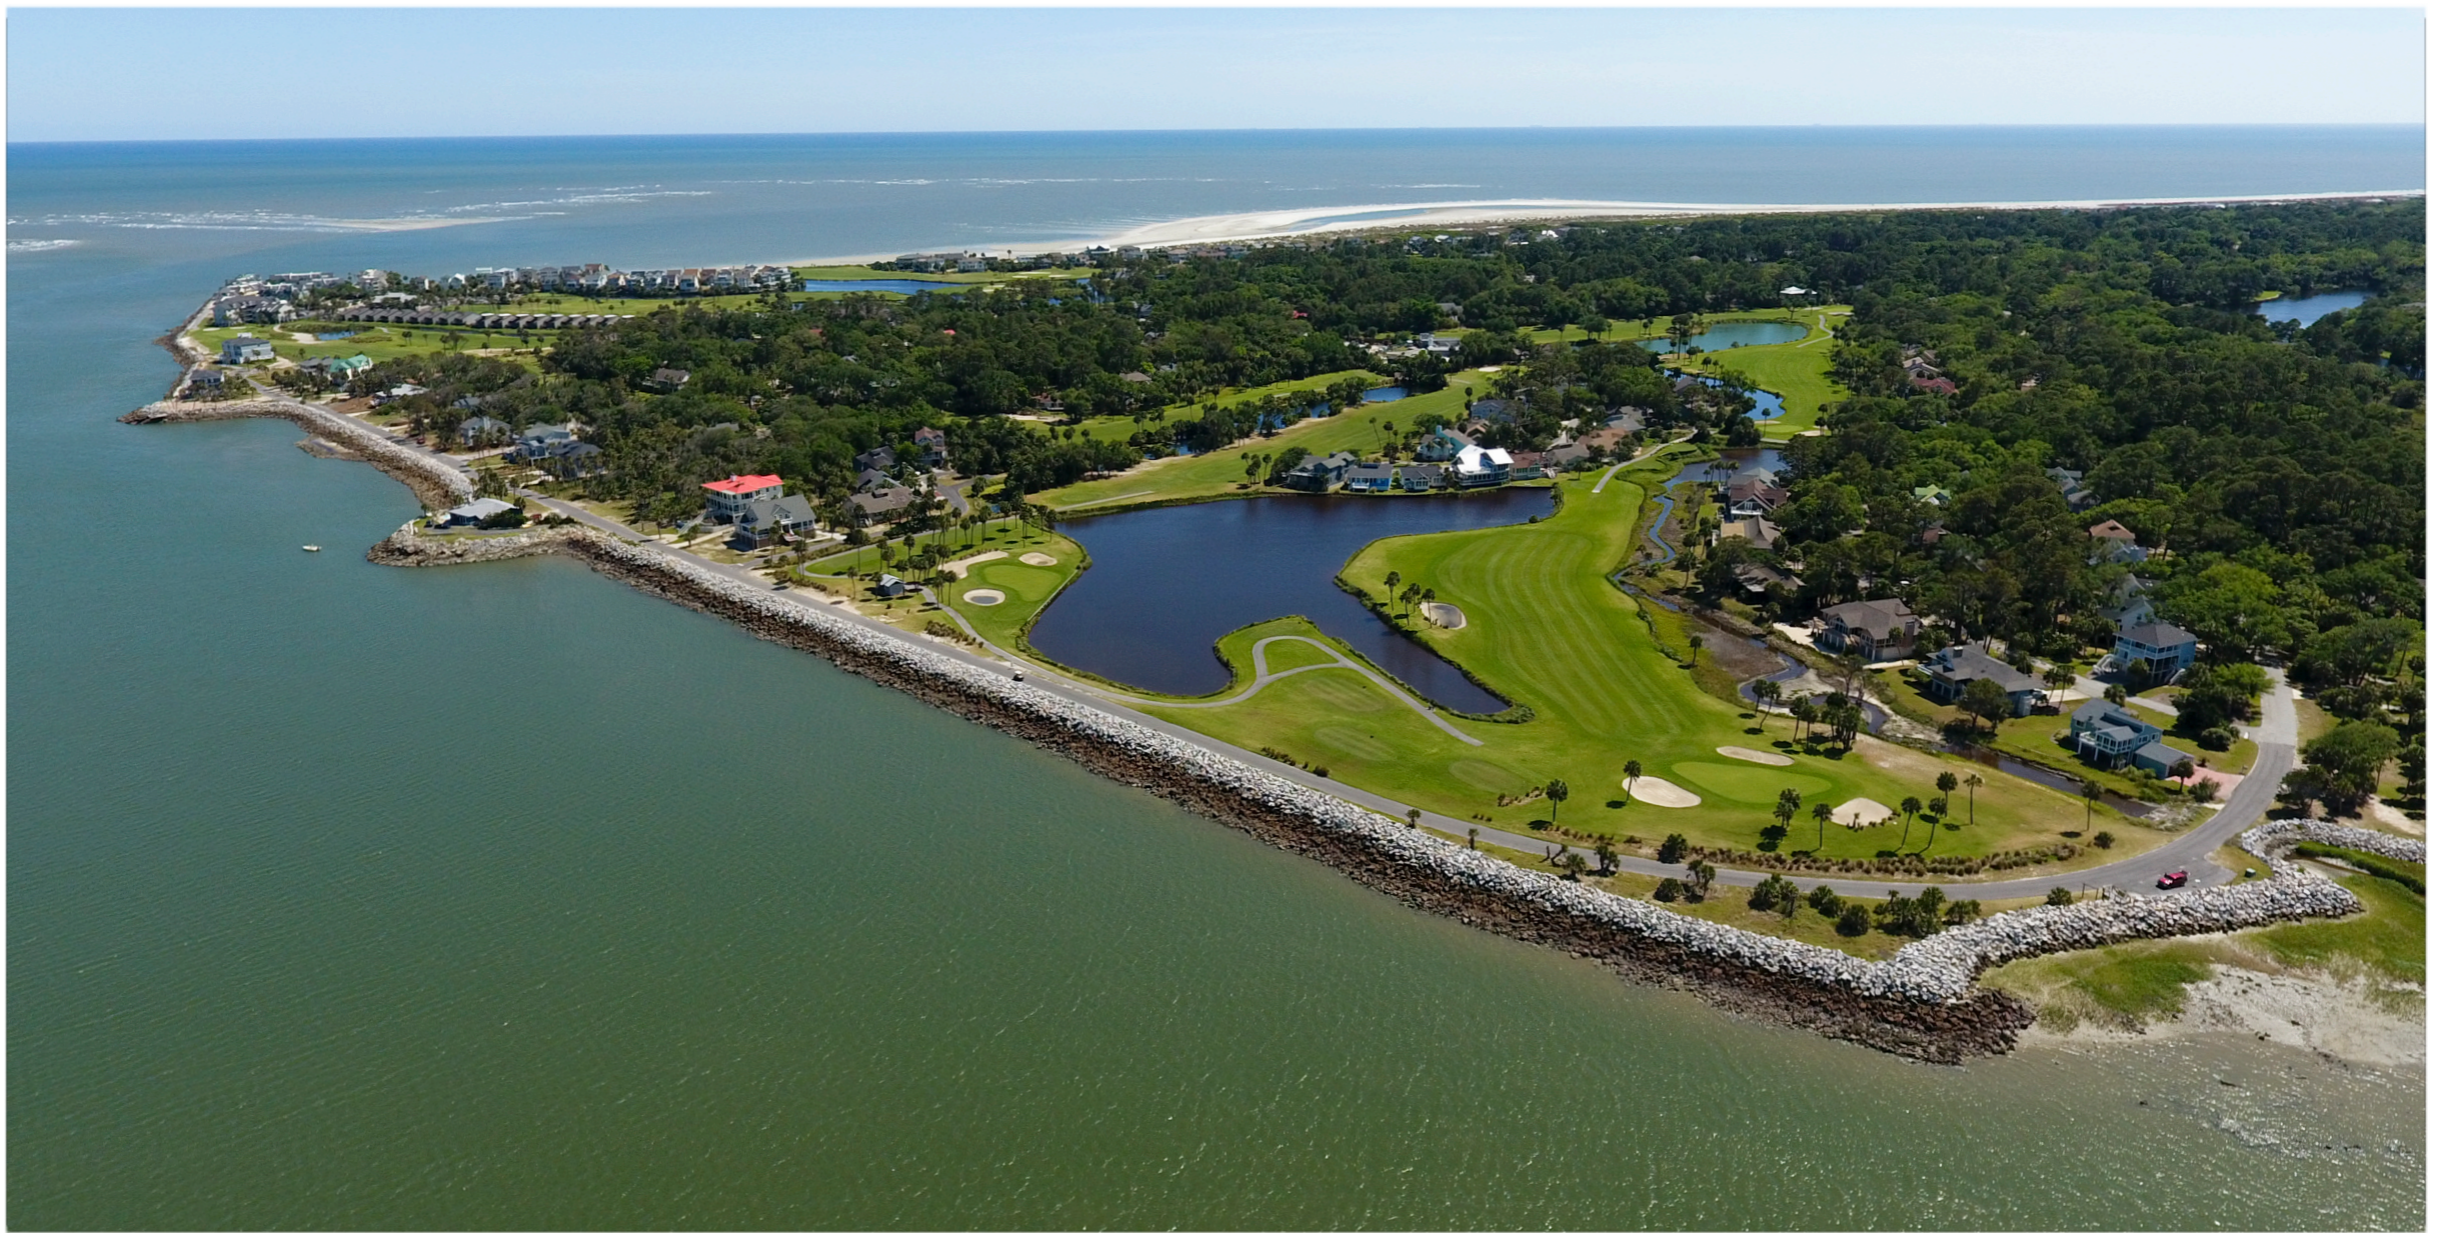
The rock revetment wall will serve more and more as a front line defense protecting property and utilities from storms and waves.

The entire rock revetment will play a vital role in not only protecting the utilities that run along the edge of Porpoise Drive, but also the entire side of the island itself. The structure should be looked at as a whole unit and not as individual parts in order to avoid a weak-link-in-the-chain scenario. Baselines should be established that define integrity, strength, and composition. Areas of weakness should be identified and reinforced. An island-wide maintenance schedule should be created as the wall becomes more important in maintaining the island's existence.

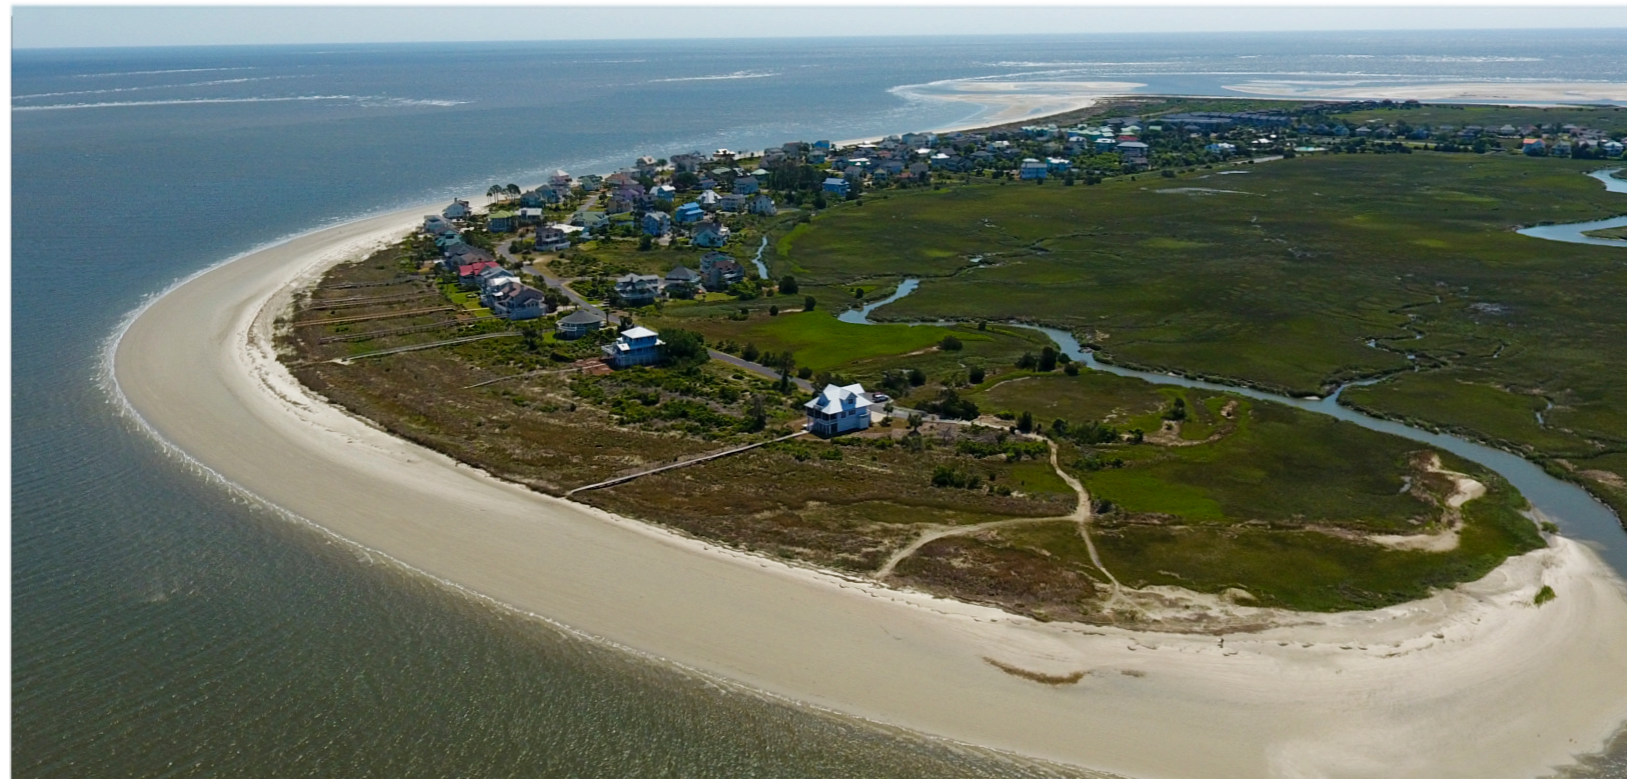
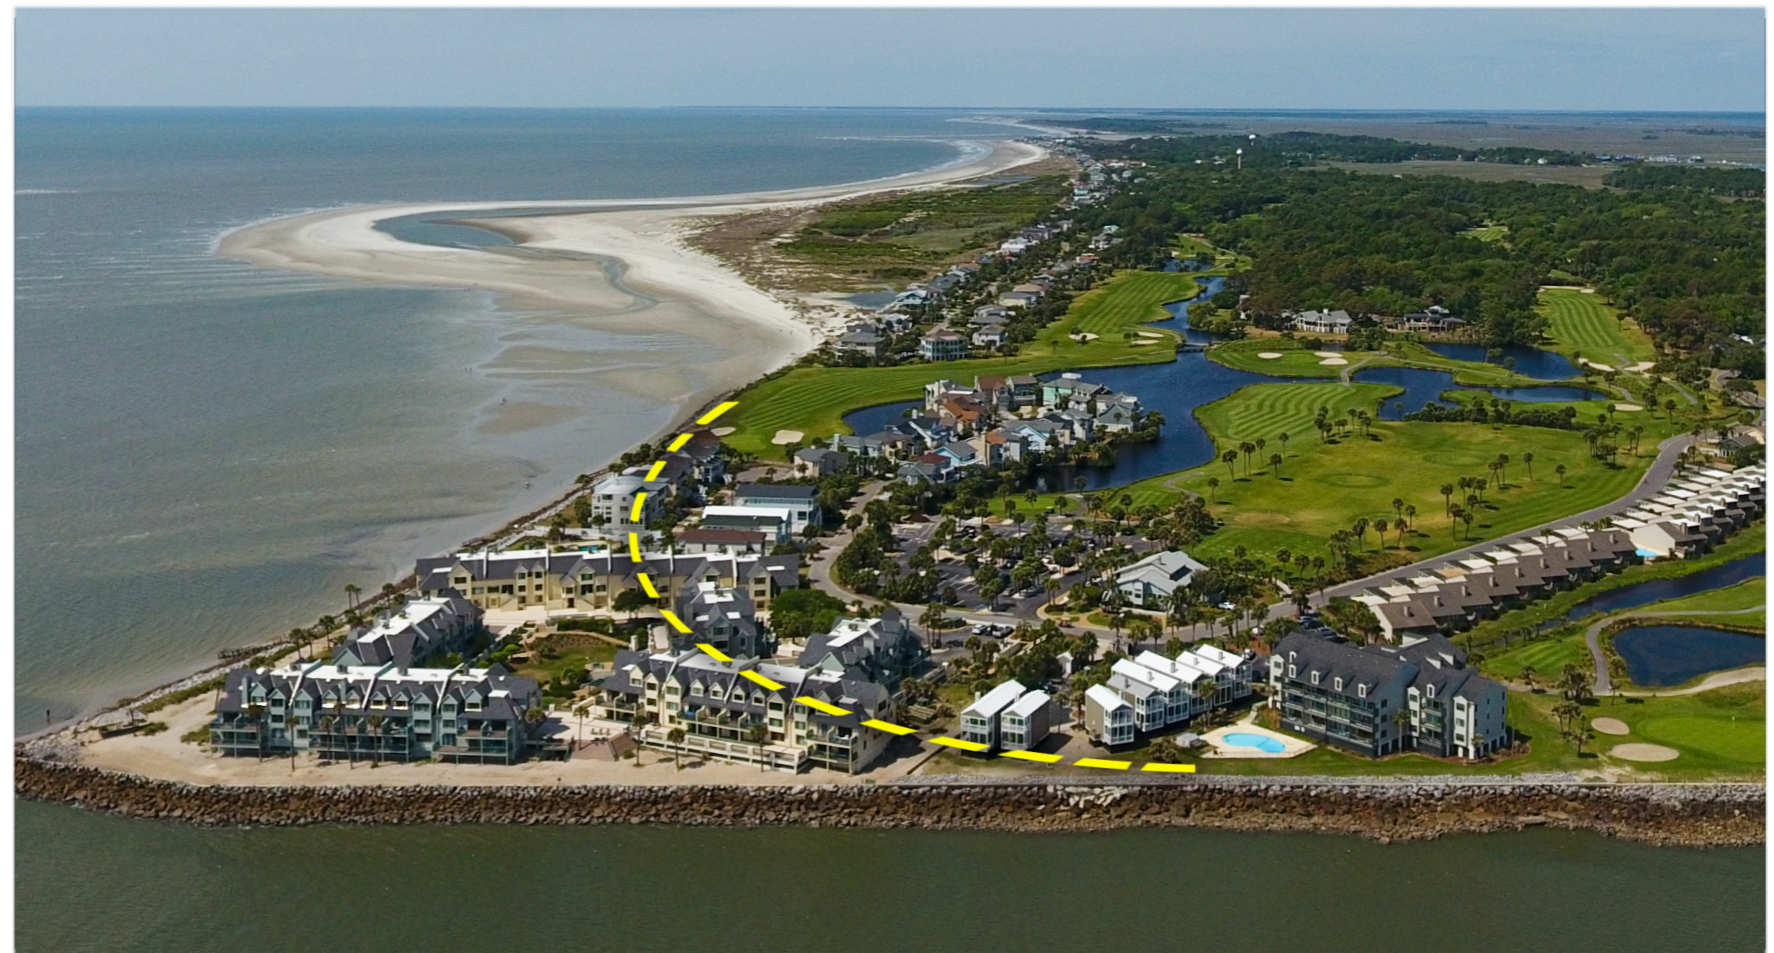
The curve

The northern tip of Harbor Island has no hard structures to protect its sandy shoreline from the erosive sawing action of the tide entering and leaving Harbor Inlet. As a result an almost perfectly round arc is formed by the repeated action to the loose granular material.

Because the northern tip of Fripp Island is protected entirely by a rock revetment the rounding doesn't occur. If the same erosive sawing action did happen to an unprotected side of Fripp Island, the damage would be catastrophic to a large number of homes.

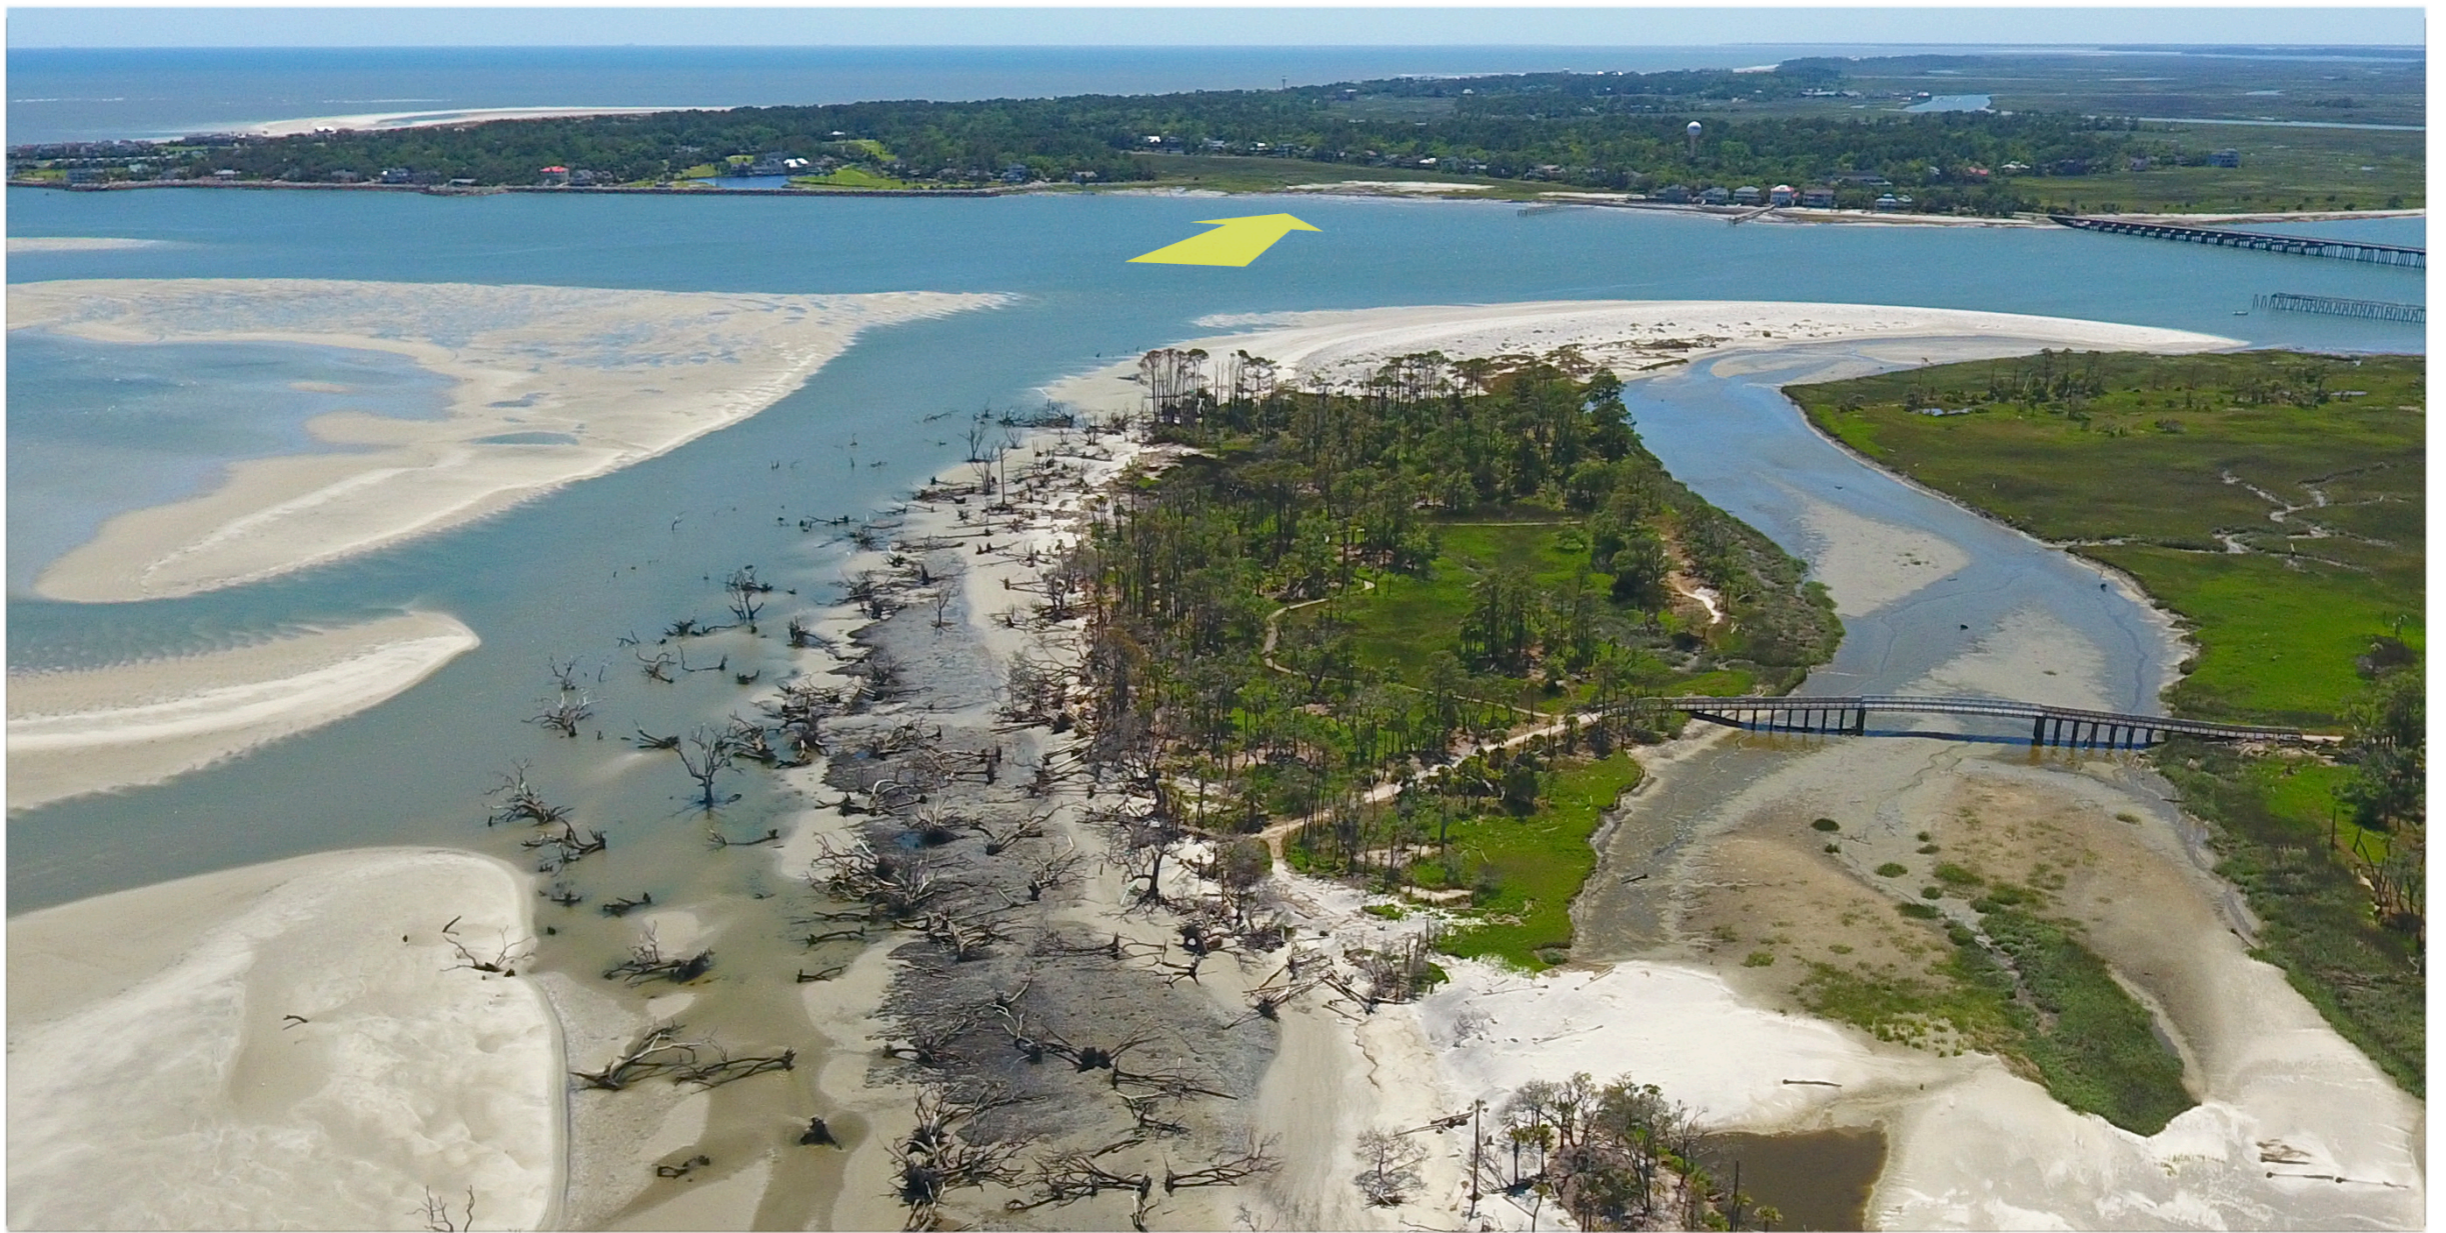
Areas of concern

Exposed areas on the inlet side of Fripp Island are changing fast due to the increased wave action.

The protection once offered by the southern end of Hunting Island is becoming less as the island erodes leaving the salt marsh located on the inlet side of Fripp Island more exposed to the wave and tidal forces of the open ocean. The salt marsh is currently experiencing a scouring effect from the waves that plow the existing sand and sediment further into the marsh, smothering the vegetation.
