Fripp Island - May 16, 2020

The Changing Shoreline

Darryl Zoeckler

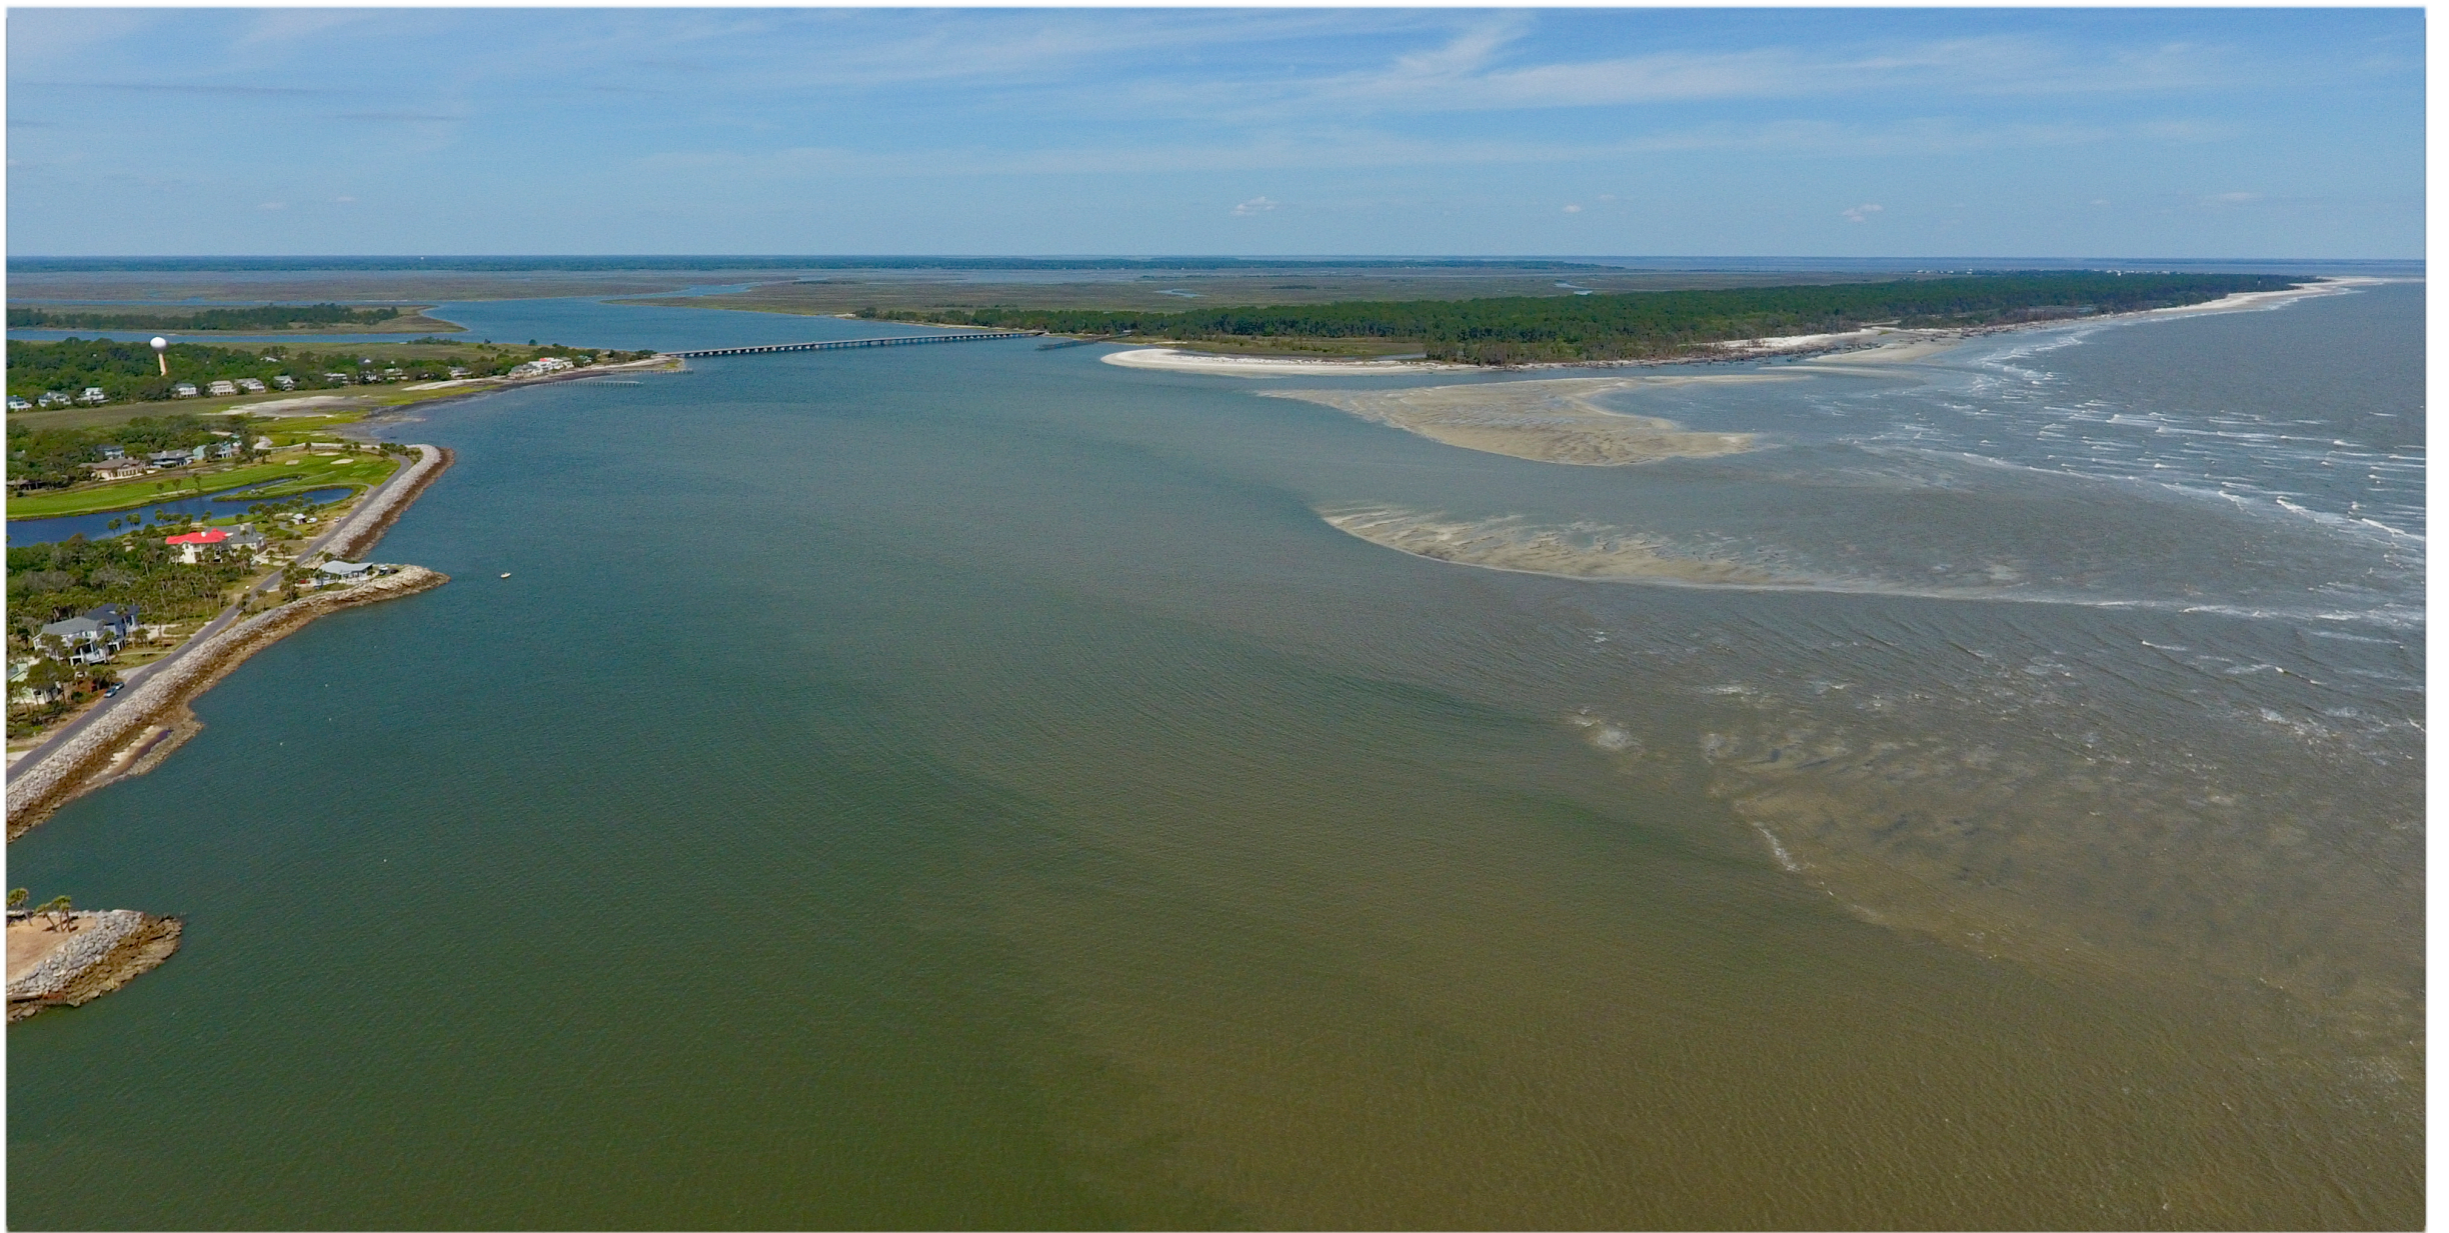
The tidal flow

Observing the impact of tidal flows as they interact with vulnerable areas.

In this photo, the incoming tide is starting to flow into Fripp Inlet. By observing the direction of the sediment laden seawater, it becomes apparent that a big part of the flow heads towards the unprotected entrance of the salt marsh. Normal tides such as this may not cause as great an impact, but if a storm surge, wind-driven, or seasonal flood tide were to accompany the tidal inflow, a lot of damage could occur in a short time frame.

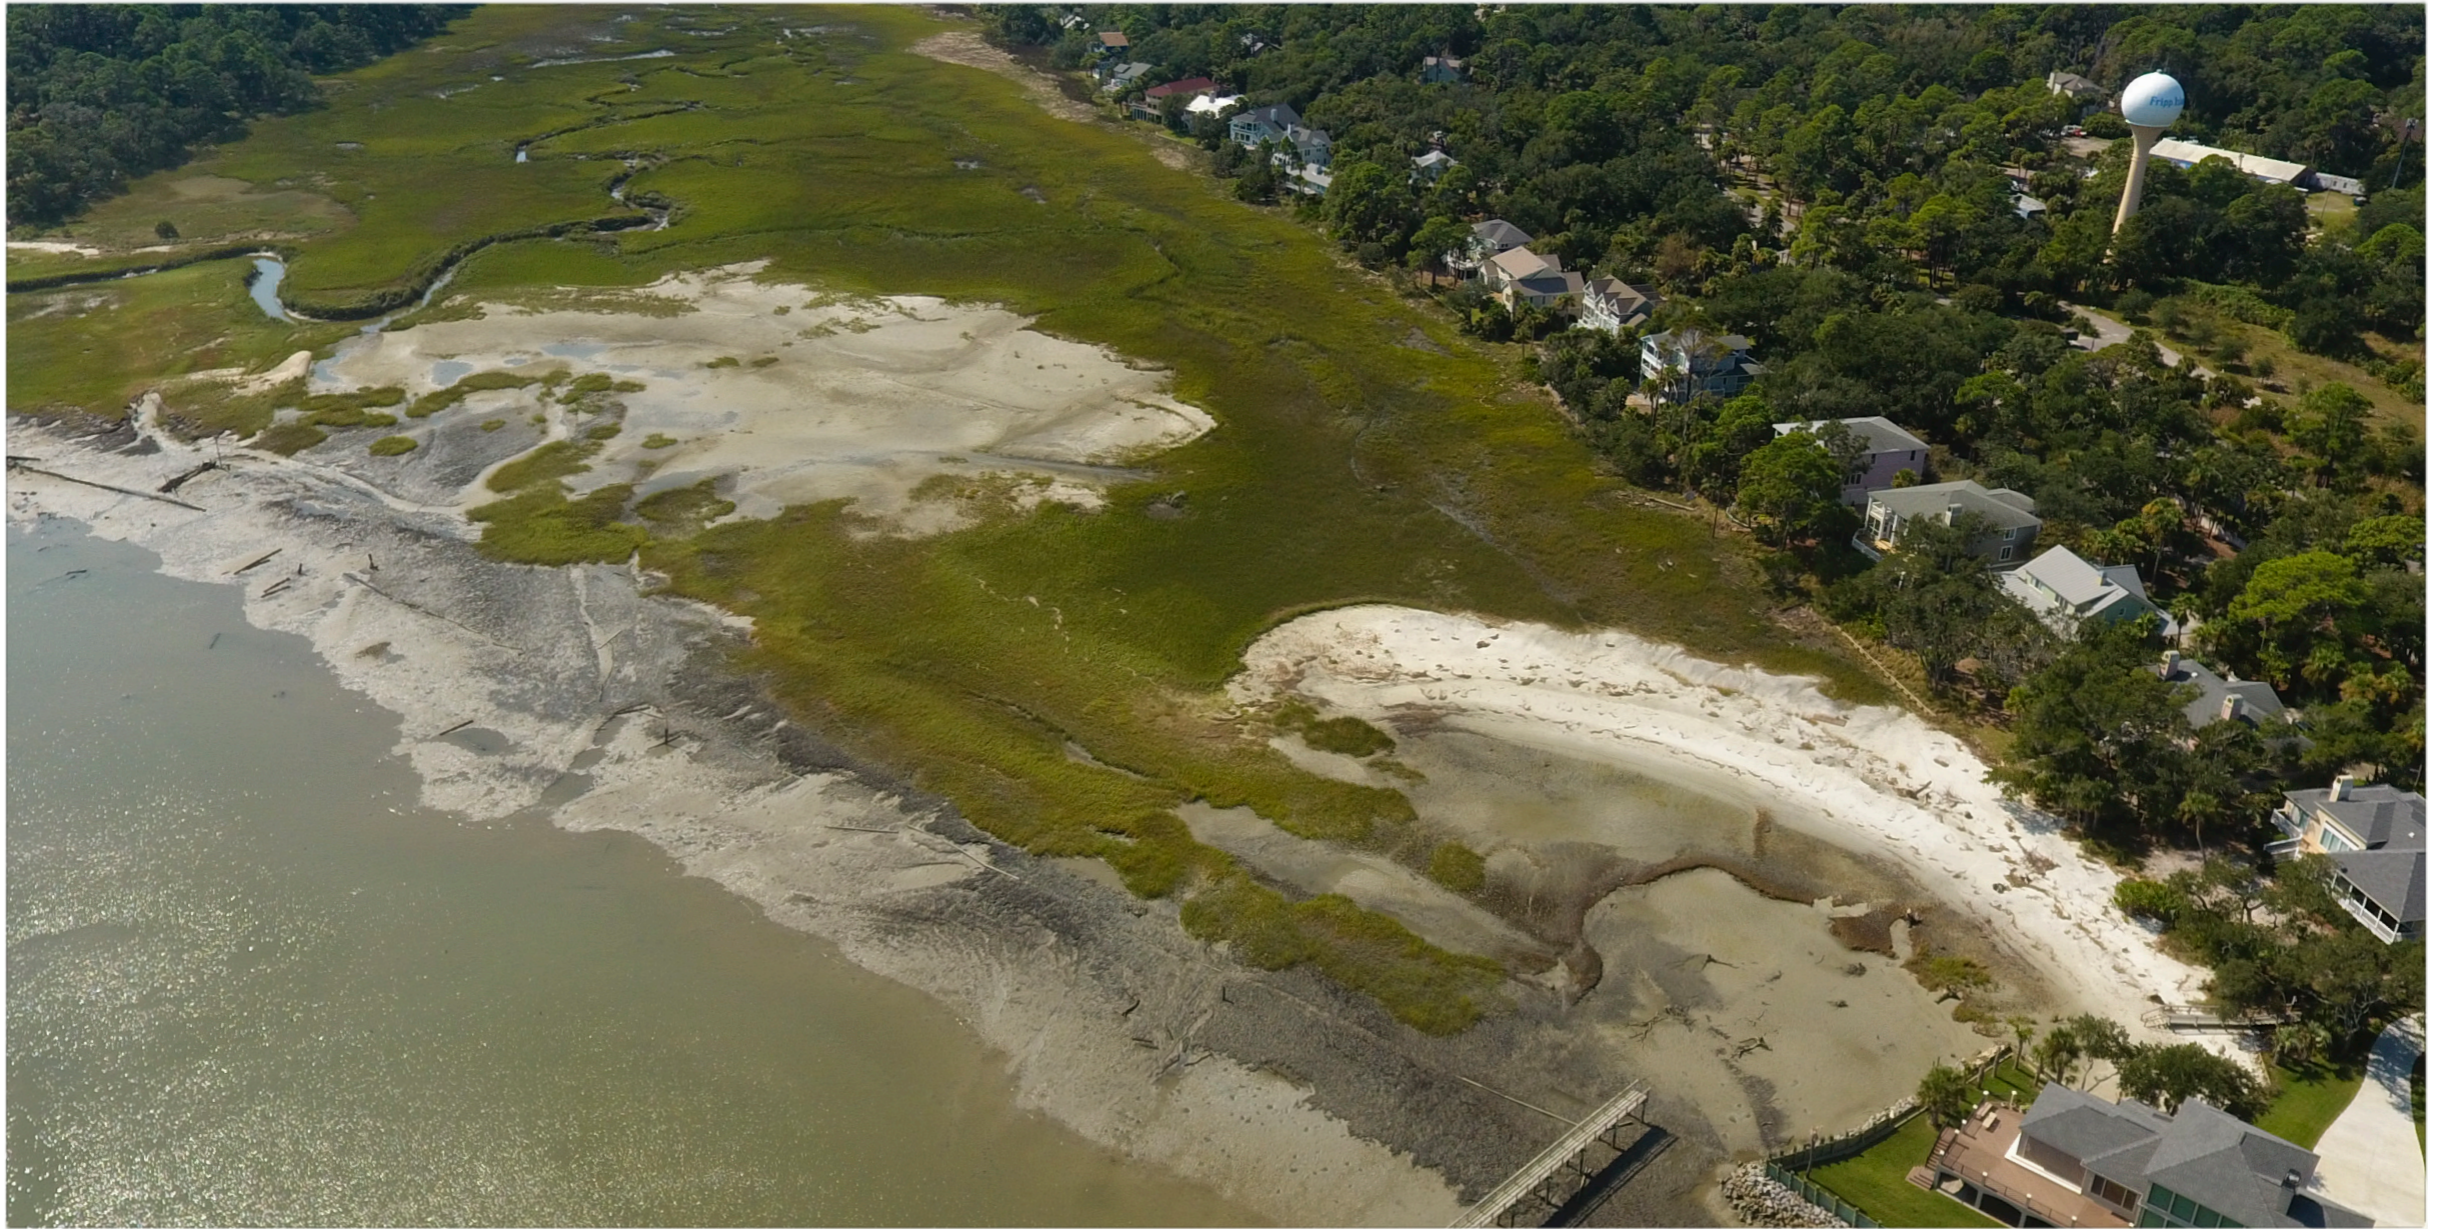
The salt marsh

Scouring occurs when the waves from the Fripp Inlet plow the existing sand and sediment further back into the marsh, smothering the vegetation.

The vegetation in the salt marsh reduces the wave action that flows into the marsh area. When the vegetation is smothered by sand and sediment there is nothing slowing down the waves that enter the marsh. As a result, the waves travel further in unimpeded and push more sand and sediment with them exacerbating the destructive cycle until eventually the area is permanently damaged or destroyed. This salt marsh acts as a protective buffer to the surrounding homes and the inland lakes at the far end.

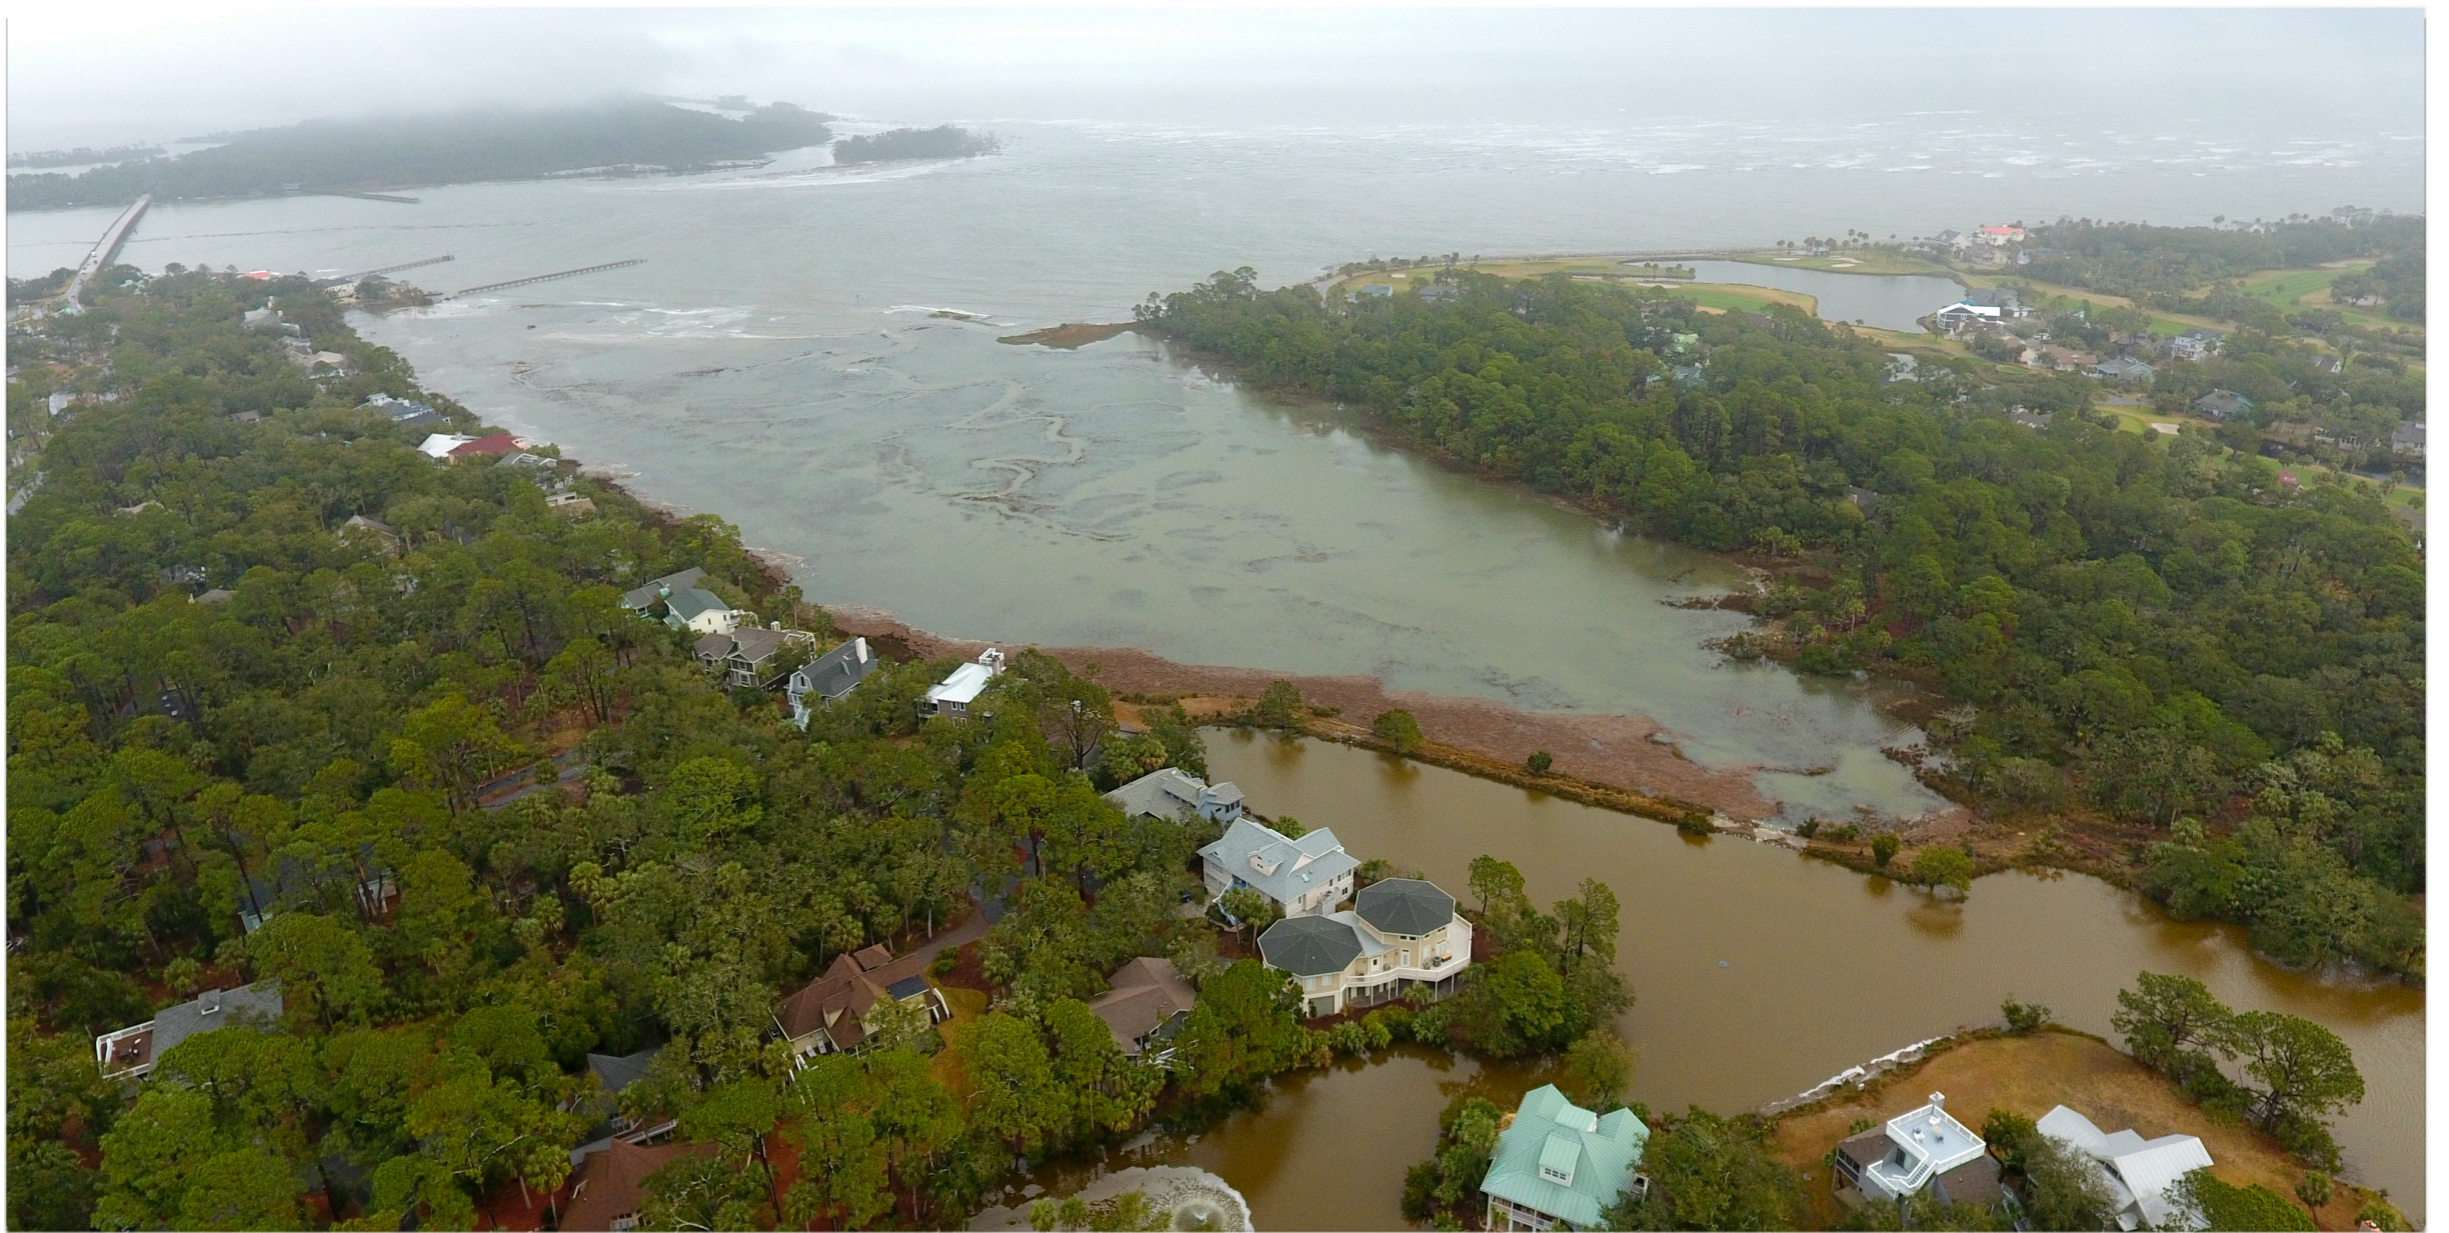
Flooding

A weakened or destroyed marsh area will allow the ocean to penetrate the interior of the island.

During “king” tides, floods, or other storm situations, the salt marsh becomes less effective at protecting the inland lakes such as Deer Lake and Blue Heron Lake from being exposed to the wave action of the open ocean. This also introduces an “in” for the ocean to enter and increase the destruction to the interior of the island. A worse case scenario would be the lakes to become tidal and changing the lakes from brackish to saltwater will unquestionably change the nature of the wildlife that utilize them.

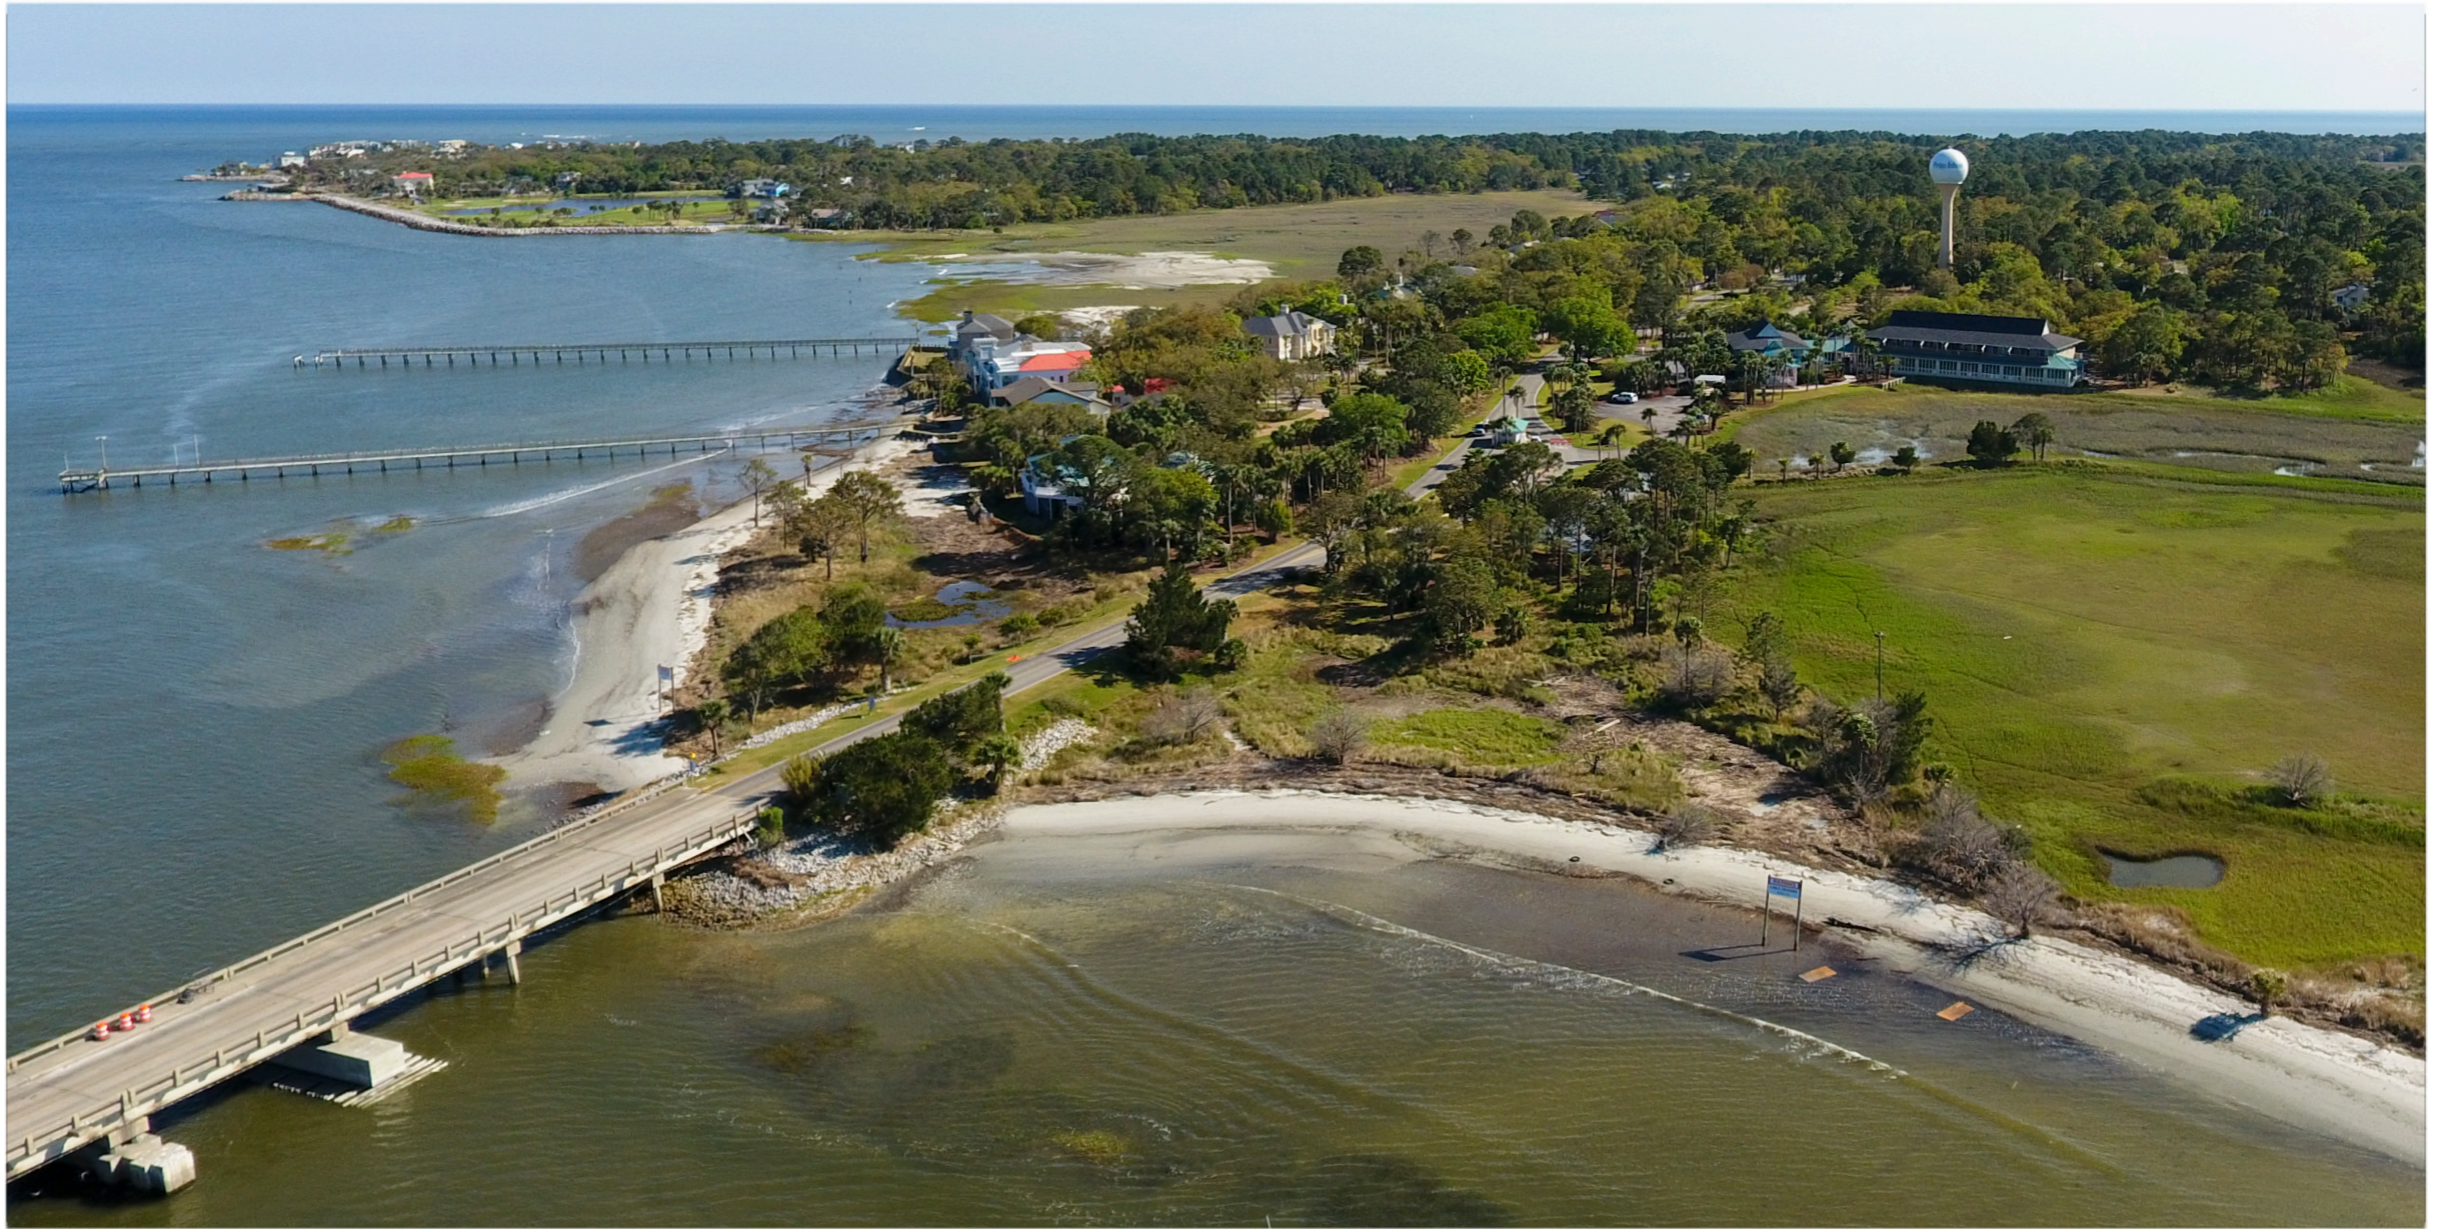
The bridge abutment

As increased tidal forces act against the approach ramp of the bridge, erosion activity is increasing.

Another vital area directly effected by the increased exposure to the ocean and the erosion of the south end of Hunting Island is the bridge abutment at the entrance of Fripp Island. Wave action has begun eating into the sides of the earthen structure and will most likely continue. It will force either the bridge to be extended or the abutment to be rebuilt, or both. Evaluating the structure and/or the surrounding area should be a priority due to it being a key link to accessing the entire island. Flooding is also an issue to this area.
