# Shoreline Status

The aerial photographs used in this presentation were taken on March 13th, 14th, and 16th of 2021

Fripp Island - Shoreline Committee

March 18, 2021

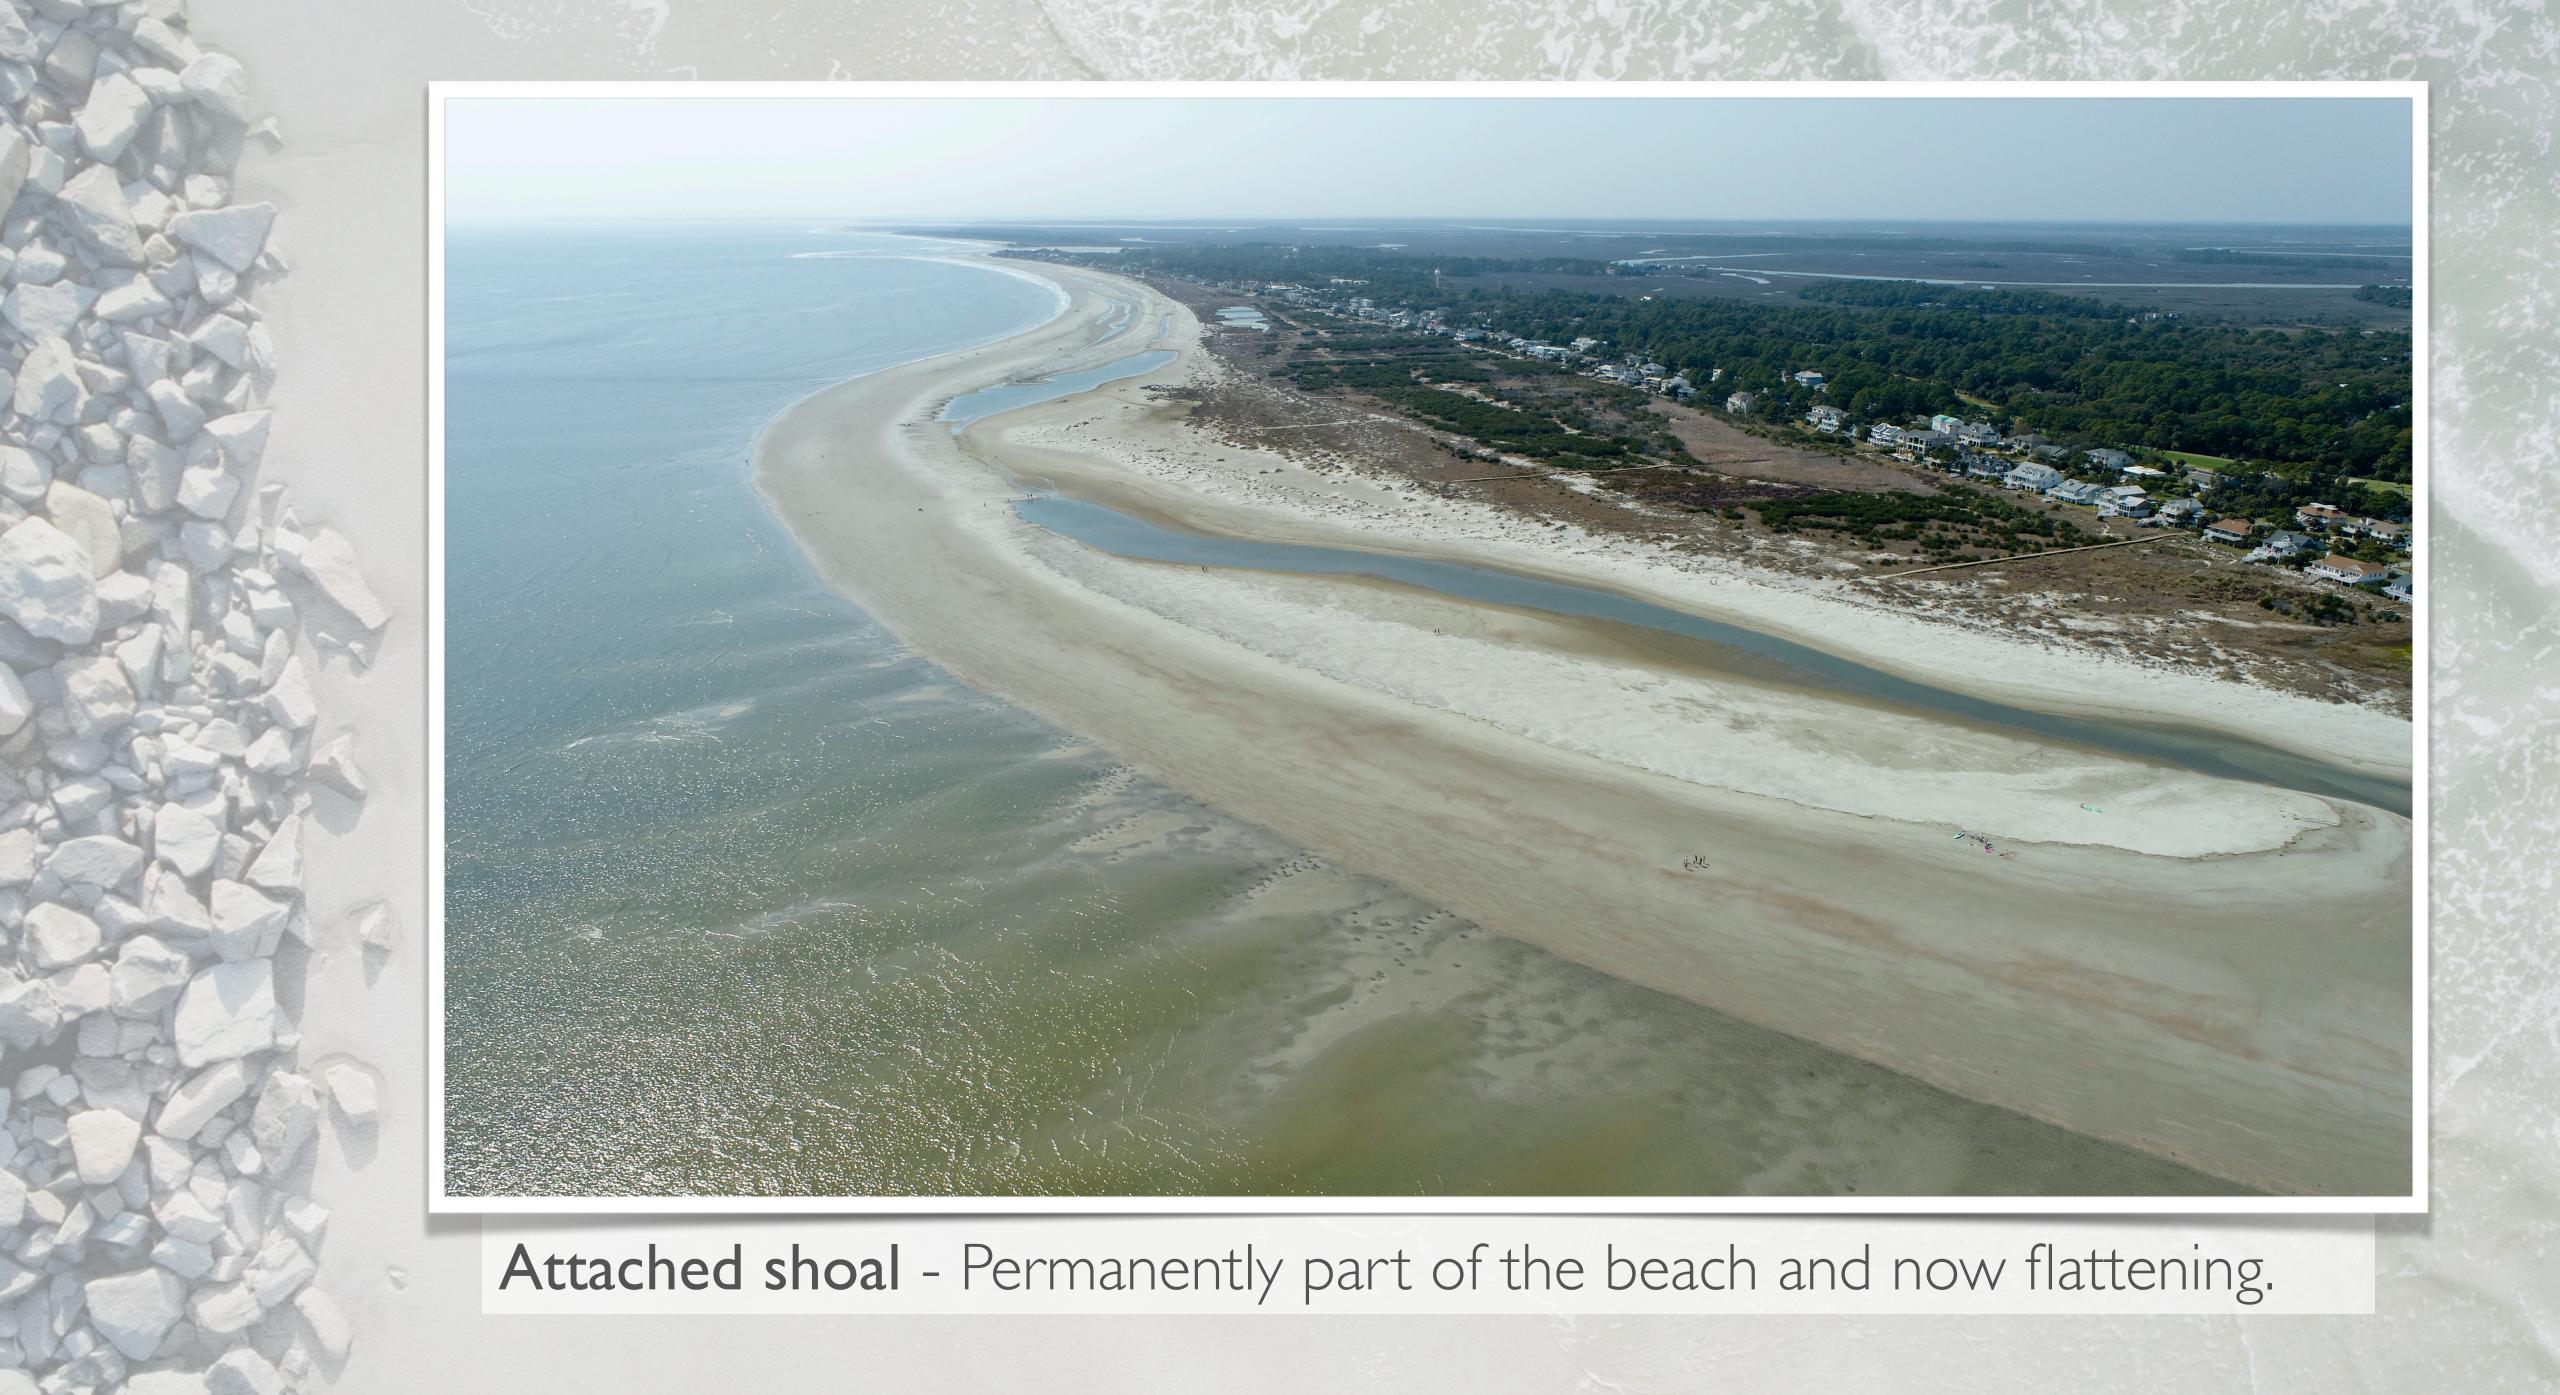
#### Looking South

The flattening of the attached shoal has separated the tidal pools. The "south pool" drains southwards along the beach into a series of smaller pools.

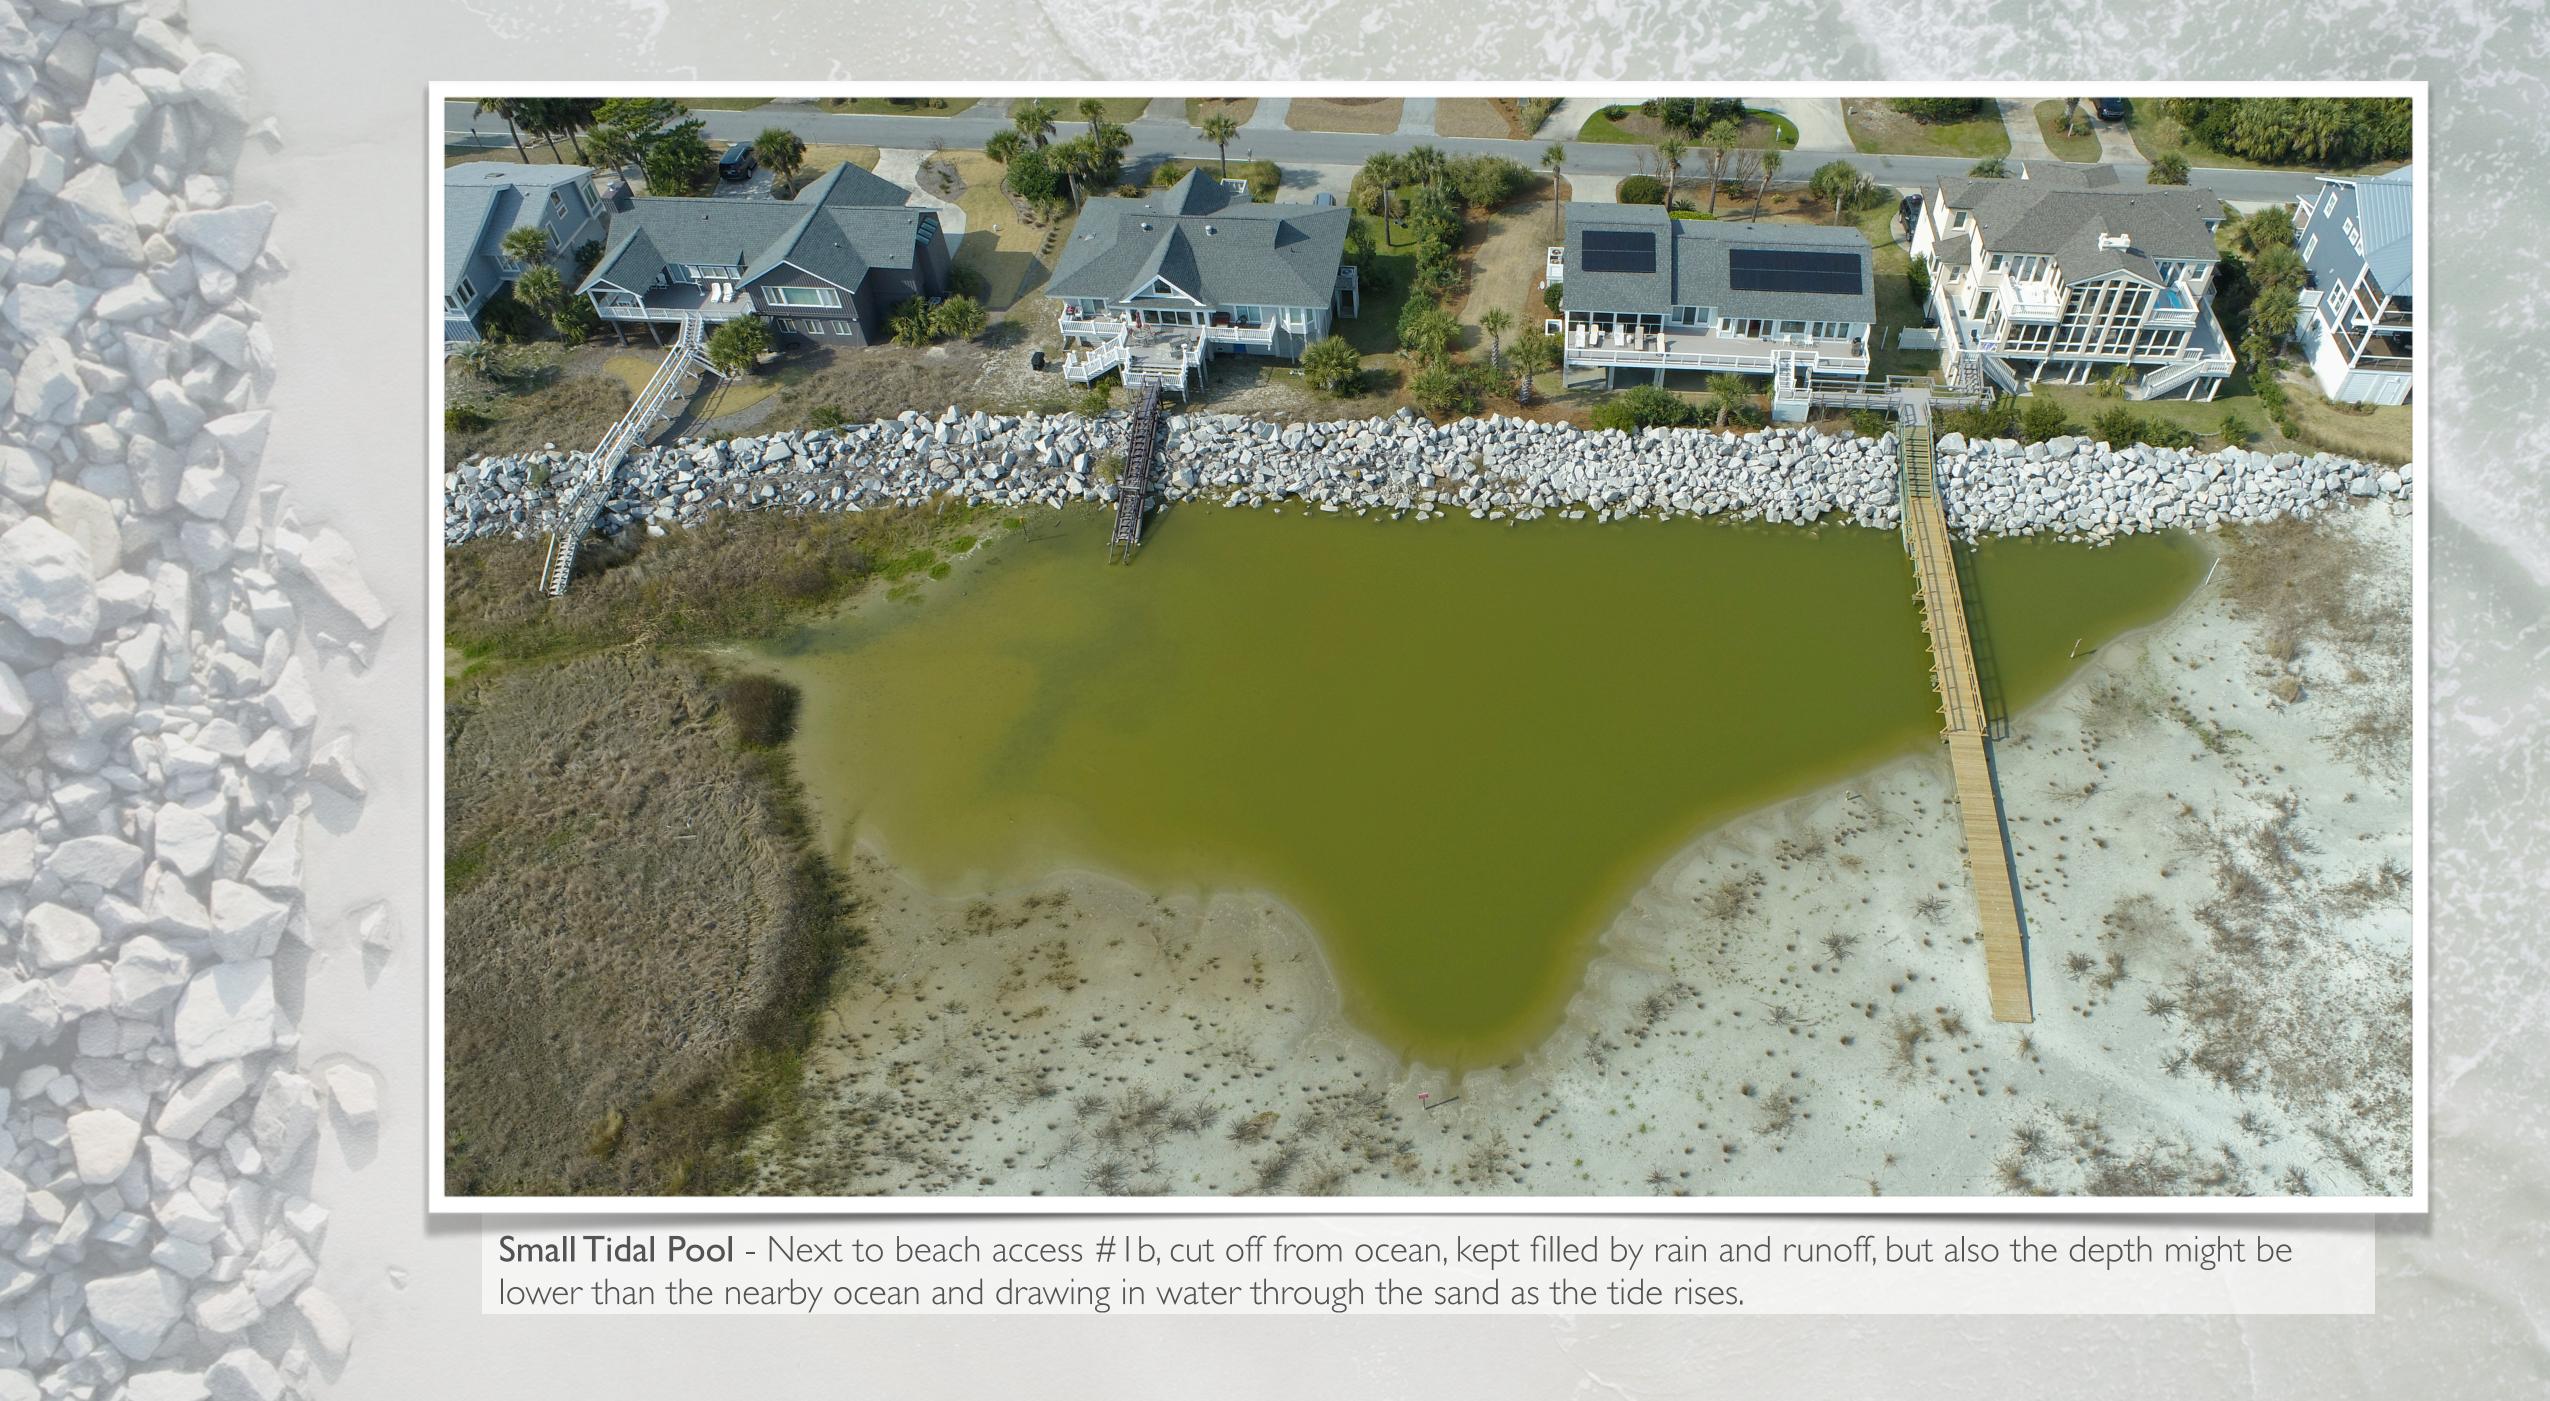
The recently formed tidal pool at #1b, rises and falls with tide cycle but doesn't drain completely. Not impassable, but user would get wet feet at high tide. Also, very slick mud around the area of the stairs even at low tide. Mud could be an issue.
