# THE SHIFTING SANDS

Photographing the dynamic shoreline around Fripp Island, SC

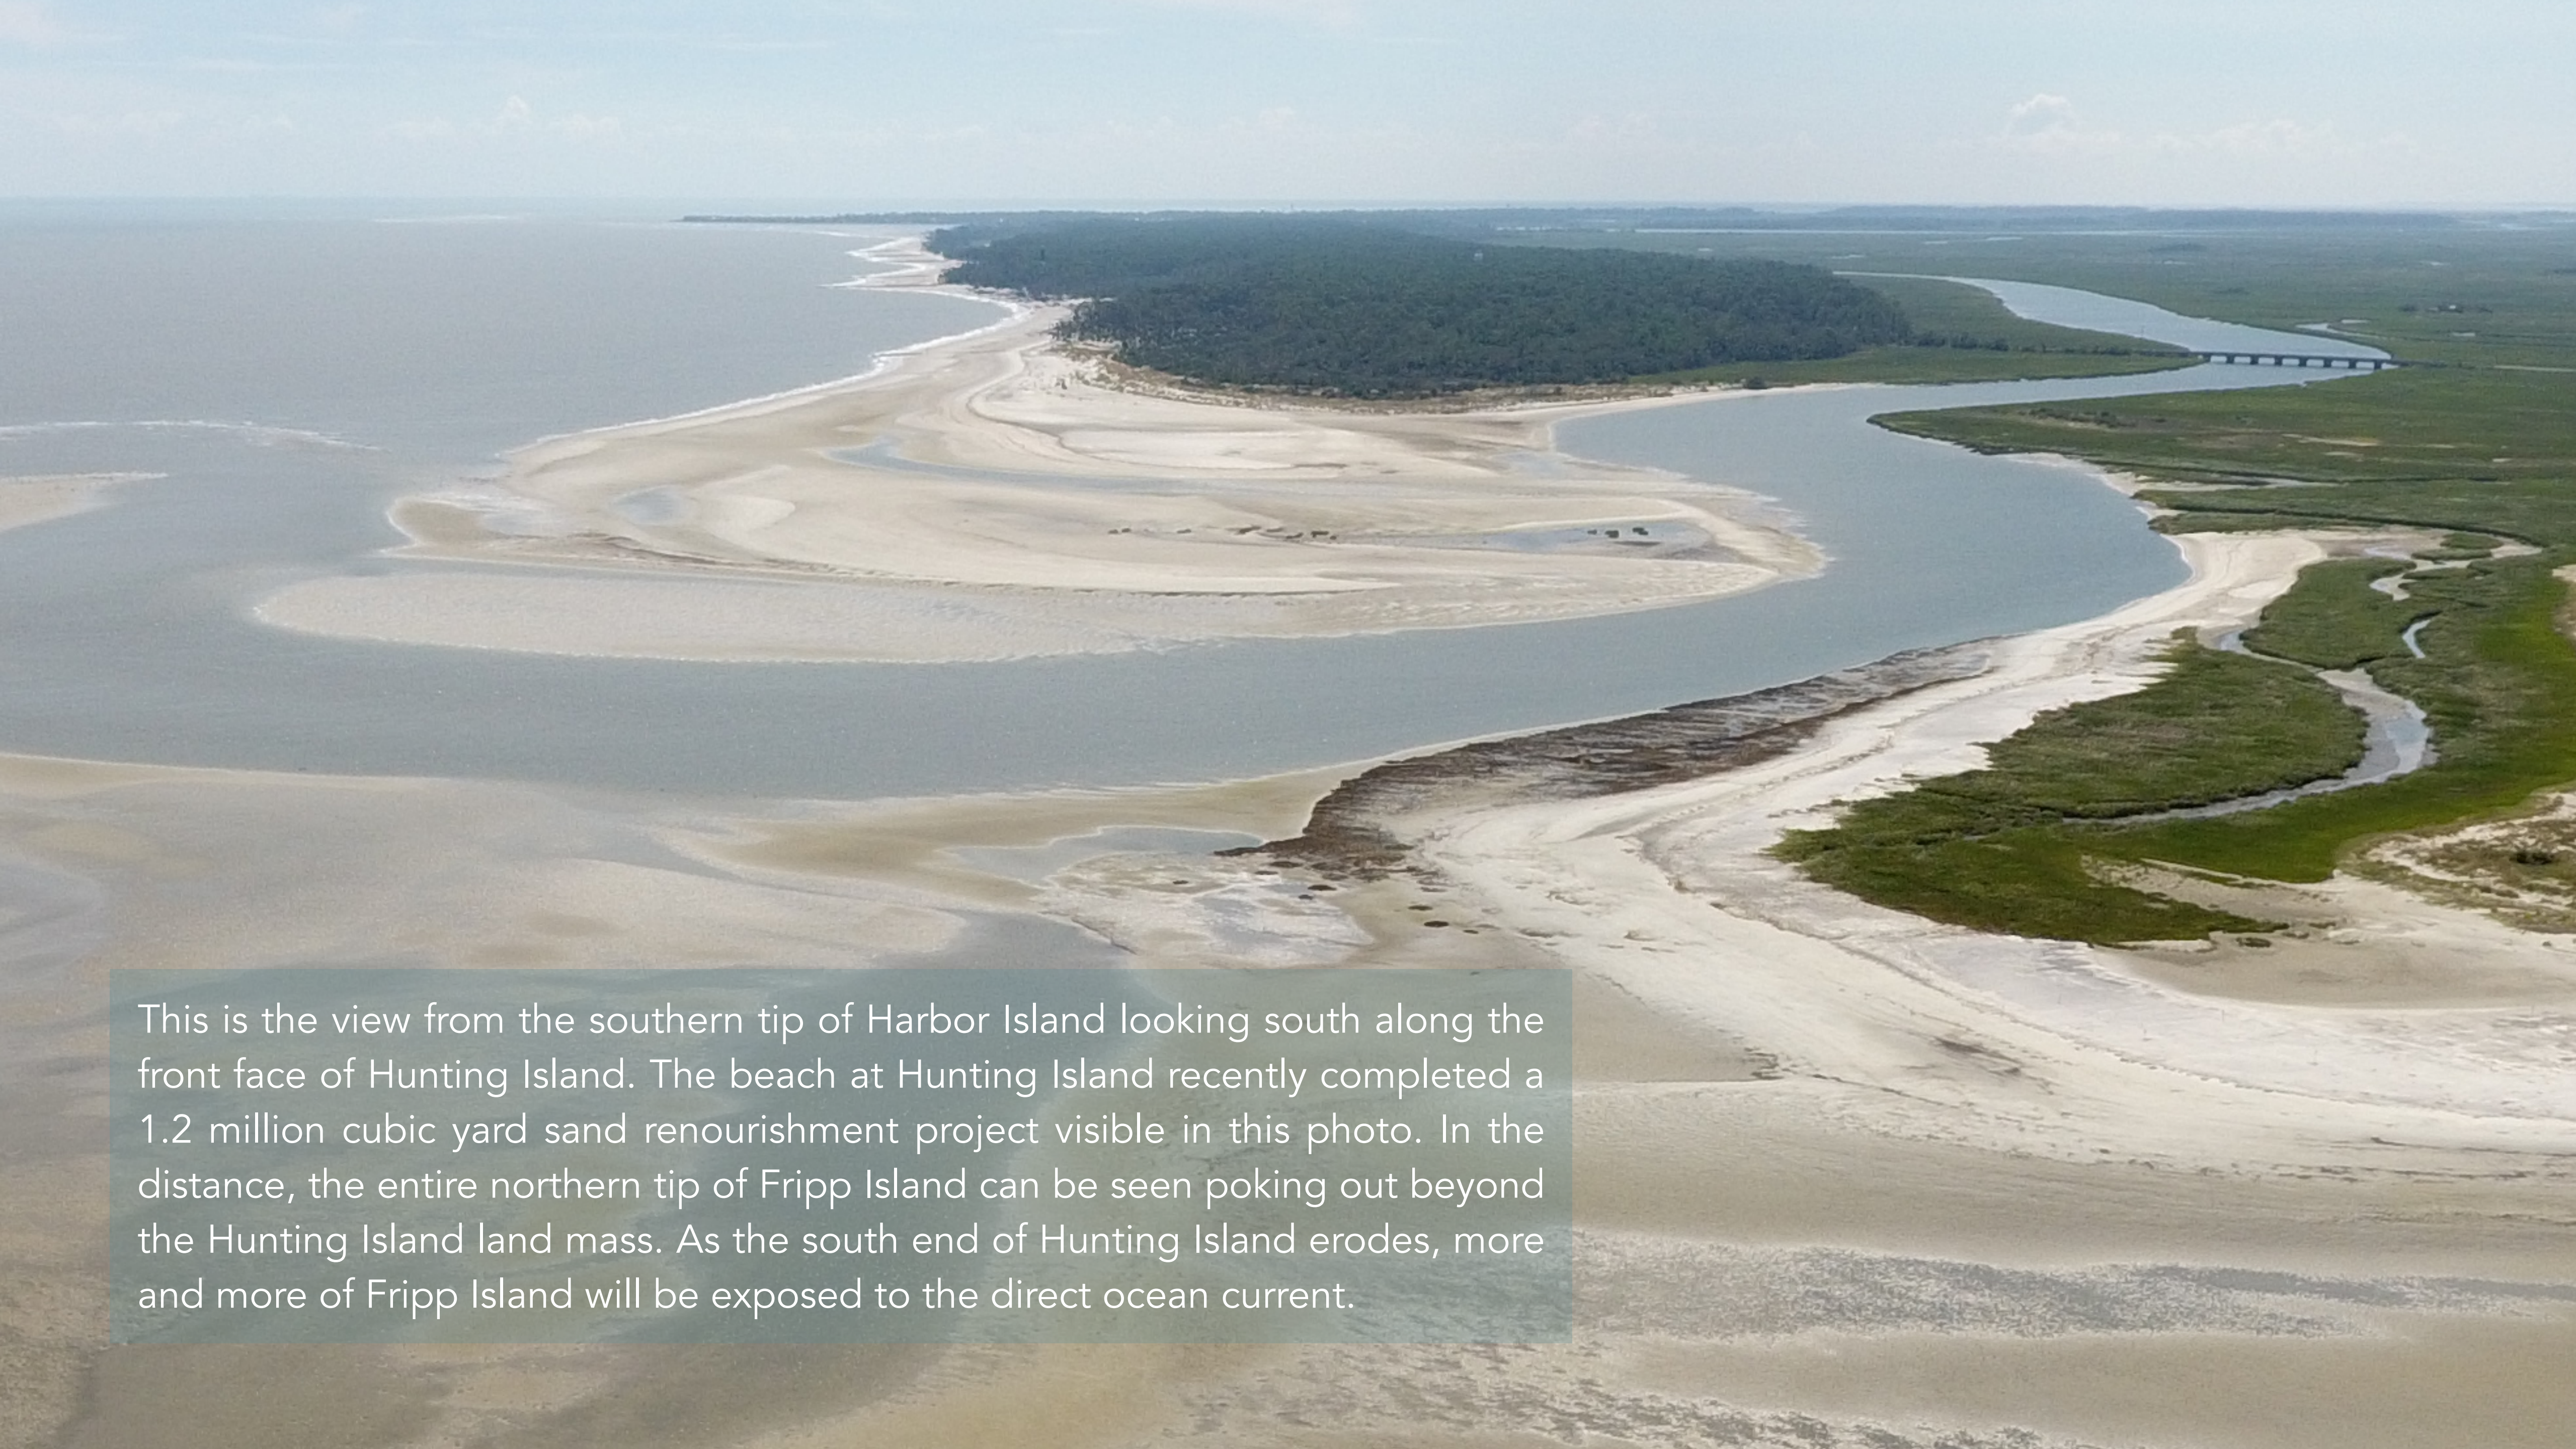
This is the view from the southern tip of Harbor Island looking south along the front face of Hunting Island. The beach at Hunting Island recently completed a 1.2 million cubic yard sand renourishment project visible in this photo. In the distance, the entire northern tip of Fripp Island can be seen poking out beyond the Hunting Island land mass. As the south end of Hunting Island erodes, more and more of Fripp Island will be exposed to the direct ocean current.

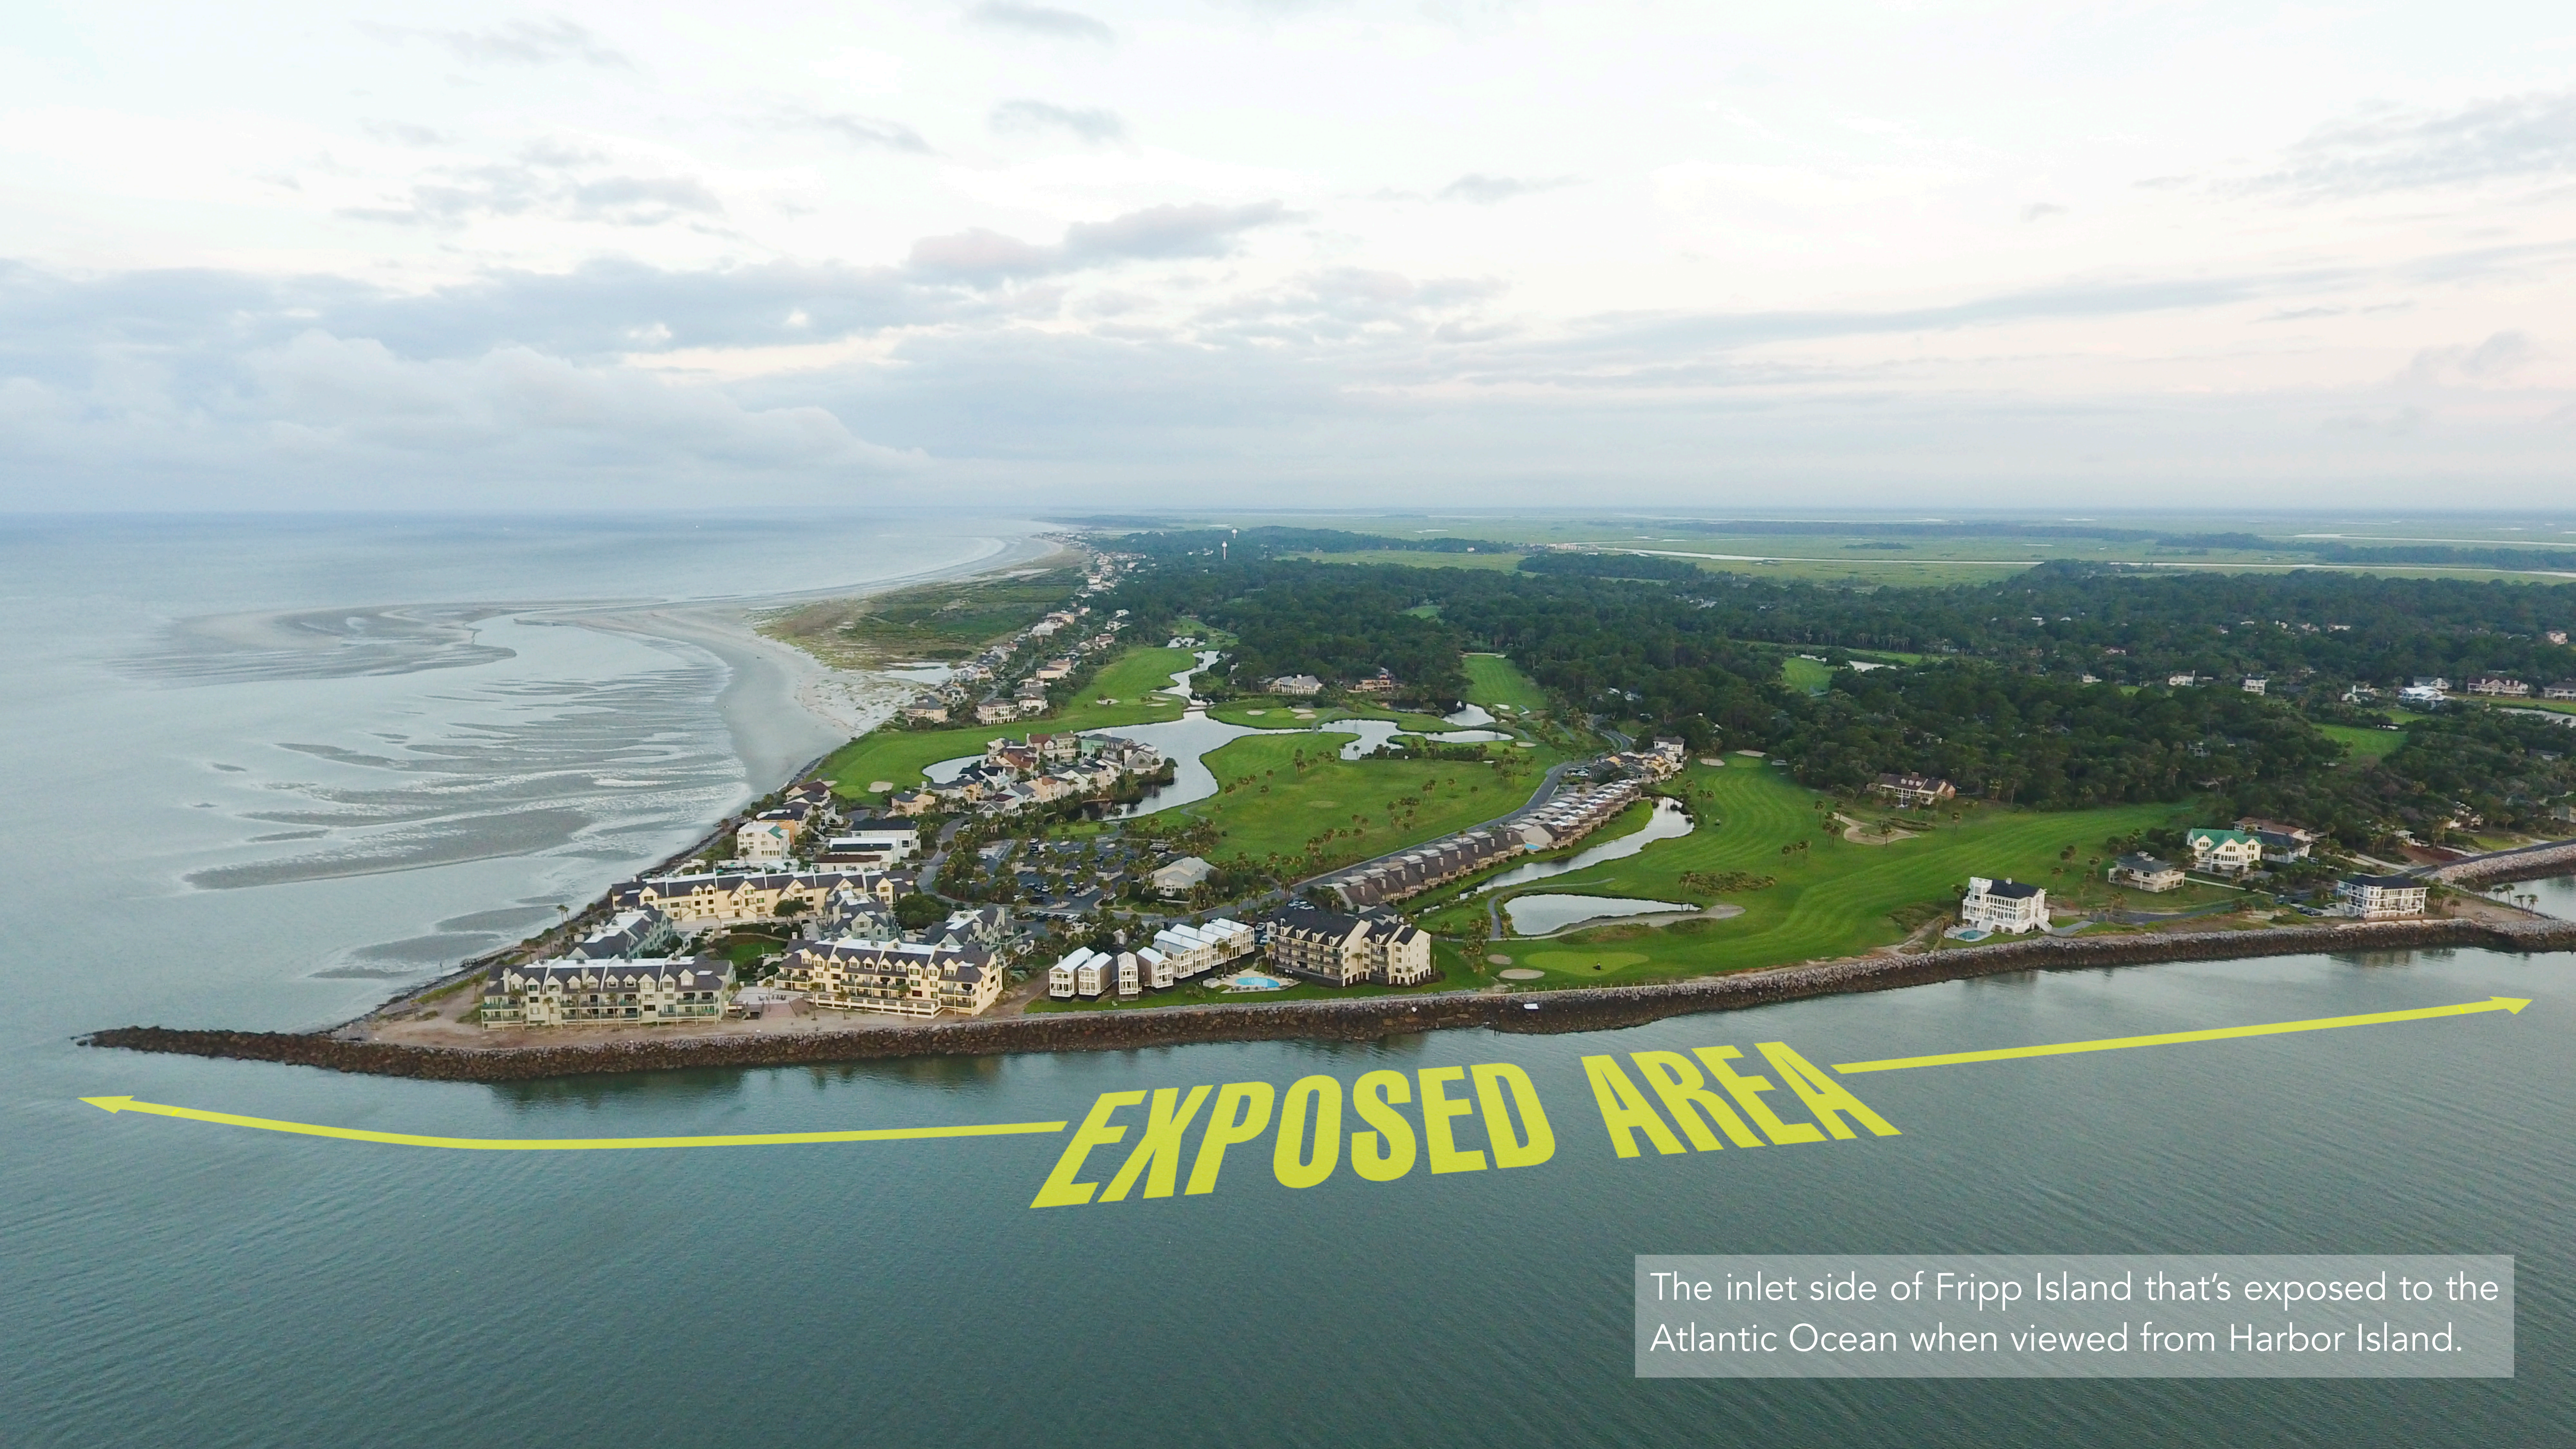
# *EXPOSED AREA*

The inlet side of Fripp Island that's exposed to the Atlantic Ocean when viewed from Harbor Island.

Harbor Island has no hard structures to protect its shoreline from the erosive sawing action of the tide entering and leaving Harbor Inlet. As a result an almost perfectly round curve is formed.

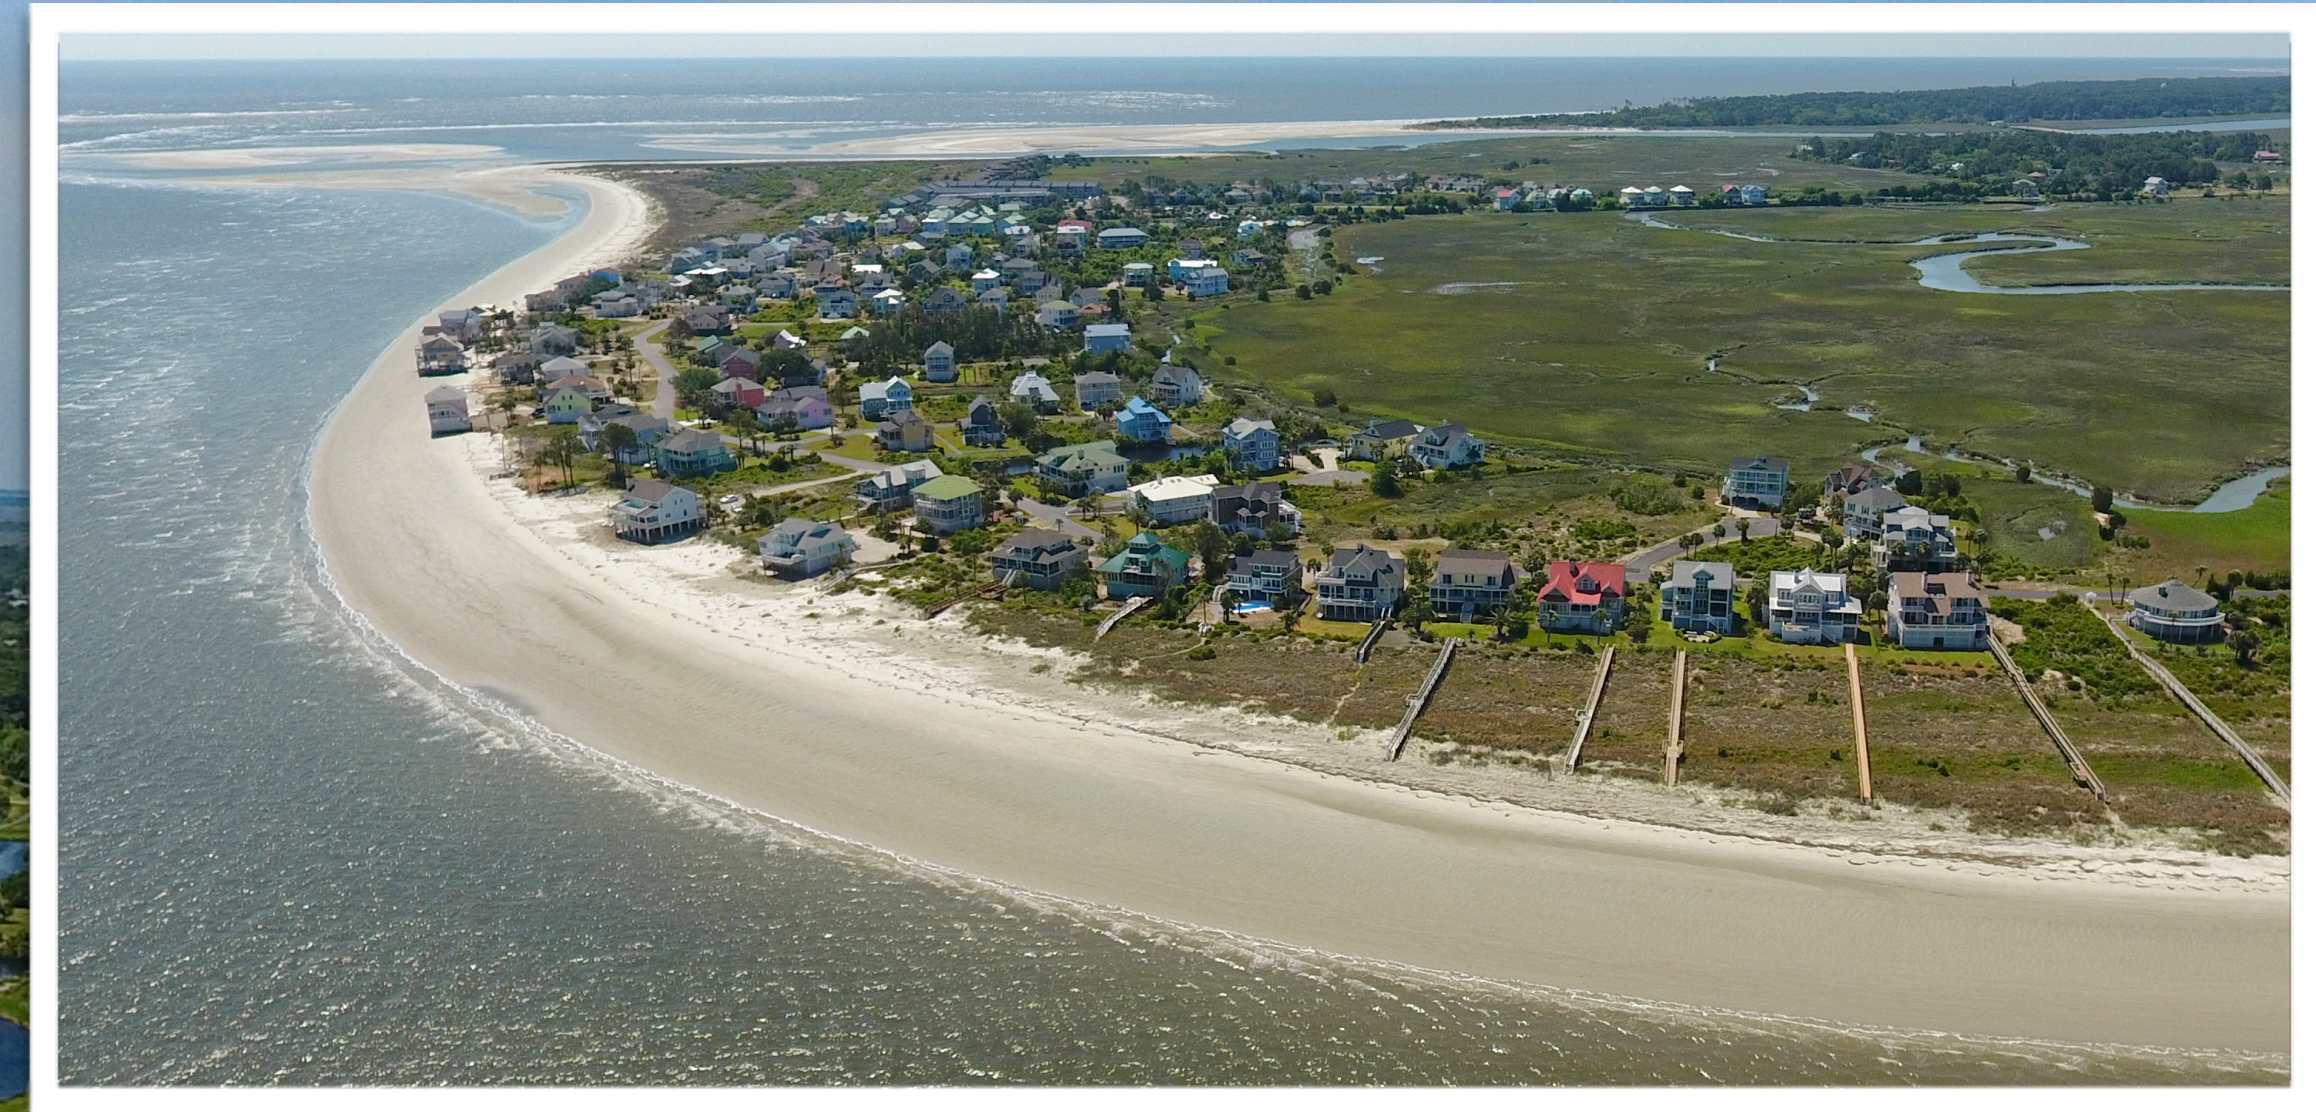
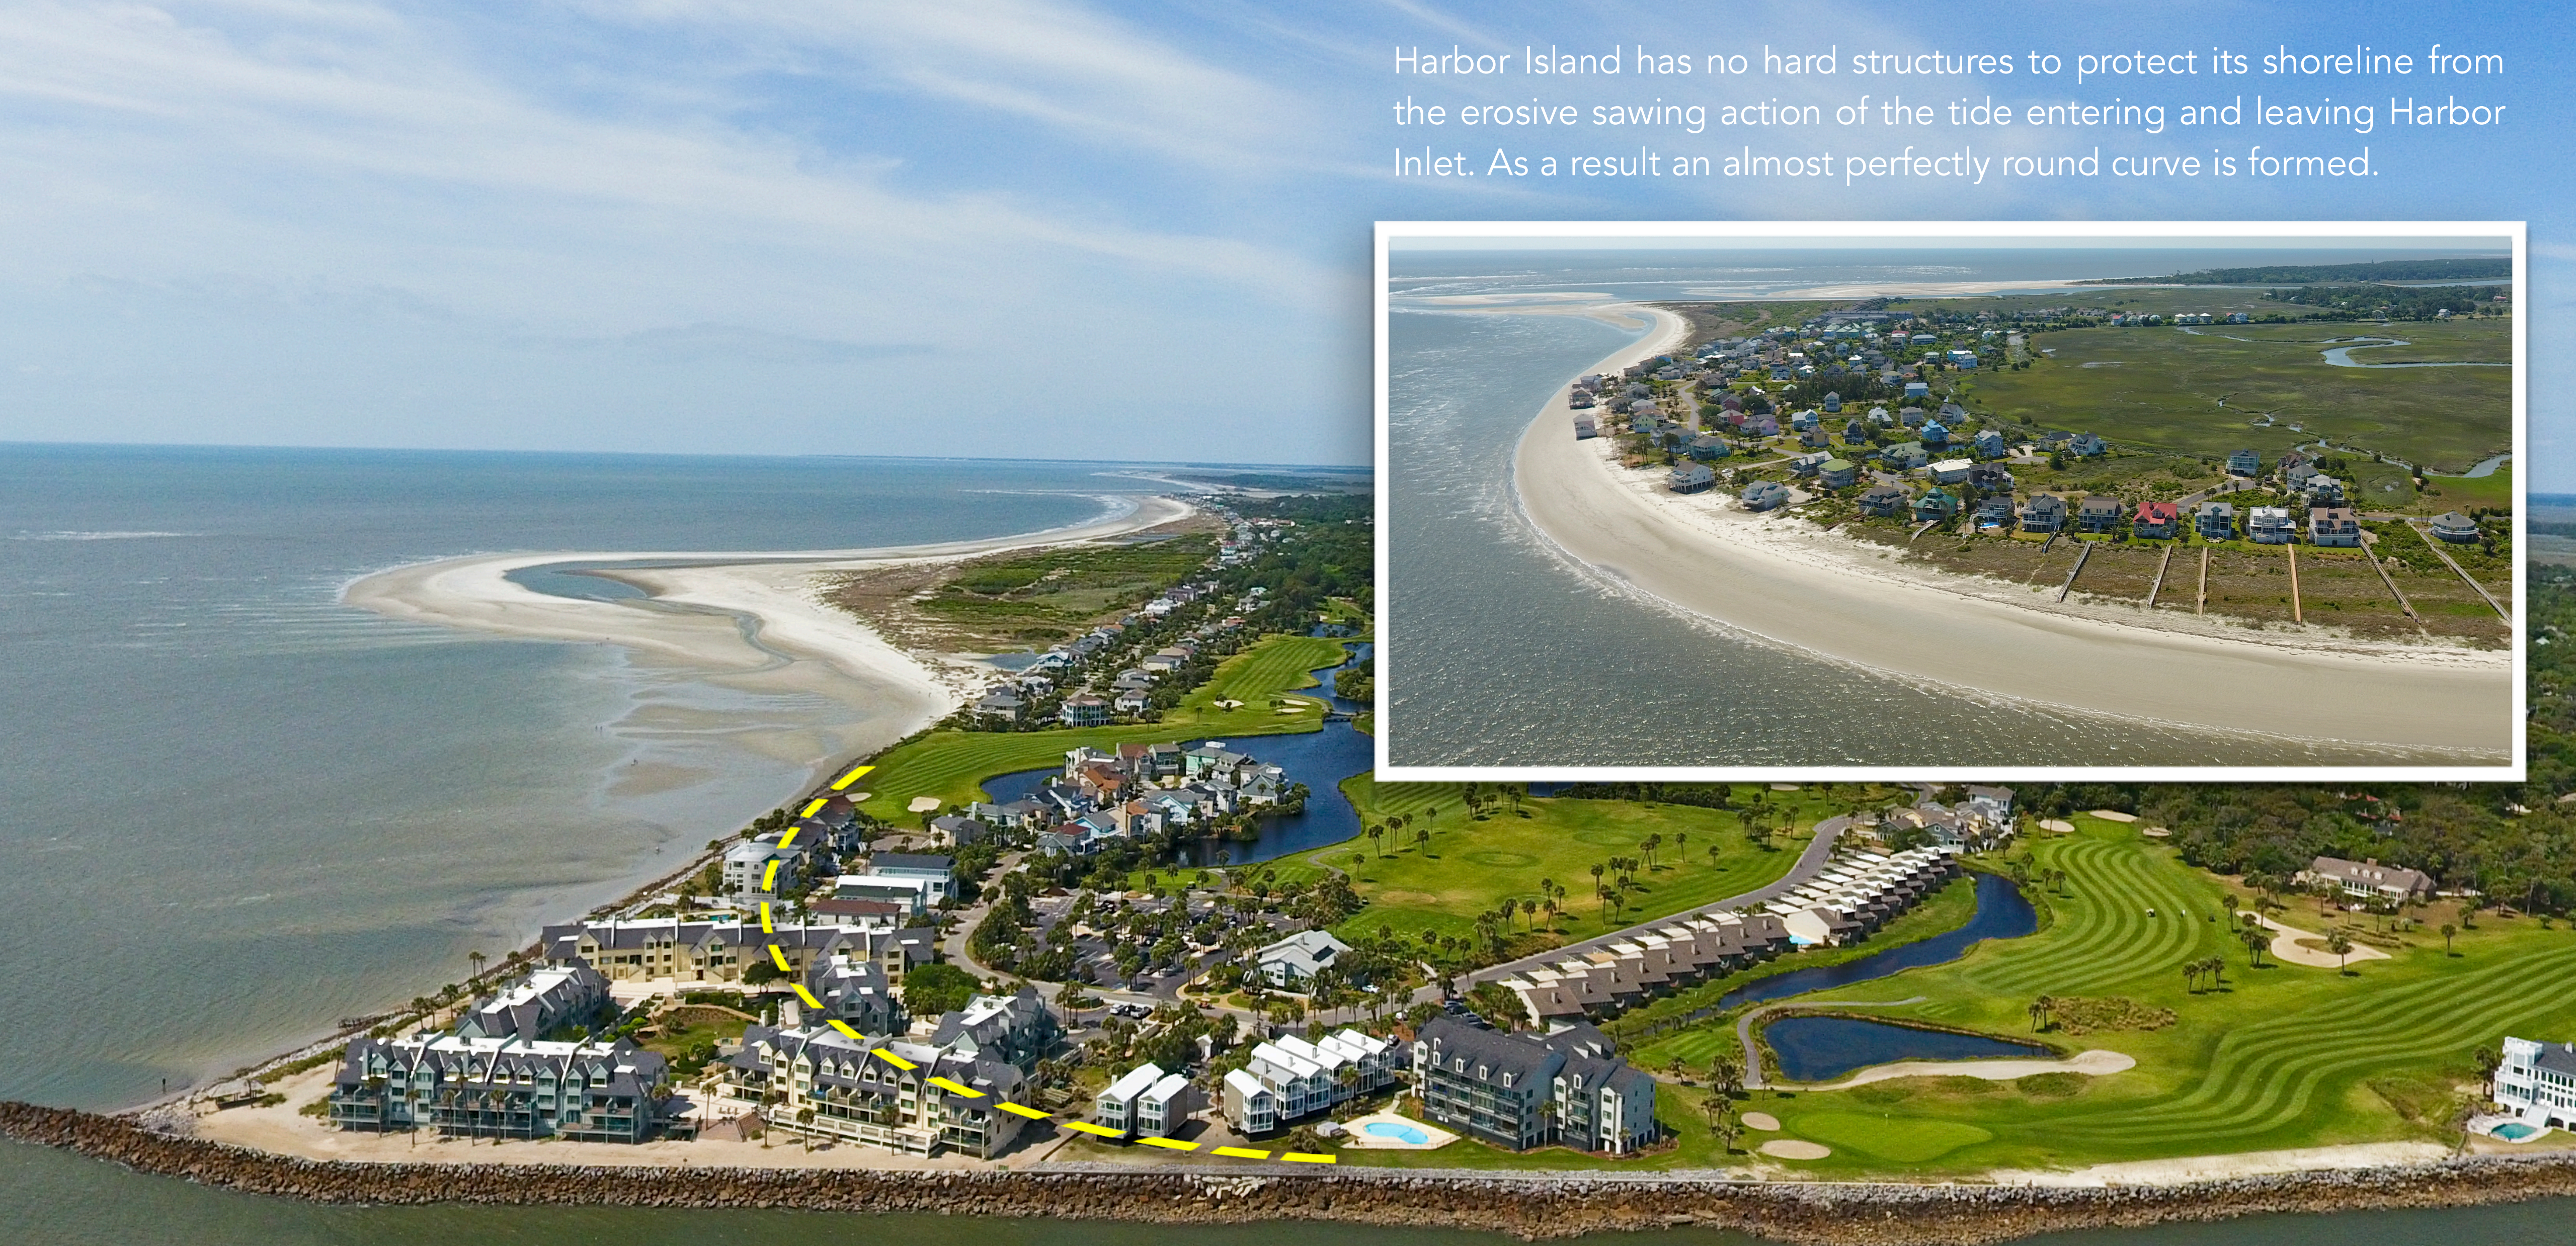
The northern tip of Fripp Island is protected by a rock revetment so the rounding doesn't occur. If the same sawing motion were to occur to an unprotected side of Fripp Island, the damage would be catastrophic to a large number of homes.

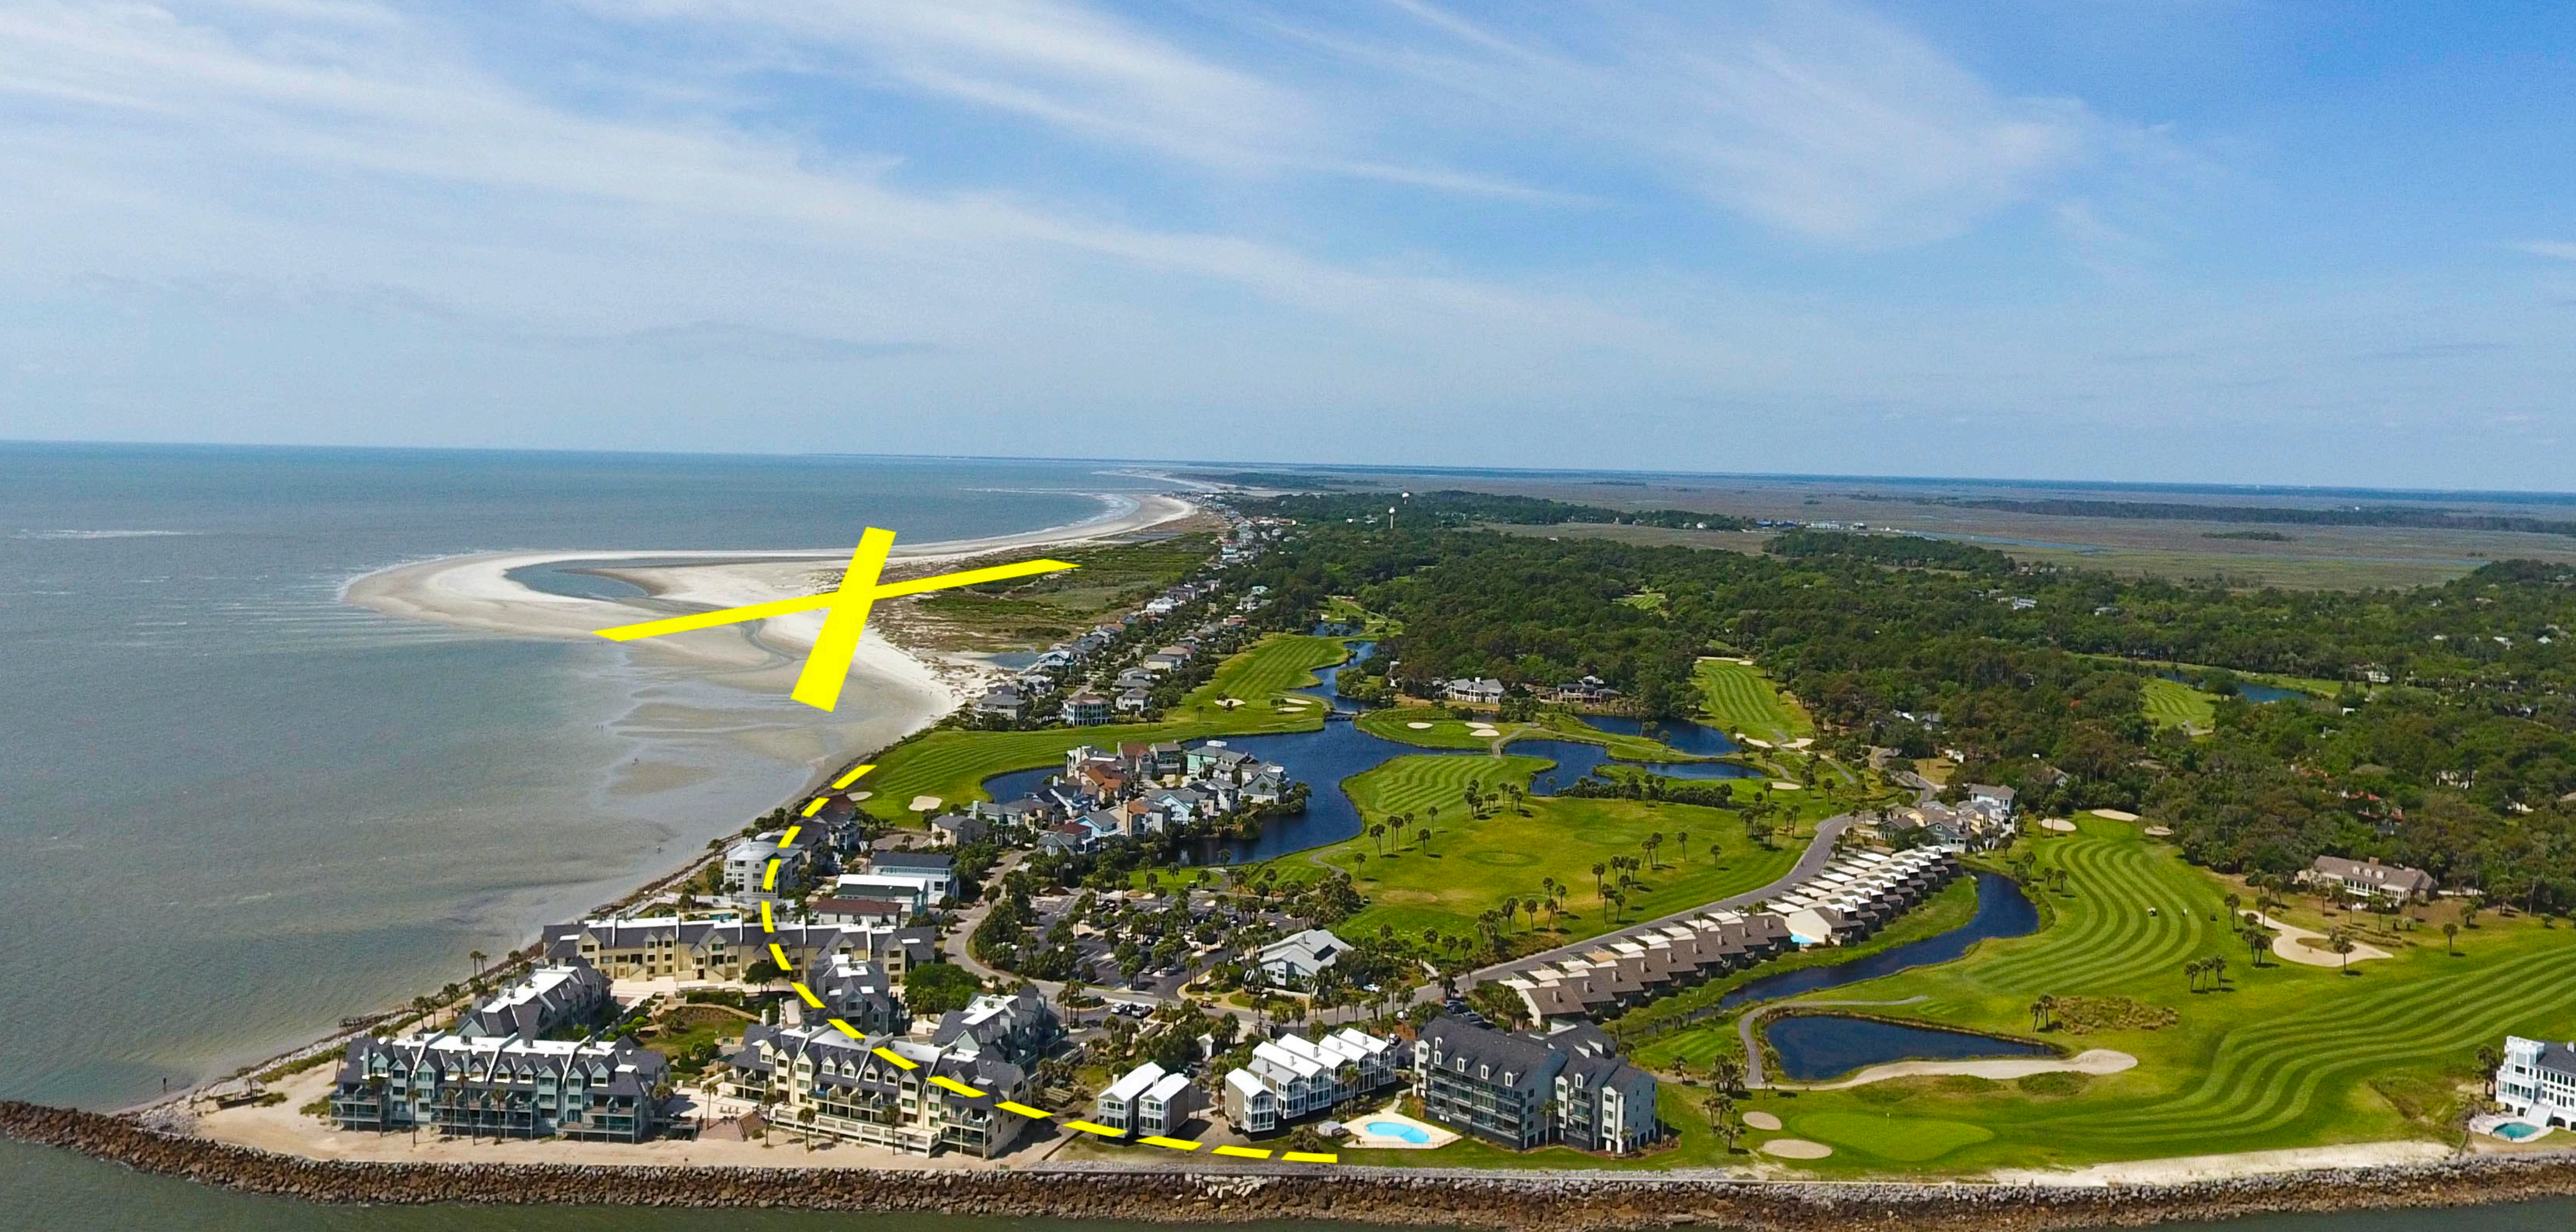
Without the rock revetment, or any other hard structure wall in its place, the inlet tidal current would round the northern corner and the large sand build-up that continues to replenish Fripp Island's beach would most likely not occur.

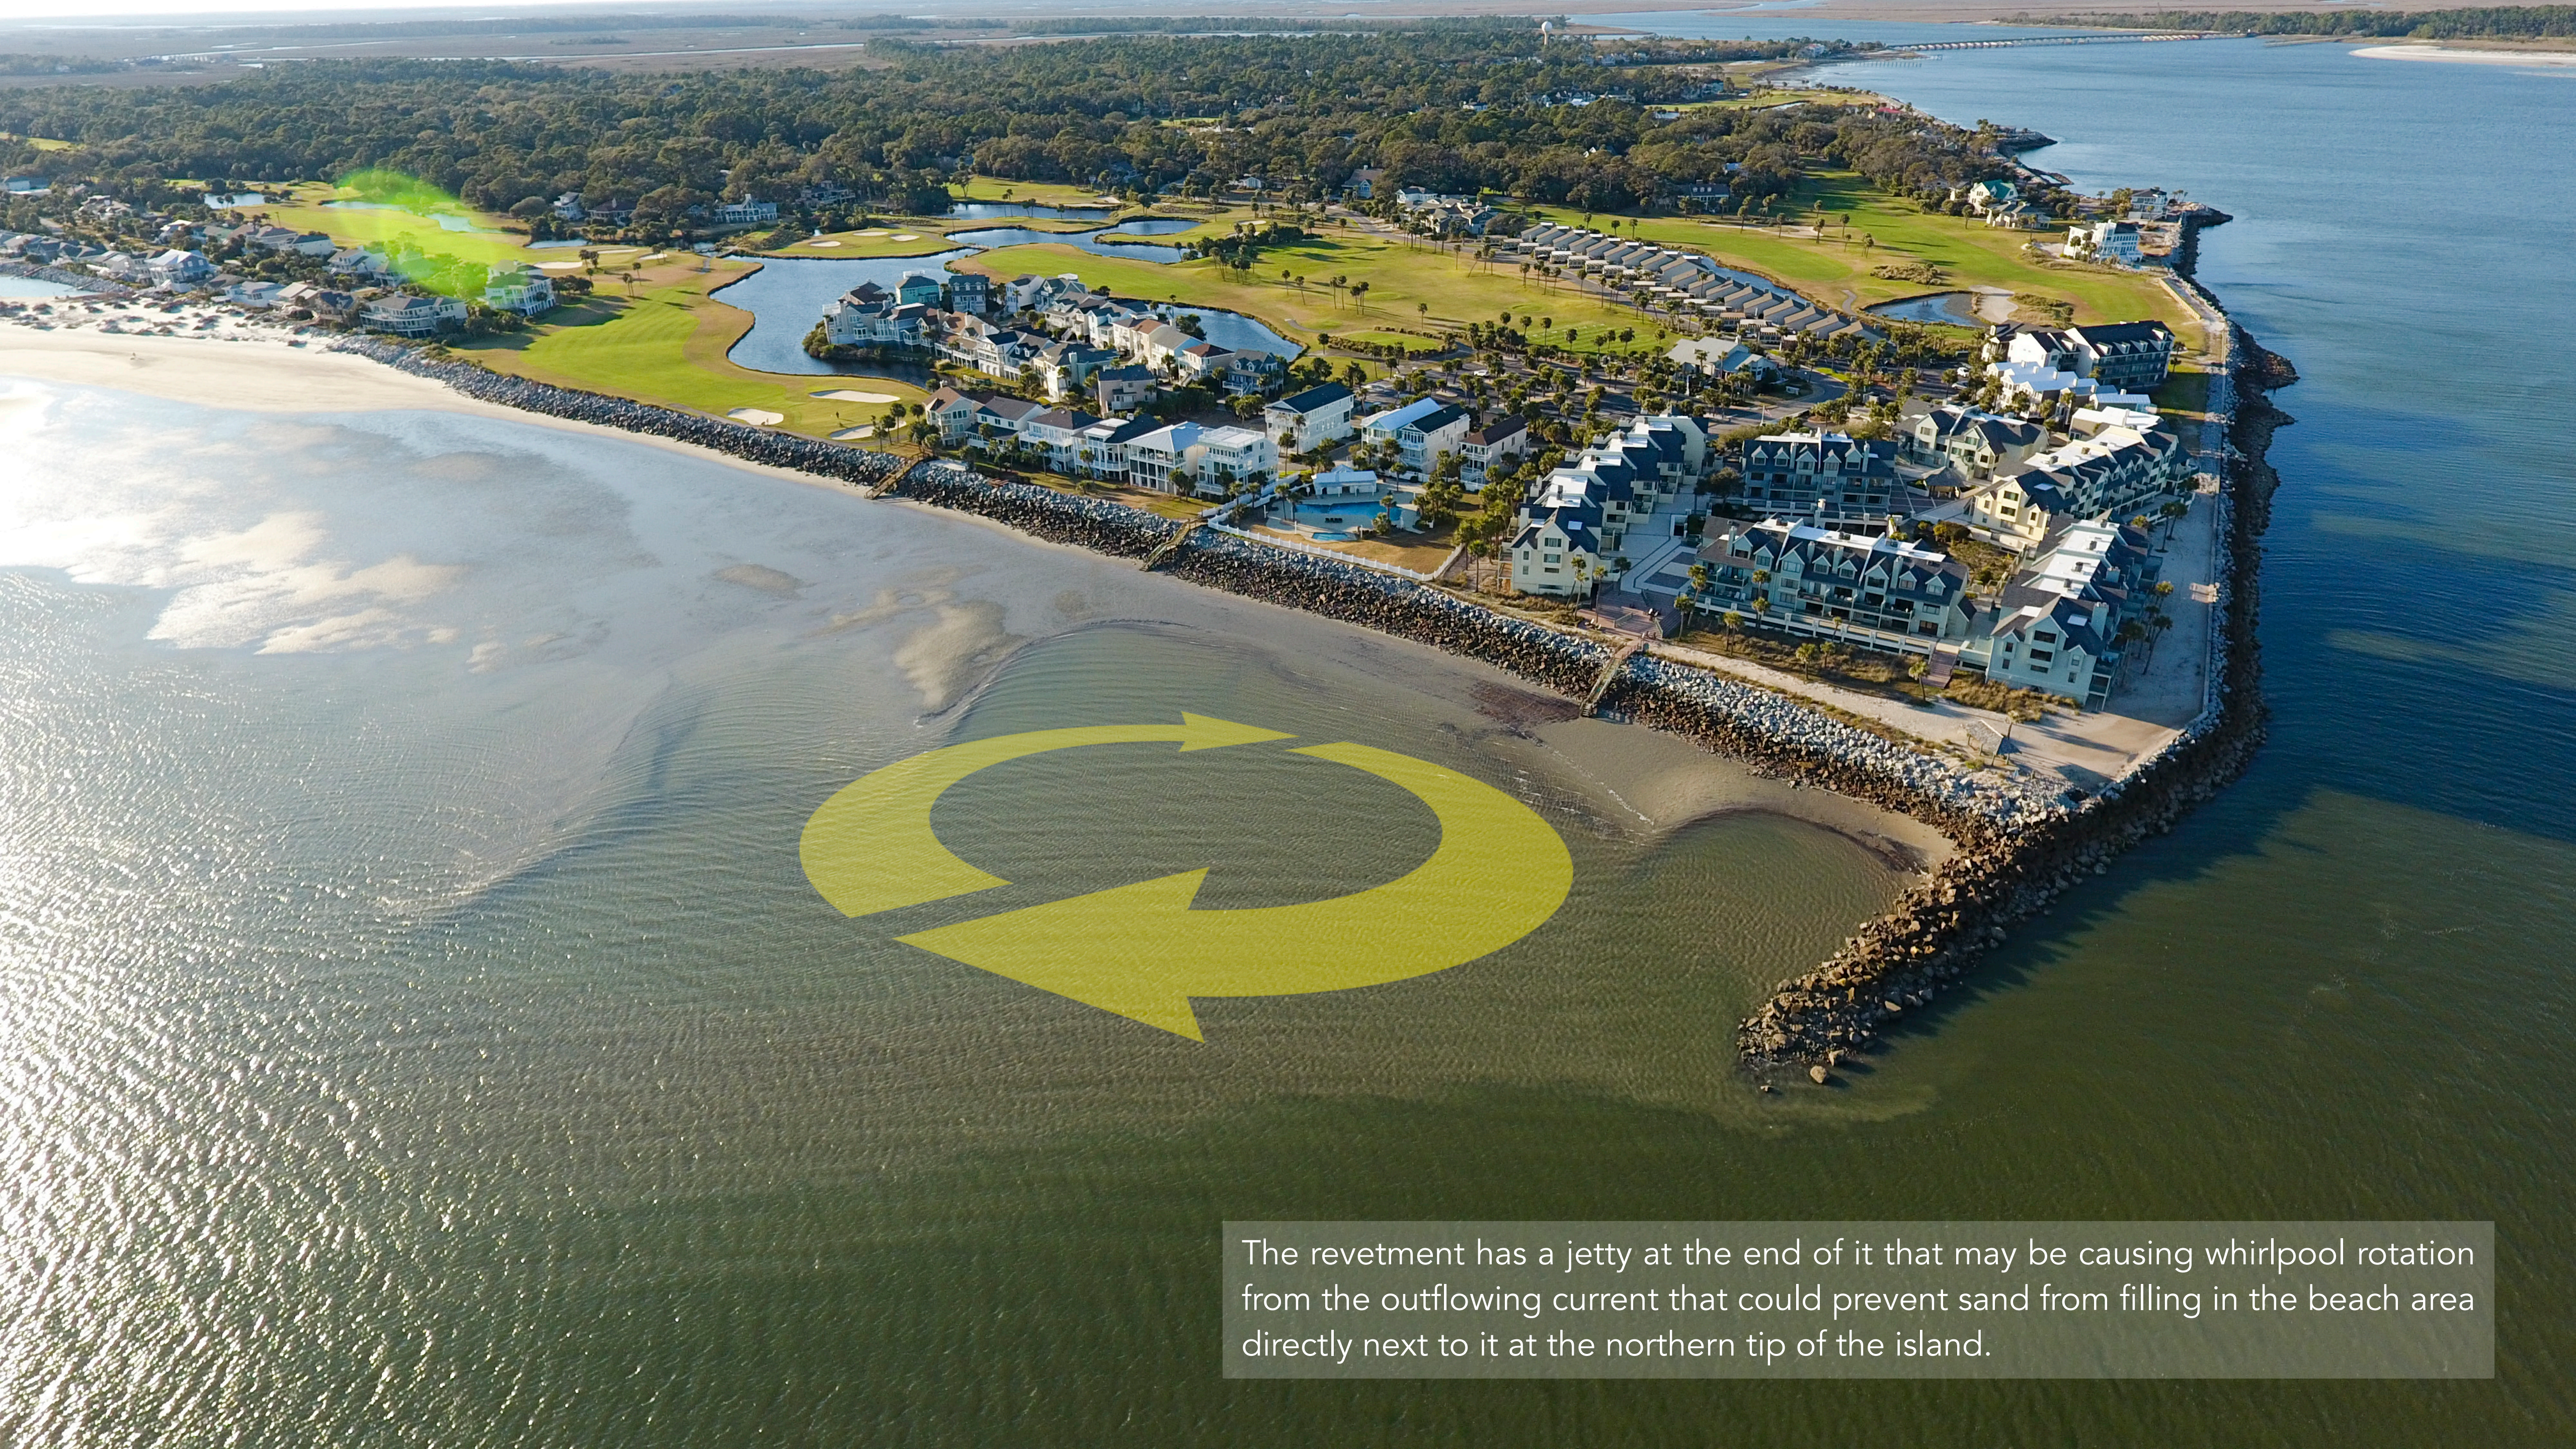
The revetment has a jetty at the end of it that may be causing whirlpool rotation from the outflowing current that could prevent sand from filling in the beach area directly next to it at the northern tip of the island.
