# THE SHIFTING SANDS

Photographing the dynamic shoreline around Fripp Island, SC

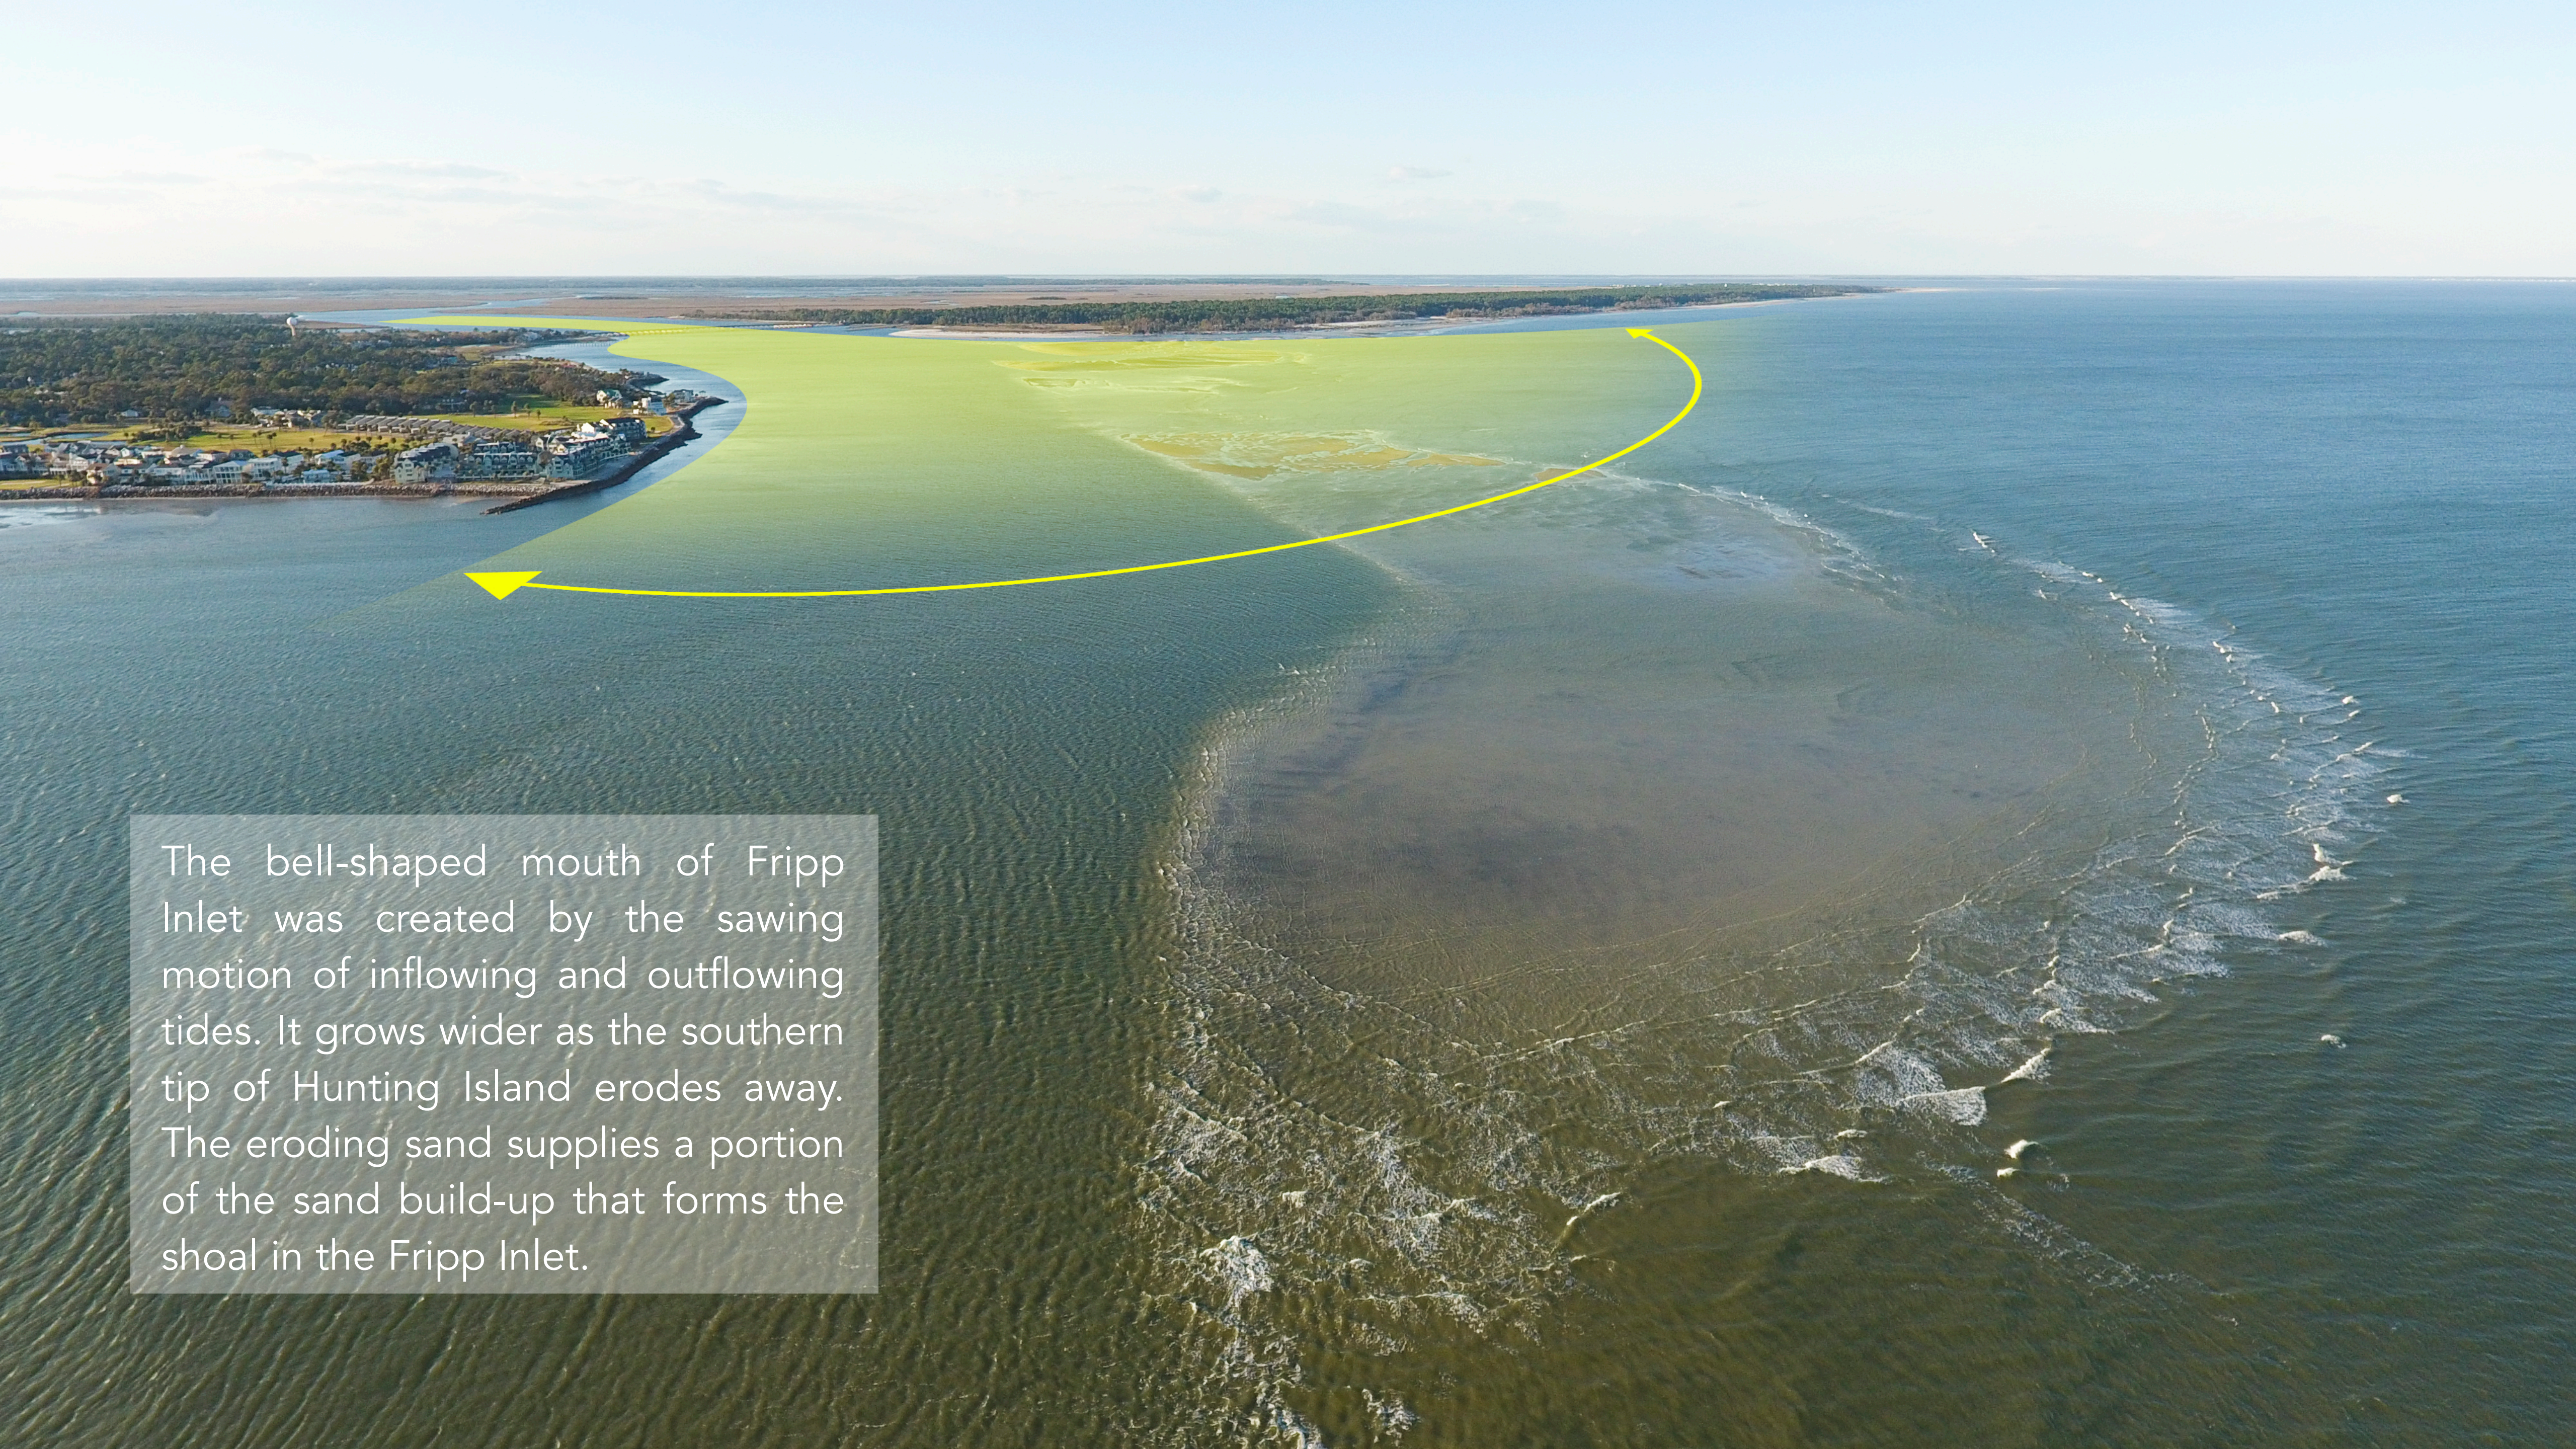
The bell-shaped mouth of Fripp Inlet was created by the sawing motion of inflowing and outflowing tides. It grows wider as the southern tip of Hunting Island erodes away. The eroding sand supplies a portion of the sand build-up that forms the shoal in the Fripp Inlet.

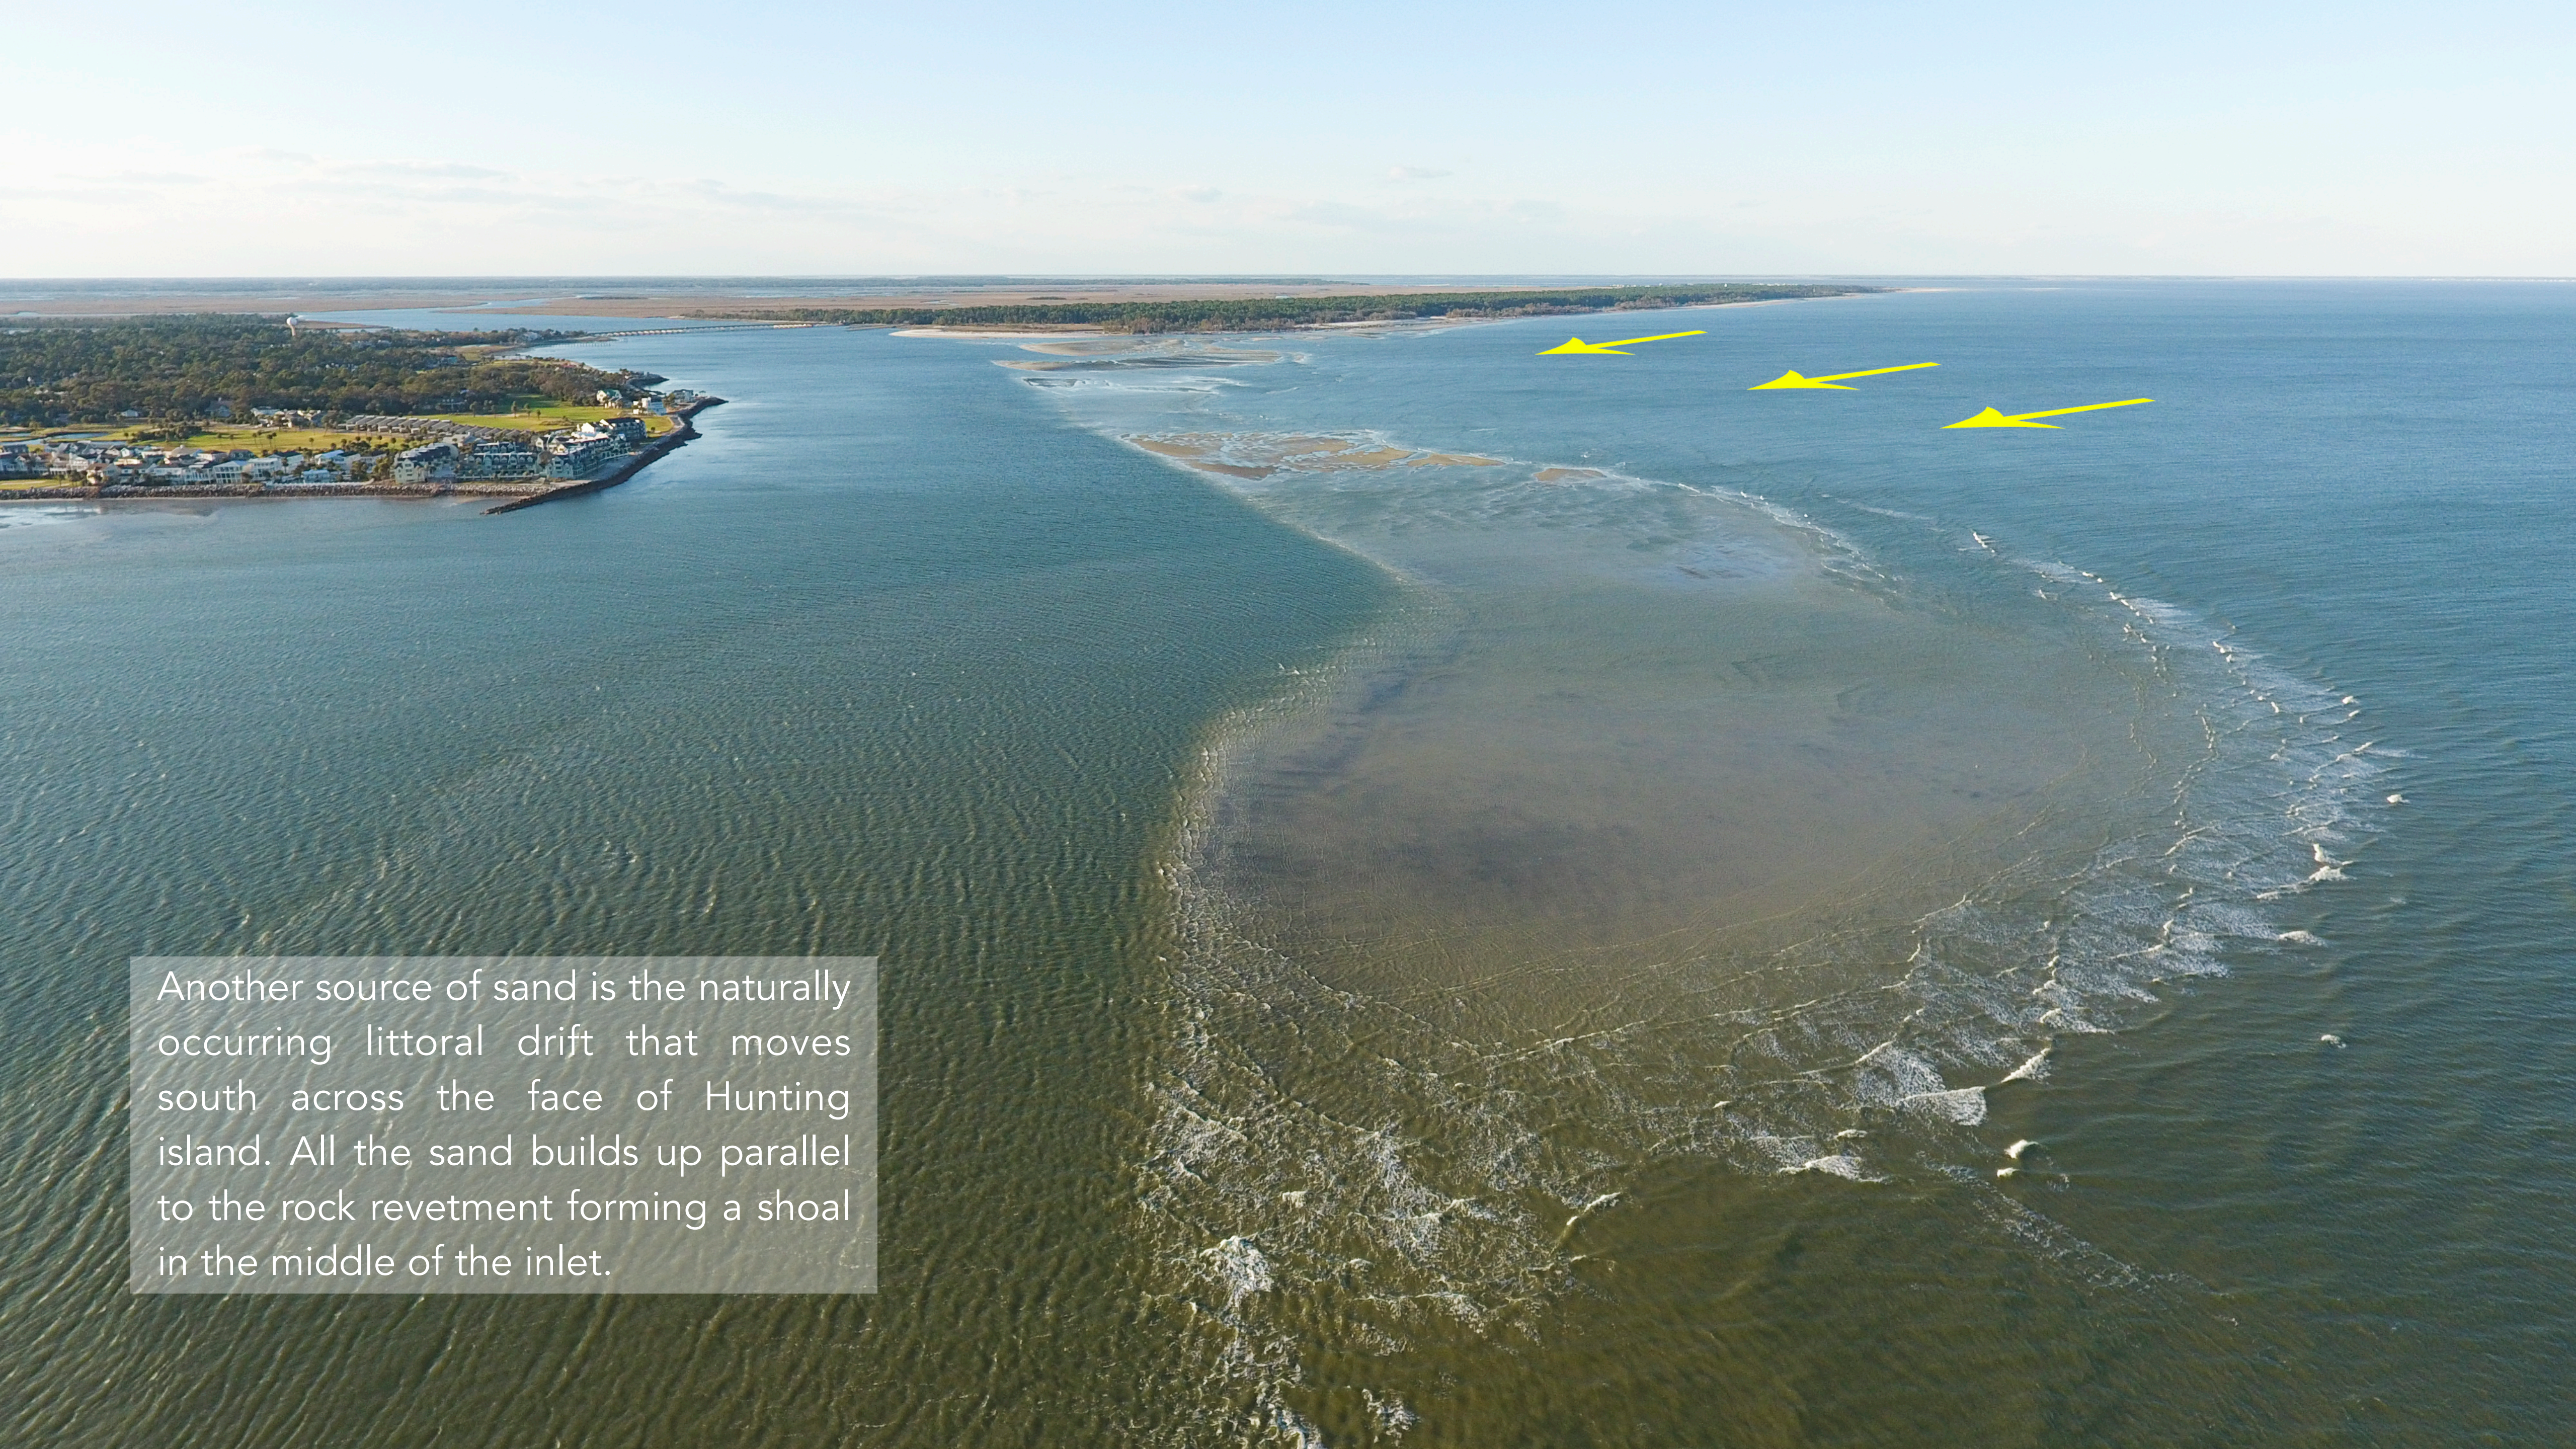
Another source of sand is the naturally occurring littoral drift that moves south across the face of Hunting island. All the sand builds up parallel to the rock revetment forming a shoal in the middle of the inlet.

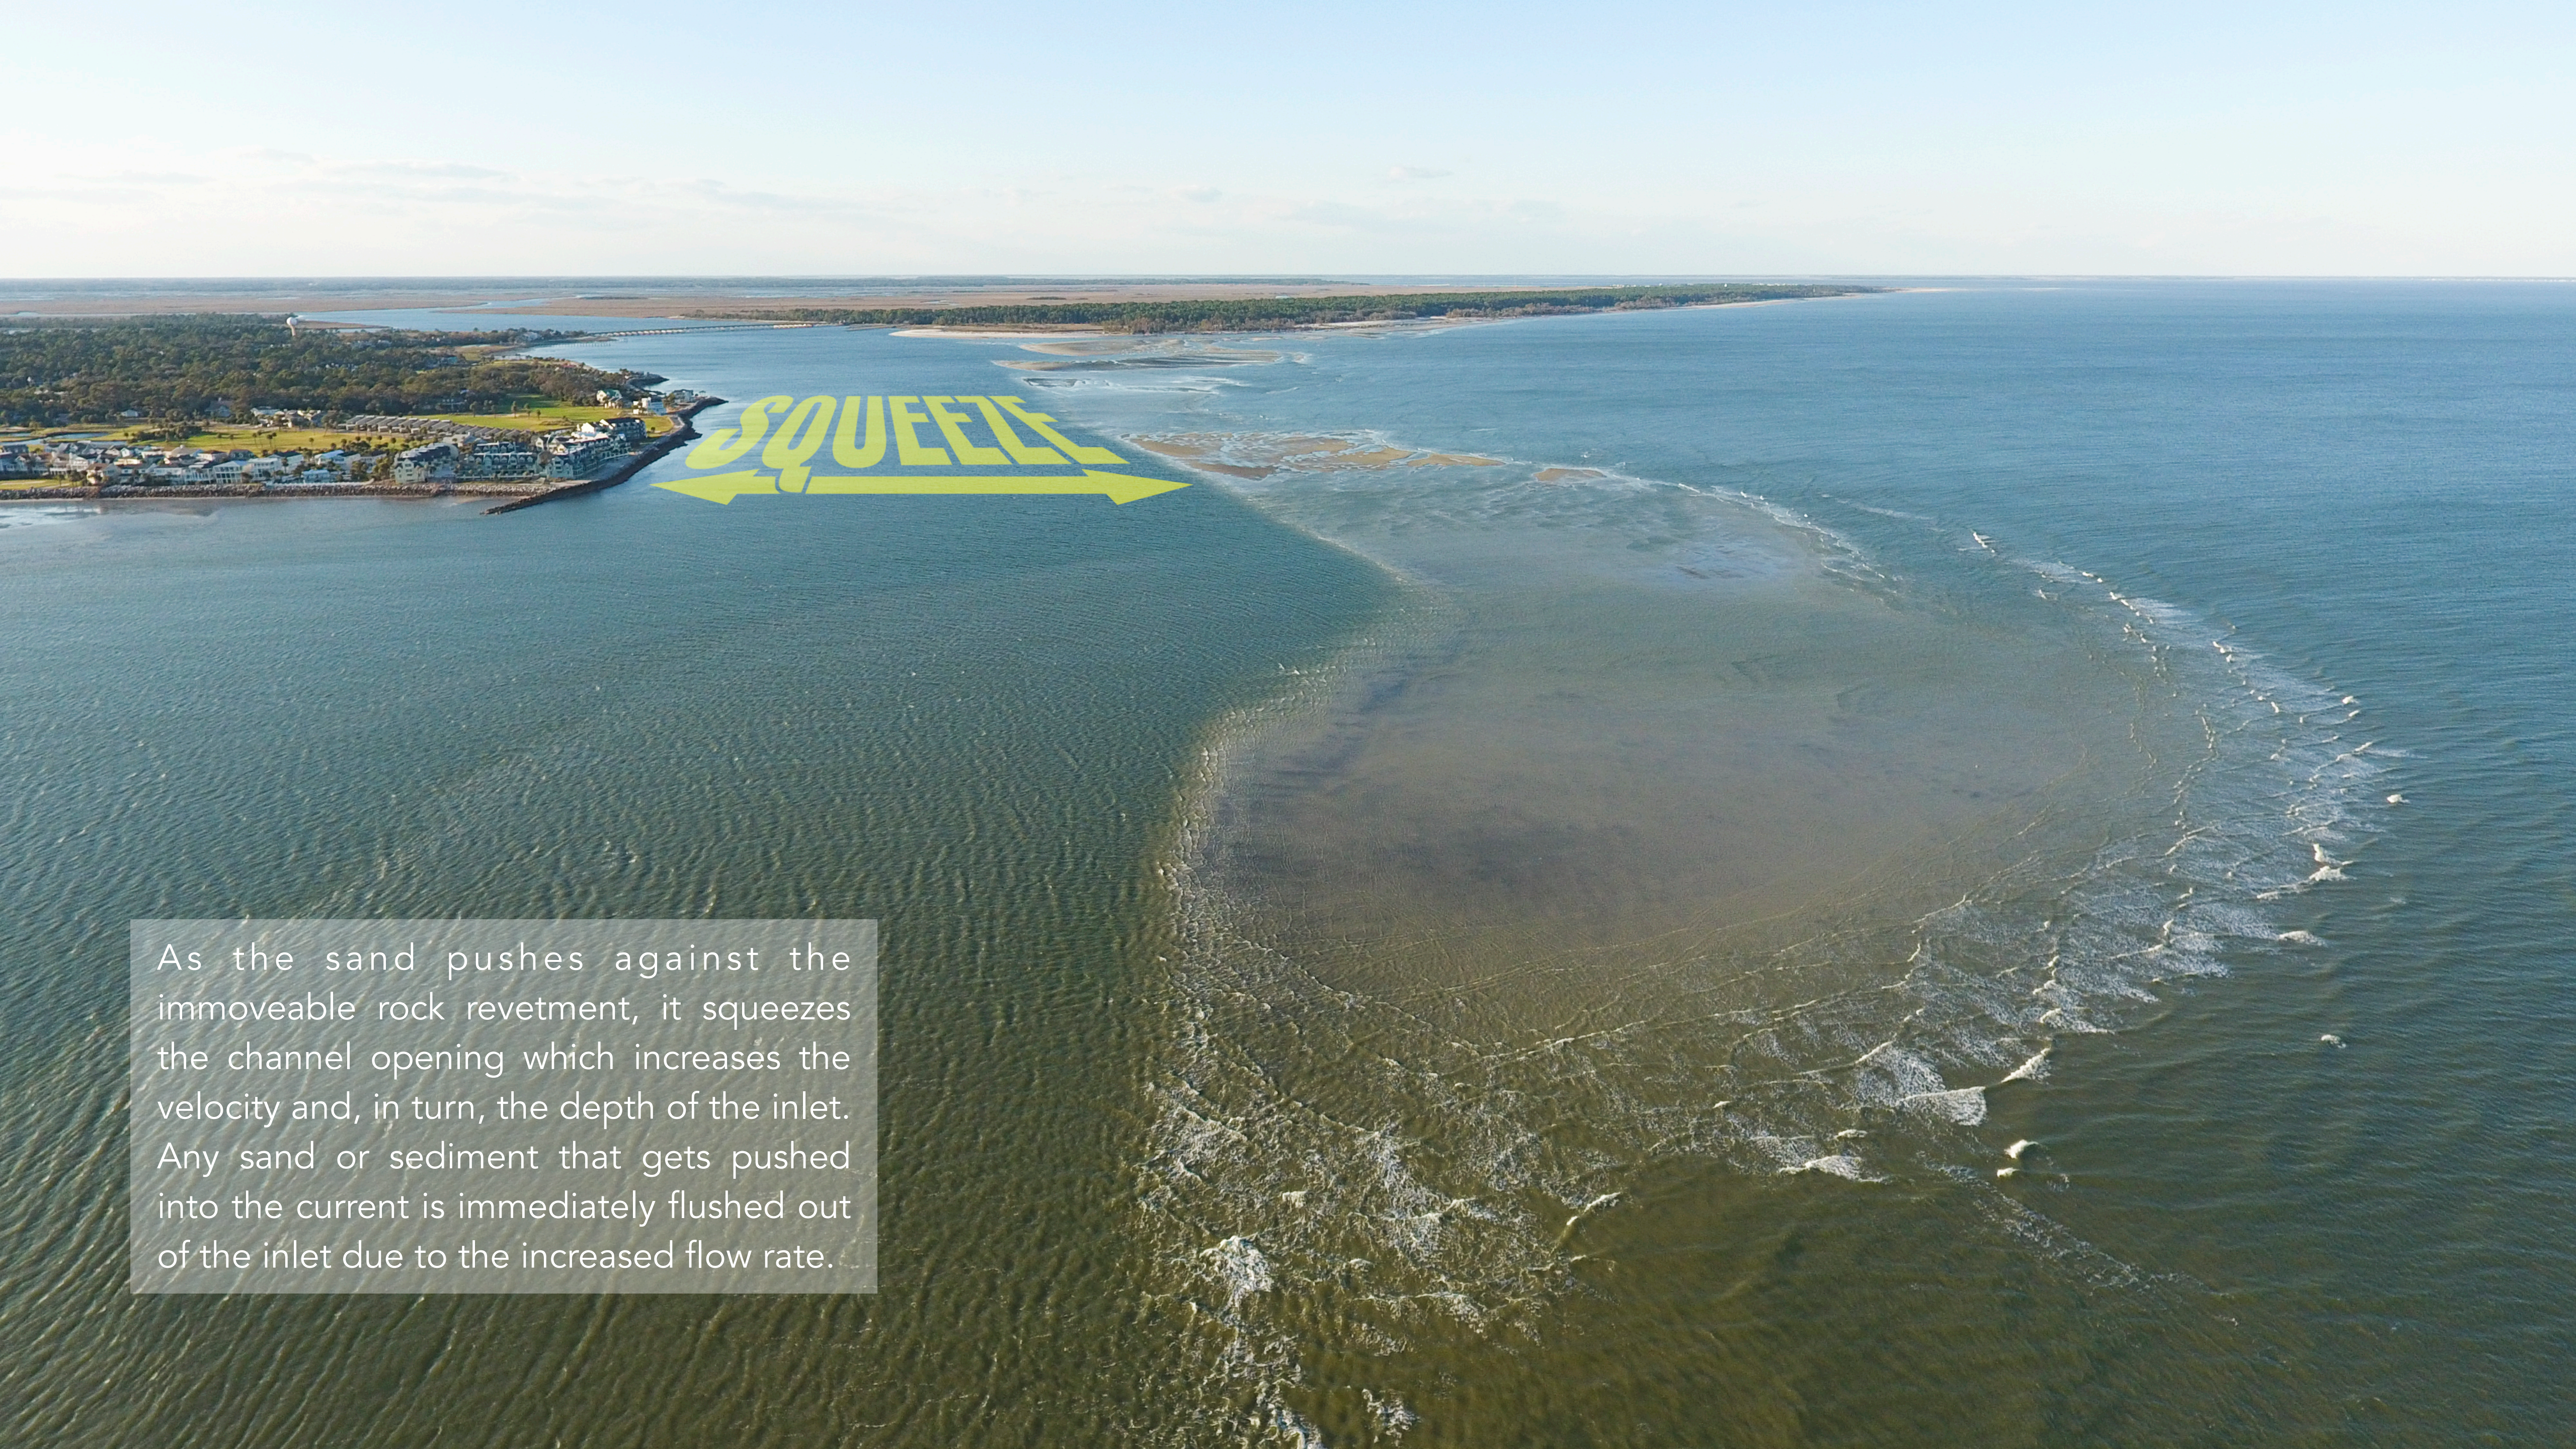
As the sand pushes against the immoveable rock revetment, it squeezes the channel opening which increases the velocity and, in turn, the depth of the inlet. Any sand or sediment that gets pushed into the current is immediately flushed out of the inlet due to the increased flow rate.

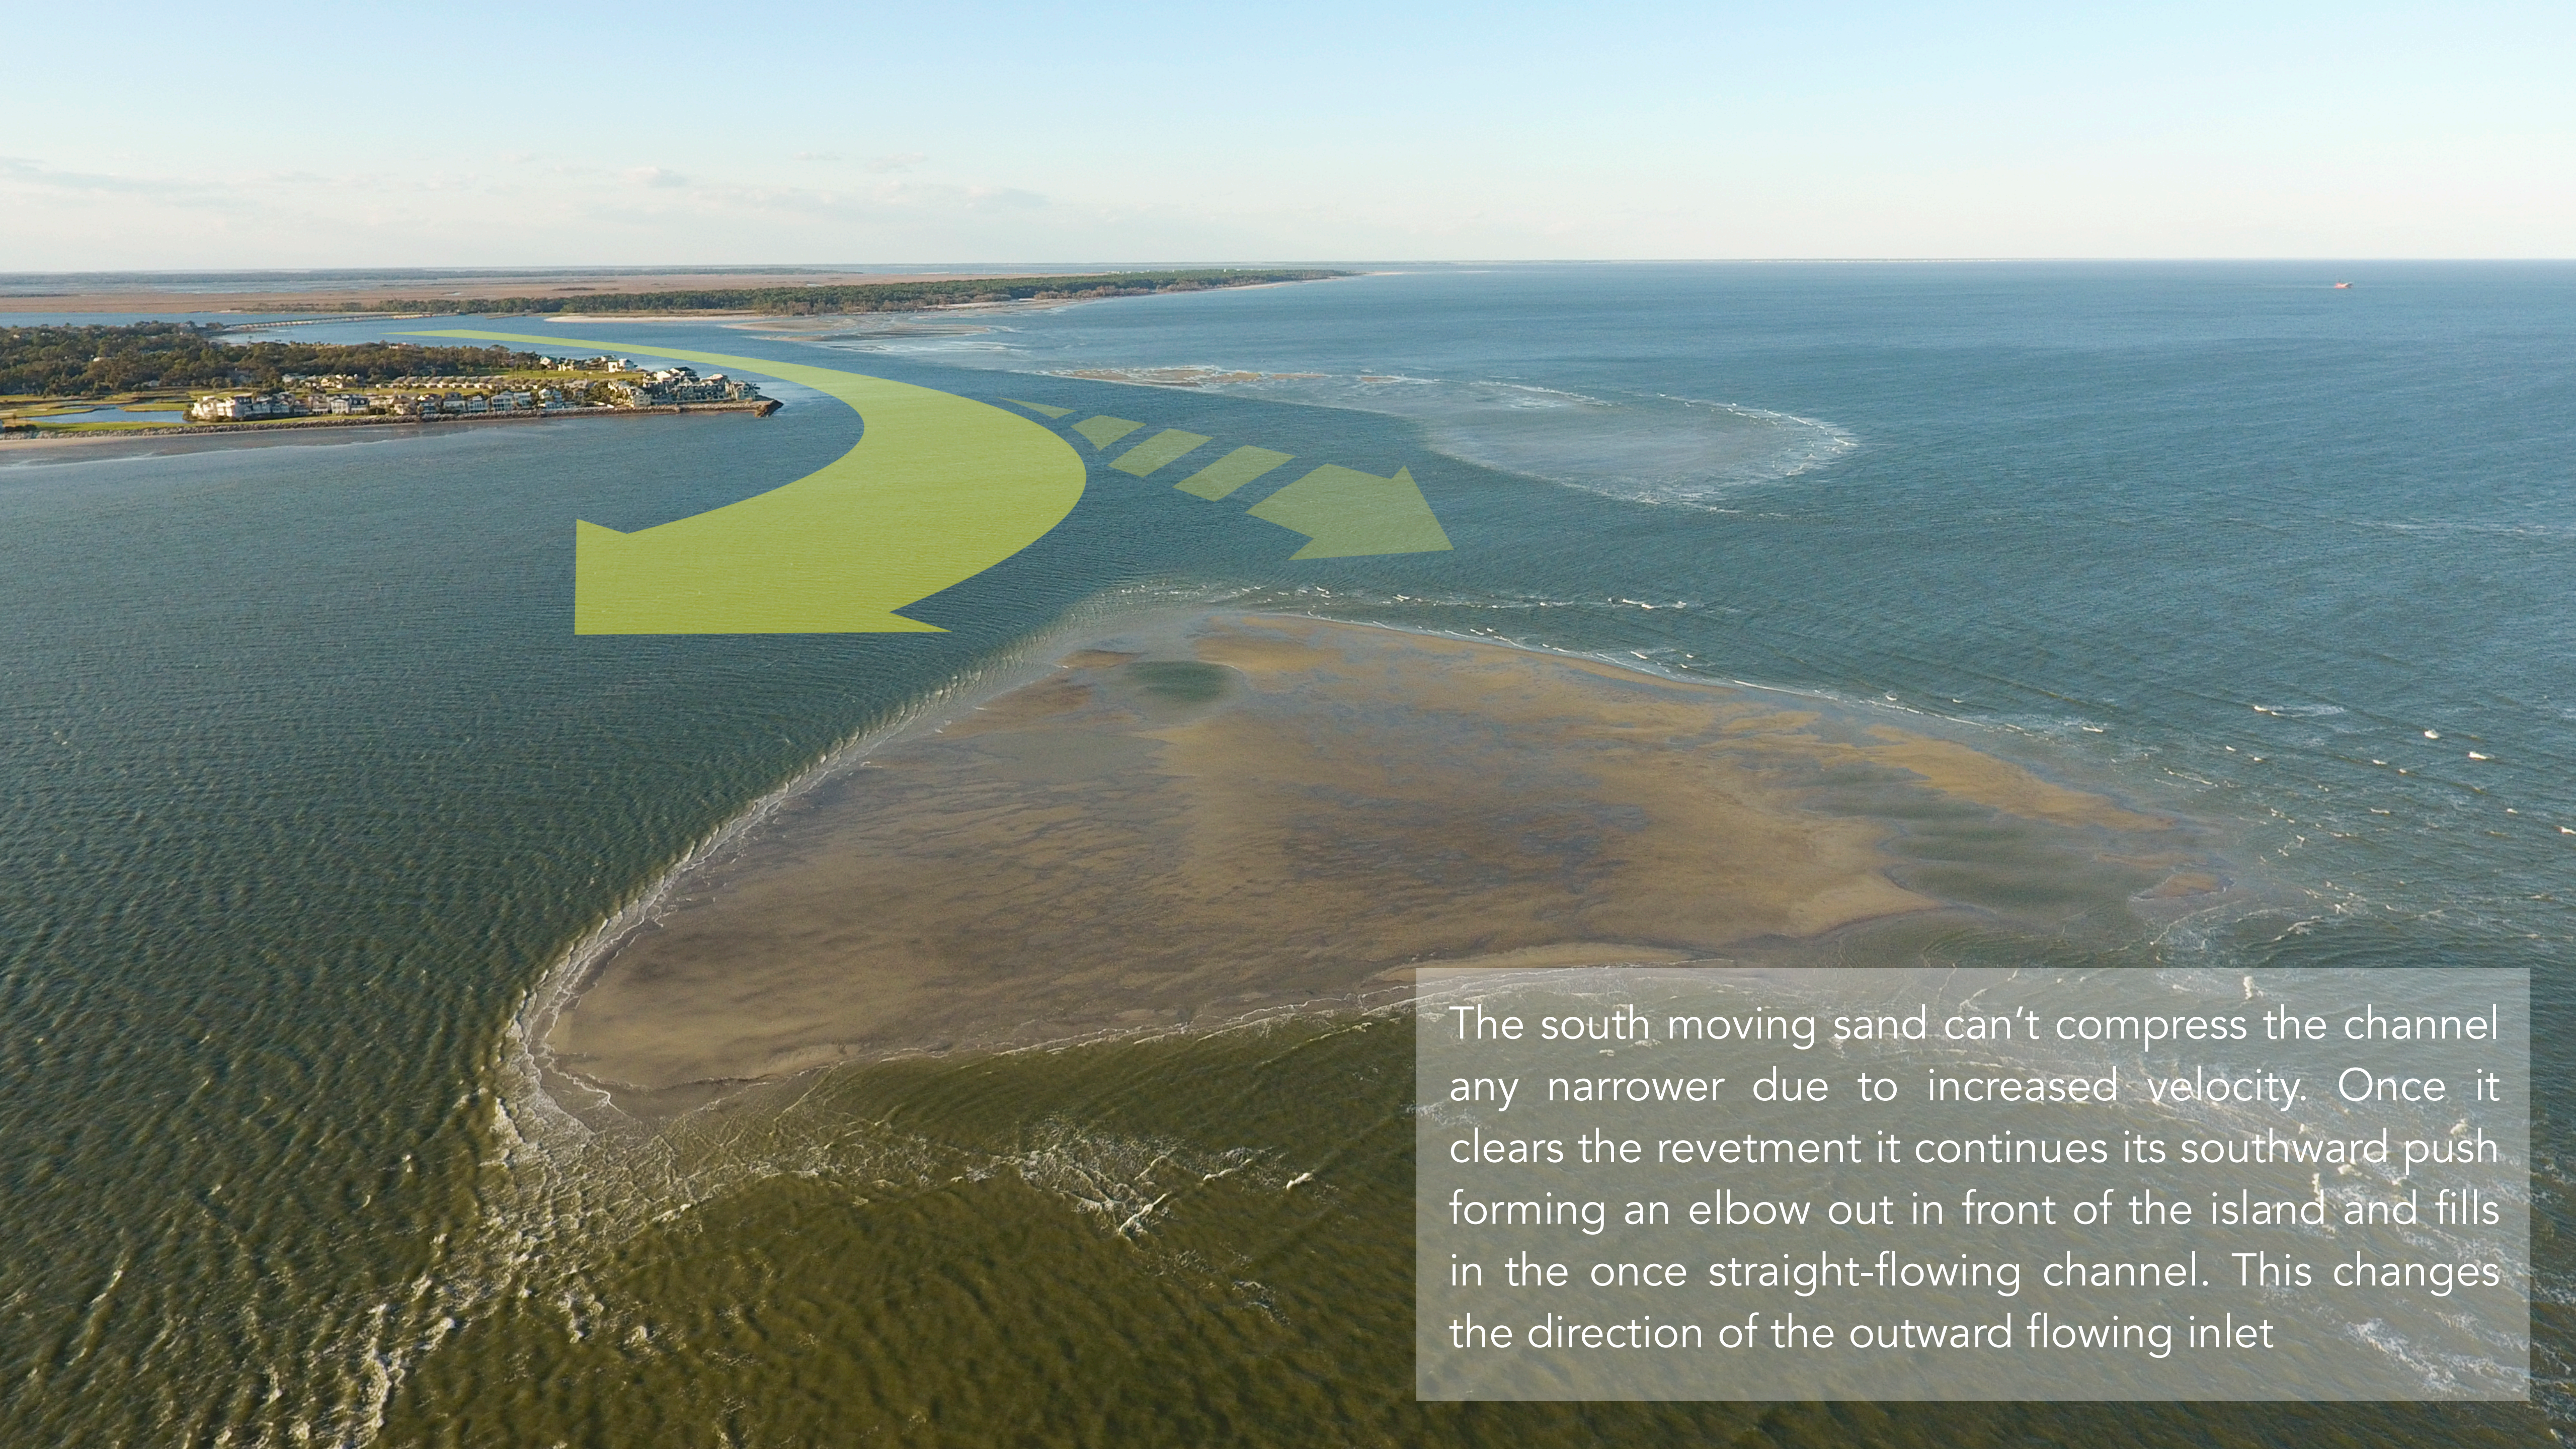
The south moving sand can't compress the channel any narrower due to increased velocity. Once it clears the revetment it continues its southward push forming an elbow out in front of the island and fills in the once straight-flowing channel. This changes the direction of the outward flowing inlet

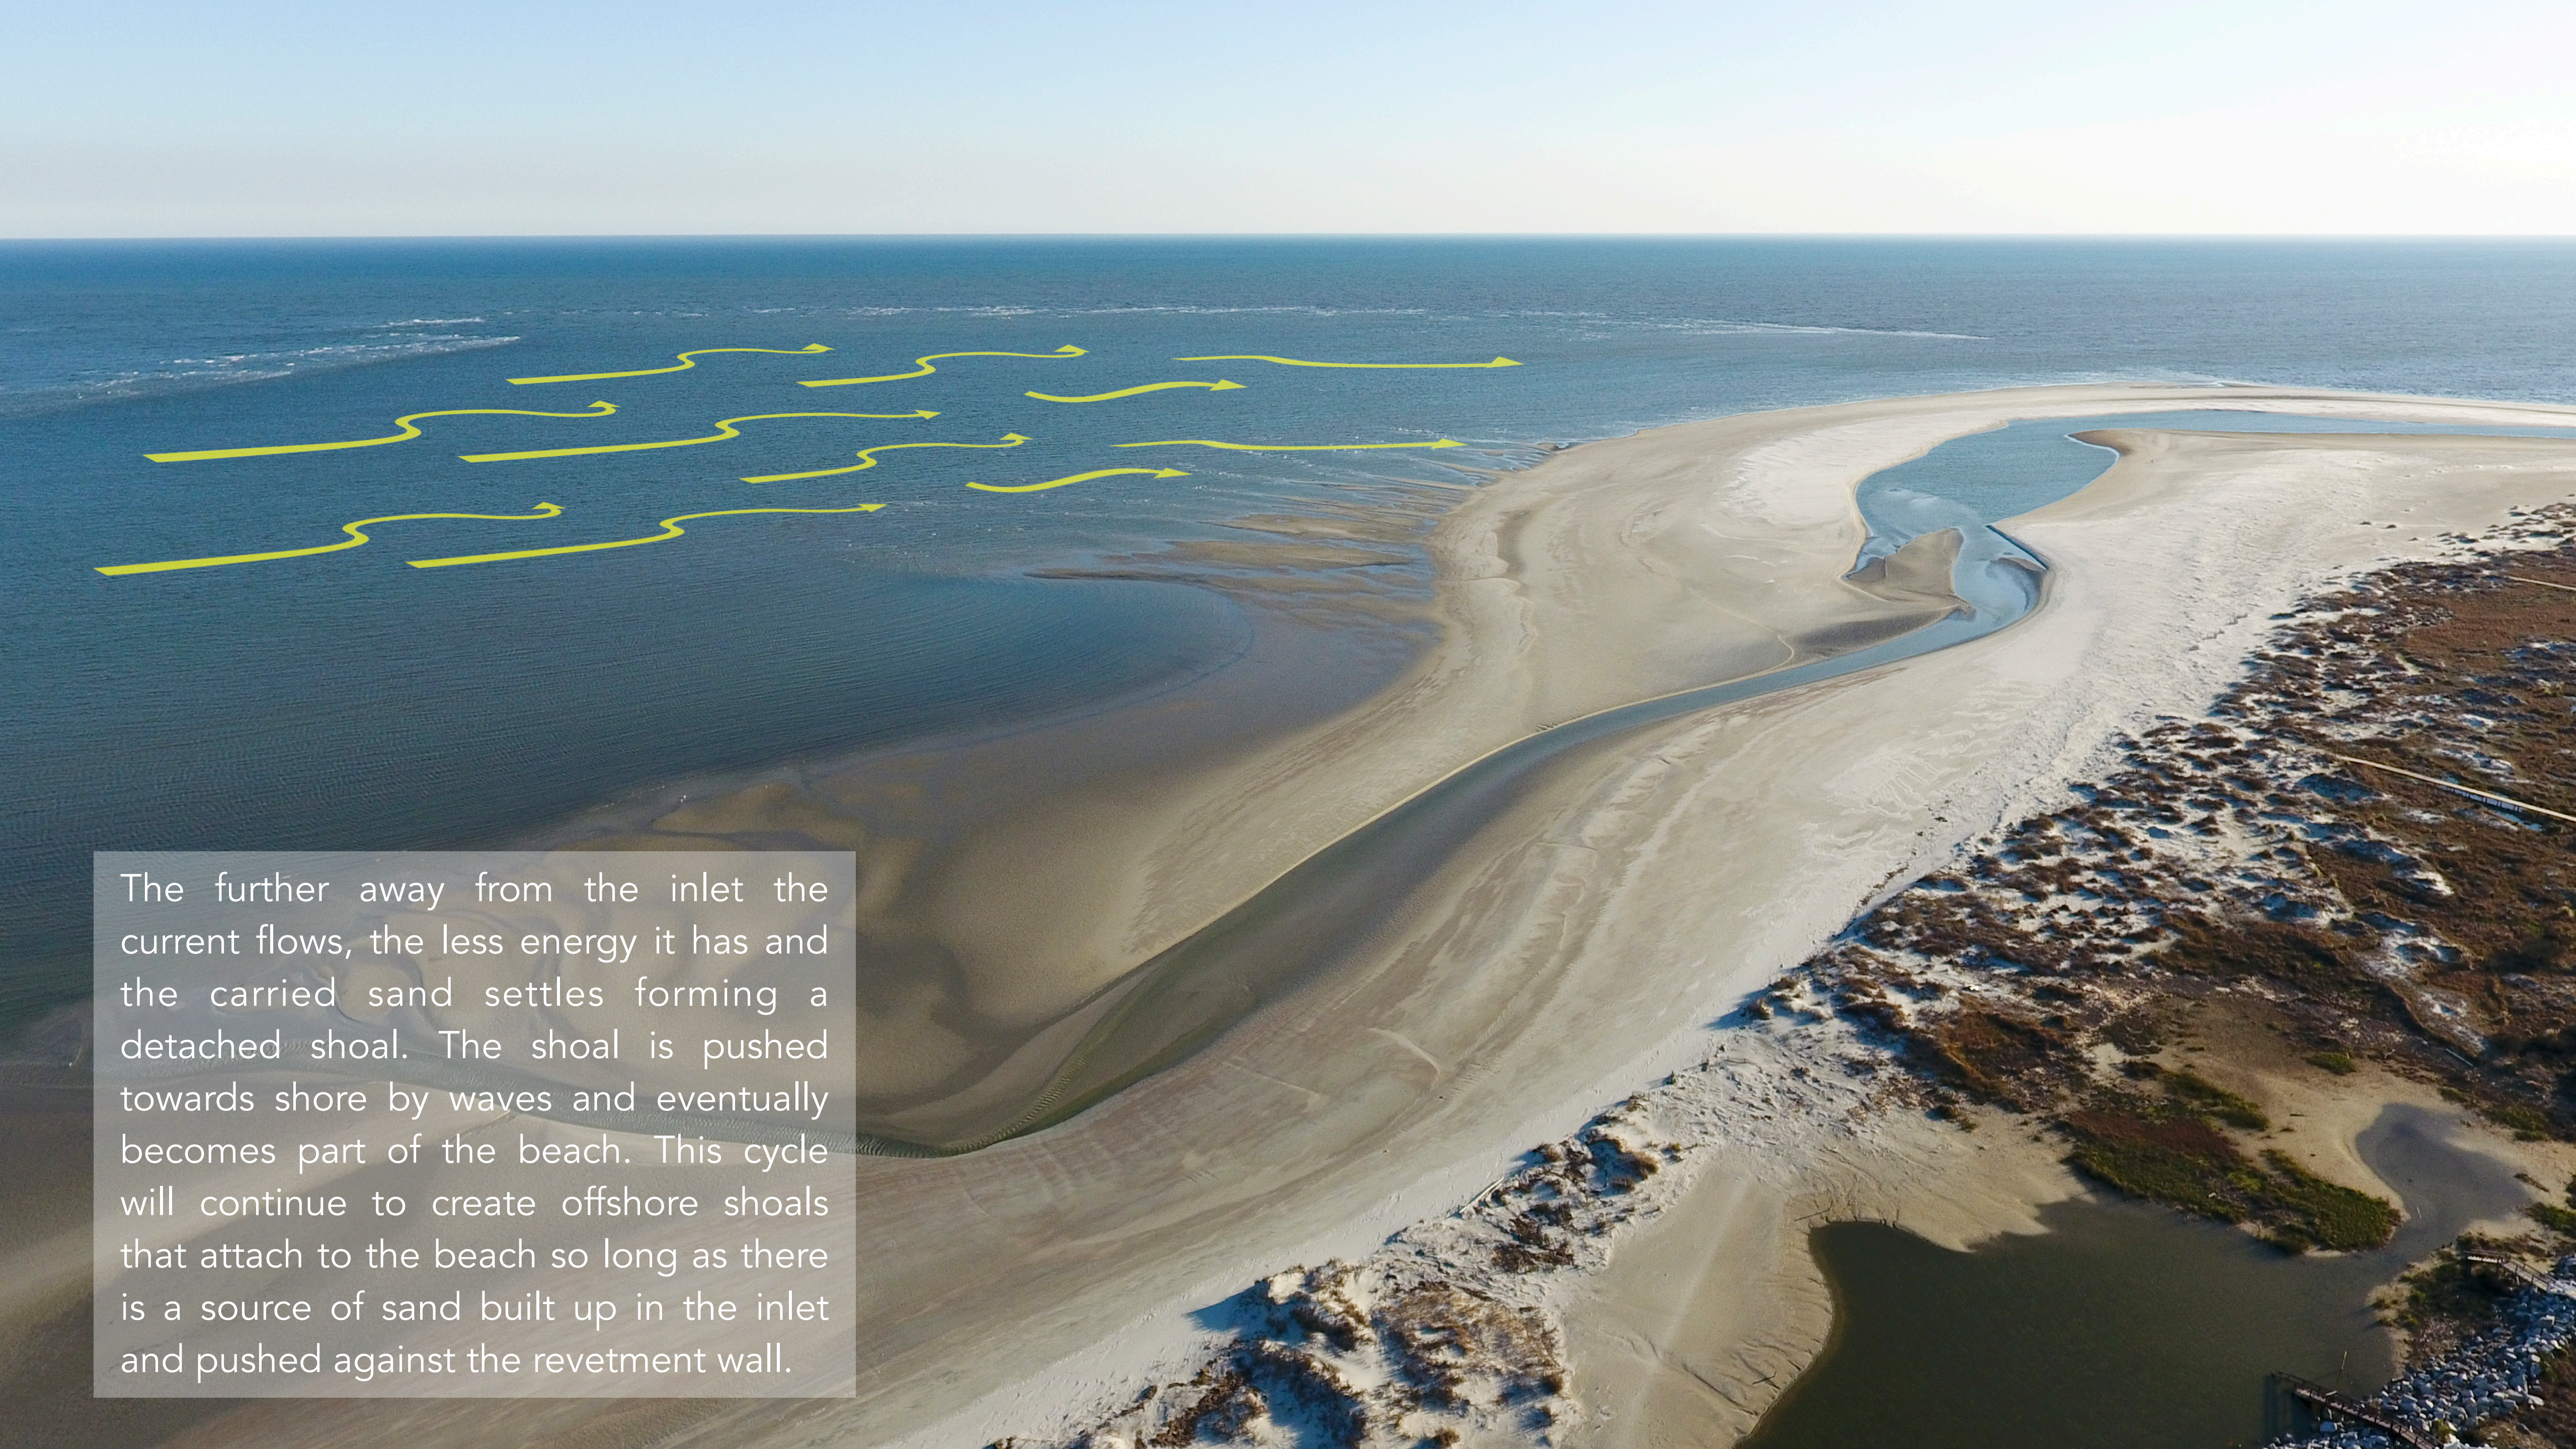
The further away from the inlet the current flows, the less energy it has and the carried sand settles forming a detached shoal. The shoal is pushed towards shore by waves and eventually becomes part of the beach. This cycle will continue to create offshore shoals that attach to the beach so long as there is a source of sand built up in the inlet and pushed against the revetment wall.

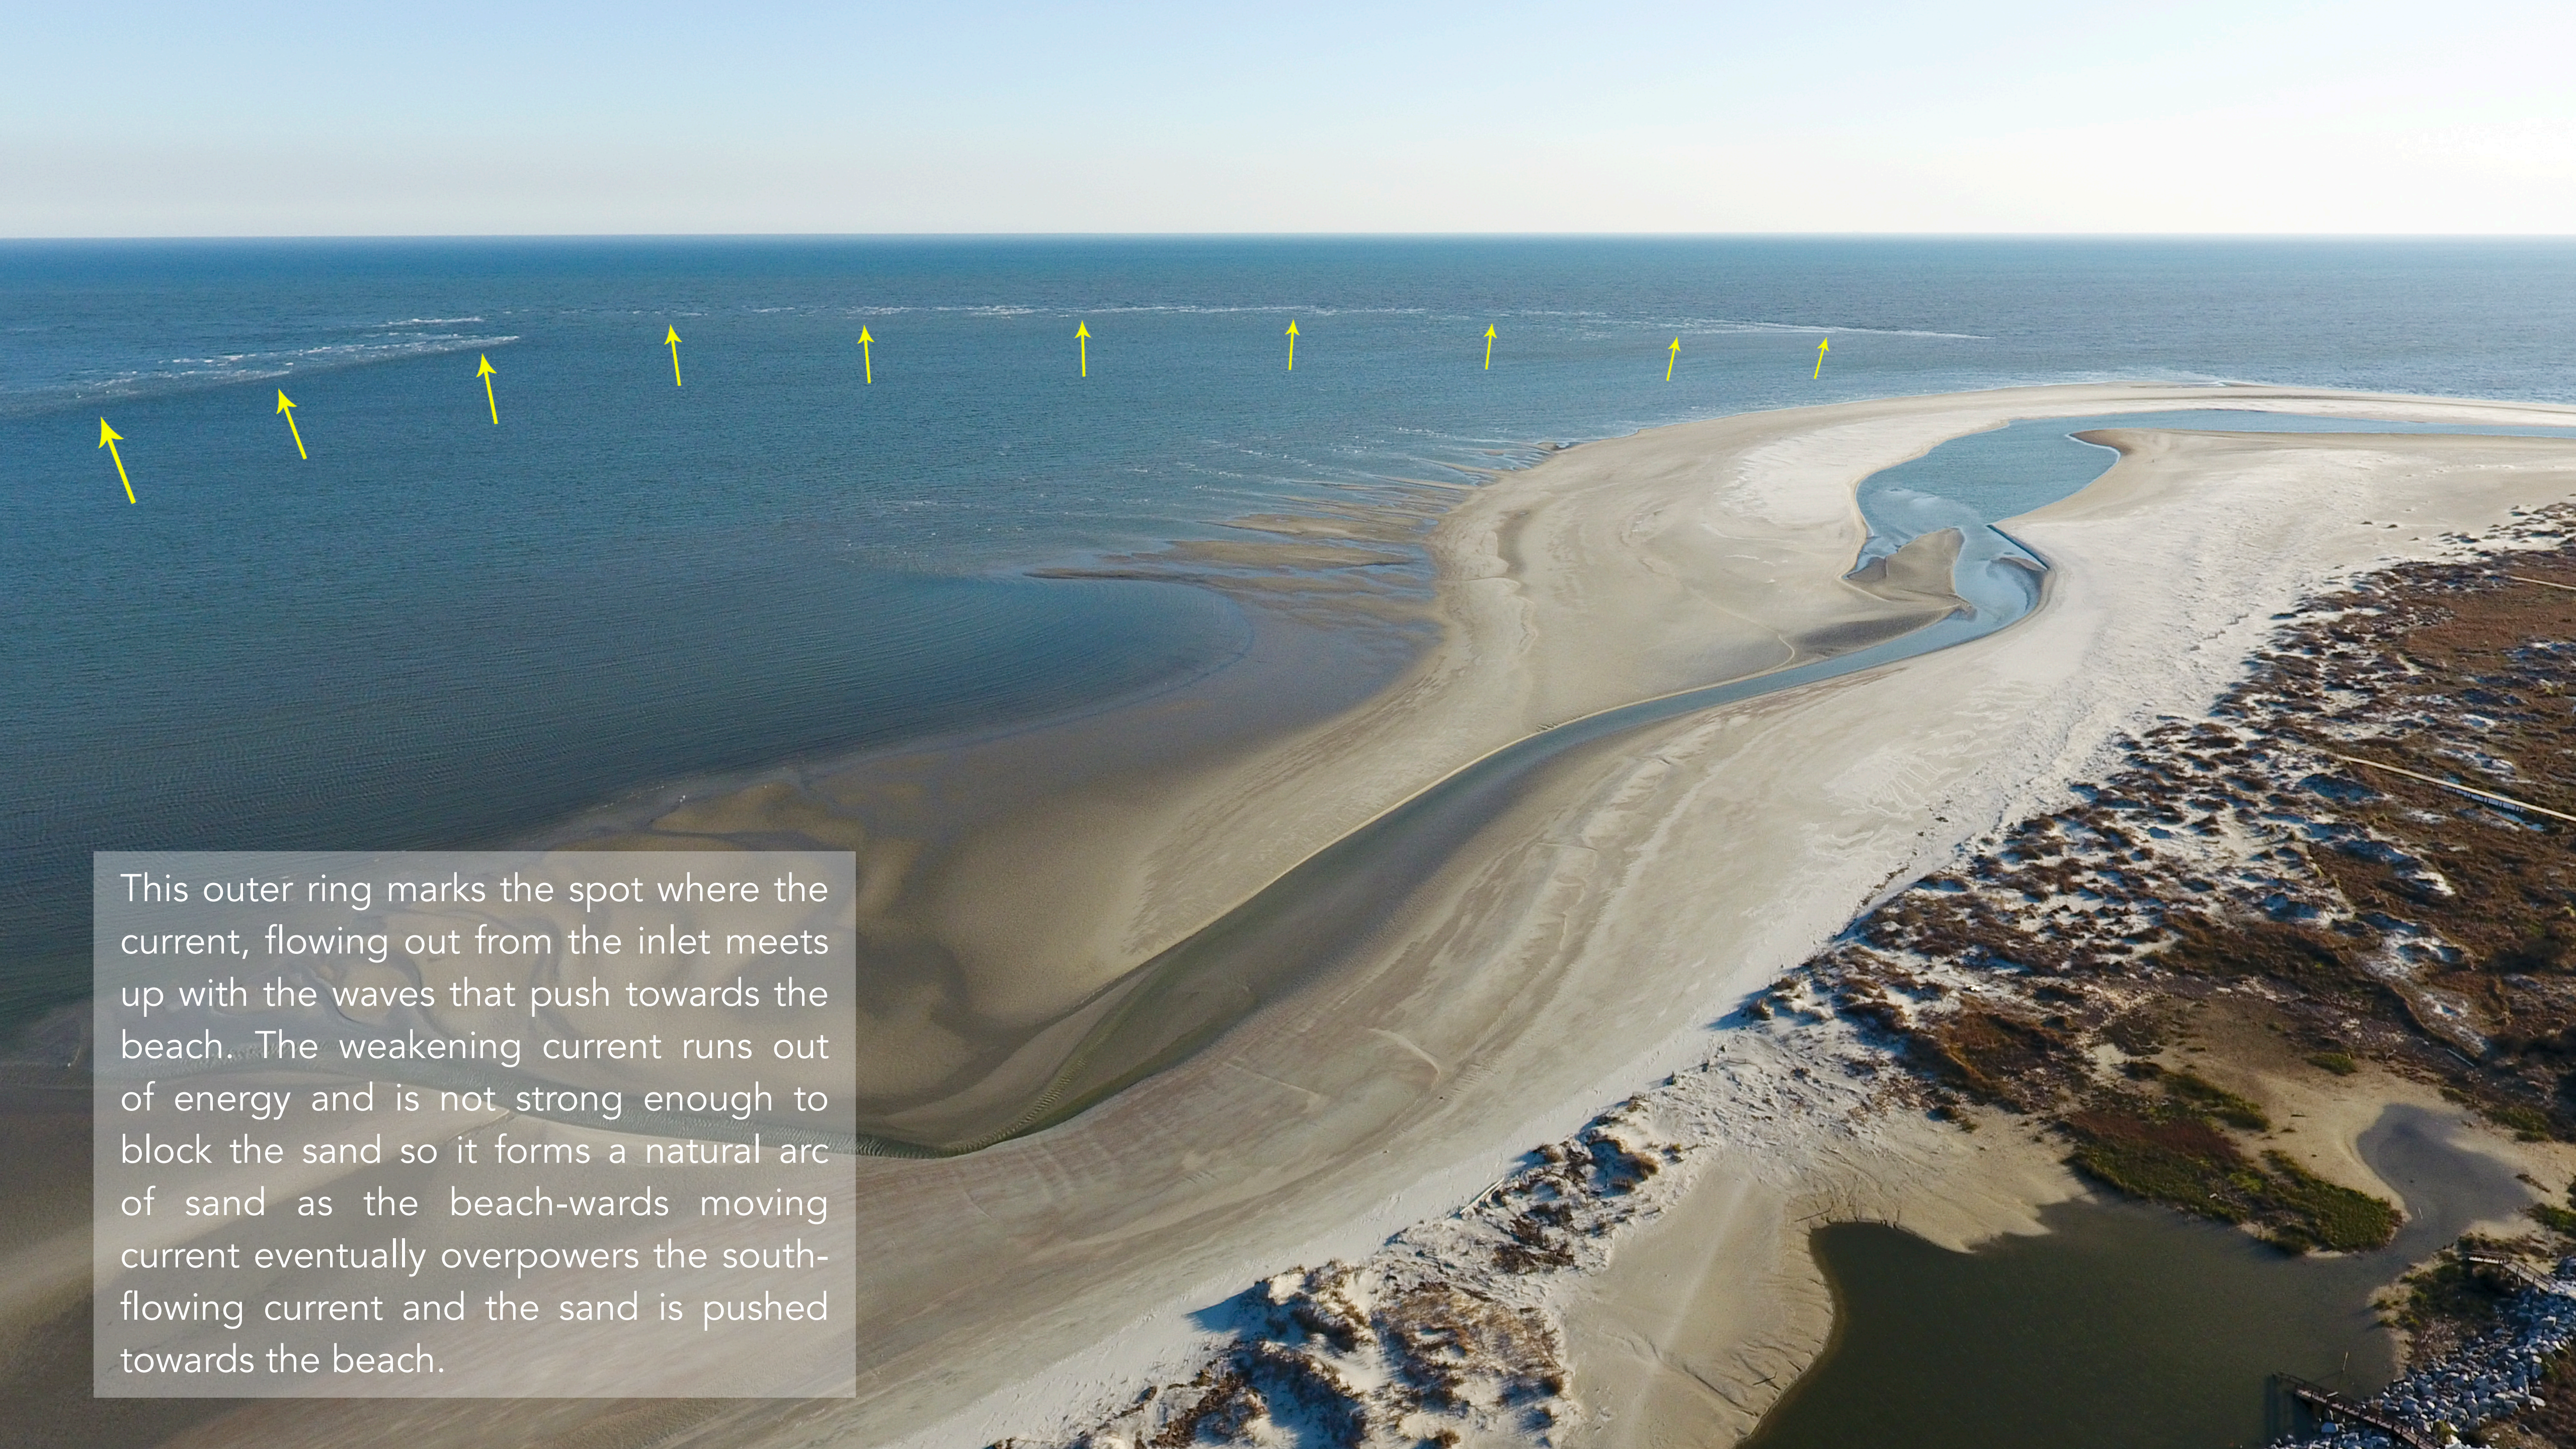
This outer ring marks the spot where the current, flowing out from the inlet meets up with the waves that push towards the beach. The weakening current runs out of energy and is not strong enough to block the sand so it forms a natural arc of sand as the beach-wards moving current eventually overpowers the south-flowing current and the sand is pushed towards the beach.
