# THE SHIFTING SANDS

Photographing the dynamic shoreline around Fripp Island, SC

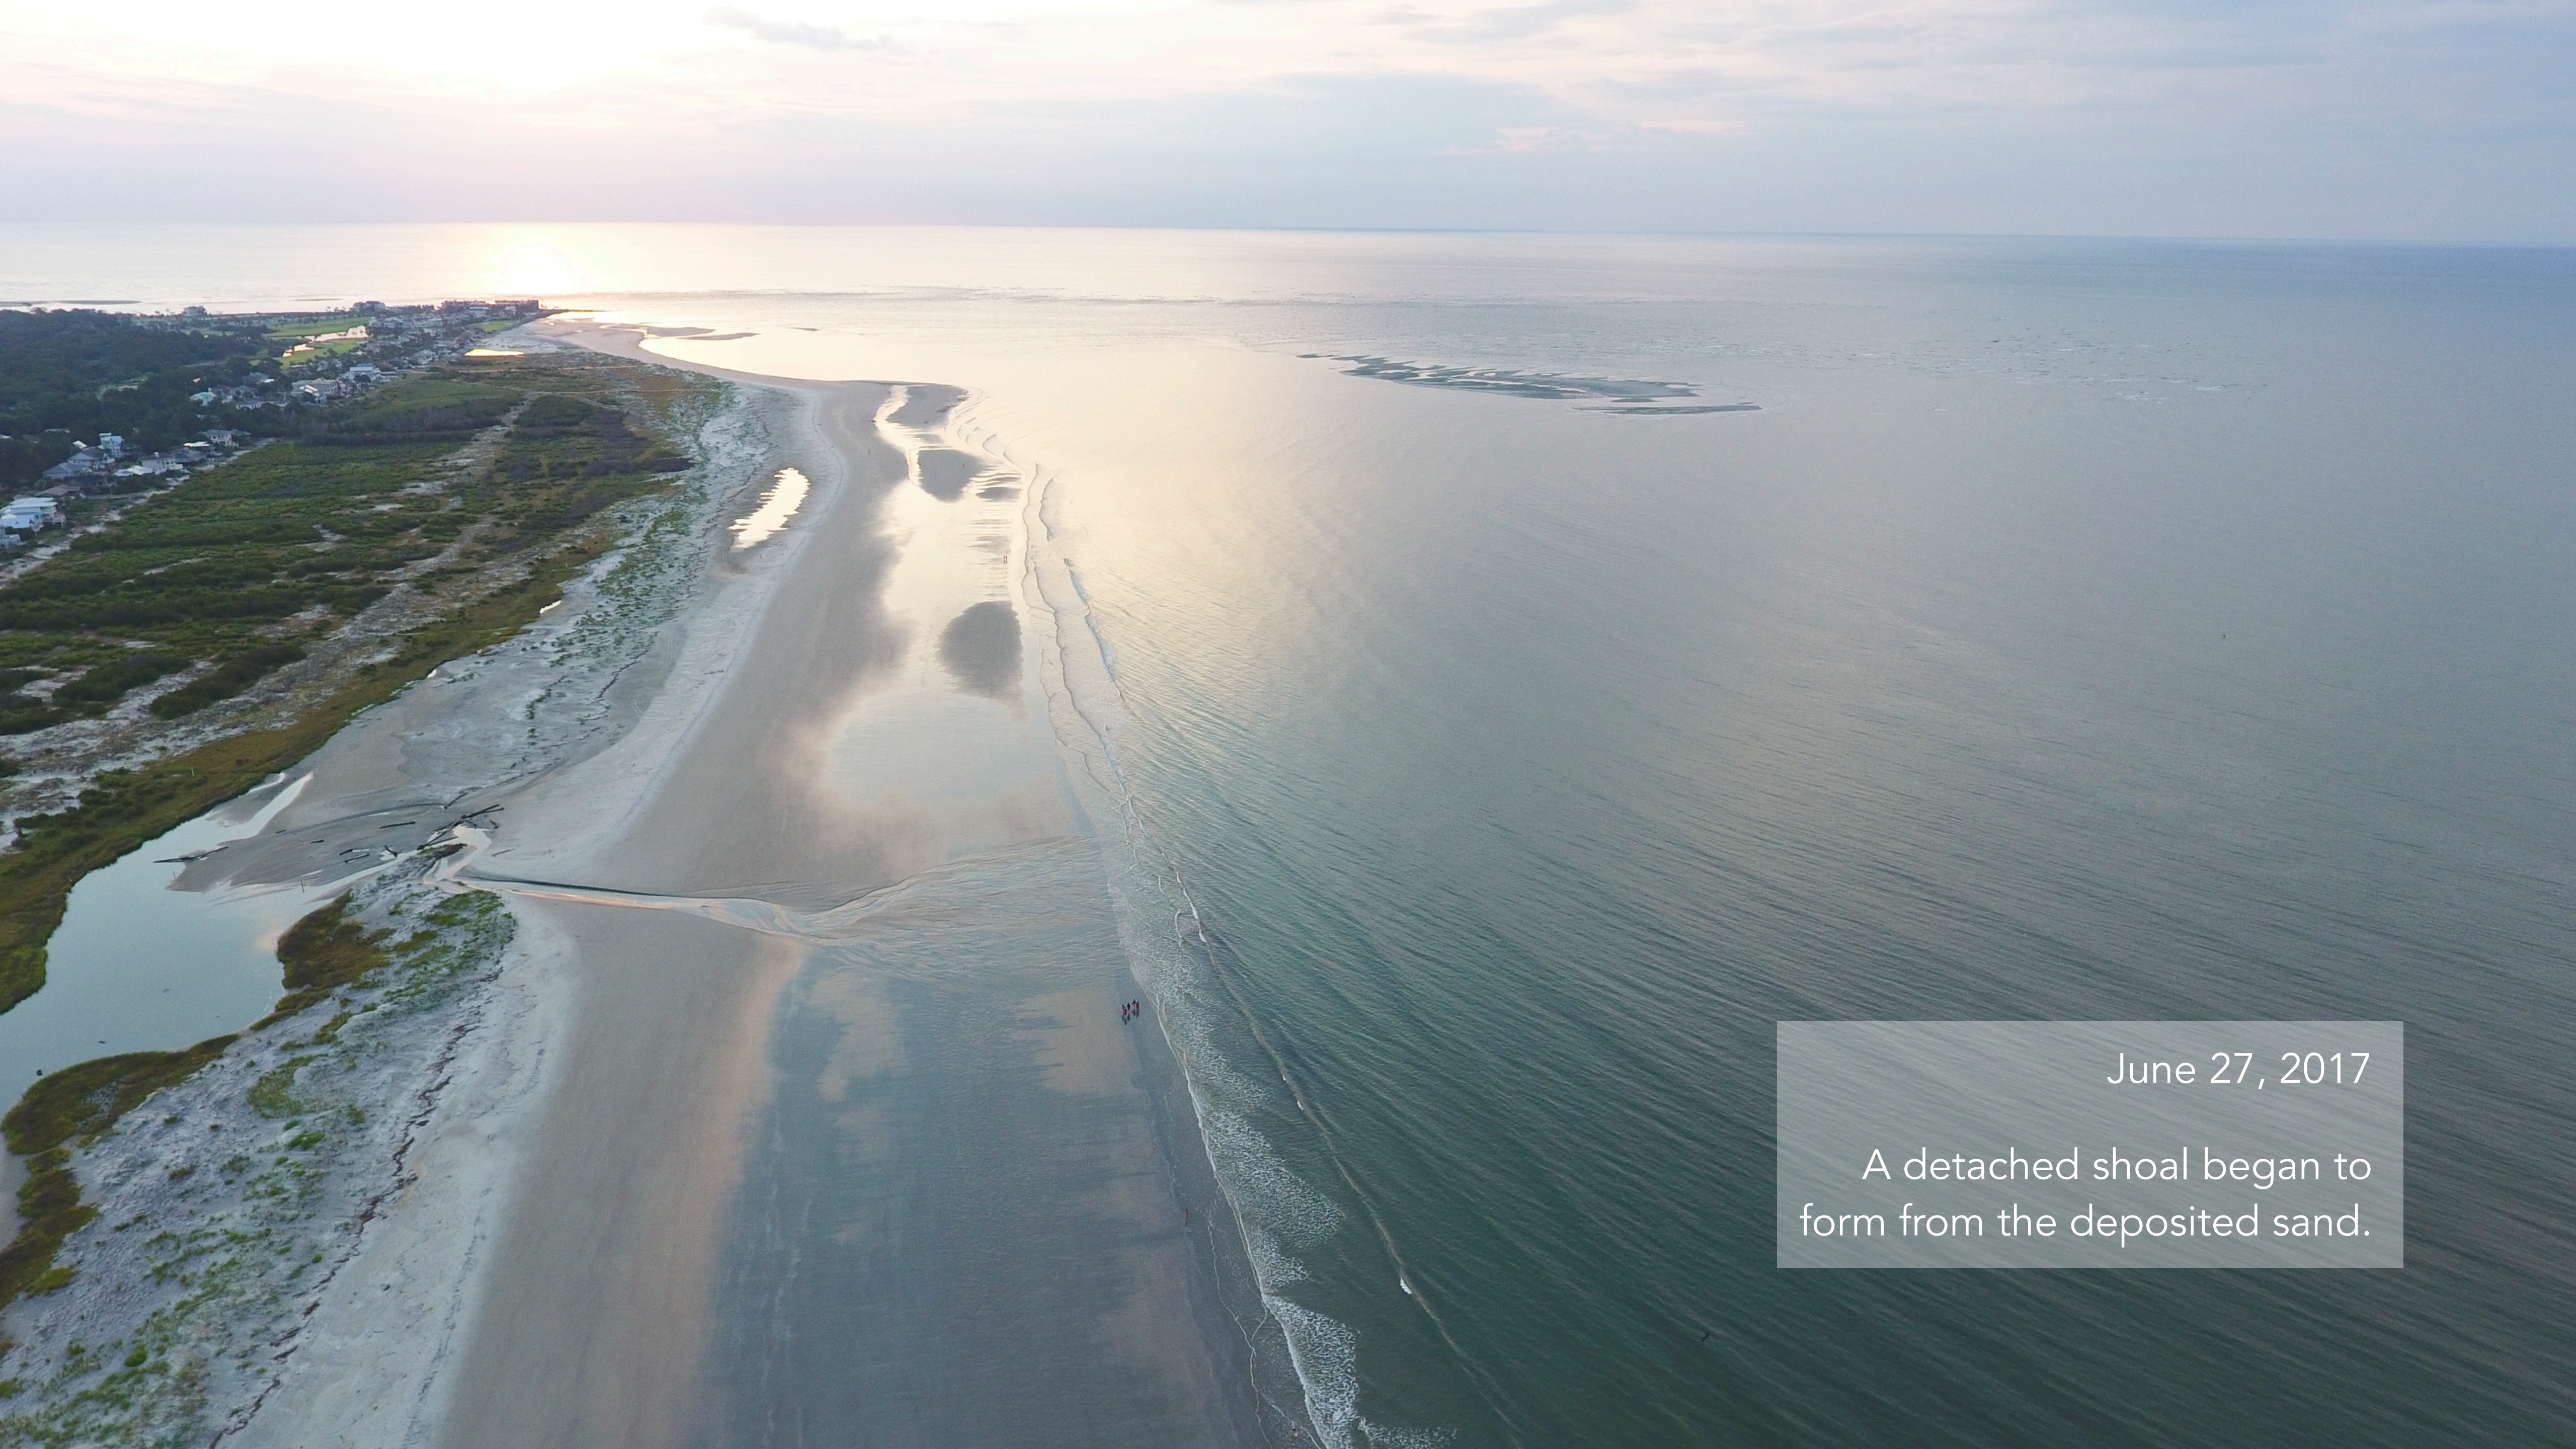
June 27, 2017

A detached shoal began to form from the deposited sand.

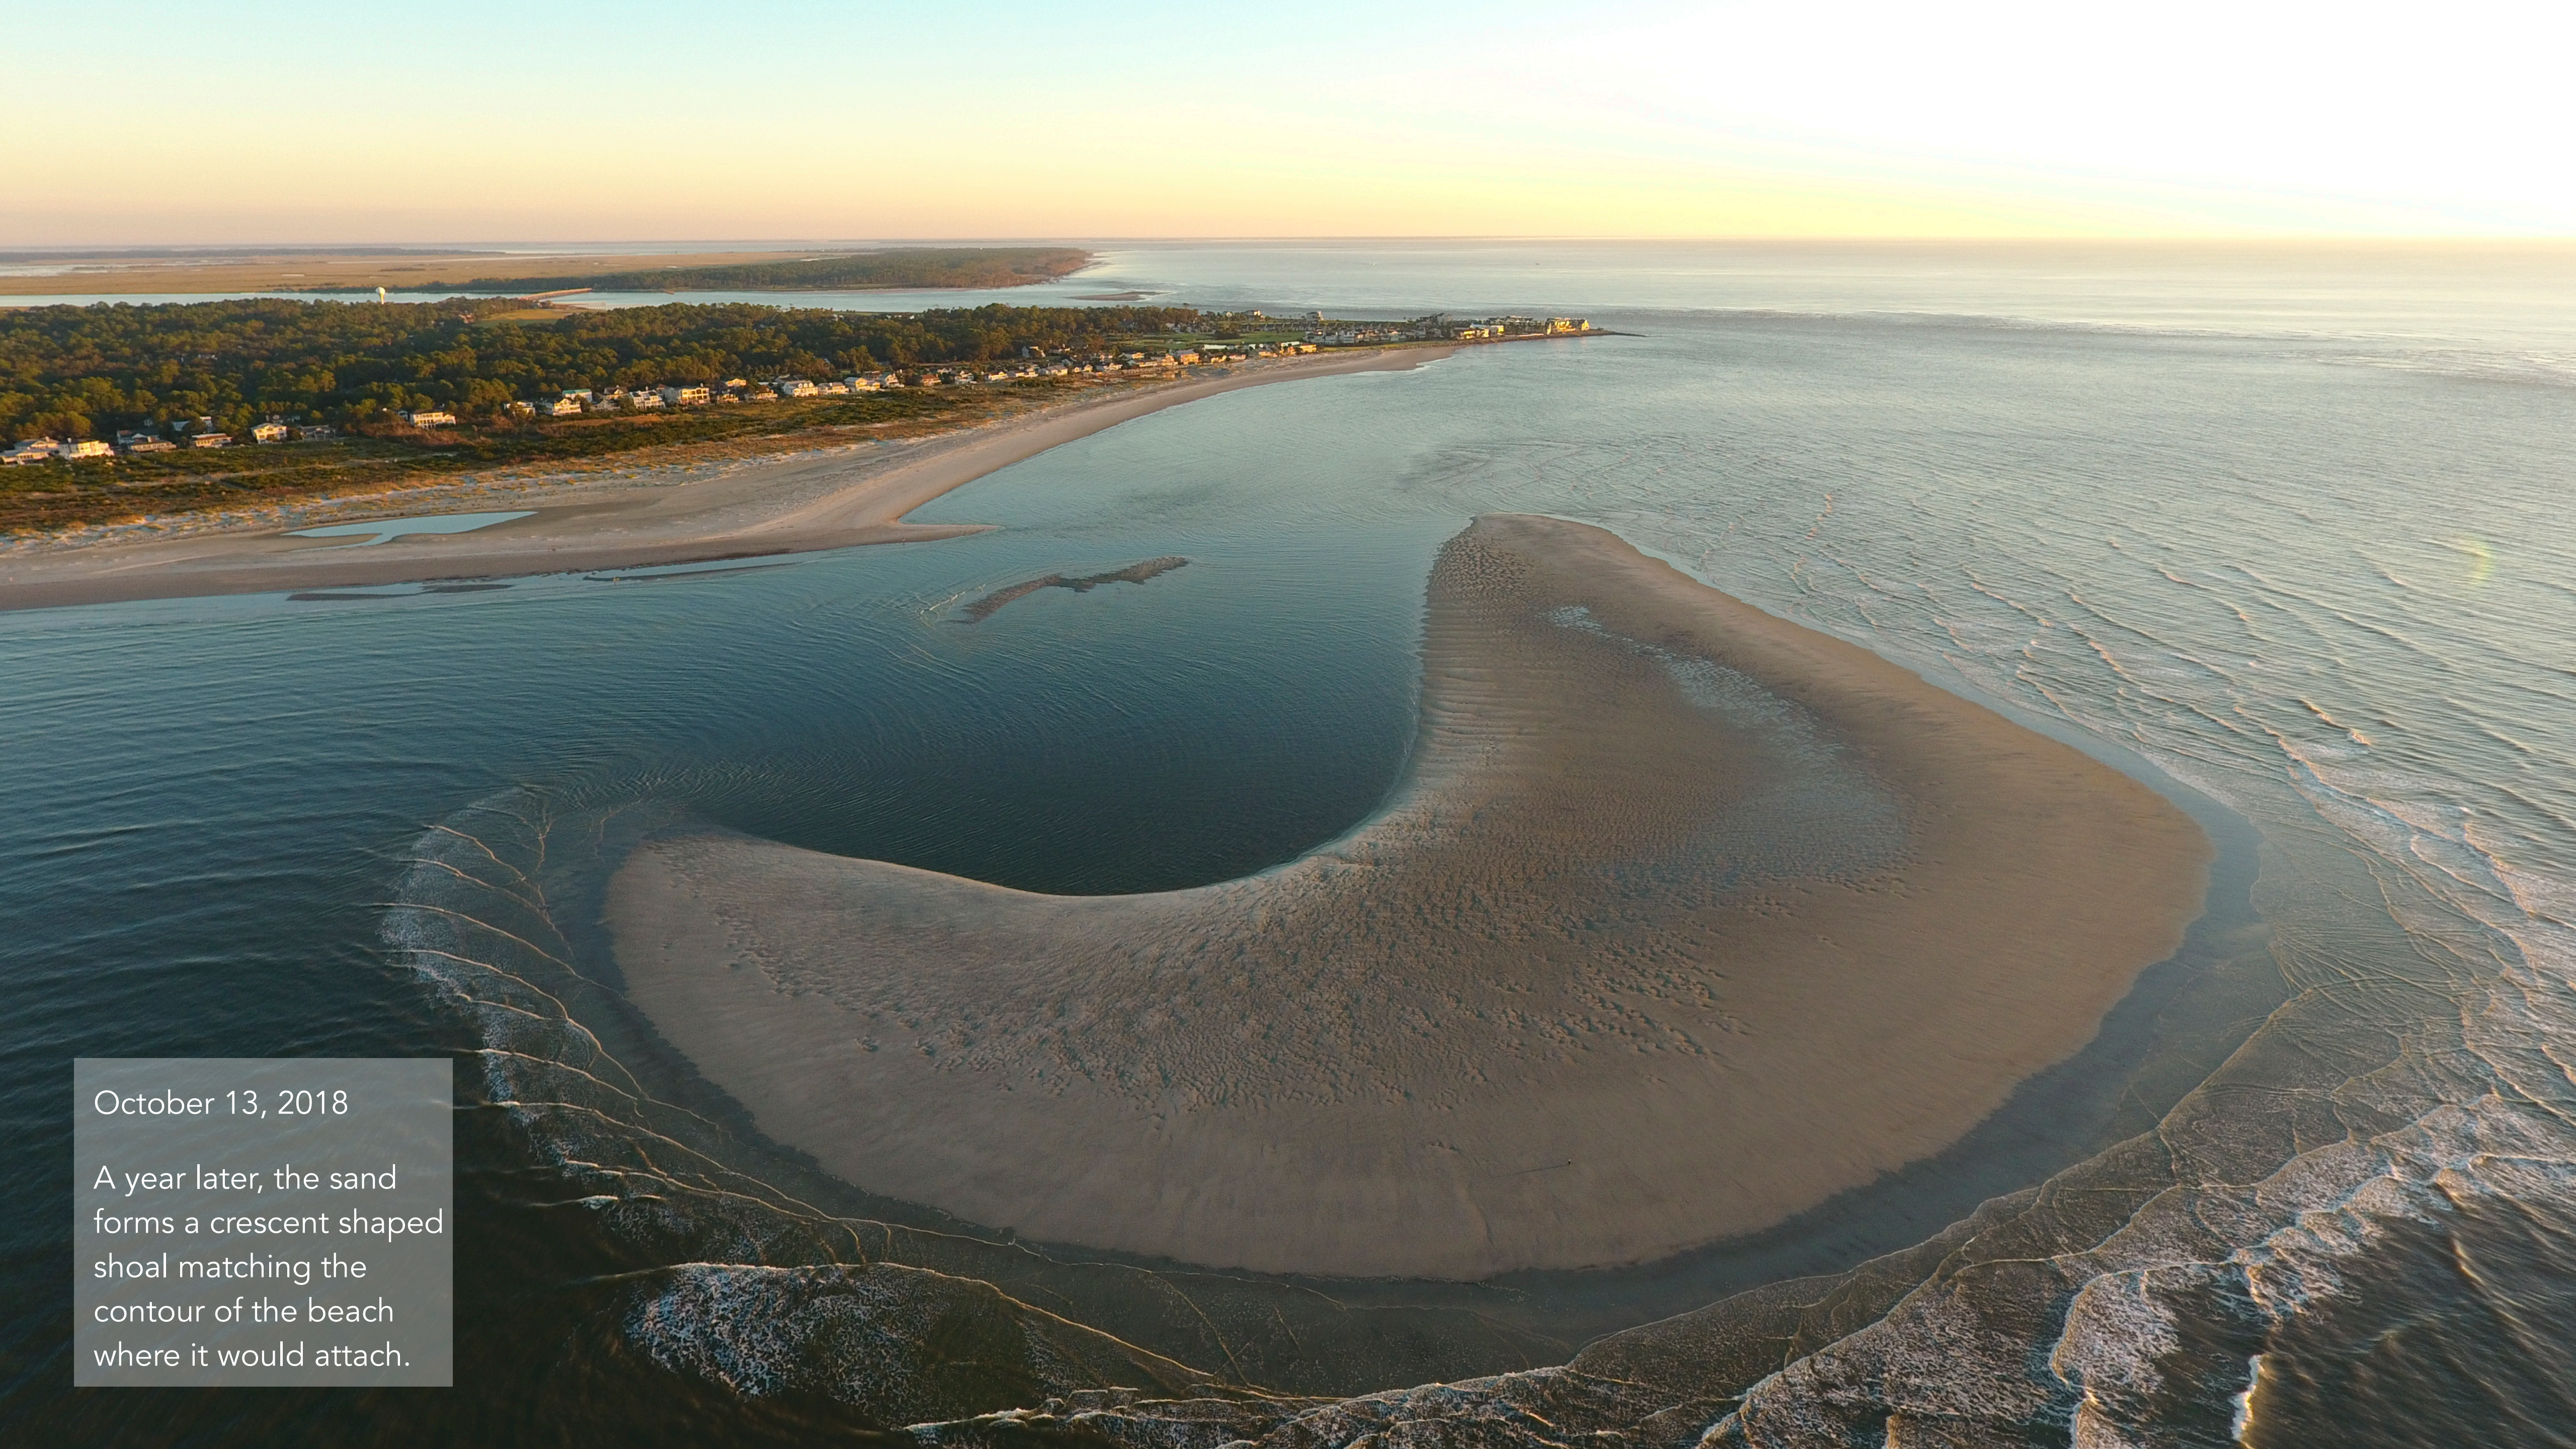
October 13, 2018

A year later, the sand forms a crescent shaped shoal matching the contour of the beach where it would attach.

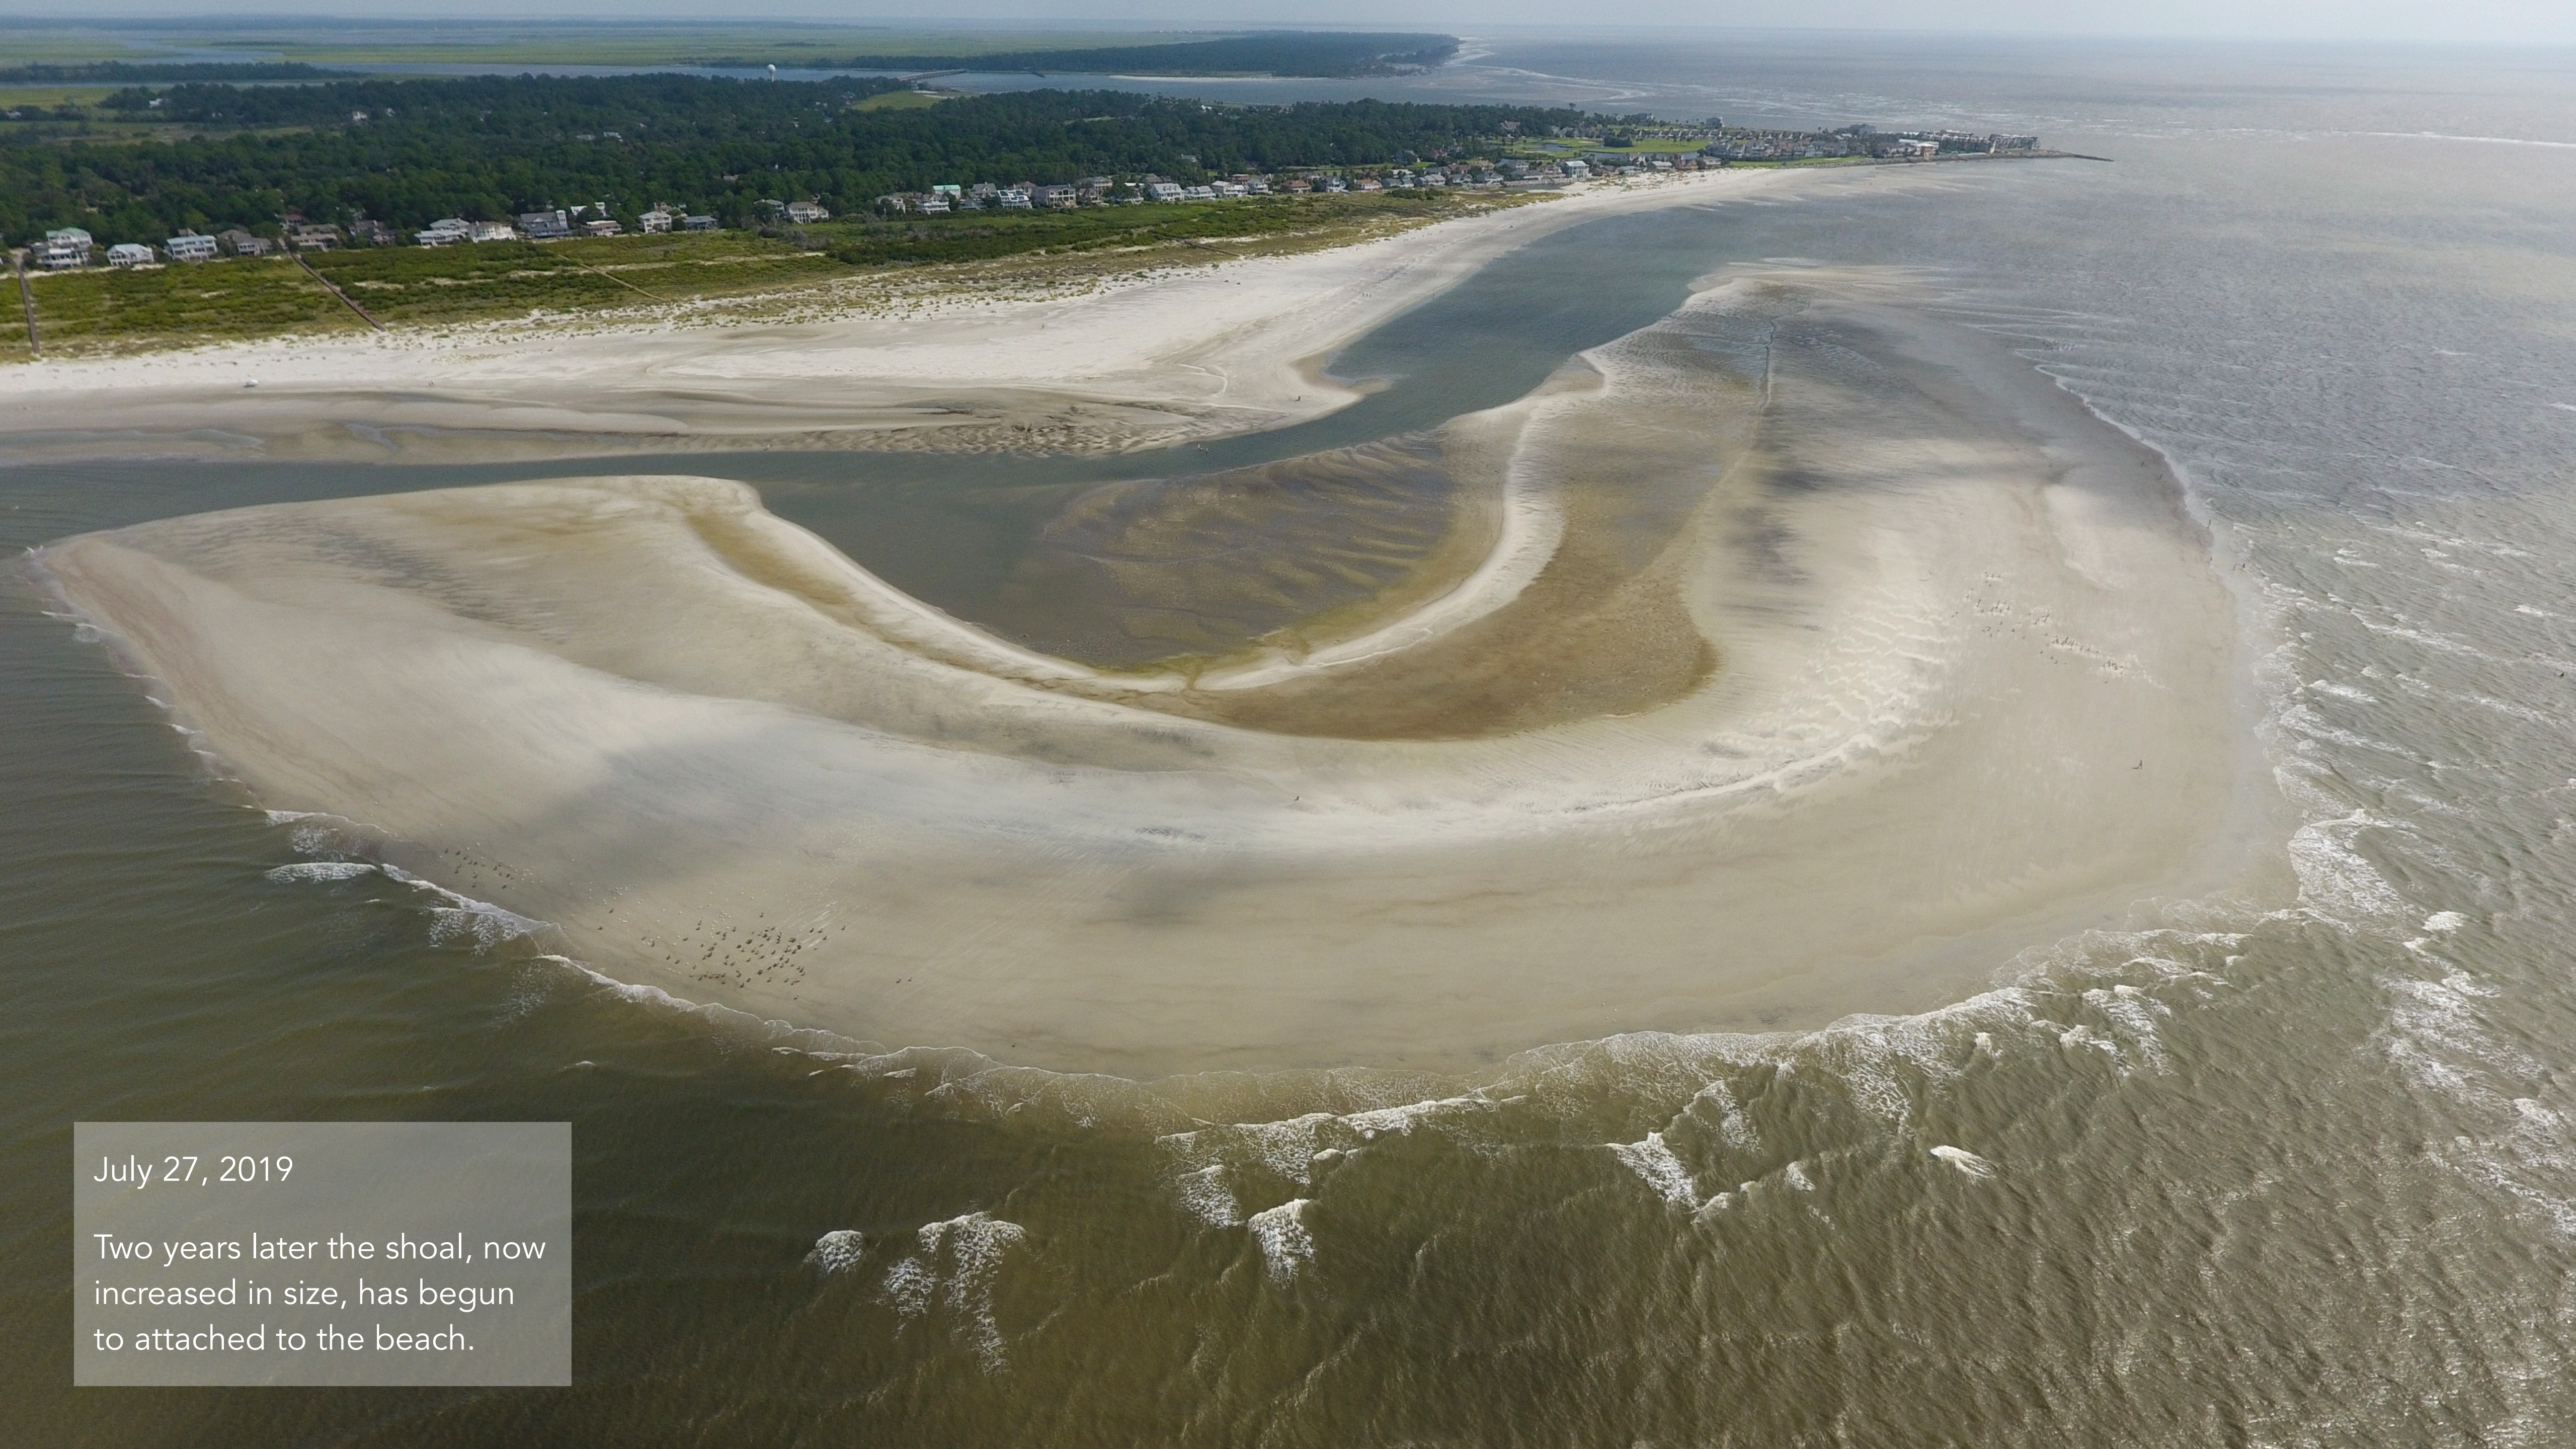
July 27, 2019

Two years later the shoal, now increased in size, has begun to attached to the beach.

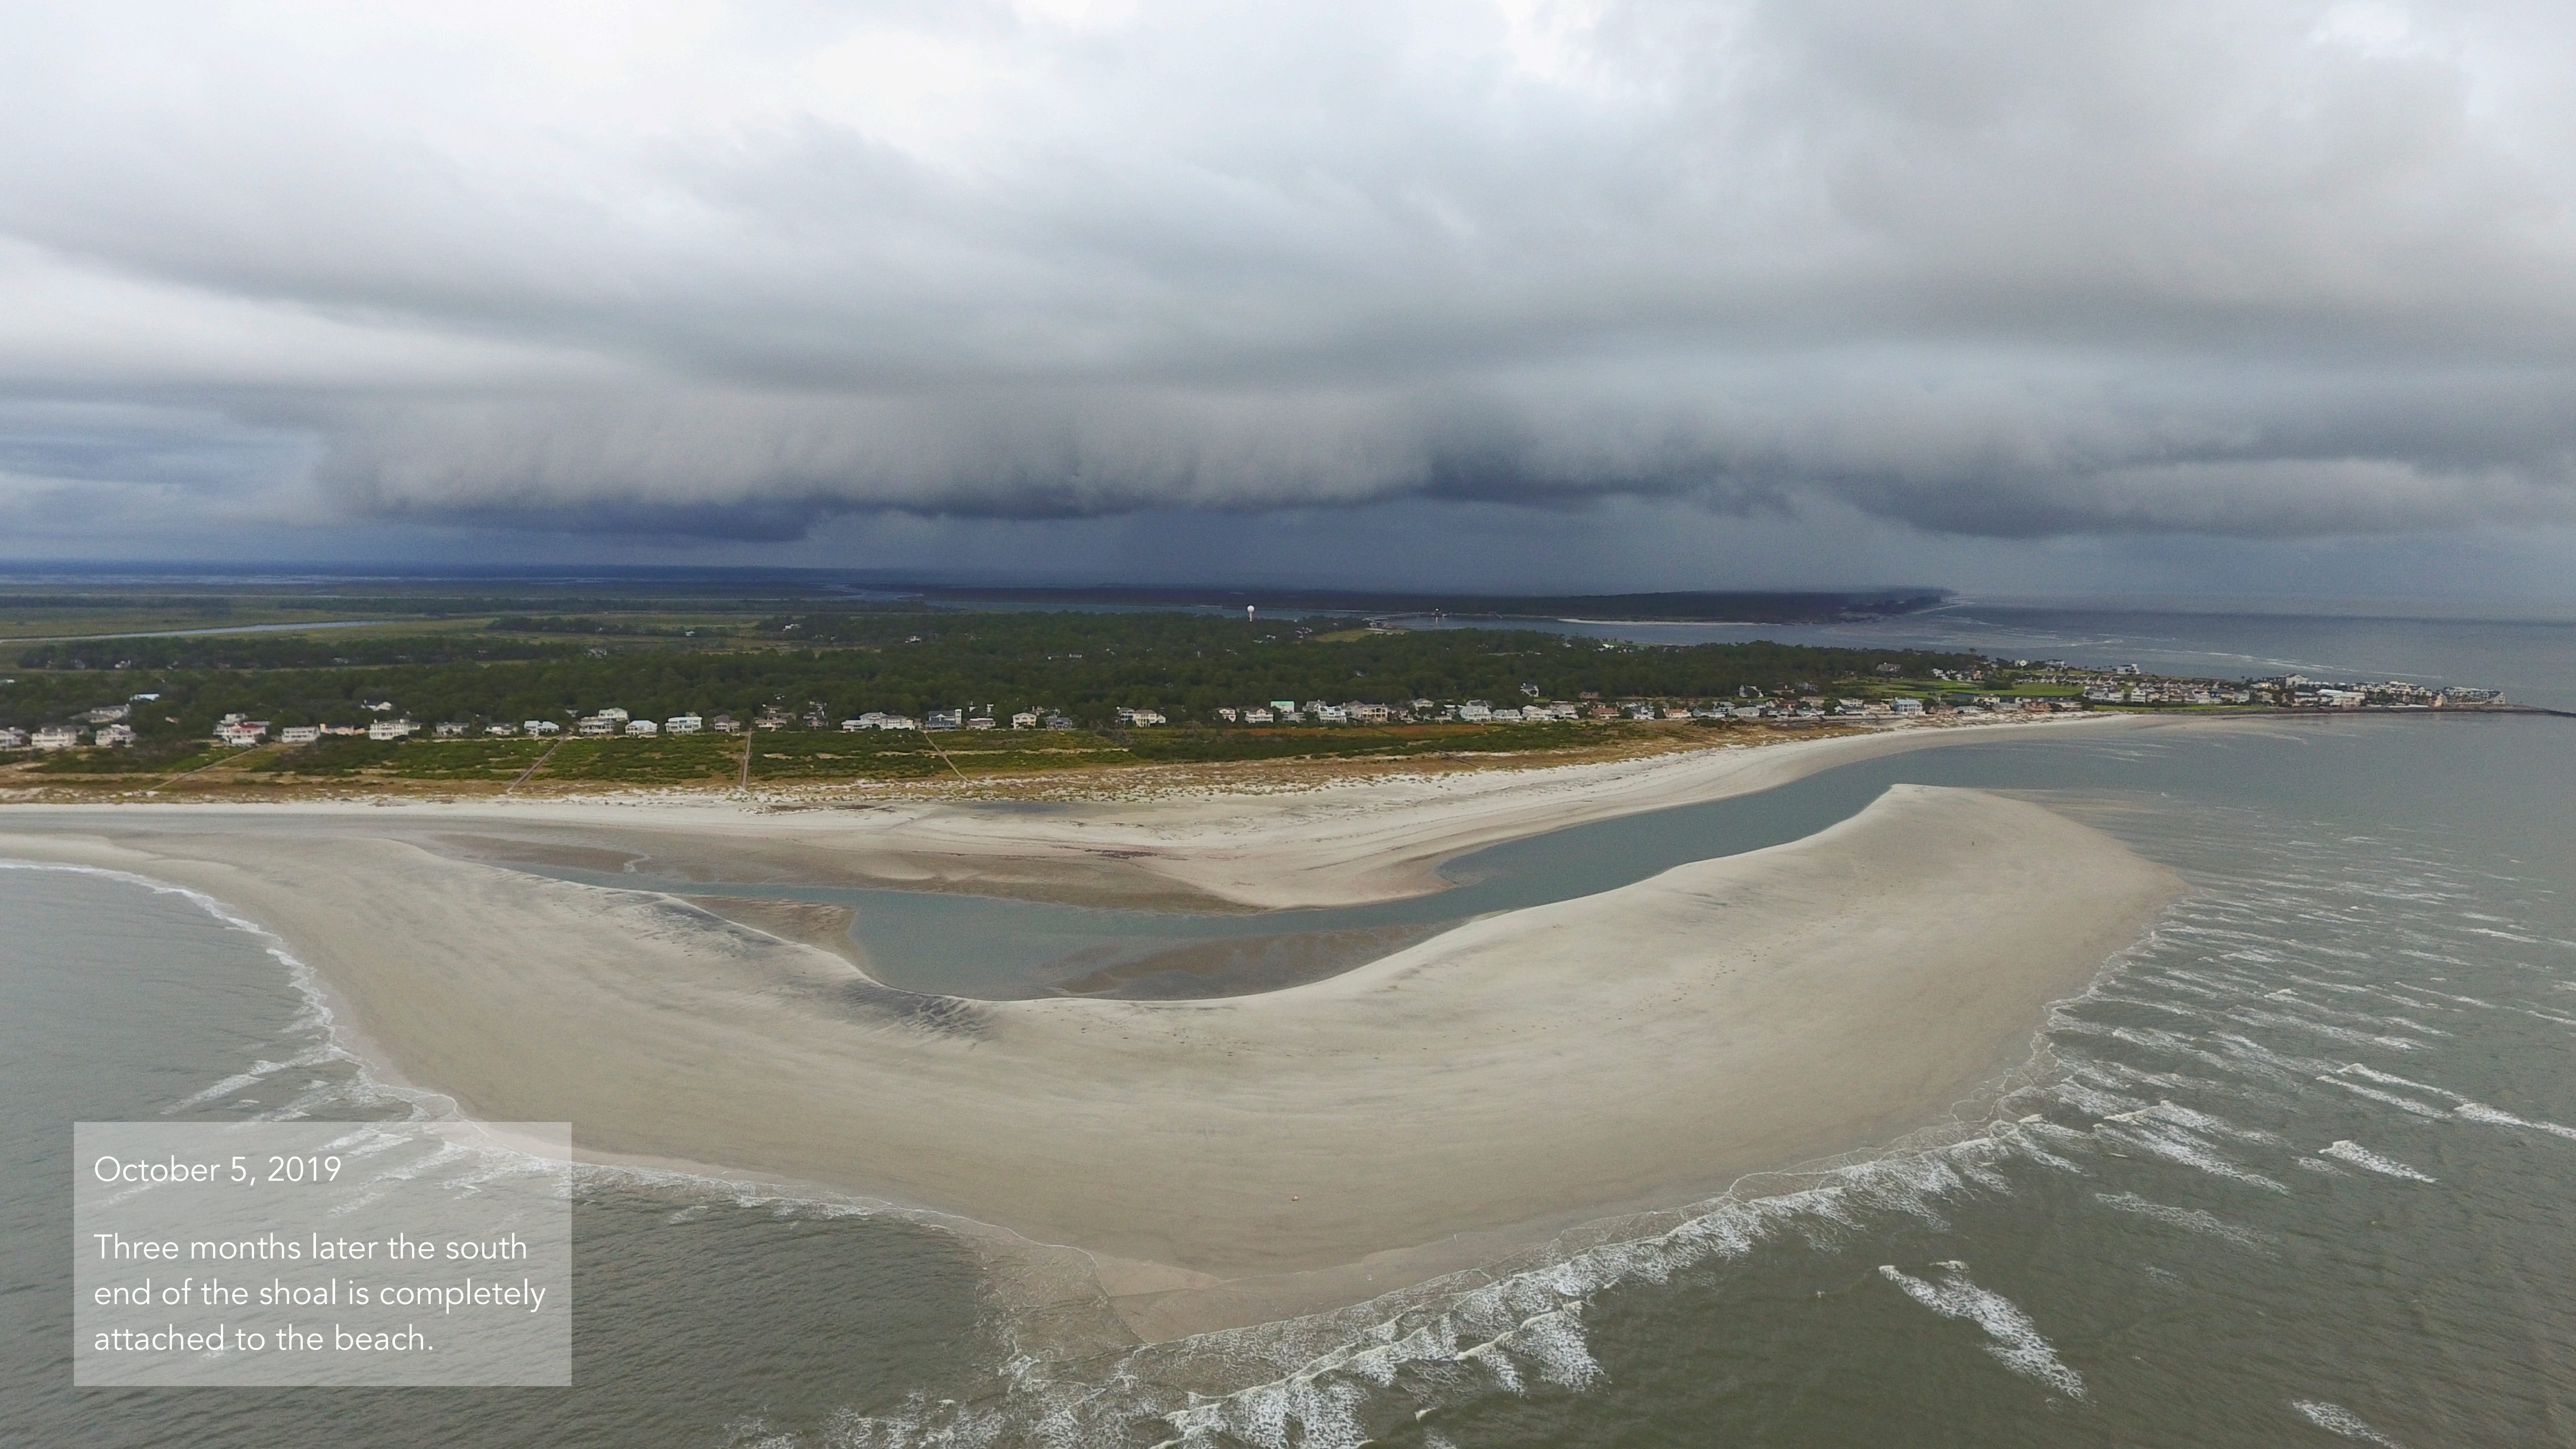
October 5, 2019

Three months later the south end of the shoal is completely attached to the beach.

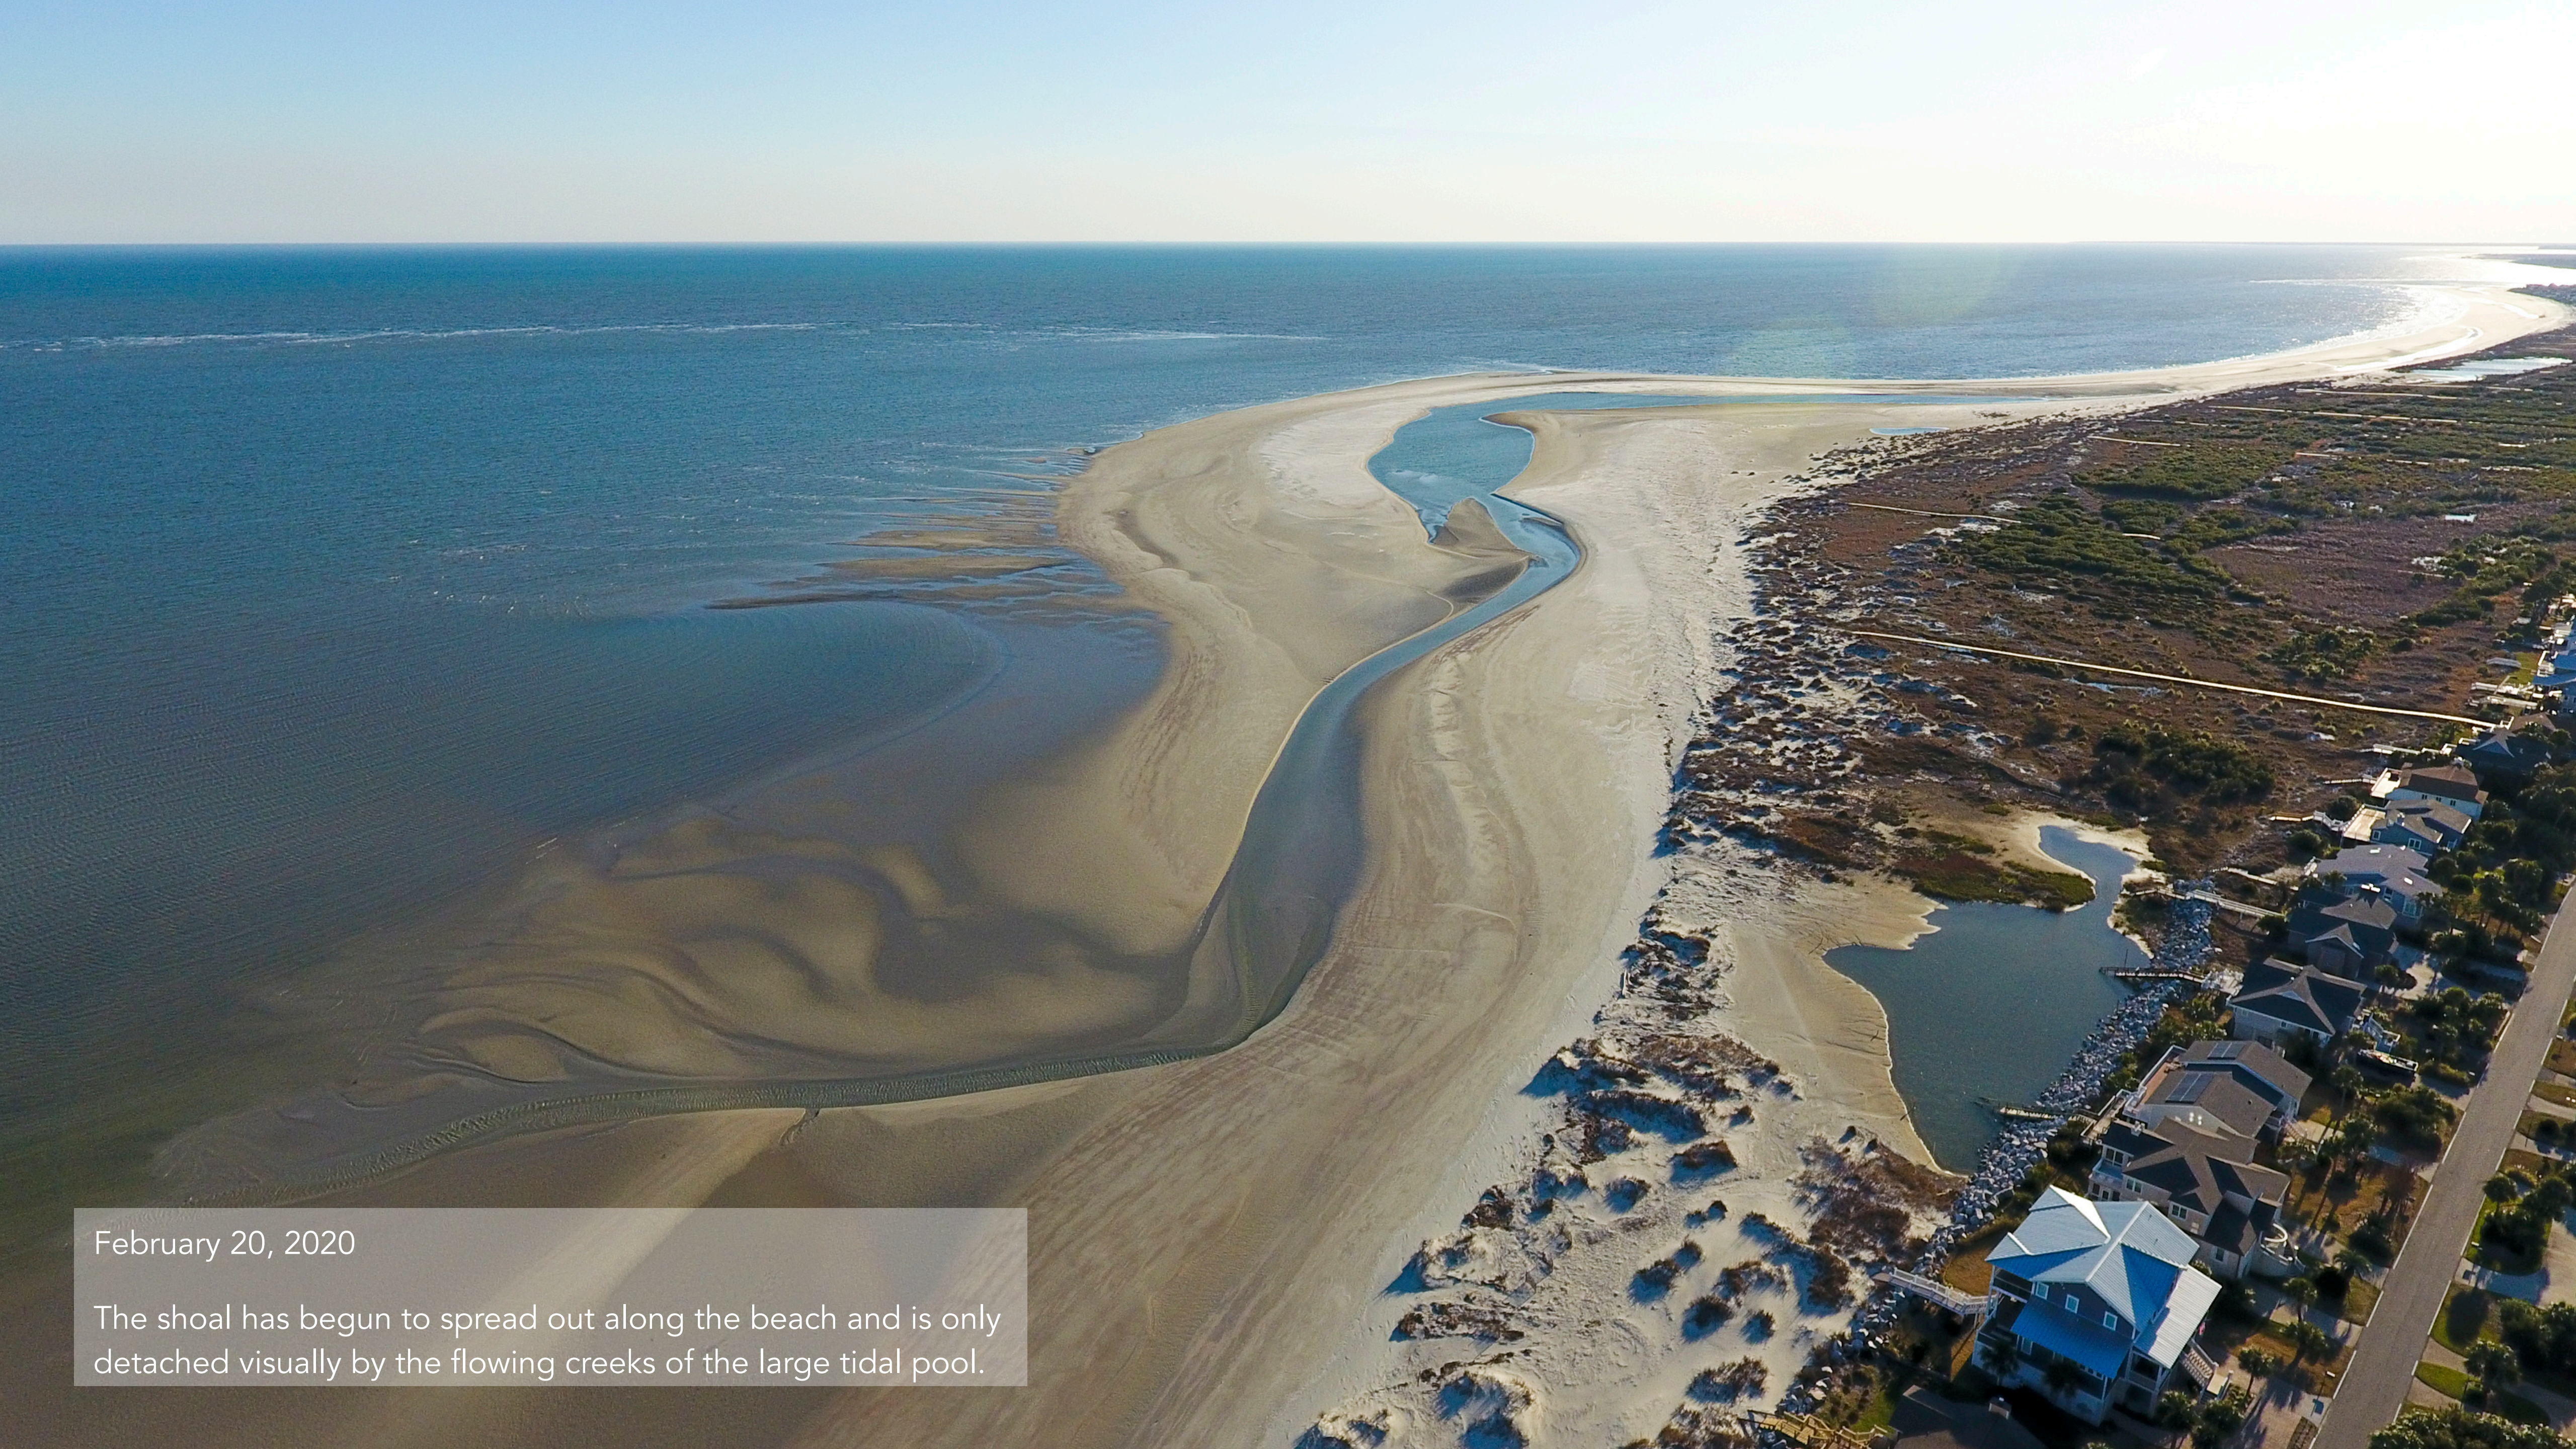
February 20, 2020

The shoal has begun to spread out along the beach and is only detached visually by the flowing creeks of the large tidal pool.

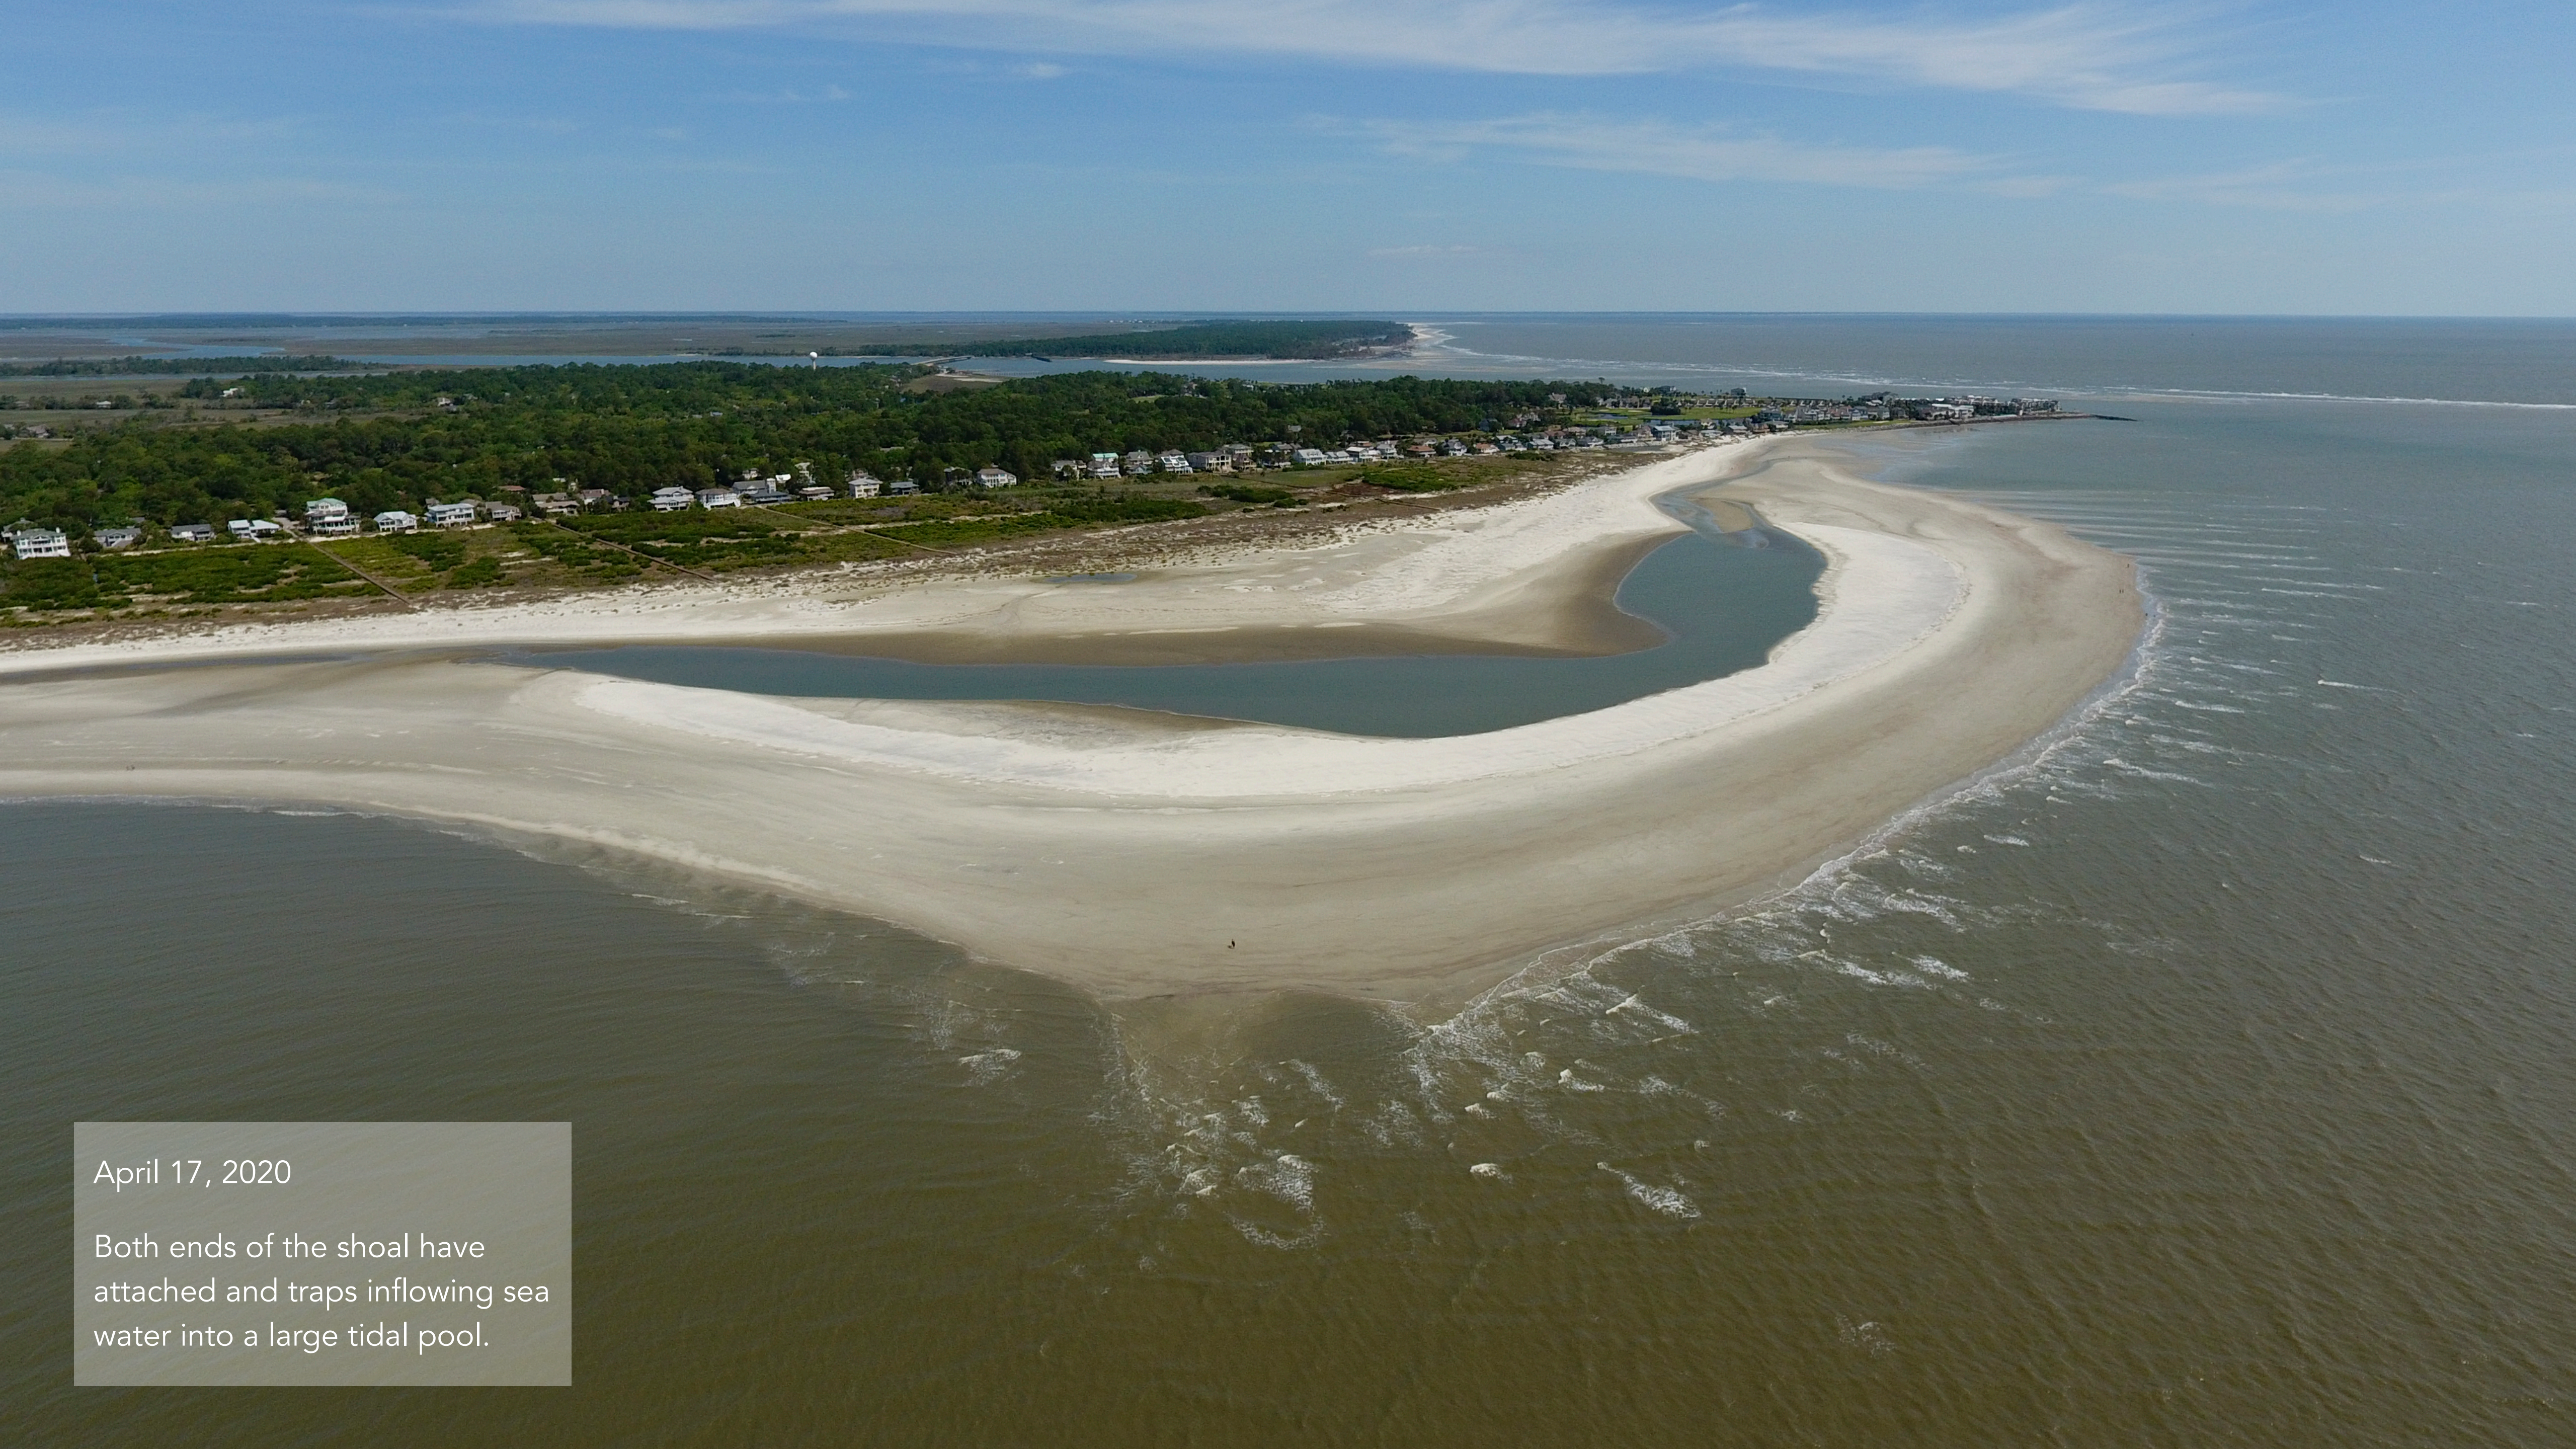
April 17, 2020

Both ends of the shoal have attached and traps inflowing sea water into a large tidal pool.
