# THE SHIFTING SANDS

Photographing the dynamic shoreline around Fripp Island, SC

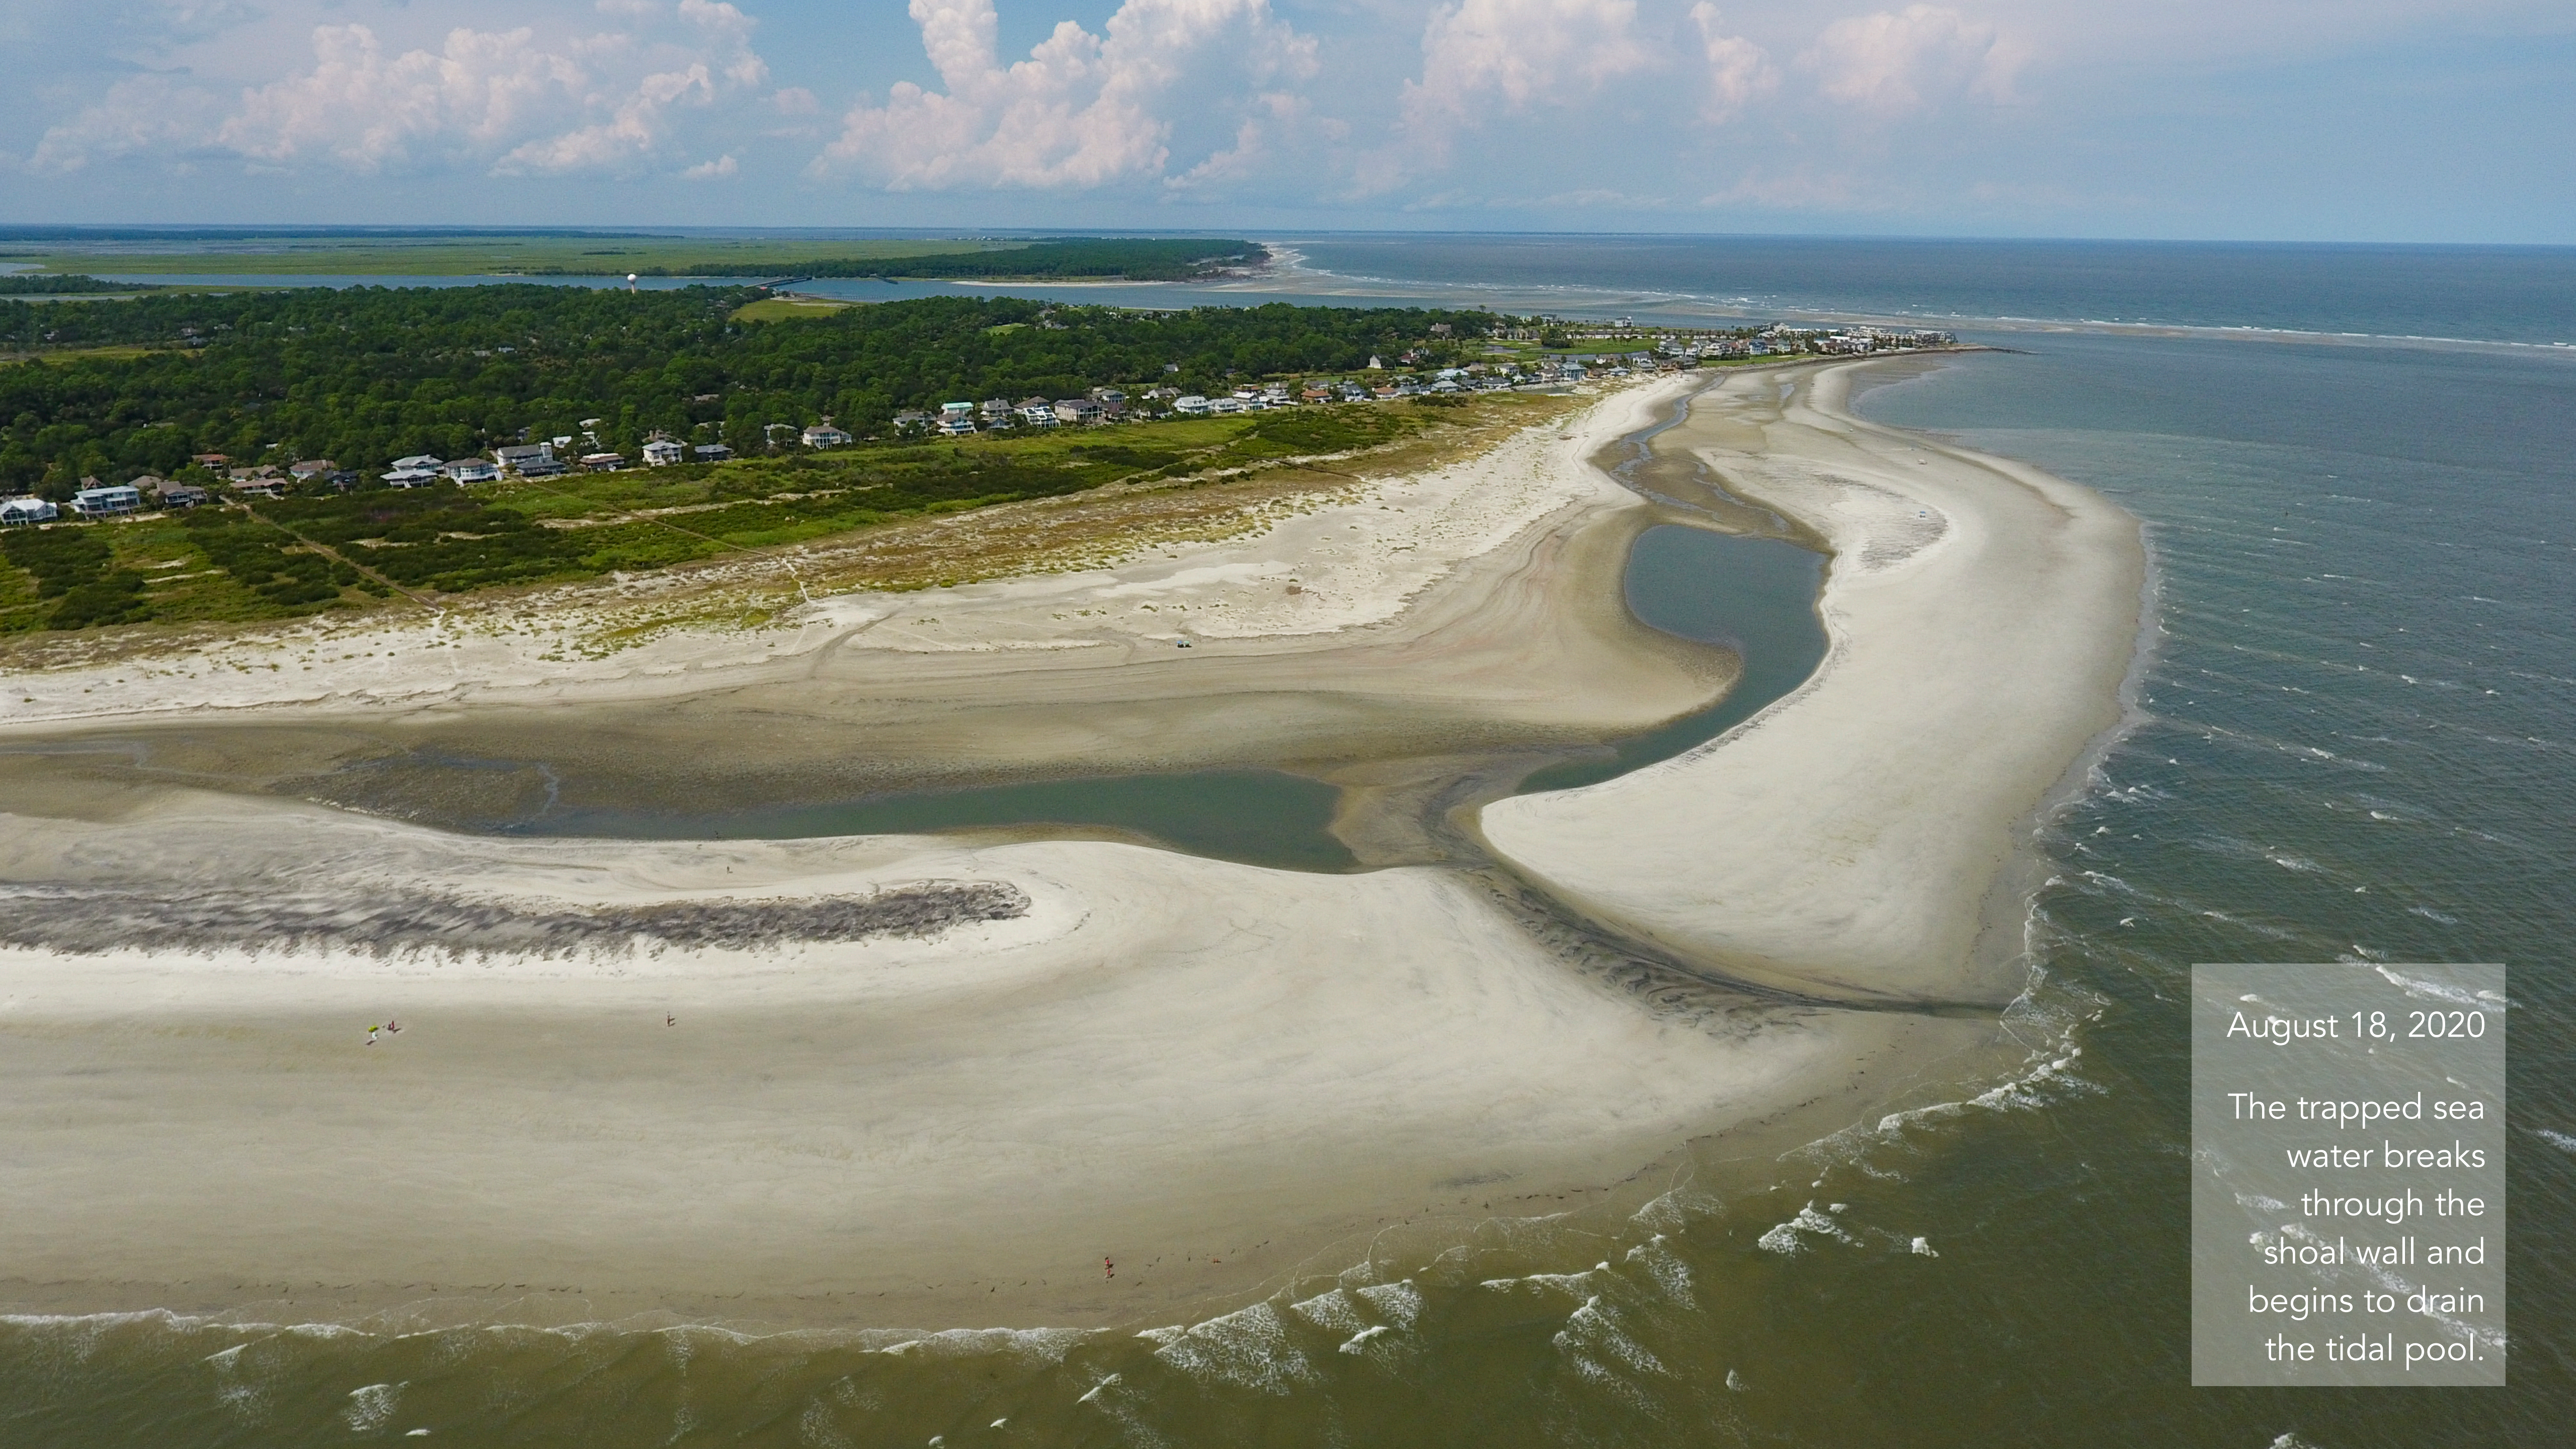
August 18, 2020

The trapped sea water breaks through the shoal wall and begins to drain the tidal pool.

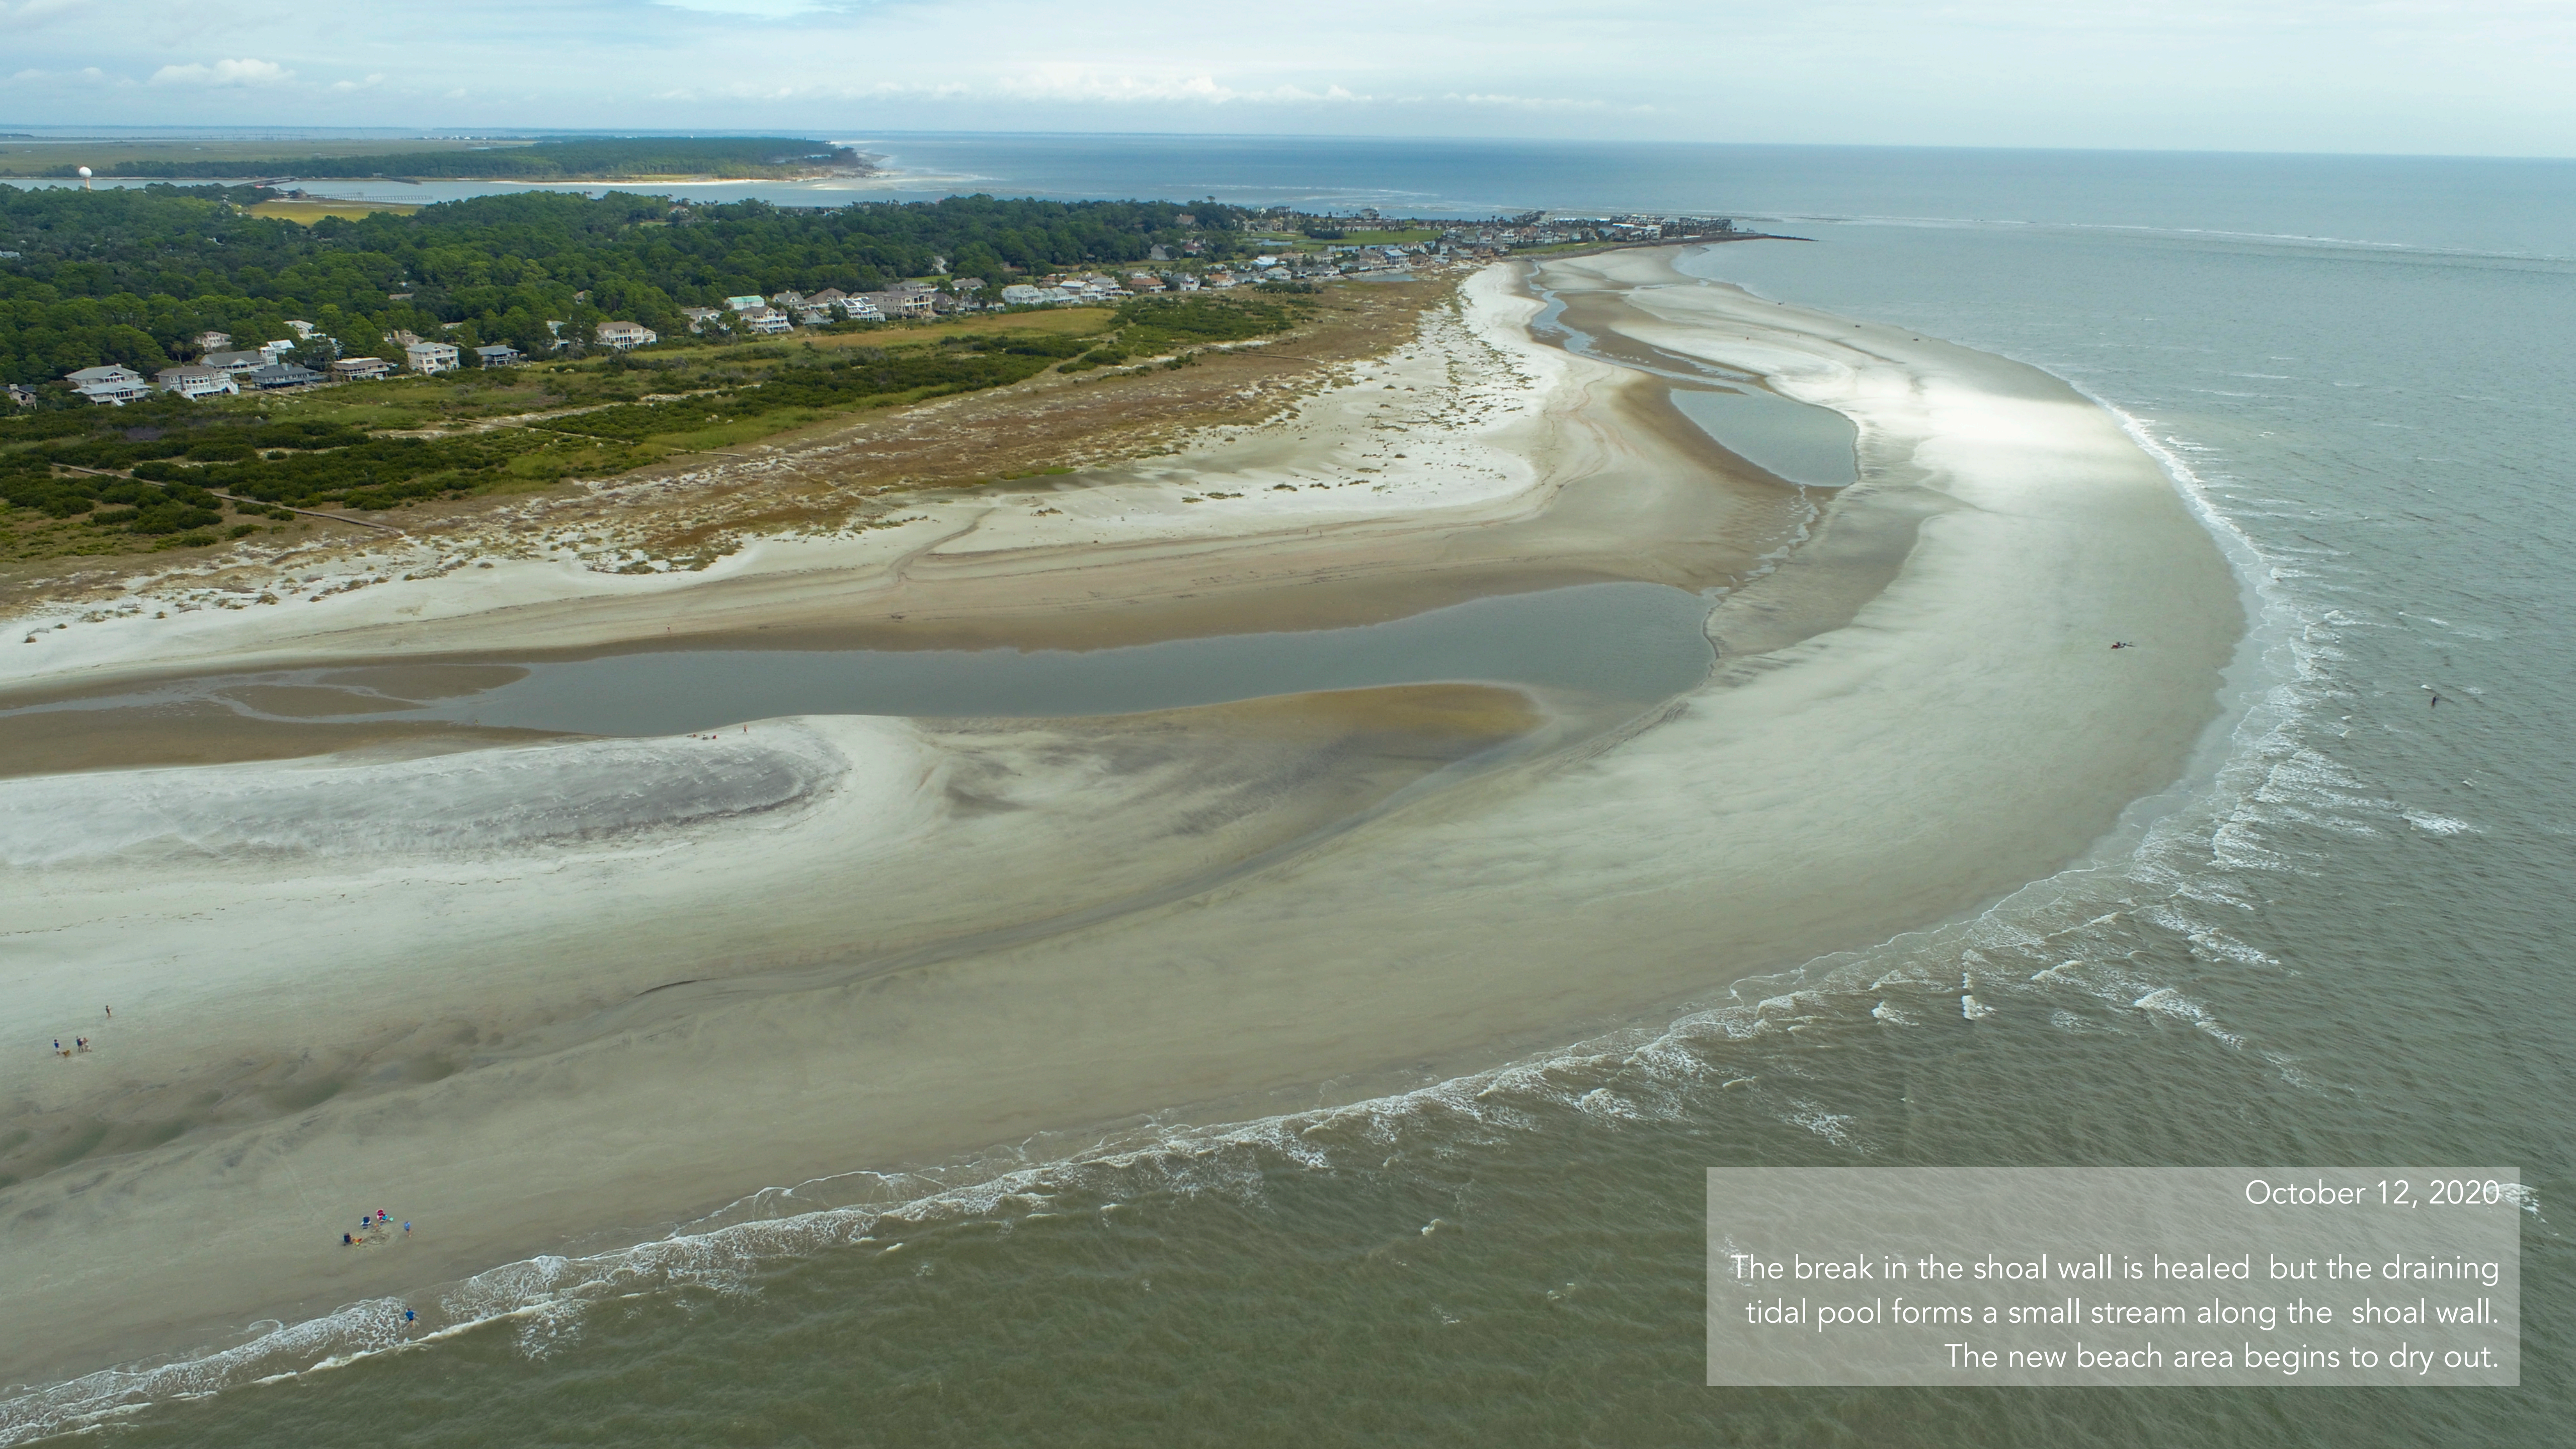
October 12, 2020

The break in the shoal wall is healed but the draining tidal pool forms a small stream along the shoal wall. The new beach area begins to dry out.
